*Massachusetts Coastal Infrastructure
Inventory and Assessment Project
Massachusetts Department of Conservation and Recreation
Office of Waterways*

North Shore - North

Manchester
Beverly
Salem

July 6, 2009

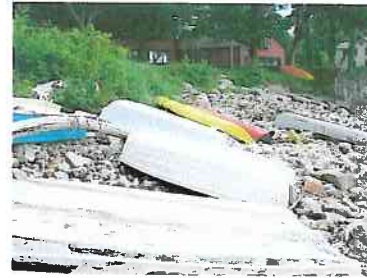
A stone revetment at the top of beach, in fair condition. The toe is unravelled and there is a lawn area behind the revetment.

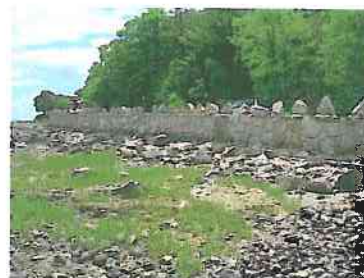
A mortared stone rubble seawall along the road, in fair condition. The concrete toe is exposed in some areas. Some overtopping damage with recent pavement patching is apparent and some missing mortar causing backfill loss.

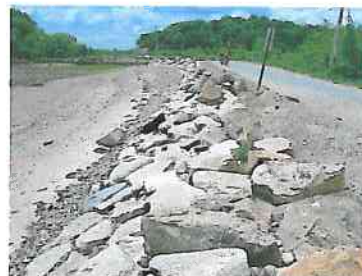
A stone revetment with significant overtopping crest damage, in poor condition, causing reduced protection for the roadway.

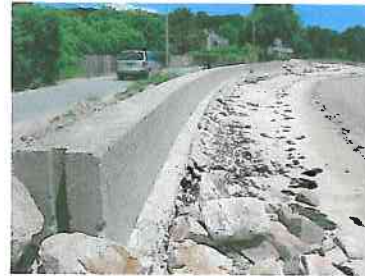
A cast in place concrete seawall with toe stone revetment adjacent to the road that may fail in a storm. There is apparent overtopping with the wall footing exposed. There is an under cut void up to 1.5 feet high at the west end.

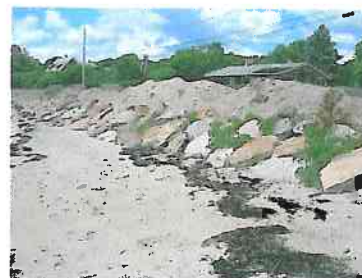
A stone rubble revetment adjacent of the road, in fair condition. There is overtopping damage with dislodged crest stones.

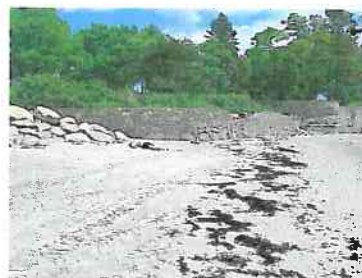
A mortared rubble stone seawall in poor condition. The upper wall failed in 2 locations, approximately 25 linear feet each. There are numerous horizontal cracks to indicate it likely to fail more significantly in another storm. It appears to be a relatively new wall.

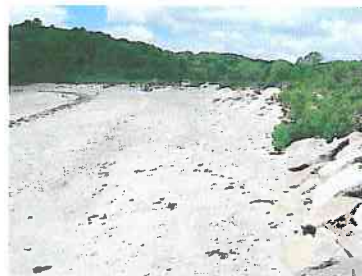
A stone revetment along top of beach with typical overtopping damage. The middle 1/3 of the revetment is totally destroyed and random stones are scattered. Anticipate future damage to the adjacent road unless it is rebuilt.

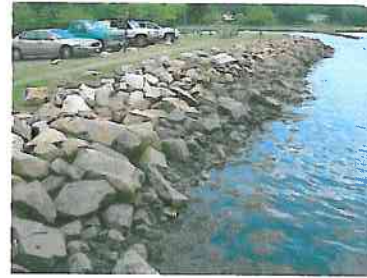
A stone rubble revetment in fair condition at the edge of the park . There is some erosion and crest stone movement.

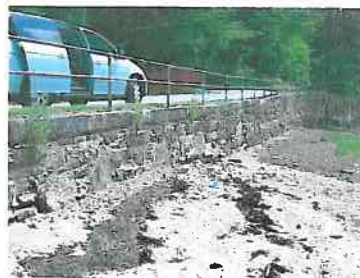
A mortared rubble stone seawall with granite block cap adjacent to the street, in fair condition in a residential area. Some cap stones are loose. There is some mortar loss and one missing toe stone adjacent to the road.

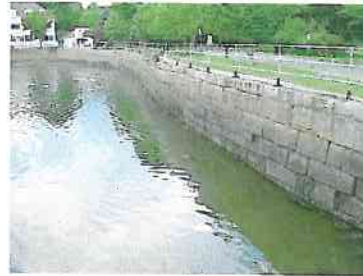
A granite block wall in fair condition at park entrance road. There is differential stone movement, block settling, wall bulges and a slight offshore lean to the wall.

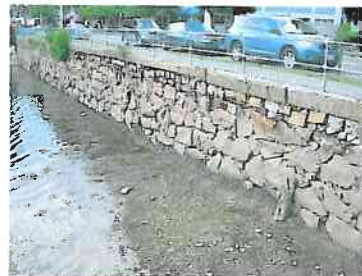
A dry rubble stone wall with granite block cap in satisfactory condition. It is adjacent to Beach Street with two areas of bituminous sidewalk with some slight subsidence.

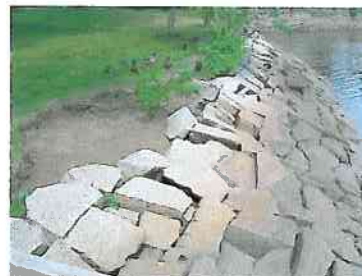
An armor stone revetment in overall fair condition. Some stones have settled locally and there is crest erosion. The armor is set on 1 inch crushed stone which is washing out. There is localized damage in the park lawn area.

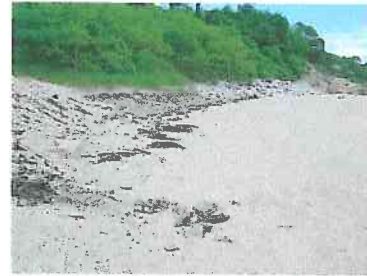
A stone revetment that is failing. It has a single layer of placed stone armor on exposed geogrid over undersized stone underlayer. There is some loss of small underlayer stone which is typical. There are some armorstone subsidence areas due to underlayer loss. It is in poor condition and may fail in a storm.

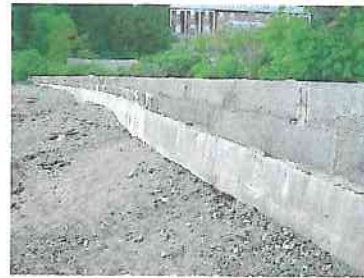
A mortared stone block wall on concrete footing adjacent to a street, in satisfactory condition. There is some mortar loss and some concrete cracking.

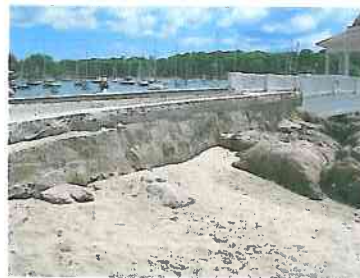
A mortared rubble stone wall with granite cap in fair condition. There are a few areas with missing mortar and the mortar is typically cracked. The wall forms an access to park pier.

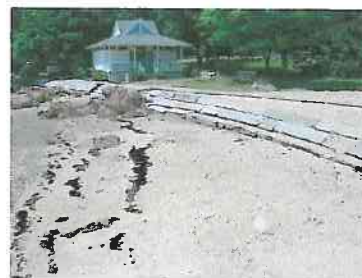
A granite block revetment with toe undercut at west end. There is a void up to 8 inches high under the toe for approximately 10 feet. Overall, it is in fair condition. The park toilet building is nearby.

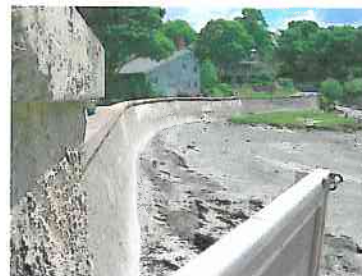
A cast in place concrete seawall adjacent to the road in fair condition. The face of wall is cracked with exposed embedded stones at a few locations. Some repair patching is apparent and this wall may actually be a concrete veneer over stone wall or cyclopean concrete.

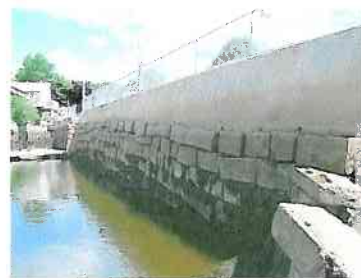
A dry set granite block wall with concrete cap in satisfactory condition. There is minor deteriorating of the concrete cap and some loss of bedding under stone steps, with the steps in poor condition. A police station is approximately 100 feet away.

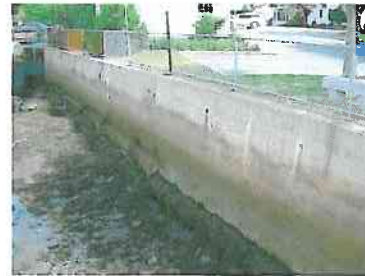
A cast in place concrete seawall in satisfactory condition. There are a few cracks in cap. A police station is approximately 100 feet away.

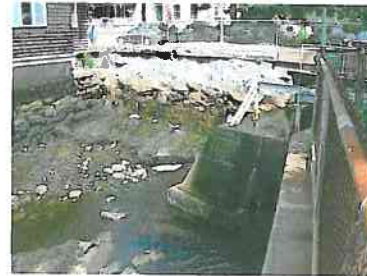
A stone seawall at Central street, skim coated with mortar above high waterand with a granite cap. The wall acts as a stream dam for the adjacent stream and there is seepage between stones. In fair condition.

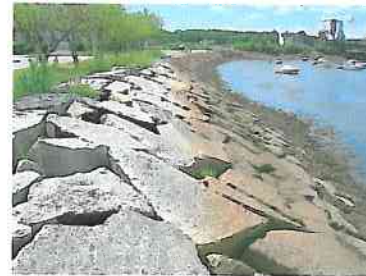
A stone revetment with large stone face parallel with slope in good condition. This structure is adjacent to the wastewater treatment plant.

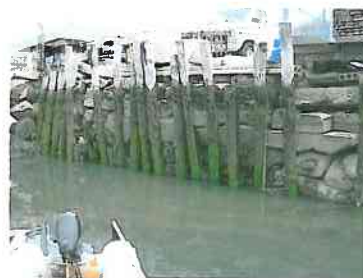
A dry rubble stone wall with timber fender piles in poor condition. The top of the wall is leaning out. There is concrete rubble backfilled and under building, horizontal timbers behind piles and a portion with a mass concrete overlay repair. Sandbags fill a sinkhole at the building, 2 feet by 5 feet, and another sinkhole is filled with crushed stone. The building appears to be on the pile supported pier.

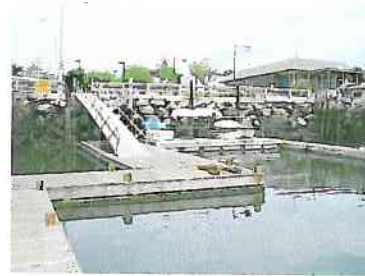
A rubble stone seawall with mortared stone cap in poor condition. The stones appear to be moving with dislodged stones that are loose, typically with no chinking and rounded unstable stones. A parking lot is behind this structure.

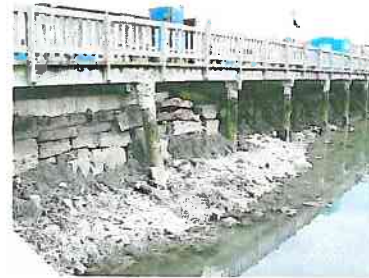
A granite block seawall with concrete cap in satisfactory condition. There are a few fallen blocks (small). There is a sinkhole at the pier abutment 1 foot by 4 feet. The harbormaster office is adjacent to wall, resulting in the high priority rating.

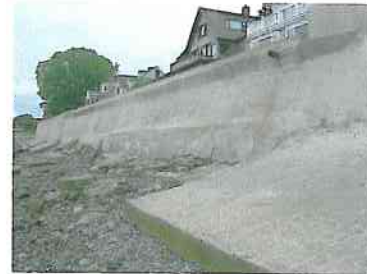
A concrete parged seawall in satisfactory condition overall, but there is exposed rebar at the toe and concrete deterioration. There are several houses near the wall.

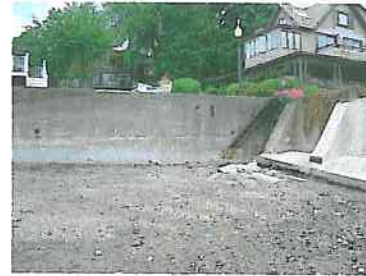
A concrete seawall with wave return face in satisfactory condition. There are several houses near the wall.

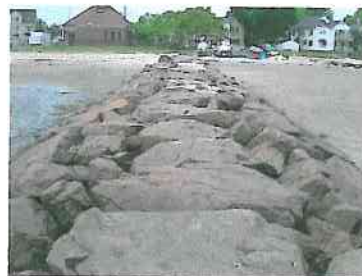
A quarry stone groin over sewer outfall in satisfactory condition, but it is functioning adequately. There are a few smaller dislodged stones along the crest.

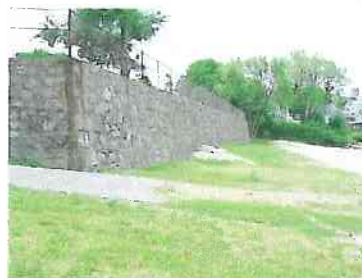
A mortared stone rubble wall above beach in fair condition. There is some localized cracking, one small cap stone missing at stairs, localized missing mortar but no signs of wall movement. This is a high retaining wall with a playground behind.

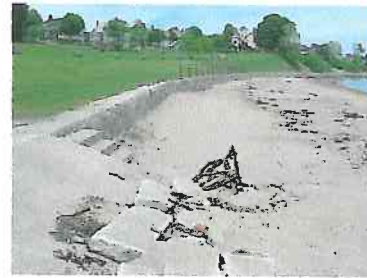
A mortared granite block park seawall in satisfactory condition. The railing is missing along the length of the wall.

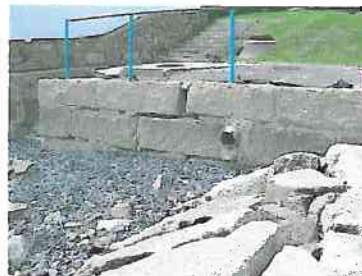
A granite block seawall in fair condition with some missing mortar and chinking. There is a sinkhole behind the wall, 2 feet by 5 feet by 1 foot deep and a house nearby.

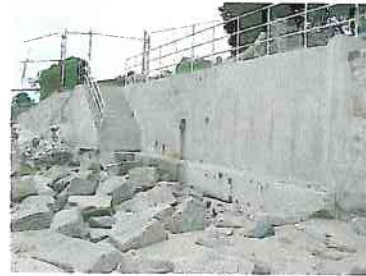
A concrete seawall with footing exposed and undercut in areas. The toe stone is unravelled. The stairs end 3 feet above current beach level, indicating significant sand loss. Fair overall condition with concerns of possible damage or failure due to footing undermining. There are houses in the vicinity.

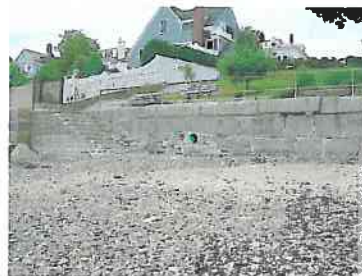
A granite block seawall with mortared joints and some mortar missing; in fair condition. There are houses in the vicinity.

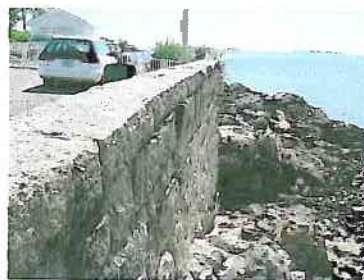
A granite block seawall with dislodged cap blocks at the east end for 6 linear feet. No other signs of distress and it is founded on bedrock. In fair condition.

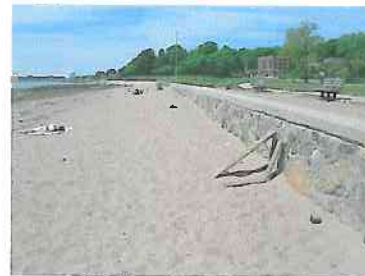
A concrete and stone park seawall (mortared stone with concrete cap) in satisfactory condition. One portion of the seawall is all concrete, some minor cracking cap, some minor spalling at the east end on the cap. A stone toe revetment is adjacent at the west end.

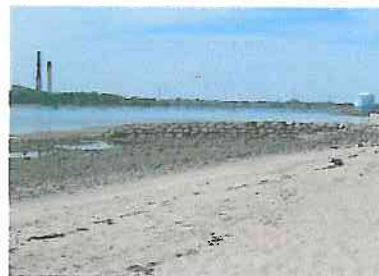
A quarry stone groin in a park setting, in satisfactory condition.*Condition***B***Rating***Good***Level of Action***Minor***Description*

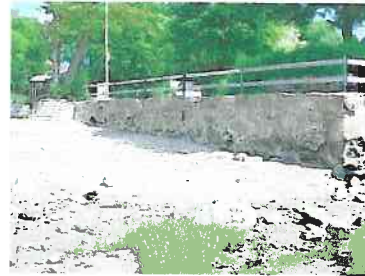
A mortared rubble stone street end wall in fair condition with some cracked mortar, holes in mortar, and one sinkhole behind that is 1 foot by 3 foot by 1.5 feet deep in pavement.

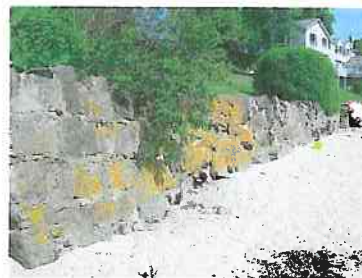
A mortared rubble stone wall with irregular batter, in overall satisfactory condition.

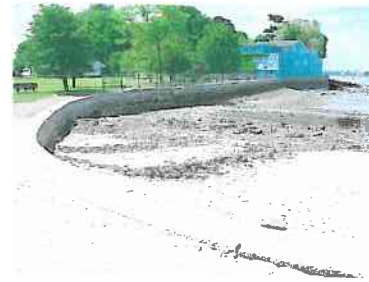
A mortared stone rubble park seawall with granite block cap stones in fair condition. There are some mortar joints cracked, one area with some 12 inch riprap and erosion areas inshore of wall.

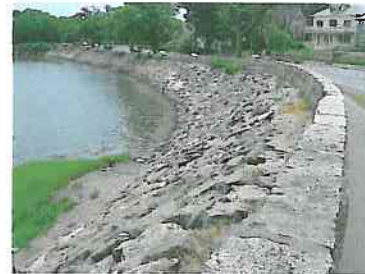
A flat face placed stone revetment parallel to slope, in good condition, but with localized crest erosion at west end. The mortared granite block cap wall has minor mortar loss and cracking. The wall is in satisfactory condition. Adjacent to the main road.

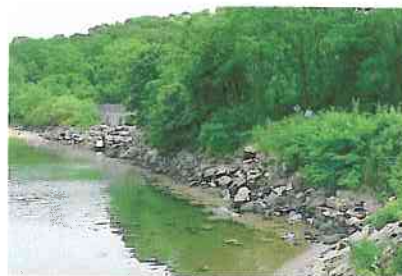
A dumped stone revetment with overgrown tree/shrub covered crest; in satisfactory condition.*Condition***B***Rating***Good***Level of Action***Minor***Description*

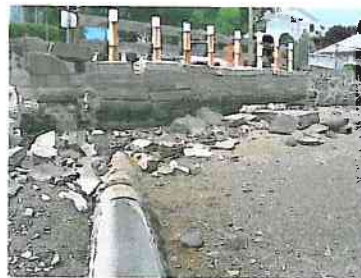
A mortared granite block seawall leaning offshore at the top. A few blocks are dislodged, and sinkholes (5 feet long by 2 feet wide and 2 feet deep) and (3 feet long by 1 foot wide and 1 foot deep) are visible. It may fail in a major storm event. A large sewer main passes under wall. In fair condition.

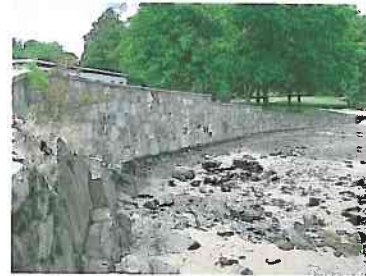
A mortared rubble stone seawall that is undercut and likely to fail soon on the south side. It is in the park with lawn and is a low priority risk.

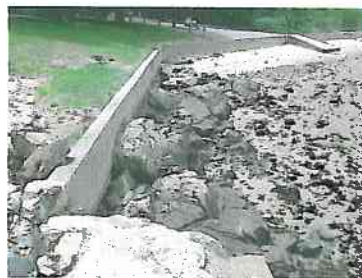
A cast in place concrete seawall with toe undercut at the east end. A section of wall is broken and leaning offshore, approximately 40 linear feet long, with other sections also leaning offshore. This is a park area.

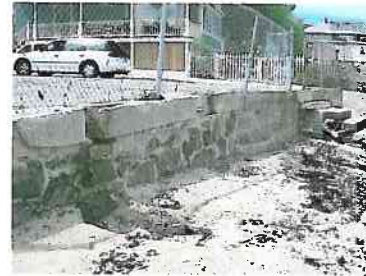
A mortared granite block seawall above the beach. Some mortar is cracked and missing, and a stone dislodged. It is in fair condition. At a street end with some houses in the vicinity.
