***South Shore Coastal Infrastructure Inventory
and Assessment Demonstration Project
Coastal Hazards Commission***

Town of Marshfield

Prepared for:
Office of Coastal Zone Management
Boston, MA

Presented by:
Bourne Consulting Engineering
Franklin, Massachusetts

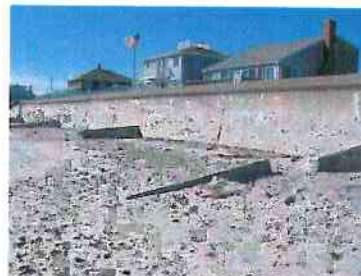
This is a concrete seawall with slab, concrete abutments perpendicular to the wall at approximately 50 foot spacing. There is severe cracking and spalling throughout the crest and face of the wall. Large areas of surface repair are evident along the crest and face. White discoloration and staining is evident along the face of the wall for much of its length.

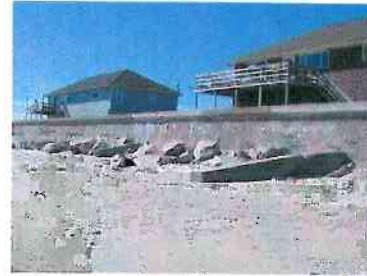
This structure is continuation of the adjacent struture, but now has riprap along the toe. This concrete seawall also exhibits major cracking, spalling and deterioration. The crest has been repaired for most of the length however major issues remain with the face of the wall.

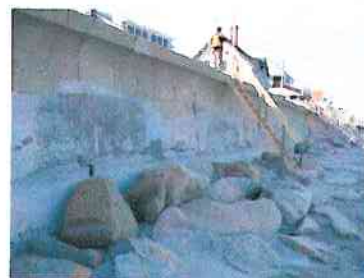
This structure is a concrete seawall with a toe wall and rip rap along the front. There is significant cracking and spalling along the base of the wall, above the toe wall.

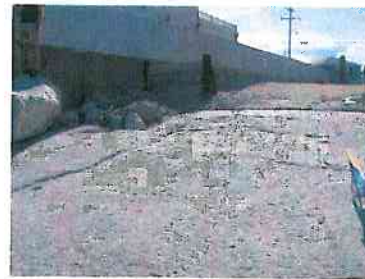
This structure is a concrete access ramp to the beach. There is major cracking in places, some of which has been repaired with grout.

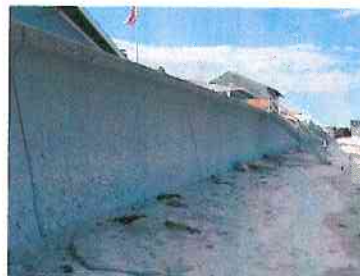
This structure is a concrete seawall with a concrete toe wall with rip rap along the front. There is cracking and spalling evident especially along the wall crest.

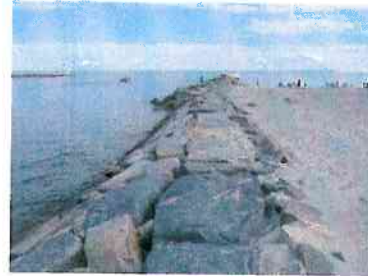
This structure is a stone jetty along the south of the entrance to Green Harbor. There are some sections of armor stone which have come unraveled. There is a large failed section along the trunk which prevents safe access to the jetty head.

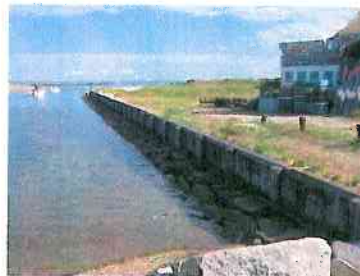
This structure is a timber bulkhead with a stone revetment along the base. Some boards along the crest of the wall are split and cracked. Sections of some boards are missing completely. Some of the bolts in the wall are also missing. The revetment exhibits some minor slumping but is generally in good condition.

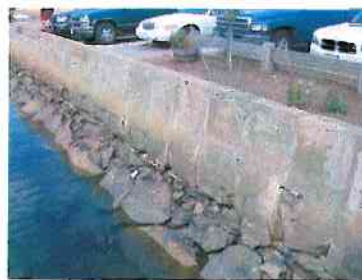
This structure is a concrete seawall with stone revetment serving as a foundation. This wall lies behind the main wooden pier. The wall shows significant cracking and spalling especially along the toe where the concrete and stone meet.

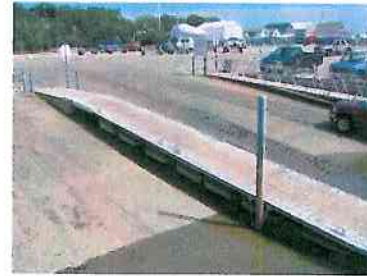
This structure is the concrete town boat ramp. The ramp and sidewalls show minor weathering and are generally in good condition.

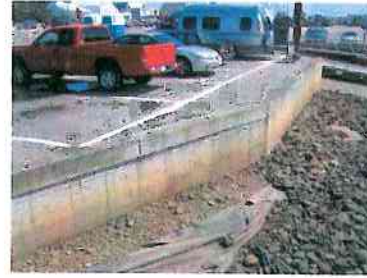
This structure is a small concrete seawall topped with timber wale. This wall lies behind the main pier. There is minor spalling evident.

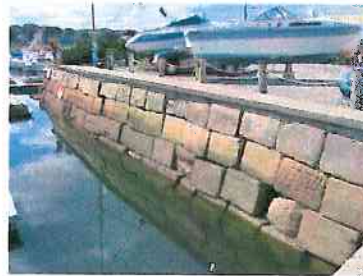
This structure is a seawall constructed of stacked concrete blocks. The blocks along the water line show spalling and erosion. Some blocks appear to have shifted and become displaced.

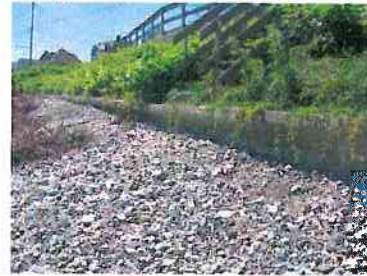
Concrete seawall fronted by cobble beach. There is cracking and spalling and some stone missing from the crest. Toe is buried. There is some stones above the crest. The crest is covered with vegetation.

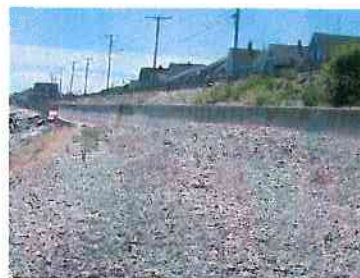
This structure is a concrete seawall fronted by a cobbly beach. The north end of the wall is covered to the crest by the beach while the south end has no fronting beach and the toe of the wall is exposed. There is cracking and spalling along the wall and the base of the wall is eroded. The south end of the wall would benefit from a cobbly nourishment.

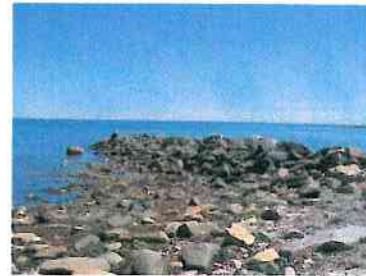
This is a short stone groin. The sideslopes along the base are coming unraveled. Otherwise the structure is in fair condition.

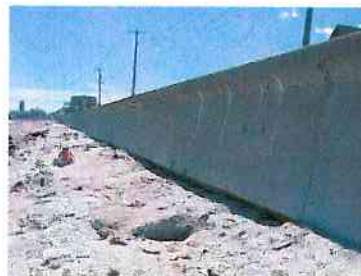
This structure is a concrete seawall. There is grouted armor stone along the base of the wall. The exhibits only minor cracking and is generally in good physical condition. However, the toe of the wall is becoming exposed along a large section.

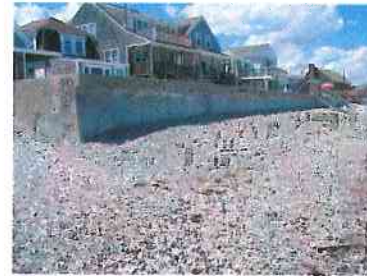
The structure is a concrete seawall fronted by a cobble beach. There is cracking and spalling evident and some large cracks which have been sealed. The toe is well buried.

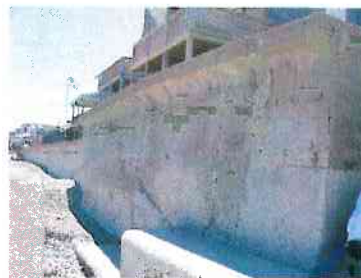
This structure is a concrete seawall with a wave return face. There is major cracking and some spalling along the face. Previous repairs are evident.

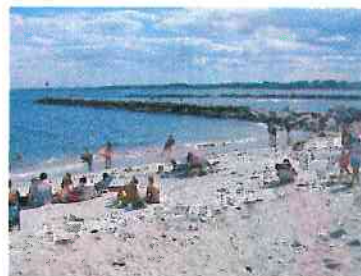
This structure is a stone jetty which is along the north side of the inlet to Green Harbor. The armor stone is slumped and unraveled along the base of the jetty. There are at least two large areas along the jetty trunk which are slumped and failing. The head of the jetty is in fair condition.

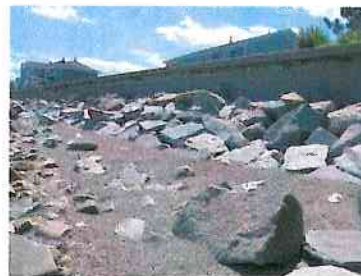
This structure is a concrete seawall with a wave return face. There is a stone revetment along the toe. There is spalling and cracking for the length of the structure. Some sections show severe cracking and major areas of repairs.

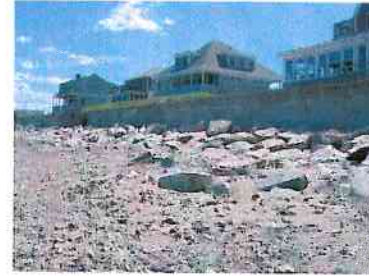
This structure is a concrete seawall with a fronting toe revetment. There is surface spalling and cracking throughout.

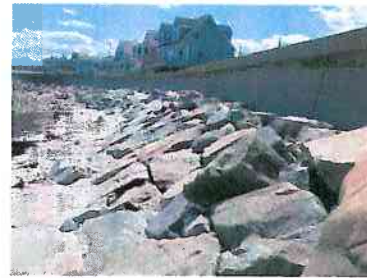
This structure is a concrete seawall with a wave return face. There is armor stone placed along the toe of the wall. The wall exhibits some cracking and spalling. The foundation is visible in some southern sections but is not undermined.

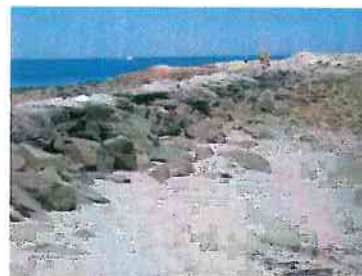
This structure is a stone groin with the outer portion surrounded by a natural rock outcropping. The sideslopes and crest are in good condition with only minor weathering of the armor stone.

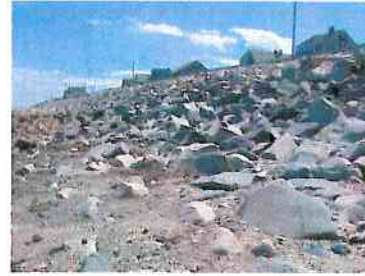
This structure is a rubble mound revetment. The armor stone has shifted along much of the structure and some stones are broken. There are no areas of major failure.
