**Massachusetts Probation Service  
Training and Operations Center  
Clinton, MA**

**HVAC SYSTEM  
EVALUATIONS  
COVID-19**

Office of Court Management  
June 14, 2022

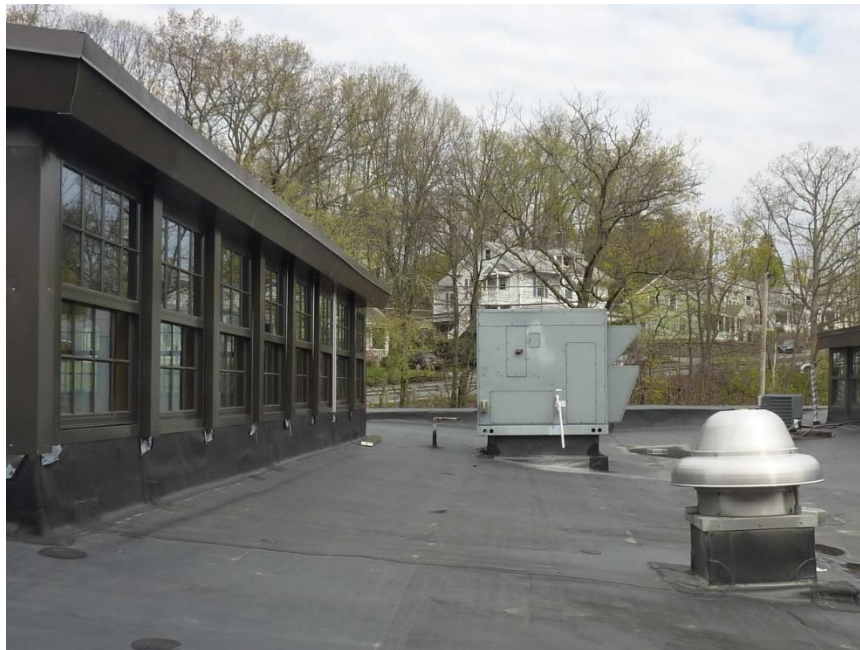
Photo 1 – Representative Rooftop Unit (RTU-1, note gas supply not connected)

These units were existing prior to the 2019 renovation and appear to be 10-15 years old. We were unable to access these units for a better inspection, to determine whether they were running, and if the outdoor air dampers are operational. One RTU, which serves the single-story training department, does not have its gas heat connected. This area of the building was heated this winter by portable electric resistance heaters. There are 10 RTUs on the roof, but two have no distribution ductwork on the plans and are most likely serving areas on the lower level that are not leased by the Trial Courts.

Light commercial-grade packaged rooftop units have a life expectancy of 10-15 years. These units were existing prior to the 2019 renovation and appear to be at the end of their service lives. This is based on a visual assessment from a distance, as we were unable to access the roof for a better inspection. Consider replacing these units in the next 1-2 years.

True VAV units that have variable-speed fans and air-source heat pumps could provide significant energy savings, a significant reduction in noise, increased comfort, and use MERV-13 filters. The replacement units should be specified with capacities sufficient to handle the proper amount of ventilation air for all spaces, under full occupancy.

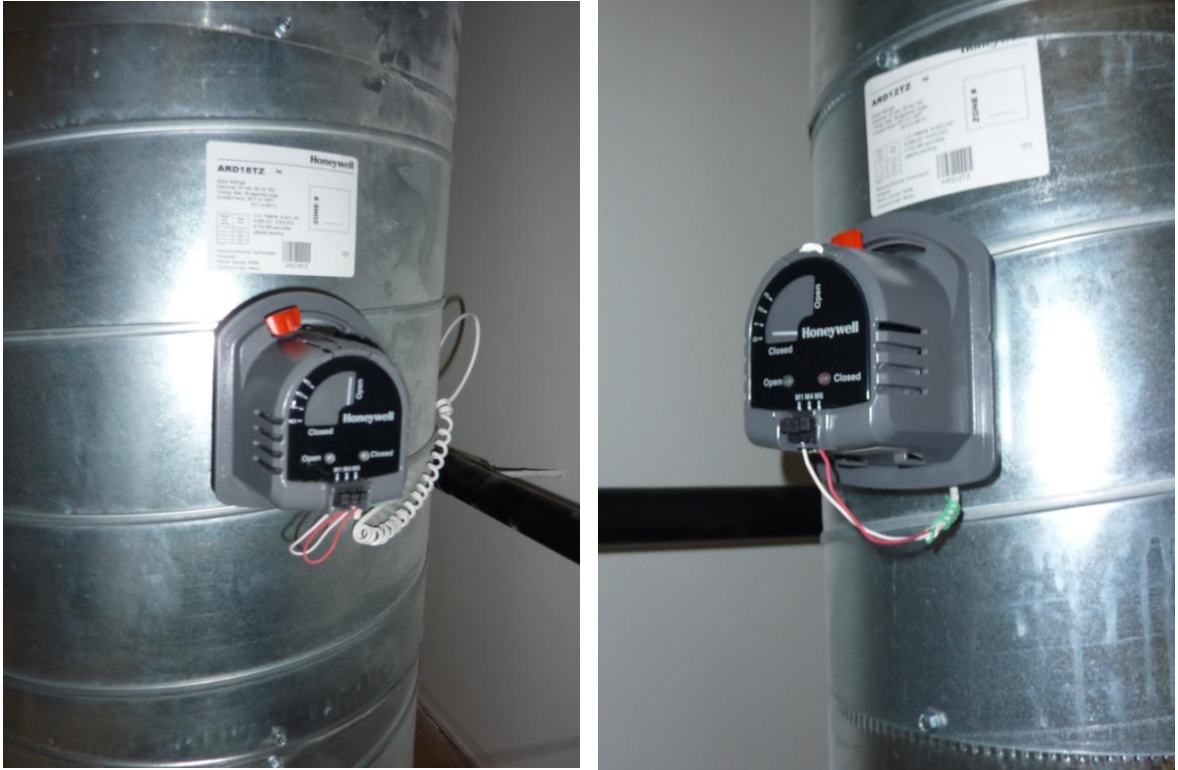
Photo 3 – Zone Dampers in Fully Open and Fully Closed Positions

We recommend setting the minimum positions for all zone dampers based on required ventilation rates. The controls appear to be presently set up to close zone dampers fully when space temperatures are satisfied, which also cuts off ventilation air to the spaces. We based our ventilation calculations on minimum zone damper positions of 50% for classrooms, conference rooms, and break rooms, and 40% for offices and other areas. Minimum zone damper positions were not specified on the design documents.

**RE-4:** *Inspect zone dampers, bypass dampers, and controllers.*

Zone dampers regulate the supply air delivered to each space, and bypass dampers regulate the supply air short-circuited to the return duct when zone temperatures are satisfied. At a minimum, we recommend cycling the damper positions and testing the airflow to verify the maximum and minimum airflow rates are being delivered as designed. Any dampers not delivering the expected airflow rates should be rebalanced or replaced.

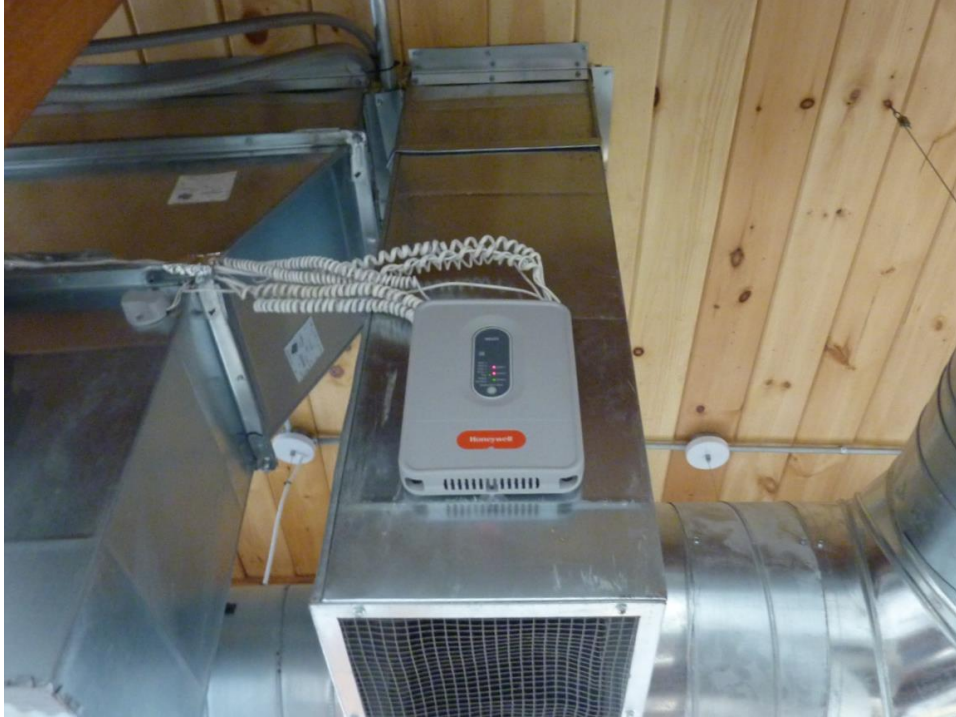
Each RTU is controlled by Honeywell TrueZONE bypass VAV system, which consists of a zoning panel, thermostats, zone dampers, a pressure relief damper, and a discharge air temperature sensor. It is a simple, low-cost system usually used for residential or light commercial applications.

Photo 4 – Bypass VAV System Controller

We recommend replacing the existing residential/light commercial controls with a Building Management System to control and monitor HVAC equipment. This recommendation is an energy saving and maintenance measure and does may affect the indoor air quality of the building.

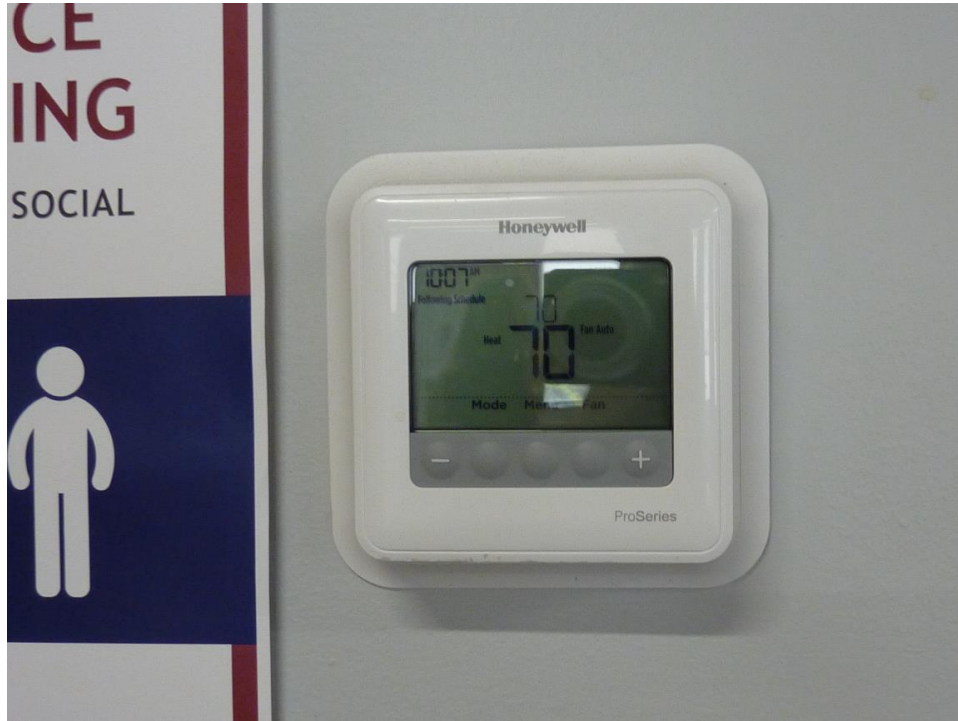
Zone thermostats control temperature setpoints, fan operation, and unit start/stop with seven-day schedules. We noted all thermostats had the fan set to “auto” mode, which shuts down the supply fan and mechanical ventilation when space temperatures are satisfied. MTOC personnel noted that schedules have been overridden for occupied mode 24/7.

Photo 5 – Representative Zone Thermostat

All units were set to run the fan in "auto" mode, which runs the supply fan only when the unit is actively heating or cooling. This should be changed on each of the systems to run the supply fans continuously in occupied mode, to supply ventilation air to the spaces. Note that this may cause comfort issues because supply air temperature can fluctuate as the heating or cooling is staged on and off, and the systems may not have been designed to operate like this originally.
