APPENDIX C:
BUILDING CONDITIONS SURVEY

DCR Building Conditions Survey & Assessment for: Gate Lodge at Maudslay State Park Newburyport, MA

DCR BUILDING CONDITIONS SURVEY & ASSESSMENT
for
Gate Lodge at Maudslay State Park
Newburyport, MA

January, 2016

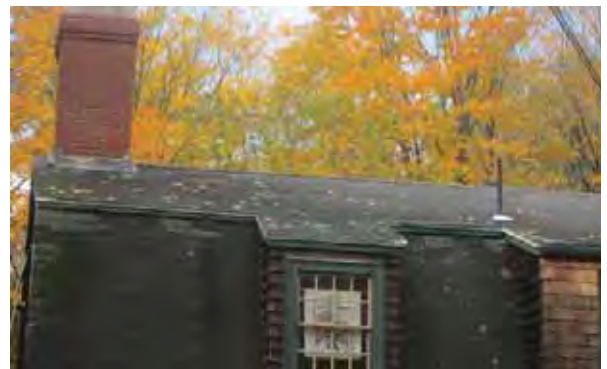
The main roof of the house, including the roof over the attached shed consists of 2x8 wood rafters (true 2" width) 16 inches on center with 3/4 inch wood sheathing covered with asphalt shingle roofing (#14). The structural members are in good condition; the asphalt shingles are in fair condition. While immediate replacement does not appear necessary, the age of the current roofing is unknown and replacement should be planned for as a long term maintenance item. Currently, there are loose or missing shingles visible under the wood trim at the breakline of the gambrel which should be replaced. The wood trim at that breakline also appears to be deteriorating and should be replaced (#13).

Image #13: Missing asphalt shingles at gambrel breakline, deteriorating trim

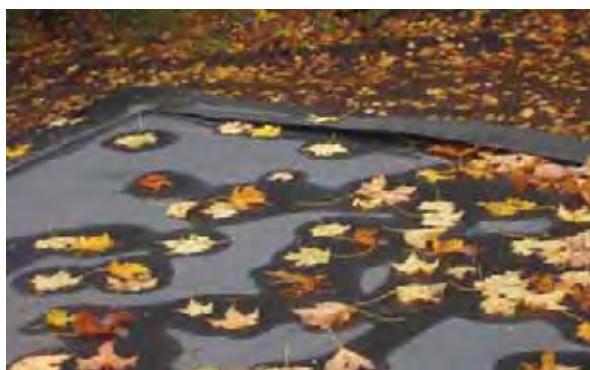
The framing of the front porch roof was not visible during the assessment. The membrane roofing on the porch is in poor condition and has failed in several locations along the eave allowing

water into the roof sheathing and framing (#17). It can be assumed that the framing and sheathing have been damaged by the water infiltration. As noted in later sections, it is recommended that the entire porch structure be replaced. When the porch is replaced, new membrane roofing is recommended.

Image #17: Failing membrane roofing on porch

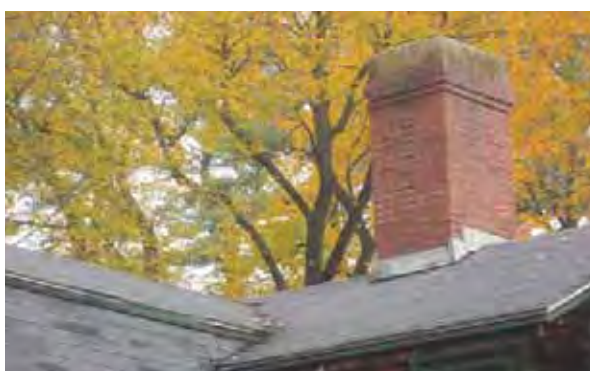
There are two brick chimneys in the house (#18). Both appear to be in good condition. The permittee replaced the south chimney in 2014. His report states that at that time, the masons confirmed that the chimney below the roof line was in good condition and they inserted a steel flue liner to make the chimney functioning for a new wood fireplace insert in the living room.

Image #18: Chimney & flashing

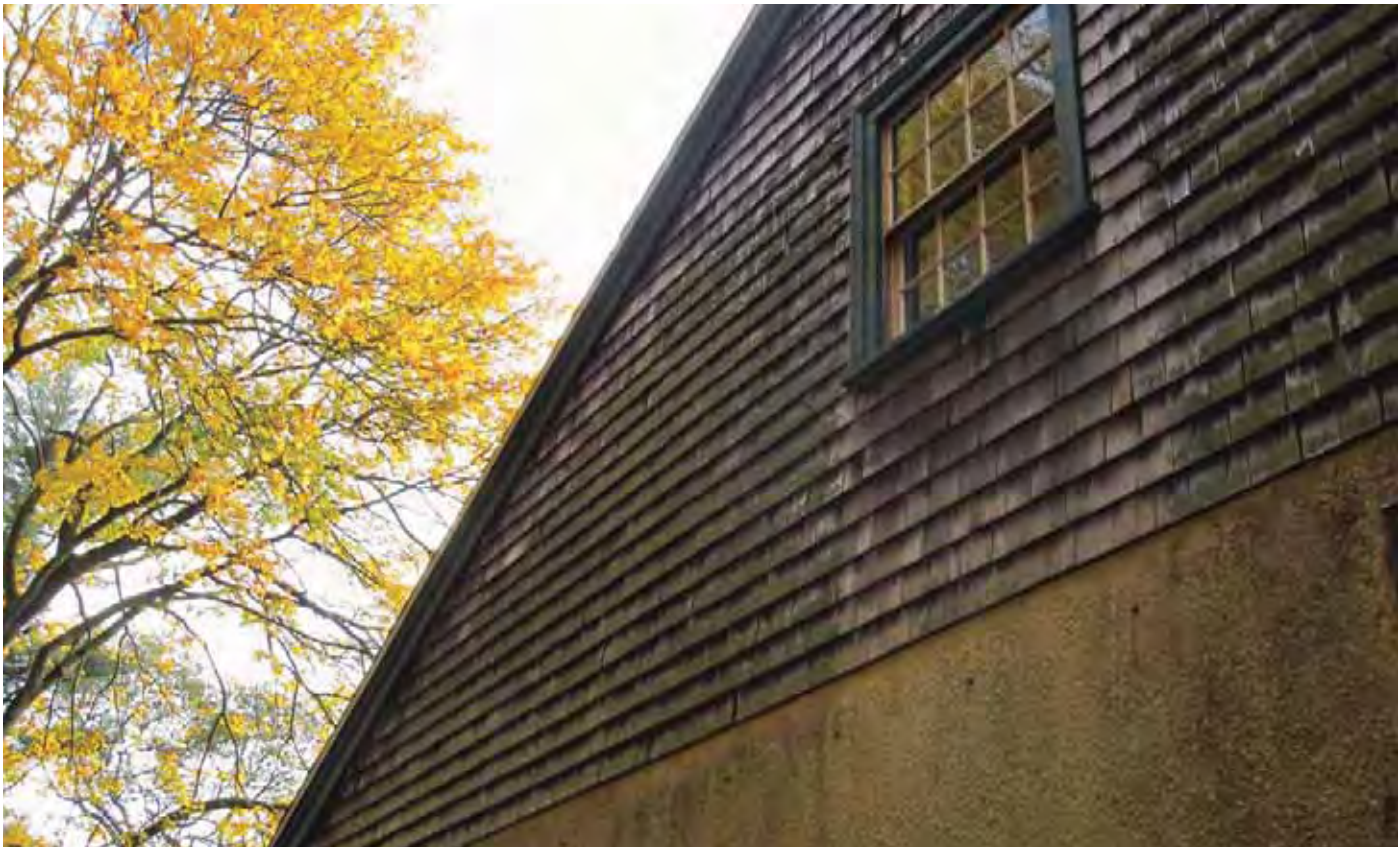
Image #21: Stained shingles on north elevation

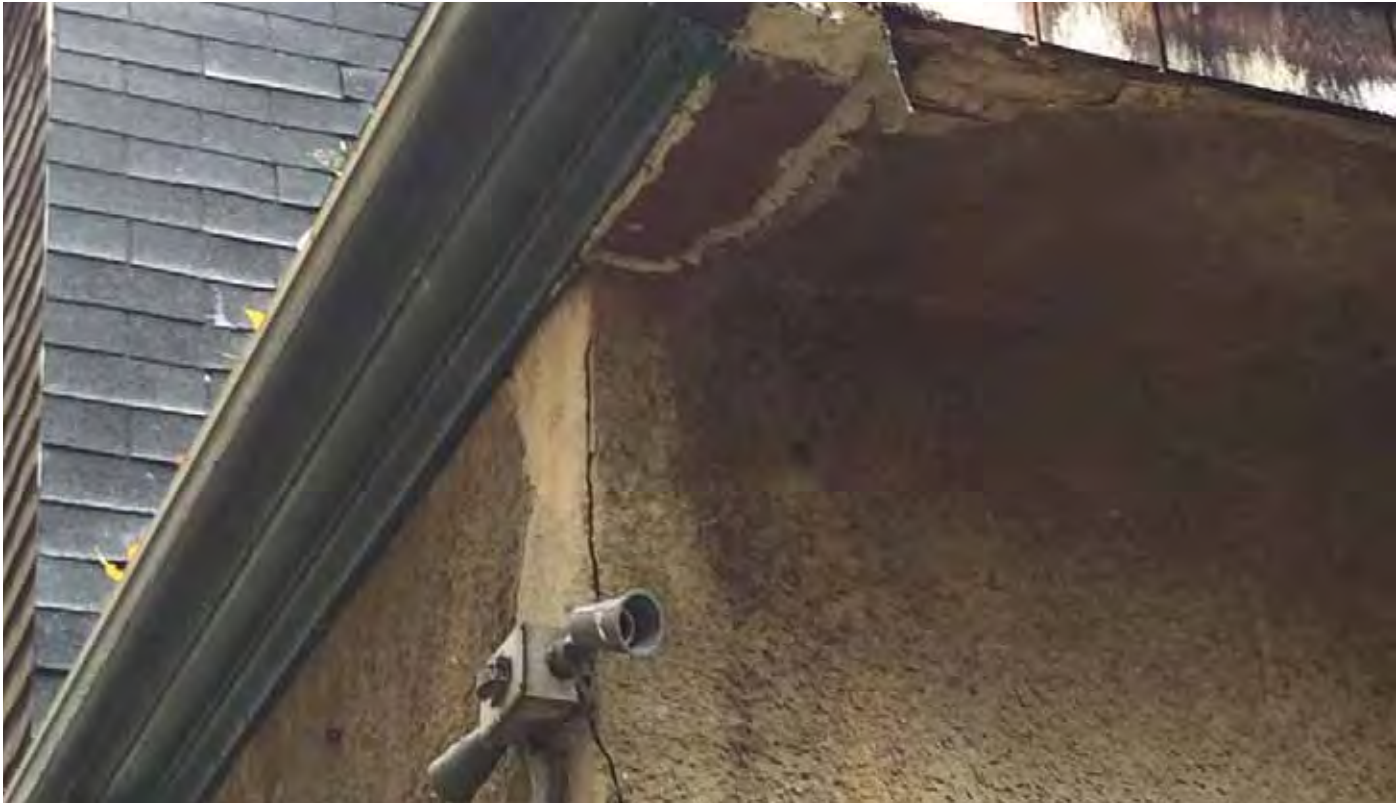
Image #22: Cracked stucco on northwest corner of house

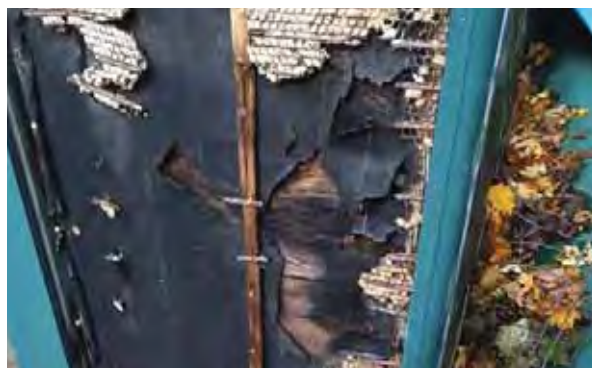
Image #26: Failing south wall of shed

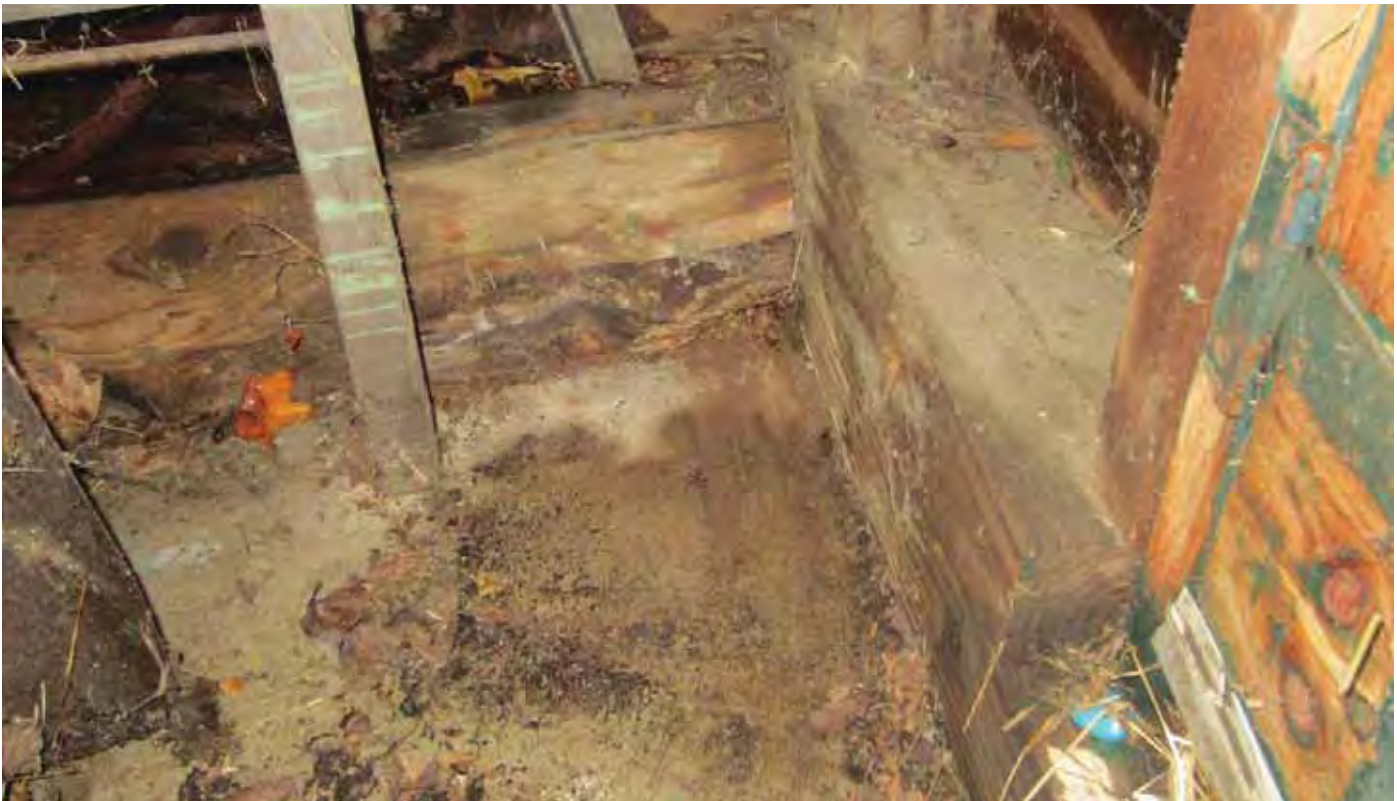
Image #27: Rotted framing in shed at southeast corner

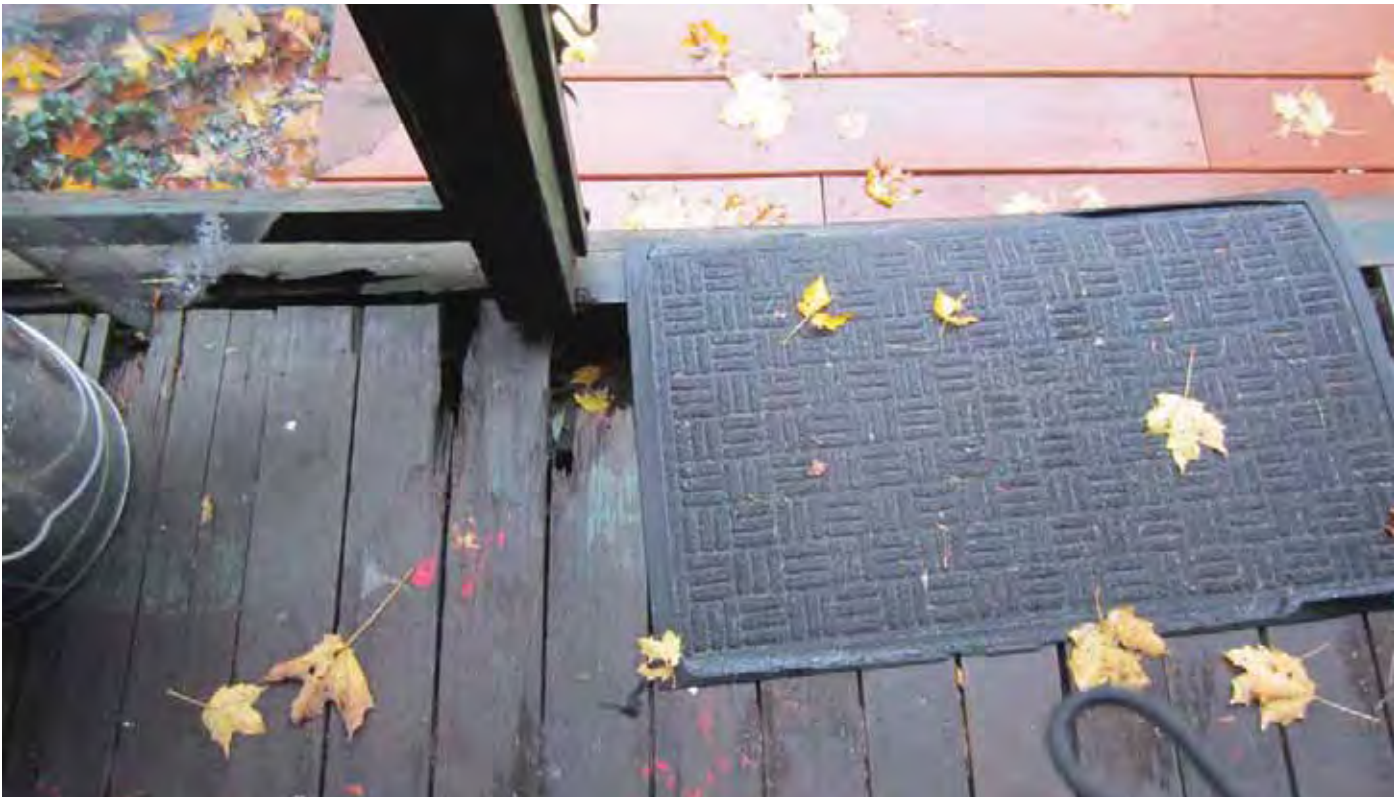
Image #28: Front porch deterioration at front steps

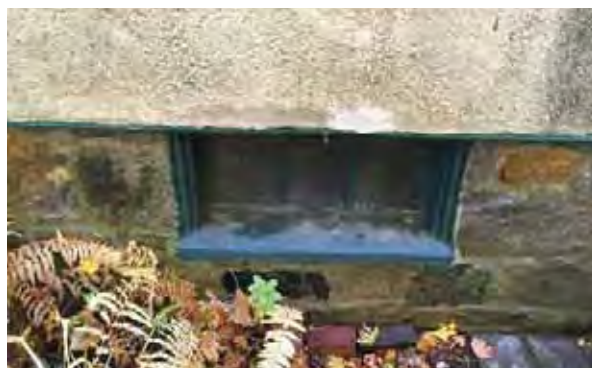
Image #29: Typical foundation wall condition

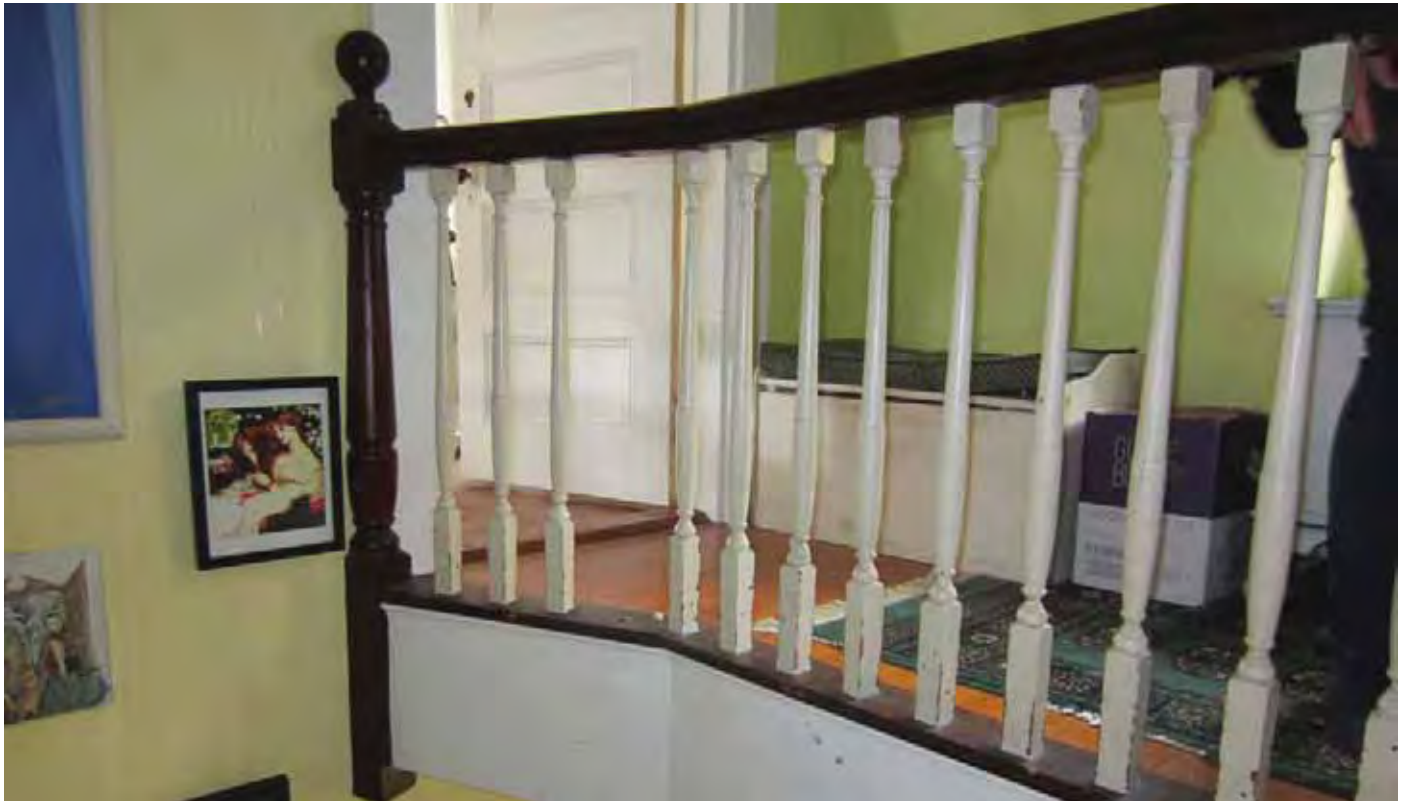
Image #45: 2nd floor guardrail with missing balustrades

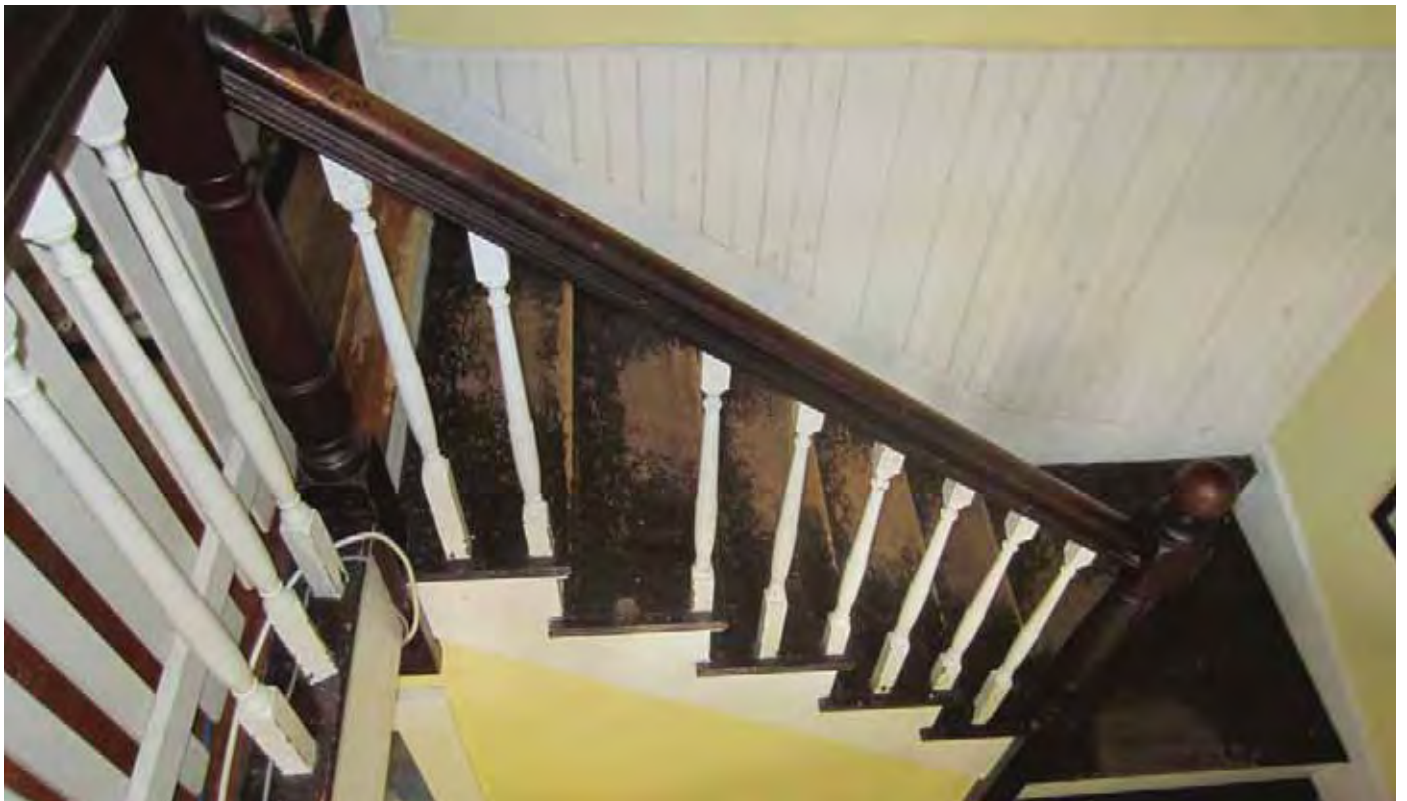
Image #46: Main stair with worn treads and missing railing balustrades

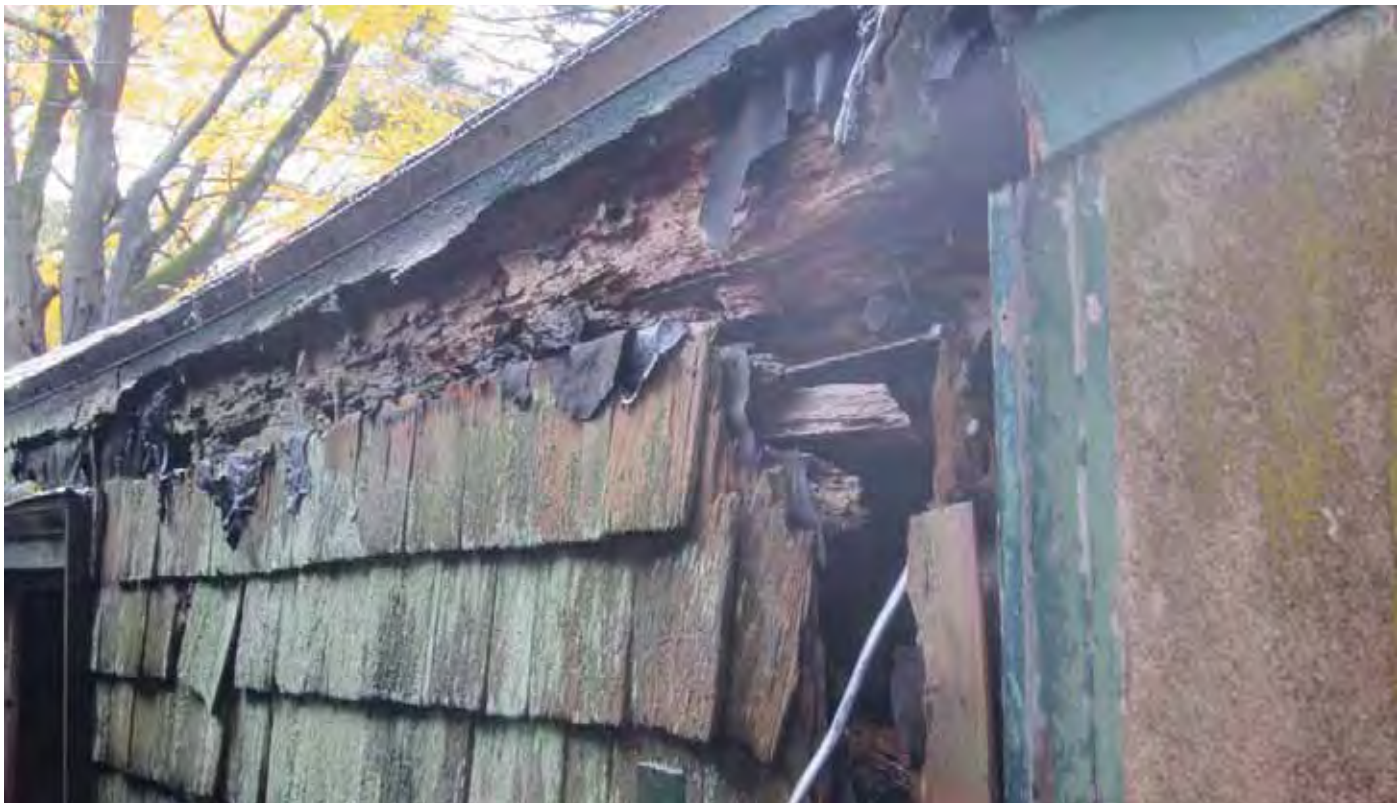
Image #51: Deteriorated east wall of shed

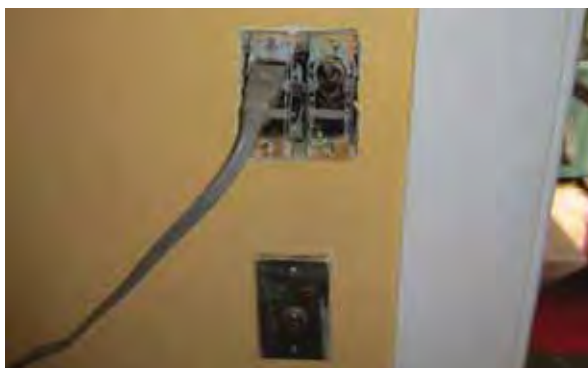
Image #55: Receptacles without covers

Outlets and switches in the kitchen do not have coverplates. Most are the non-grounding type and some are old and in poor condition.

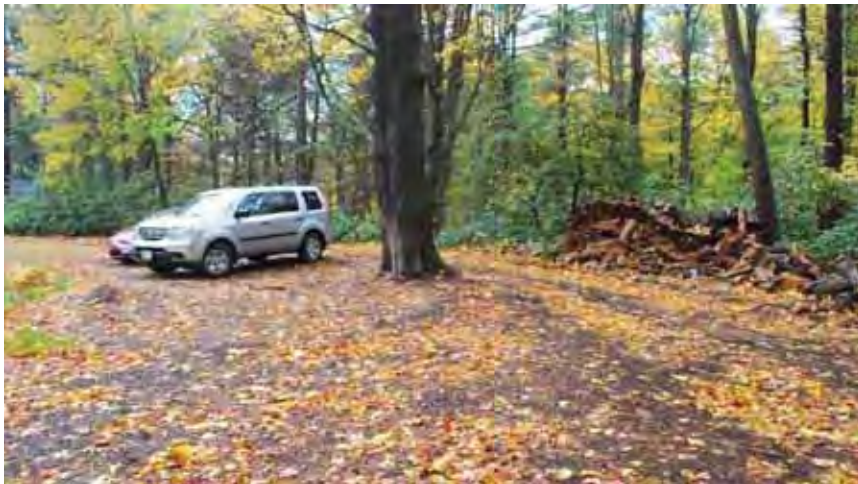
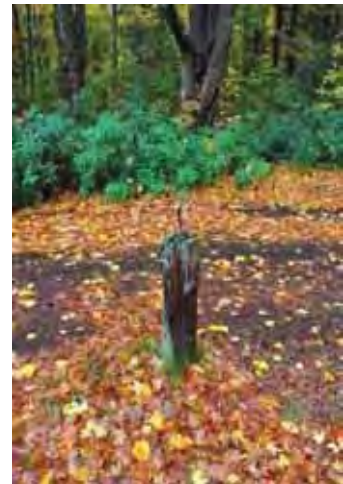
Image 4: Informal parking along septic pit and dirt drive and decaying wood post along dirt drive

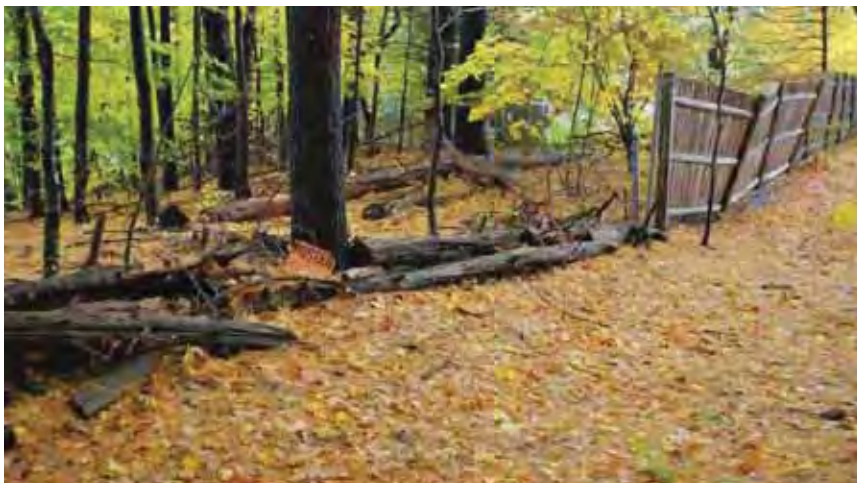
The north property line is delineated partially by solid wood fence shared with the abutter, fallen tree trunks, and broken wire and slat fence. Sections of the wire fence are growing into adjacent trees. Some posts in the solid wood fence are leaning (*Image 15 and 16*).

Image 16: Fallen tree trunks along north property line.

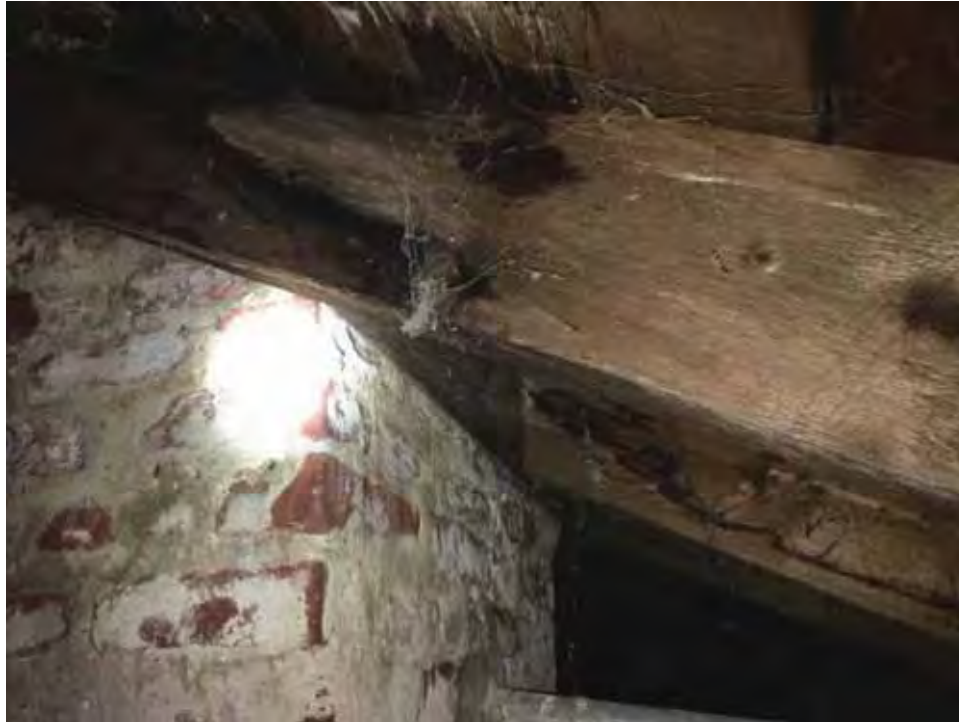
Photo 9 – Water staining on the main building roof framing.

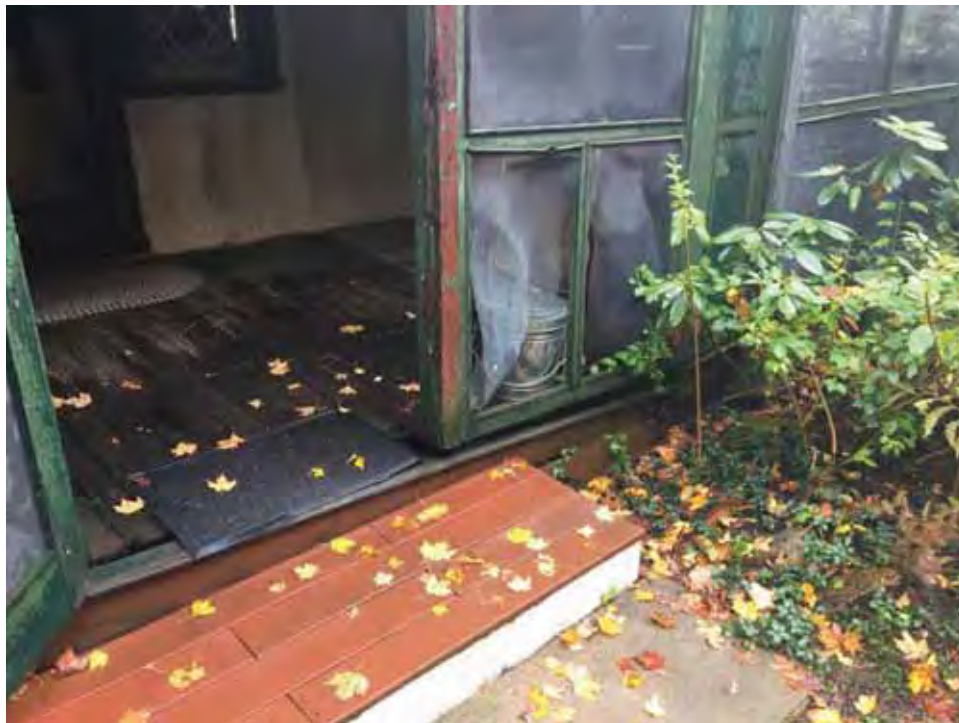
Photo 10 –Deteriorated framing at porch perimeter near the entrance.

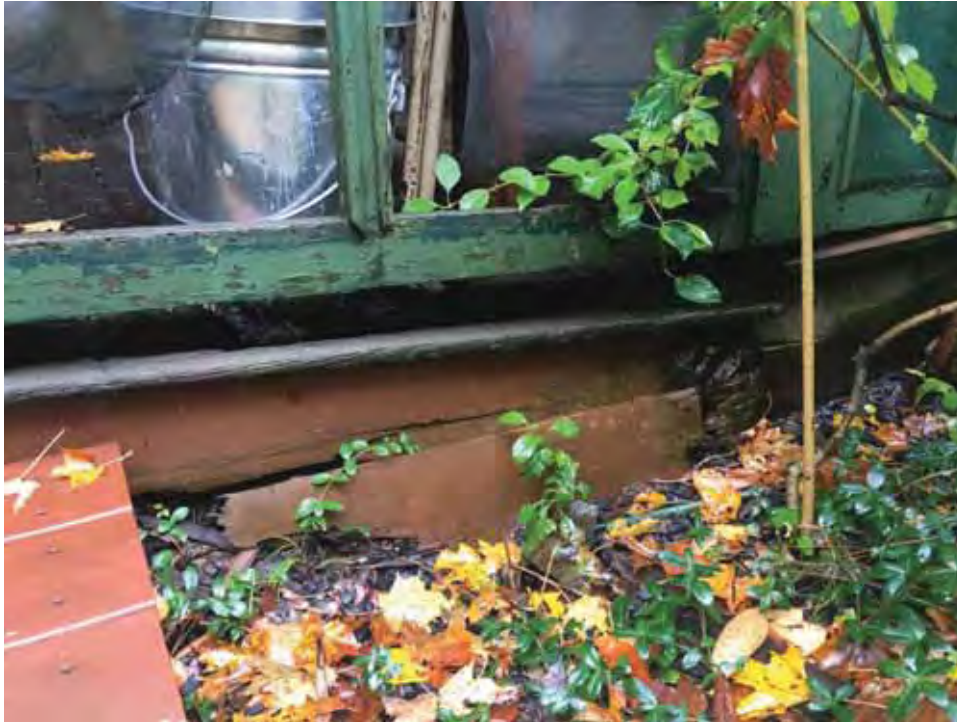
Photo 11 – Close-up of the deteriorated framing near the porch entrance.

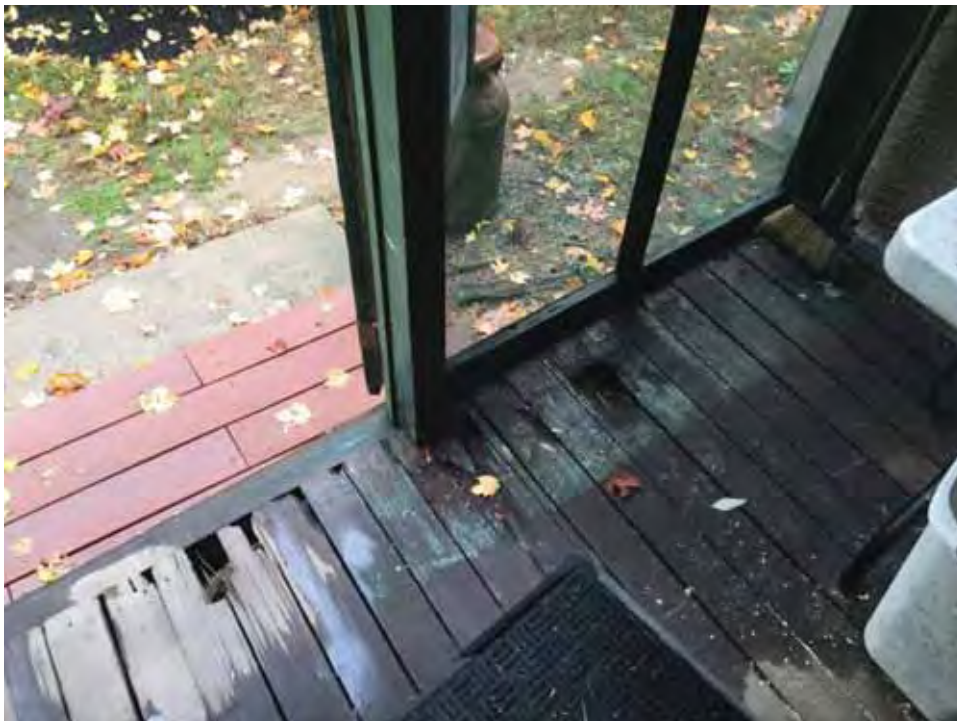
Photo 12 – Deteriorated decking at the porch perimeter near the entrance.

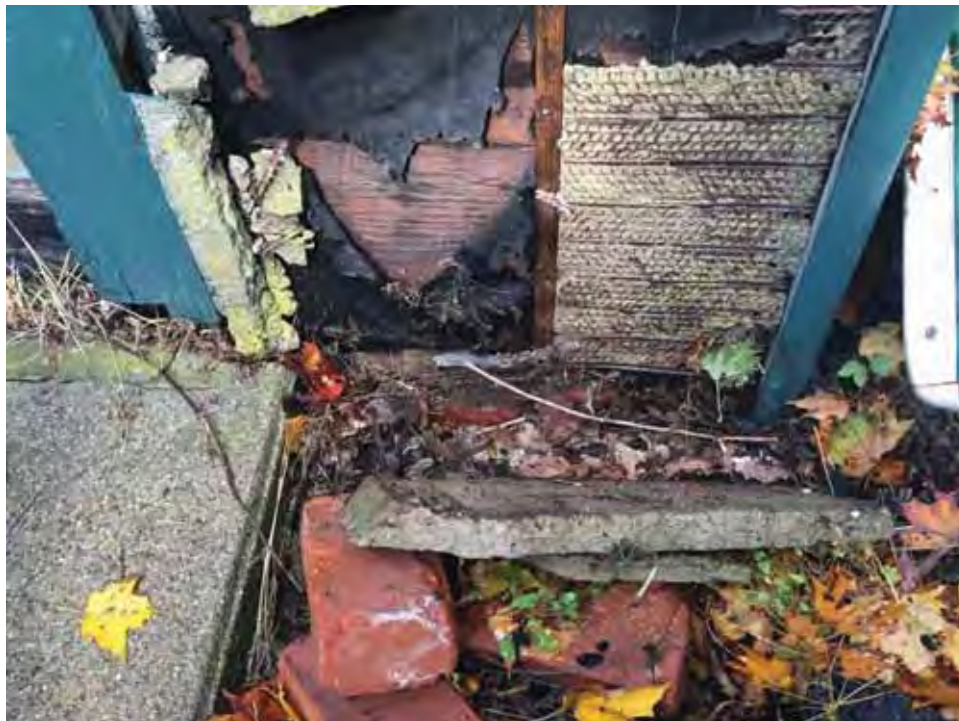
Photo 14 – Deterioration on the east side of the attached shed's south wall.

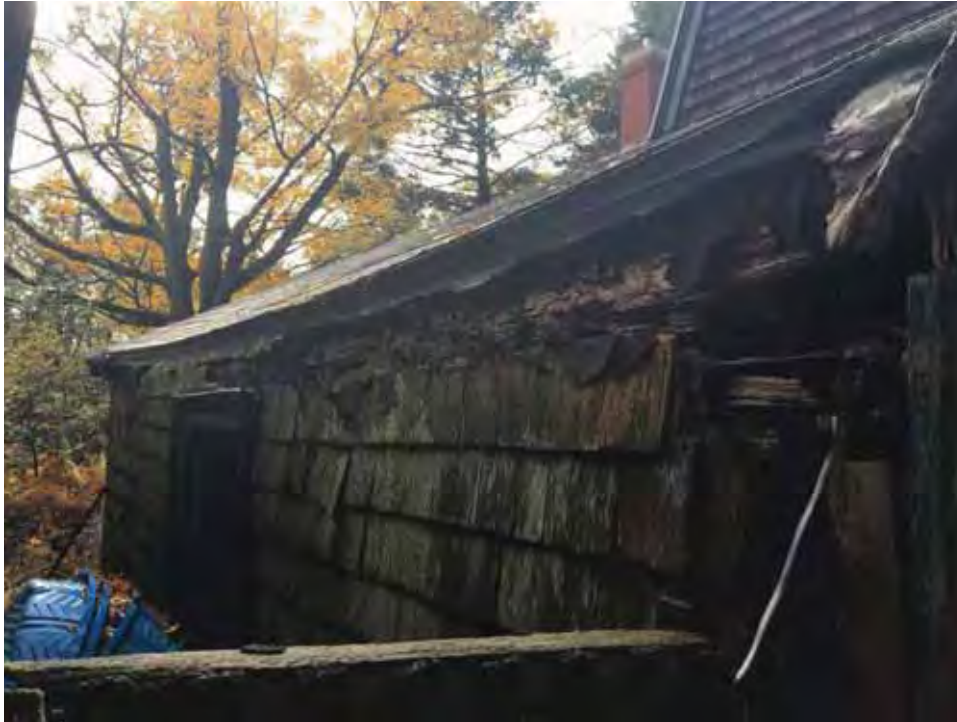
Photo 15 – Deterioration at the top of the attached shed's east wall.
