INDOOR AIR QUALITY ASSESSMENT

**Hall of Justice
50 State Street
Springfield, Massachusetts**

**Prepared by:
Massachusetts Department of Public Health
Center for Environmental Health
Emergency Response/Indoor Air Quality Program
May 2006**

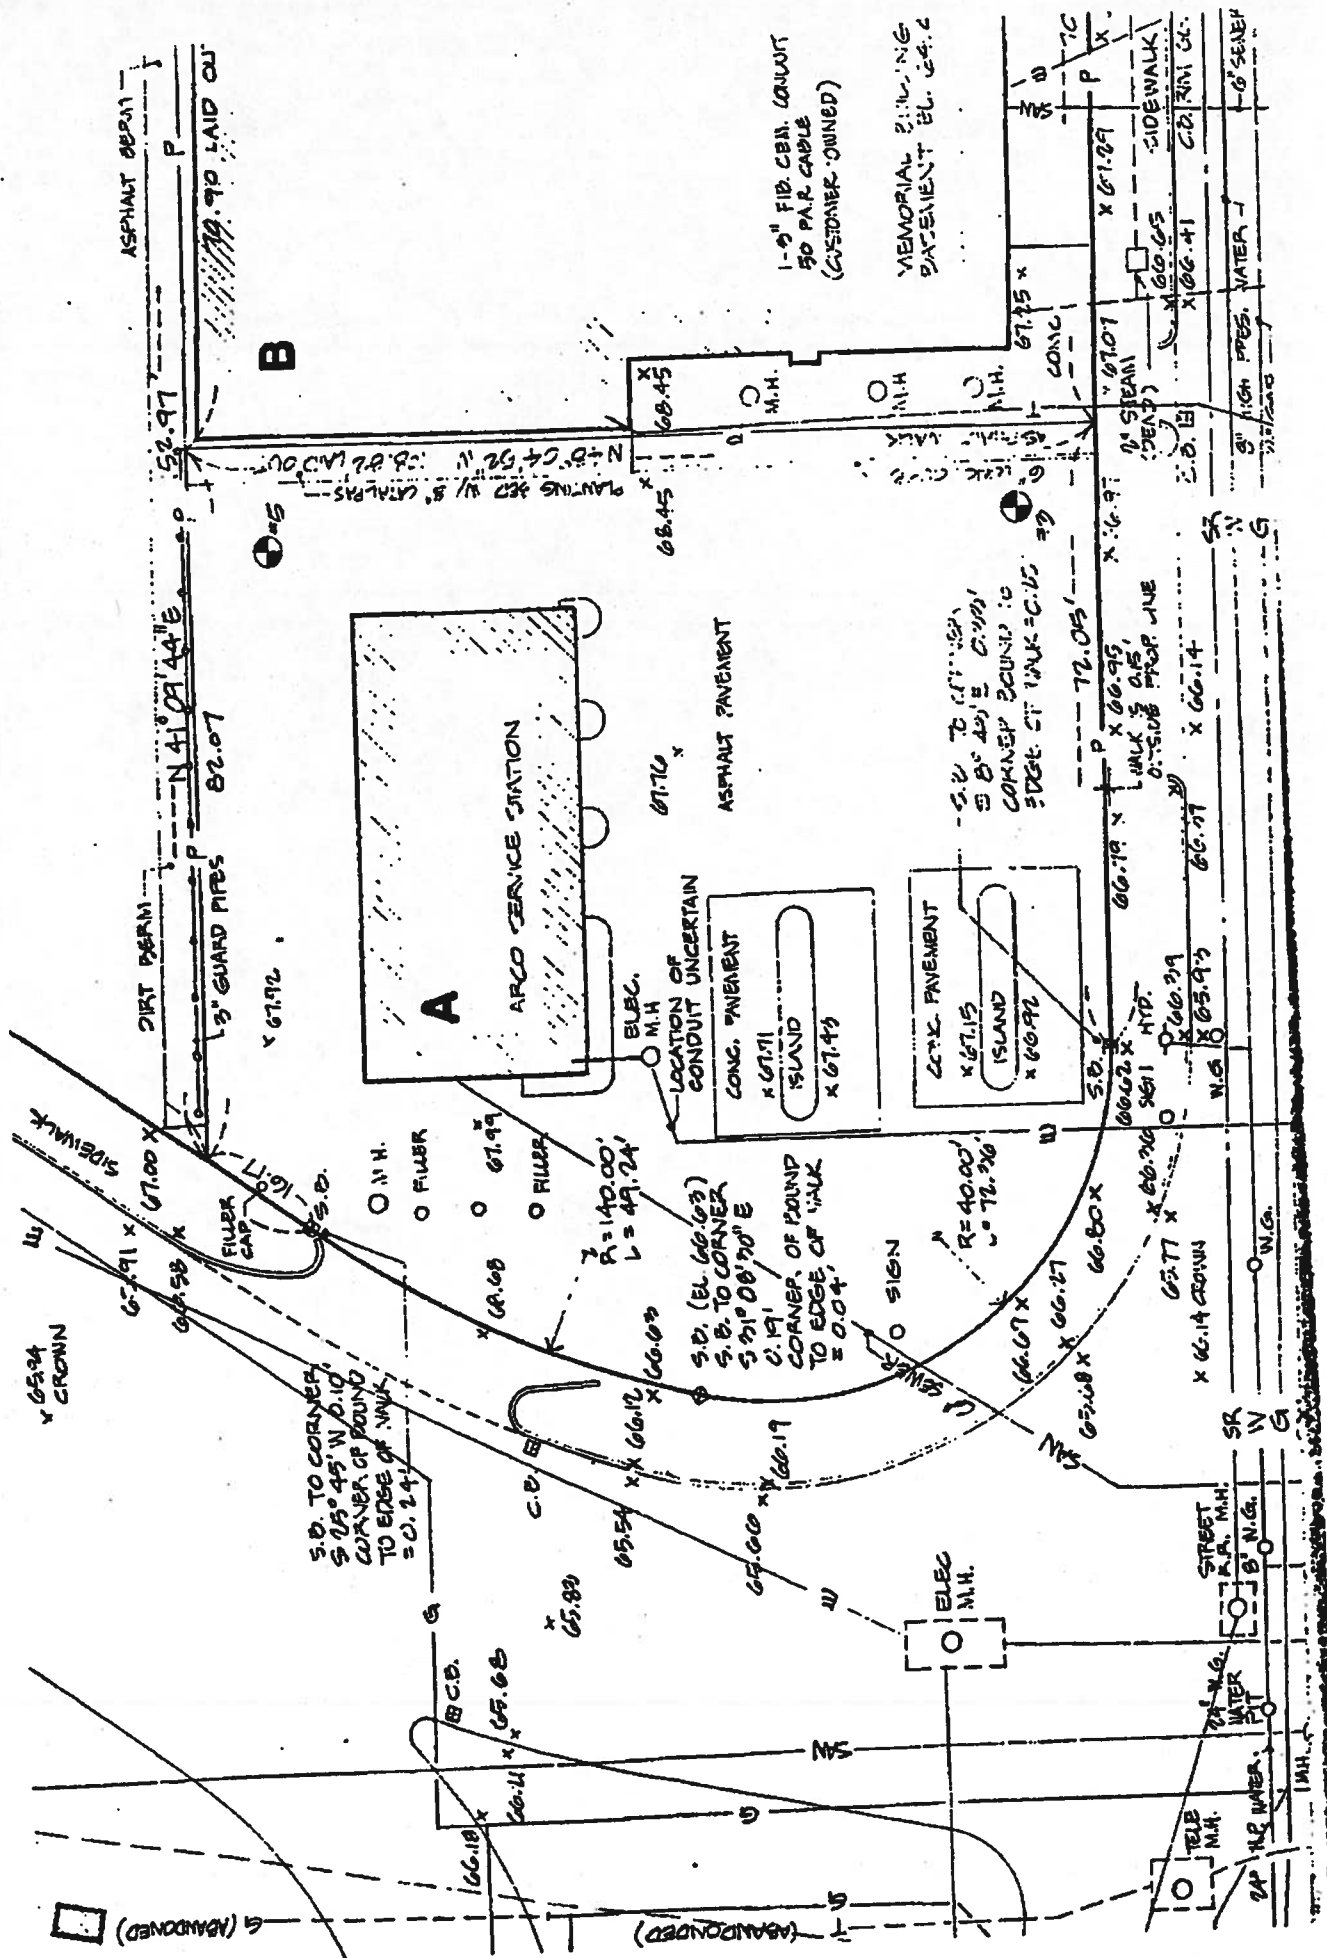
Blueprint 1
Blueprint of Hall Of Justice Plot, Indication a Gasoline Station Existed on the Site Previous to Construction

The HOJ is a four-story, tiered, cement and steel frame building constructed in 1973 as an energy efficient facility. A gasoline service station existed on the HOJ site prior to construction (Blueprint 1). According to HOJ staff, the building was originally designed to have a fifth floor. A number of characteristics were found in the building that support this hypothesis:

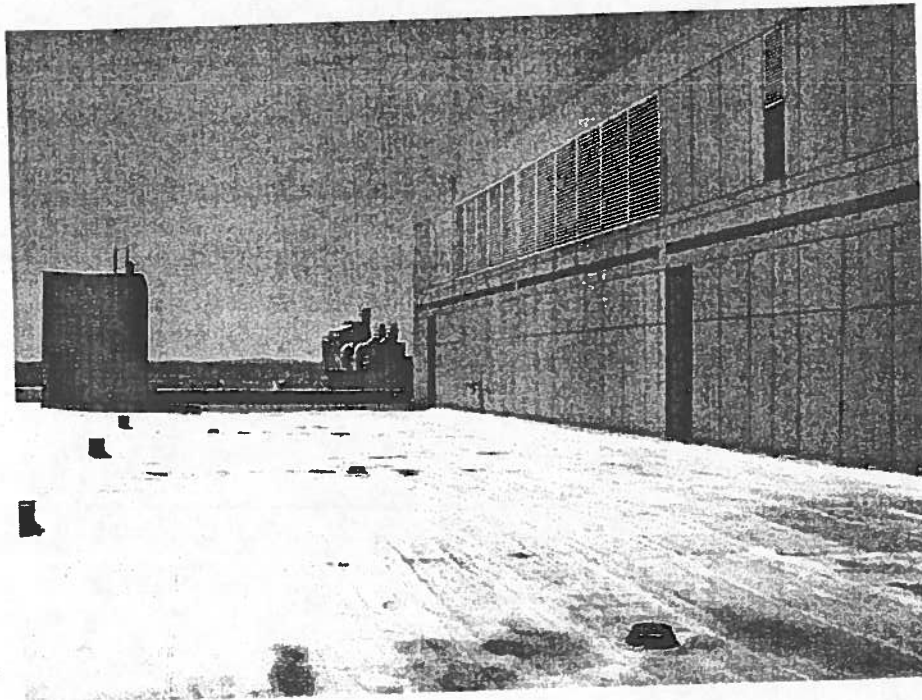
Picture 1

Two-Story Rooftop Penthouse

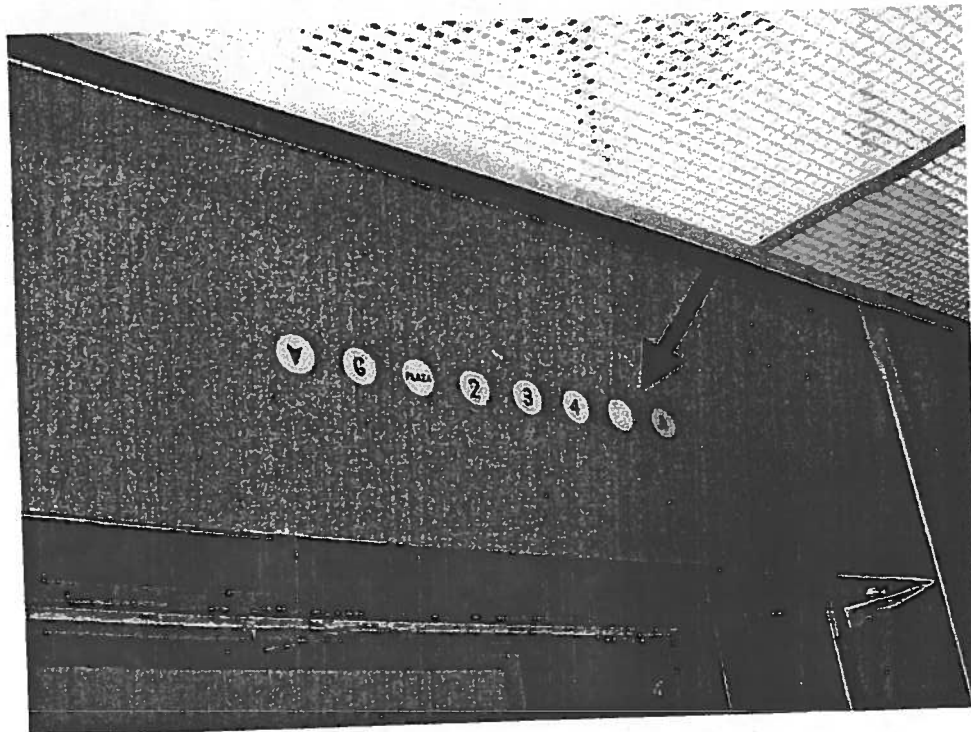
Picture 2

Elevator Floor Indicator Has an Extra-Unlabelled Light

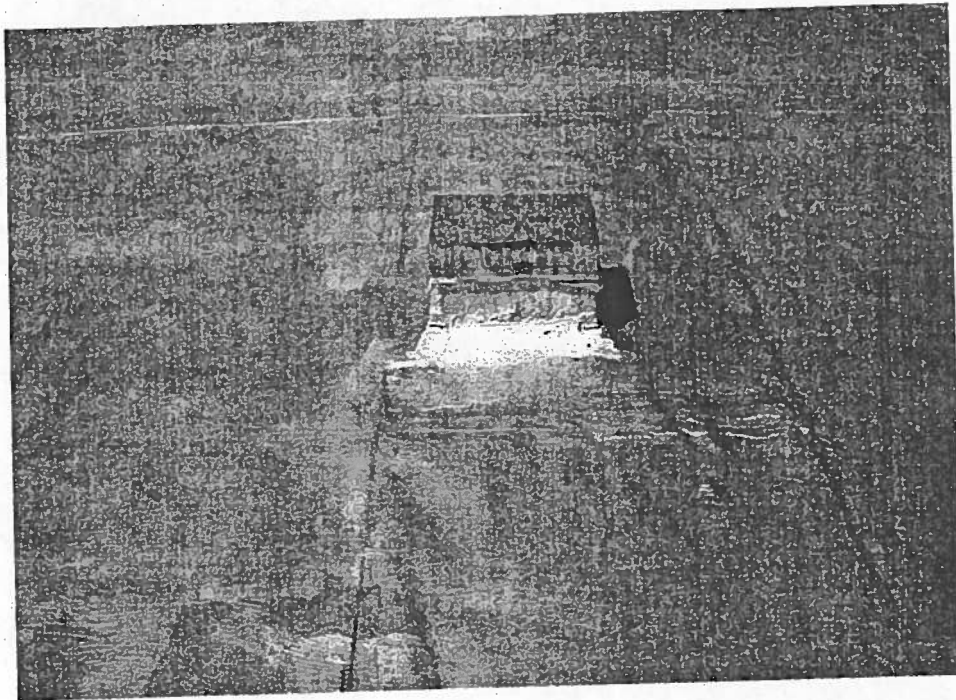
Picture 3

Roof Membrane, Note I-Beams Installed Through Roof

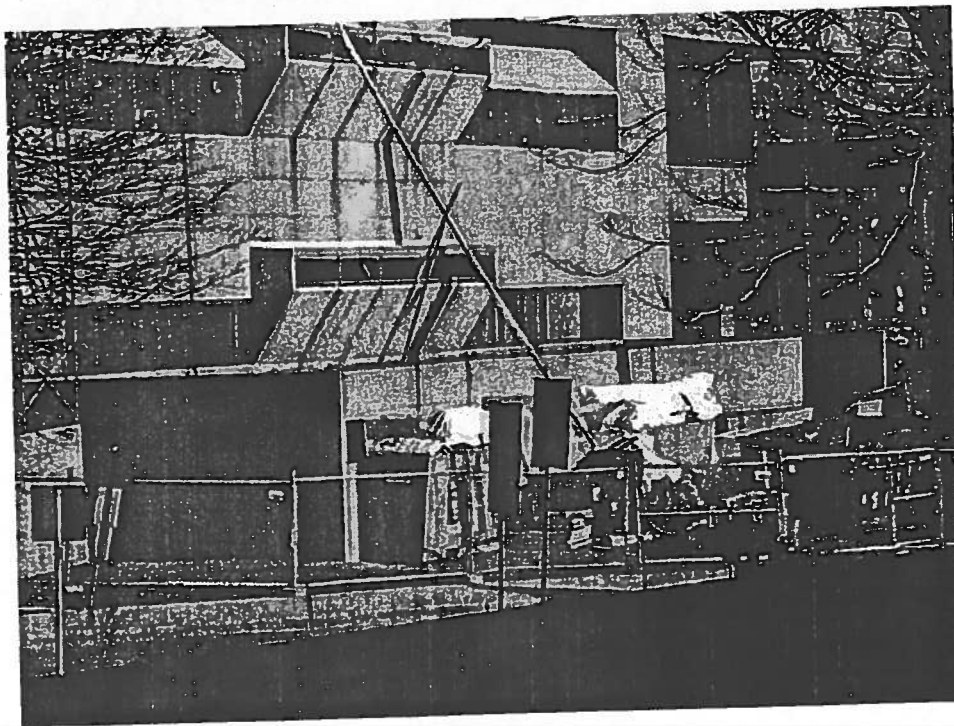
Picture 4

Roof Work Staging Area

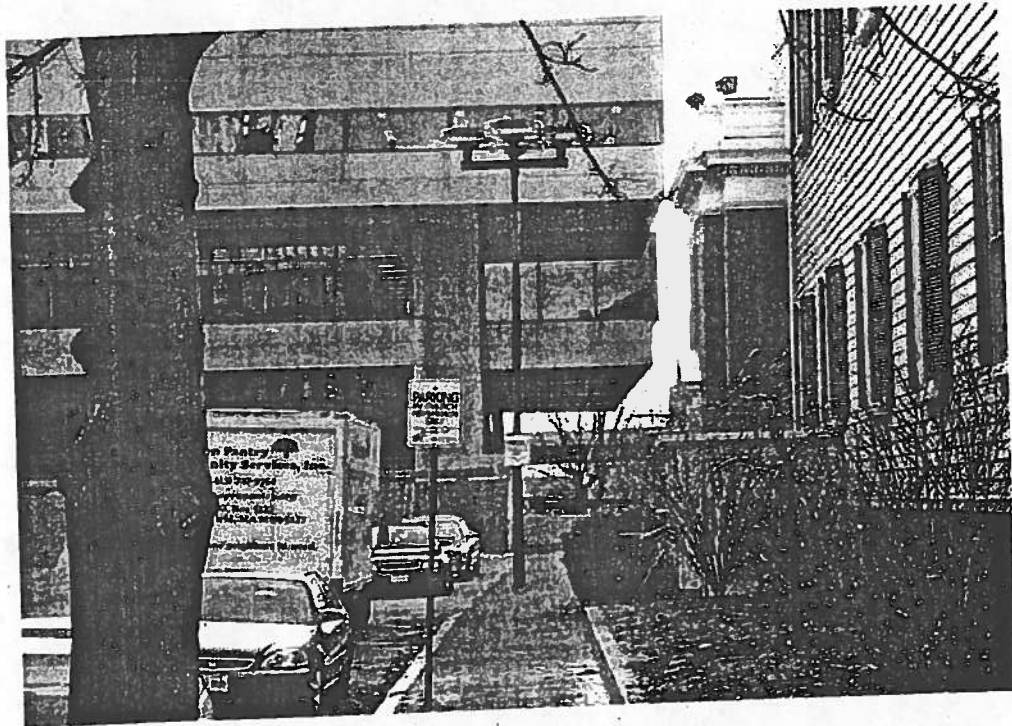
Picture 5

Floor Overhang over Driveway, North

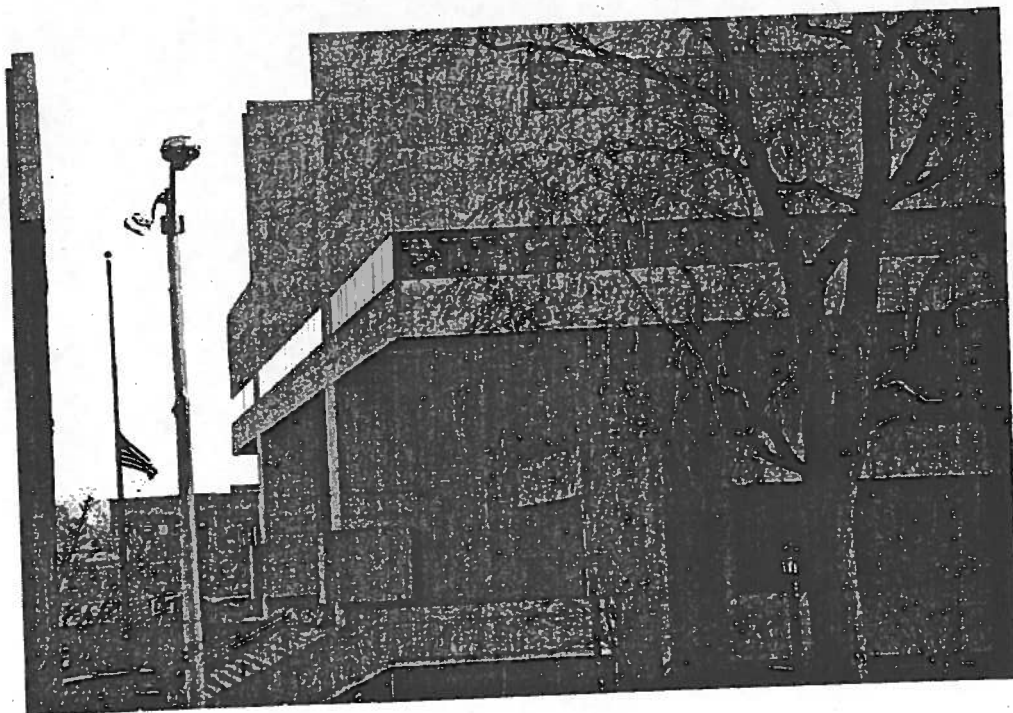
Picture 6

Floor Overhang, East

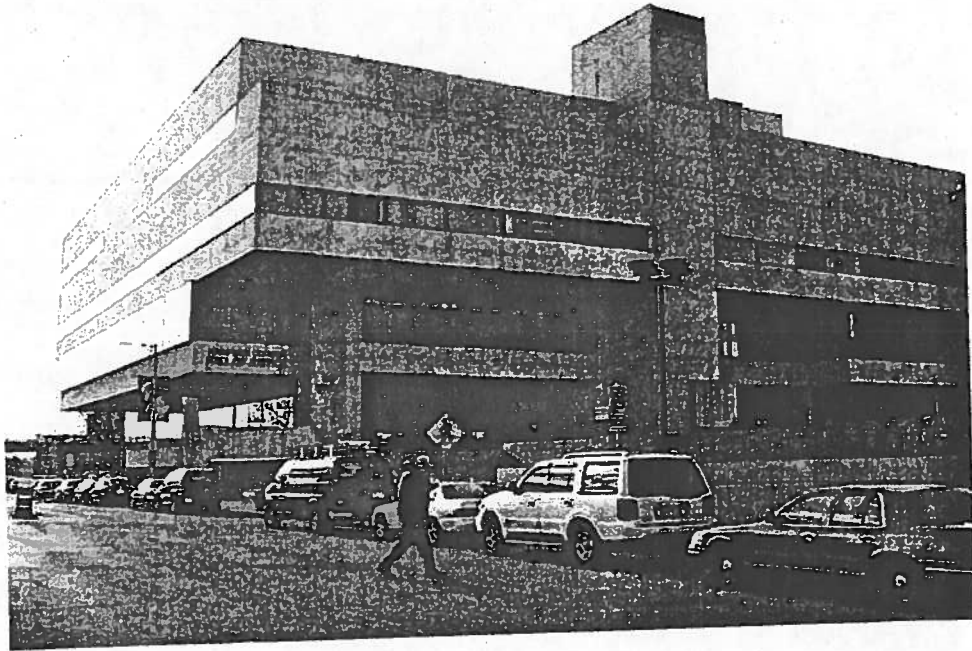
Picture 7

Floor Overhang, South

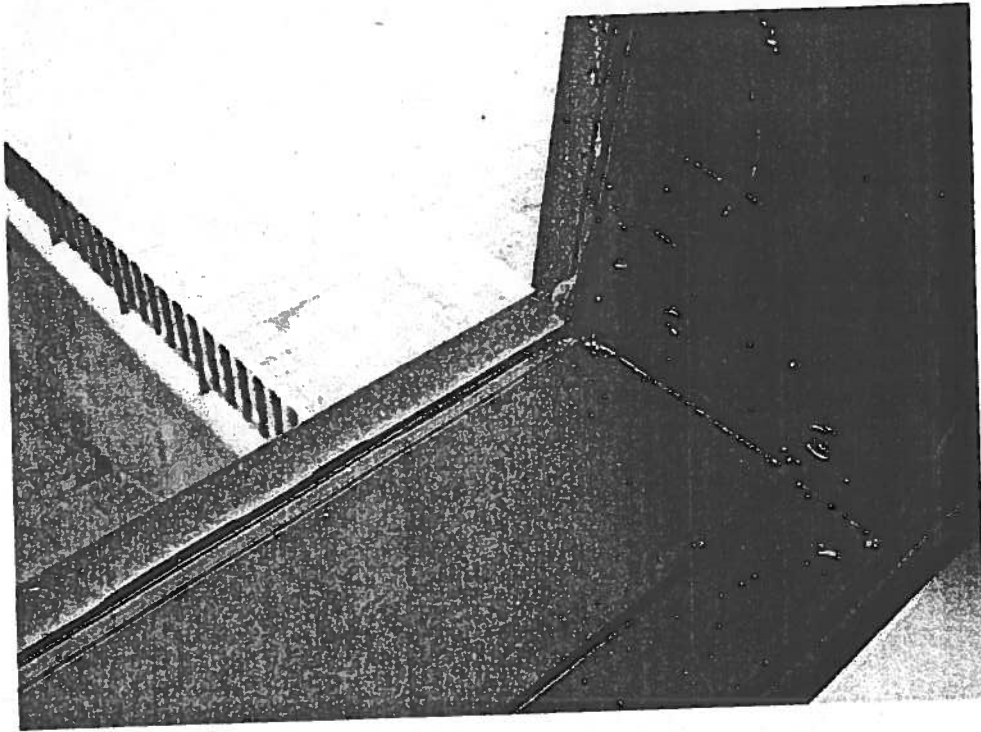
Picture 8

Windows Are Single Glass Panes in Metal Frames

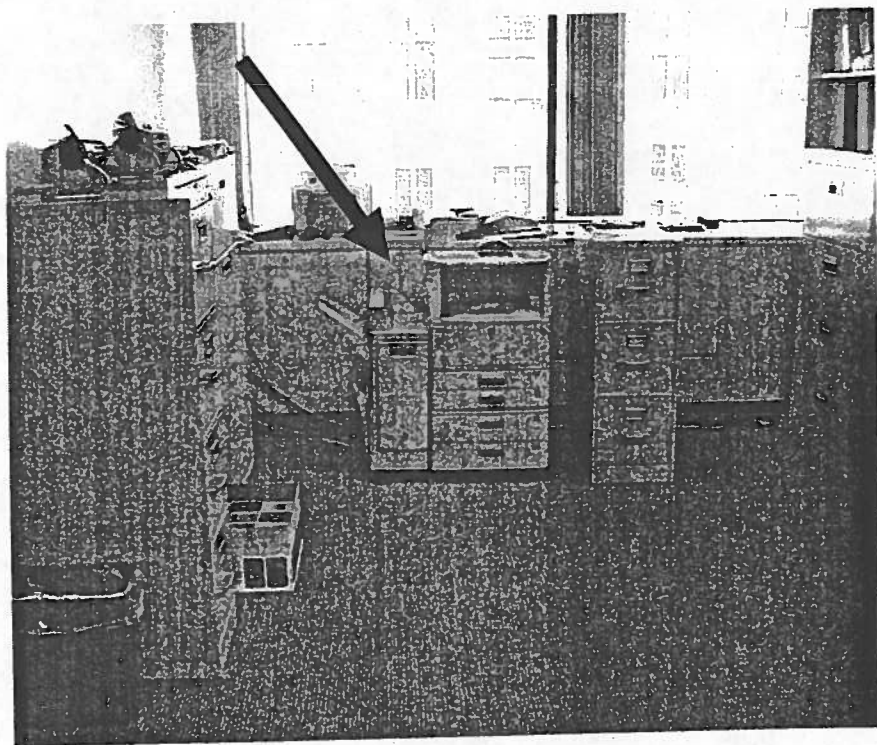
Picture 9

Fan Coil Unit (Arrow) Blocked By Photocopier

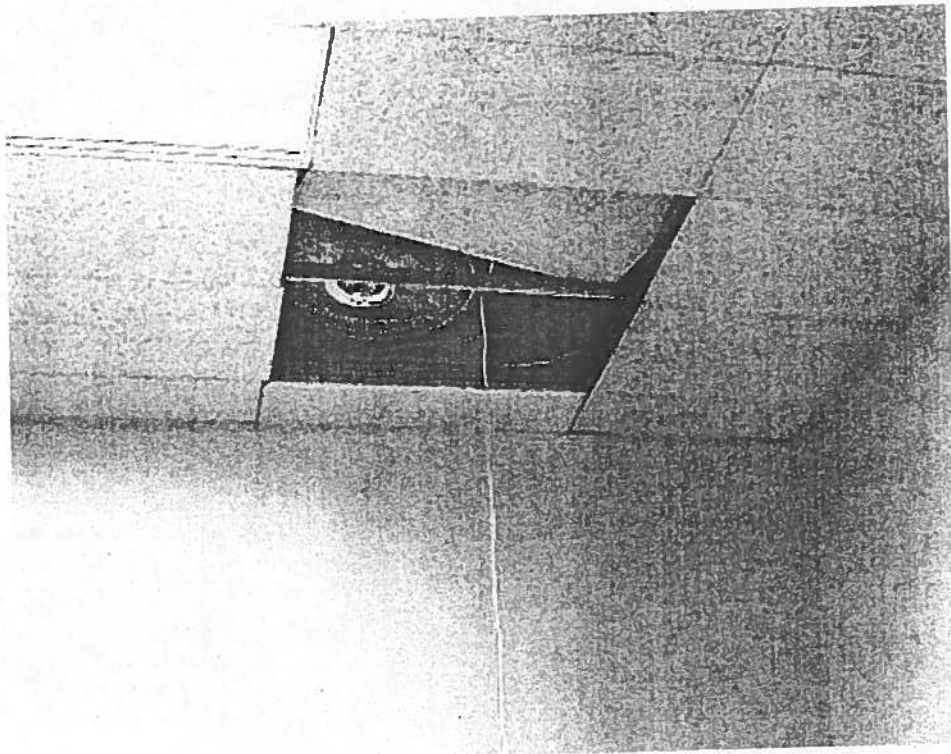
Picture 11

The fourth floor registry of deeds office had a series of retrofitted wall fans installed and were operating during the CEH visits. According to Registry of Deeds staff, a fan was placed in the suspended ceiling to provide heat relief (Picture 11). CEH staff recommended the removal of the fan from the ceiling since it could be a fire hazard.

Fan Placed In Ceiling Plenum in Room Of Registry of Deeds

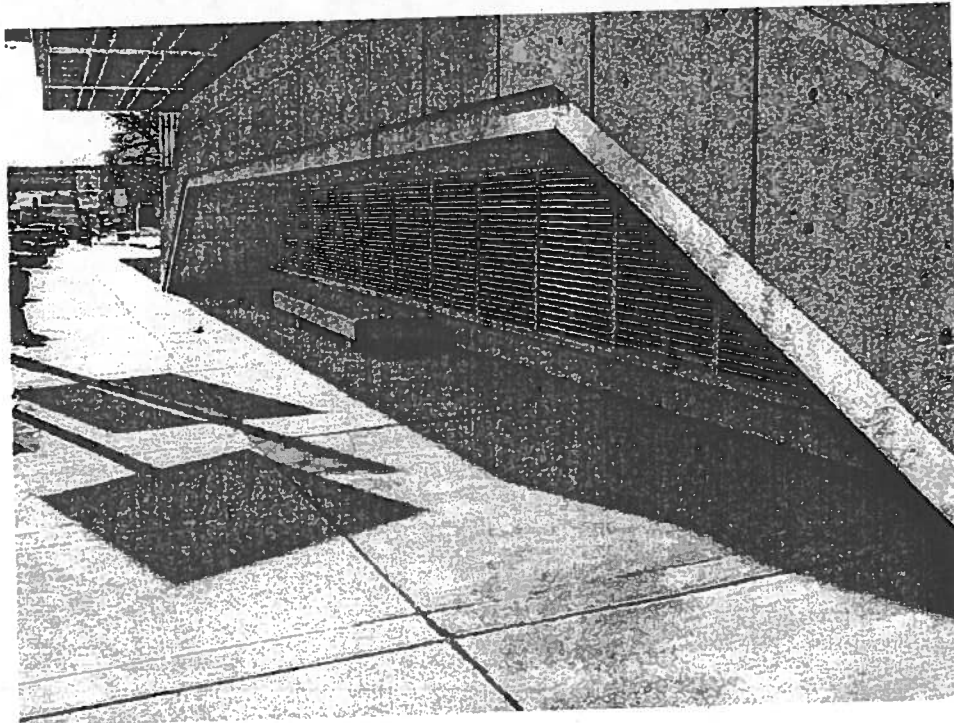
Picture 12

Exhaust Vent for Parking Garage

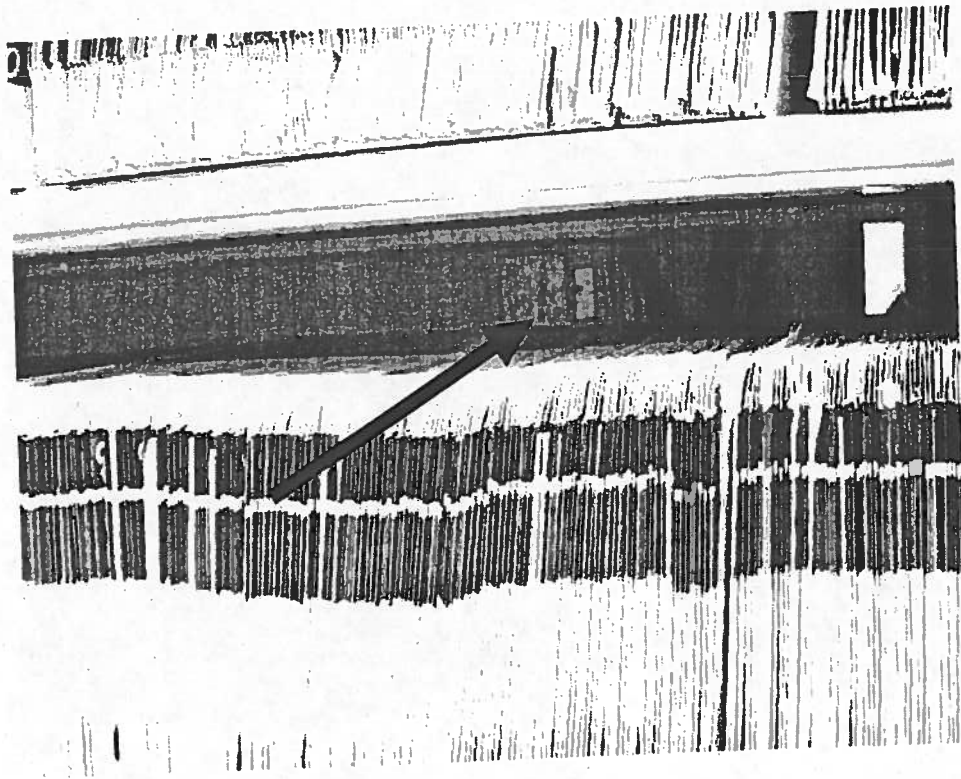
Picture 13

Thermostat Located Behind Files on Shelf

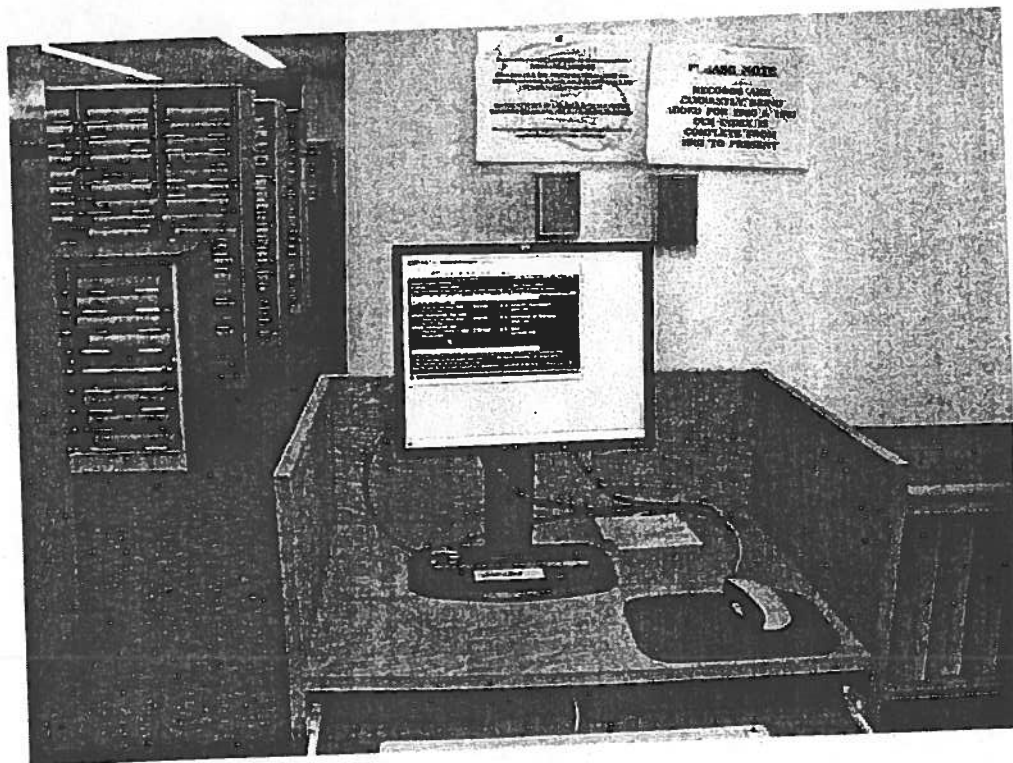
Picture 14

Thermostat Located Above Computer Monitor in Registry of Deeds

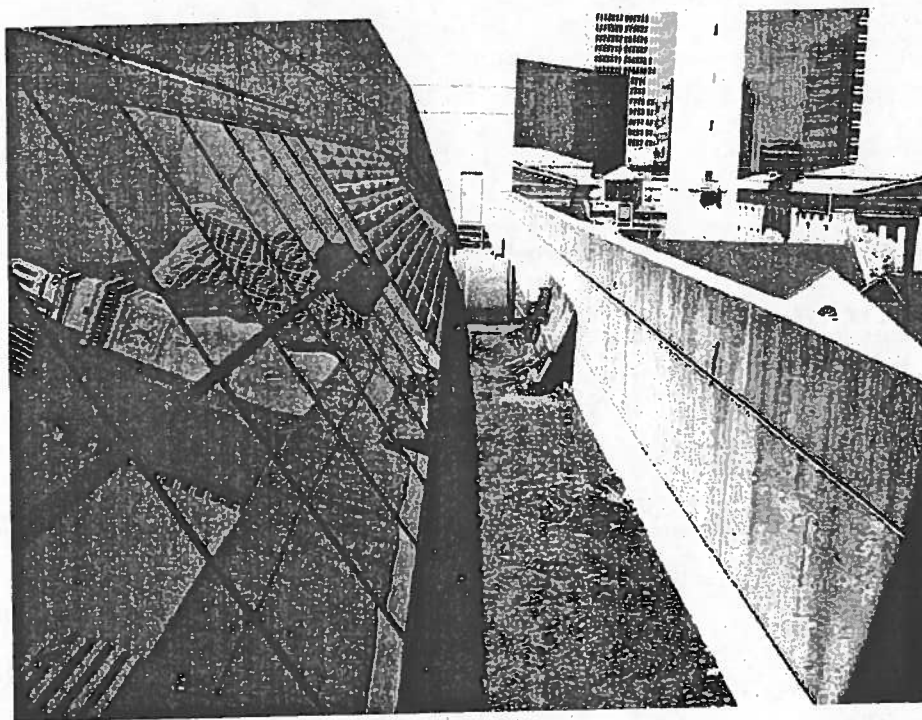
Picture 15

parapet (Picture 15). Heavy moss growth was noted on this roof, particularly around drains (Picture 16). Moss growth around these drains is an indication of chronic water pooling on the roof. The freezing and thawing of water during winter months can lead to roof leaks and subsequent water penetration into the interior of the building. Areas in the District Attorney's office and law library had extensive water damage (Pictures 17 and 18).

Short Roof over Library at Fourth Floor Level, Note Moss and Debris on Roof

17. Remove debris from the short roof.
18. Continue with replacement of wet ceiling tiles and channel leaking water into collection containers until roof repairs are complete. Once the roof repair is complete, repair the water damaged areas in the building in a manner consistent with guidelines set forth in "Mold Remediation in Schools and Commercial Buildings" published by the US Environmental Protection Agency (US EPA, 2001).

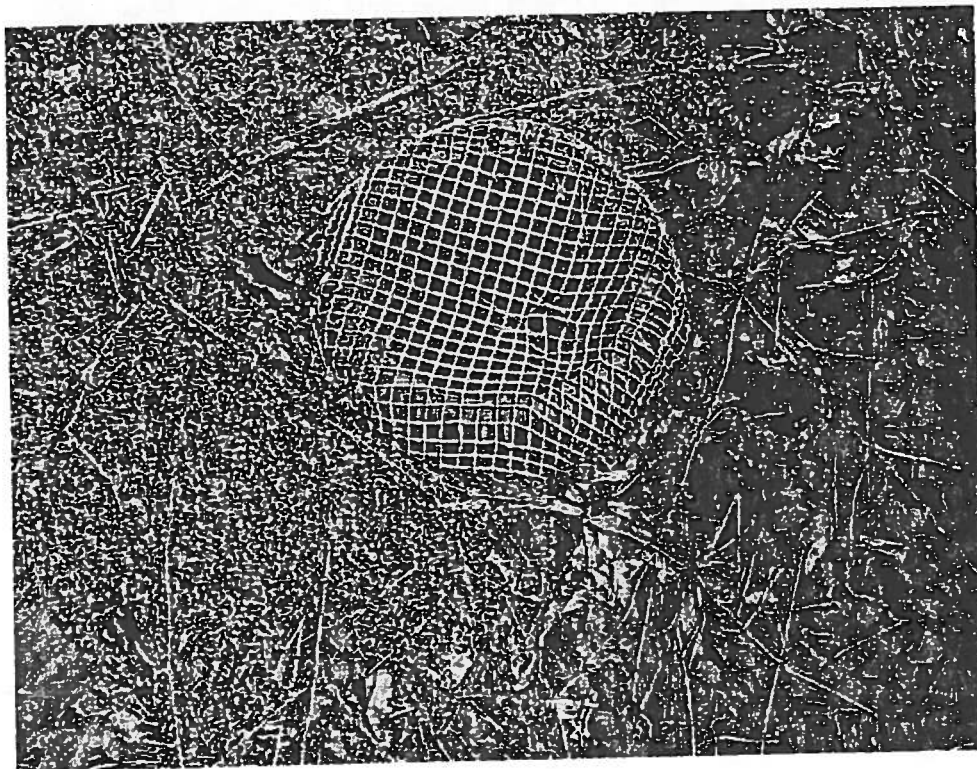
Picture 16

Roof Membrane Damage and Moss Growth

1. Continue with repairs to establish a functional, insulated roof to eliminate water leaks and improve temperature control.

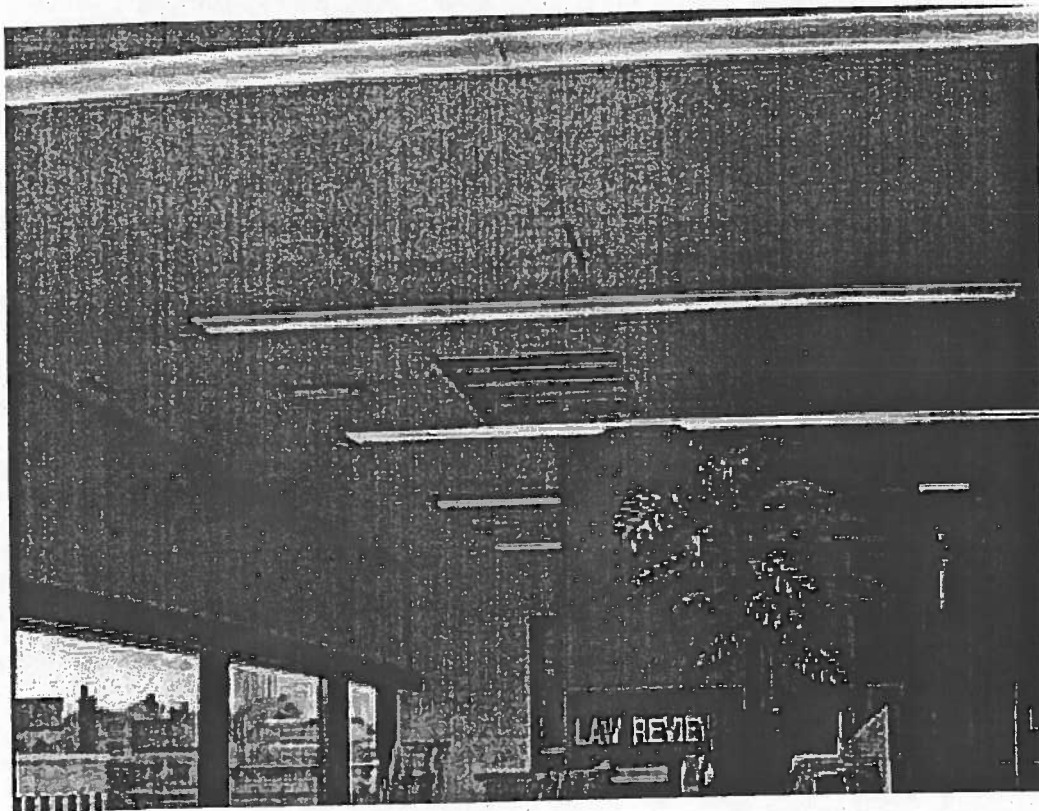
Picture 17

Water Damage Ceiling in Library

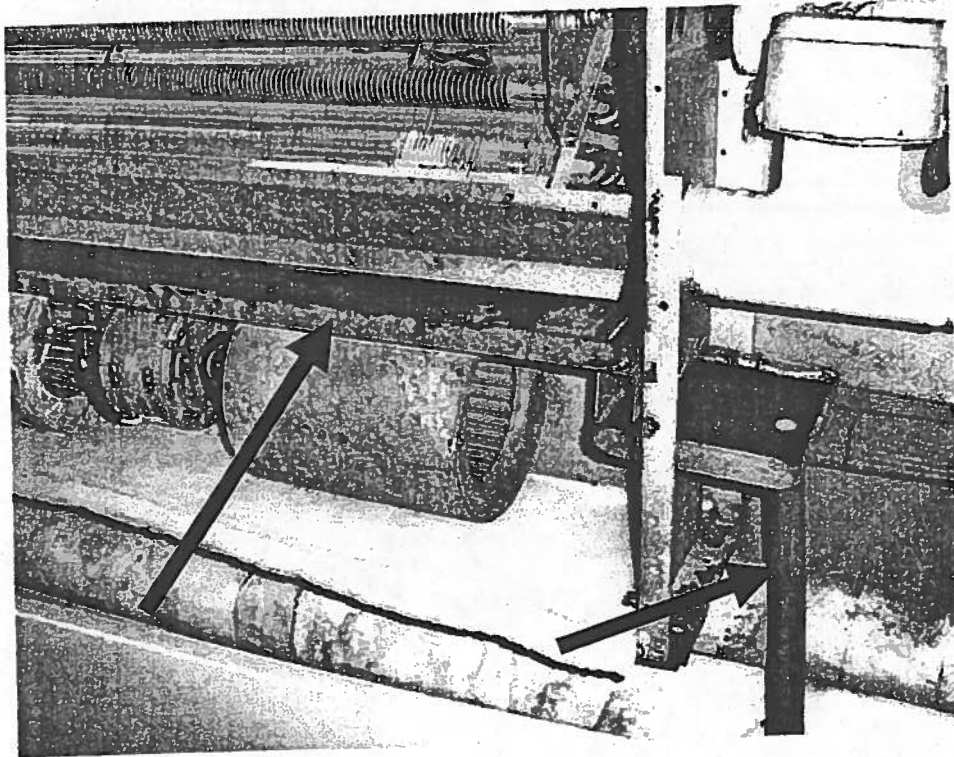
Picture 19

The Registry of Deeds built a server room that requires air conditioning (AC) for computer equipment. A self-contained AC system was installed in this room. As air conditioning equipment operates, moisture accumulates in the cooling coils that require a drain to remove water from the cabinet. CEH staff located the drain, but could not identify if the drainpipe was connected to a building drainage system. If not connected to a building drainage system, water likely accumulates and pools within the AC unit. Pooling water of this nature can serve as a mold growth medium. CEH staff inspected several FCUs, which were equipped with drip pans and drains connected to a drainage system (Picture 19).

Drip Pan and Drain in FCU (Arrows)

12. Examine the feasibility of connecting the self-contained air conditioner in the Registry of Deeds' server room to the drain system. Connect this drain to the main HVAC/FCU drain system. Any installation of air chilling equipment must provide for adequate means to drain condensation. Any installation of such equipment should be done in consultation with the Bureau of Court Facilities to ensure that adequate drainage for equipment exists.

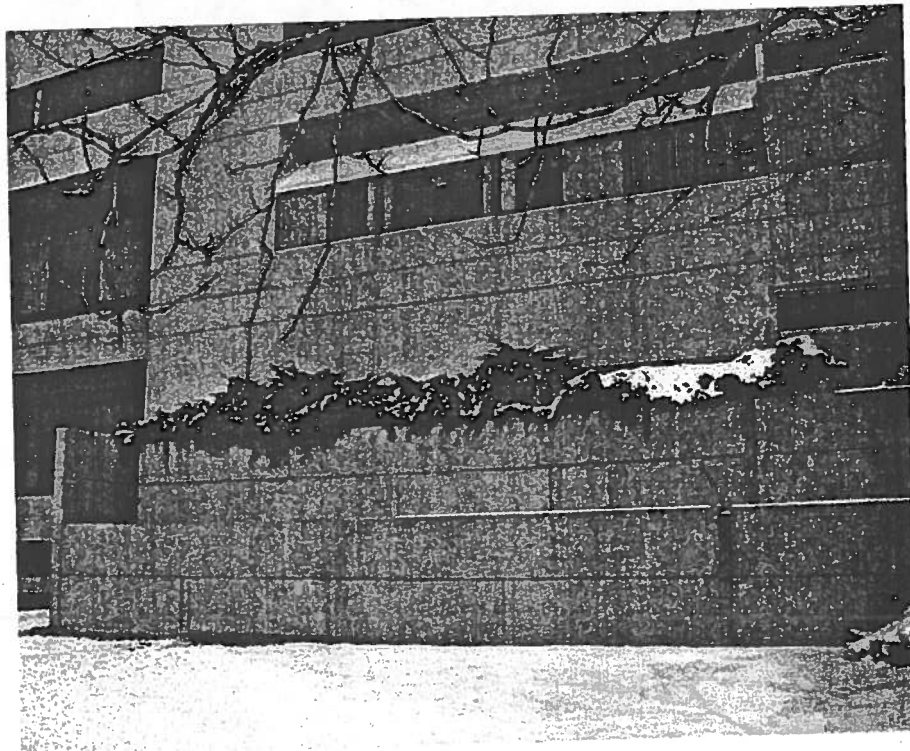
Picture 20

A large planter is located along the western wall of the HOJ (Picture 20). A public records area exists beneath and adjacent to the planter. The ceiling in this area appeared to be water damaged in a manner similar to the third floor of the HOJ. As with roofs, planters of this type must adequately drain in order to prevent water damage to adjacent walls and ceilings.

Planter Built Into Building

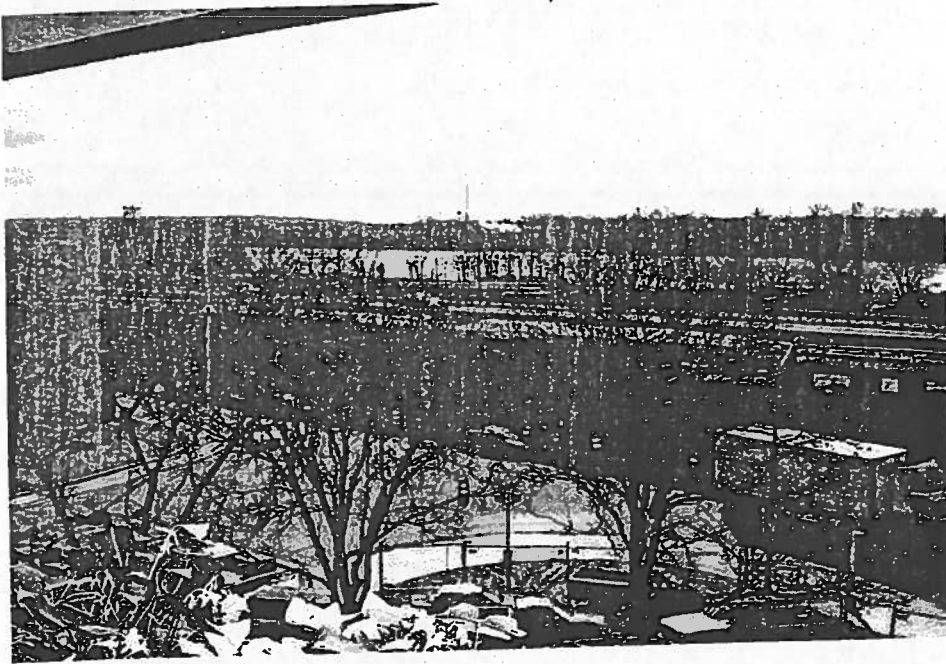
Picture 21

- A major truck route intersects State Street and E. Columbus Avenue at a stop light to the southwest of the building (Picture 21). Exhaust from idling vehicles is directed toward the HOJ under certain wind conditions.
- Building occupants reported periodic odors, mainly during southwest winds, from Bondi Island, which contains the Springfield Regional Wastewater Treatment Facility (Map 1).
- Approximately 30 feet above E. Columbus Street is an elevated portion of Interstate-91 (Picture 22).
- A construction project was observed beneath an Interstate 91 overpass west of the building (Picture 23).

Intersection of E. Columbus Avenue and State Street, Southwest of HOJ, Second Floor Judge's Lobby

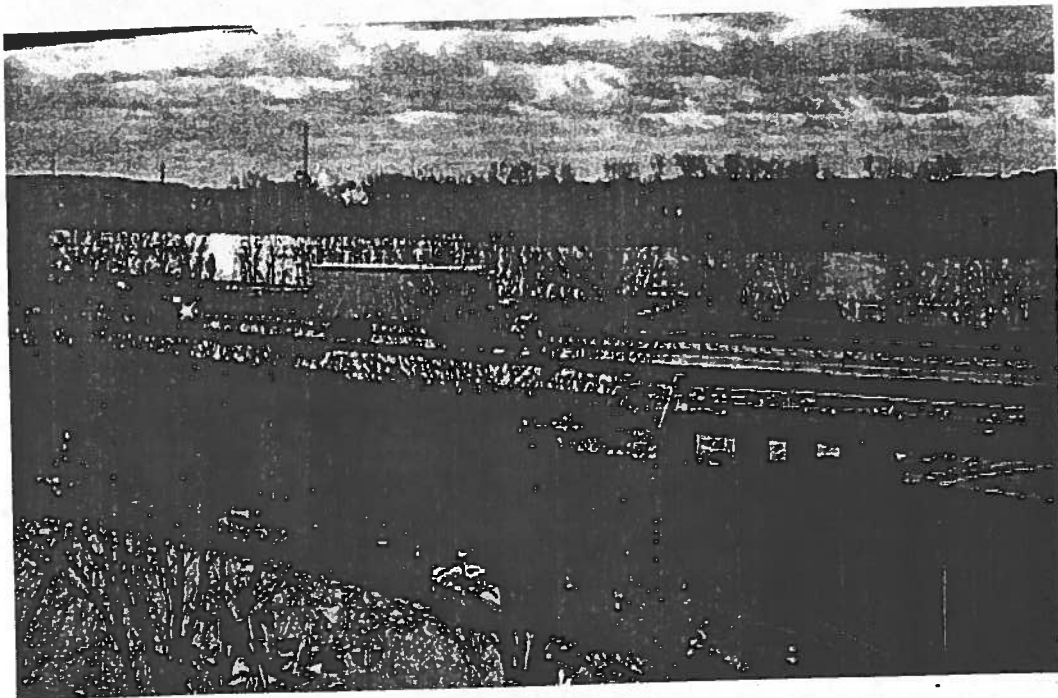
Picture 22

Interstate 91, View from inside HOJ, Second Floor Judge's Lobby

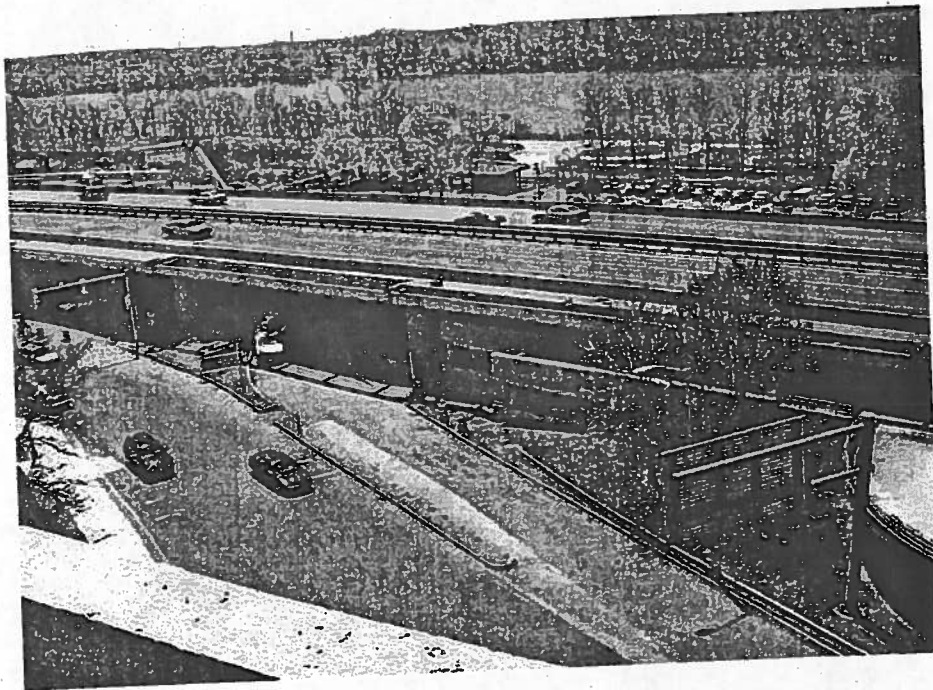
Picture 23

Construction beneath I-91 Overpass, West Of HOJ

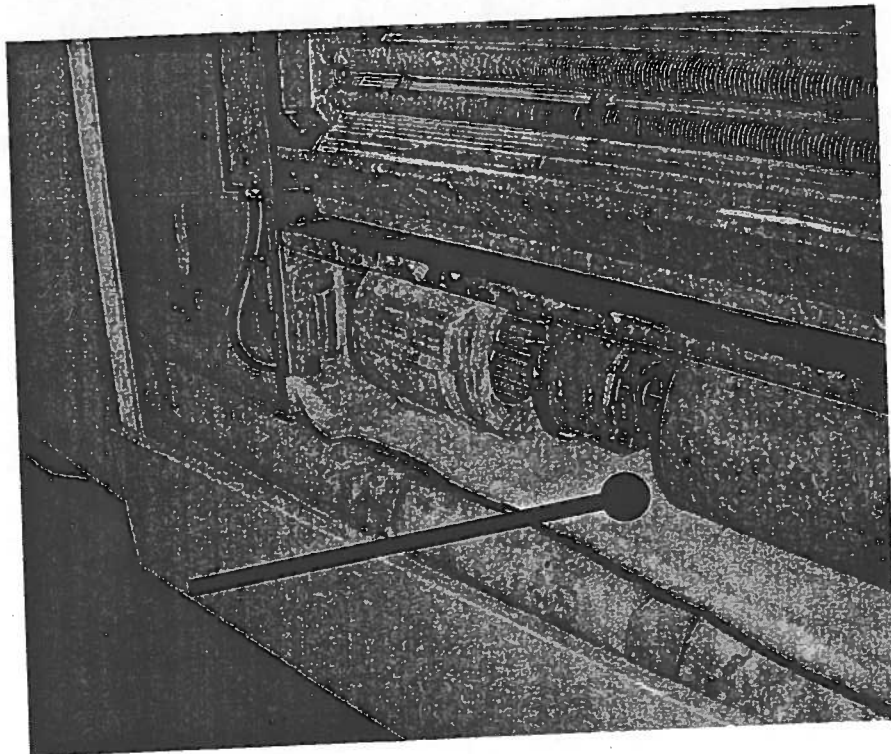
Picture 24

FCUs are normally equipped with filters that strain particulates from airflow. Filter materials cut to size were found inside the FCUs (Picture 24). Air may bypass improperly sized filters through spaces in the frame and result in aerosolization of dust. In order to decrease aerosolized particulates, disposable filters with an adequate dust spot efficiency should be installed. The dust spot efficiency is the ability of a filter to remove particulates of a certain diameter from air passing through the filter. Filters that have been determined by ASHRAE to meet its standard for a dust spot efficiency of a minimum of 40 percent would be sufficient to reduce airborne particulates (Thornburg, 2000; MEHRC, 1997; ASHRAE, 1992).

Filter Media Cut To Fit FCU

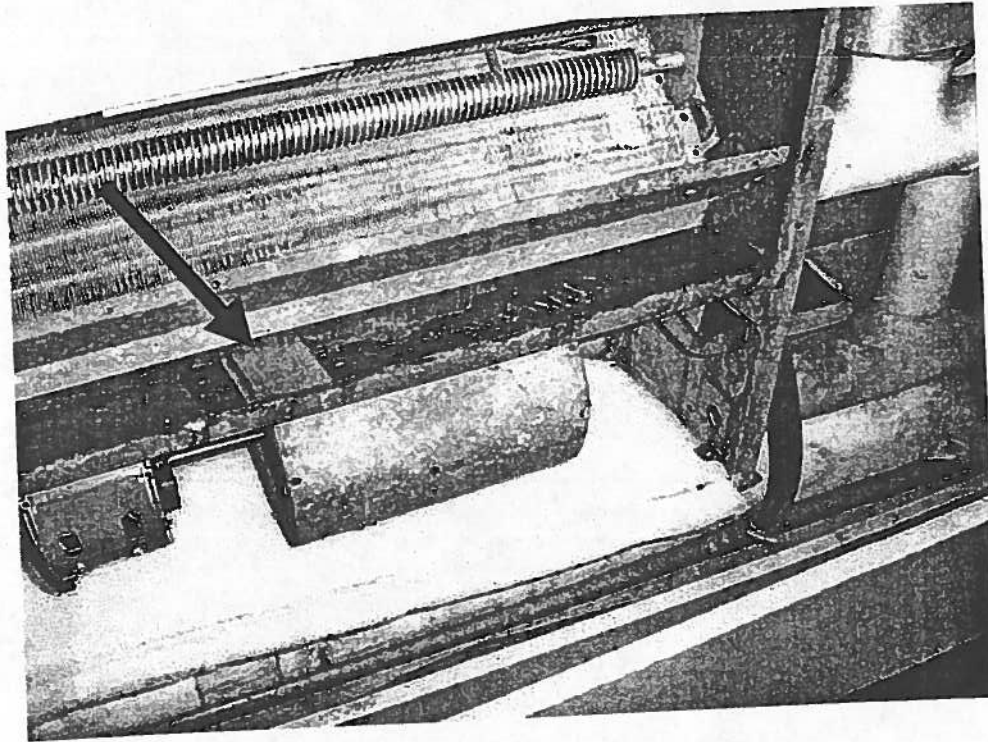
Picture 25

The interiors of a number of FCUs were examined. An antimicrobial agent was found in FCU drip pans (Picture 25). The use of this product in FCU drip pans is not necessary. In order to support bacteria growth such as *L. pneumophila*, moisture within a certain temperature range must be achieved. The ideal temperature for this microorganism to grow is at temperatures between 80 to 120° F (27 to 49° C) in the presence of sunlight, oxygen, and nutrients such as phosphorous, nitrogen, sulfate and carbon dioxide (Lane, R.W., 1993). Organisms such as algae, mold, *Legionella pneumophila* (Gold, D. 1992) and other microbes have been found to grow within HVAC equipment that reuses water, such as cooling towers. The purpose of cooling towers in an HVAC system is to remove heat from coolant, which warms water to the requisite temperature for microbial growth.

The purpose of drip pans is to drain moisture generated by *cooling coils*. The temperature of FCU coils in the cooling mode during the summer is less than 60° F. Lower temperature and removal of moisture through proper drainage would limit microbial growth in FCUs, rendering the use of the antimicrobial agent unnecessary.

Of note are the constituents of the antimicrobial product that are frequently alkaline materials. The odor produced by this product is characterized as a "mothball-like" odor. As condensation comes into contact with the antimicrobial ingredients they form a solution. This solution may become aerosolized during FCU operation if standing water exists in drip pans. Exposure to this product may cause irritation to the eyes and skin.

Antimicrobial Agent in FCU Drip Pan

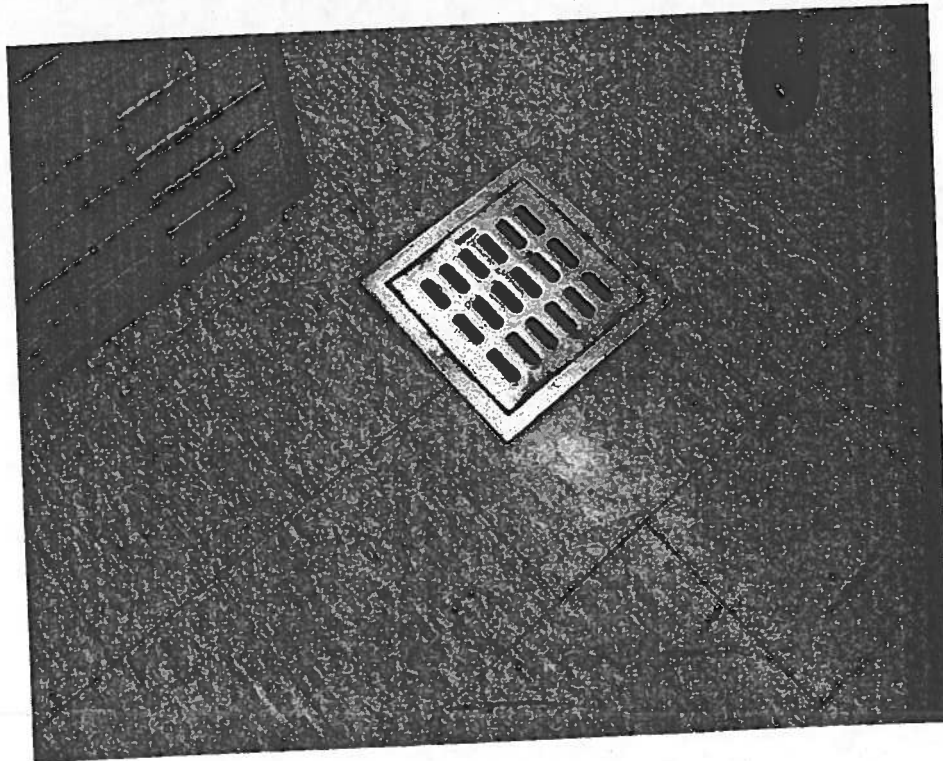
Picture 26

An unused drain was found in the floor of a room in the Registry of Deeds (Picture 26). The drain likely has a dry trap, which can allow sewer gases/odors to migrate from the drain system into occupied space. The drain should be filled regularly with water or sealed to prevent this contingency.

Drain In Floor of Registry of Deeds
