# MA FACE Occupational Fatality Report

## Mechanic Crushed When the Dozer He Was Lowering Shifted and Fell off the Jack - Massachusetts

Release Date: March 12, 2015  
Investigation: # 13-MA-002-01

Massachusetts Department of Public Health  
Occupational Health Surveillance Program

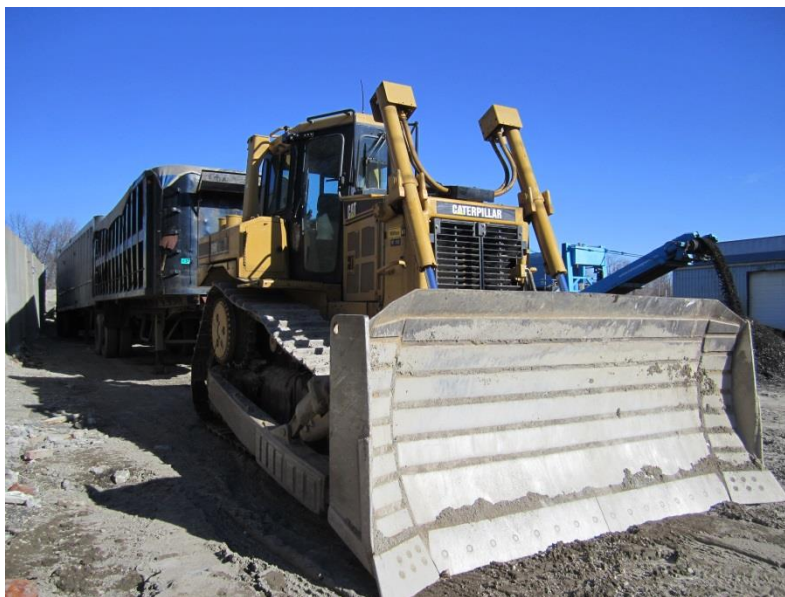
**Figure 1 – The track type tractor (dozer) involved in the incident**

The machine involved in the incident was a track-type tractor (dozer) that had been manufactured in 2006. The company purchased the dozer in the same year it was manufactured (Figure 1). The dozer was equipped with an enclosed cab and an elevated sprocket undercarriage. The dozer had an operating weight of just over 44,200 pounds.<sup>1</sup> The dozer was 10'6" high, 8'8" wide, and 12'8" long without an attachment. The victim was replacing the dozer's right front track adjuster at the time of the incident. The defective track adjuster was under warranty by the manufacturer, but the labor cost to replace the part was not covered with the warranty. Therefore, the company was going to remove the defective track adjuster and send it to the manufacturer. Then the manufacturer was then going to send a new track adjuster to the company to install.

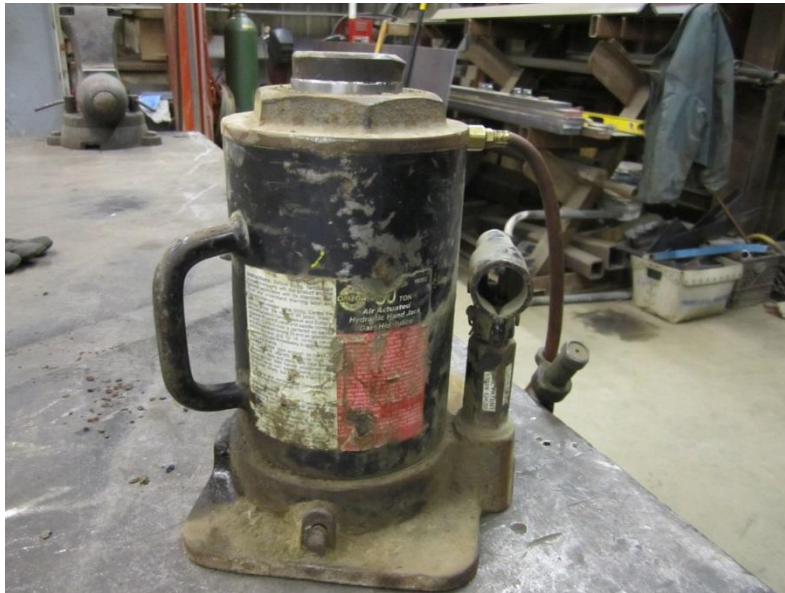
**Figure 2 – The 30-ton bottle jack being used during the incident**

To perform the repair, the dozer had to be lifted to remove the dozer's weight from the track. A 30-ton air actuated hydraulic bottle jack was used to raise the dozer (Figure 2). The bottle jack had a lifting capacity of 60,000 pounds and a maximum lift height of 18 inches. The base of the bottle jack was 10 ¼ inches long by 8 ¼ inches wide and the diameter of the saddle, the point of contact between the jack and the load being raised, was 2 ½ inches.<sup>2</sup> The jack had a warning label but it was no longer in readable condition. The company had the operating manual for the jack and the warning labels were included in the manual. The warning labels included that work should never be performed under or around a load supported only by the hydraulic jack. In addition, the operating manual included two warnings that were specific to this type of incident. These warnings were to ensure that: 1) all tools and employees are clear before lowering a load and 2) employees never place any portion of their body under a load while it is being raised or lowered.

**Discussion:** In this case, the warning label on the bottle jack was worn and no longer legible. While housekeeping was not the root cause of this fatality, if the warning label had been visible the employees might have been reminded of the hazards associated with using the bottle jack. As mentioned above, the warning label included that work should never be performed under or around a load supported only by the hydraulic jack.

Routine inspections of the bottle jack could have previously led to the observation and replacement of the worn warning label. In addition, the visual inspections would include looking for any abnormal conditions such as excessive wear, cracked welds, and damaged, loose or missing parts. If any of these or other conditions are observed, the jack should be immediately tagged and removed from service until it is repaired. OSHA also requires that all jacks, which are constant or intermittently used at one locality, to be inspected once every six months by the manufacturer or an authorized repair facility.

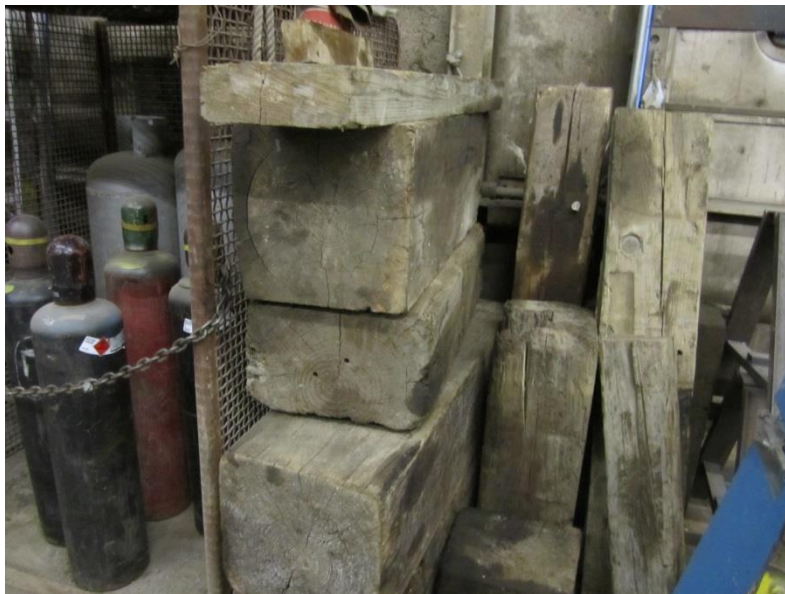
**Figure 3 – The oak block cribbing being used during the incident**

One of the first steps performed during the replacement of the track adjuster was to remove the dozer's blade attachment. The 30-ton air actuated hydraulic bottle jack was used to raise the dozer and 12x12x4 oak blocking was used as cribbing to secure the raised dozer. Once the cribbing was in place, the jack was removed from underneath the dozer. While waiting for the new track adjuster to arrive, the dozer remained raised and supported by the cribbing inside one of the garage bays (Figure 3).

In this case, the dozer was raised by the bottle jack and then lowered onto cribbing in the form of oak blocks placed in a cross pattern underneath the dozer.<sup>3</sup> The dozer remained supported on the cribbing throughout the repair process. Once the dozer was ready to be lowered, the bottle jack was used to raise the dozer and the cribbing was removed. While lowering the dozer an issue was encountered and the victim then went partially underneath the dozer while it was only being supported by the bottle jack to try and observe the problem. At this point, prior to going underneath the dozer, the cribbing should have been put back in place to ensure the dozer was stable. A quicker alternative would be to use jack stands instead of cribbing. If jack stands are used, employers must ensure that the jack stands are rated to support the weight of the intended load. In addition, jack stands should only be used when the task is being performed on a hard level surface.
