WHEELLOCK SCHOOL

Location: 17 Elm Street

Year Built: 1968

PHOTOGRAPHIC DOCUMENTATION of RALPH WHEELLOCK SCHOOL, MEDFIELD, MA

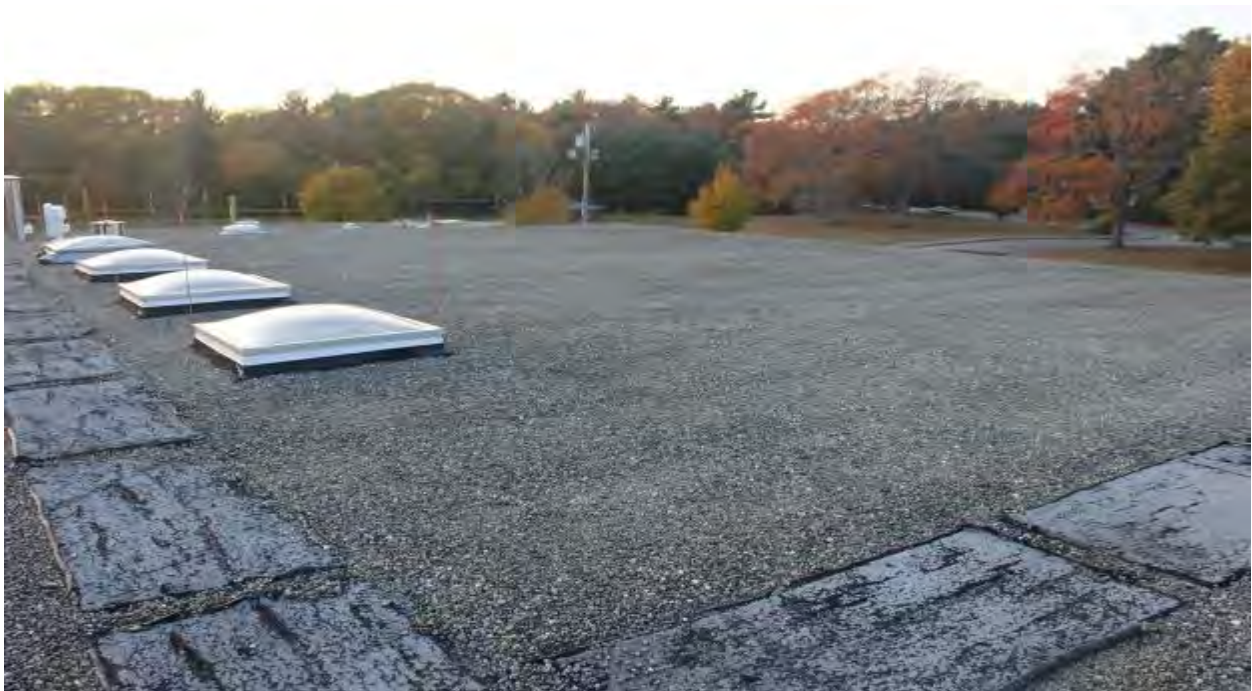
BUR roof Thinning stone ballast, walk pad failing, curb flashing is separating from vertical rise.

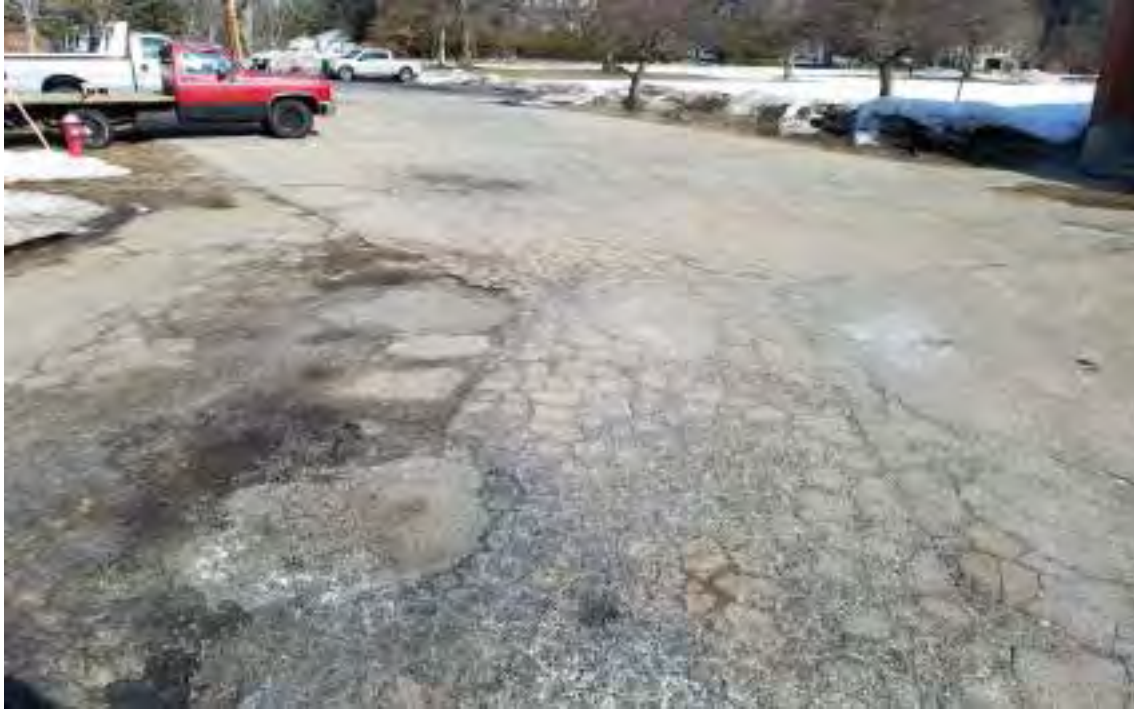
Showing poor condition of paving on west side and routine parking on lawn areas

Remove and replace all the remaining pavement. Recommend that existing bituminous be reclaimed, sub-grades regraded and new binder & topcoat be installed according to Town of Medfield road construction standards. \$200,000

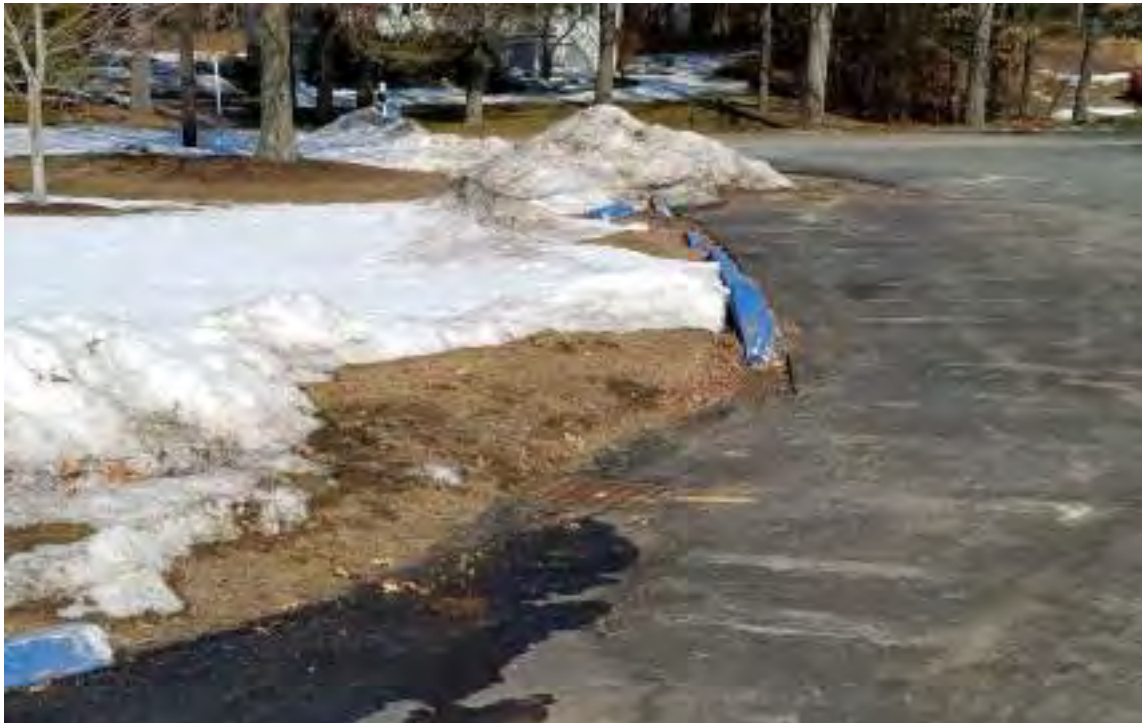
Showing front driveway / parking area with dislodged curb stops and lack of pavement markings

Recommend bituminous asphalt berm be used in lieu of loose curb stops at perpendicular parking areas and along lawn areas to restrict vehicle access.

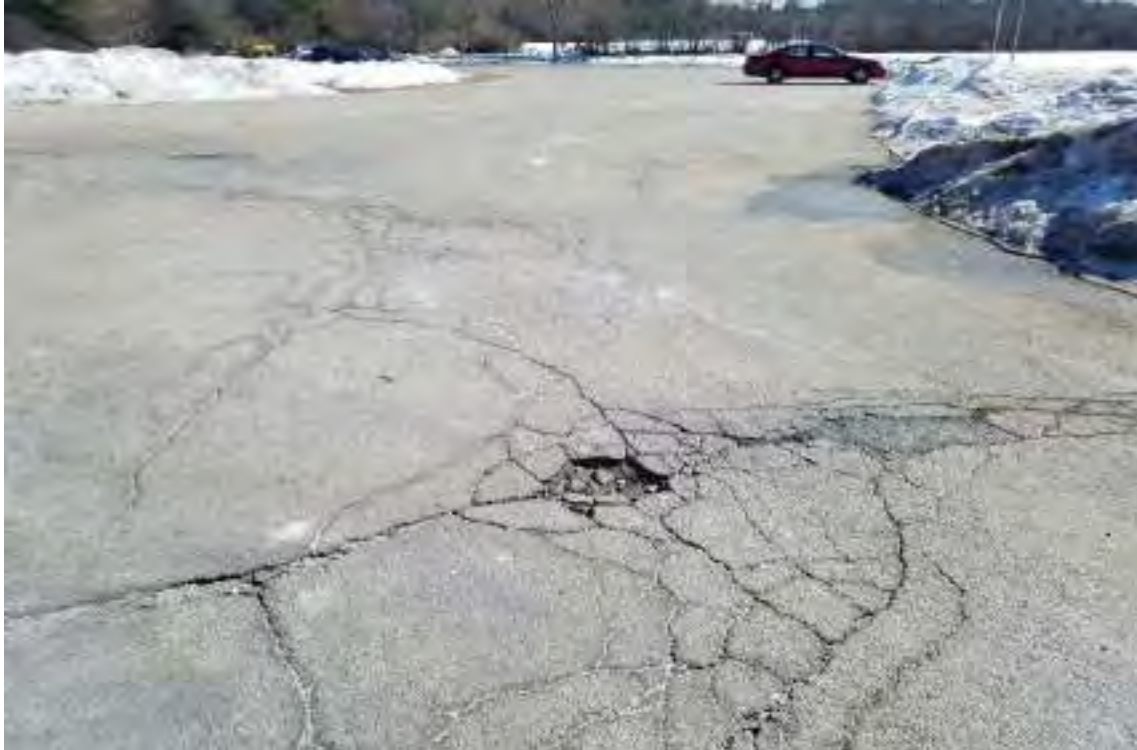
Showing deteriorated pavement and pothole at rear driveway area

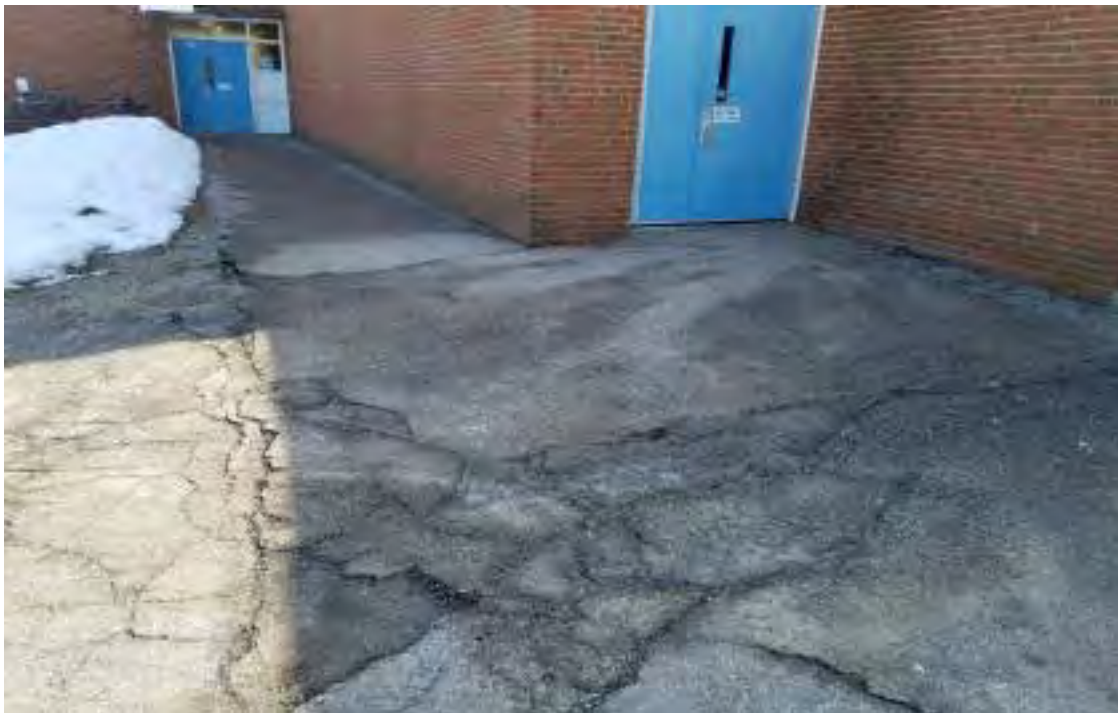
Deteriorated paving at egress path from exits

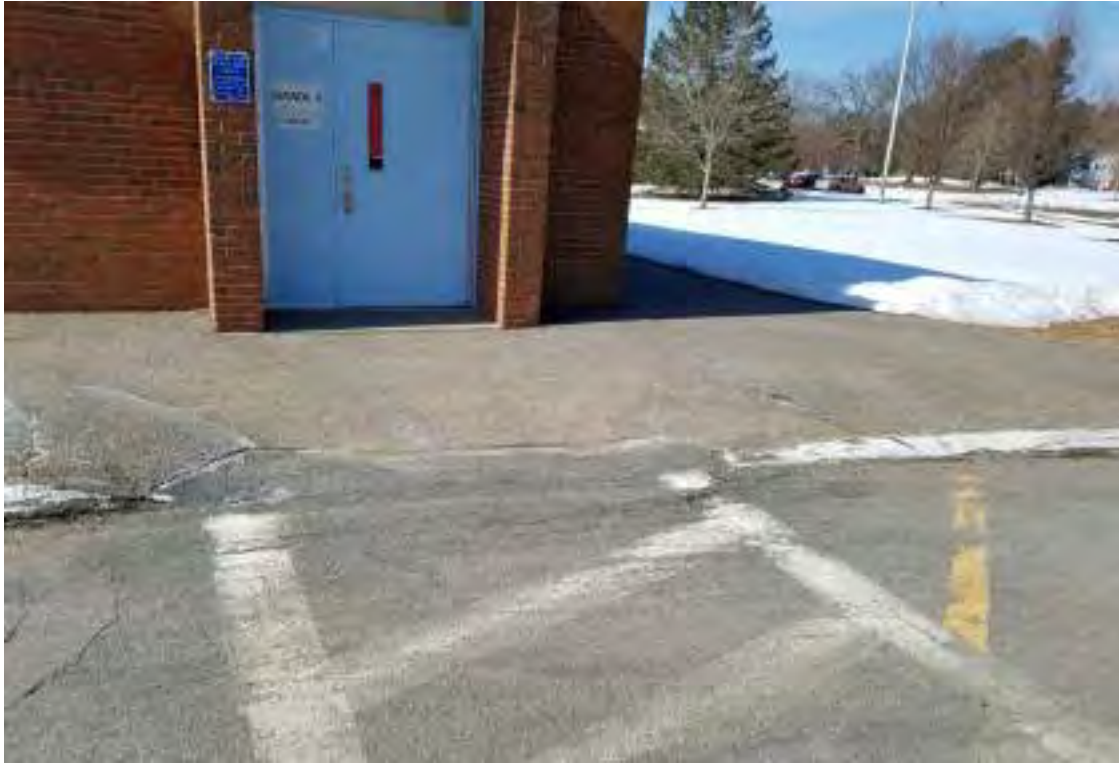
Poorly constructed curb cut and worn pavement markings

Curb cuts need to be reconstructed using concrete with new transition curbs. Almost impossible to construct a compliant curb cut with bituminous asphalt. Remaining sidewalks along driveway could be bituminous, but recommend concrete walks and curbing along the front walk area.

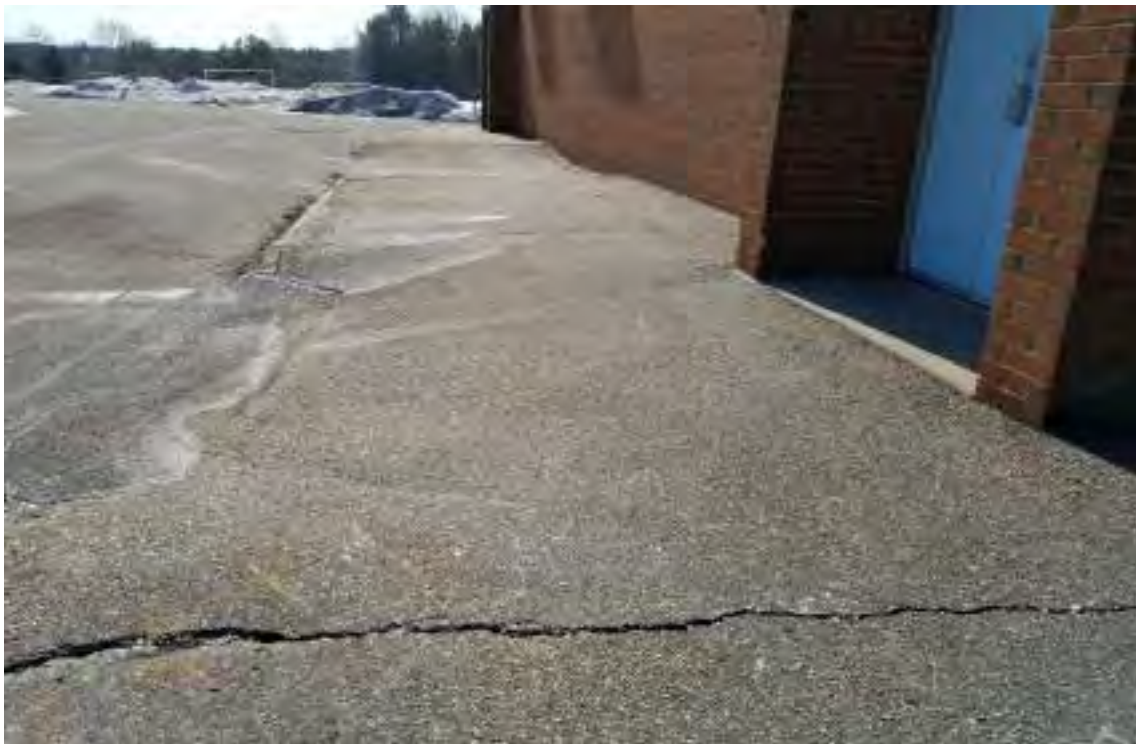
Egress door lacking 5' level landing before slope to curb cut, and deteriorated paved walkway

Areas with sloped paving right up to exterior doors should be replaced with a minimum of a 5' x 5' concrete landing meeting MAAB regulations of 2% max slope. \$20,000

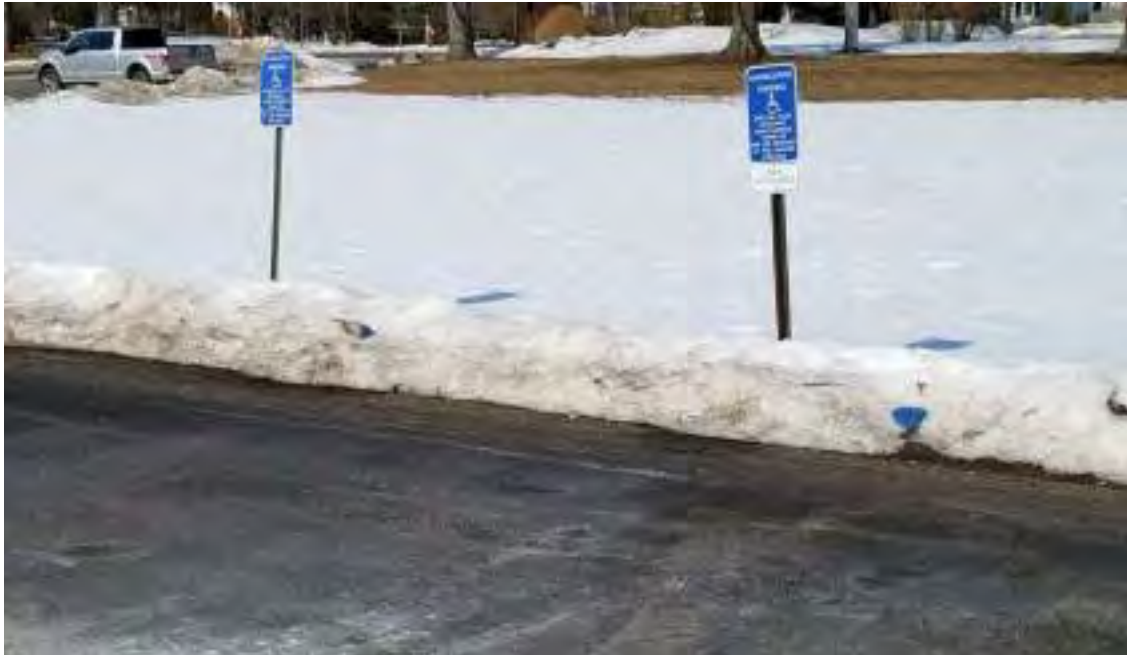
Accessible parking spaces lacking pavement markings & non-compliant sign height

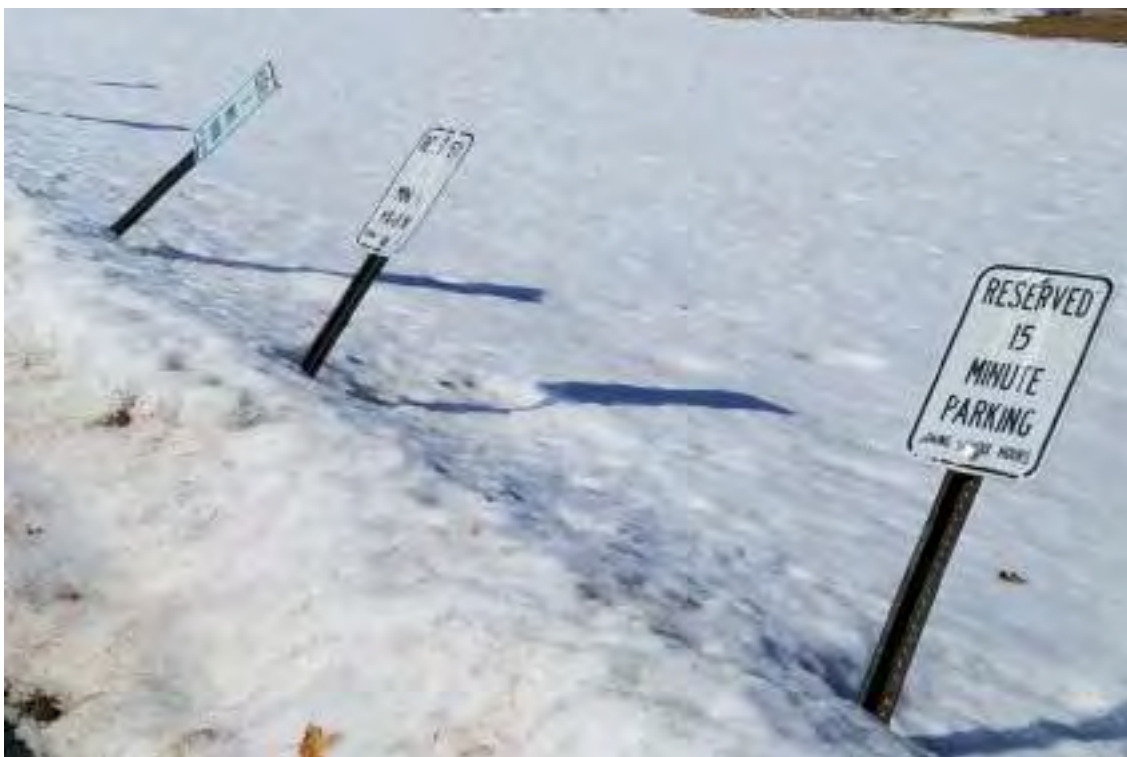
Signage needing repairs

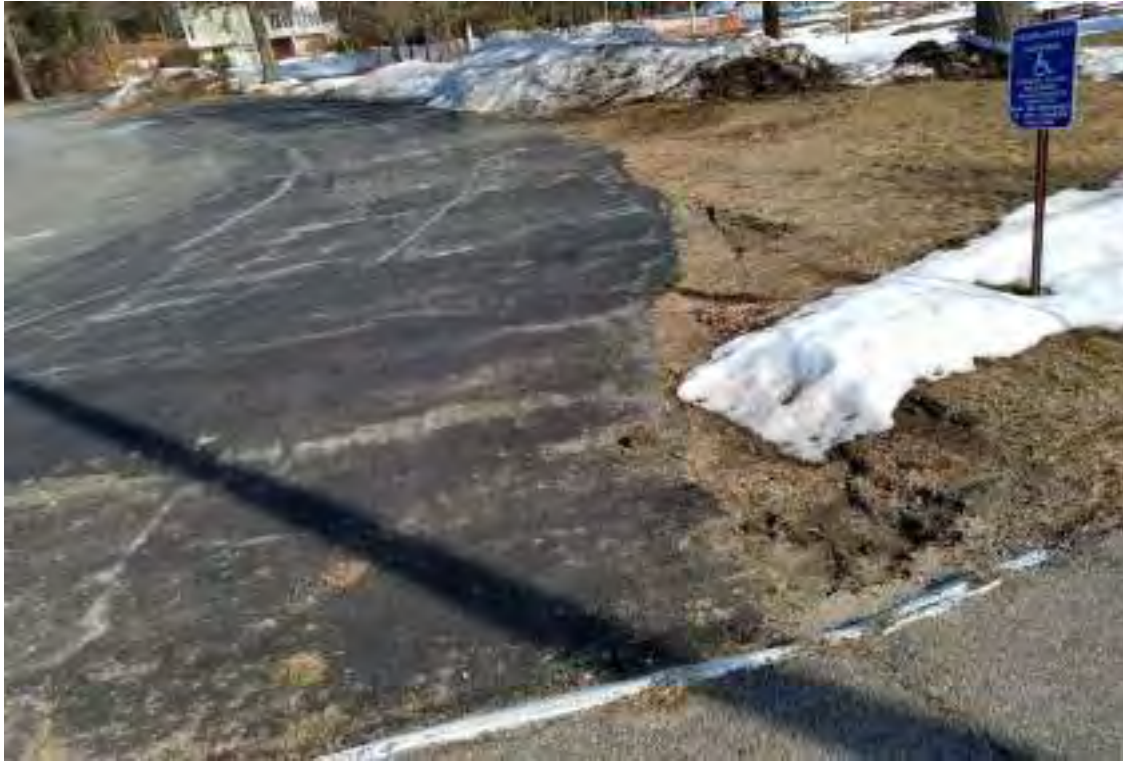
Showing lack of pavement markings and excessive slope at accessible parking space

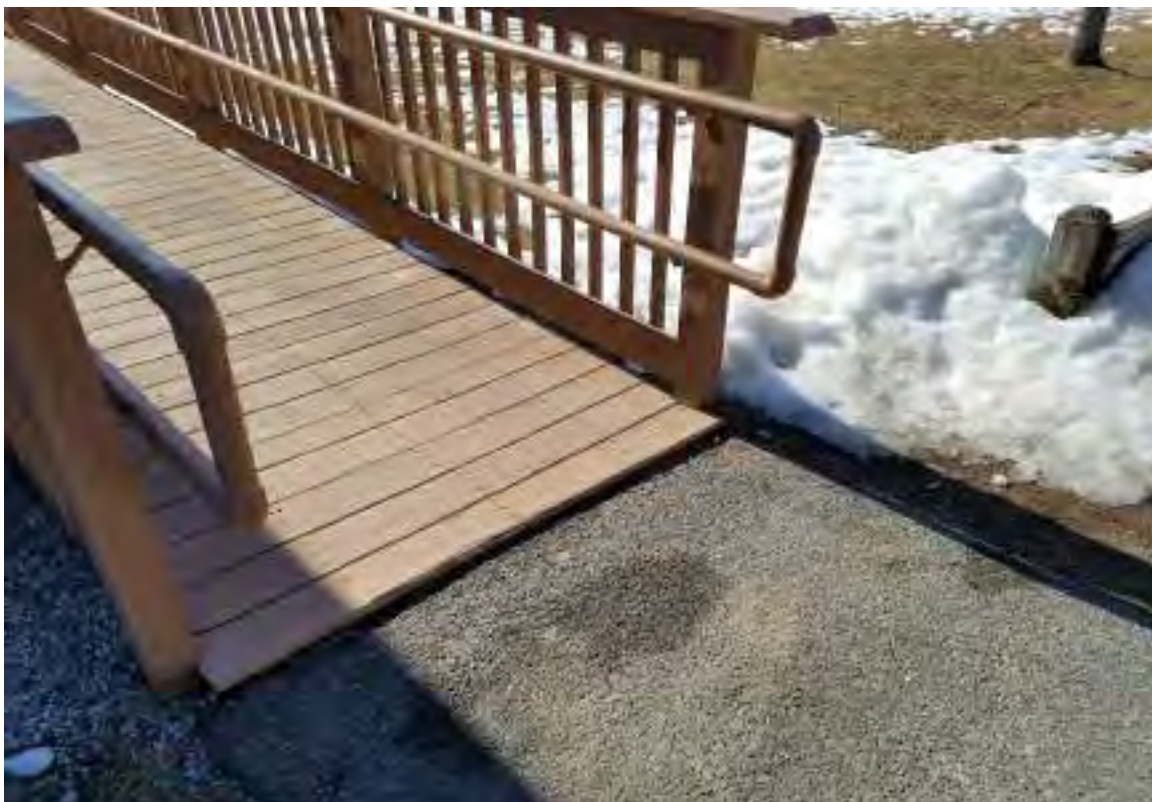
Showing tripping hazard lip at edge of ramp and non-compliant rail system at After School Center

Eliminate lip in paving to provide flush condition at After School Center ramp. \$3,000

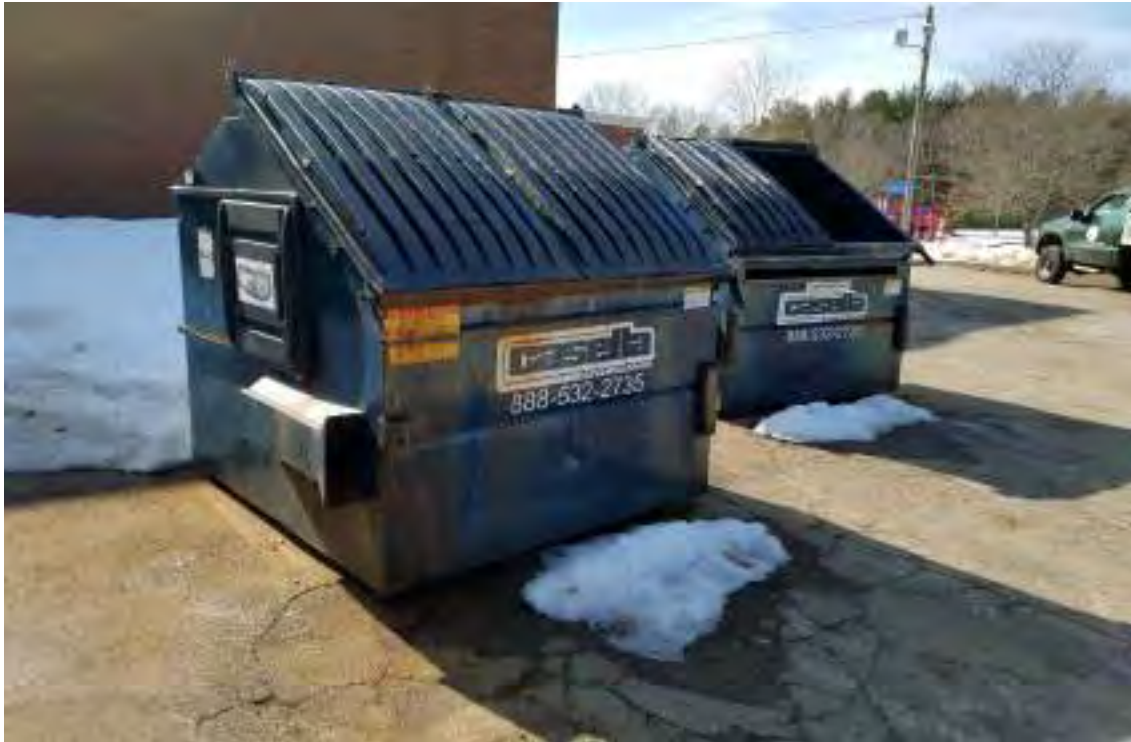
Showing unenclosed dumpsters in visually prominent location

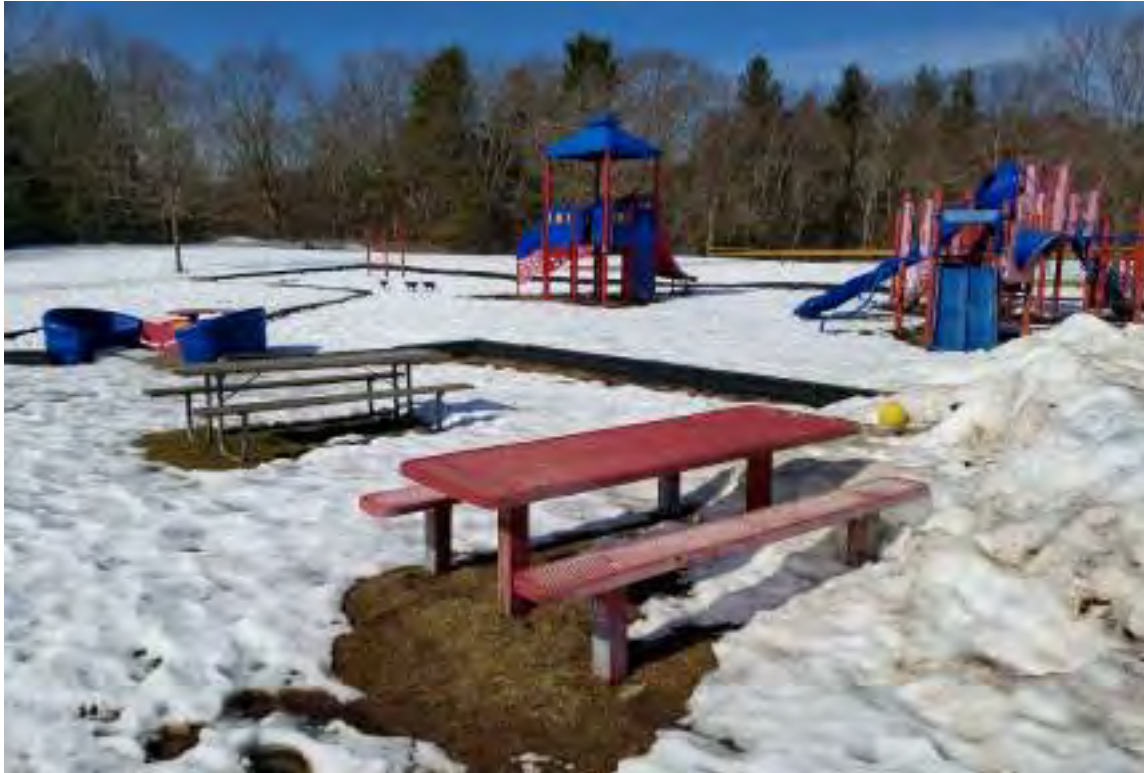
Showing non-accessible picnic area and berm obstacle around play area beyond

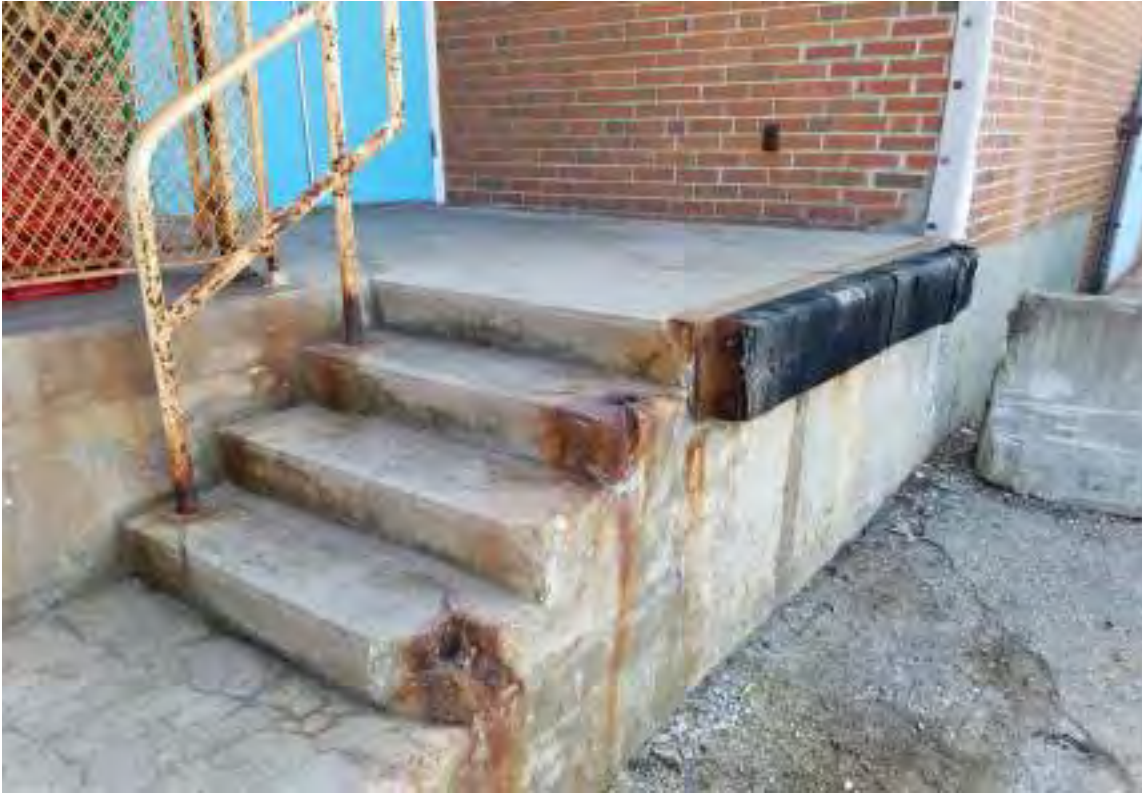
All exposed metal components at loading dock are rusted and in need of paint.
Concrete steps need some repair and a portion of guardrail is missing.

Showing deteriorated concrete steps, lack of handrail and areas needing paint

Repair concrete steps and provide new galvanized piperail where missing. \$8,000

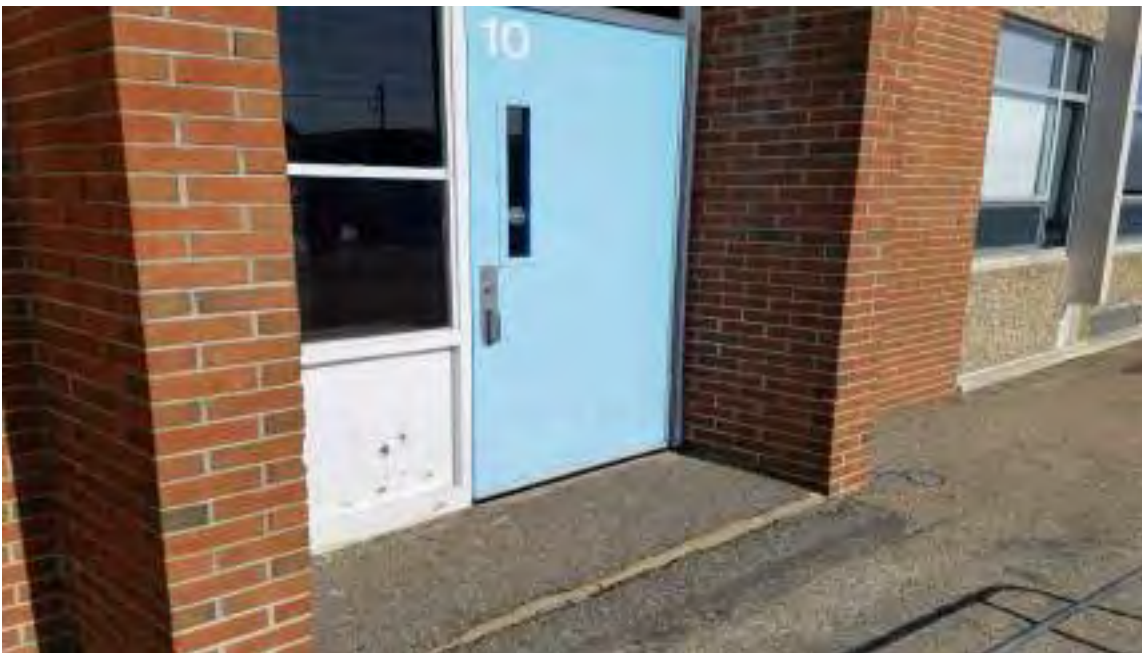
Showing lack of 5' level landing at egress door and HM frames needing paint

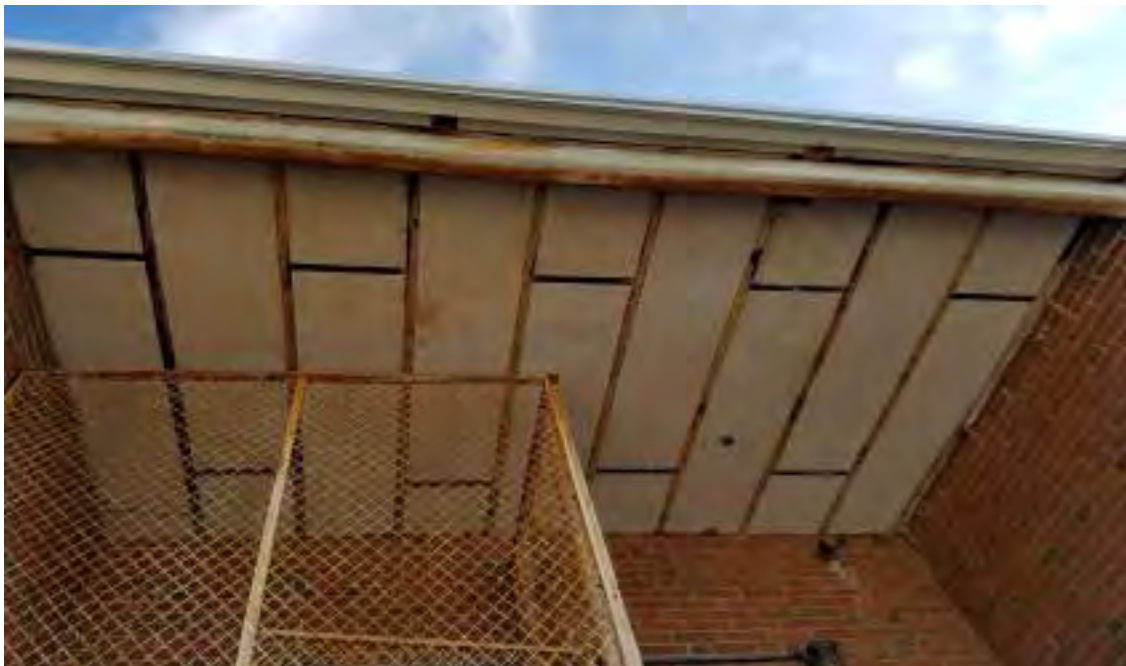
Rusted metal components at covered truck dock (West)

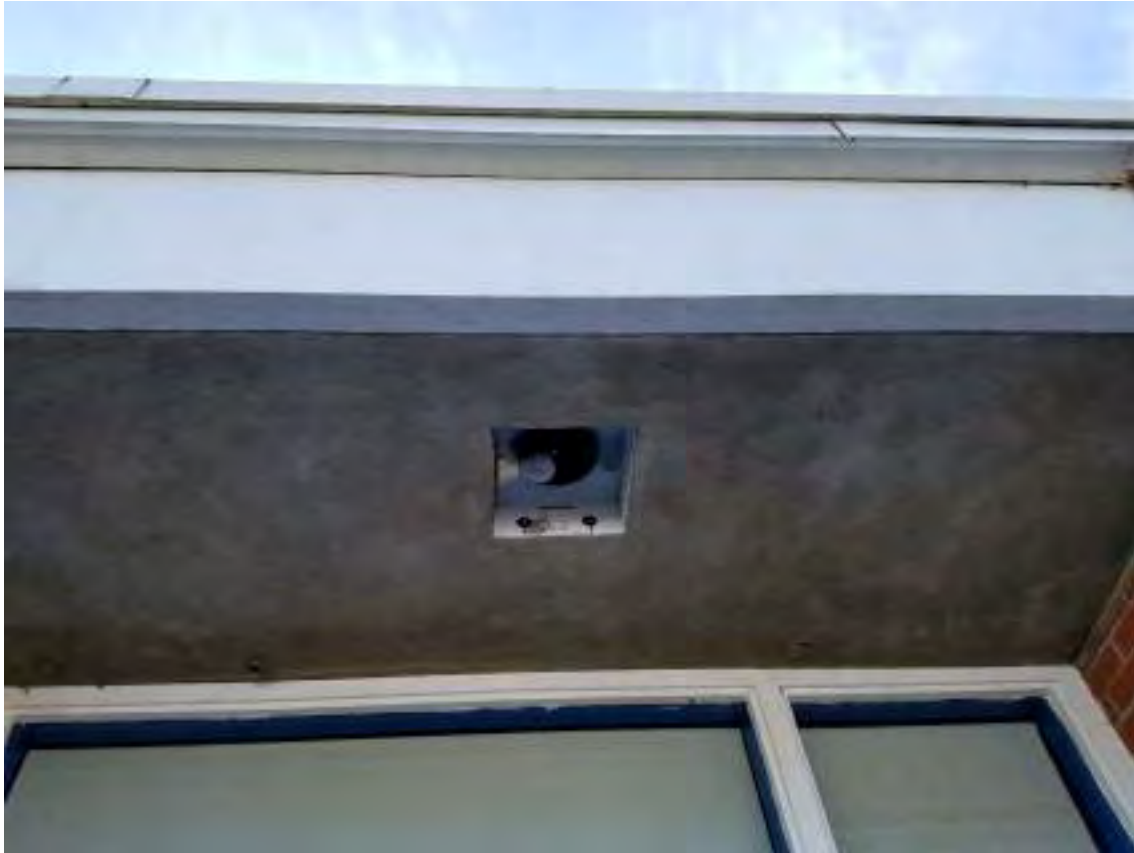
Outdated incandescent fixture and water-stained ceiling of covered entry

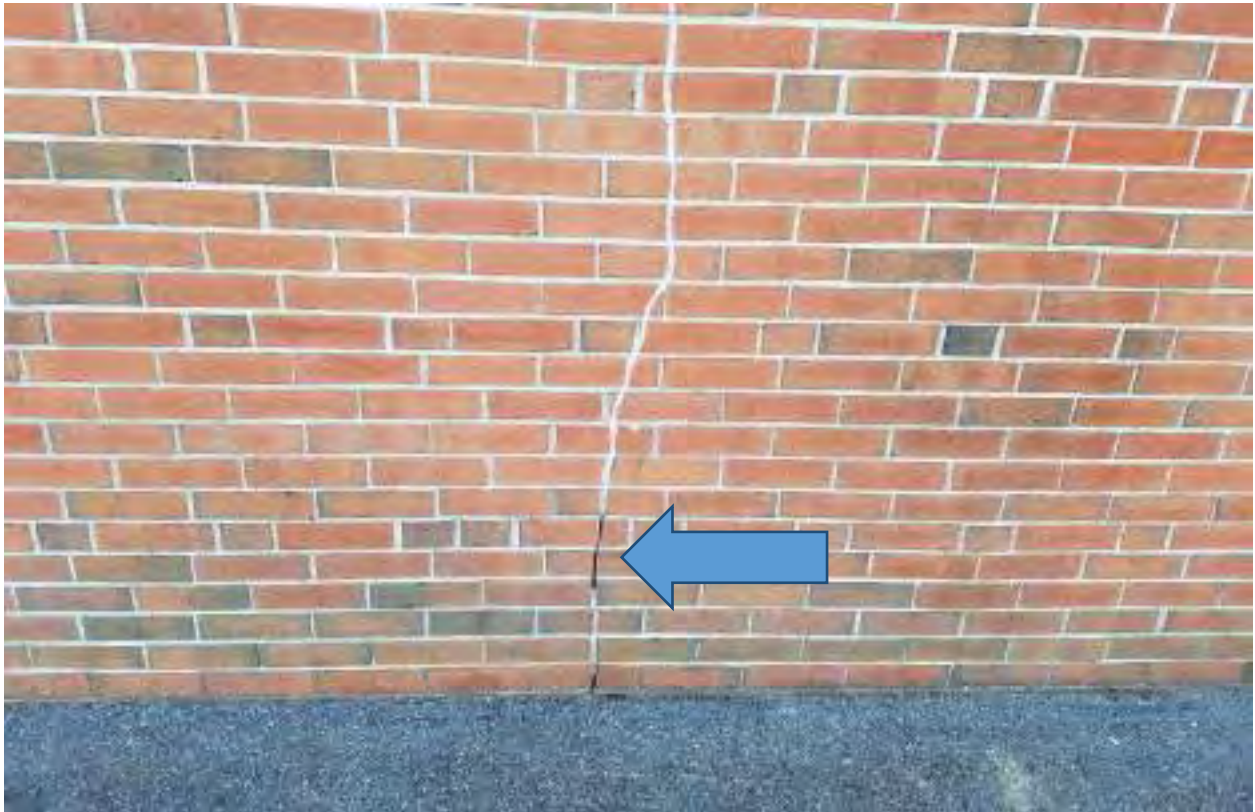
The original brick and mortar is in good condition. Some previous repairs to brick was observed, and some areas are now in need of additional repairs. There are several specific areas of concern that will need a structural engineer to inspect and investigate as to the cause of the structural cracking. The cracking appears to be created due to the lateral movement of the building, the lack of expansion joints, possible settlement of specific areas of the foundation, and possible past water/moisture penetration within the brick that caused expansion and cracking due to freeze thaw. **Specific areas that will require further investigation of the structure are North elevation structural crack, west side loading dock**

Example of cracks in brick veneer needing repair (north elevation)

Hire a structural engineer and exterior envelope specialist to evaluate areas of concern and create repair documents as well as review entire building envelope. \$70,000

Repair all damaged walls identified by the engineer. \$500,000

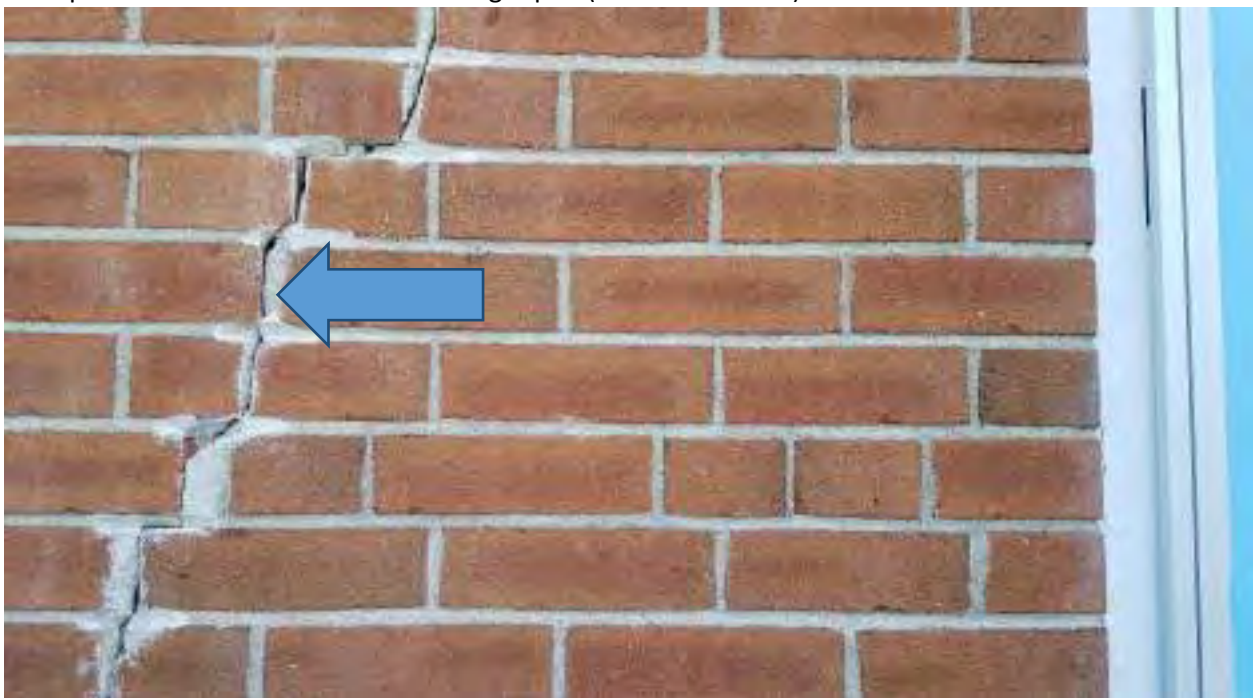
brick facade, west side boiler room wall, main gym (wall cracking observed on interior walls) and wall/cast in place concrete vestibule roof locations. At these locations, the cracking is pronounced and radiate through the wall.

Example of cracks in brick veneer needing repair (west elevation)

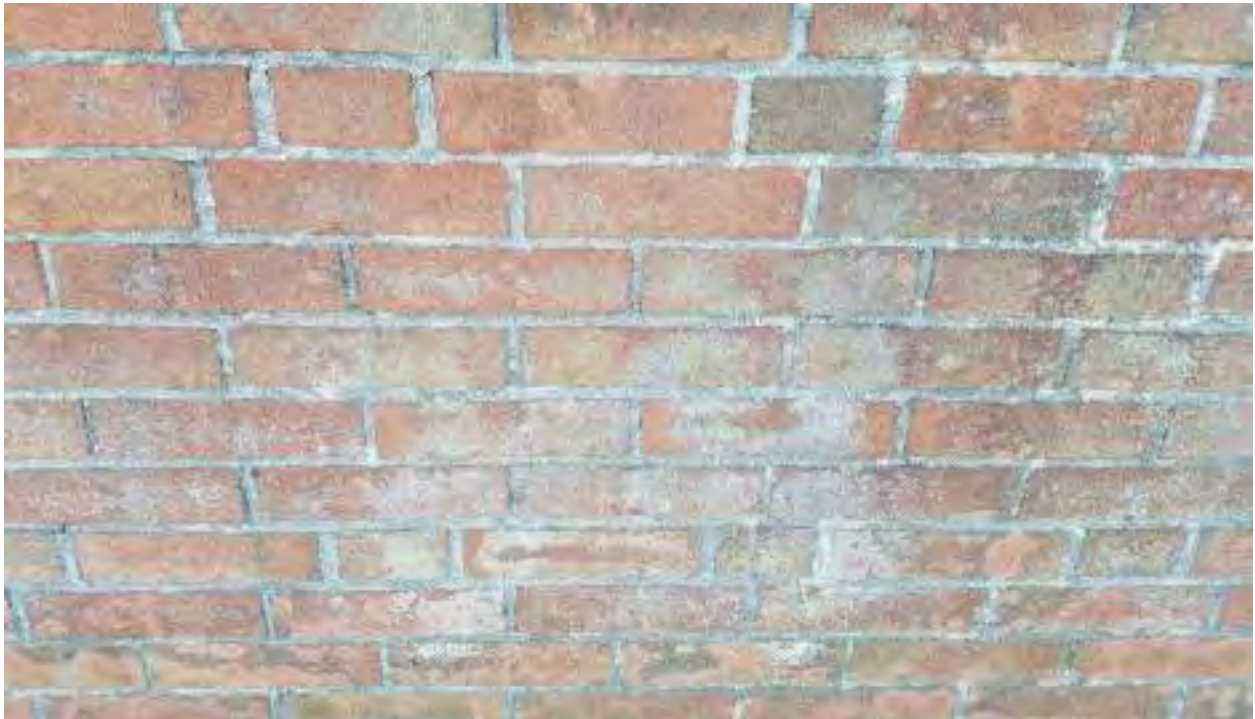
Example of brick veneer exterior surface condition needing cleaning & sealing

A restoration detergent is recommended. \$100,000

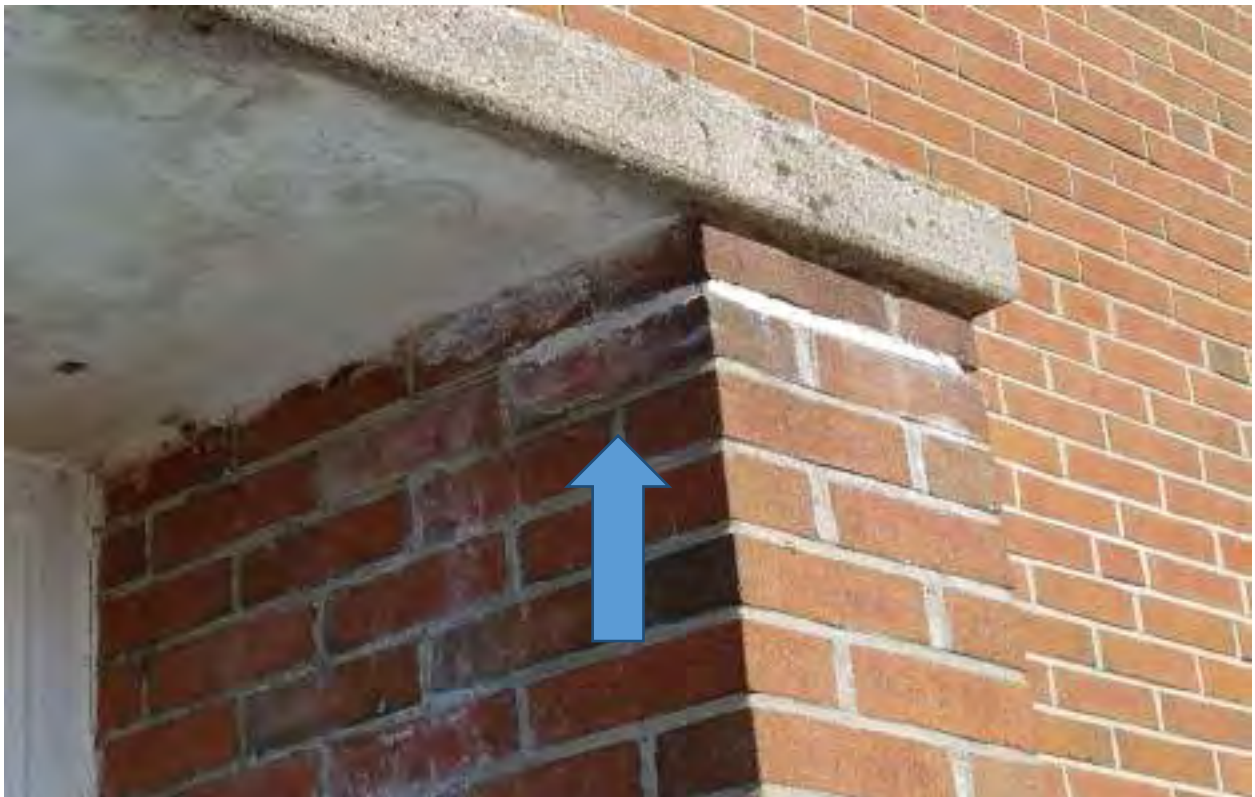
The precast concrete caps over covered entrances are porous and allowing water to infiltrate below into light fixtures and adjoining brick work. The cap is minimally sloped, with no weather protection or flashing into adjoining vertical brick surfaces.

Showing water penetration through concrete entry cap deteriorating brick (efflorescence shown)

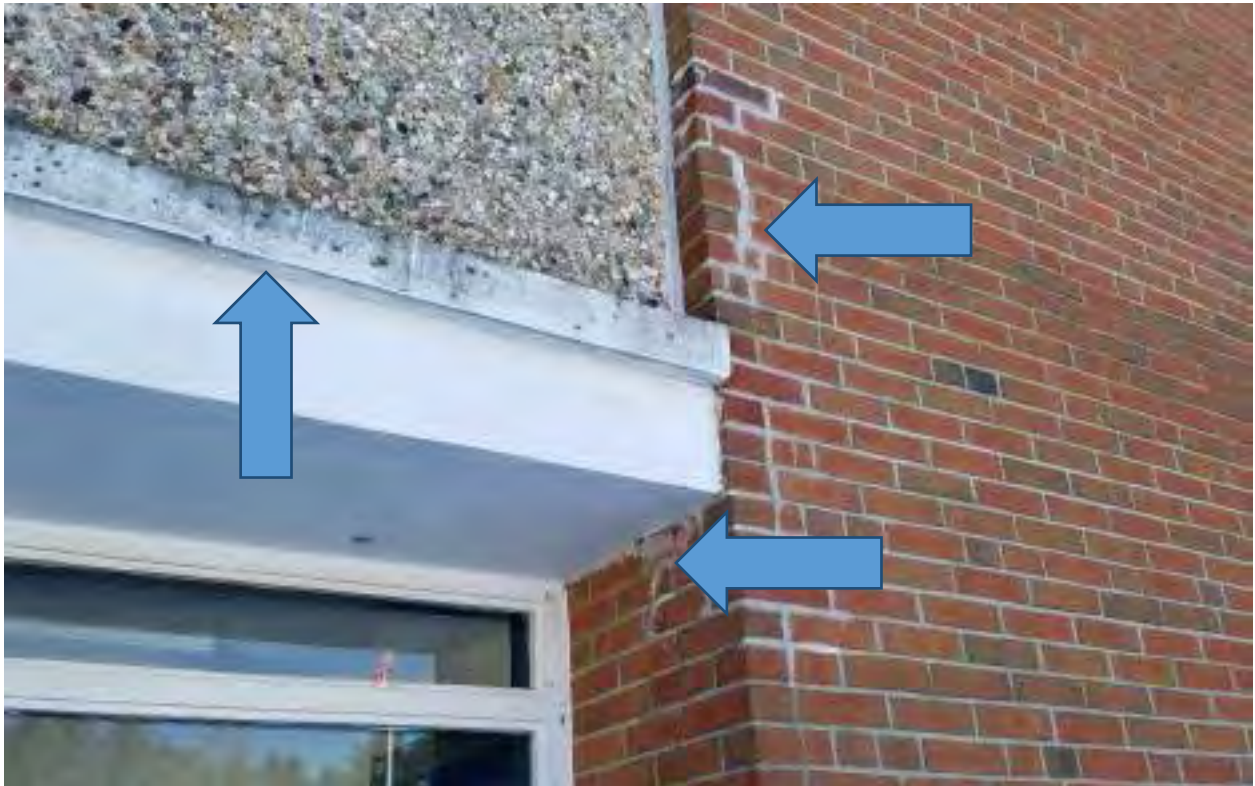
Signs of water infiltration and associated brick damage (previously repaired) and mildew on flashing

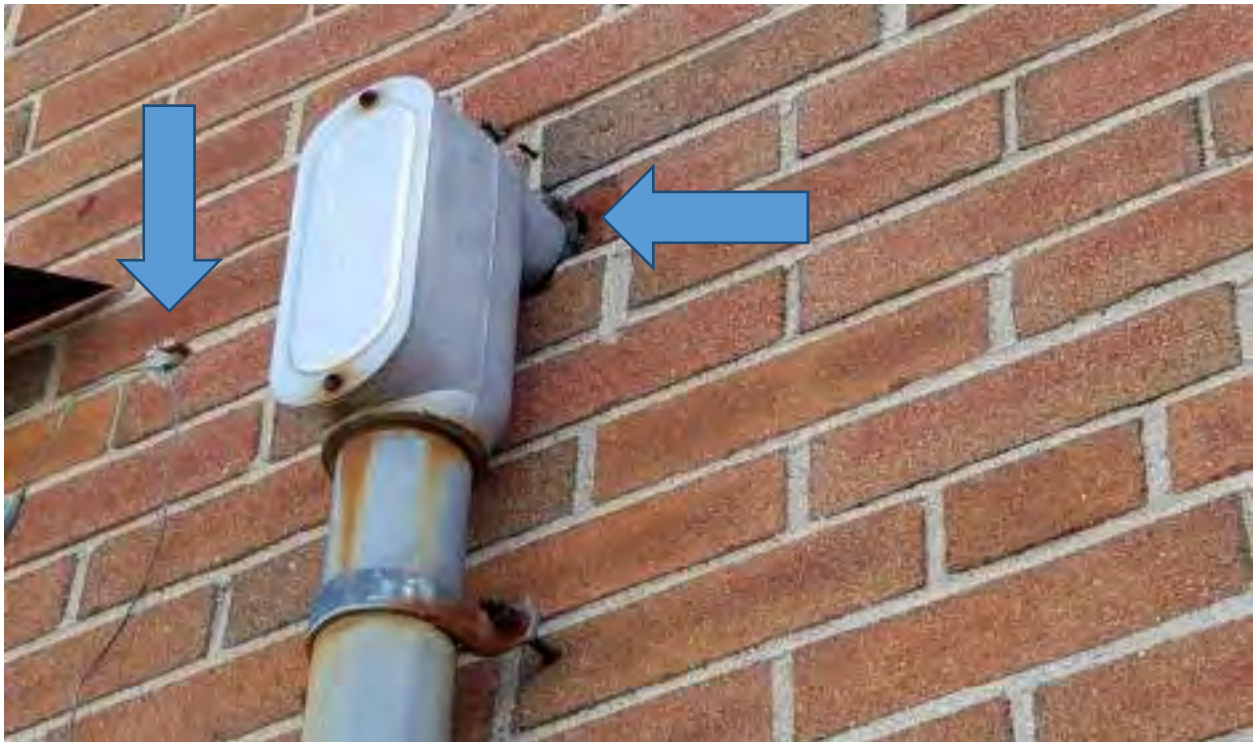
Gaps were observed around existing electrical service penetrations on west side and at some random penetrations that could also allow water infiltration.

Example of brick penetrations needing sealant (west elevation)

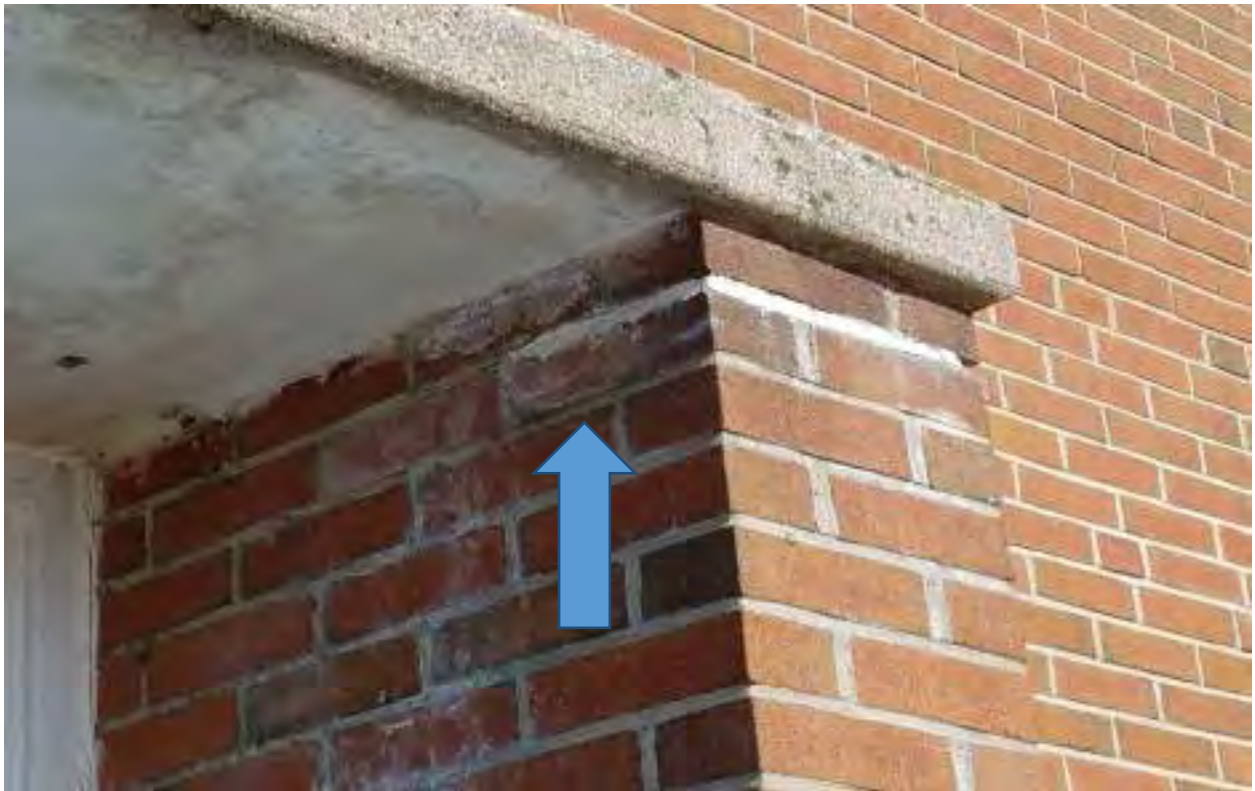
Another typical example of porous concrete entry cap that has caused brick deterioration
