WHEELLOCK SCHOOL

Location: 17 Elm Street

Year Built: 1968

PHOTOGRAPHIC DOCUMENTATION of RALPH WHEELLOCK SCHOOL, MEDFIELD, MA

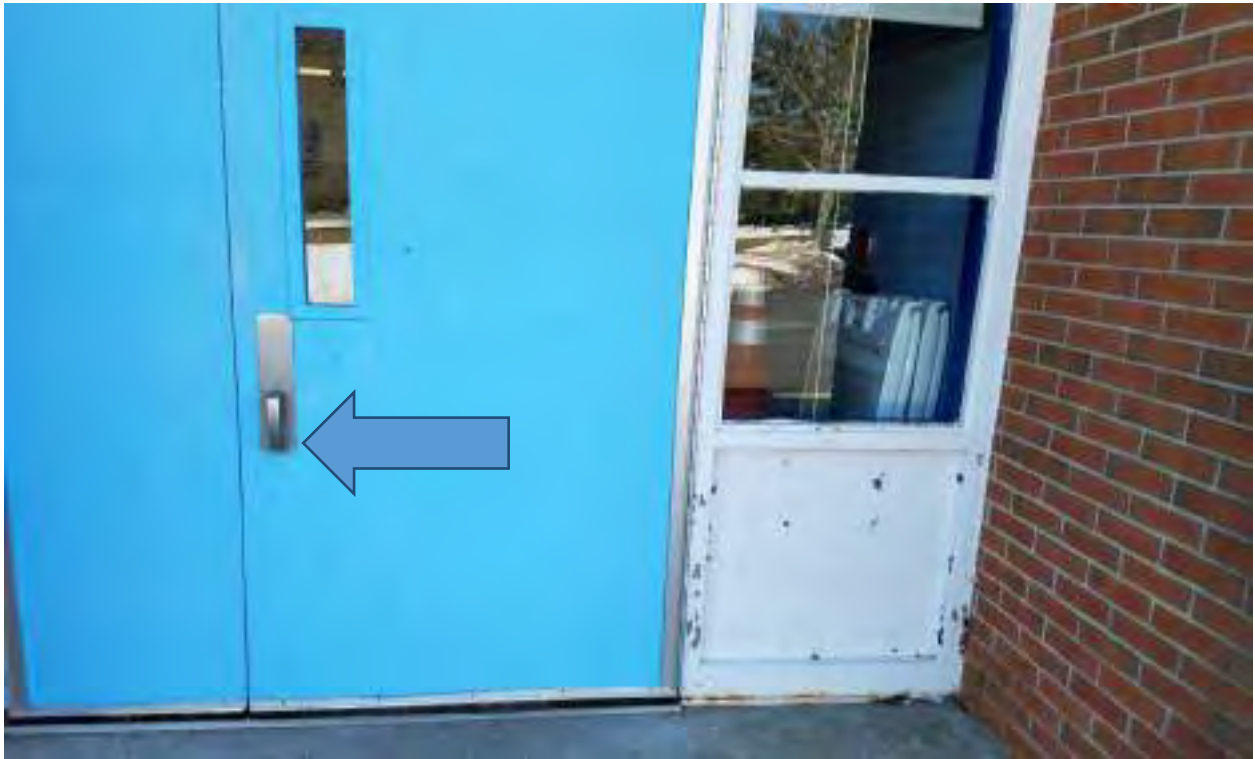
Hollow metal exterior doors are set in hollow metal frames appear to be in fair condition, showing normal wear. The latching hardware on most doors looks original and does not conform to ADA or MAAB standards.

Typical entry showing non-compliant door latching hardware and hollow metal frames needing paint

Sand, repair and Repaint all exterior doors and frames. \$50,000

Replace non-compliant latching hardware with new compliant lever latches. Check closers for proper operation (effort & closing speed) \$50,000

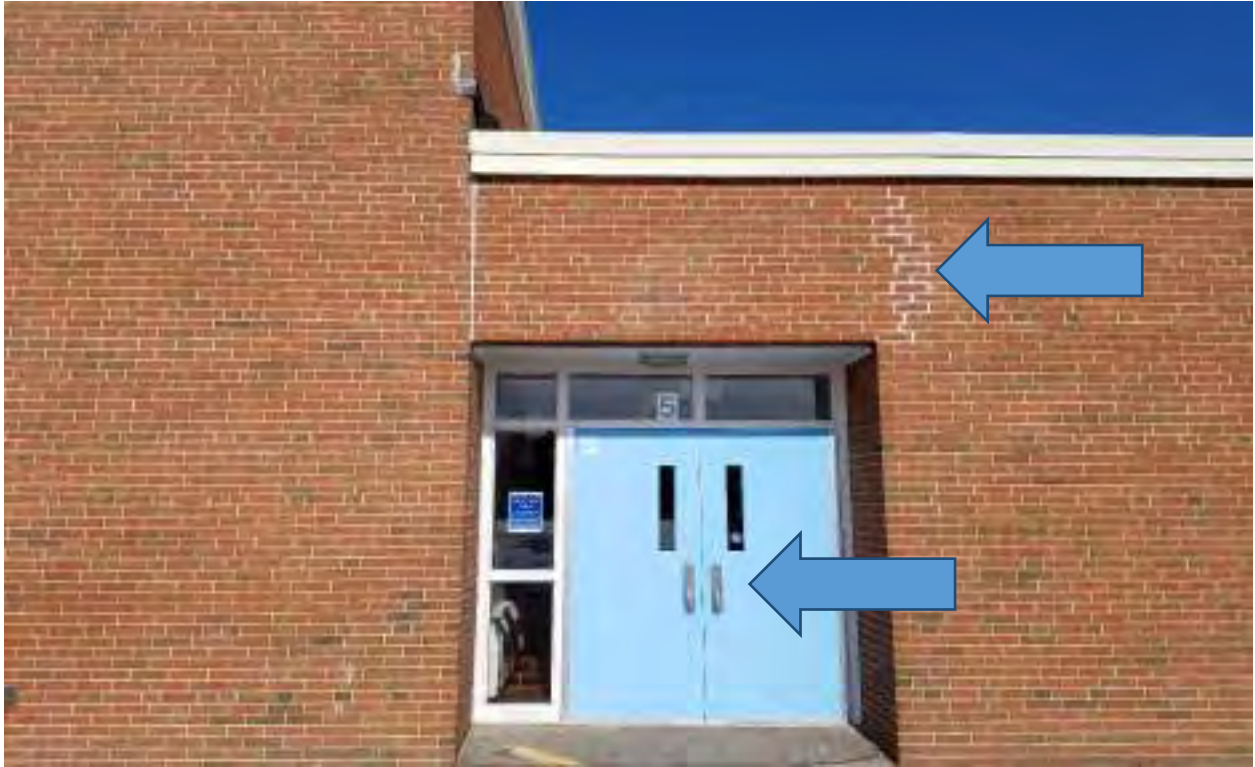
Another example of non-compliant hardware and previous repair of brick damage

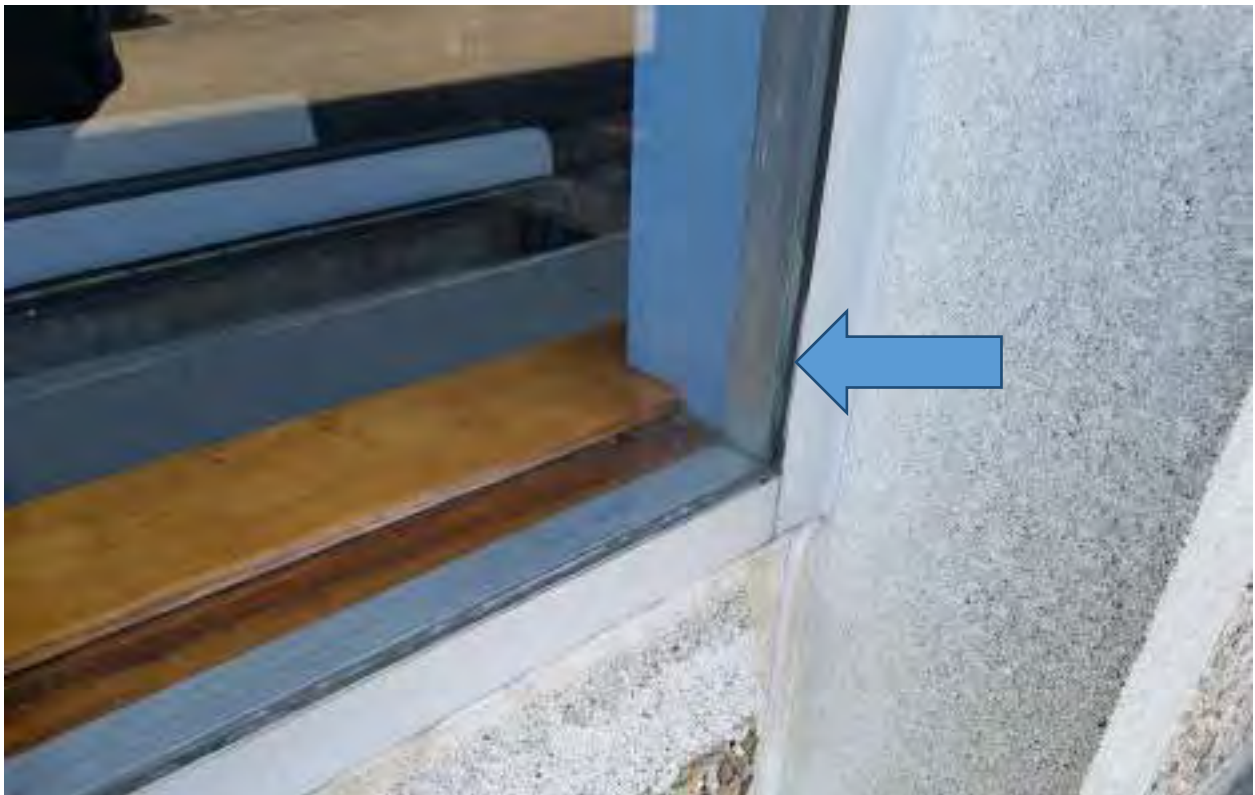
Windows appear in fair condition, but have exceeded their life expectancy. These original windows are aluminum framed single pane glass that have no thermal break or energy efficiency. The thermal break in the metal frame reduces the exterior cold from radiating into the building. Many of the windows have been altered to install residential style air conditioning units. These alterations contribute to the lack of energy efficiency. Commercial window frames are not designed for an air conditioner retrofit and are considered a poor installation. At a couple locations, the window AC units protrude into a sidewalk area and become an obstruction. Replacement due to age and energy in-efficiency is recommended.

Typical window with single-pane, uninsulated glass

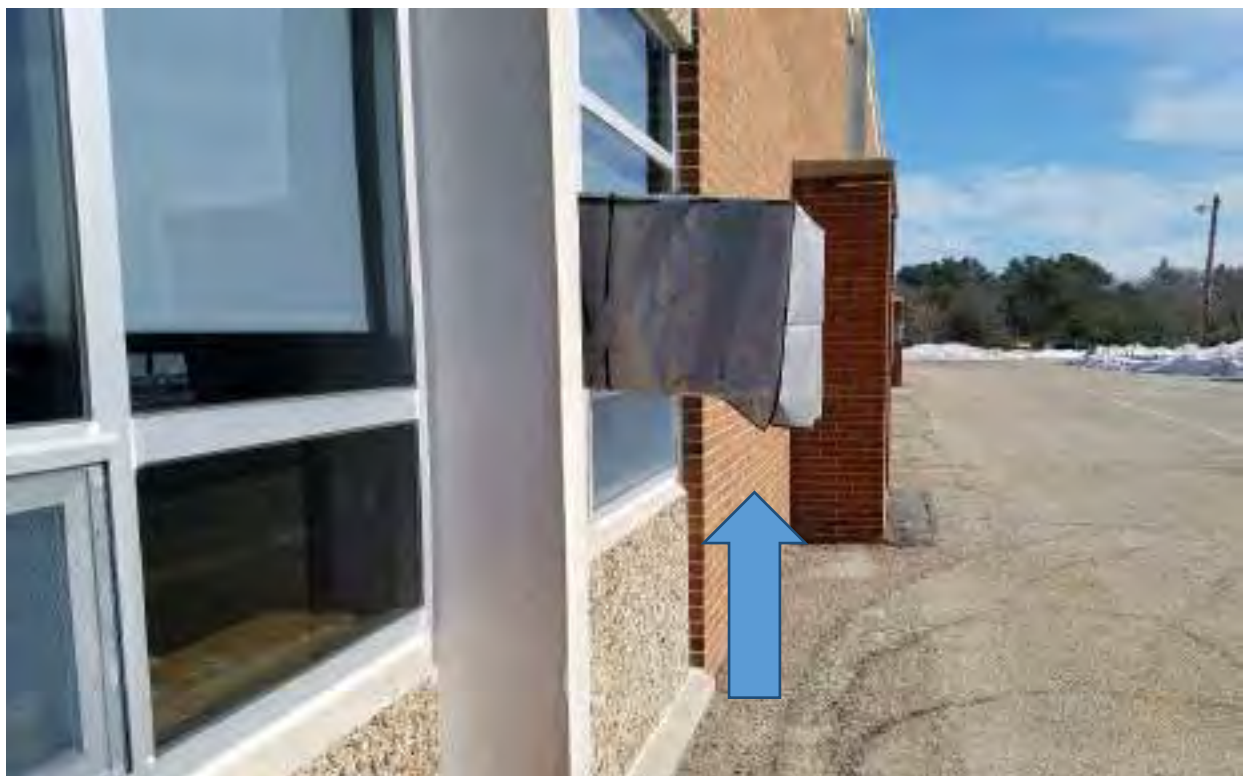
Potential hazard of protruding air-conditioner along walkway

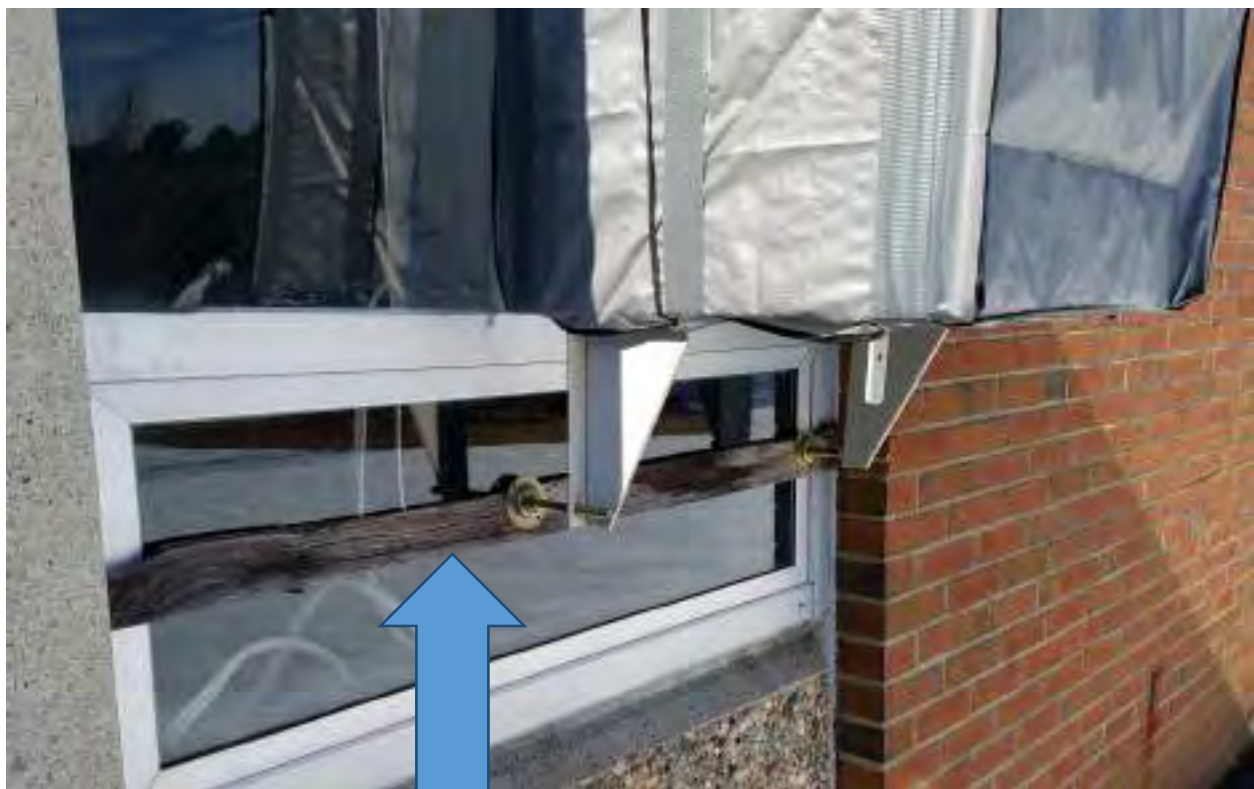
Poor installation of air-conditioner using scrap wood- potential to damage window glass

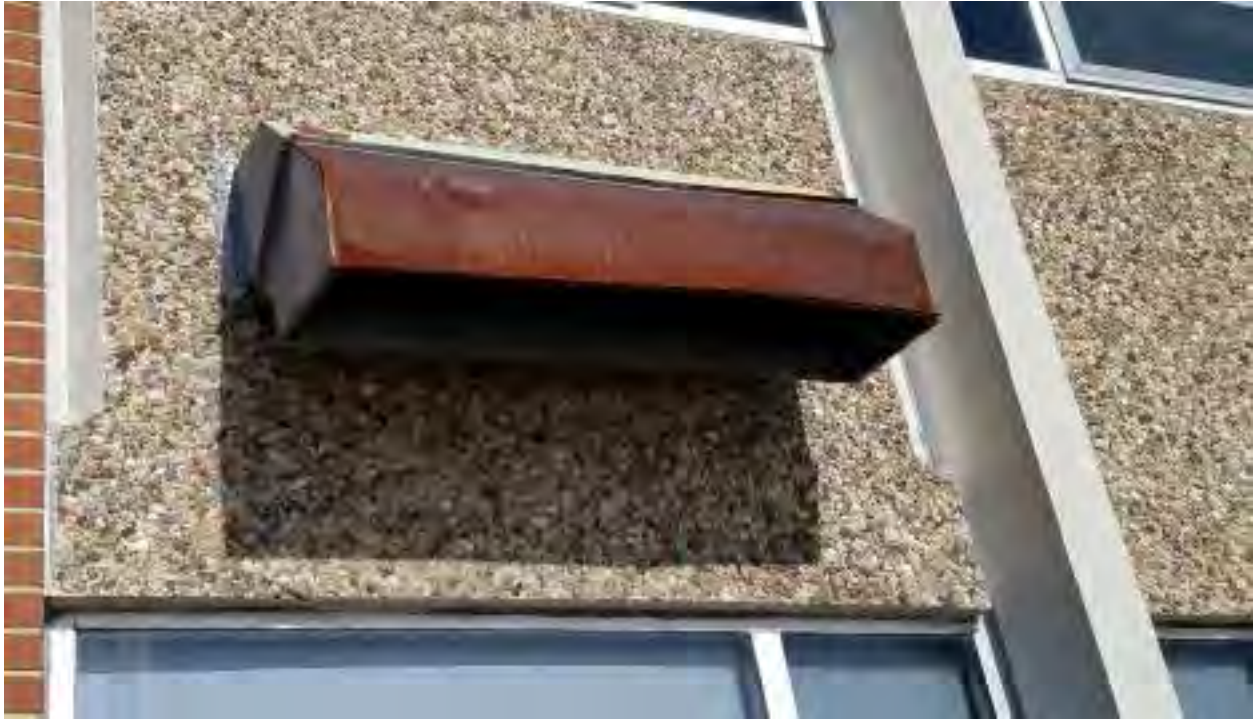
Many of the mechanical louvers are rusted, others dented and need of paint. There are also many abandoned electrical boxes & fixtures causing rust staining on the brick.

Typical rusted condition of second floor UV louver hood needing replacement

Scrape and paint existing painted louvers, replace dented and rusted louvers. Refasten existing louvers to UV's so tight to wall. \$10,000

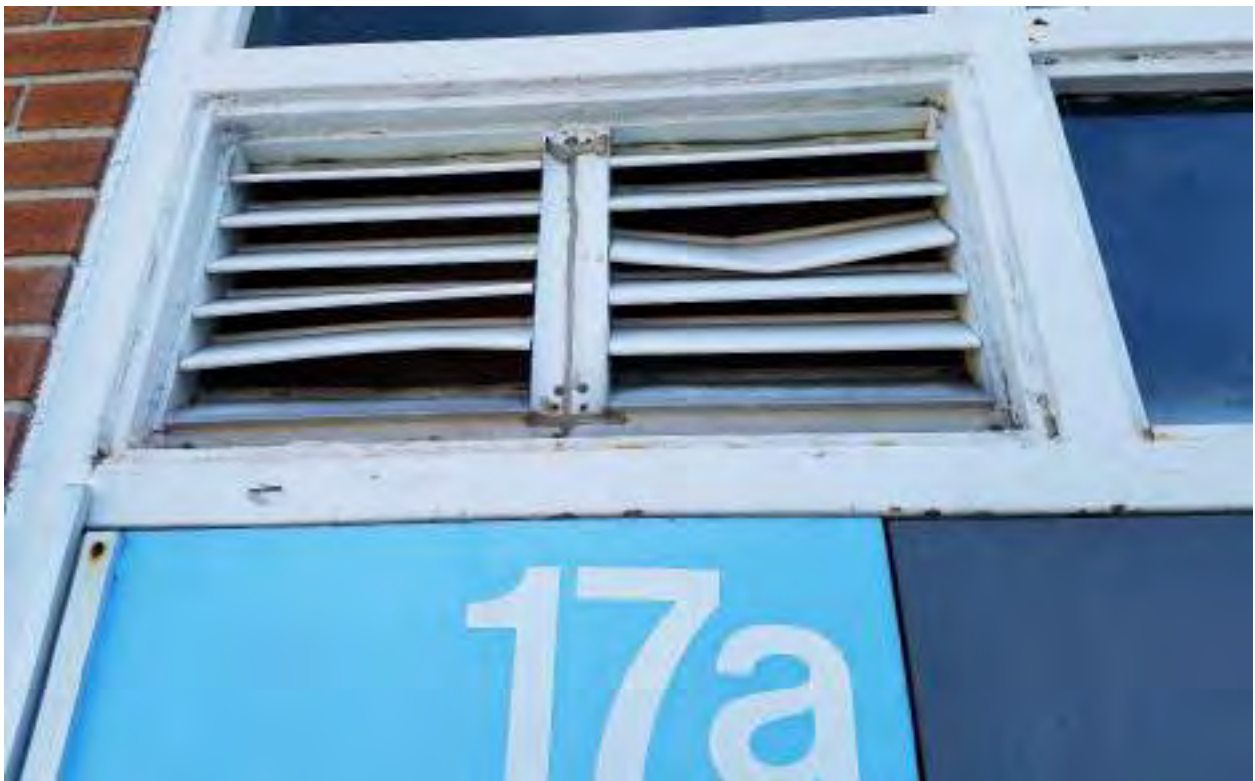
Example of mechanical louver needing repair/replacement

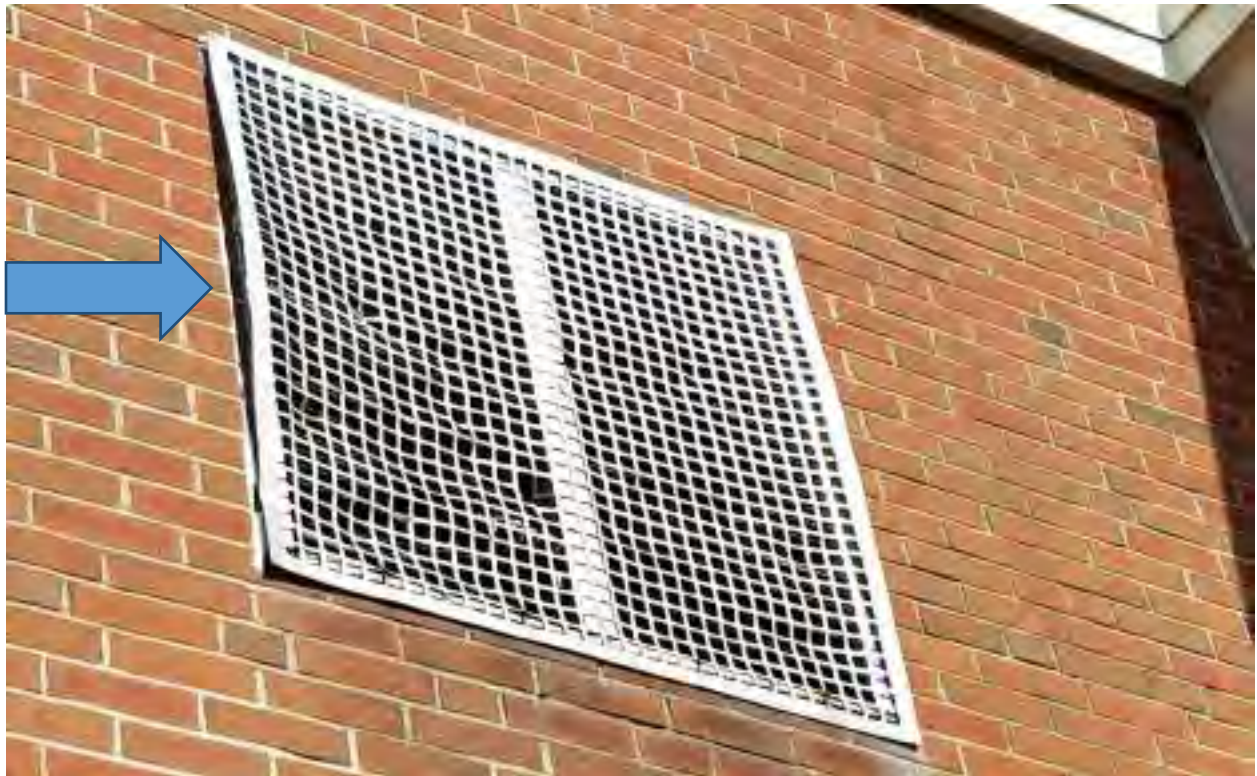
Mechanical louver needing replacement

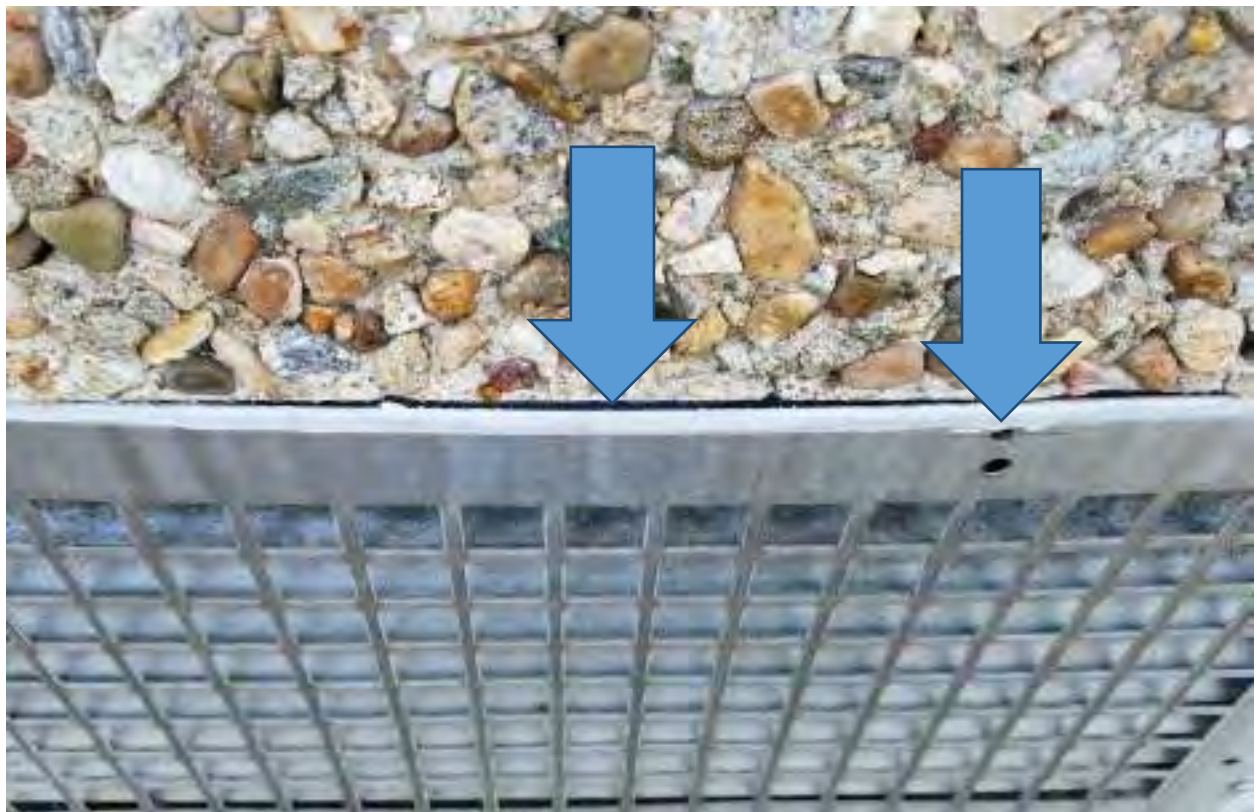
Gaps around UV louver needing refastening and new sealants

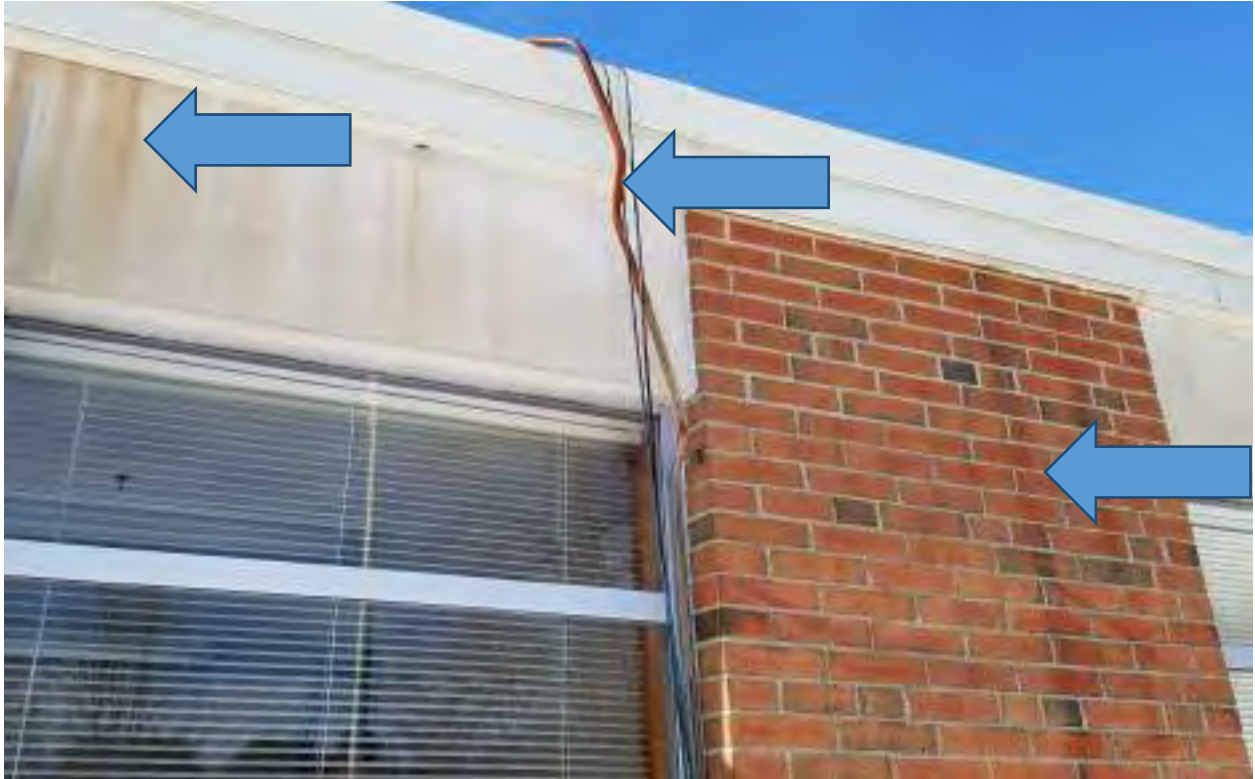
Showing stains from water infiltration from above / unsecured electrical conduits and moist brick

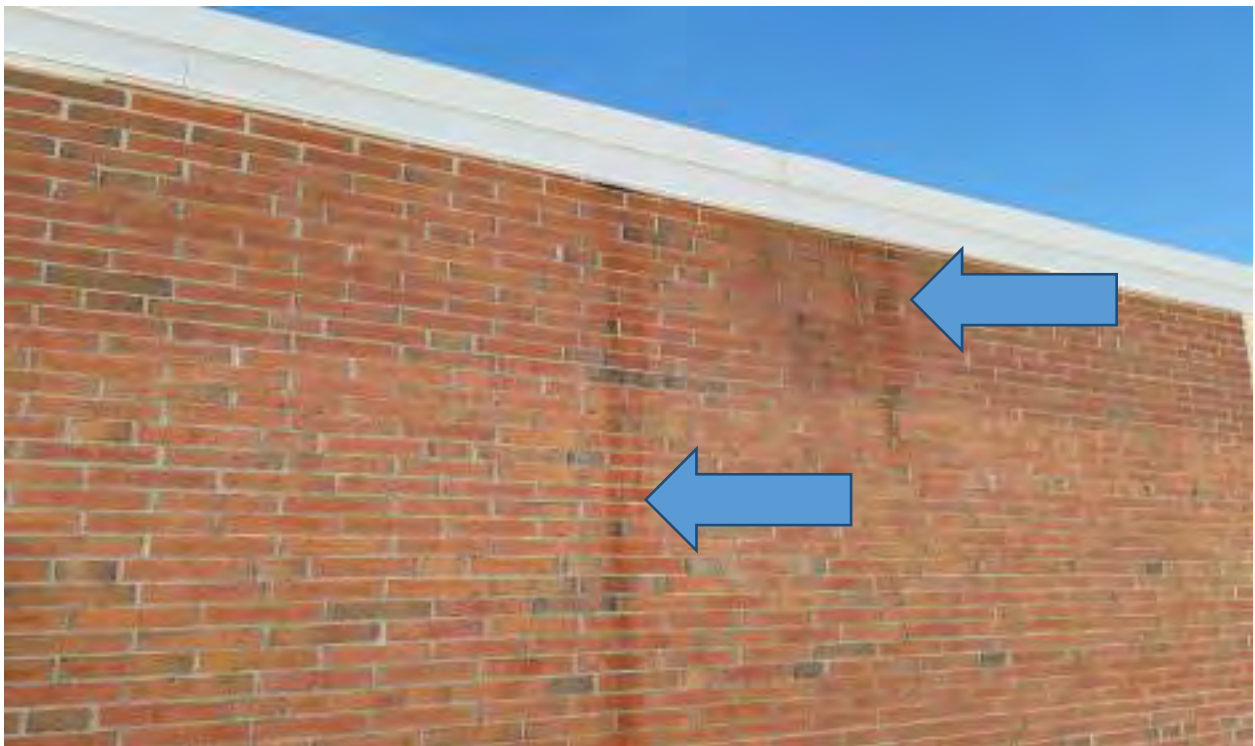
Additional example of moist brick from apparent leak in metal coping system above

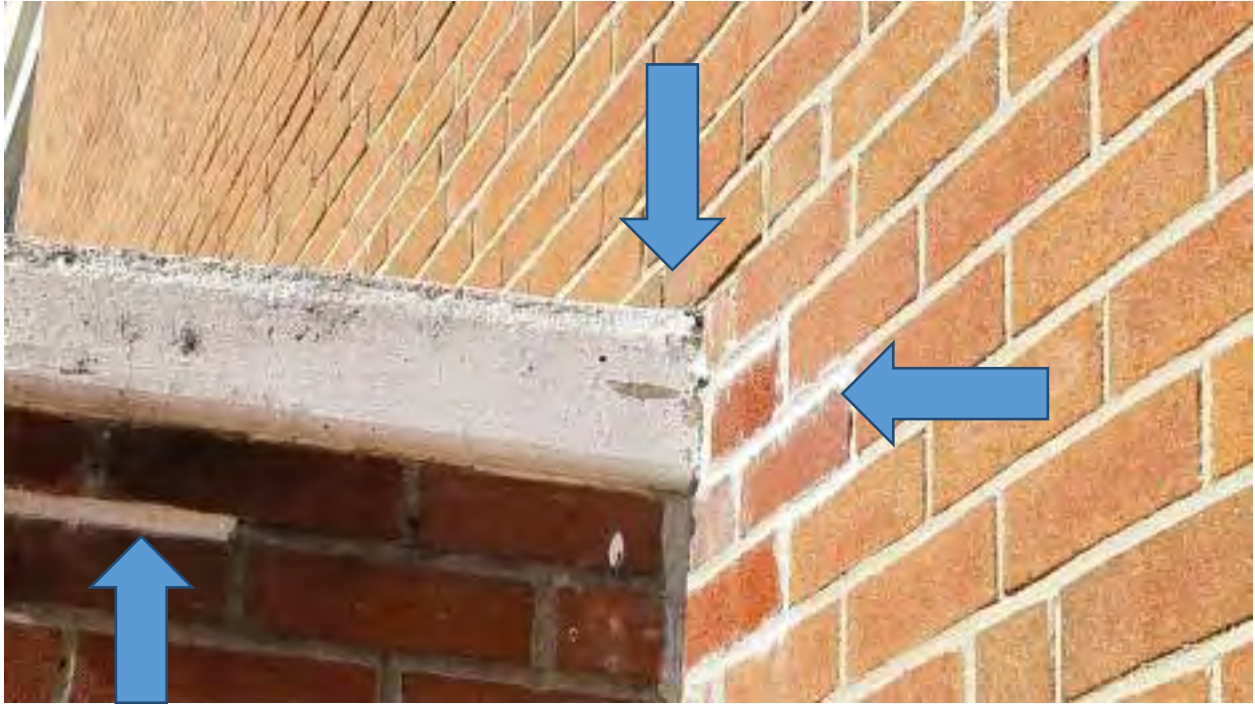
Sloped concrete entry cap with no protective membrane and no flashing to vertical brick surface – also signs of brick deterioration and previous repairs

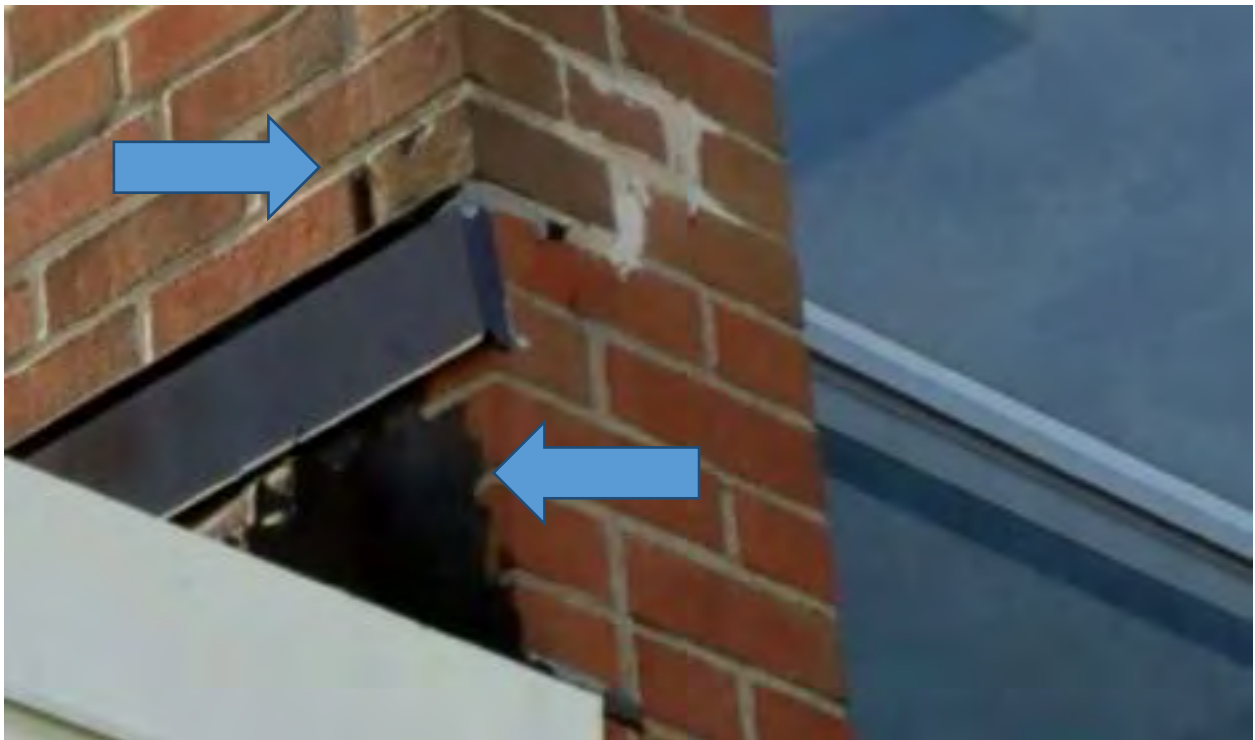
Poor roof flashing transition and open brick joints needing repair (north elevation)

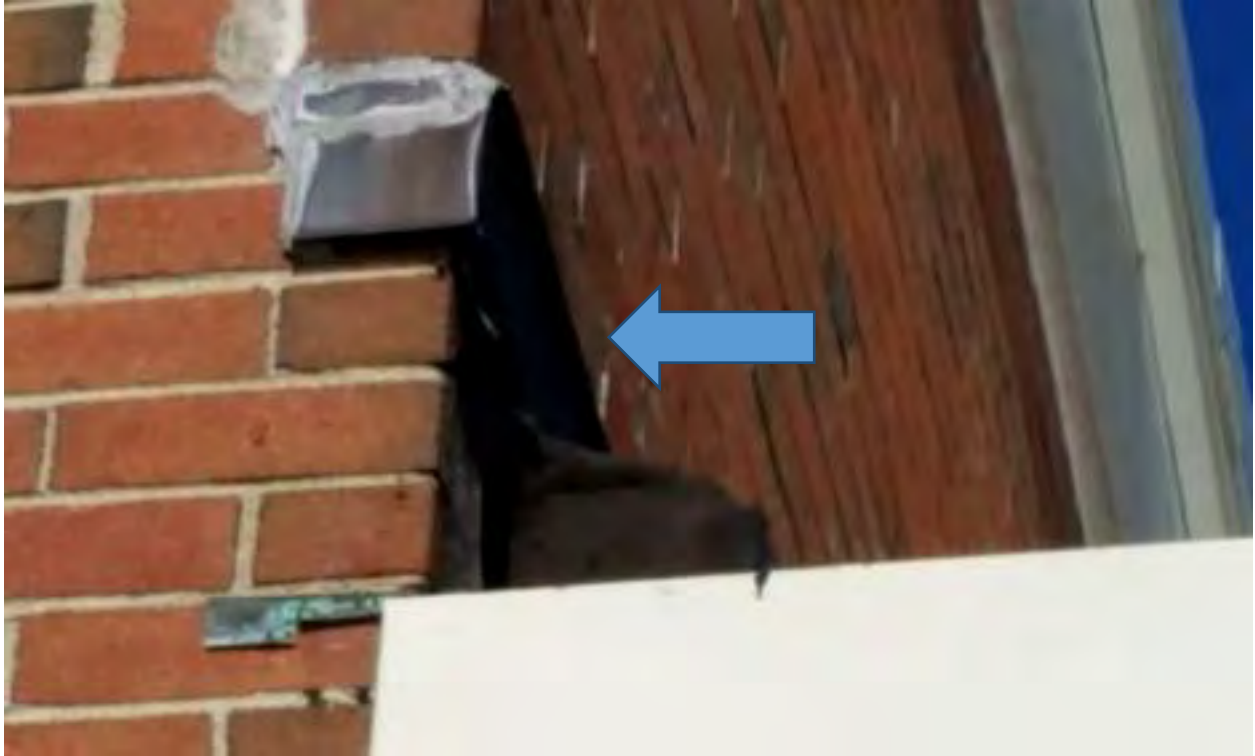
Another example of poor flashing transtion (South elevation)

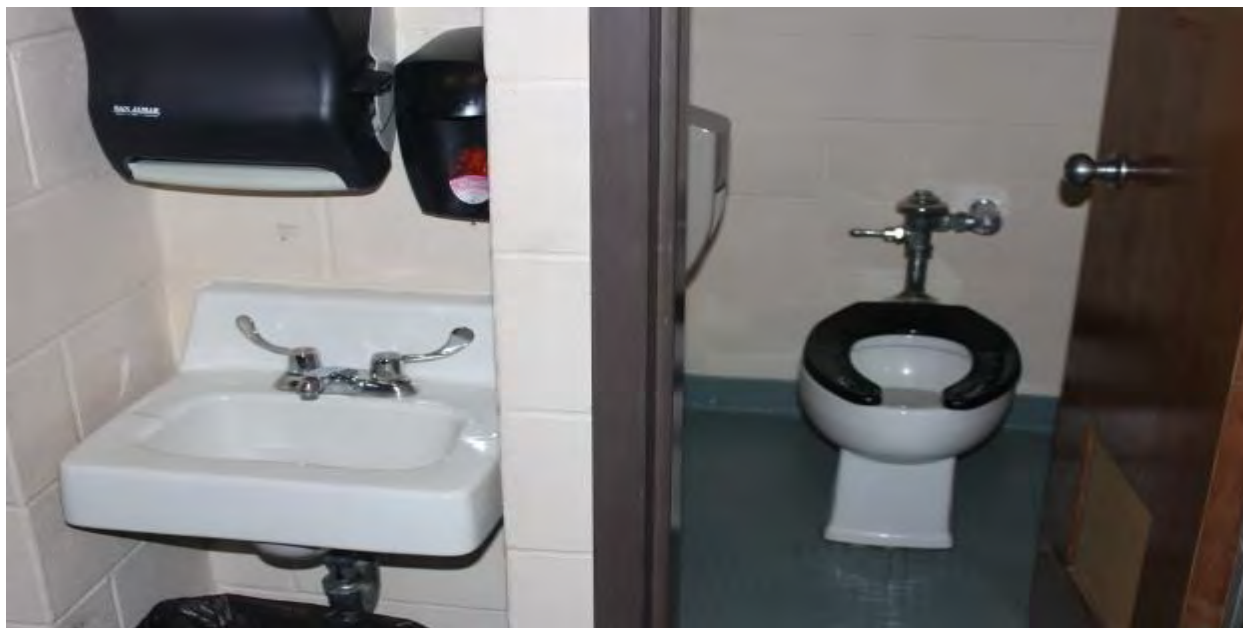
Current undersized bathrooms at classrooms. Non ADA compliant and operationally extremely small.

Perform a full ADA compliance evaluation in conjunction with a full use and needs assessment to determine future course of action with this building. \$20,000

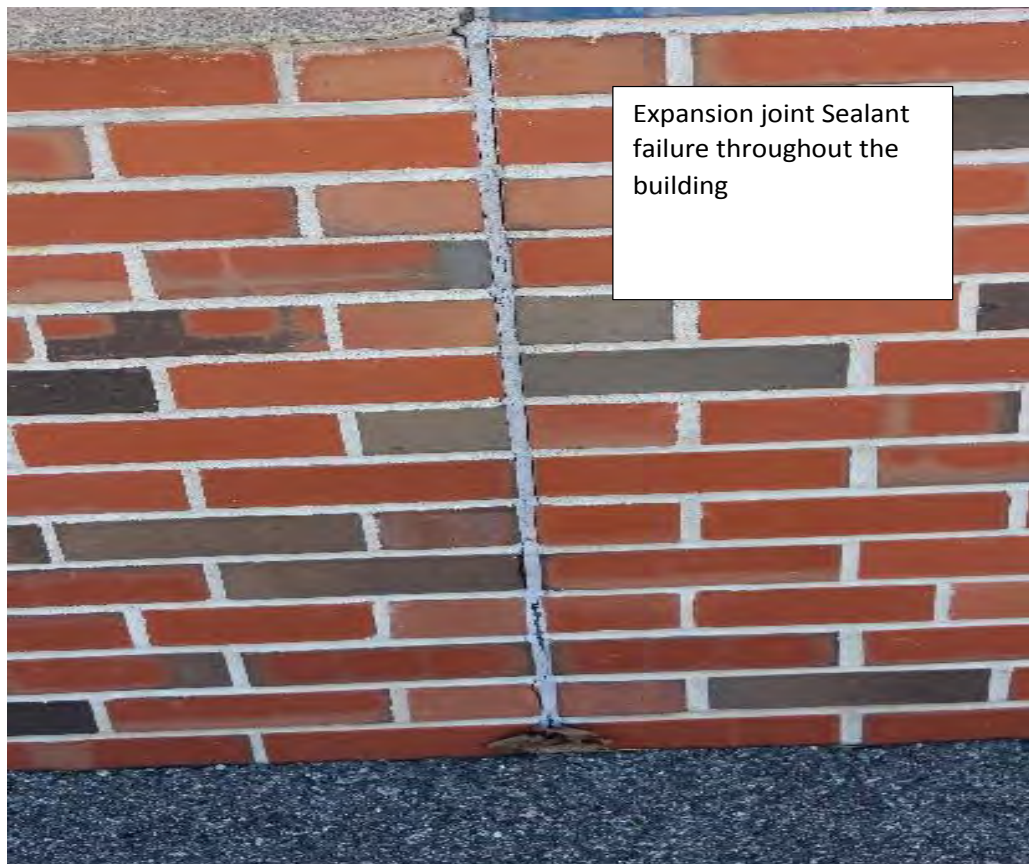
Expansion joint Sealant failure throughout the building

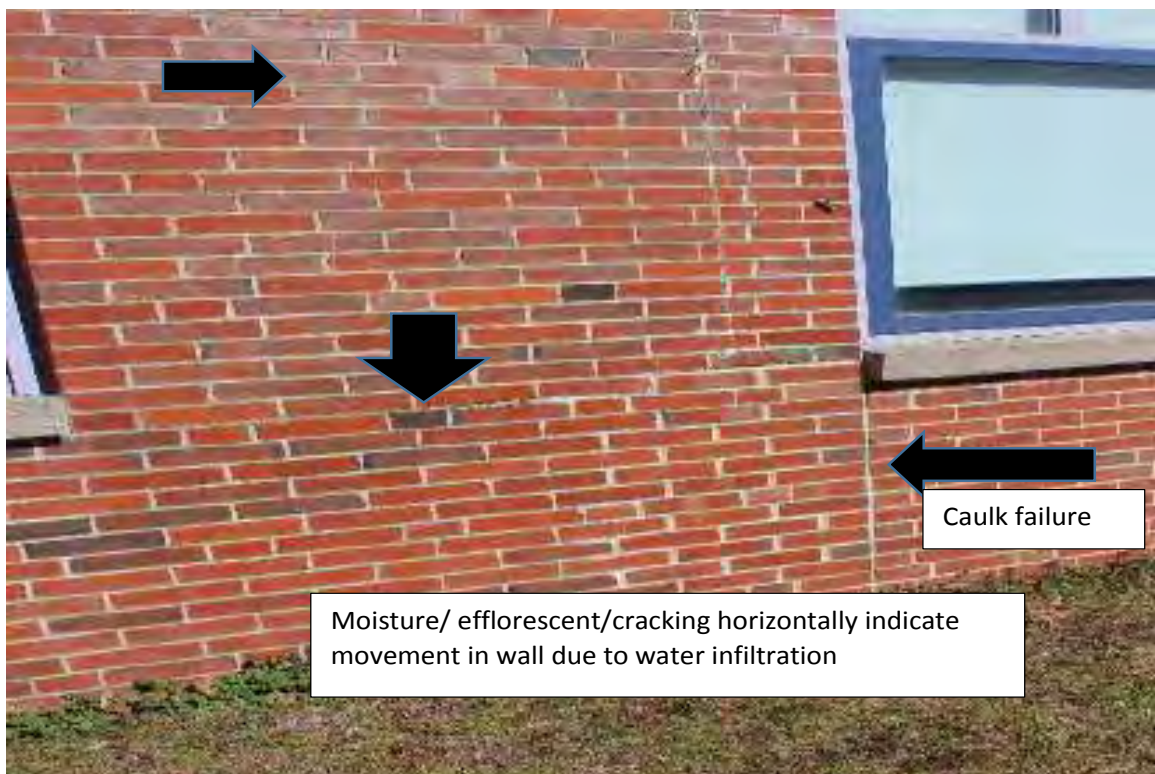
Caulk failure

Moisture/ efflorescent/cracking horizontally indicate movement in wall due to water infiltration

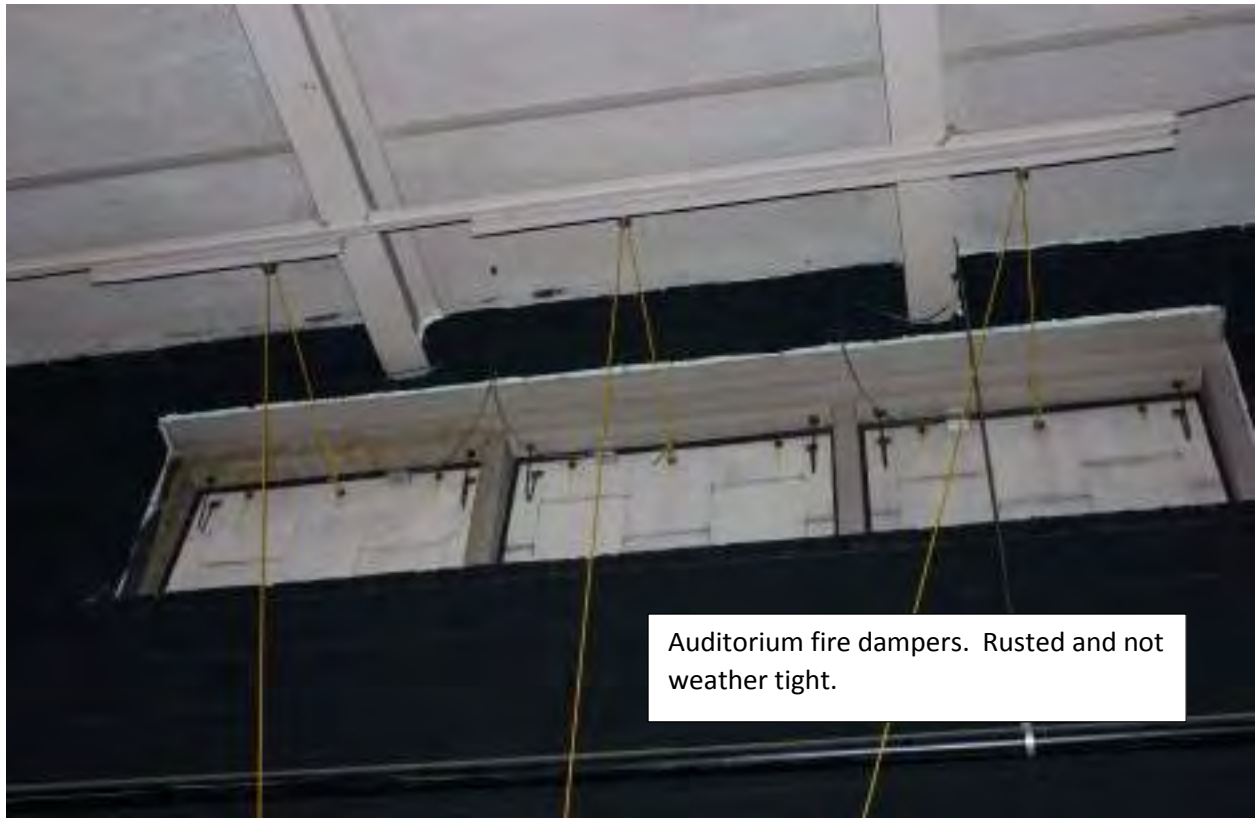
Auditorium fire dampers. Rusted and not weather tight.

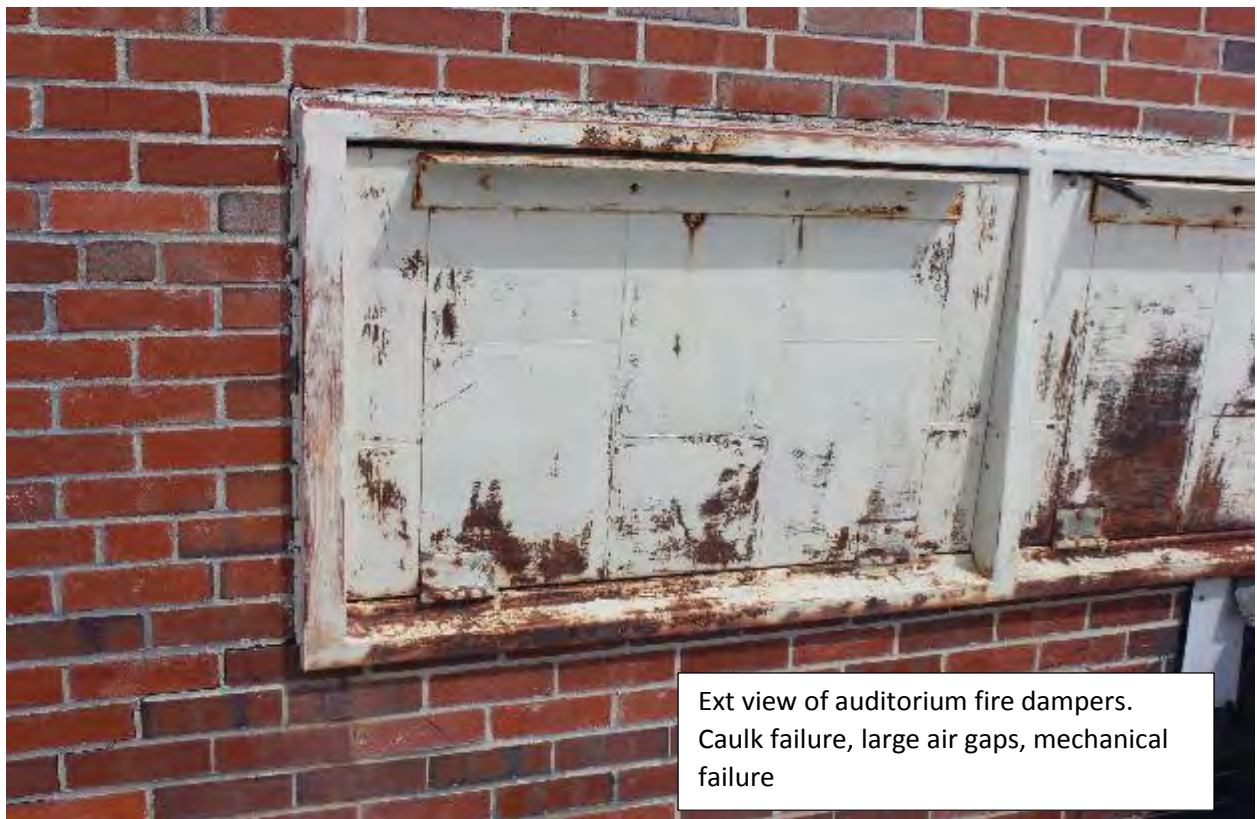
Ext view of auditorium fire dampers. Caulk failure, large air gaps, mechanical failure

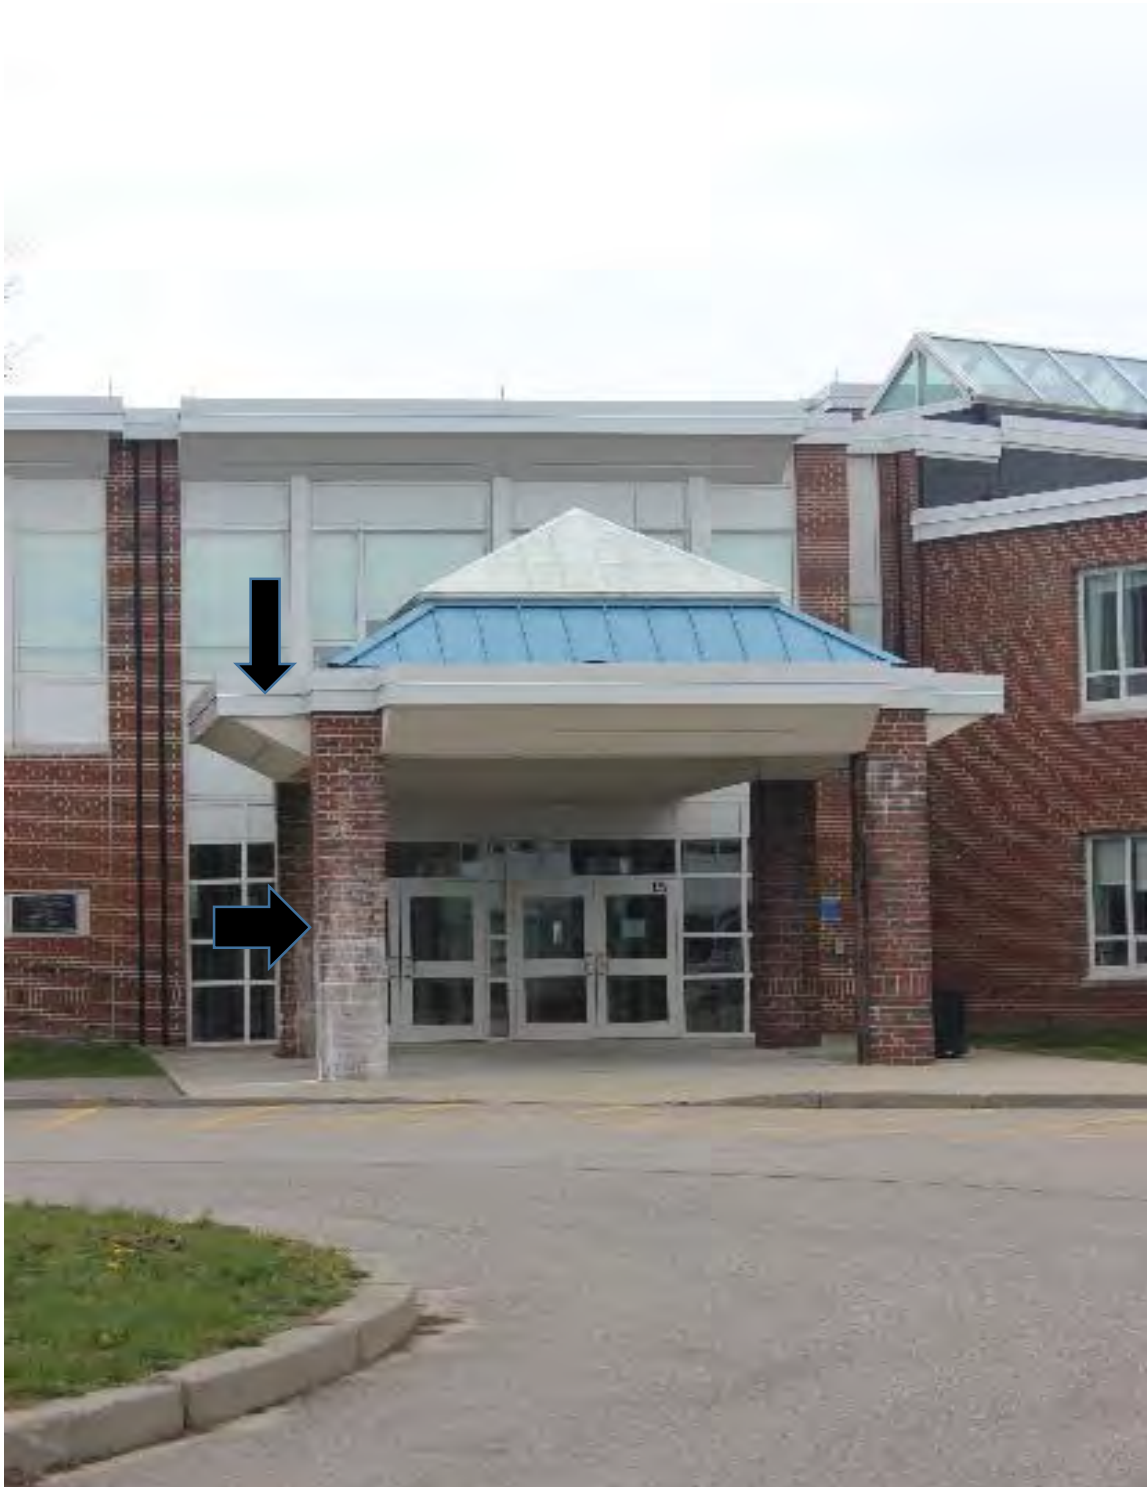
Internal roof drains may have split and come apart and allowed water to saturate the columns masonry from the interior to exterior. Excessive efflorescence, calcification, and structural cracking has occurred in the brick façade.

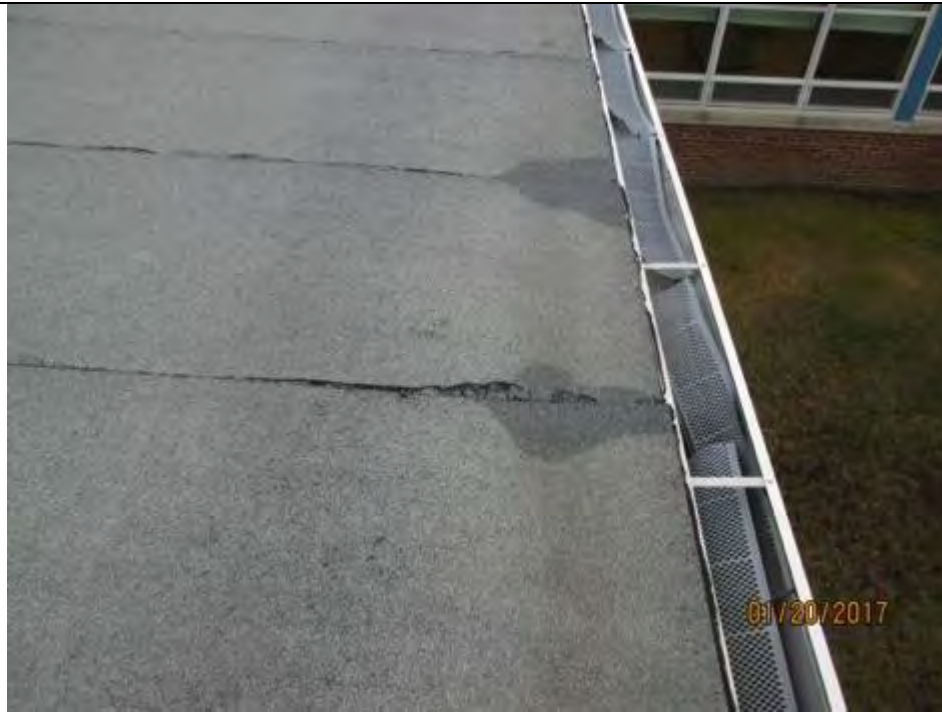
Photo 29

Poorly pitched roof edges allow ponded water and possible leaks.
