REPORT#: 18MA046

REPORT DATE: May 11, 2020

Municipal Crossing Guard Fatally Injured When Struck by a Car – Massachusetts

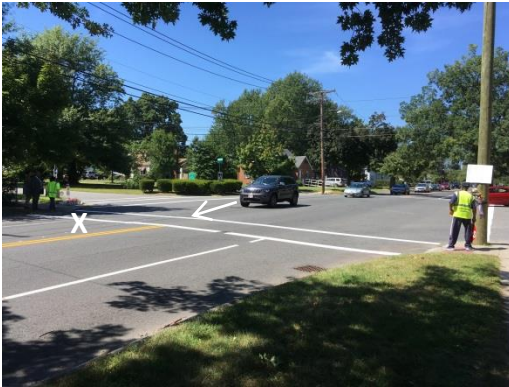
Figure 1 – Incident location. X marks victim location and the arrow indicates direction of travel of the vehicle.

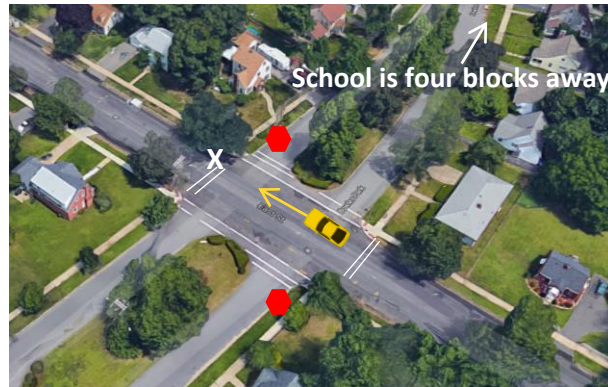
Figure 2 - Aerial view of incident location. X marks victim location and the yellow arrow indicates vehicle travel direction. The red hexagons indicate stop signs for the side streets. The school is located four blocks away.

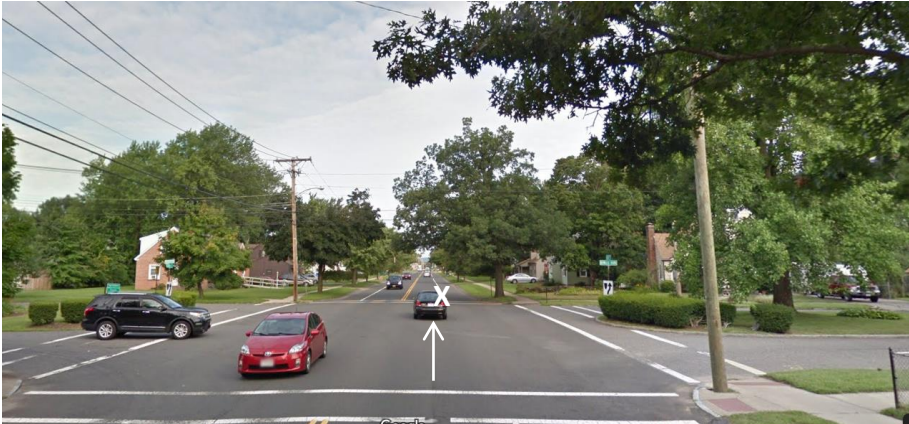
Figure 3 - Incident location. X marks victim location and the arrow indicates vehicle travel direction.

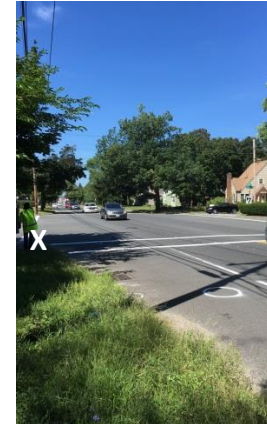
The victim's assigned location was the unsignalized four-way intersection of the island-divided side street and the main roadway (Figure 3 and 4). This intersection was about four blocks from the school. Because the side street had a wide grass median island and the main roadway had wide paved shoulders, this resulted in a large intersection. At the intersection, stop signs were located only for the side street and both the side street and the main roadway had sidewalks separated from the roadway edges by grassy areas. On-street parking was allowed on both the side street and the main roadway. All of the painted crosswalks at the intersection were cracked and fading and in need of being repainted. There was no roadway signage warning motorists of the crosswalks across all four areas of the intersection (Figure 5).

Figure 4 - Incident location. X marks victim's assigned location.

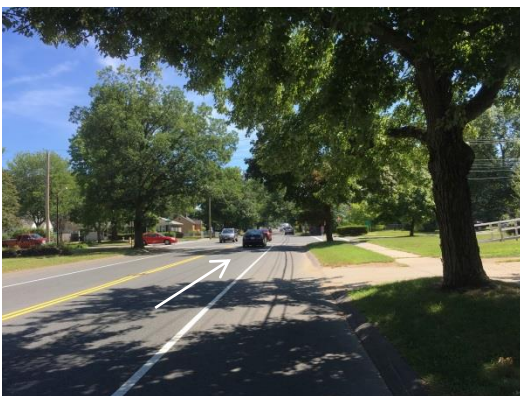
Figure 5 – Roadway leading up to the intersection. Note that there is no signage warning motorists of the crosswalk ahead.

In this case, prior to the incident, no traffic control signage was present at the crosswalk locations. The least effective crosswalk roadway markings, which are two white parallel lines with no center lines, were being used and these markings were faded and cracked. Although at the time of the incident there were no cars parked on the roadway edge, on-street parallel parking was allowed within 20 feet of the crosswalk and on both sides of the roadway. This is prohibited by the MUTCD, Part 3 Figure 3B-21. Cars parked within 20 feet of a crosswalk could possibly contribute to a motorists' decreased visibility of pedestrians in the crosswalks.

In order to make the crosswalk location safe for crossing guards, students, and other pedestrians using the crosswalk, and to make the area more visible to motorists, municipalities should ensure that permanent MUTCD compliant, fluorescent yellow-green signage are installed prior to and at all crosswalk locations and that painted crosswalks are highly visible and in good condition. Municipalities should also routinely review crosswalk signage for compliance with the MUTCD and routinely evaluate crosswalk roadway markings to ensure they are not faded and are in good condition.

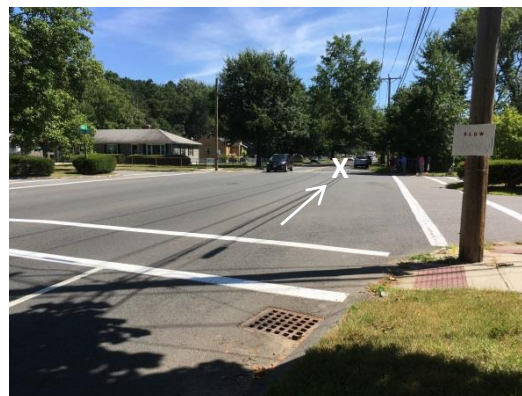
Figure 6 – Incident location. X marks victim location and the arrow indicates vehicle travel direction.
