## **Massachusetts FACE • Occupational Fatality Report**

### **Municipal Electrician Dies after Falling from the Raised Bucket of a Vehicle-mounted Aerial Lift That Was Struck by a Tractor-trailer – Massachusetts**

Investigation: # 11-MA-043-01  
Release Date: October 31, 2012

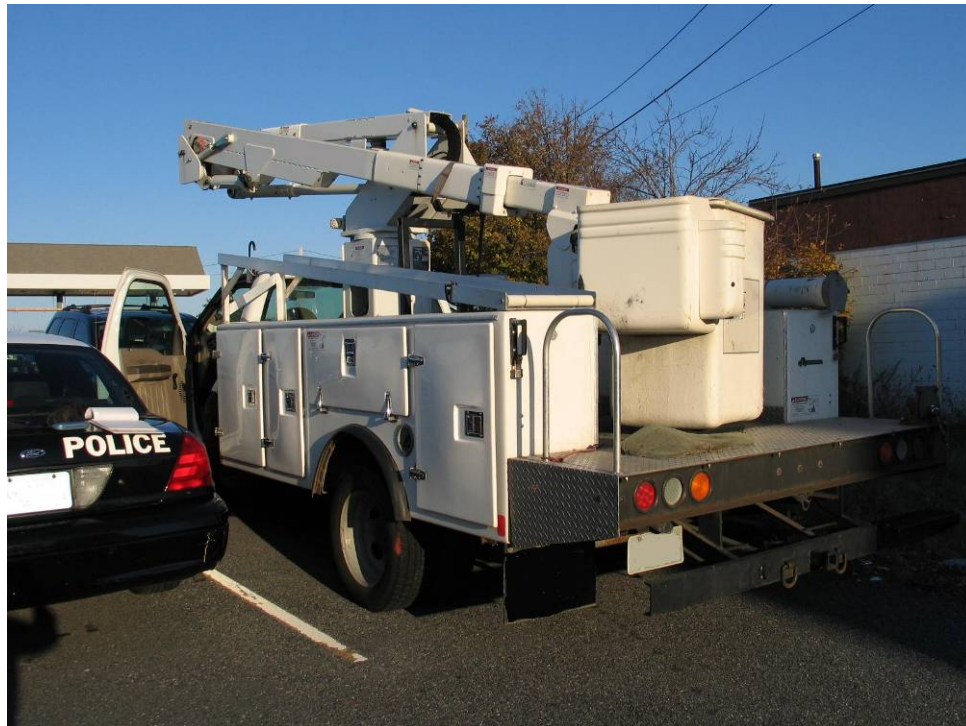
About a year before the incident, the Department of Traffic and Parking had removed their aerial lift truck from service and began renting an aerial lift truck while a new replacement truck was being built. The aerial lift truck that was involved in the incident was the truck being rented and the victim was the only employee assigned to operate it. The rental aerial lift truck's chassis and aerial lift body were both manufactured in 2008 and were white in color (Figure 1). The truck's gross vehicle weight rating was 8,845 pounds, and it was equipped with dual rear wheels and a diesel engine. The telescoping and articulating boom platform had height and weight ratings of 38 feet and 300 pounds respectively. There were two sets of controls for the movement of the truck's boom/bucket. One control was mounted to the bucket and the other control was mounted to the truck's body at the ground level. The vehicle was equipped with yellow light-emitting-diode (LED) strobe lights located in the truck's bumper. There was also a fall protection anchor point located at the truck's bucket along with a danger decal warning of the fall hazard and the need to use fall protection (Figure 2). A body harness and lanyard with signs of past use was observed during the site visit in the side cabinet of aerial lift truck.

**Figure 1 – Vehicle-mounted aerial lift involved in the incident**

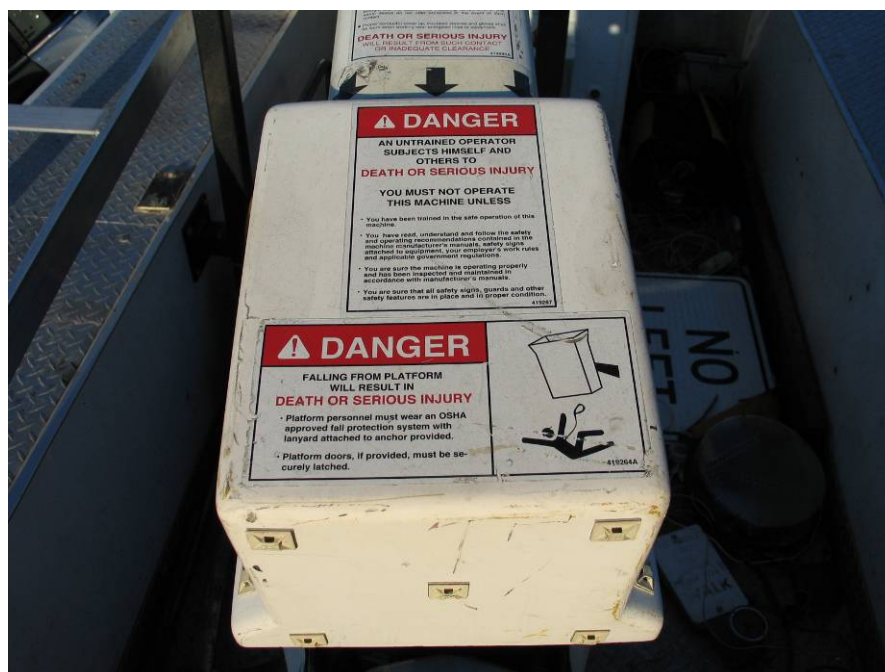
**Discussion:** In this incident, the victim was working from a raised aerial lift truck without fall protection, although fall protection was available. Fall protection is required to be used whenever working from an aerial lift truck's raised platform.<sup>1</sup> There are two main types of fall protection systems that can be used with aerial lift trucks.

**Figure 2 – Vehicle-mounted aerial lift fall hazard danger decal**

### **Recommendation #1: Municipalities should ensure that fall protection is used when working from an aerial lift truck's raised bucket/platform.**

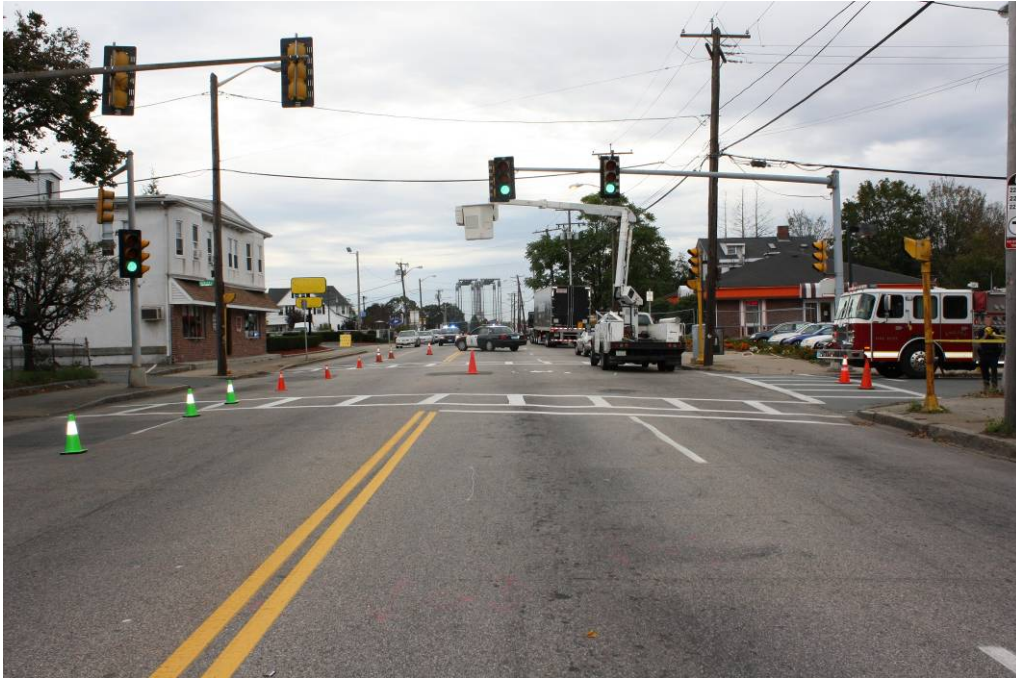
The intersection has multiple cantilevered traffic signal structures. One of these cantilevered structures was the traffic signal that was being accessed at the time of the incident. The base of the cantilevered structure is located on the sidewalk and the vertical section is approximately 18 feet high. The cantilevered section is fastened to the top of the vertical section and extends perpendicularly out over the two southbound main roadway lanes (Figure 3).

The police report suggested that several factors might have contributed to the victim's position being less noticeable to passing motorists. These factors include: the boom of the aerial lift following the same 90 degree angle as the cantilevered traffic signal structure, the lack of contrast between the white truck and boom against the light gray sky, and the strobe lights drawing attention away from the raised bucket and towards the aerial lift truck's bumper.

**Figure 3 – Incident location with vehicle-mounted aerial lift**

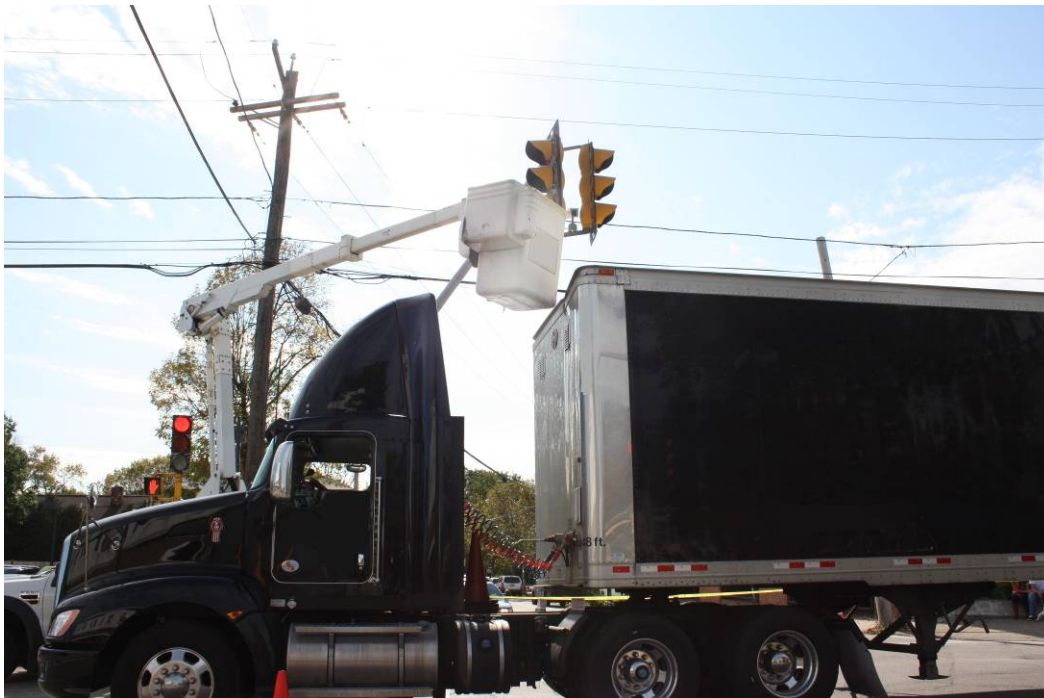
While the victim was in the raised bucket, an 18-wheeled tractor-trailer was traveling on the main roadway heading southbound in the left hand travel lane. The enclosed trailer section of the tractor-trailer is 53 feet long and 13 feet 6 inches high. As the tractor-trailer approached the intersection, the cab with its wind deflector passed underneath and cleared the raised bucket. When the trailer section reached the raised bucket, the trailer impacted the bucket causing the bucket to bounce up and land on top of the trailer's roof (Figure 4). The victim was ejected out of the bucket and fell approximately 17 feet to the asphalt roadway below. The tractor-trailer operator stopped the truck immediately after the incident occurred. A call was placed for Emergency Medical Services (EMS). Within minutes EMS and the local police arrived at the incident location, and the victim was transported to a local hospital where he was pronounced dead.

**Discussion:** The operator of the tractor-trailer indicated that he did observe the aerial lift truck in the roadway and the truck's bumper strobe lights, but that he did not notice the extended boom and the worker in the bucket.

**Figure 4 – Tractor-trailer with raised bucket**

**Recommendation #8: Manufacturers of aerial lifts and municipalities should consider using contrasting colors and installing strobe lights along the booms of aerial lifts.**
