Department of Conservation and Recreation

Nantasket Beach Seawall Repair and Reservation – Master Plan Services – Existing Infrastructure

September 2007

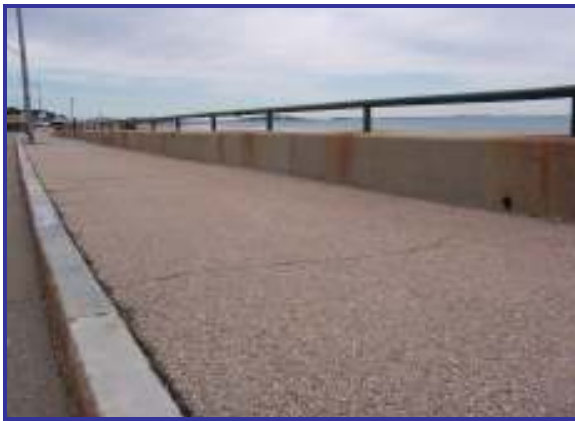
There is a beachfront promenade/walkway along the entire length of the Reservation, providing beach users physical and visual access to the 1.3 mile beachfront as well as to passive and active recreation opportunities (Figure 1-3). The promenade is located between the parking areas adjacent to the beach and the seawall and connects to various seating and shade areas. Accessibility to the beach from the promenade is provided via intermittent entry points in the seawall. Access to the beach from these points is provided by either a concrete stair or ramp. Many of the existing seawall entry points have been in need of improvement. For example, some of the ramps are too steep and/or are blocked by large revetment boulders. New entry stairs and ramps are being constructed during 2007. The promenade is sloped to carry runoff toward the wall which has weep hole drains to convey the water onto the beach.

Figure 1-3: Promenade along seawall with weep holes for drainage

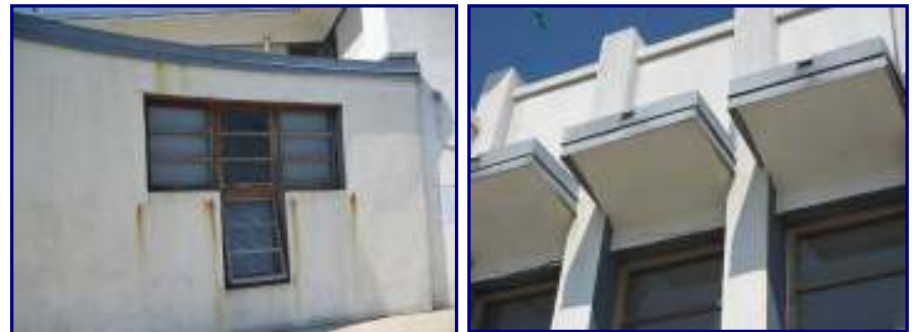
The building currently has some problems with water penetration from deteriorated caulking and flashing on the roof. There is also some rust, spalling and cracking along some of the walls of the building. The windows on the ocean side require painting.

Figure 1-6: Rust and painting requirement on the southern side of the MJM bath House (left). Cracking above the window on the southern side (right).

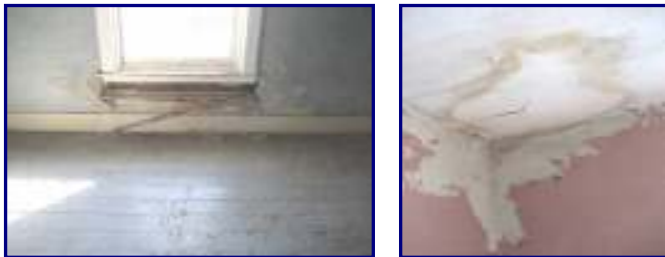
The building is in poor condition. The roof was leaking in the past, resulting in damaged walls and ceilings. Plaster is falling in places. The roof was replaced in 1994-1995 as part of exterior renovations. Currently, there is still a leak above one of the first floor offices (supposedly due to a problem with the gutter).

Figure 1-12: Damaged wall (left) and ceiling (right) in Island District Operations Building.

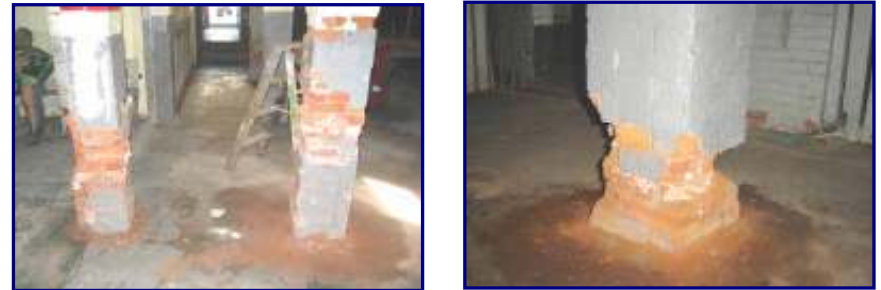
The basement experiences intermittent flooding. On July 26, 2007, Mark Gershman from The Louis Berger Group, Inc. performed a quick visual inspection of the state of several deteriorated brick columns in the basement. He was accompanied by Mike Galvin and Leonard Meleger from DCR. Following is an excerpt of his report:

"DCR indicated that the building is currently used as a headquarters by DCR staff and from a quick observation appears to be under utilized and not fully loaded. The columns in the basement were observed to be approximately 12 inches square and comprised of mortared red bricks extending from the basement slab to the underside of the first floor timber framing. A majority of the columns have experienced deterioration of the bricks along the lower lengths of the columns (see photos below). DCR confirmed that the basement experiences flooding and standing water on a regular basis as a result of ocean storm events. No other visible distress in the columns was noted indicating that they continue to safely support the building structure above. As a result of the inspection, Berger recommends that columns be removed and replaced in kind, or with steel lally columns. This should be undertaken in the near future once the use and purpose of the building is determined by DCR. At that time other structural elements should also be inspected and appropriate repairs determined."

Figure 1-13: Damaged support columns in basement of the Island District Operations Building.

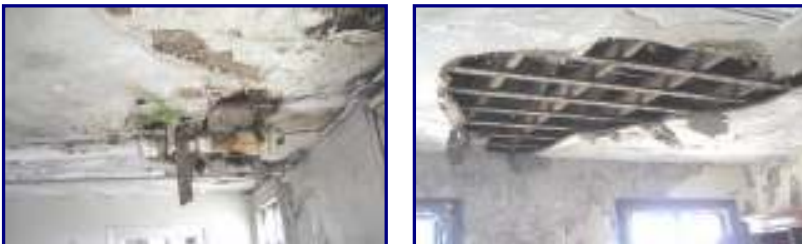
In 1993, the building was inspected and surveyed for asbestos-containing materials. Asbestos was identified in roof flashing and caulking material. In 1996, a lead-based paint inspection report found that most of the paint used on the interior of the station contains a relatively high concentration of lead. The roof is apparently tight at this time, although was leaking in the past. As a result, water damage to the walls and ceilings is wide-spread. Parts of the first floor is structurally unsound. The building has no utilities (heat, water, electricity). The area in the basement section to the west of the building was observed to be moist during the site visit on July 26, 2007. A crack was observed at the base of the outside wall out the building (to the left of the entrance door), suggesting potential structural problems.

Figure 1-15: Extensive wall and ceiling damage in former Police Station.

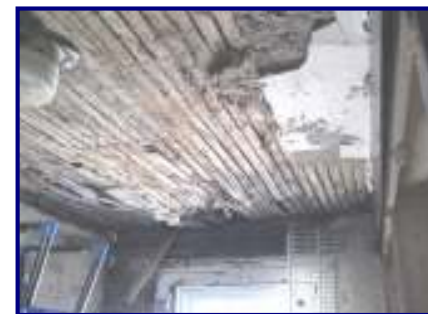
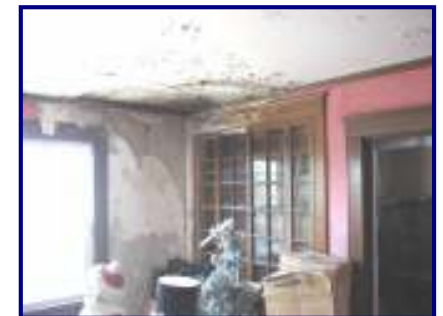
It was not known at the time of the site visit on July 26, 2007, if there was asbestos in the plaster, or lead paint. The roof supposedly does not leak, but was damaged for many years in the past. As a result, the second floor of the building has substantial ceiling and wall damage.

Figure 1-26: Extensive wall and ceiling damage on the second floor of the Clocktower Building.

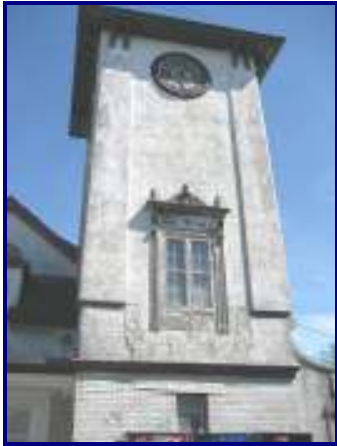
Some structural damage was observed on the clocktower. The facades of the two buildings require painting. The western side of the Clocktower Building facing George Washington Boulevard also could be improved aesthetically (Figure 3-28).

Figure 1-27: Possible structural damage on clocktower.

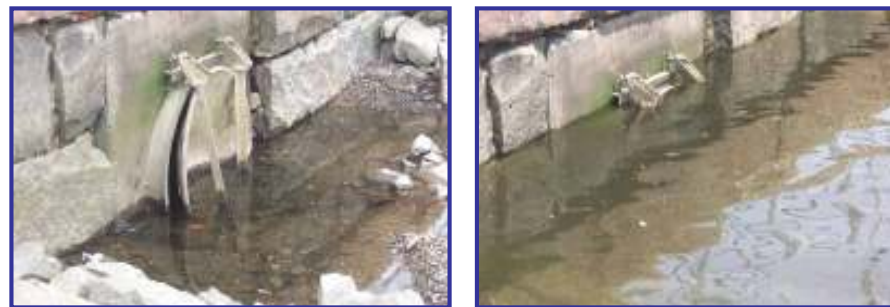
This 24" outlet has since been replaced with a 48" reinforced concrete pipe with vertical lift tide gate at the seawall as shown in Figure 2-1. Berger did not locate any plans showing the construction of the 48" pipe and gate, but it is believed that these improvements were constructed within the last 25 years.

Figure 2-1: Outlet A, consisting of a 48" RCP outlet with tide gate at low tide (left) and high tide (right). The tide gate is locked in a slightly open position.

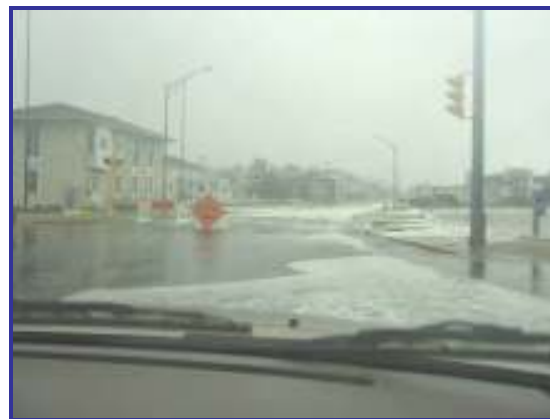
The Rational Method analysis calculations are presented in Appendix 2-3. StormCAD models of the existing drainage system were analyzed at 2-year and 10-year design storm frequencies. The results of the modeling indicate that Drainage Lines A, C, D and E are severely deficient for 2-year and 10-year storms. Hydraulic profiles for each drainage line are presented in Appendix 2-4. The profiles show that the capacity of the storm drain system is exceeded, resulting in ponding of the roadways. Specifically, the hydraulic grade line, as shown by the heavy dashed line in the profiles in Appendix 2-4, establishes the elevations along the system to which the water level will rise. In essence, the water level will exceed the existing ground elevation resulting in flooding of the roadway during storms (e.g., Figure 2-5).

Figure 2-5: Roadway flooding at intersection of Wharf Avenue and Nantasket Avenue

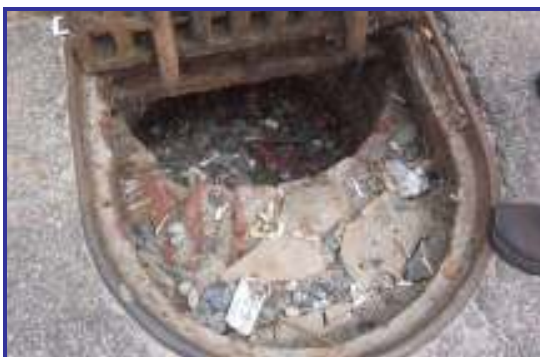
Figure 2-9: Litter and debris collected in catch basin

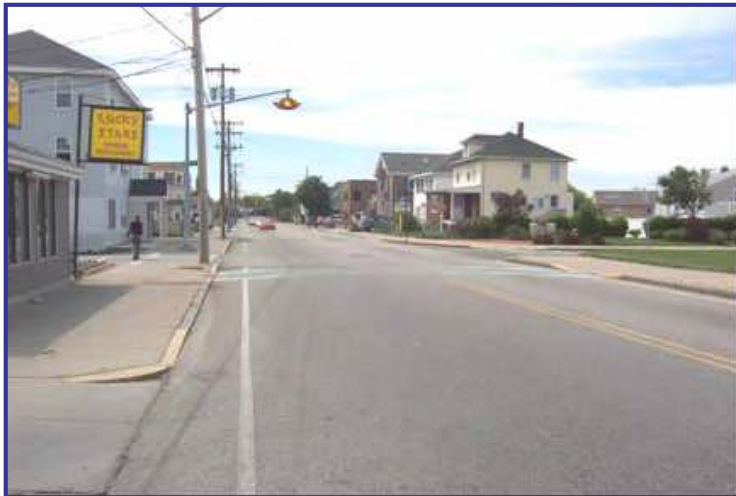
Figure 3-6: Location 1 (Nantasket Avenue at Phipps Street and Mountford Road)

Signing and pavement markings at the intersection are not adequate for one-way operation and do not conform to the Manual on Uniform Control Devices (MUTCD) criteria.

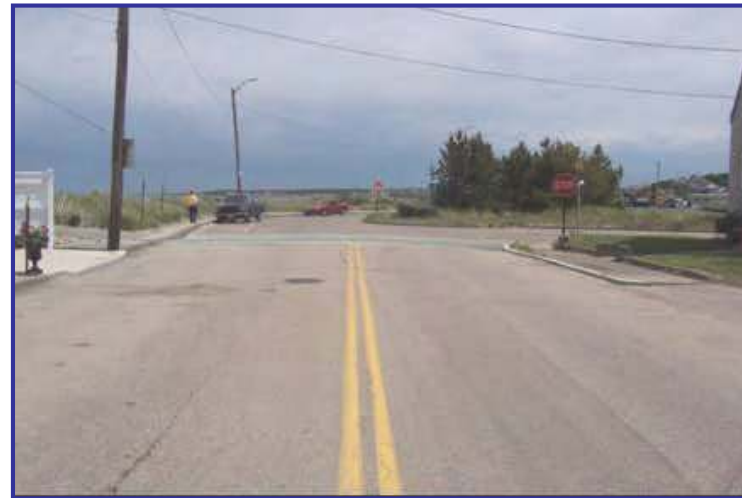
Figure 3-7: Location 2 (Hull Shore Drive Extension at Phipps Street and Manomet Avenue)

Signing for one-way operations and turn restrictions are not adequate and do not conform to MUTCD.

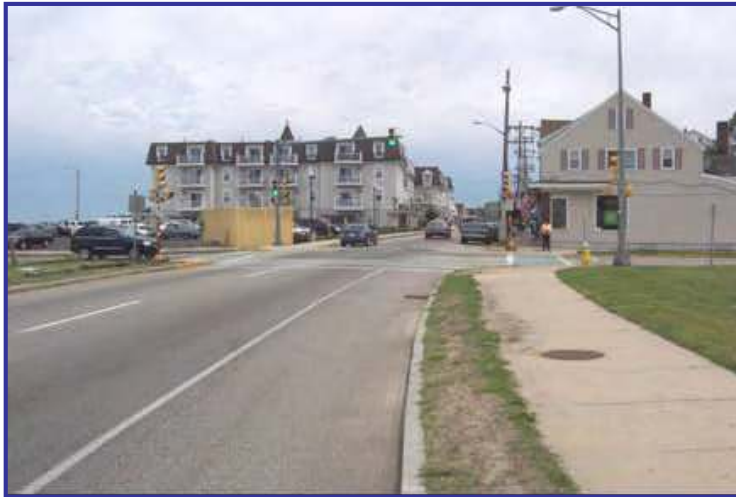
Figure 3-9: Location 3 (Nantasket Avenue at Water Street and Bay Street)

Pavement markings are adequate at this location, but better signage is necessary for Nantasket Avenue one-way southbound operation.

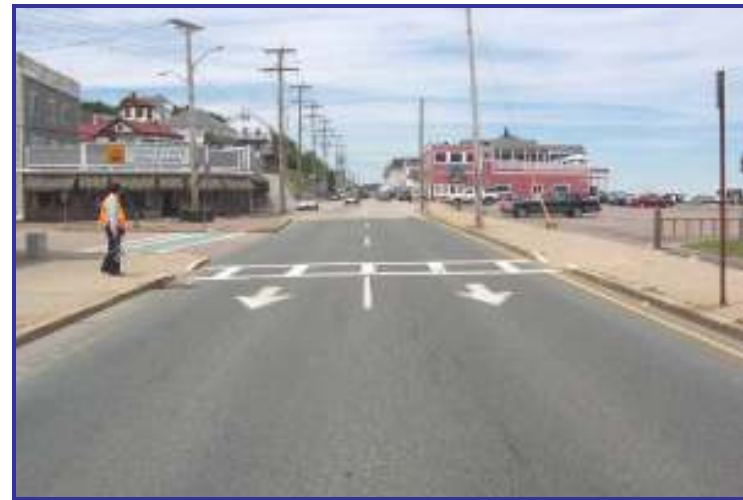
Figure 3-10: Location 4 (Nantasket Avenue at George Washington Boulevard)

Signage for one-way operation is not adequate.

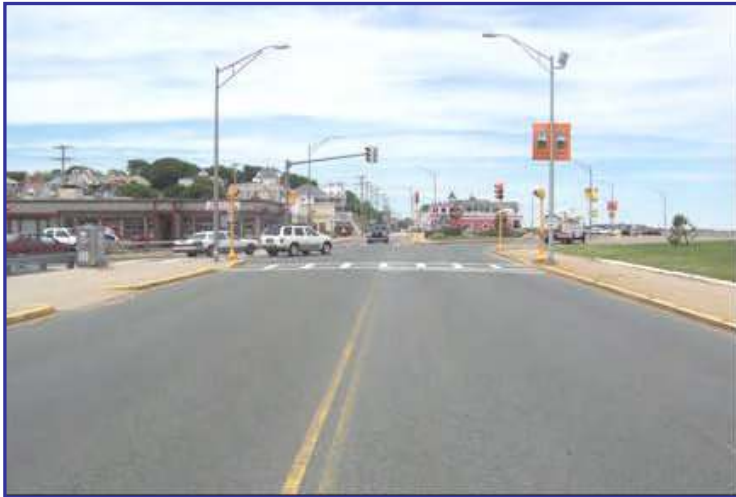
Figure 3-11: Location 5 (Nantasket Avenue at Hull Shore Drive and George Washington Boulevard)

Signage for one-way and turn restrictions are not adequate and does not conform to the latest edition of MUTCD.

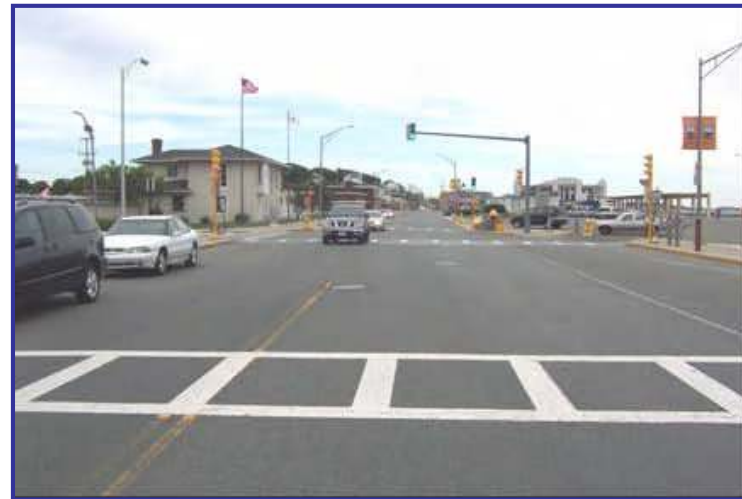
Figure 3-12: Location 6 (Nantasket Avenue at Wharf Avenue)

Signage and pavement markings for the dedicated turn lanes at the intersection are not adequate and do not conform to the MUTCD criteria.

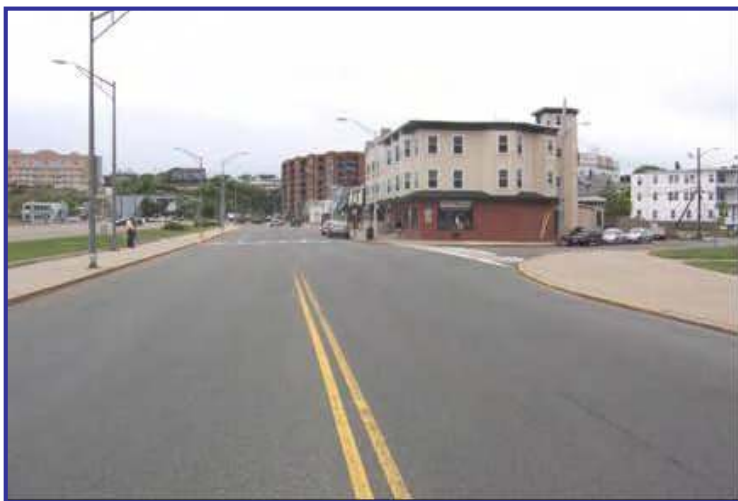
Figure 3-13: Location 7 (Nantasket Avenue at Park Avenue)

Pavement markings as described above are inadequate and do not conform to the latest edition of MUTCD.
