MassDEP Field Assessment and Support Team (FAST)

After Incident Report

DEP RTN 4-22,102

NEW BEDFORD – New Bedford Waste Services

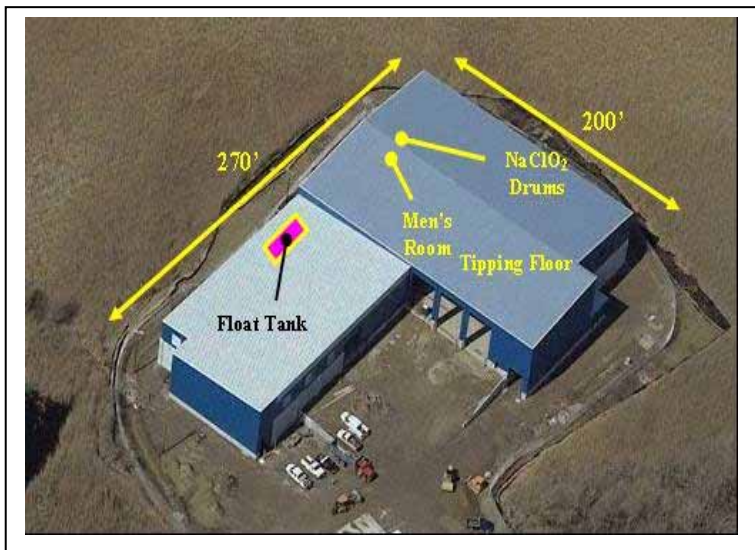
It was initially reported that two 55 gallon drums of sodium chlorite were contained in an (unused) lady's restroom on the first floor of the facility, immediately adjacent to the men's room. Subsequent reports indicate that there is only one drum containing product in this area, along with two other drums that are apparently empty.

Two metering pumps are situated on top of the partially filled drum. One pump directs solution to the 10,000 gallon Float Tank, located about 100 feet away. The other tank is pumped into an adjacent sink, where it is mixed with running water from a faucet, and discharged into the plant's sewer system. There is some question as to whether the pump to the sink was plugged in prior and during the incident.

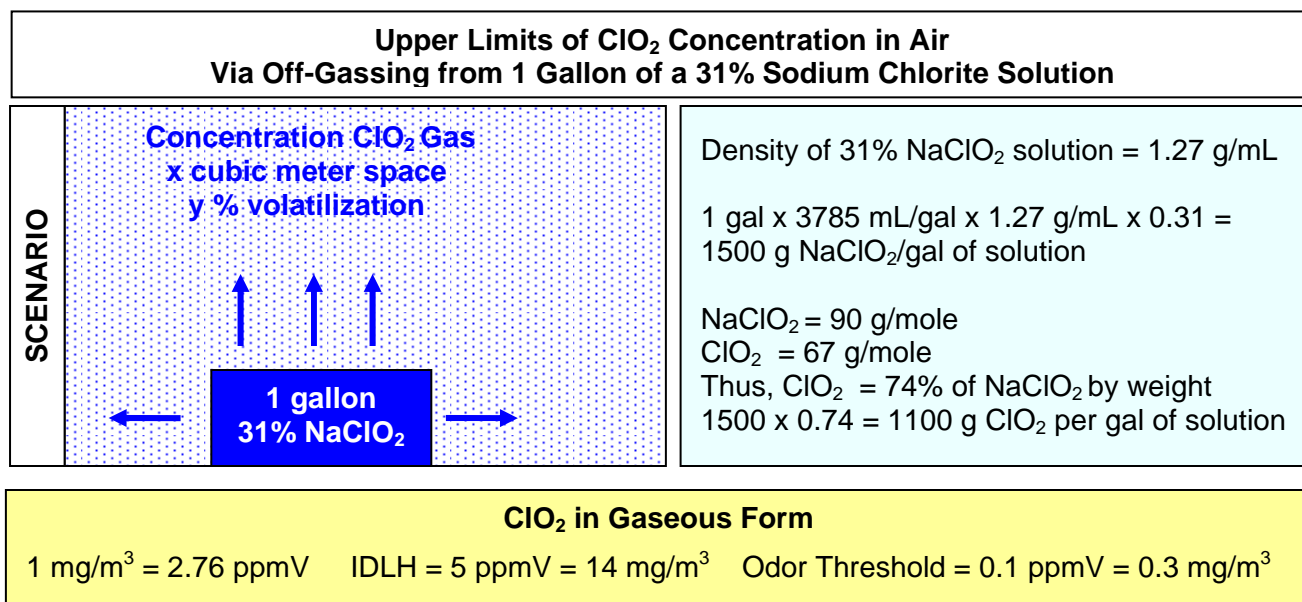
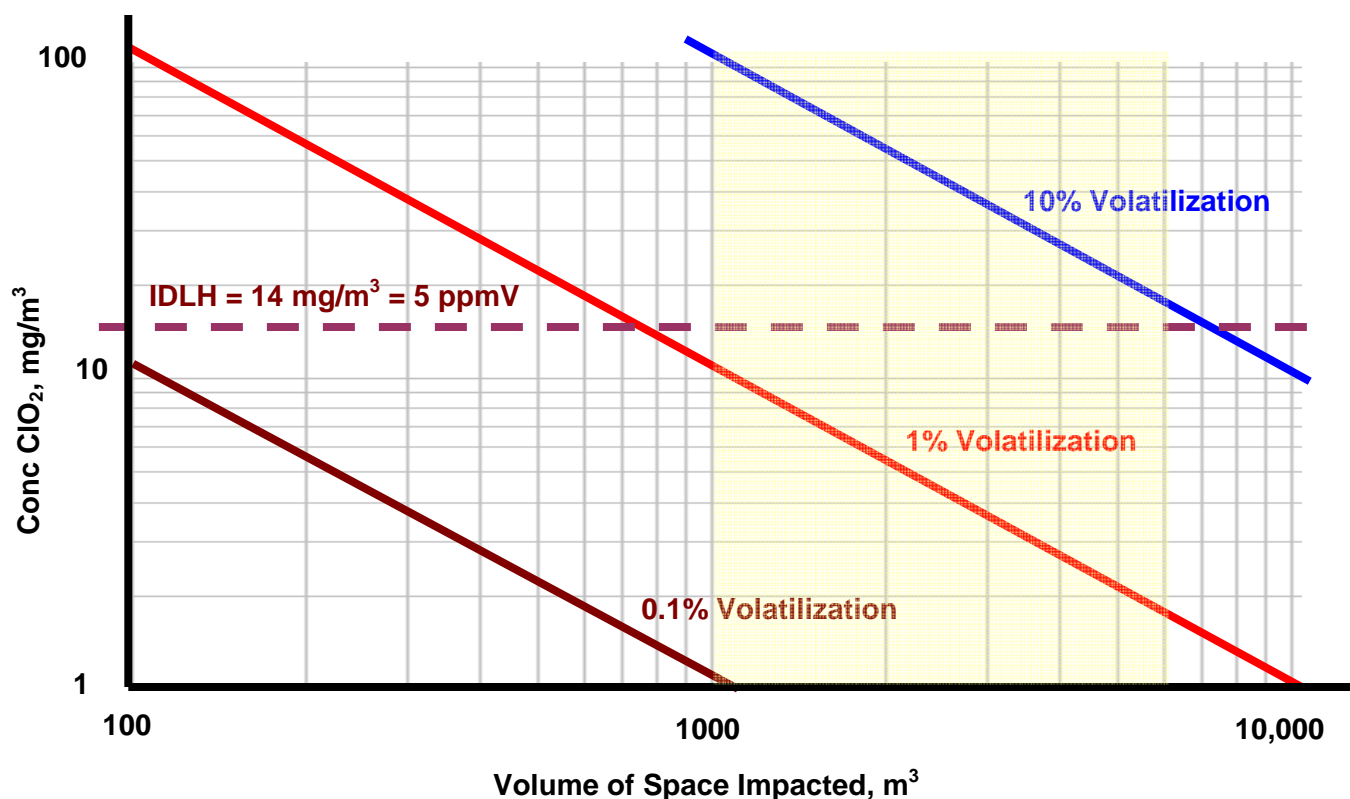
The following analysis considers the maximum amount of chlorine dioxide gas that could exist in an enclosed space based upon the use of 1 gallon of a 31% sodium chlorite solution, assuming 0.1%, 1%, and 10% of the available chlorine dioxide is released into an enclosed space of between 100 and 10,000 m³.

On the basis of the above, it appears *possible* that the reported use of sodium chlorite *could produce levels of chlorine dioxide that could explain the symptoms noted during this incident*. For example, if 1% of the ClO_2 in a one gallon solution of sodium chlorite off-gassed into a 1000 m^3 space, the calculated air concentration in that space would be about 11 mg/m^3 . If there were a total of 2 gallons of this solution in the Float Tank, and 1% of the possible ClO_2 emissions occurred into this 1000 m^3 space, the calculated value would be 22 mg/m^3 (8 ppmV), which is greater than the IDLH value of 5 ppmV. Off-gassing of 10% or more of the ClO_2 would likely exceed the IDLH virtually anywhere in the facility.

While the above indicates that sodium chlorite cannot be ruled out in this matter, it does not provide definitive evidence that such a reaction and emission occurred, given unknowns on what reactants may have existed, the extent and kinetics of that reaction and off-gassing, and the ventilation rate in the area of impact.
