*Massachusetts Coastal Infrastructure
Inventory and Assessment Project
Coastal Hazards Commission*

New Bedford

July 6, 2009

**Bourne Consulting Engineering
Franklin, Massachusetts**

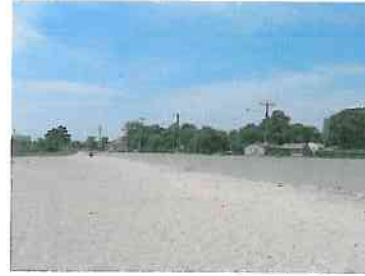
The cast in place wall is 1 foot wide. There is minor cracking and spalling. There is a sidewalk, road, and parking lot located behind it and a sandy beach in front of it. There is no visible scour.

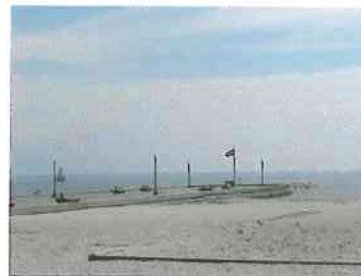
The stone block seawall with cast in place cap has stones that are approximately 5 feet by 2 feet. They are mortared together. There is no sign of scour or stone movement. Above the wall is a park. The cap has minor cracks and spalling.

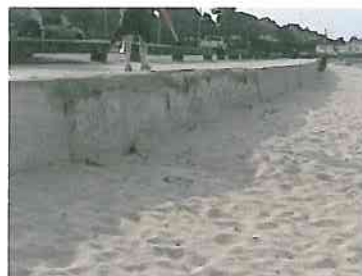
The cast in place wall is 2 feet wide. There is a walkway, road, and houses located behind it. There is no visible scour. There is minor cracking and spalling. Areas of the wall has riprap set at a 1 on 2 slope with stones that are approximately 3 feet by 2 feet by 1 foot in size.

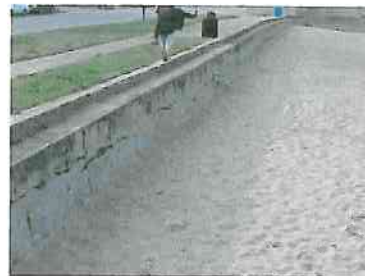
The cast in place wall is 1 foot wide with a walkway, road, and houses behind it. There is minor cracking and spalling, and no visible scour.

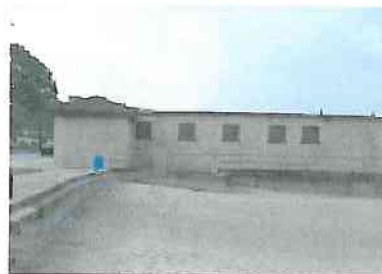
The cast in place wall is 1 foot wide with public bath house behind it. There is minor cracking and spalling, and no visible scour.

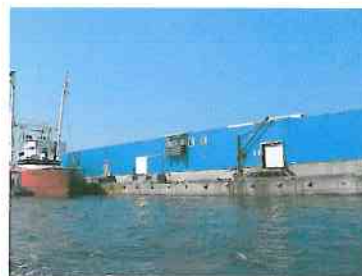
The cast in place concrete bulkhead has a fish processing plant behind it. There is minor cracking and spalling on the bulkhead. At the time of the survey, the fender system was being repaired.

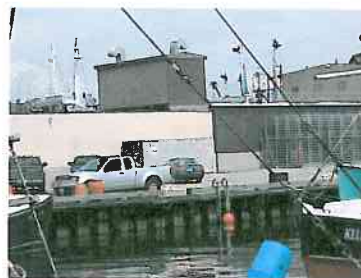
The sheet pile bulkhead has a steel cap. There is moderate corrosion at the tidal zone, but no visible erosion behind the piles. The bulkhead has fender piles in the corners. There is a parking lot, fishing equipment storage, warehouses, and building above the structure.

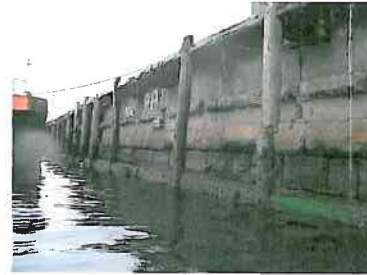
The stone block seawall has a cast in place concrete cap which is approximately 10 feet in height. There is moderate to severe cracking and spalling on the concrete. Damaged fender piles are in front of the structure. Connected to the structure are timber piles supporting the pier. There is also a ferry terminal on the pier.

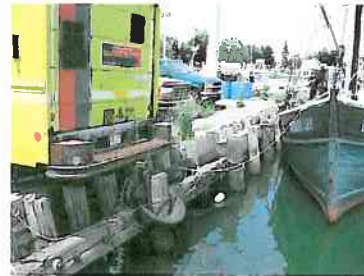
The cast in place concrete bulkhead has timber piles that are 2 feet on center offshore. The construction material is not visible below the water line. There is moderate cracking and settling of the concrete. Behind the pier is a parking lot.

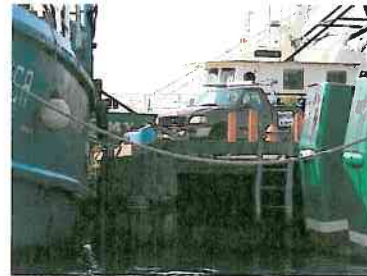
The sheet pile bulkhead has a steel cap. There is moderate corrosion at the tidal zone. There is no visible erosion behind the piles. There are fender piles along the bulkhead and in the corners. A parking lot and fishing equipment storage are above the structure.

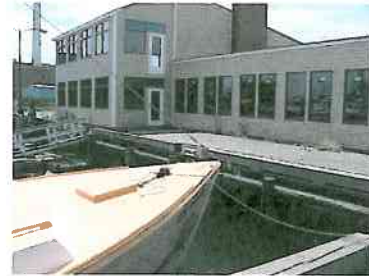
The sheet pile bulkhead has a steel cap. There is moderate corrosion at the tidal zone, but no visible erosion behind the piles. The bulkhead has fender piles. There is a building directly behind the bulkhead.

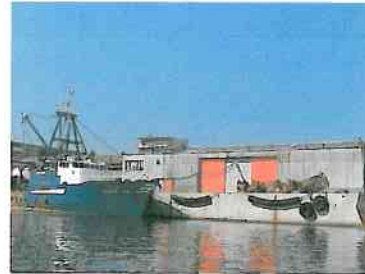
The cast in place concrete bulkhead has a factory behind it. There is minor cracking and spalling. The mean high water is approximately 10 feet from the top of the bulkhead. The top of the wall contains drainage holes.

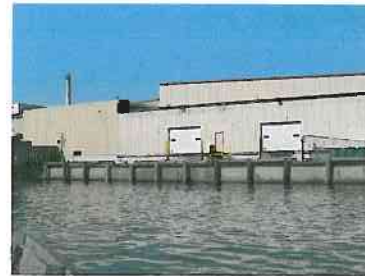
The cast in place concrete bulkhead has timber fender piles. There is a factory behind the structure. There is minor spalling and cracking in the concrete. Mean high water goes to approximately 10 feet from the top of the bulkhead. The top of the wall contains drainage holes.

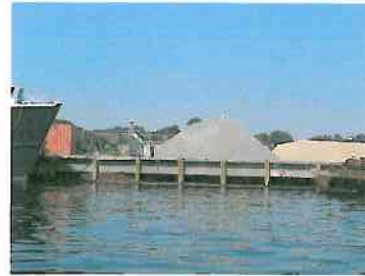
The steel sheet pile bulkhead has a concrete cap and timber fender piles on it. Behind the structure is a storage area for sand and gravel as well as warehouses and buildings. There is moderate corrosion at the tidal zone of the sheet piles.
