## NORTH SHORE WATERSHEDS

# North Shore Watersheds

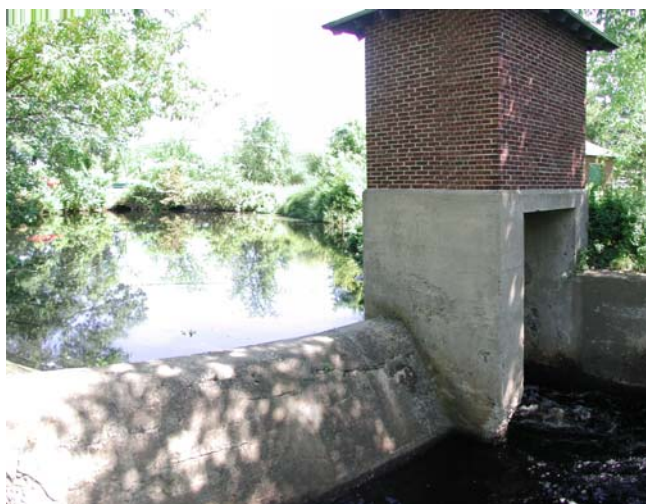
Lynn Waterways Dam at the Colonial Country Club

Since the breaching of the Saugus Iron Works dam, river herring have had access to the Colonial Golf and Country Club dam at river mile 9.4 and have been observed at the base of that dam as well as in Camp Nihan Pond at river mile 6.0. Further development would be costly due to outlet structure design at the first and second dams and is greatly reduced in priority by the fact that stream flows can be very low in summer and fall. Rainbow smelt are known to spawn in the area below the remains of the Saugus Iron Works dam.

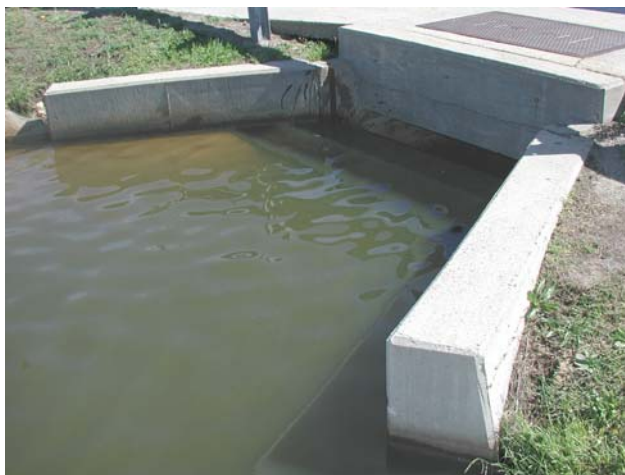
Lake Quannapowitt Dam

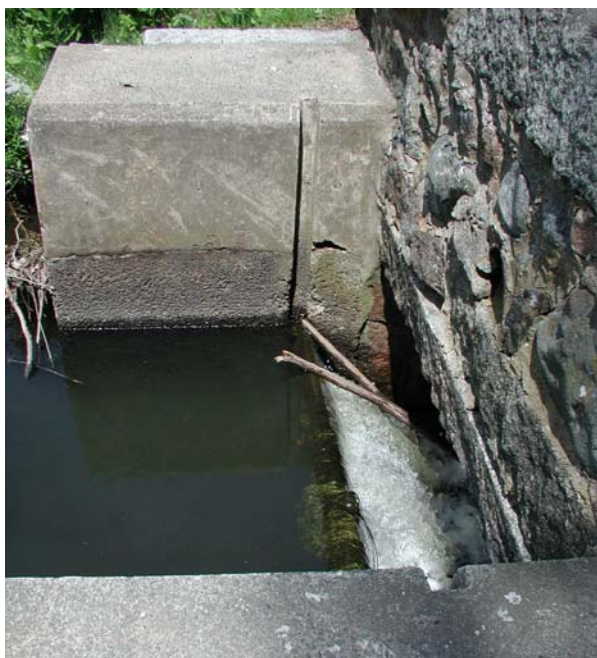
Mill Pond Dam (from above)

Crane River is another small tributary to Beverly Harbor. A 4.6 acre impoundment provides the only potential river herring habitat in the system. Small schools of river herring have been observed in the stream on occasion by DMF biologists. During the period 1995 to 1997 DMF introduced fertilized smelt eggs to this stream and removed a sluice gate, which blocked smelt passage to spawning habitat. In recent years small numbers of smelt eggs have been observed on the substrate and may be a result of this stocking.

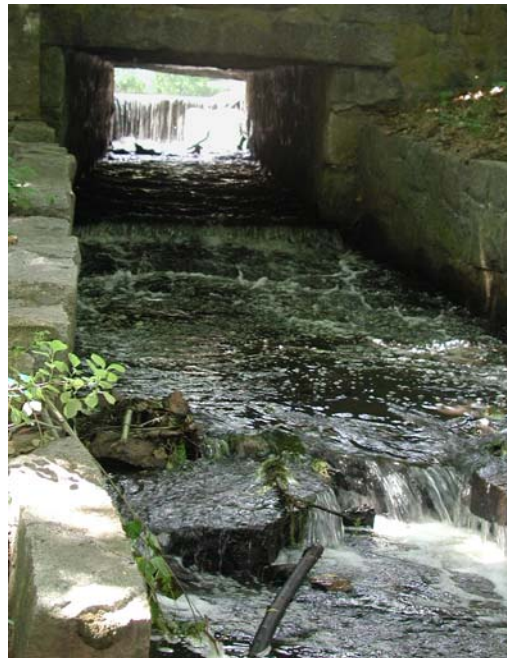
Downstream of Mill Pond Dam

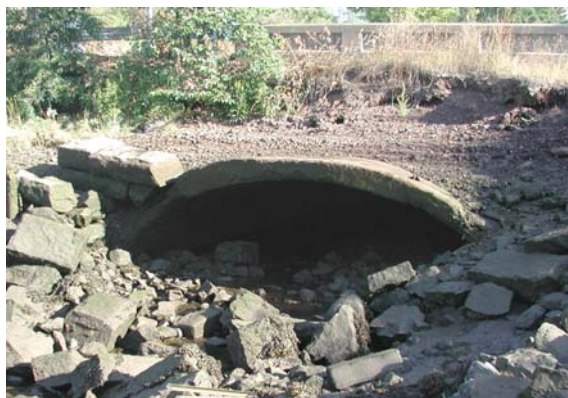
Elliot Street culvert

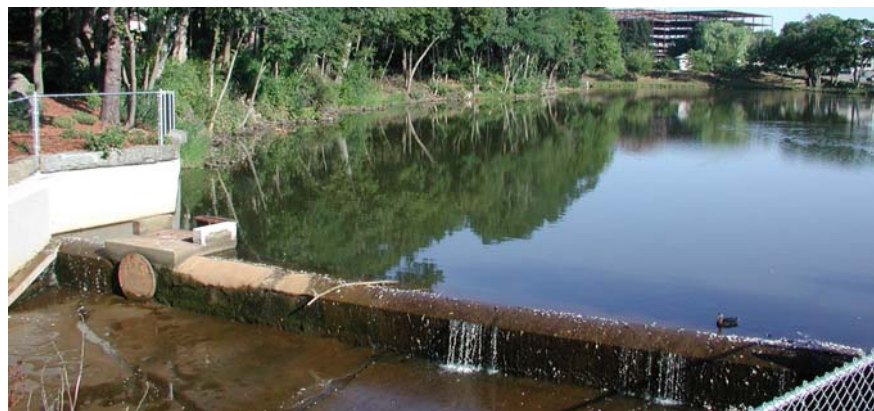
Dam above Elliot Street parking

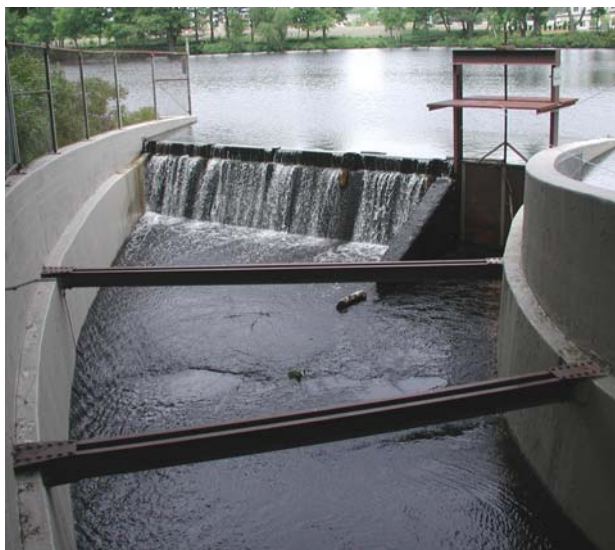
Shoe Pond Dam

Although this tributary to Beverly Harbor offers over 15 acres of potential river herring habitat in its two impoundments, the difficulty of providing fish passage at the obstructions gives it a very low priority for development.

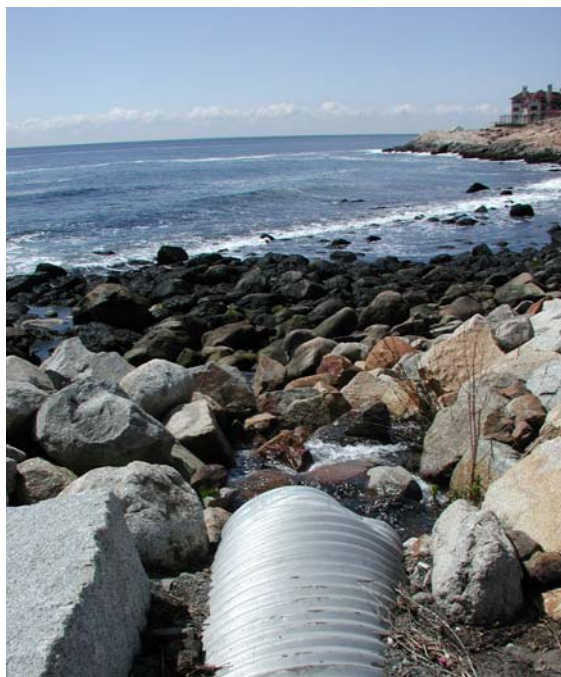
Outlet of Shore Road culvert

The stream draining this 7.3 acre pond enters Massachusetts Bay by way of a small corrugated metal culvert. There is no access to the culvert entrance across the rocky beach and no development potential.

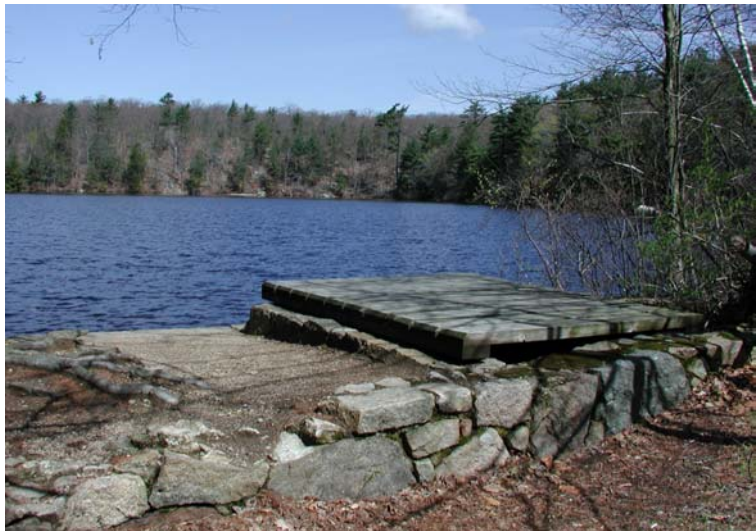
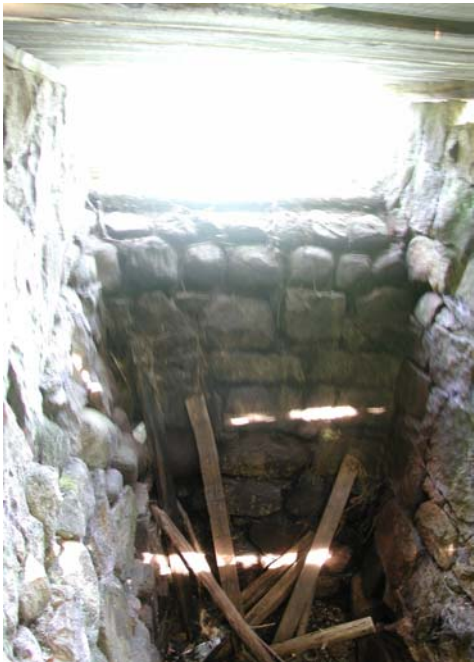
Buswell Pond with covered spillway

Spillway

Four obstructions block passage to this 4.3 acre pond, making any anadromous fish development costly and unlikely due to the small potential resource return for the investment..

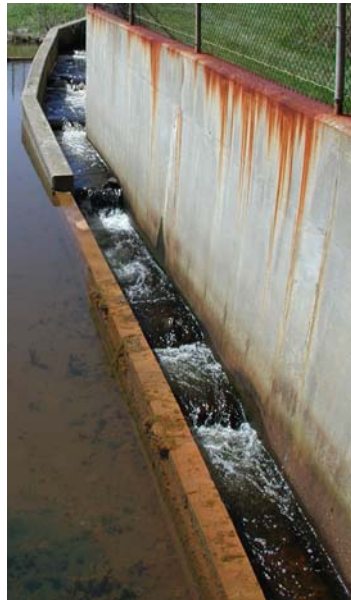
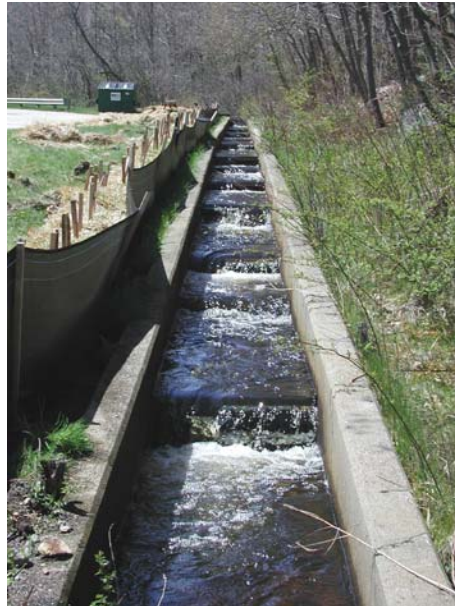
Lower portion of fishway

Upper portion of fishway at Treatment Facility

Design	Material	Length (ft)	Inside W (ft)	Outside W (ft)	# of Baffles	Baffle H (ft)	Notch W (ft)	Pool L (ft)	Condition/Function
Notched weir-pool	Concrete walls with cinder block and plywood weirs	310	3.1	Varied (4.5 & 5.1)	27	Varied (1.3-1.6)	1.5	Varied (2, 7-15)	Good Passable

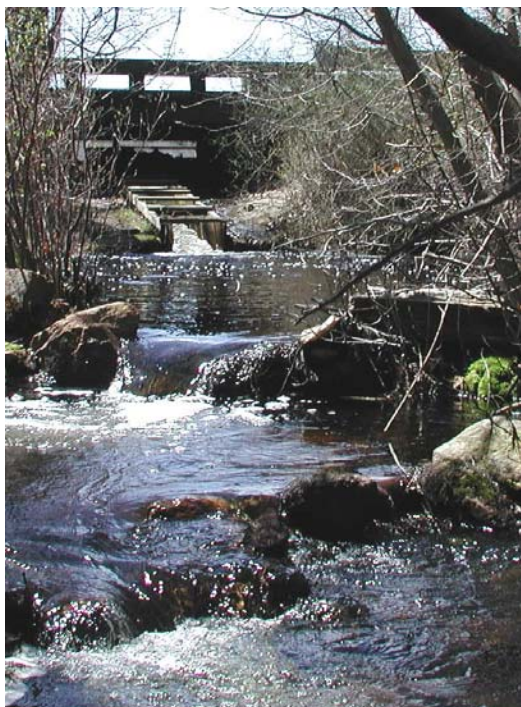
Stream baffles and denil ladder at Lily Pond

<b>Design</b>	<b>Material</b>	<b>Length (ft)</b>	<b>Inside W (ft)</b>	<b>Outside W (ft)</b>	<b># of Baffles</b>	<b>Baffle H (ft)</b>	<b>Notch W (ft)</b>	<b>Pool L (ft)</b>	<b>Condition/Function</b>
Stream baffle	Stone	~460	Varied (5-12)	Varied (5-12)	10	Varied (0.7, 1.2, 1.7)	Varied (1.4, 1.7, 2.0)	Varied (7, 10, 21)	Fair Passable
Denil	Wood	32.0	2.0	2.4	16	1.9	-	-	Good Passable

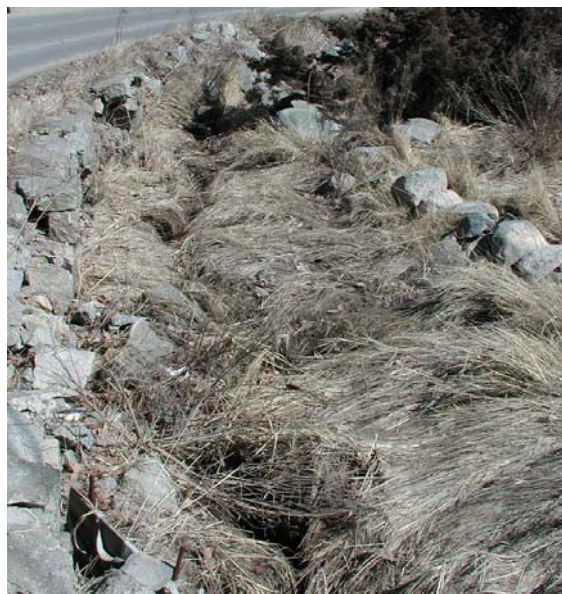
Overgrown channel downstream of Atlantic Street culvert

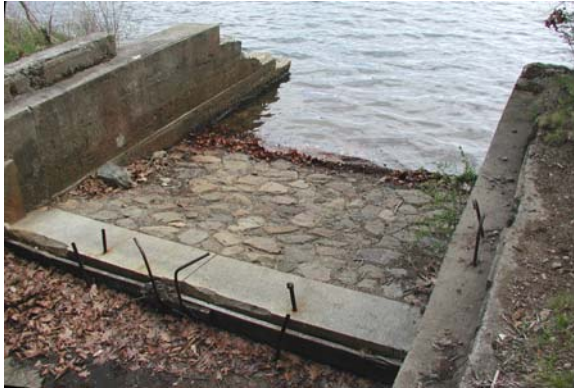
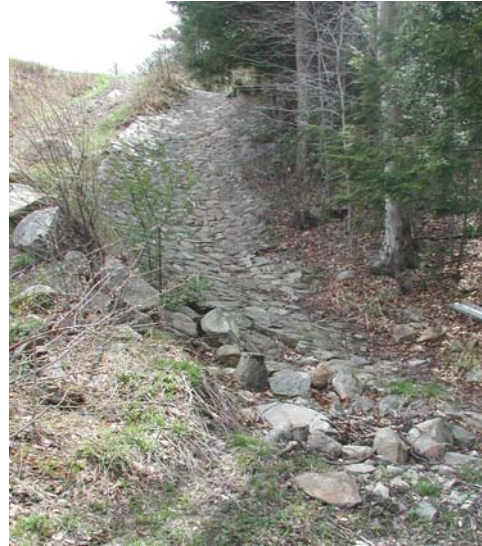
Upper section of Haskell Pond spillway (no outflow)

Lower section of spillway (dry)

Walkers Creek flows from 50 acre Haskell Pond to Essex Bay. Two obstructions, the dam at Haskell Pond and a smaller privately owned dam prevent anadromous fish access. In spite of the significant potential habitat available in the upper impoundment, the height of the dam and the lack of sustained outflow relegate this stream to a low priority for development. Smelt spawning was reported in the lower river in the past, but none have been observed in recent years.

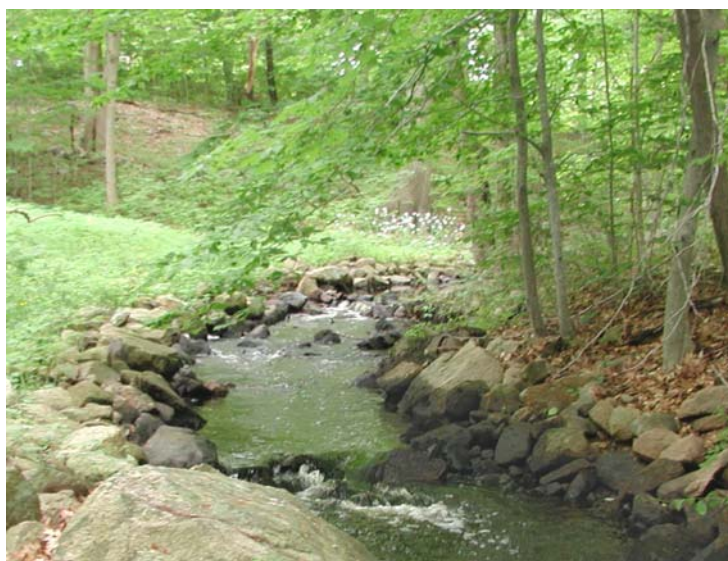
Stream baffles off Apple Street

Design	Material	Length (ft)	Inside W (ft)	Outside W (ft)	# of Baffles	Baffle H (ft)	Notch W (ft)	Pool L (ft)	Condition/ Function
Stream baffle	Stone	12.0	7.0	Stream edge	2	0.8	-	12.0	Poor Inefficient passage

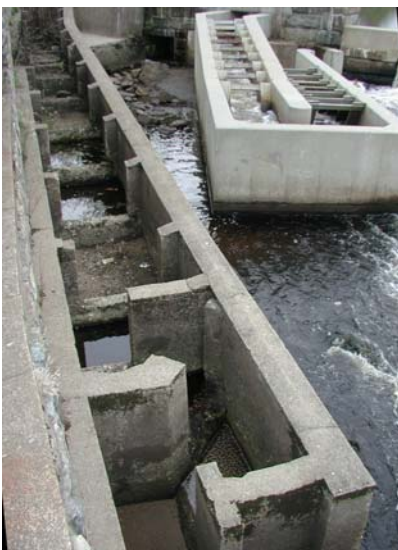
Design	Material	Length (ft)	Inside W (ft)	Outside W (ft)	# of Baffles	Baffle H (ft)	Notch W (ft)	Pool L (ft)	Condition/Function
Denil	Concrete with wooden baffles	85.4	2.5	4.8	17	4.5	-	-	Good Passable

Old (left) and new (right) fishways at Ipswich Mills Dam

1. Continue to monitor adult river herring returns in the Ipswich River at the Ipswich Mills fishway. If significant increases in returns are observed, consider removal of the Willowdale dam with fishway construction as an alternative.

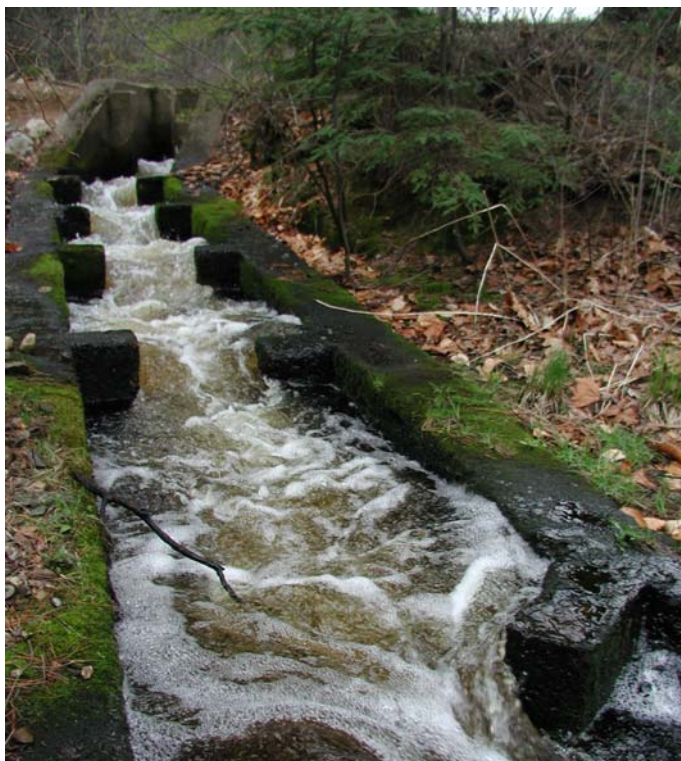
<b>Design</b>	<b>Material</b>	<b>Length (ft)</b>	<b>Inside W (ft)</b>	<b>Outside W (ft)</b>	<b># of Baffles</b>	<b>Baffle H (ft)</b>	<b>Notch W (ft)</b>	<b>Pool L (ft)</b>	<b>Condition/Function</b>
Notched weir-pool	Concrete	61.0	3.1	5.0	13	Varied (2.6-5)	1.6	Varied (4-6.5)	Poor Inefficient passage

Fishway at Willowdale Dam

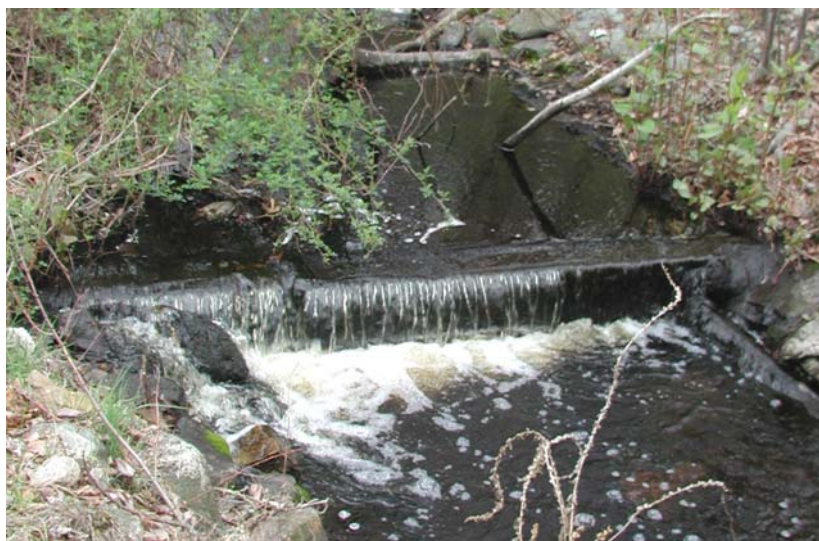
Stream baffle at Municipal Electrical Generating Plant

Design	Material	Length (ft)	Inside W (ft)	Outside W (ft)	# of Baffles	Baffle H (ft)	Notch W (ft)	Pool L (ft)	Condition/Function
Stream baffle	Stone	224.0	Varied (9-10')	Stream edge	7	0.9	-	Varied (21, 20, 20.5)	Poor Inefficient passage

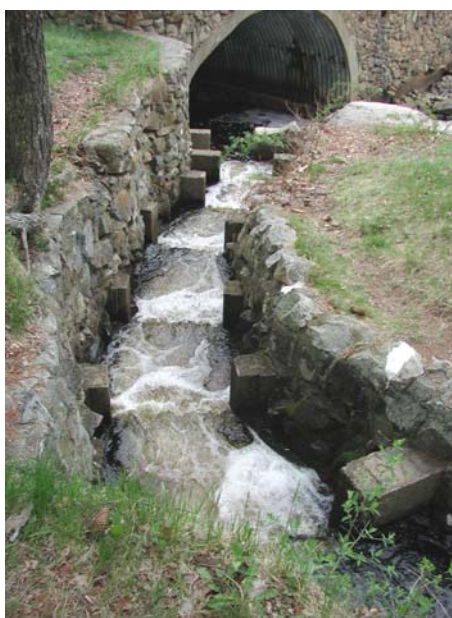
Design	Material	Length (ft)	Inside W (ft)	Outside W (ft)	# of Baffles	Baffle H (ft)	Notch W (ft)	Pool L (ft)	Condition/Function
Notched weir-pool	Concrete and stone	104.0	Varied (3-10)	Varied (2-3)	12	1.8	3.0	Varied (5-16.3)	Fair Passable

Fishway at Woolen Mill Dam

3. Replace the Snuff Mill and River Street ladders on the Parker River with more efficient designs.
4. Provide a low water passage channel for juvenile herring at the Woolen Mill dam on the Parker River.

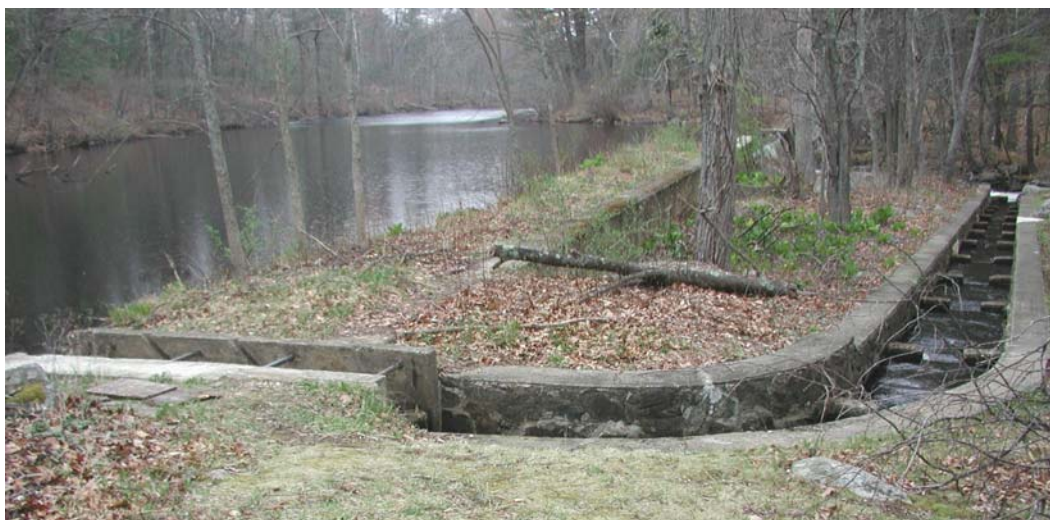
<b>Design</b>	<b>Material</b>	<b>Length (ft)</b>	<b>Inside W (ft)</b>	<b>Outside W (ft)</b>	<b># of Baffles</b>	<b>Baffle H (ft)</b>	<b>Notch W (ft)</b>	<b>Pool L (ft)</b>	<b>Condition/ Function</b>
Notched weir-pool	Concrete and stone	152.0	Varied (2.4-4.1)	Varied (4.0-6.7)	14	Varied (0.7-1.4)	1.3	11.2	Fair Passable

Fishway at Larkin Road Dam

The second fishway, at Larkin Street, was improved 1997 by volunteers who modified the entrance to increase attraction flow. The ladder now functions adequately. The next fishway, at the Snuff Mill dam, is inefficient and needs to be redesigned and replaced. The fourth fishway at the Blacksmith Shop dam was replaced in 2001 with an aluminum Alaskan Steepass ladder. A notched weir-pool fishway at River St. is passable but in poor condition and will need repair work in the near future. And finally, a new aluminum steeppass ladder was installed in 2000 at the outlet of Pentucket Pond. Access for cleaning and a screen in the spillway channel of the dam are needed to provide maximum efficiency for this facility.

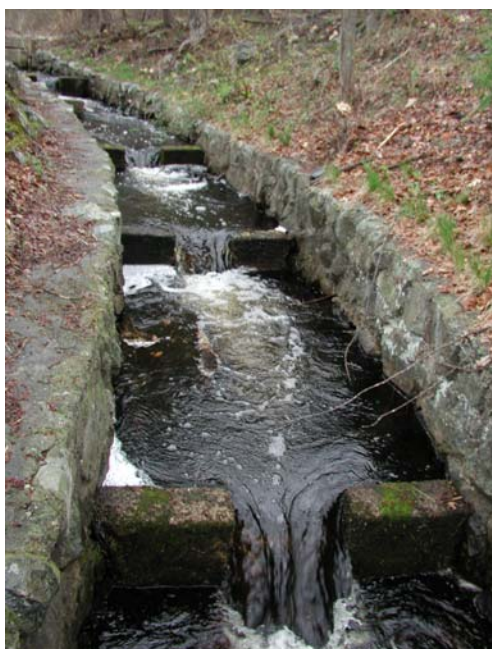
<b>Design</b>	<b>Material</b>	<b>Length (ft)</b>	<b>Inside W (ft)</b>	<b>Outside W (ft)</b>	<b># of Baffles</b>	<b>Baffle H (ft)</b>	<b>Notch W (ft)</b>	<b>Pool L (ft)</b>	<b>Condition/Function</b>
Notched weir-pool	Concrete and stone	106.0	Varied (2.2-4.6)	Varied (4.1-5.8)	13	1.9	1.5	Varied (8.3-10.4)	Fair Inefficient passage

Fishway at Snuff Mill Dam

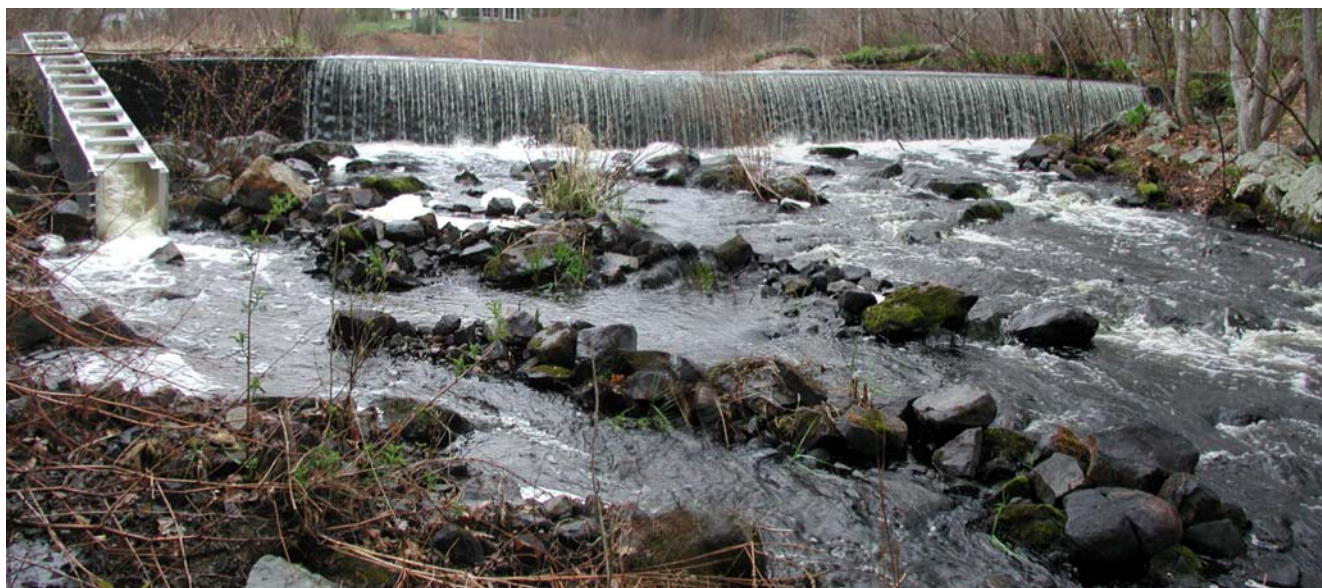
Blacksmith Shop Dam with fishway (left side of photo)

<b>Design</b>	<b>Material</b>	<b>Length (ft)</b>	<b>Inside W (ft)</b>	<b>Outside W (ft)</b>	<b># of Baffles</b>	<b>Baffle H (ft)</b>	<b>Notch W (ft)</b>	<b>Pool L (ft)</b>	<b>Condition/Function</b>
Alaskan steeppass	Aluminum	20.0	2.0	-		2.5	-	-	Excellent Passable

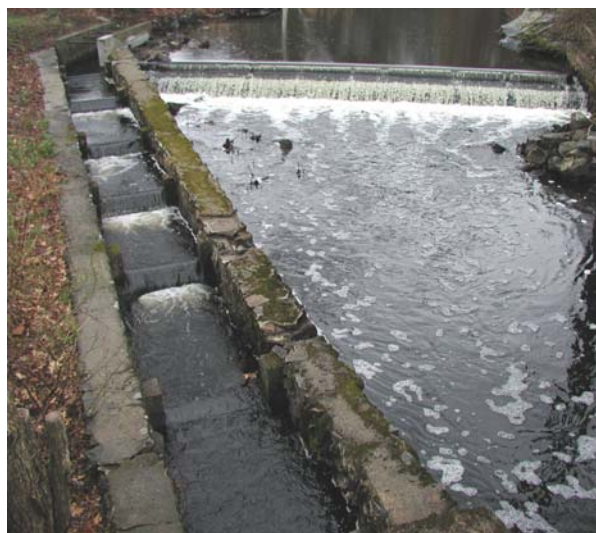
Design	Material	Length (ft)	Inside W (ft)	Outside W (ft)	# of Baffles	Baffle H (ft)	Notch W (ft)	Pool L (ft)	Condition/Function
Notched weir-pool	Stone and concrete	65.0	3.9	7.0	8	1.5	3.1	Varied (7.1, 8.4, 6.9)	Poor Passable

Fishway at River Street Dam

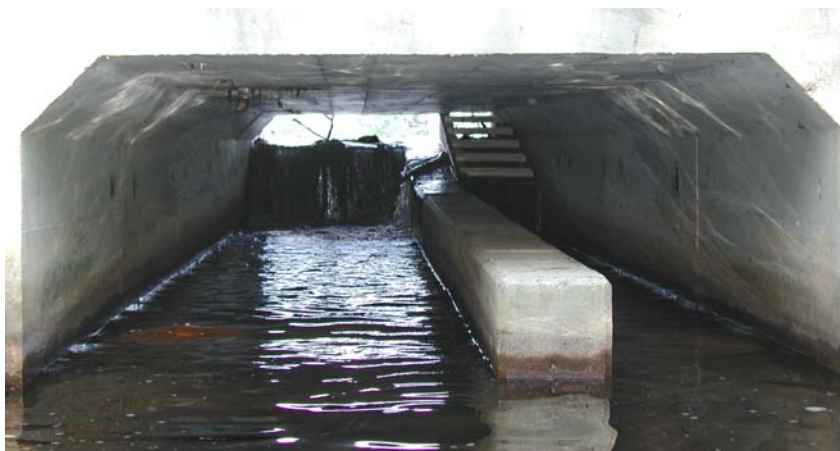
Pentucket Pond Dam and fishway (right side of photo)

<b>Design</b>	<b>Material</b>	<b>Length (ft)</b>	<b>Inside W (ft)</b>	<b>Outside W (ft)</b>	<b># of Baffles</b>	<b>Baffle H (ft)</b>	<b>Notch W (ft)</b>	<b>Pool L (ft)</b>	<b>Condition/ Function</b>
Alaskan steeppass	Aluminum	10.0	2.0	-		2.6	-	-	Excellent Inefficient passage
