Orleans District Court Orleans, MA

HVAC SYSTEM EVALUATIONS COVID-19

Office of Court Management November 29, 2021

Section 1 Existing Conditions & Site Observations

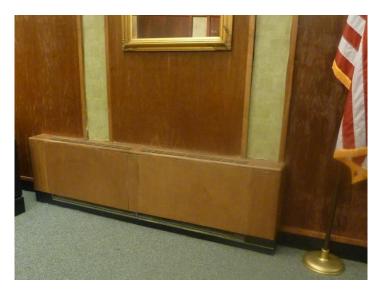
Photo 1 - Representative Unit Ventilator

All units appear to be from the original construction in 1971 and are in poor condition. The OA dampers and actuators do not appear to be functional.
