Palmer District Courthouse Palmer, MA

HVAC SYSTEM EVALUATIONS COVID-19

Office of Court Management

January 25, 2021

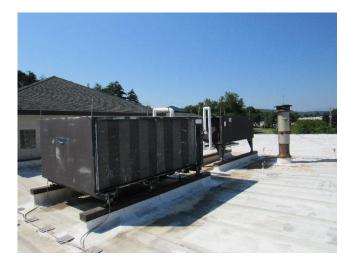
Photo 1 - RTU-1

The air handling unit is in very poor condition and is original from the 1991 installation. Courthouse staff noted that many repairs were made to help prevent water from leaking into the unit. The cooling coil drain pan was flooded with water and was not draining out of the drain. We suspect this is due to the lack of a condensate piping trap. Outside air was observed being drawn into the drain outlet. The suction pressure created by the supply fan is preventing the cooling coil condensate from draining out of the pan. The outside and return air dampers appear to be in good condition. The electric actuators appear to be in fair condition.

The rooftop air handler contains two sets of filters. There are prefilters within the outdoor air intake hood that filter the incoming outside air only. The MERV rating of these filters is unknown but the rating is assumed to be below MERV 7. There is another set of 2", MERV 10 filters inside the unit that filters both the outside air and return air. The upstream face of the adjacent heating coil appears to be dirty.

We recommend replacing RTU-1. A rooftop air handling unit has a life expectancy of 15-25 years. This unit is approximately 30 years old and is in very poor condition and is susceptible to an imminent failure.

We recommend installing a condensate trap on the cooling coil drip pan so the condensate can discharge out of the unit appropriately. Condensate trap size depends on the static pressure of the air handler.

2.7.2 Replacement of RTU-1
