INCIDENT REPORT

3 Magnolia Way, Peabody Massachusetts
March 8, 2007

Accident File 07 - 00

Report Issued - September, 2008

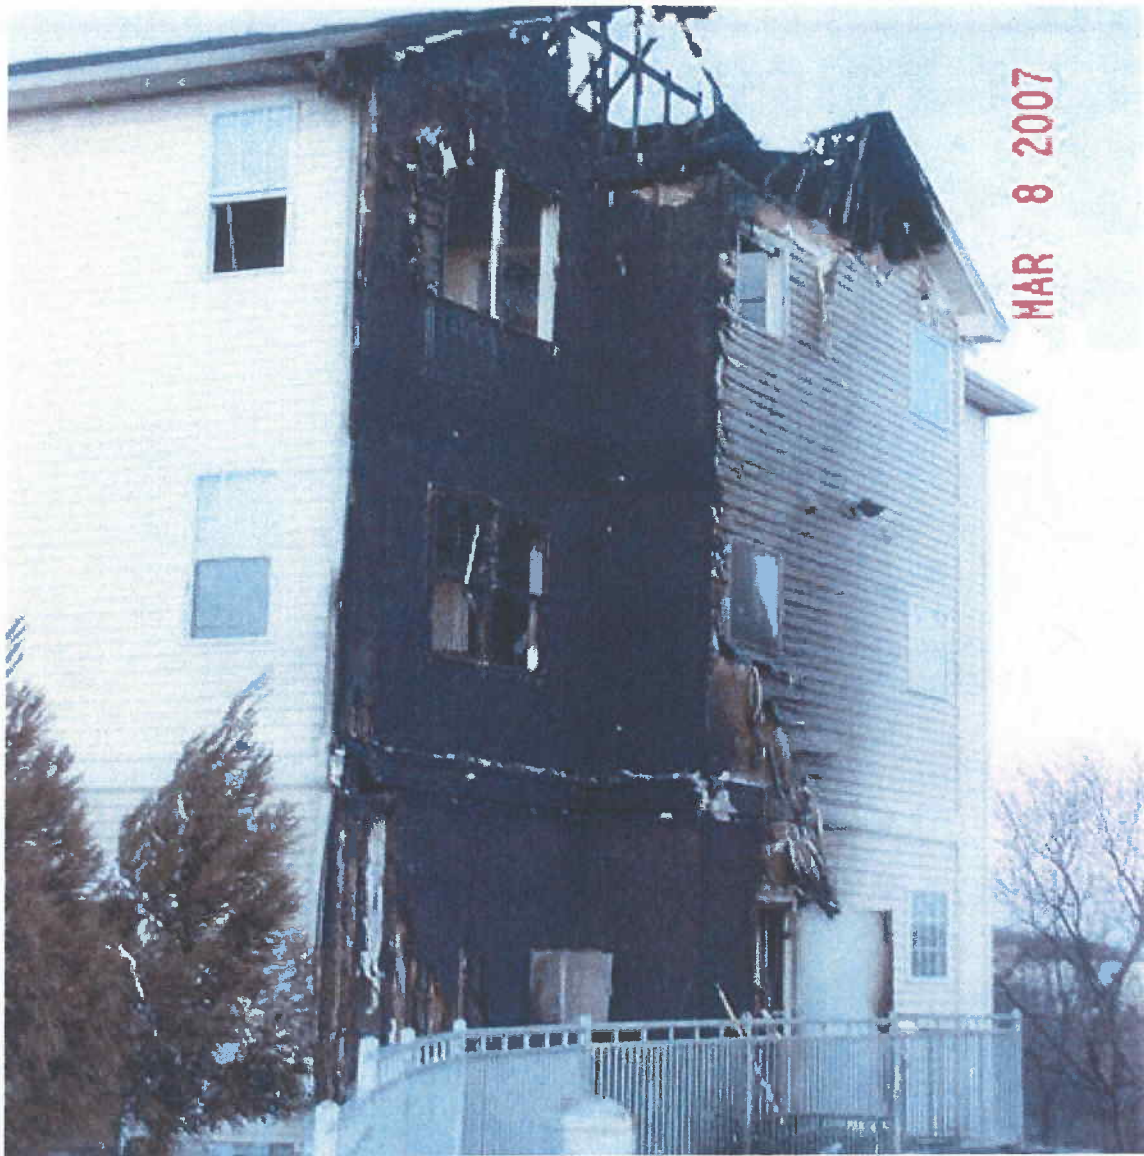
The building had fire damage directly above KeySpan's gas facilities servicing this building. The damaged area included the side of the building and a portion of the roof (Exh. 6). KeySpan's facilities consisted of an outside service riser, regulator and four meters (Exh. 7). The regulator and meters suffered extensive fire damage. Approximately 15 feet from the gas facilities was a Comcast Cable vault and two air-conditioning units (Exh. 6). The vault suffered fire damage. The gas service line was initially shutoff at the riser by the fire department. KeySpan then shutoff the gas service at the curb valve (Exh. 8).

3 Magnolia Way - Fire Damage

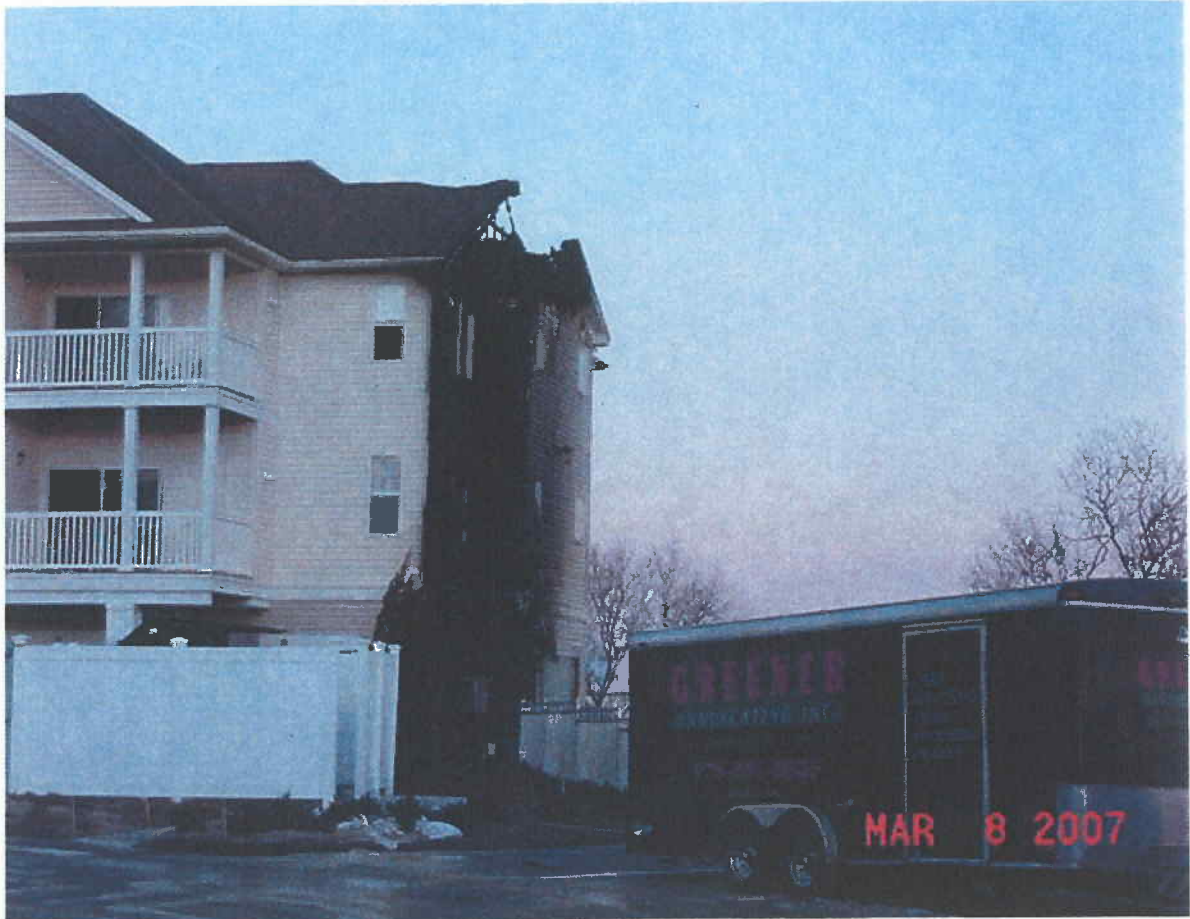
3 Magnolia Way - Fire Damage

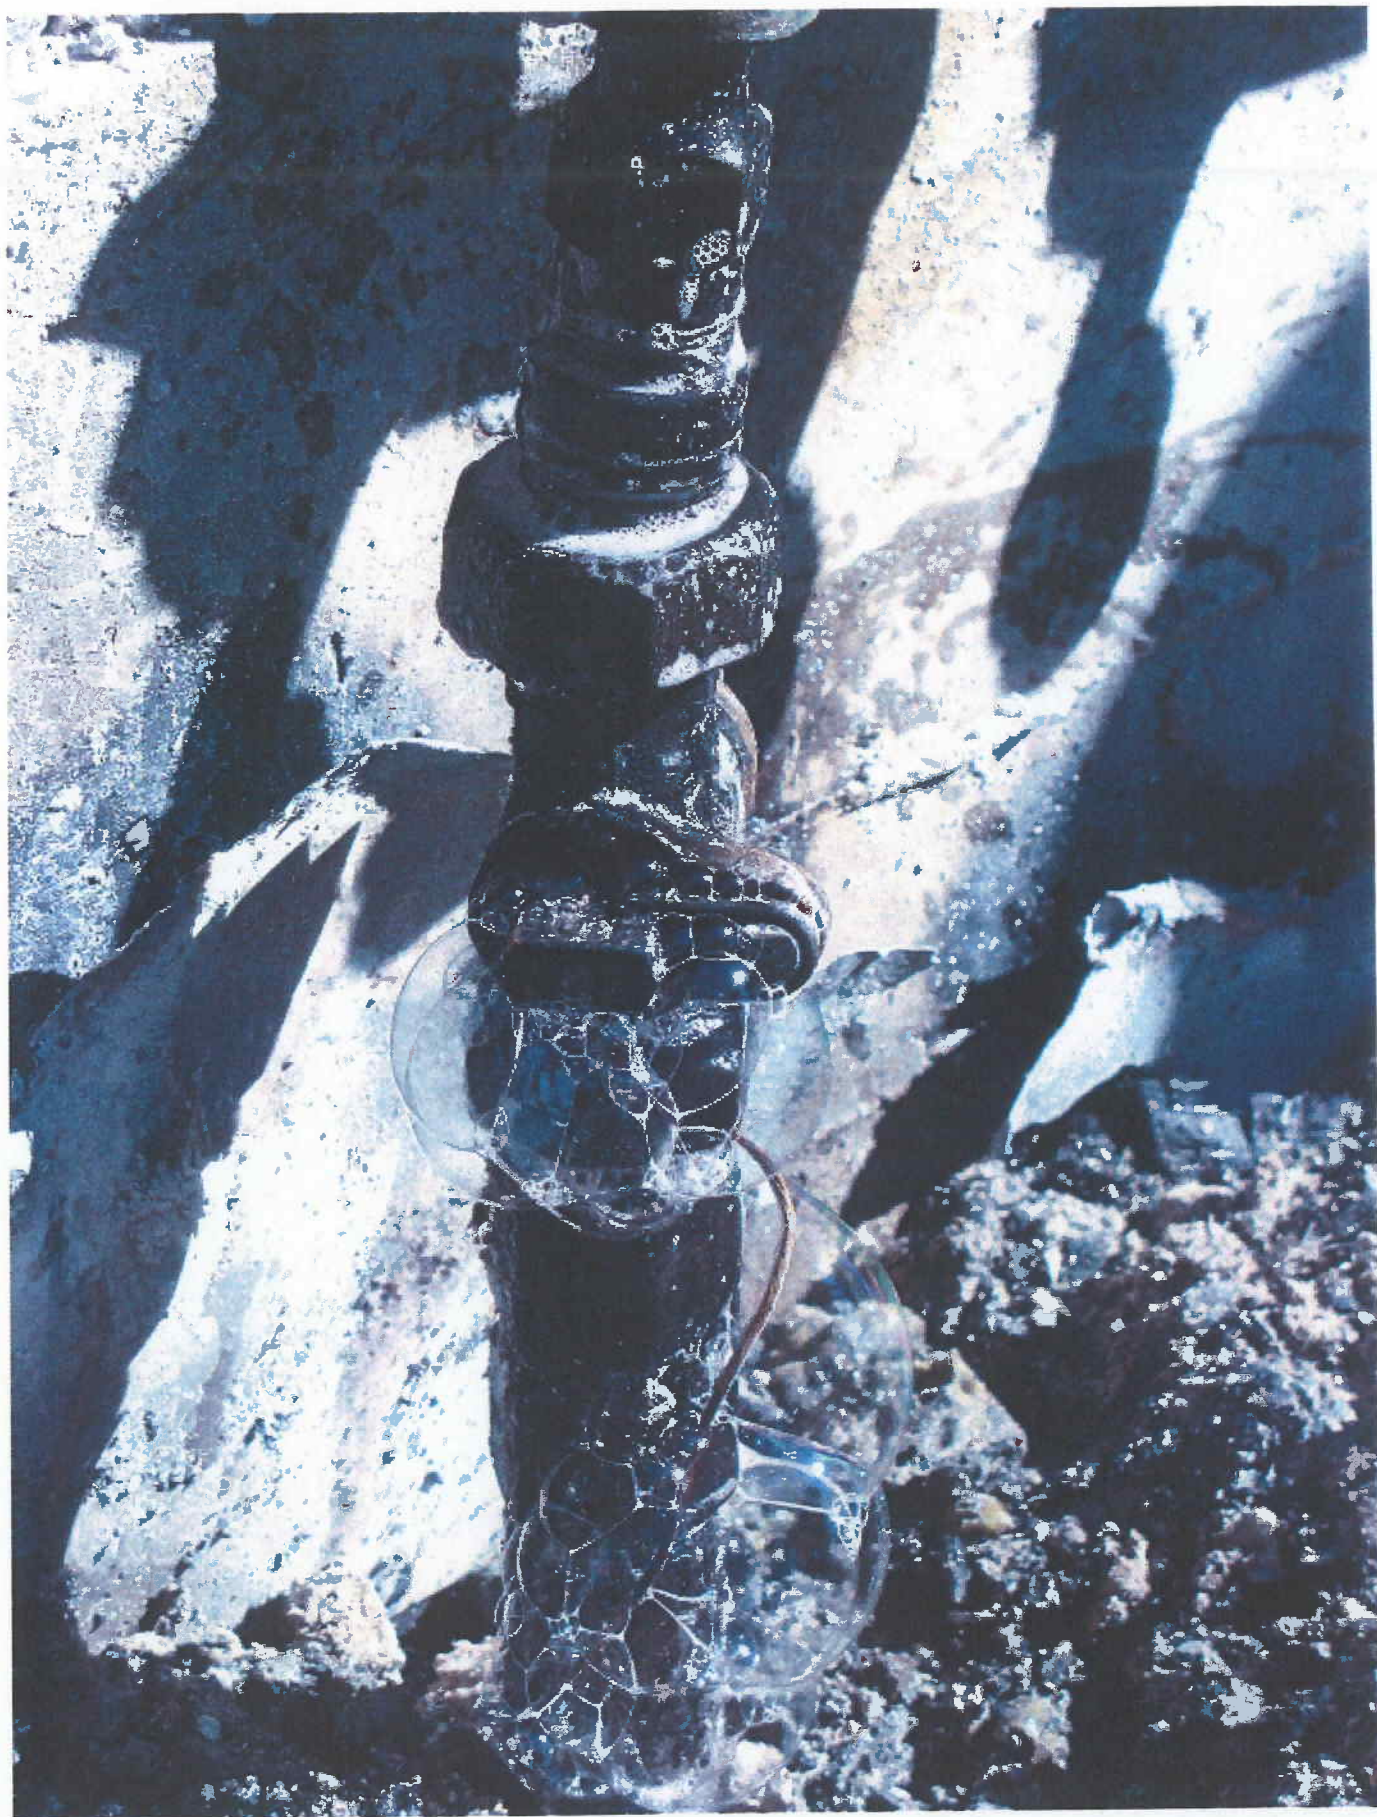
On the following day, the Division investigators requested that KeySpan pressure test the portion of the service line from the exposed curb valve to the service riser valve. The service line did not hold the 10 psig pressure test. The investigators observed leakage on the service riser valve and the insulating fitting above the valve (Exh. 6). Upon excavation of the

11. KeySpan pressure test the portion of the service line from the curb valve to the service riser valve. The service line did not hold the 10 psig pressure test. There was leakage on the service riser valve and the insulating fitting above the

Service Riser Valve and Insulating Fitting

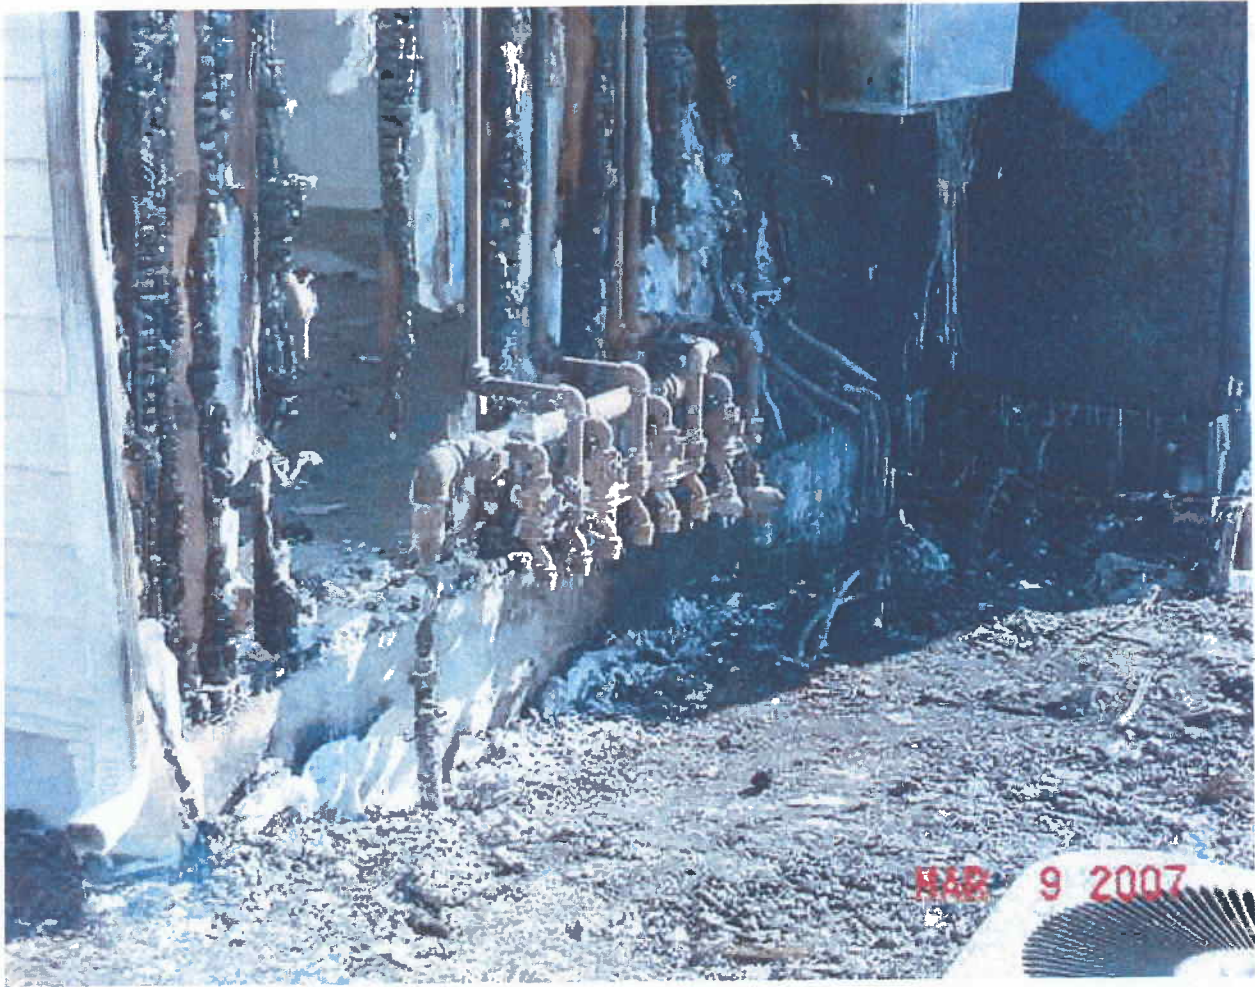
- No anomalies in the available gas equipment were revealed by this investigation that could have caused the release of natural gas at 3 Magnolia Way.
- Of the equipment available for investigation, only the universal joint gasket was too damaged to examine.
- The regulator and all four meters were melted in the fire.

Service Riser, Regulator and Four Meters

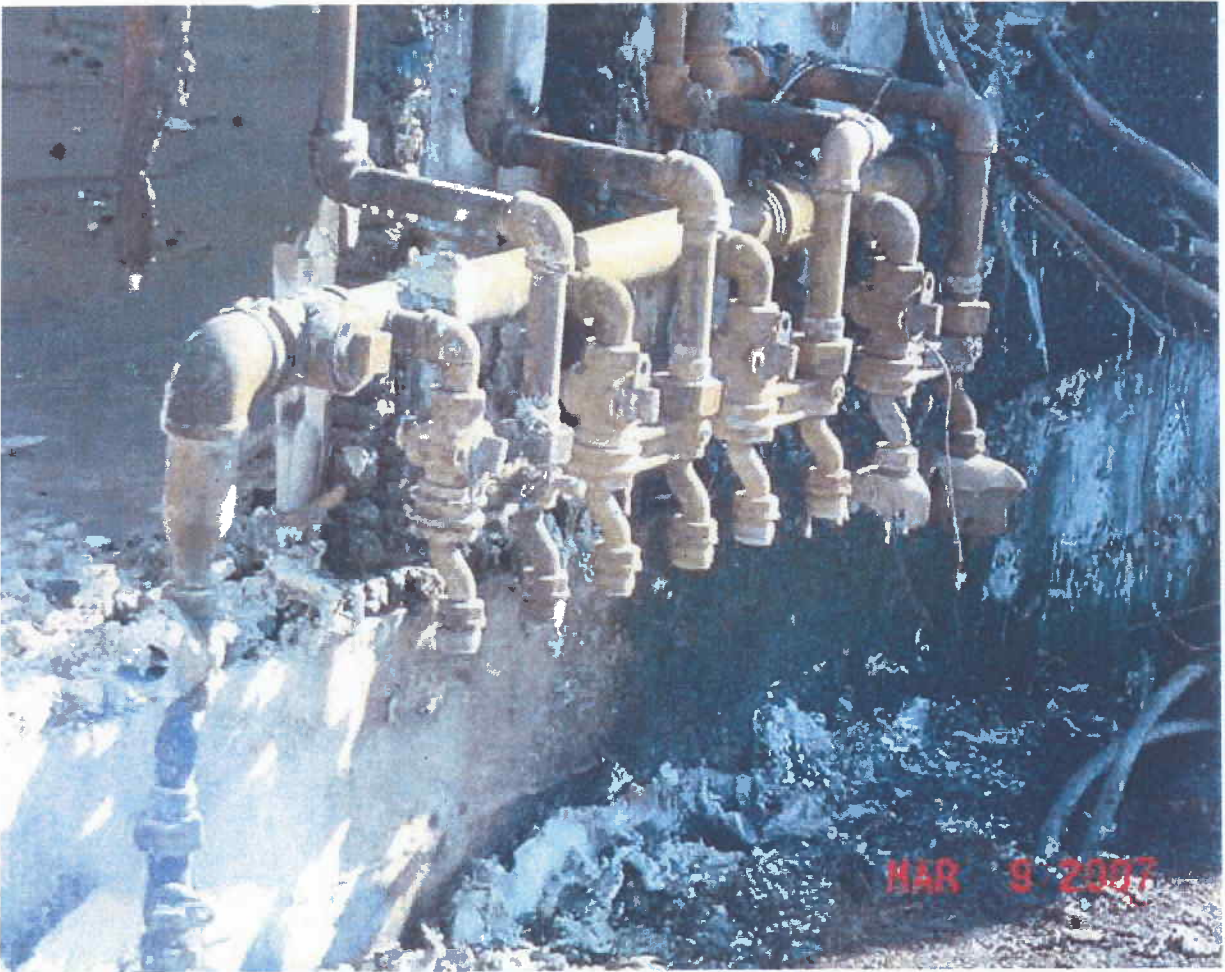
Service Riser, Regulator and Four Meters

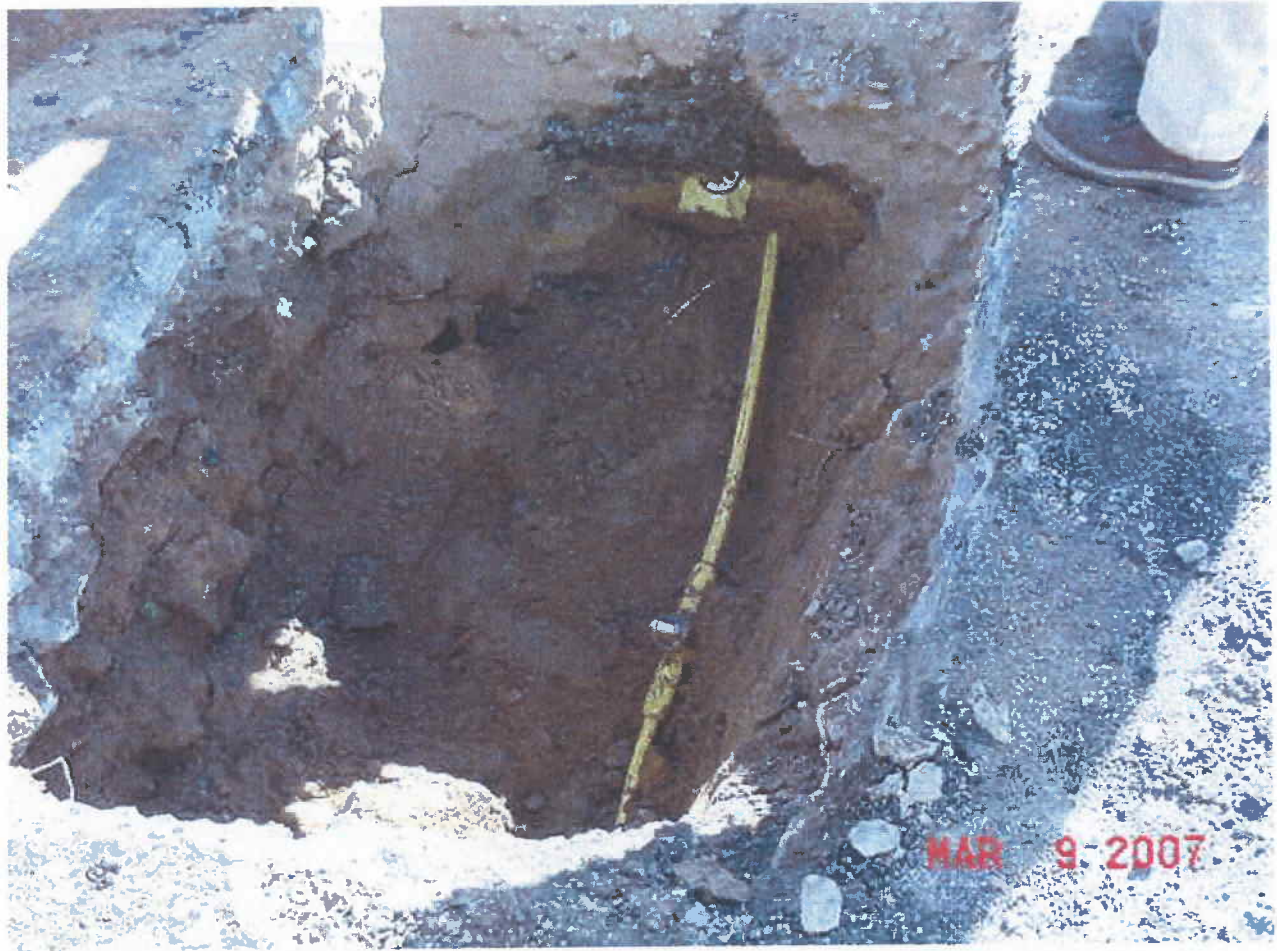
Gas Service Curb Valve

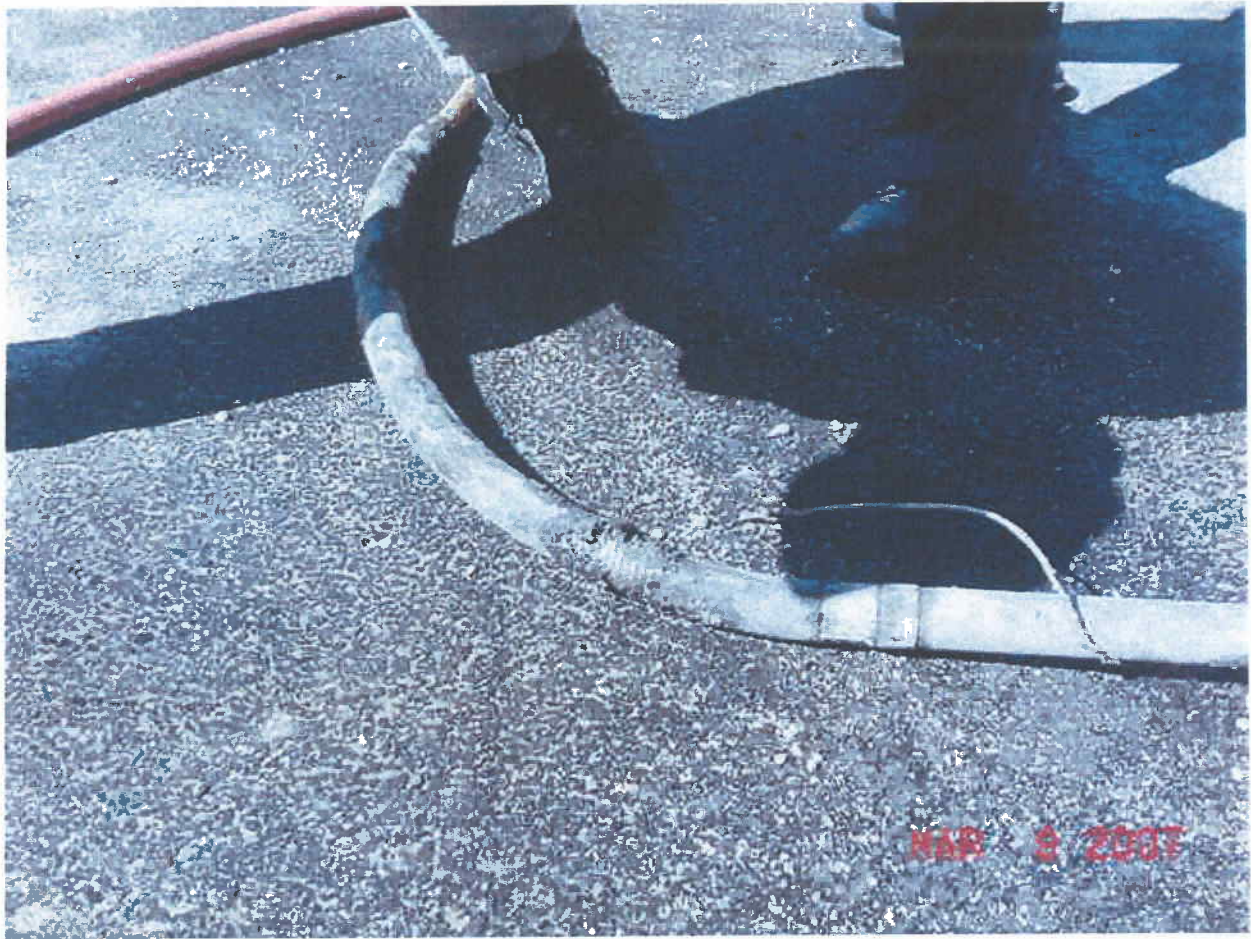
service line riser and associated piping, the inspectors noticed what appeared to be a hole in the black rubber that encased the plastic service pipe (Exh. 9). There was also a section of corrugated steel that was exposed on the service (id.). The tracer wire that is used to locate the service pipe was found wrapped around the pipe. A section of the tracer wire had fused itself to the black rubber on the riser (Exh. 10). There were bubbled sections of the riser that was also located on the riser (Exh. 11). There were also other underground facilities in the area of KeySpan's facilities (Exh. 12). The next test the Division investigators requested involved excavating the service at the building wall. The test included pressure testing the service line from the curb valve to the building. The service riser was removed. The pressure test held at 62 psig for 23 minutes (Exh. 6). The service riser with shutoff, insulator, remains of the regulator, four meter manifolds and the melted meters were taken into custody by the State Fire Marshal's Office (Exh. 13).

Damage to Service Riser

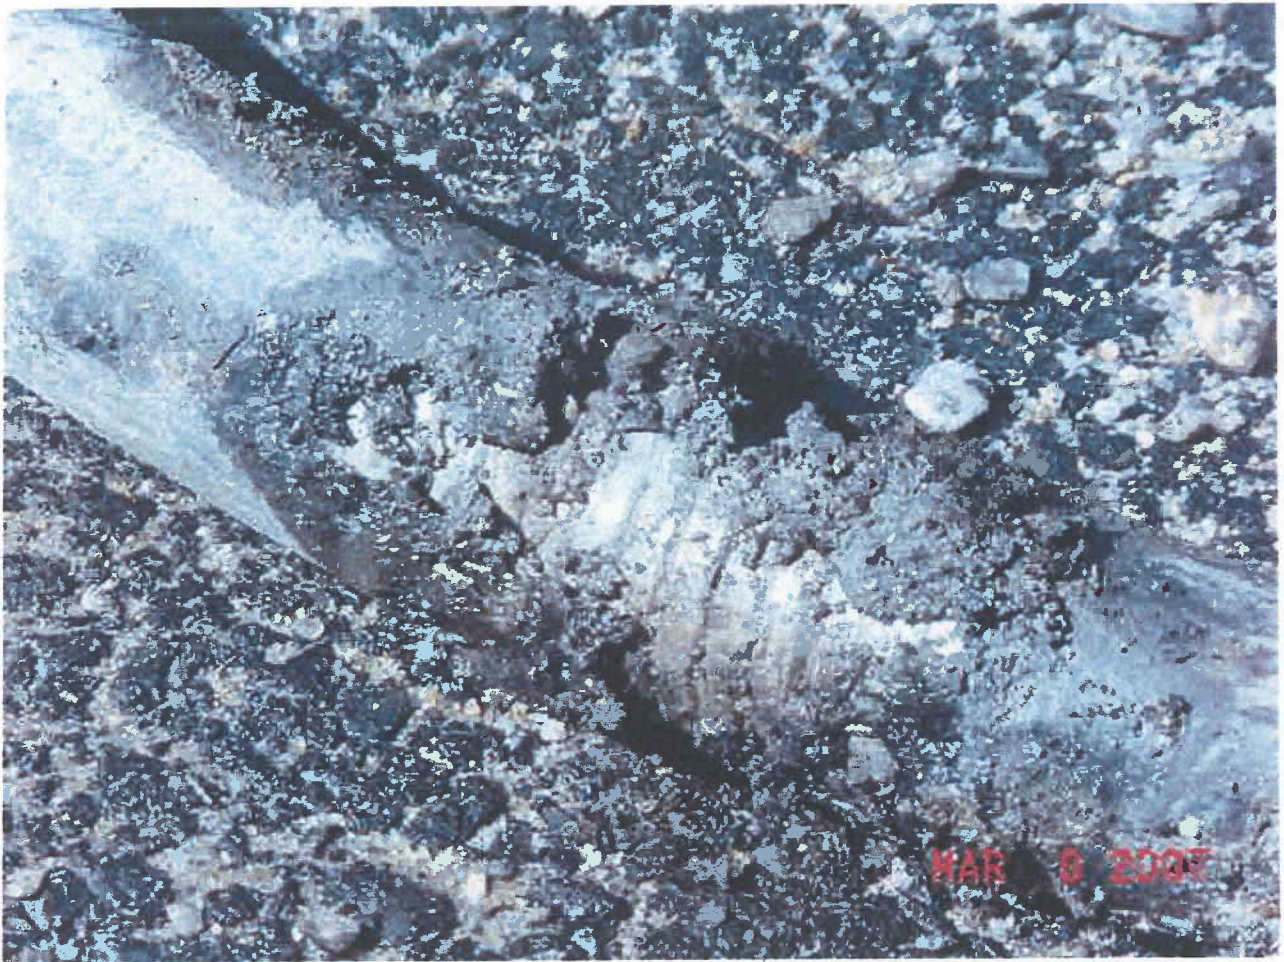
Damage to Service Riser

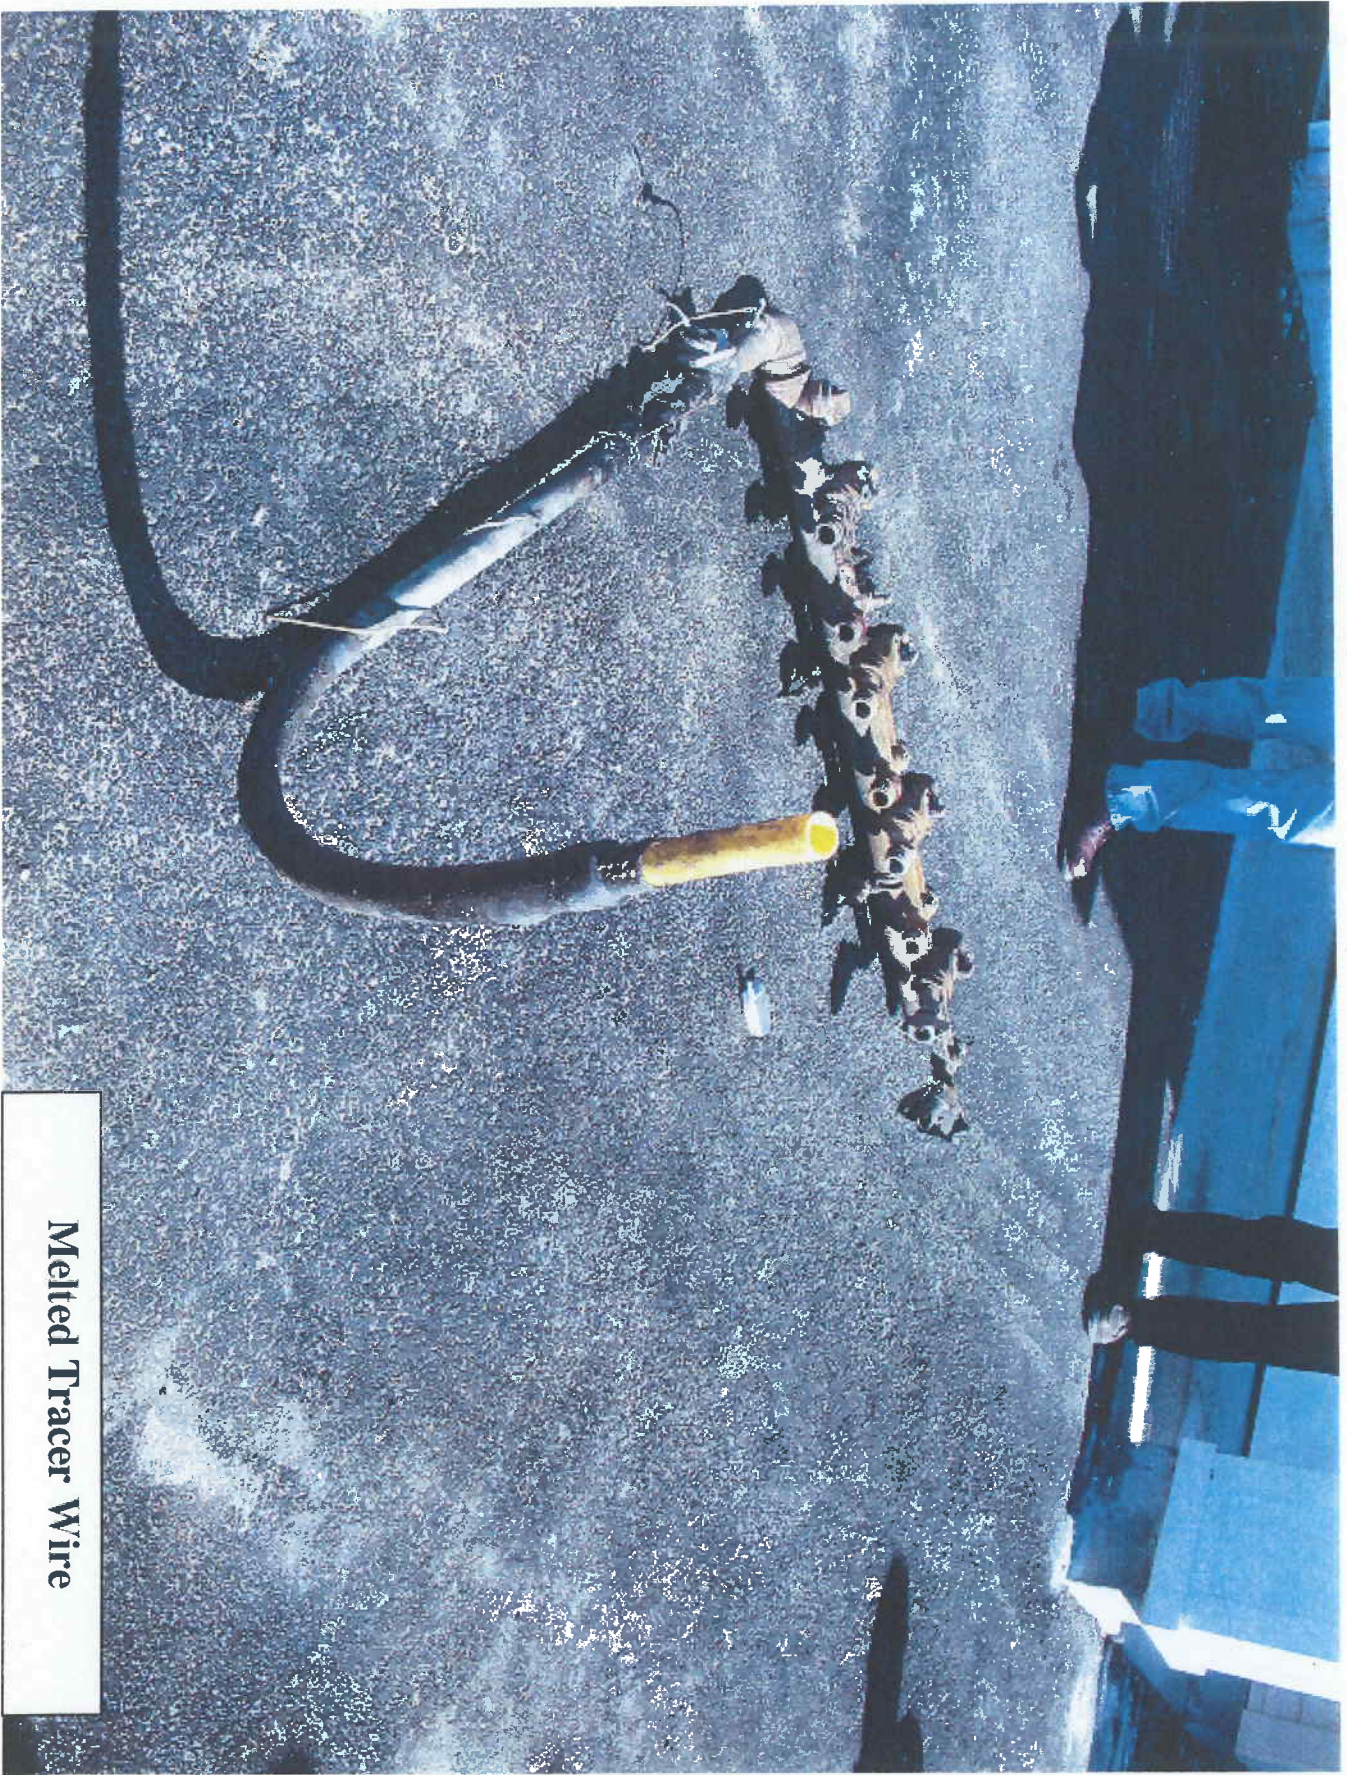
The burn damage of the below ground riser sweep appears to be in an area where the tracer wire also revealed burn damage (Exhibit#6). Melting of the riser sweep coating at this location indicated a high heat source. The condition of the 1" plastic service beneath was could not be determined through visual inspection. Please note this burn pattern could not have been the result of the above ground fire.

Melted Tracer Wire

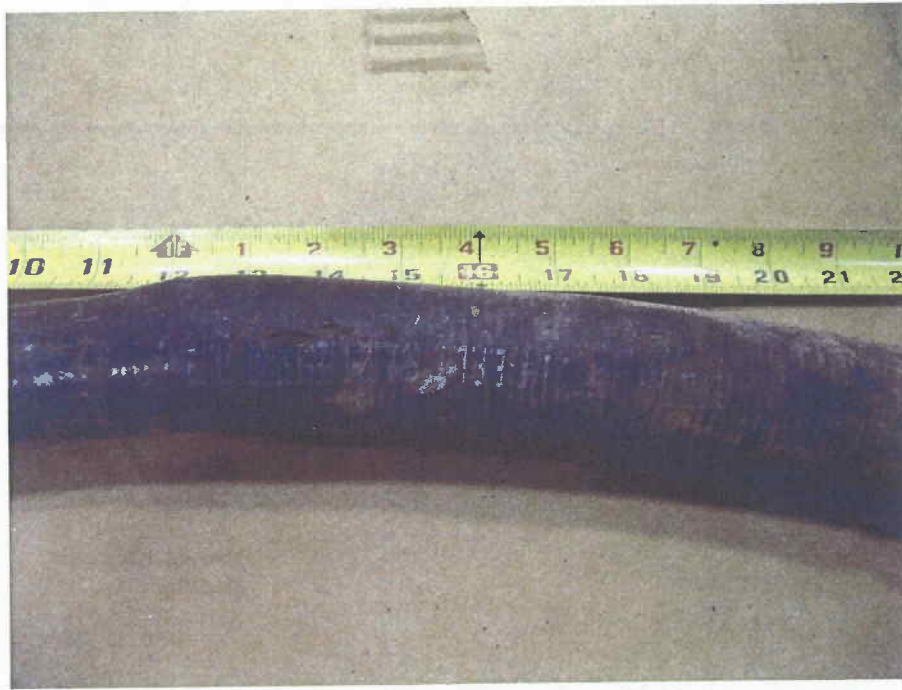
- The damage to the black polymer pigtail cover was OD-initiated, or "outside-in." This damage did not affect the gas-transporting yellow plastic pipe within the pigtail.

Figure 25: A split and bubbled region on the pigtail cover.

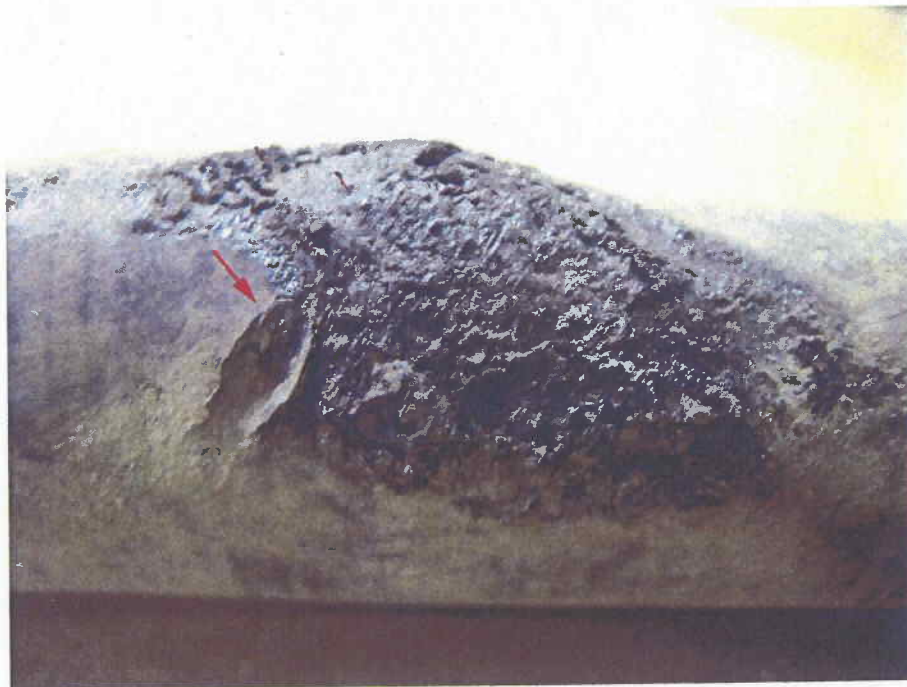
Figure 26: A bubbled region with mark that fits the tracer wire, arrow.

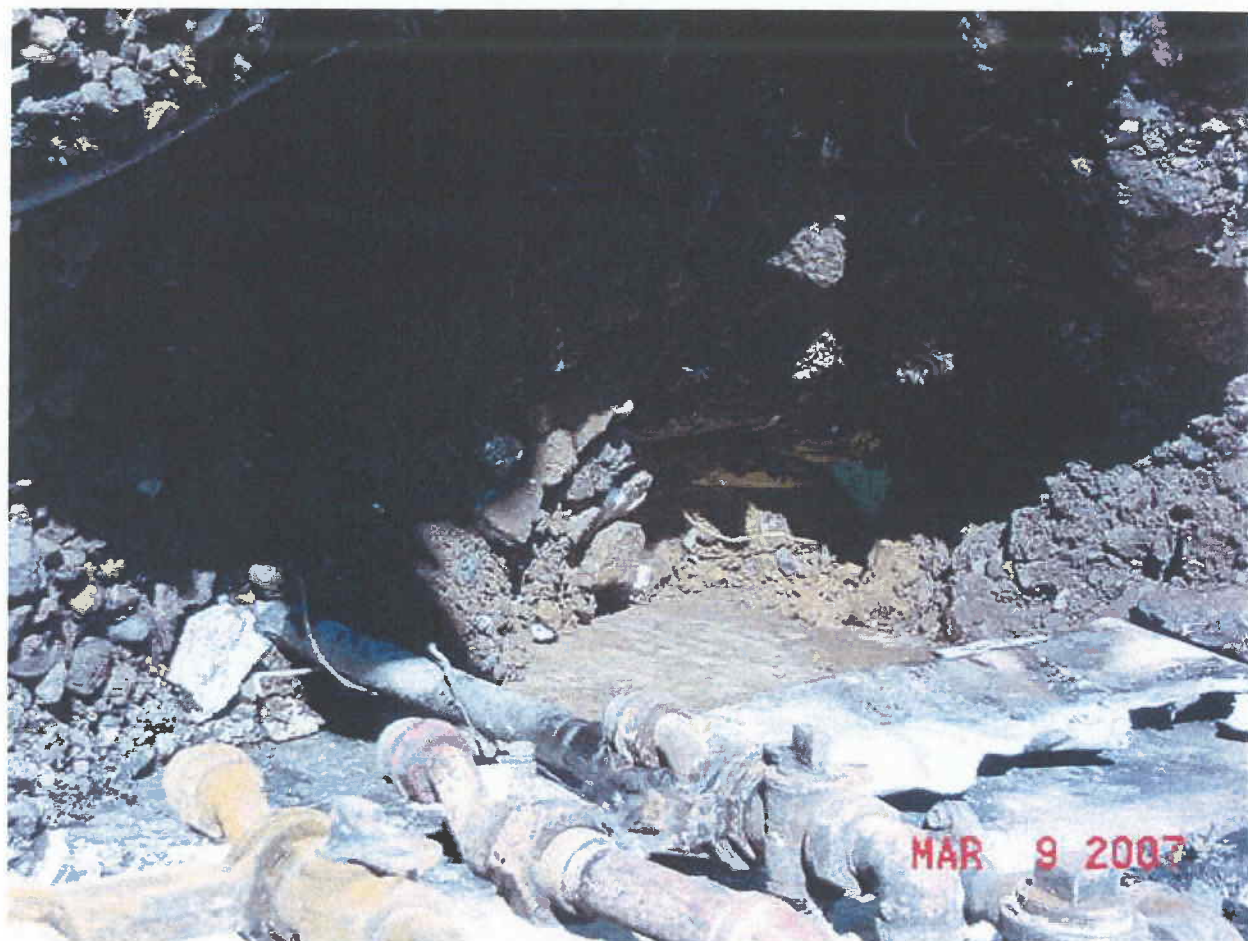
Underground Facilities
