# MassDEP Field Assessment and Support Team

## After Incident Report

NE-10-06603

## Peabody High School Mercury Spill Incident

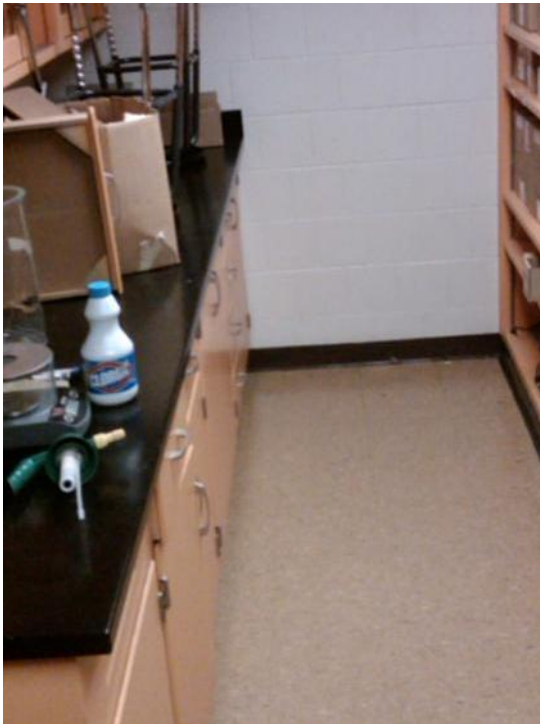
- The Laboratory Stockroom, with levels of mercury in the breathing zone of 10,000 to 20,000 ng/m<sup>3</sup>, and visual and/or analytical evidence of mercury beads on floor areas; and
- the Science Office, with levels of mercury in the breathing zone of 1500 ng/m<sup>3</sup>, and the visual presence of mercury beads at and near the door.

Stockroom – location where  
barometer was stored

Areas with visible mercury beads (the Laboratory Stockroom and Science Office) were cleaned by ENPRO personnel using a mercury vacuum. In the science office, the impacted carpet was subsequently removed (given the difficulty in adequately removing residual mercury droplets

from porous surfaces). In the Laboratory Stockroom, the water trap in sink in the most highly impacted area was removed and replaced.

The most contaminated floor surface – in the Laboratory Stockroom – received multiple applications of a highly concentrated solution (2:1 HgX<sup>®</sup>/water). Moreover, to be safe, a 1:1 solution of these agents were applied to all corridor and stair areas within the area of interest, as indicted in Figure 1.

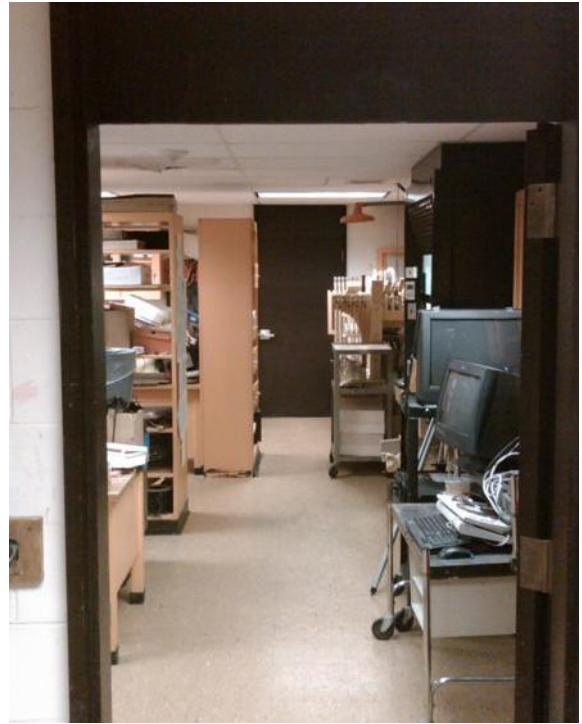
Stockroom – looking in from  
Classroom C-268

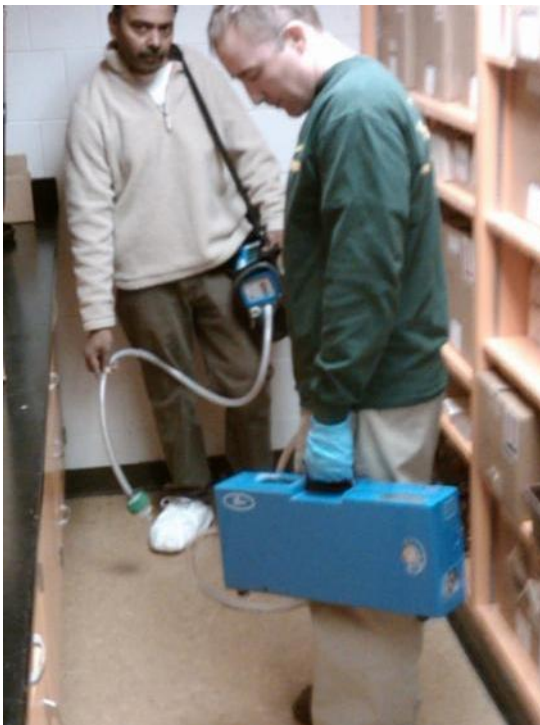
Stockroom – MassDEP and ENPRO  
Peabody High School, Peabody, MA  
NE-10-6603

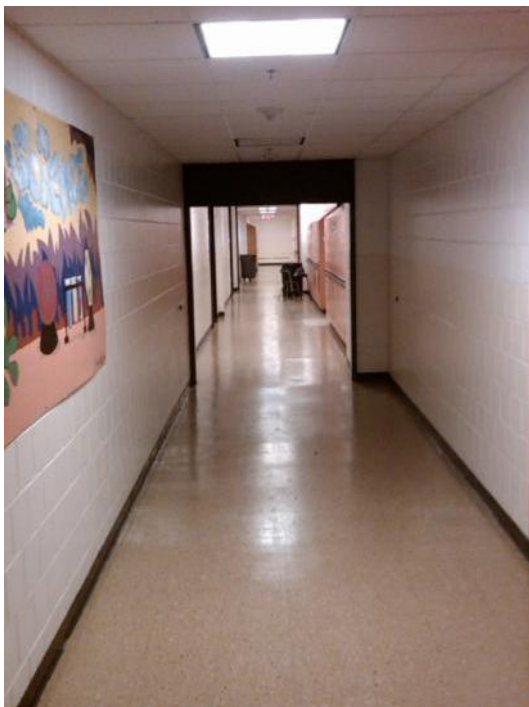
Somewhat elevated levels of mercury (several hundred ng/m<sup>3</sup>) were identified in the breathing zone within some corridors and stairways within the area of interest. Brooms and mops that had been in use in the previous week were also screened, and found to contain low to moderate levels of off-gassing mercury (200 – 500 ng/m<sup>3</sup>). According to school personnel, there were no vacuuming or buffing operations within the area of interest in the previous two weeks.

Corridor outside Stockroom and  
Science Lab Classrooms

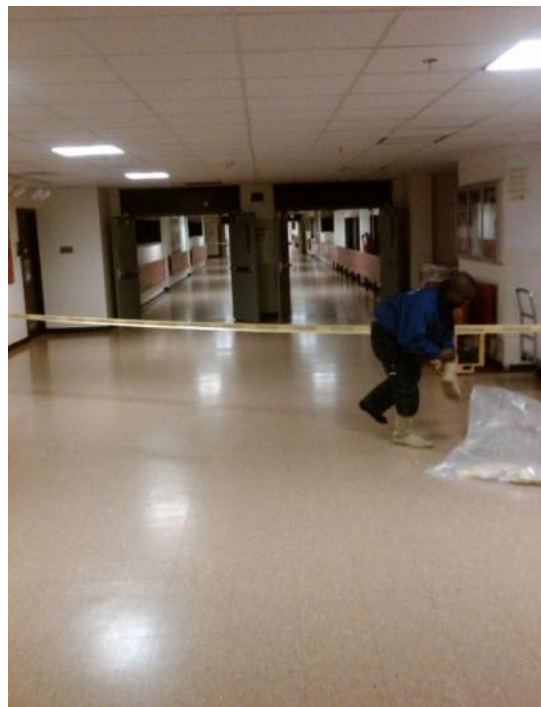
"Main Street" Corridor

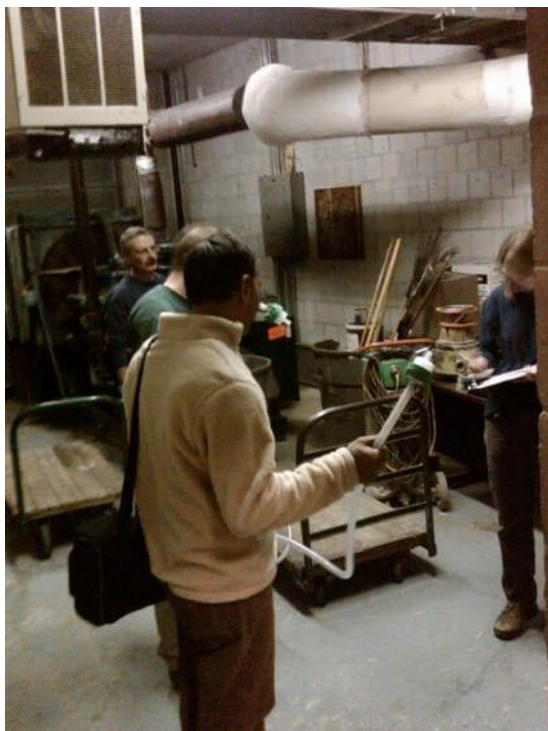
Mechanical Storage Room – Testing  
Air with Lumex Meters

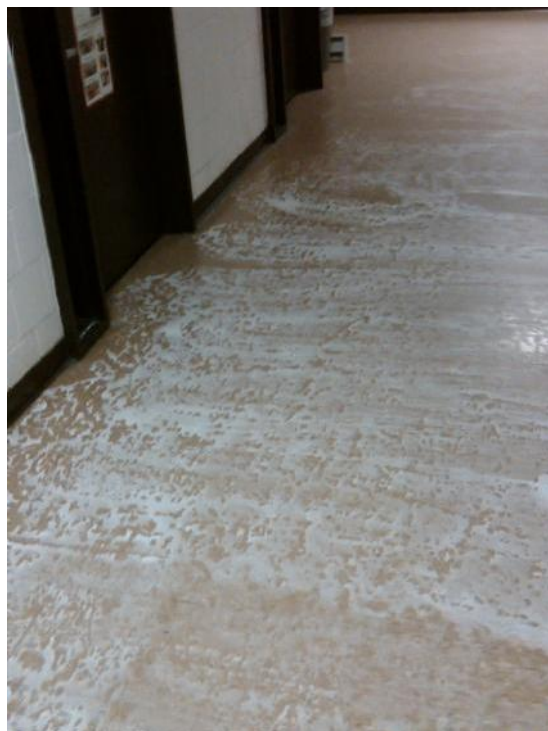
Corridor with applied "HgX<sup>®</sup>"  
neutralizing agent
