***South Shore Coastal Infrastructure Inventory
and Assessment Demonstration Project
Coastal Hazards Commission***

Town of Plymouth

**Prepared for:
Office of Coastal Zone Management
Boston, MA**

February 28, 2007

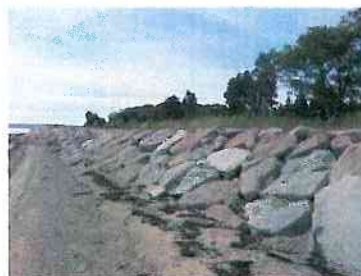
This structure is a stone revetment. The side slopes and crest are in excellent condition. There is minor and isolated cracking and displacement of some armor stones.

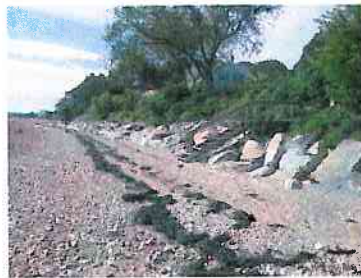
This structure is a stone revetment. There are shifted armor stone and slumping of the side slopes evident, conditions worsens towards the south end of the structure.

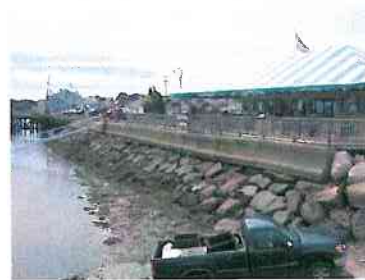
This structure is a stone revetment with a wave return face concrete cap. The cap is weathered and shows some spalling. Certain sections appear tilted forward somewhat. The stone sideslopes have slumped in some sections, appearing to create a gap between the top of the stone armor and the bottom of the concrete cap.

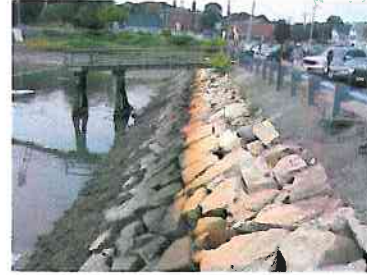
This structure is a stone revetment. The sideslopes show some weathering but are generally in good condition.

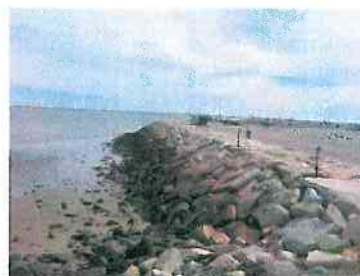
This structure is a stone revetment along the northwest corner of Plymouth Harbor Town boat ramp parking lot. The side slopes and crest are in good condition. The armor stone shows minor weathering.

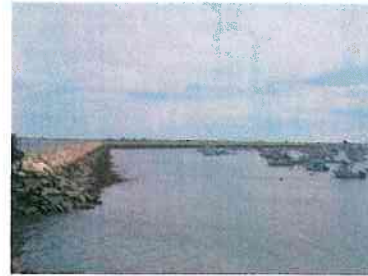
This structure is a rubble mound breakwater around the northern side of Plymouth Harbor. There is a scour apron along the inside and outside toe for the outer 175 yards of the structure. Overall the crest and sideslopes appear in good condition. However there are many small regions of slumped crest elevation and displaced armor stone.

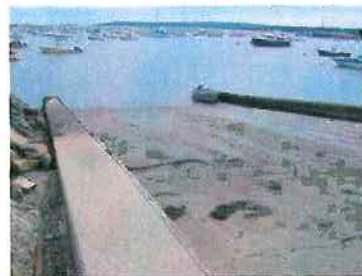
This structure is a concrete boat ramp for the town. There is some cracking along the surface of the ramp. It is generally in good condition.

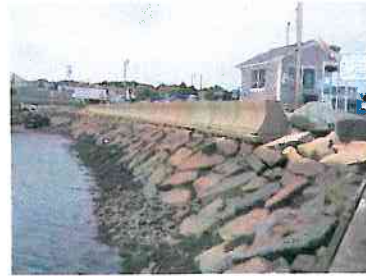
This structure is a stone revetment with a wave return face concrete cap. The concrete cap shows spalling and discoloration. The stone is weathered but in good condition. The side slopes remain entirely intact.

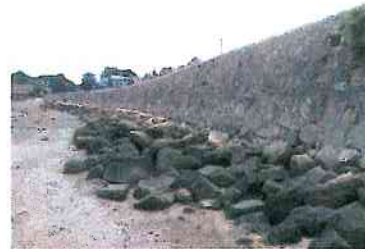
This structure is a grouted stone seawall with rip rap along the toe. The stone along the toe is slumped and unraveled to the point where it no longer protects the base of the wall. The base of the wall shows some missing grout between stones and other damage.

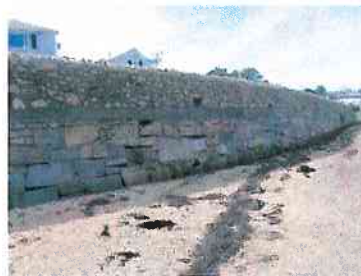
This structure is a seawall of grouted stone. The stone is stacked at the bottom and has a cap of random placed grouted stone. There is grout missing and/or broken along the base of the wall.

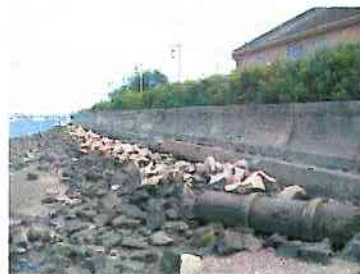
This structure is a short concrete seawall with a wave return face cap and small armor stone strewn along the base. The wall shows severe cracking and spalling along the face. The northern end is slumped.

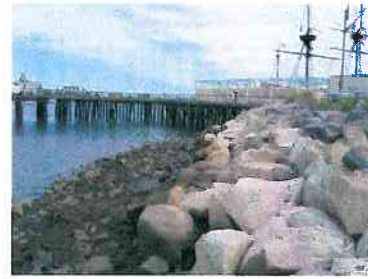
This structure is a stone revetment fronting a park. Some armor stone along the crest has slumped. Minor cracking of the armor stone evident.

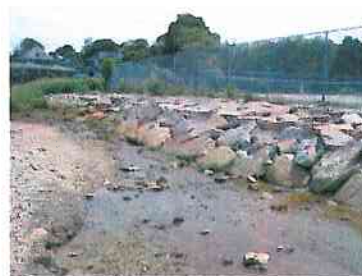
This structure is a small stone revetment fronting tennis courts. The crest is failed in one area and has slumped down.

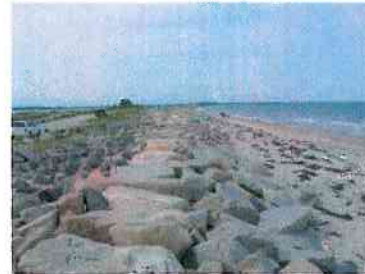
This structure is a stone dike that lies along the eastern edge of Plymouth Long Beach. The southern end of the dike is in fair condition but deteriorates to the north. There are multiple sections of failure with evidence of overwash events behind the dike.

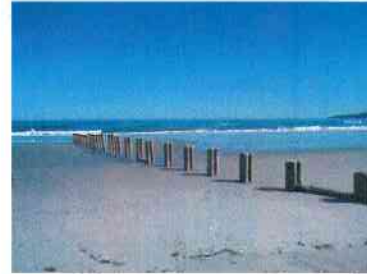
This structure is the remains of an adjustable groin. All that remains are the concrete posts. All evidence of the insert panels is removed. The structure has completely failed and is non-functional.

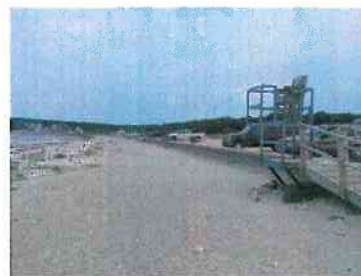
This structure is a concrete seawall fronting a dirt parking lot. The wall shows minor cracking and spalling. The toe of the wall is becoming exposed at the southern end. Each groin is approximately 75 to 180 feet long.

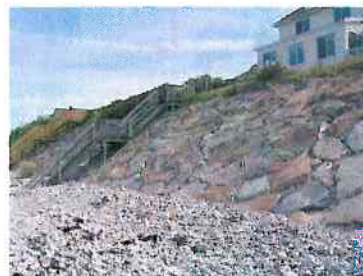
This structure is a rubble mound revetment. The sideslope is in good condition. There are single armor stones which are cracked.

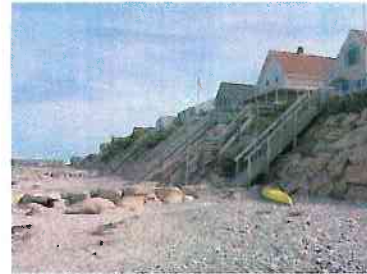
This structure is a stone revetment. The sideslopes are in good condition. There are some armor stones along the bottom which have cracked.

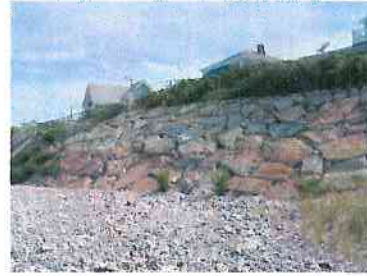
This structure is a stone revetment. The side slope is in good condition. Some armor stone is cracked.

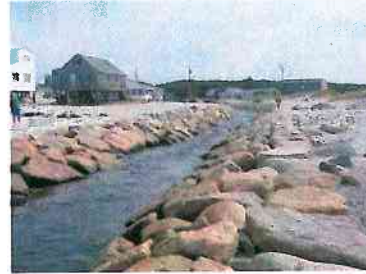
This structure is the western reveted side slope of a small channel which connects Barlett's Pond to Cape Cod Bay. The side slope and crest are in good condition with some minor loss of crest elevation.

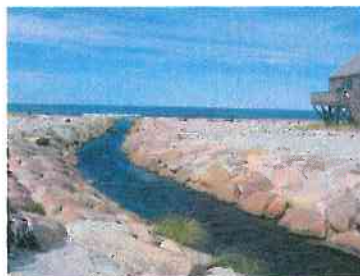
This structure is the eastern reveted side slope of a small channel which connects Barlett's Pond to Cape Cod Bay. The side slope and crest are in good condition with some minor loss of crest elevation.

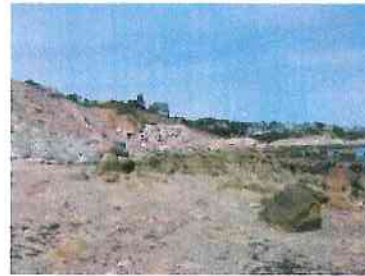
This structure is a grouted stone revetment along the base of the bluff between Stage Point and Manomet Point. There are many areas of shifted and failing armor along the base of the structure.

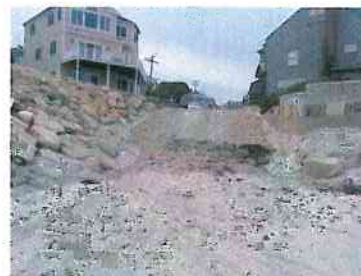
This is a stone/dirt/concrete ramp from street level down to the eastern end of White Horse Beach. There is some shifting and cracking of the concrete. The ramp is still functional, but poor condition.

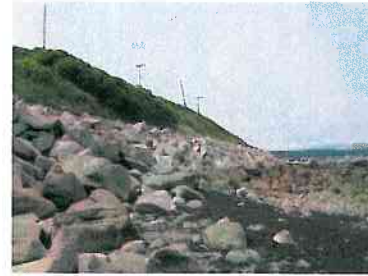
This structure is a stone revetment along the base of the the northern face of Manomet Point. The stone appears to have been dumped rather than placed and thus the interlocking of the armor layer is poor. There is some shifting and cracking of armor stone evident.

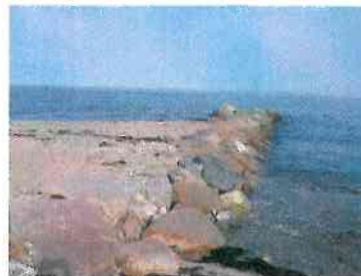
This is a field of 5 stone groins south of the entrance to Ellsville Harbor. The crests and sideslopes are in good condition. Outer head and toe of structures was not evaluated due to high tide. Each groin is approximately 150 feet long.

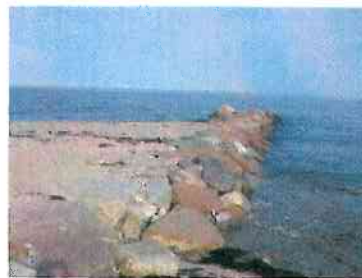
This structure is a stone groin on the open beach just north of the entrance to Ellisville Harbor. The sideslopes and crest of the trunk are generally in good condition. The head of the groin has become unraveled.
