Project Briefing: Whittier Bridge

MassDOT Highway Division
District 4 Highway Director Paul Stedman

Issue MassDOT found with Pier 1 Cap

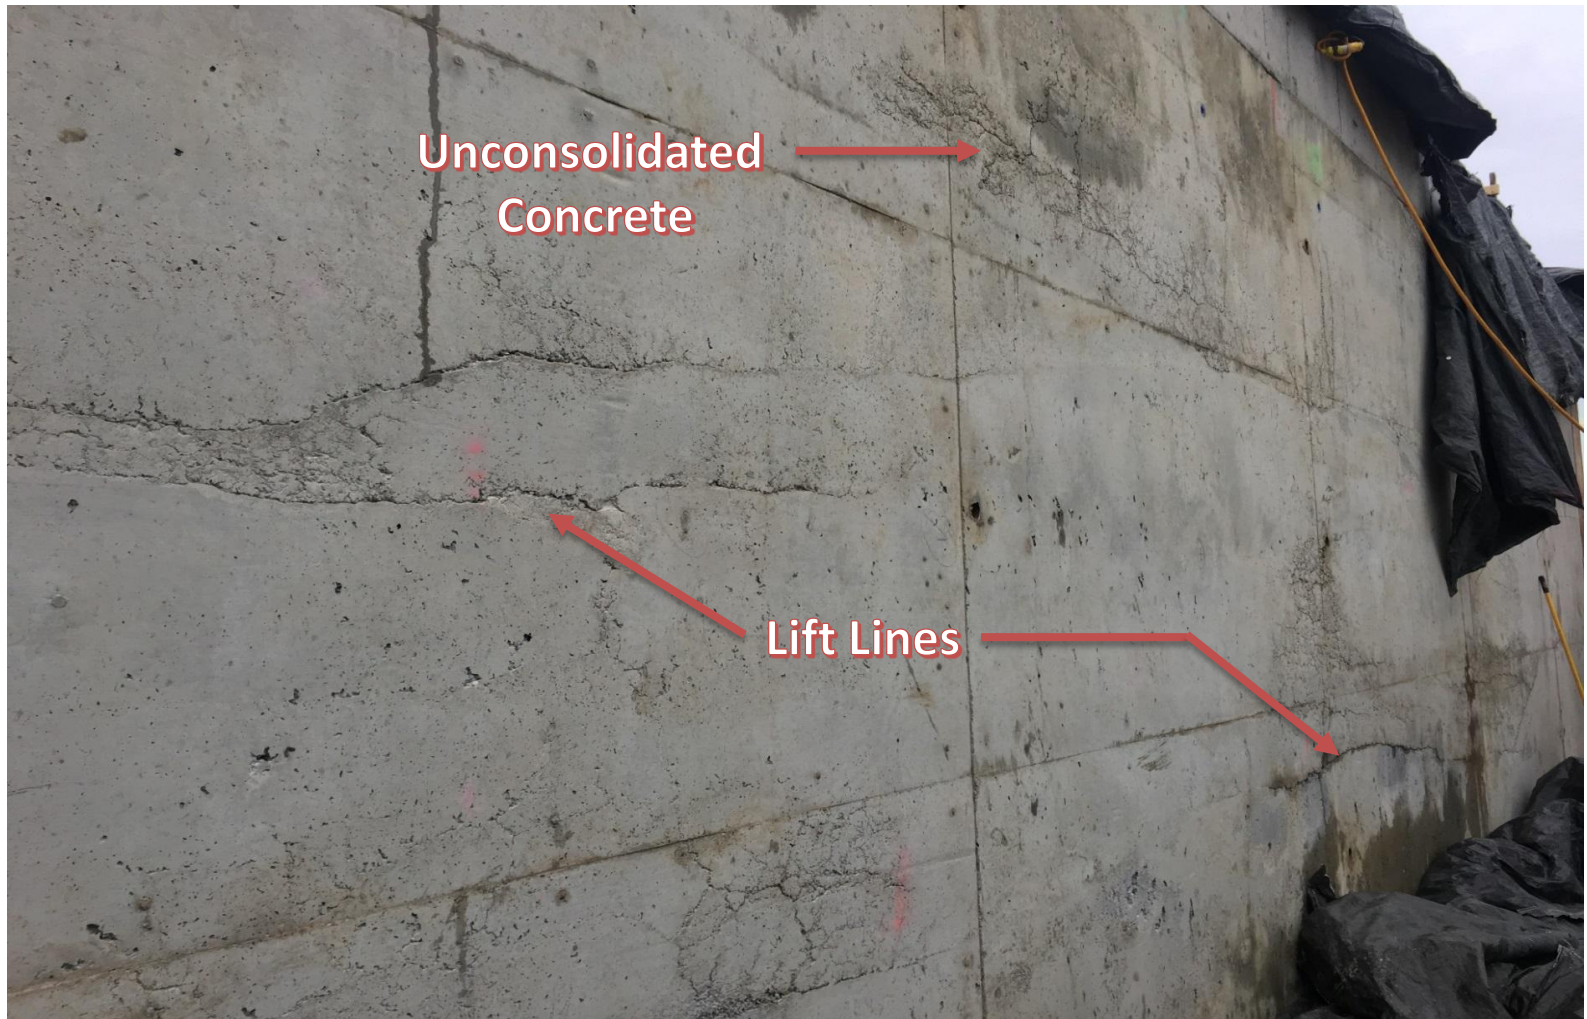
Example Defects MassDOT found in Pier 1 Cap

- On February 23, 2017, contractor placed 260 cubic yards for the pier 1 southbound cap.
- On March 6, MassDOT observed deficiencies in the pier cap and reported these to the contractor. The pier cap exhibited extensive honeycombing due to improper consolidation (see slide 8).
- On March 8, MassDOT issued a Deficiency Report to the contractor and withheld \$827K until the deficiency is corrected.
- The Deficiency Report requires the contractor to examine the work further and suggest possible repair procedures

- On April 20, the contractor submitted three alternative concept repairs for review of varying scope and impact.
- After careful review, MassDOT notified the contractor that the proposed repair procedures were rejected and the contractor would need to reconstruct the pier cap in accordance with MassDOT's standards.
- This will ensure that MassDOT is not compromising on the quality of the contractor's work to ensure the tax payers are receiving what they ordered.
- MassDOT has met with senior leadership at the company to discuss this poor performance on the job and to ensure a strong working relationship going forward.

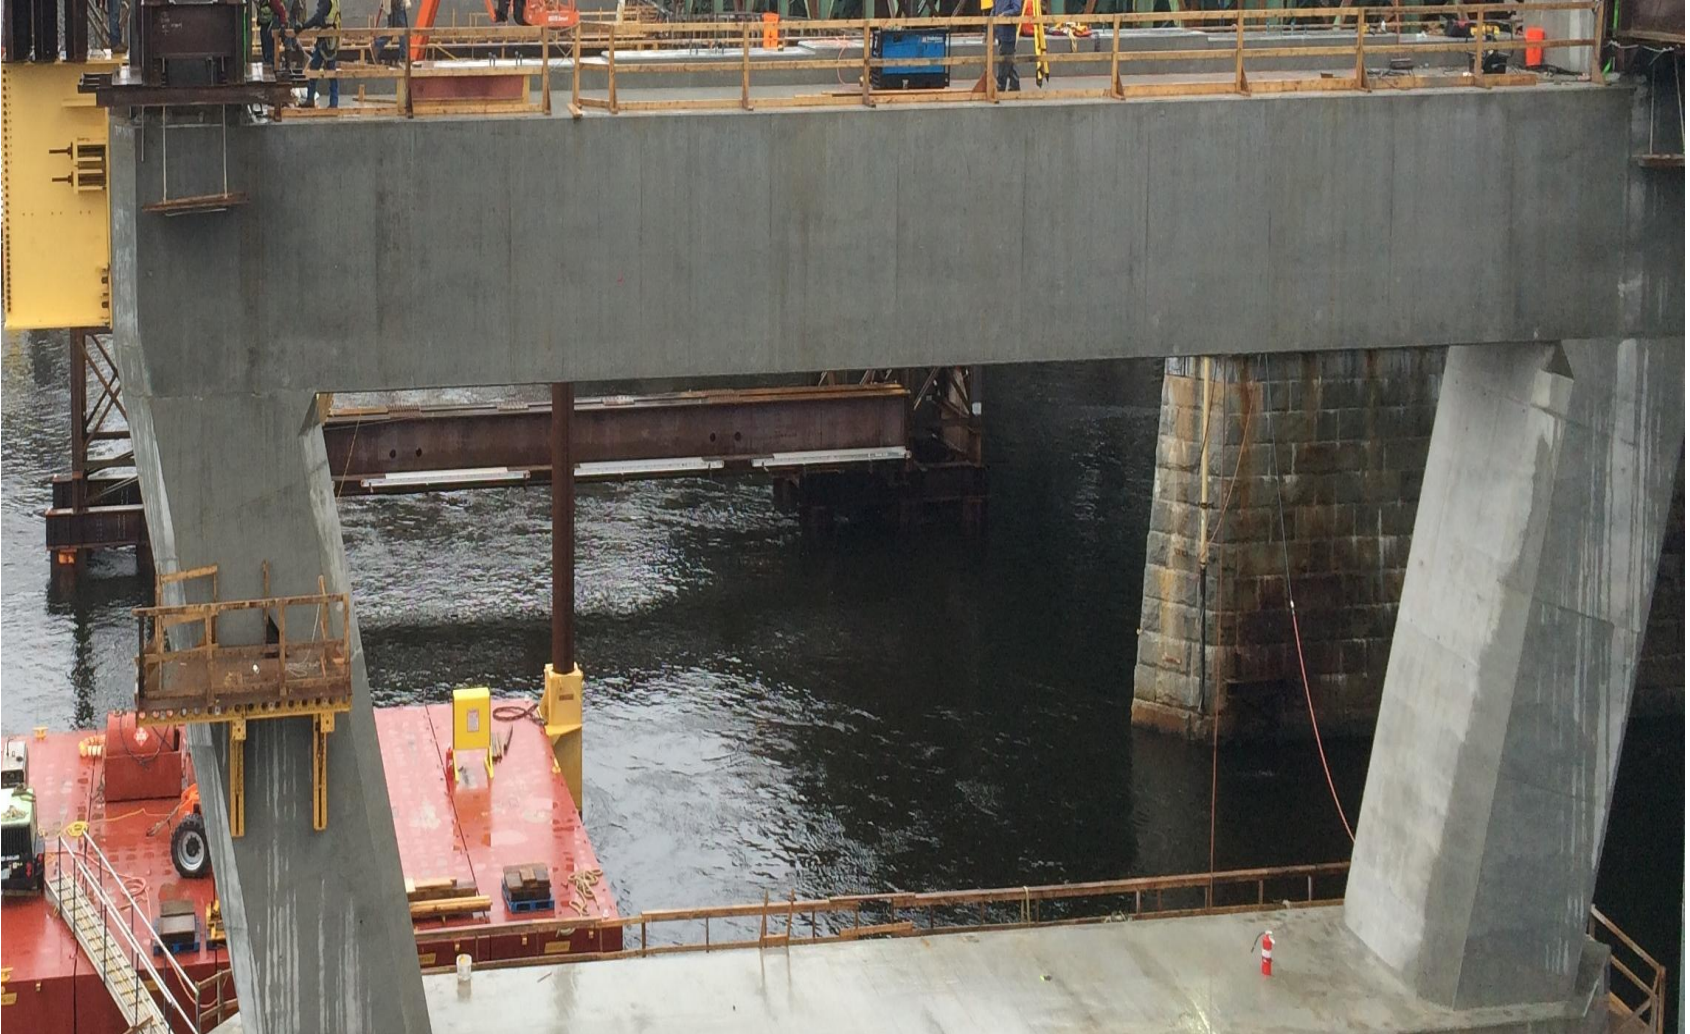
Example Pier with NO Defects
