## INCIDENT HIGHLIGHTS

**REPORT#:** 18MA035

## Property Maintenance Worker Caught between Industrial Sweeper and Low Ceiling—Massachusetts

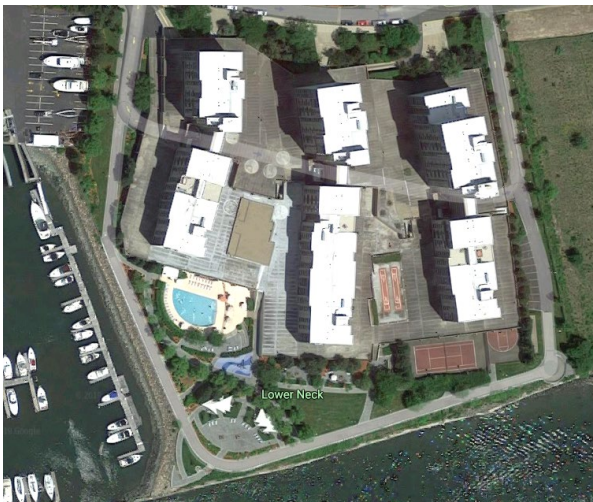
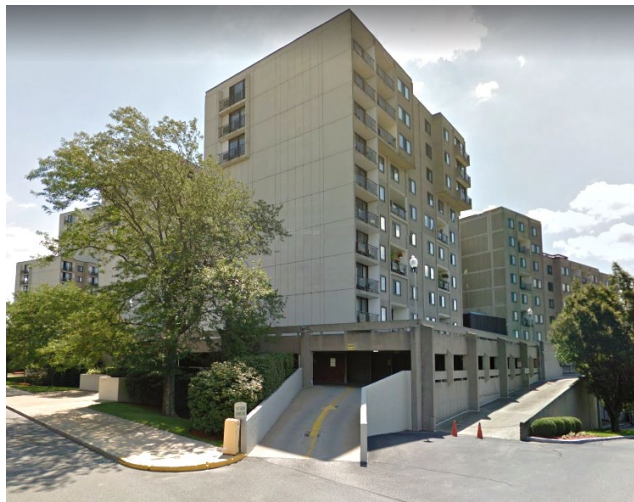
The incident occurred in a parking garage at a high-rise condominium complex (Figures 1 and 2). The three apartment buildings in the complex ranged in height from 10 to 16 stories and combined contained 38 floors and 276 housing units. The garage was under the apartment buildings and had 420 parking spaces and storage areas on two levels, a basement level and a level that was above ground. The basement level had ceiling heights of 18 feet while the second level had a general ceiling height clearance of 6'4" because of concrete beams spanning the garage. The incident occurred on the second level of the garage in a corner where there was a stairwell. The incident occurred shortly after 10:00 a.m. and the area was well-lit from sunlight entering the half-wall sides of the garage and from overhead light fixtures.

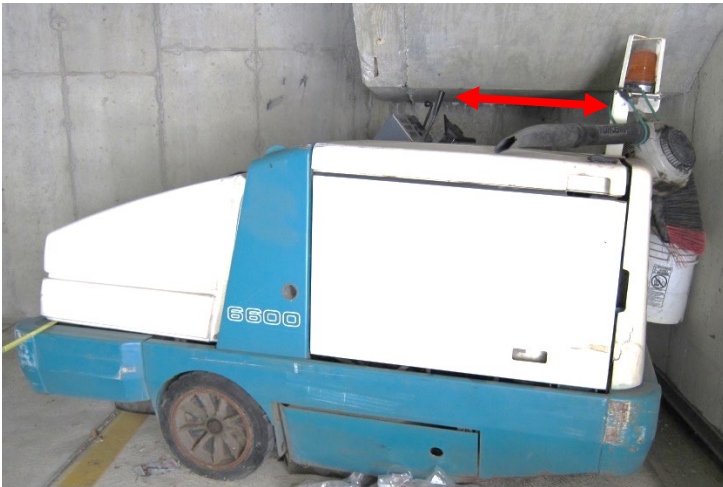
The equipment being used at the time of the incident was a 55-horsepower gasoline-powered ride-on industrial sweeper (Figures 3 and 4). The unit had rotating brushes and a vacuum system with two stages of filters in order to collect dust. According to the manufacturer's specifications, the sweeper was 93 inches long, 62.5 inches wide, and 58 inches tall. The 58 inch height dimension was the tallest point of the body of the sweeper located at the rear of the machine, and was approximately the height of the tallest operator control lever (Figures 3 and 4). The actual height of the tallest part of the machine involved in the incident was measured to be 64 inches. This is the height of the protective cage over the rotating strobe light that had been installed at the rear of the machine. The height of the sweeper's floorboard was measured to be 21 inches and the height of the seat pan was 39 inches. The manufacturer offered an overhead guard for the operator's area as an accessory for this model. Installing the overhead guard on the sweeper would have brought the sweeper's total height to 82 inches. This would have made the sweeper too tall to operate on the second floor of the garage.

Figure 3 - Industrial sweeper, left side view. Arrow indicates height of housing and controls in relation to the height of the yellow light.

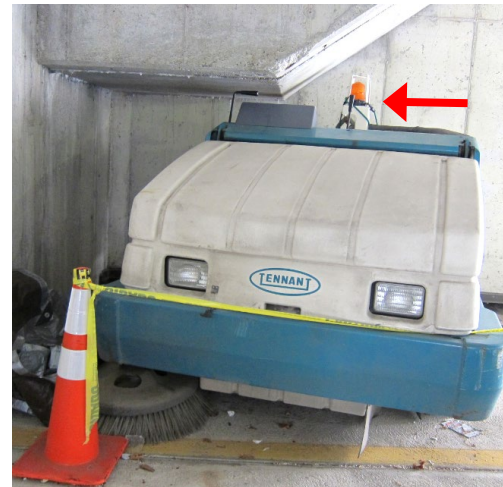
Figure 4 – Industrial sweeper, front view.

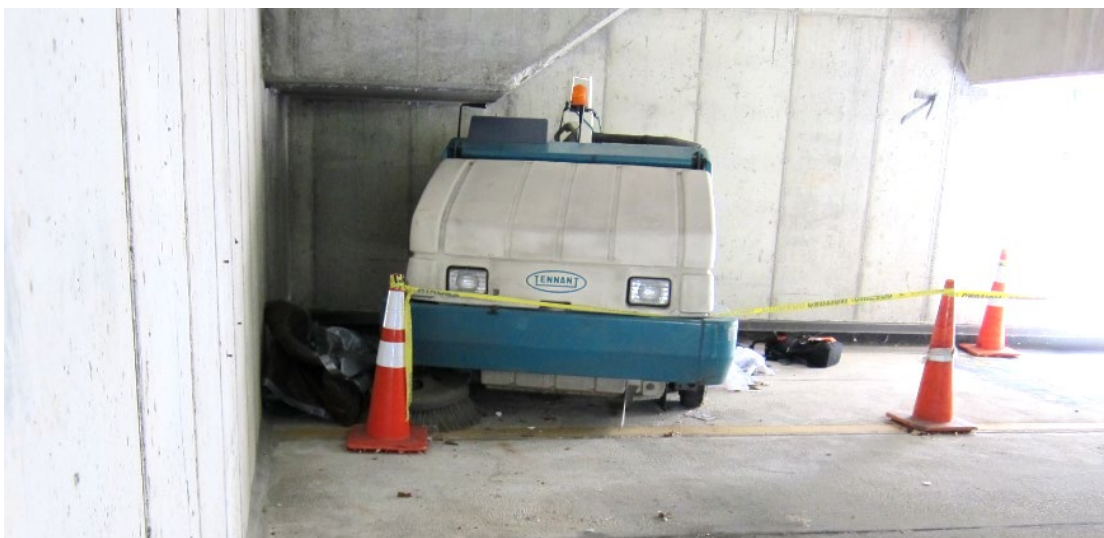
While the event was not witnessed, it appears that immediately prior to the incident the victim was operating the sweeper in reverse near the corner of the garage where the incident occurred, when the sweeper backed under the stairwell. Evidence suggests the protective housing of the strobe light scrapped along the section of the ceiling that was slanted due to the stairwell (Figure 7). The scrape line indicates the sweeper was traveling close to directly backwards, or parallel with the side wall. The operator's seat, where the victim was located, was under the lowest part of the stairwell, which had a height of 58 inches (Figure 7).

The sweeper continued travelling backwards and the victim became caught between the steering wheel and controls and the bottom of the stairwell. Part of the steering wheel was broken by the force of the impact and fell down near the victim's feet. The victim's back and then head were pressed against the underside of the stairwell.

**Recommendation #1: Employers should ensure that ride-on equipment without a protective cab is not operated in the vicinity of overhead obstructions.**

Discussion: The style of sweeper used in this incident is still available for sale in used and new condition and many of the newest sweepers and smaller ride-on floor cleaners still have a cab-less design. The absence of a protective cab and operating this piece of equipment in proximity to an overhead obstruction are factors that contributed to this incident. Employers should ensure that ride-on equipment that does not have overhead protection is not operated in areas with low ceiling clearance or other overhead obstructions. Those areas should be identified through a specific job hazard analysis (Recommendation 2). Such areas could still be cleaned using the hand blower, but steps should be taken to ensure the sweeper is not operated in those areas. A physical barrier, such as a bollard/post, railing, or curbing, could be installed to prevent the equipment from entering the space. Additionally, the knowledge of this type of hazard could be made more prominent in the warning decals and training materials for the equipment.
