*Massachusetts Coastal Infrastructure  
Inventory and Assessment Project  
Coastal Hazards Commission*

**Boston Harbor - South**

Quincy  
Milton  
Braintree  
Weymouth

**July 6, 2009**

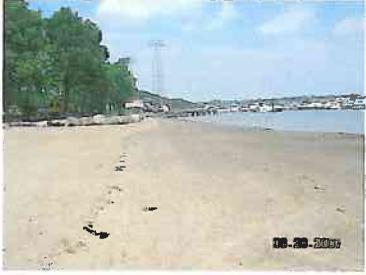
Primary Type: Coastal Beach	Primary Material: Sand	Primary Height: Under 5 Feet		
Secondary Type:	Secondary Material:	Secondary Height:		
Structure Summary : Shallow sloped, fine grained sand beach. Large boulders placed in some areas at head of beach.
