The Commonwealth of Massachusetts  
Office of the Inspector General

February 21, 2007

RE: H. Olive Day School, Norfolk, Massachusetts

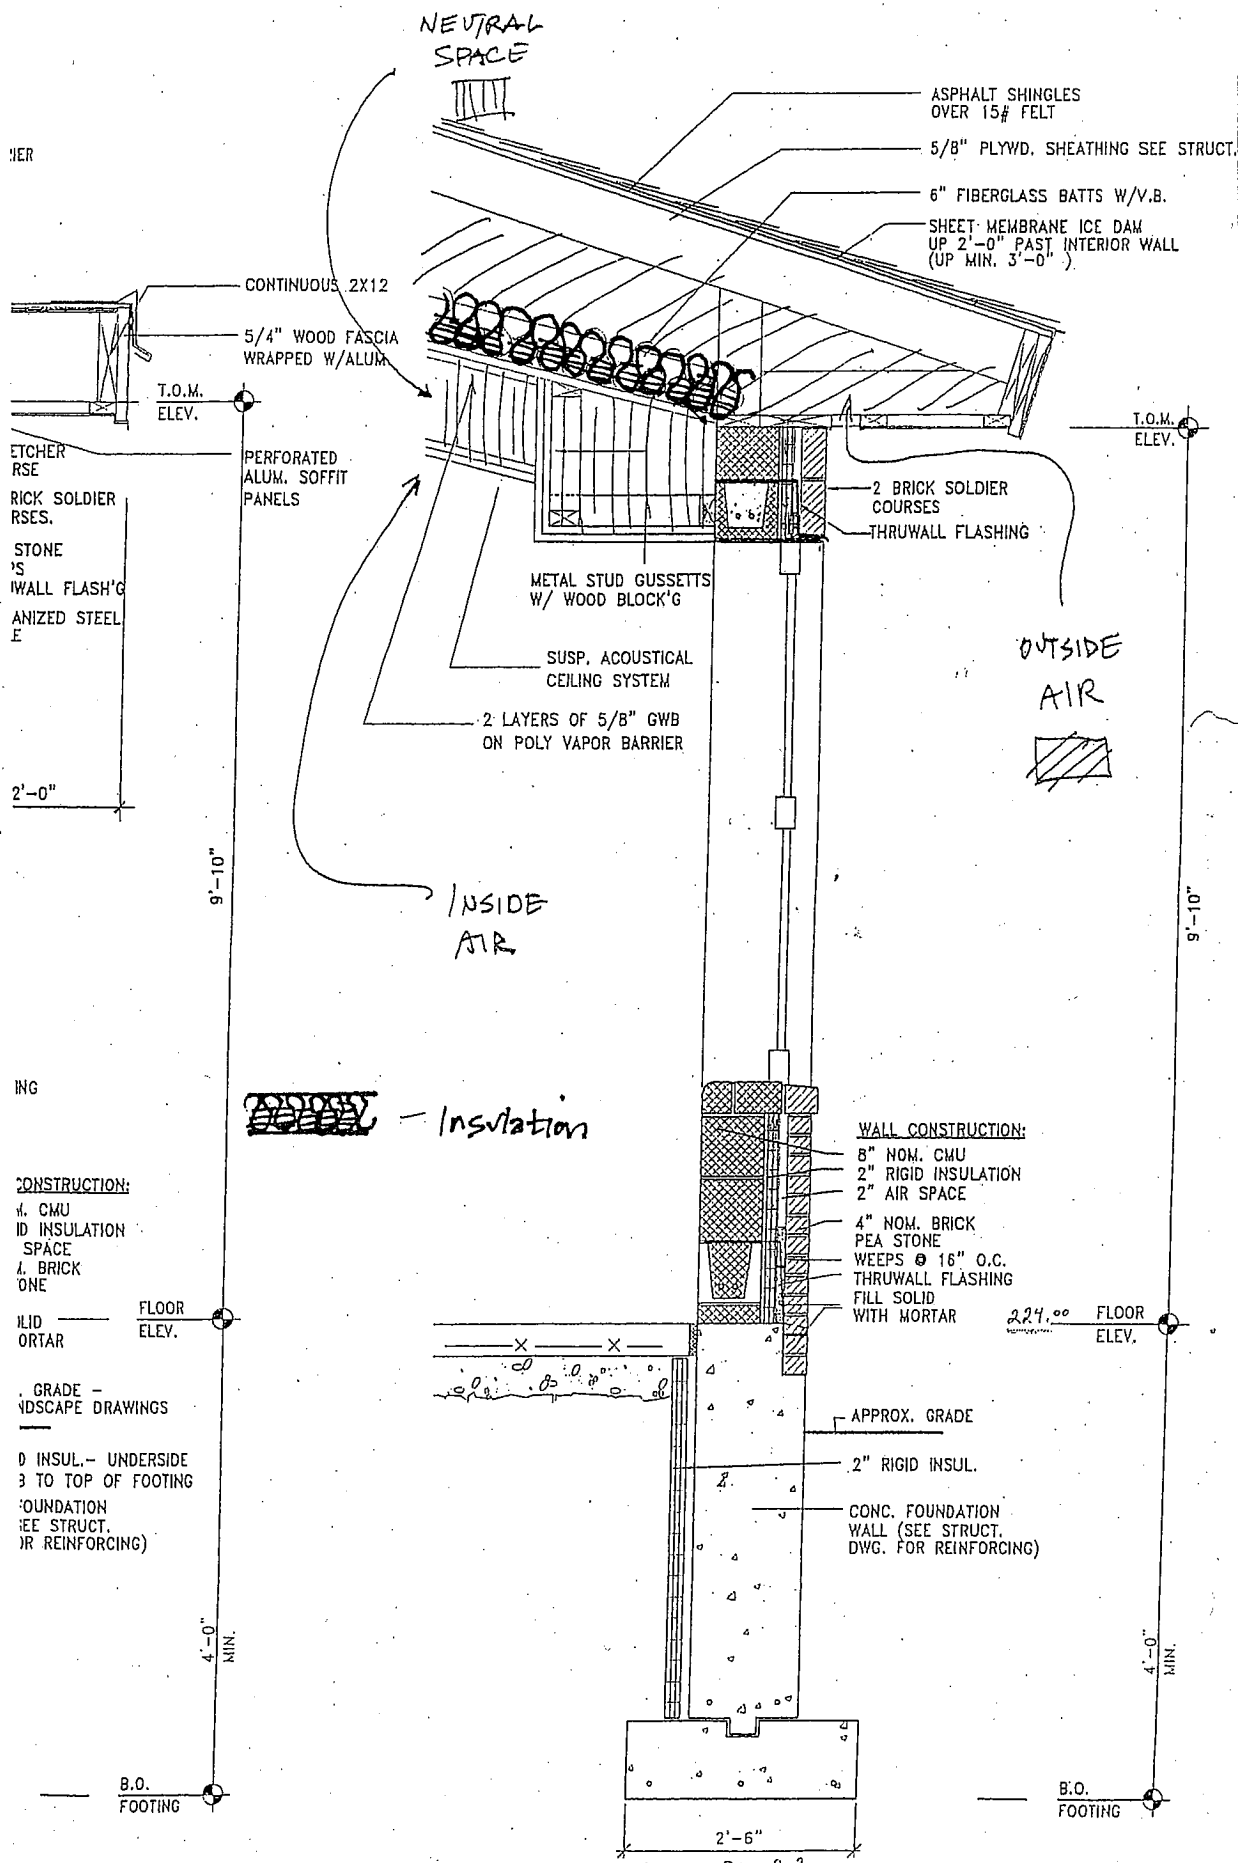
# ATTACHMENT A

If the system is dry, insulation can be laid on the floor of the attic below the pipes, as would be the case in the architect's plan (Attachment A). If, however, the system is wet, insulation would have to be installed above the pipes, as in Attachment B.

Another problem appeared in 2002—ice damming on the Addition roof, especially on the west side of the building. The insulation had been moved from the attic floor as shown in Attachment A to the attic ceiling as shown in Attachment B. The underside of the exterior roof was not designed to accommodate the type of insulation installed there.

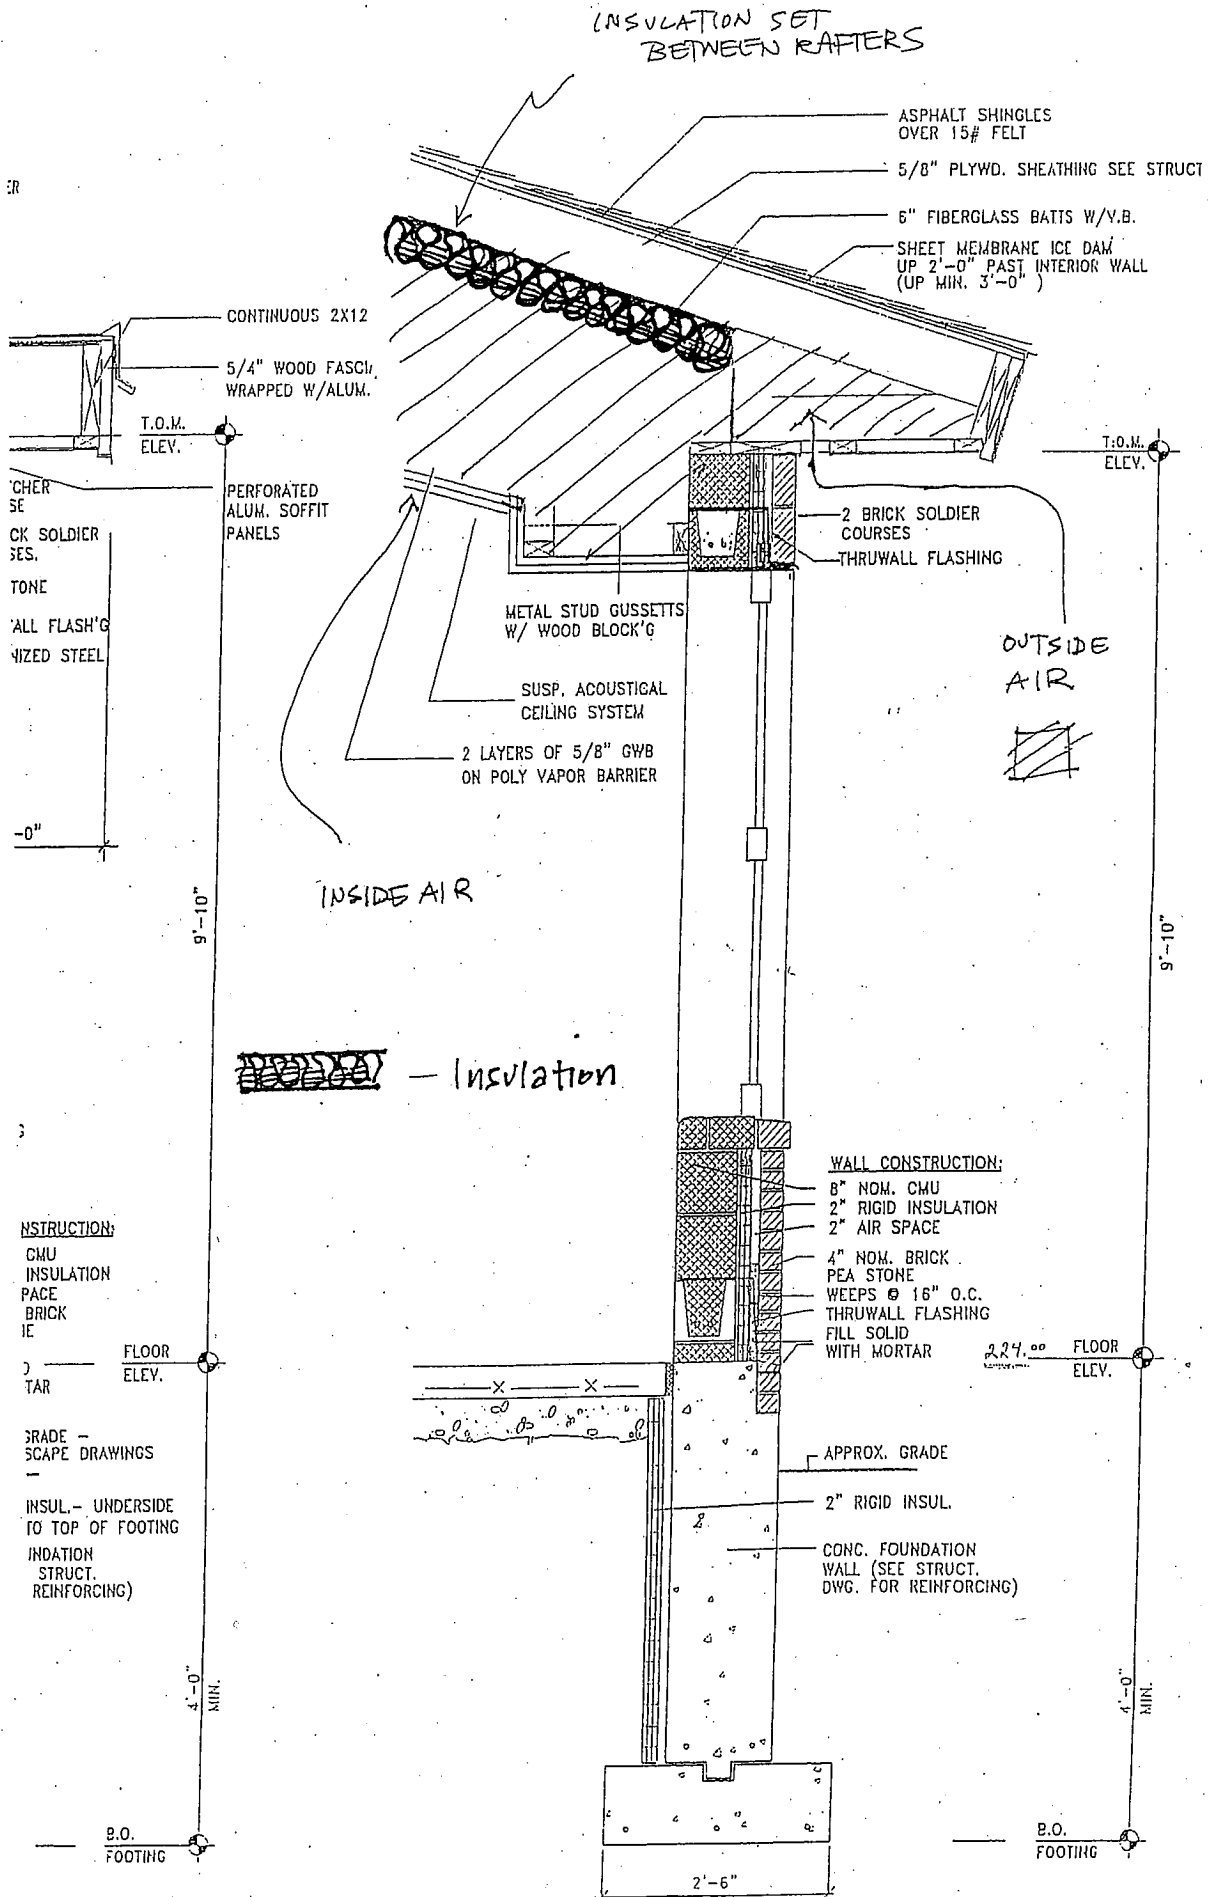
# ATTACHMENT B

A September 12, 2005 report from an independent consultant stated that the insulation could not serve its proper purpose as installed. The result was ice dams, and also "damage to wood framing, wet interior walls which lead to mold conditions, and if not addressed ...to bug damage." The consultant's report contained a proposal for correction of the roof problems. The proposal called for the readjustment and re-support of the existing roof insulation to allow ½ inch of airspace between the underside of the roof and the insulation. The consultant suggested three options, priced at \$43,540, \$48,000 and \$62,000.
