PREPARED FOR:  
NEW BEDFORD PORT AUTHORITY

**ROUTINE INSPECTION REPORT UPDATE  
PORT OF NEW BEDFORD  
POPE'S ISLAND MARINA**

JULY 2020

**ROUTINE INSPECTION REPORT UPDATE  
POPE'S ISLAND MARINA  
NEW BEDFORD, MASSACHUSETTS**

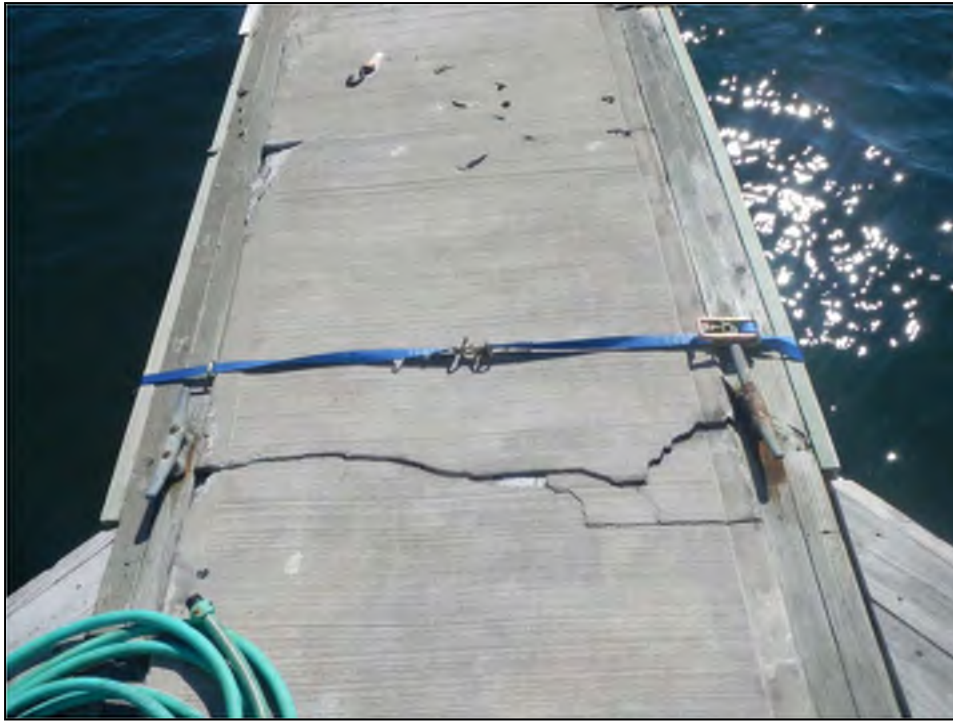
Photo No. 7: Cracking and deterioration of the concrete deck with a trip hazard.

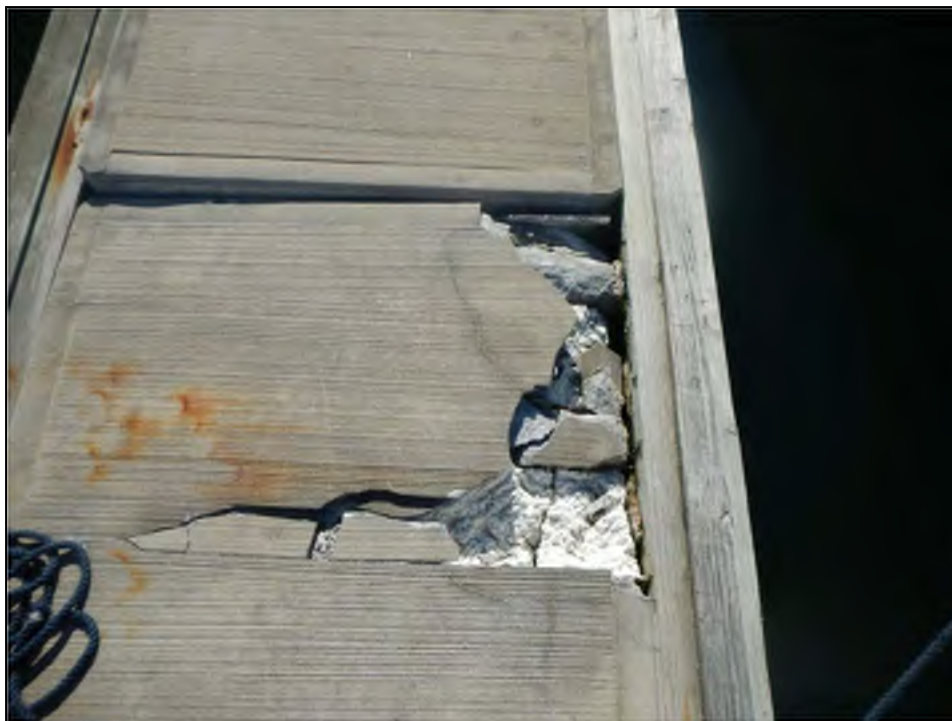
Photo No. 11: Concrete deck deterioration.

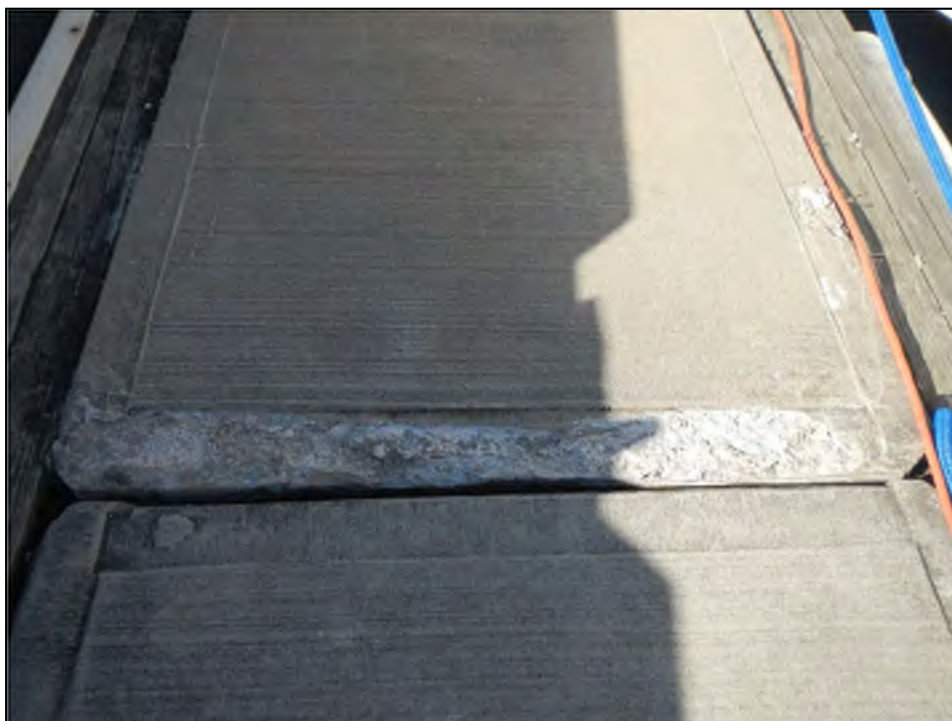
Photo No. 12: Deterioration at the edge of a concrete deck panel with a trip hazard.

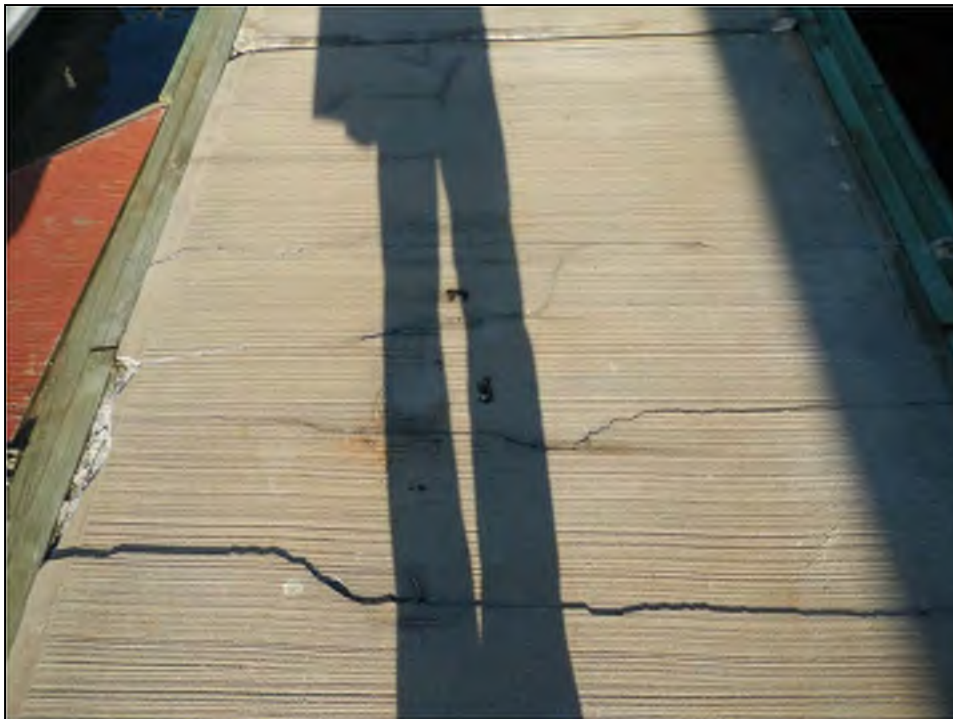
Photo No. 16: Cracking and trip hazards along the concrete deck panels.

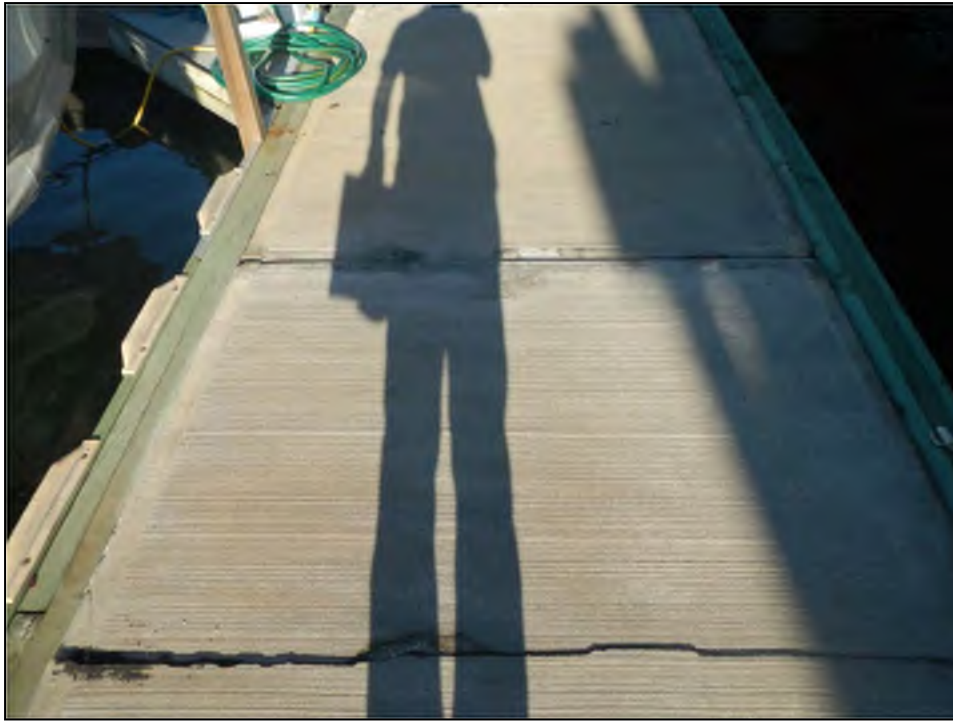
Photo No. 17: Cracking and trip hazards along the concrete deck panels.

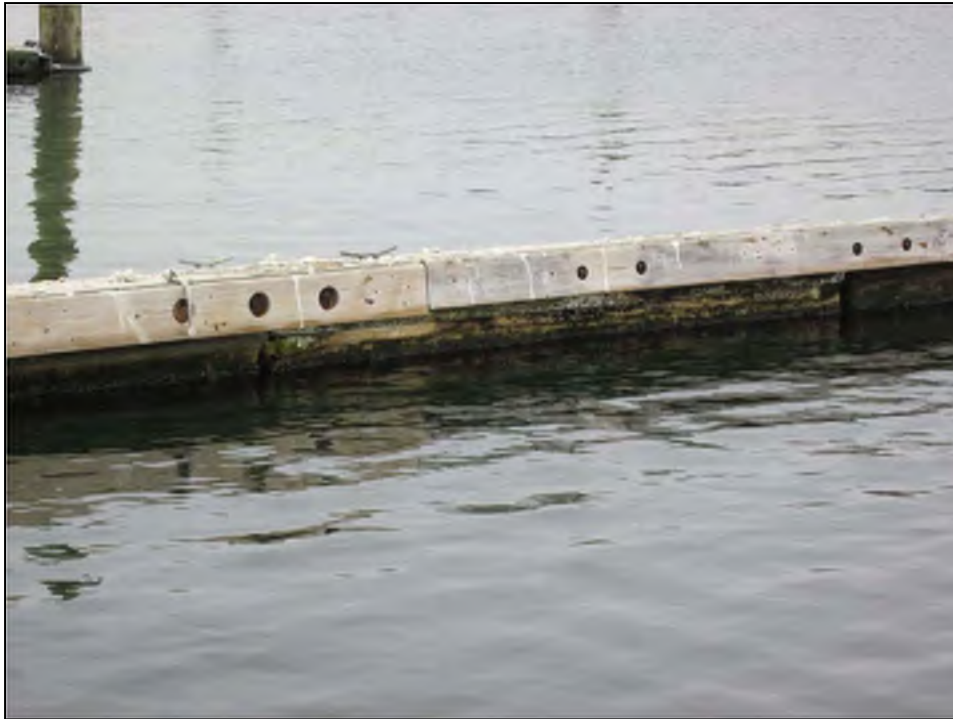
Photo No. 19: Deterioration of the concrete modules with exposed polystyrene at a finger float.

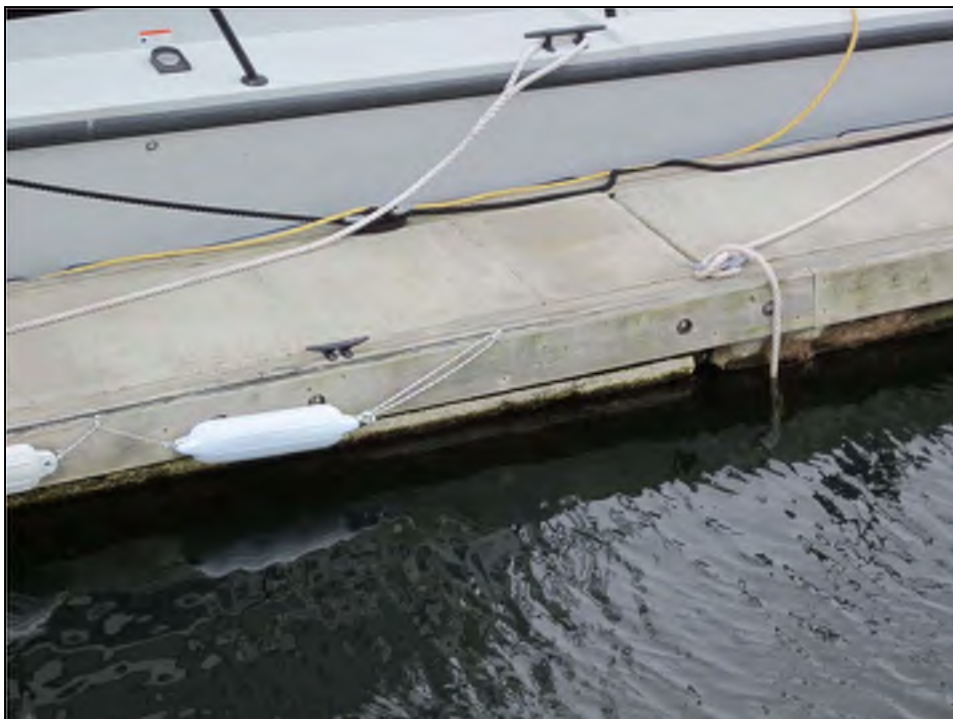
Photo No. 20: Deterioration of the concrete modules with exposed polystyrene at a finger float.

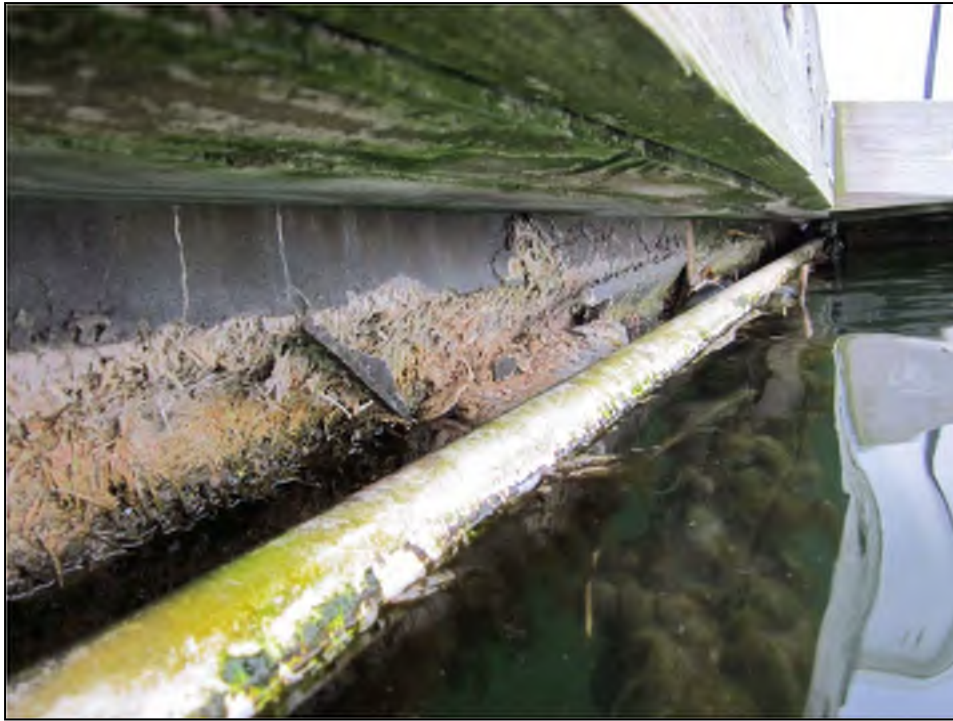
Photo No. 23: Deterioration of the concrete modules near the waterline. Note fiber reinforcement.

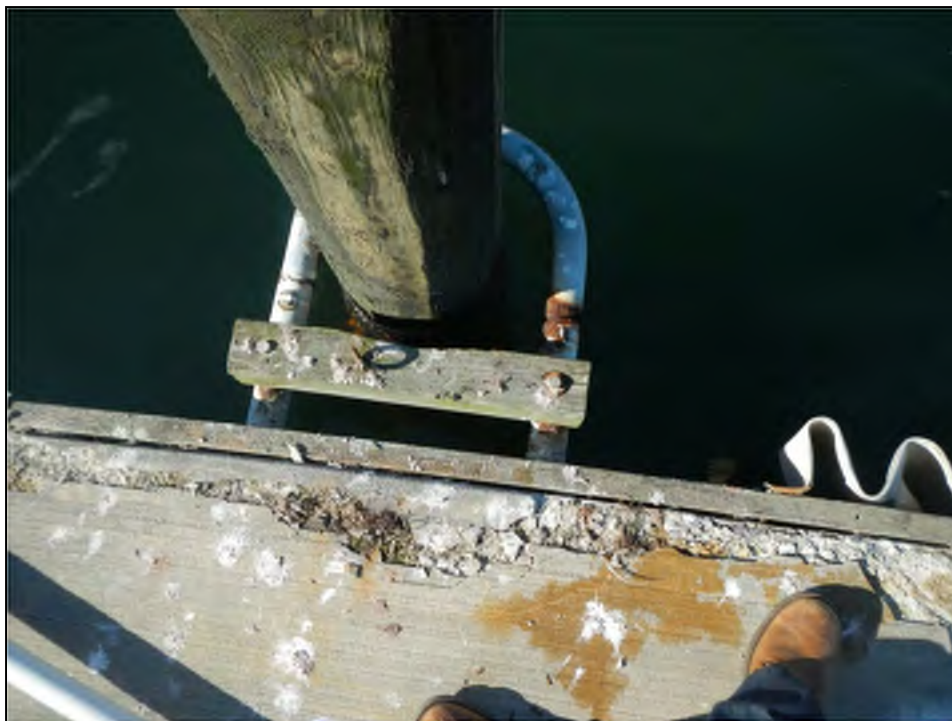
Photo No. 29: Typical existing pile hoop. Note corroded connection hardware.

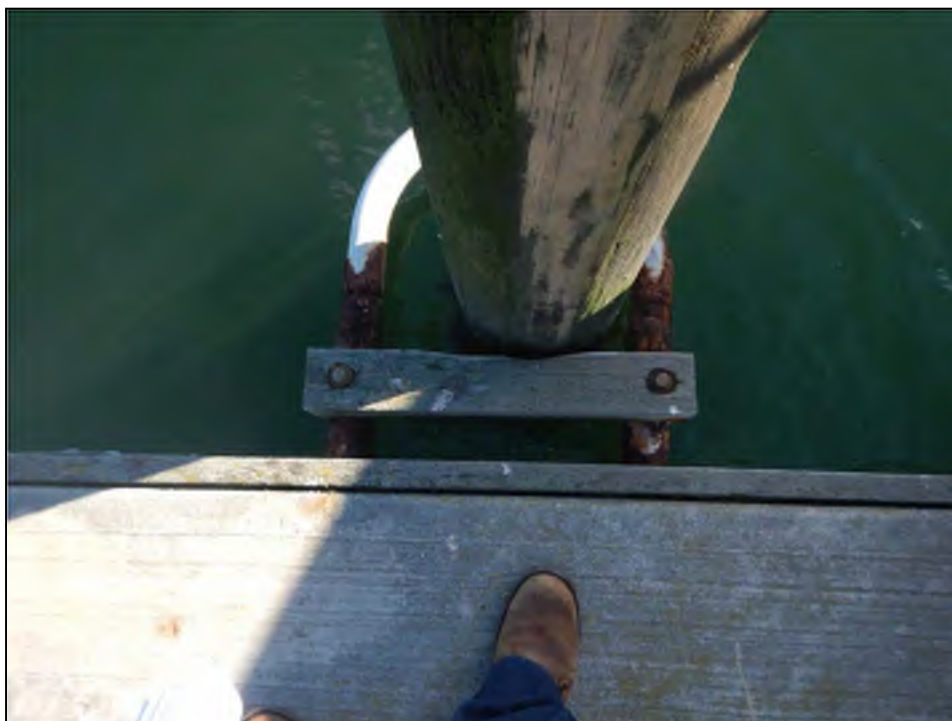
Photo No. 30: Significantly deteriorated steel pile hoop.

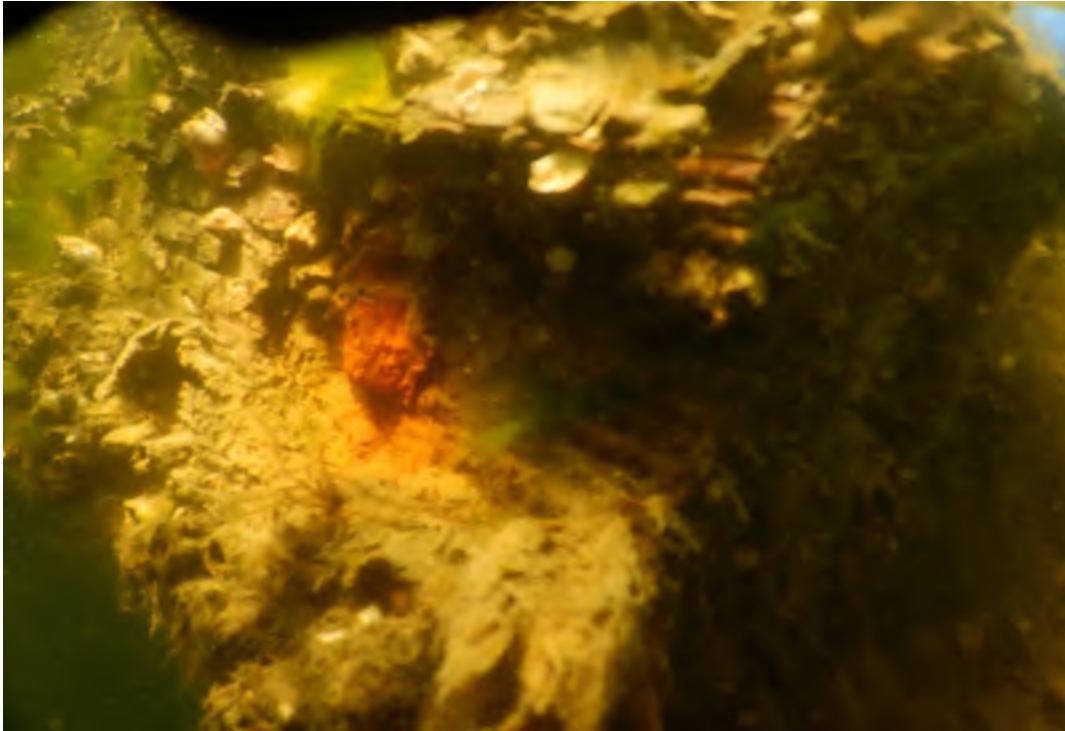
PHOTO #3 Photo of a fractured brace end and deteriorated fastener.

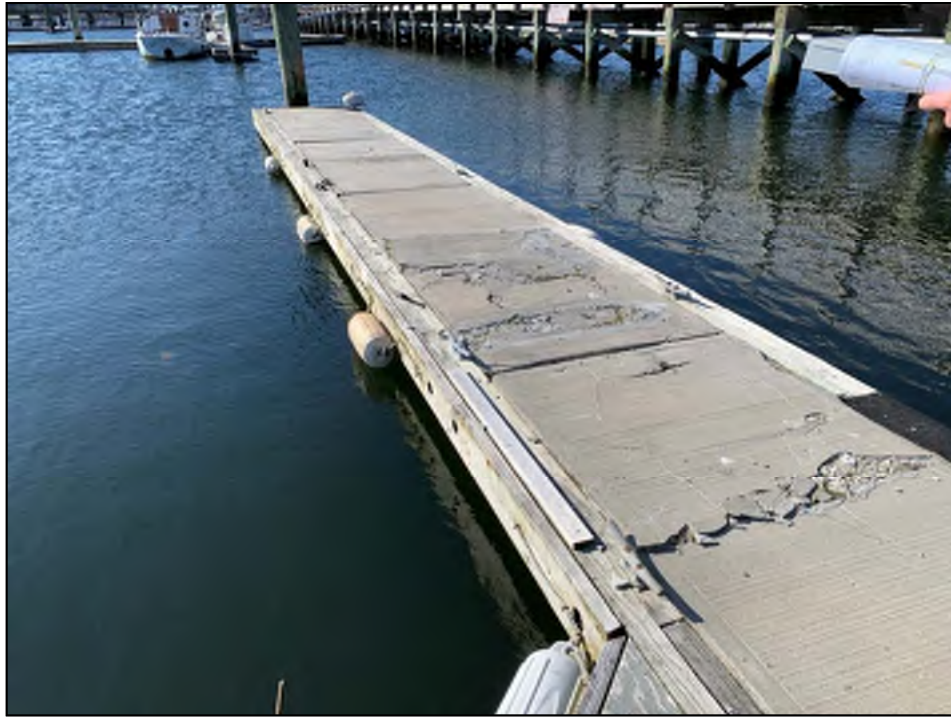
Photo No. 3: Typical spalling, cracking, and deterioration of fiber reinforced concrete modules.

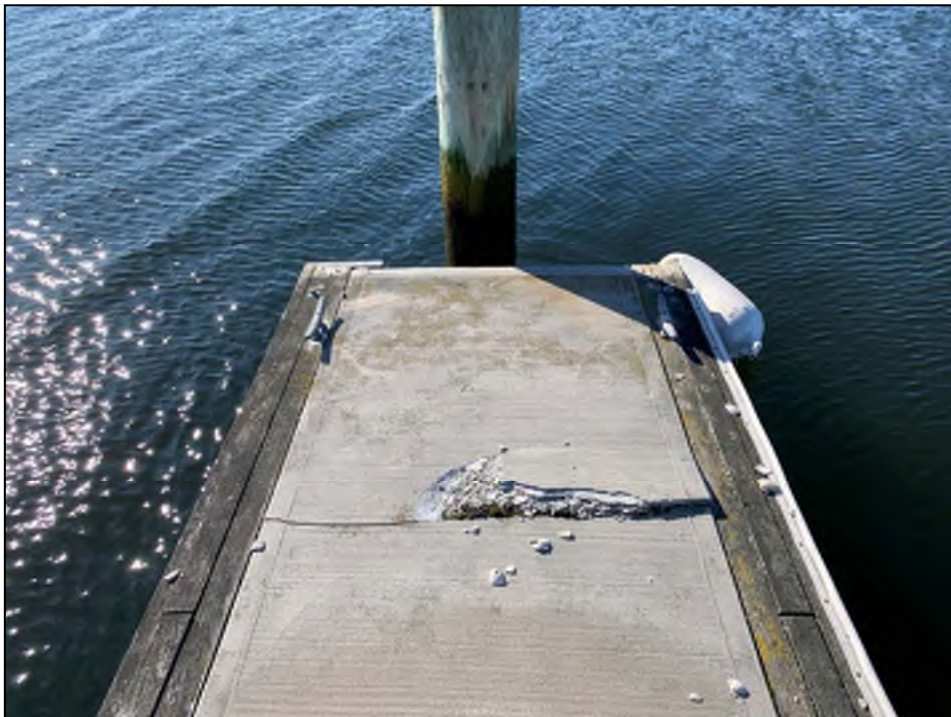
Photo No. 4: Cracking and deterioration of concrete with a trip hazard.

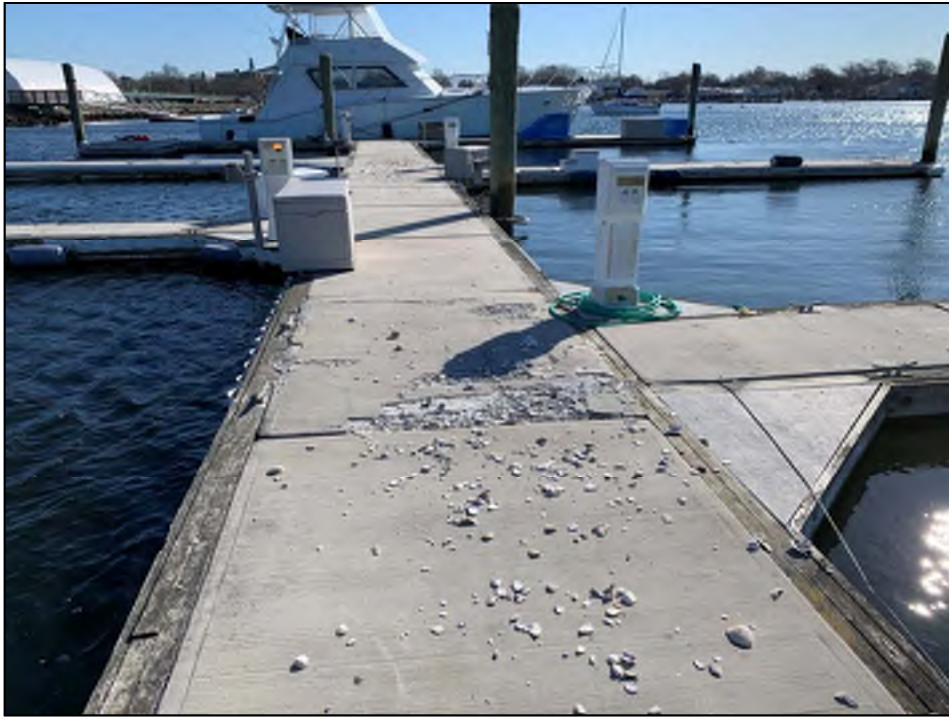
Photo No. 7: Cracking and deterioration of concrete deck with trip hazard.

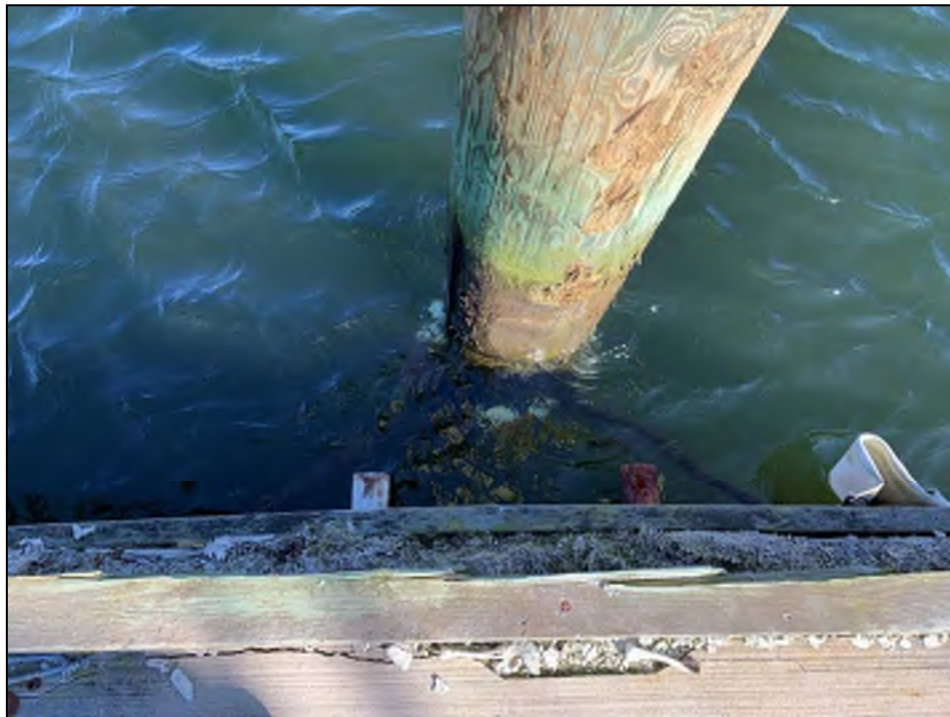
Photo No. 8: Deterioration at end of concrete module with exposed polystyrene flotation unit. Note absence of pile guide and replacement with rope.

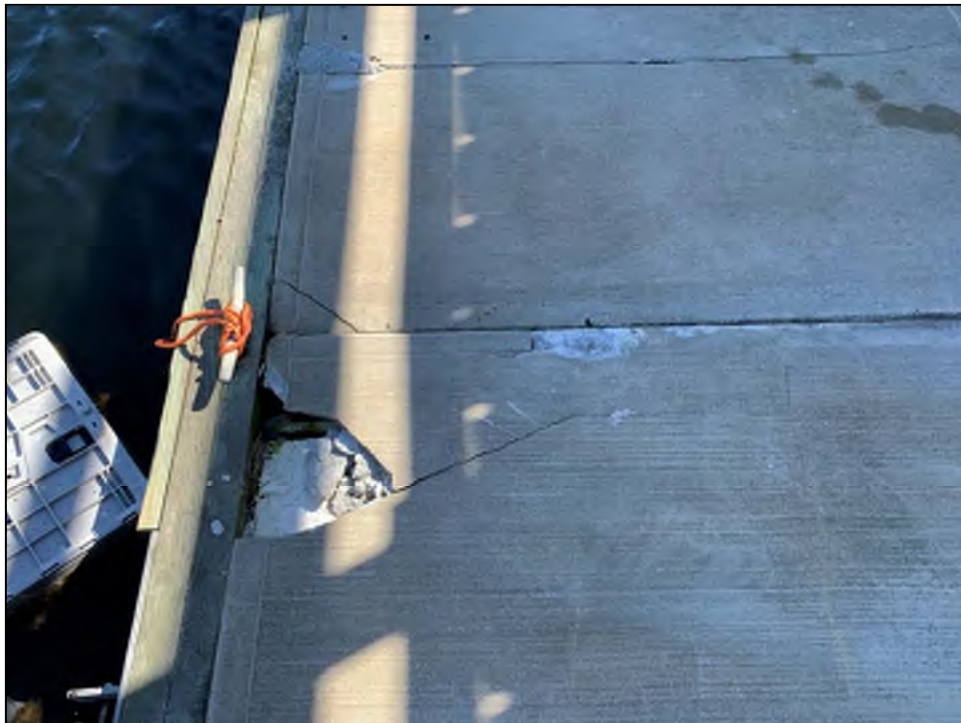
Photo No. 14: Deterioration of concrete with exposed polystyrene float unit.  
Note cracking at previously repaired spall.

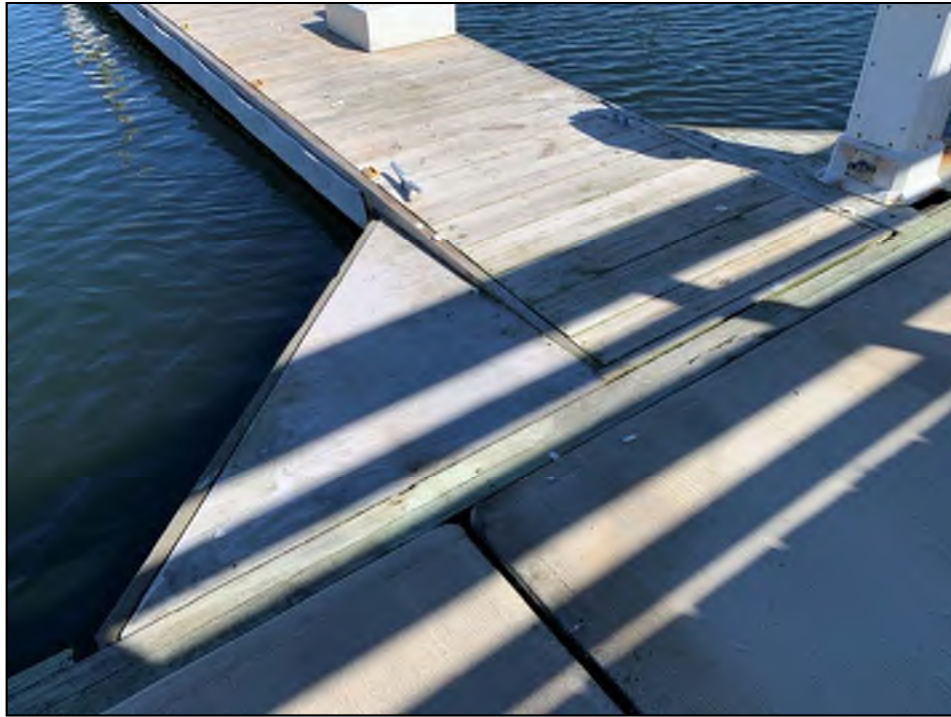
Photo No. 15: Typical uneven timber triangle for finger float connection.

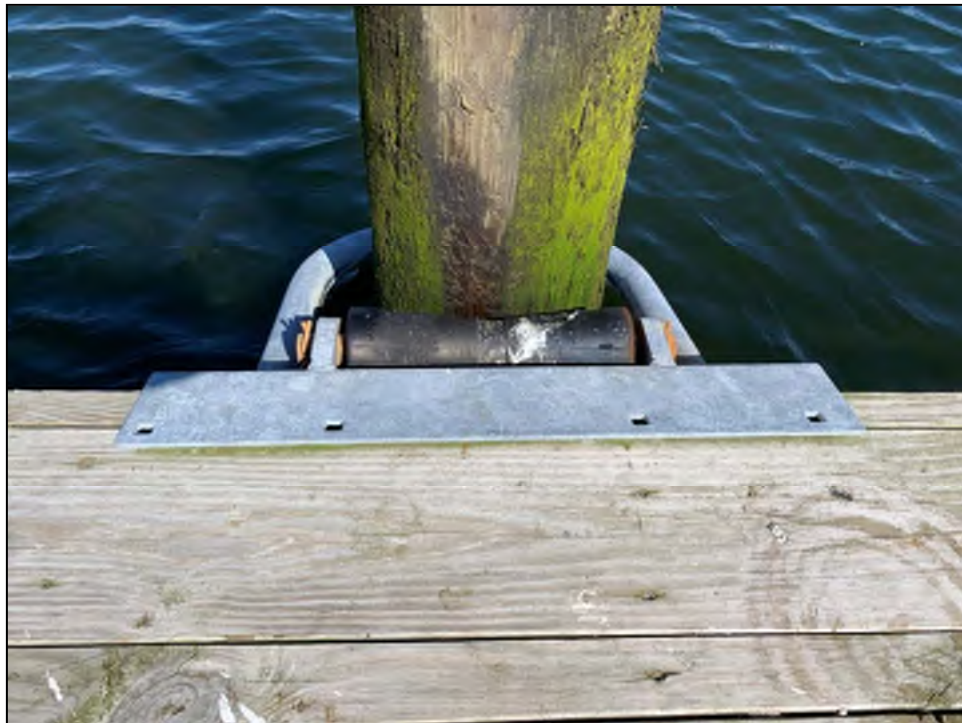
Photo No. 16: Typical top bolts missing on top of steel angle for guide pile.

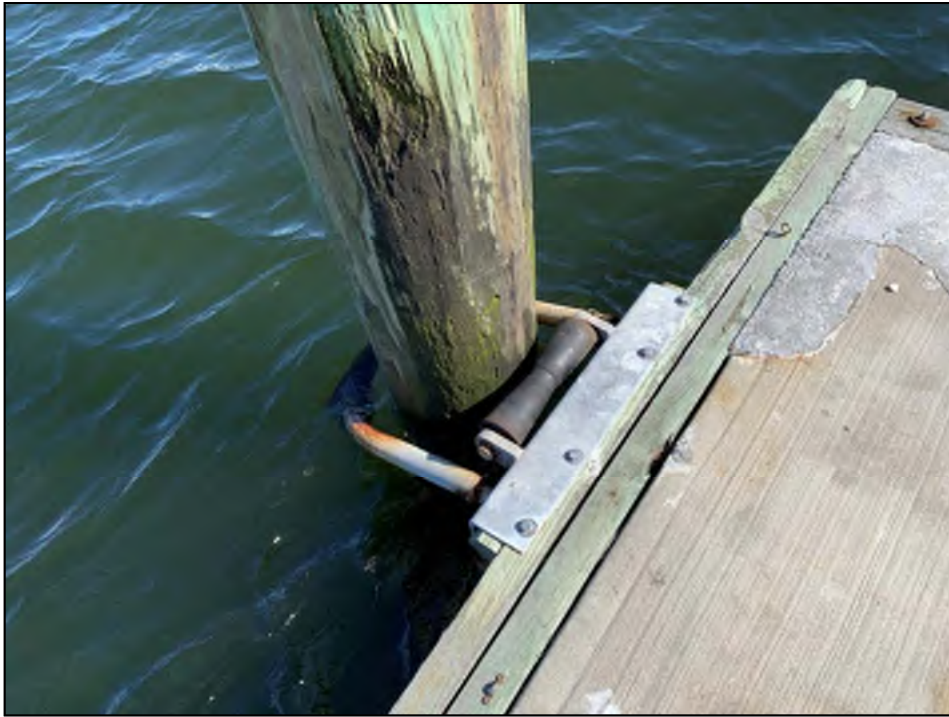
Photo No. 19: Guide pile hoop with loose connection.

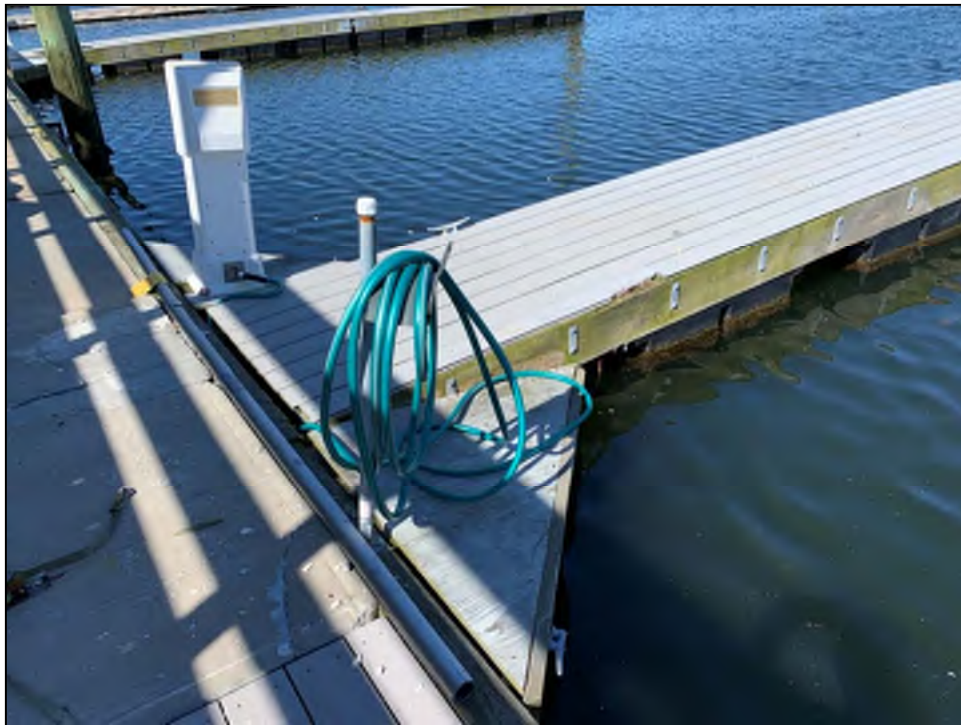
Photo No. 24: Failing timber triangle connection.

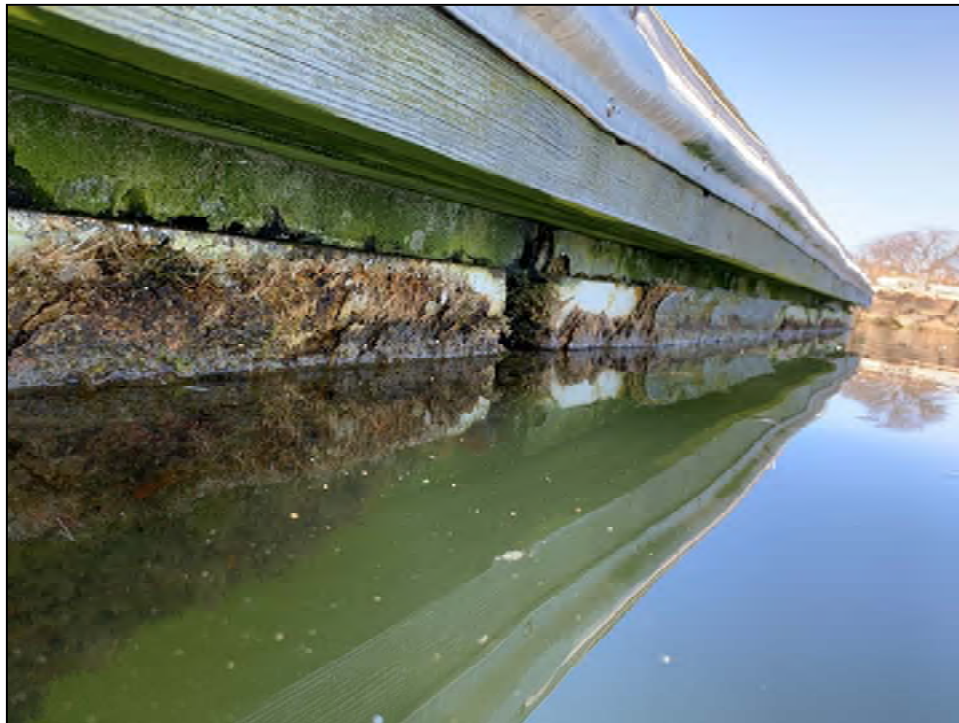
Photo No. 30: Deteriorated concrete encapsulation with exposed polystyrene flotation units.

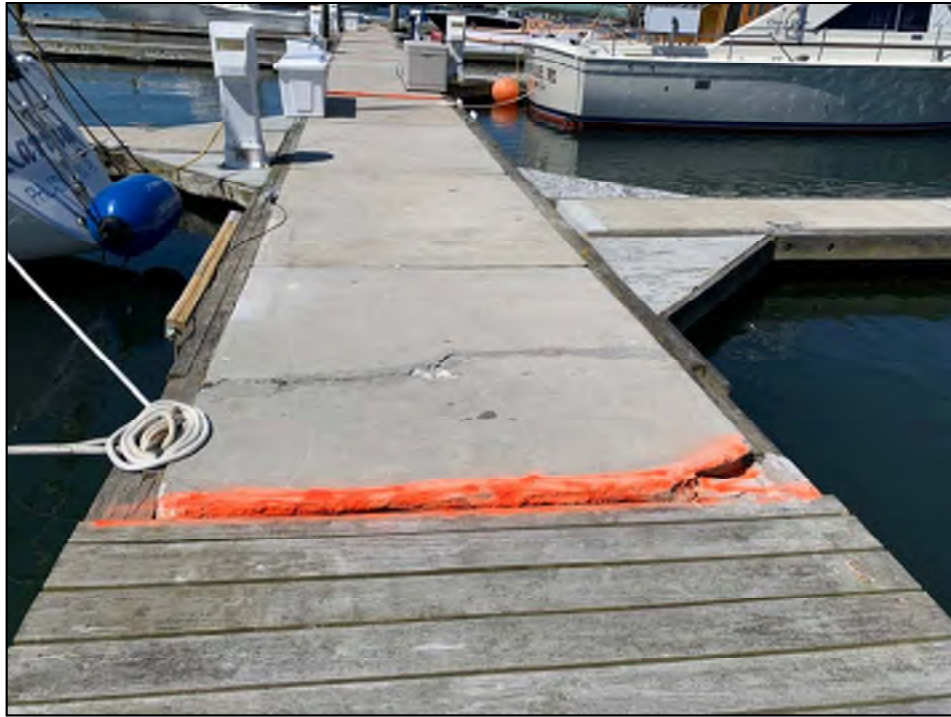
Photo No. 31: Concrete deterioration with trip hazard. Note previously repaired spall with continued deterioration..

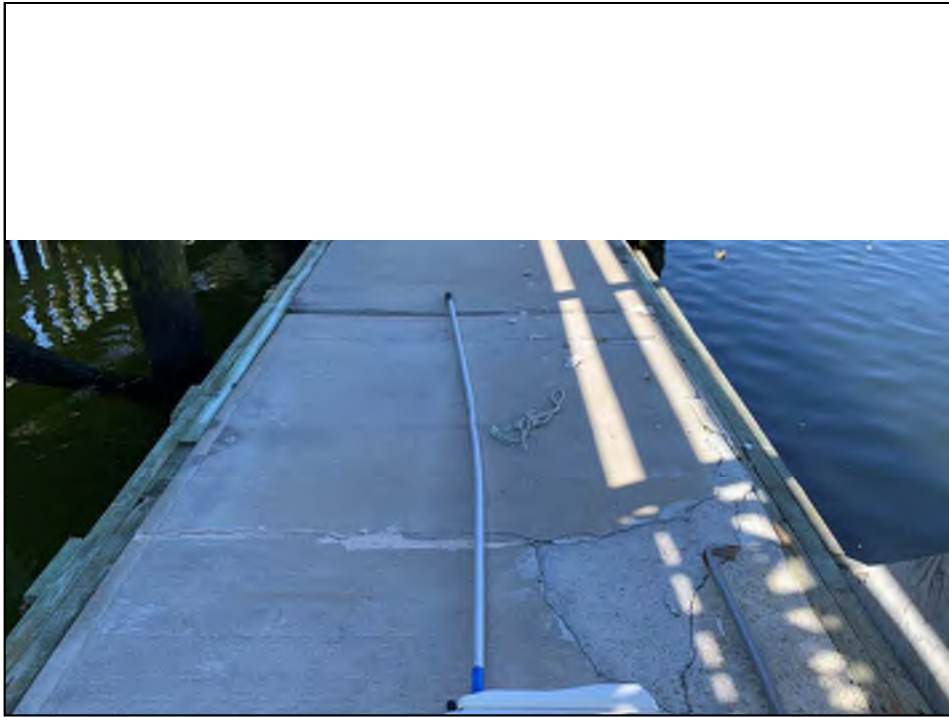
Photo No. 37: Deteriorated concrete main float along Dock D before storm.

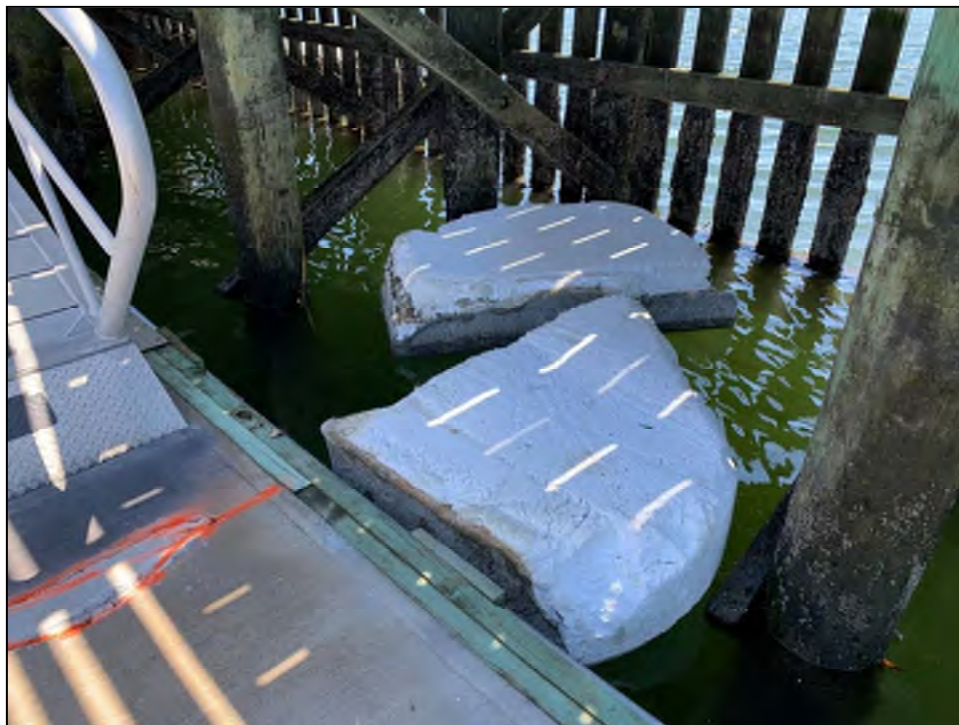
Photo No. 40: Displaced polystyrene float units after storm on Dock D.

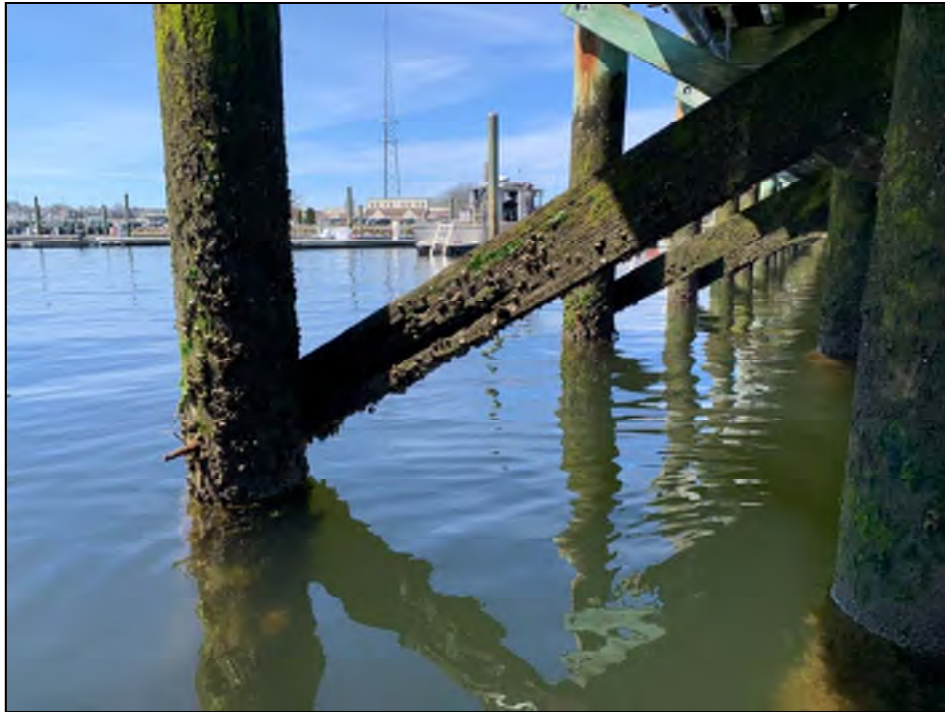
Photo No. 43: Deteriorated cross bracing hardware typical along pile supported pier.

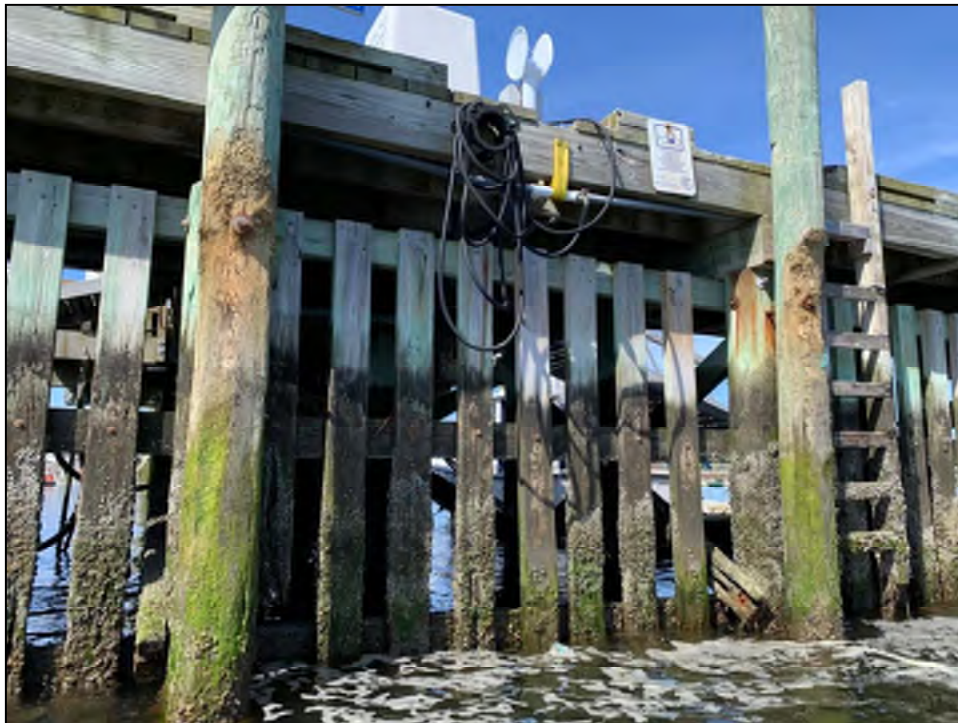
Photo No. 46: Timber fender piles with missing rub blocks and pile damage.
