**REPORT#:** 19MA072

**REPORT DATE:** December 18, 2023

## Rigging Crew Leader Crushed by Light Tower Weight — Massachusetts

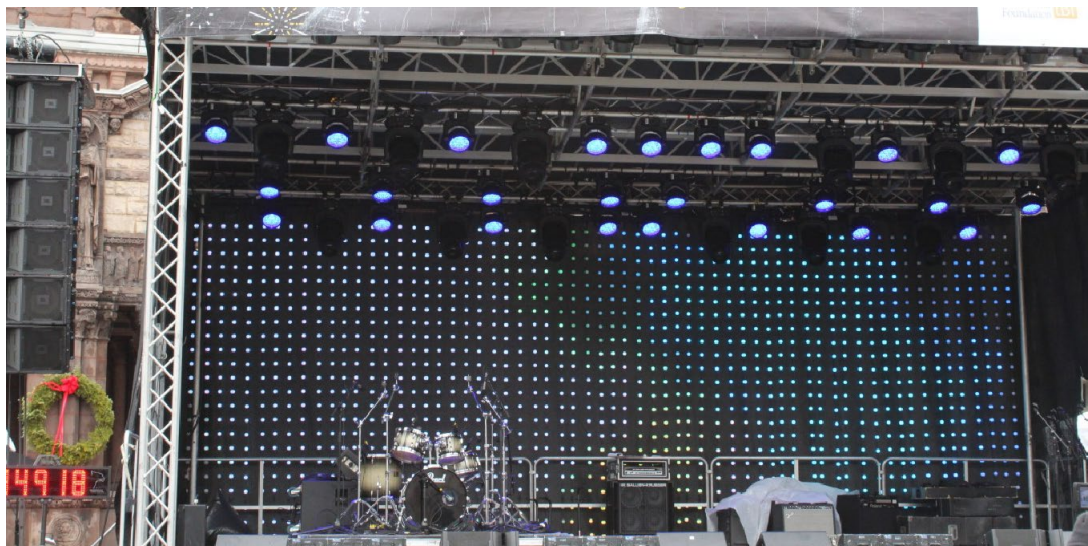
**Figure 1 – Stage and rigging with lights** (image from First Night Boston X/Twitter, [@firstnight](#))

An image of the completed stage and rigging setup is shown in Figure 1. Additional light towers were set up around the venue.

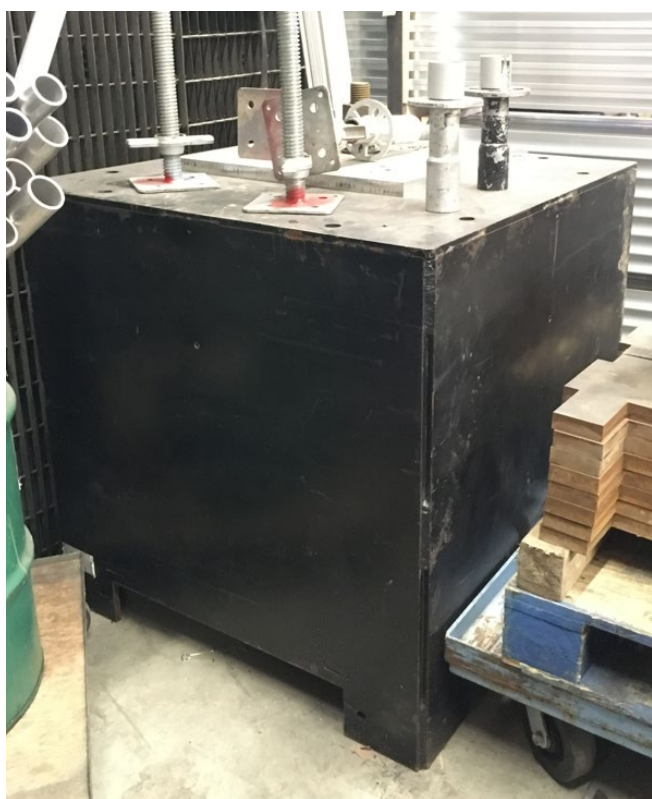
**Figure 2 – Ballast weight** (FACE investigator photo)

The ballast weight that was involved in the incident weighed 3,200 pounds (Figure 2). It was a 36" cube consisting of concrete with rebar reinforcement within a welded steel plate shell. The sides of the steel shell were 3/8" thick and the top was 5/8" thick. Holes and connections for anchoring the rigging components were built into the ballast. Various connection pieces are visible in Figure 3 which shows the ballast in storage at the company. While some weights used by the company had cutouts or holes that ran through the weight for use when lifting with a forklift, the weight involved in the incident had four feet and a gap between the feet for lifting, as seen in Figure 2.

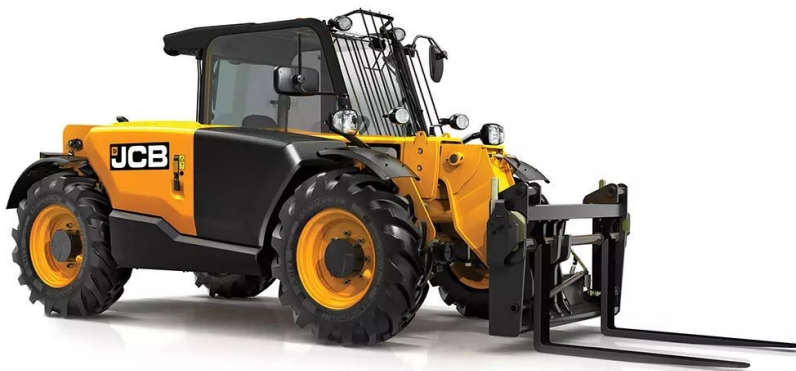
**Figure 4 – Telehandler (manufacturer image)**

Also involved in the incident was a diesel-powered four-wheel steer/four-wheel drive all-terrain telehandler (Figure 4). This type of equipment is a [class 7](#) rough terrain forklift with variable reach. It had a maximum lifting capacity of 5,500 pounds with the boom retracted. It had a lifting height of 20 feet and a load capacity of 3,900 pounds for vertical lifts. With the boom extended to its full reach of 11.5 feet, the lifting capacity was 1,750 pounds. The vehicle was six feet and two inches tall and six feet wide at its widest point at the tires. The wheelbase was seven feet and ten inches from axle to axle, and the overall length of the base unit was 13 feet and one inch plus the length of any attachment. The telehandler was equipped with a fork attachment.

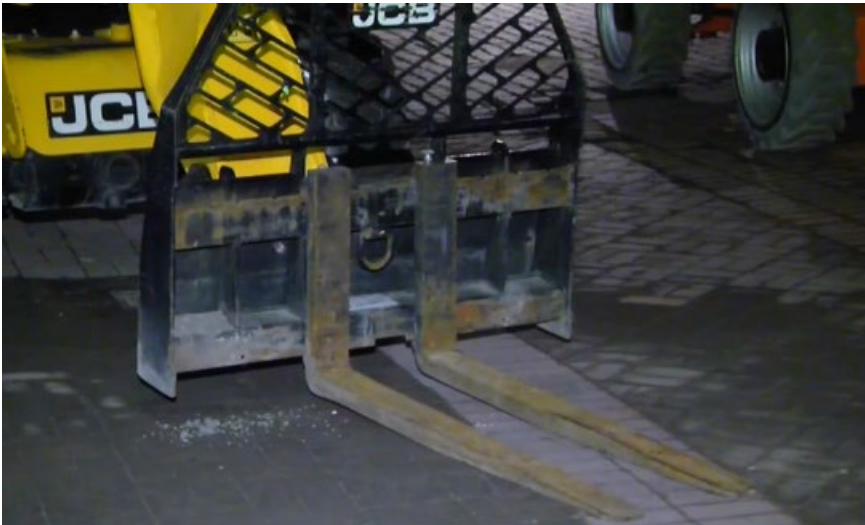
**Figure 6 – Telehandler forks and backrest (scene footage)**

In this case, the telehandler operator was attempting to move the ballast approximately four feet from its initial position. The telehandler had lifted the ballast approximately two feet from the ground. The weight of the ballast and its position on the forks made it unstable, resulting in the ballast sliding off the forks. It is unknown if the span of the forks on the telehandler had been adjusted to optimize stability when moving the larger weight. It is also unknown if the forks had been appropriately tipped backward in order to stabilize the load against the backrest. In addition, the load could have been moved at a lower height, close to the ground.

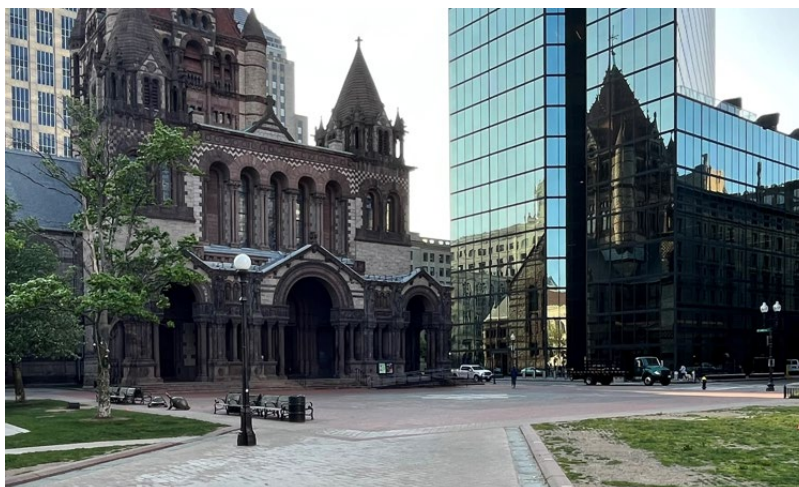
**Figure 7 – Park and paver stone area where the stage was erected (FACE investigator photo)**

The incident occurred at a park in a city center (Figure 7). The open area public space was being converted into an entertainment venue (Figure 8). The paver stone space that held the entertainment rigging and staging was approximately 12,200 square feet of the outdoor space. The lawn space in front of the stage area was approximately 16,500 square feet. The outdoor cobblestone and green space were mostly flat.

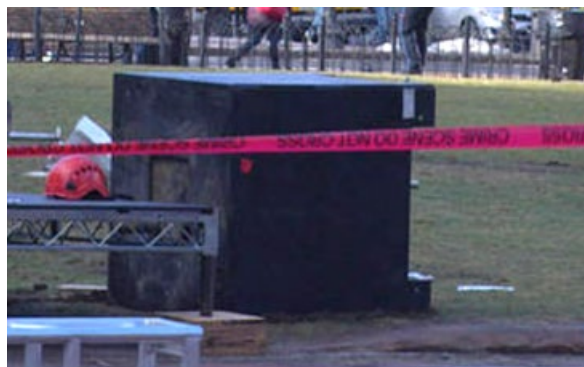
**Figure 8 – Ballast weight on its side (scene footage)**

The weight of the ballast and its position on the telehandler caused the ballast to slide or tip off of the tines. The ballast first struck the victim in the head and then fell on the victim's torso. Multiple workers at the site were able to roll the

***Recommendation #1: Employers should ensure that employees are not within the fall zone of material being transported.***

way to reduce the fall zone and hazard. Additionally, employers should ensure that transported materials are properly secured and stable prior to transport.
