Road-Stream Crossing Assessment Technical Memorandum

*Town-Wide Road Stream Crossing Assessment and
Climate Change Adaptation Plan*

TOWN OF BELCHERTOWN, MASSACHUSETTS

RE: Town-Wide Road-Stream Crossing Assessment and Climate Change Adaptation Plan – MVP Action Grant
Road-Stream Crossing Assessment Technical Memorandum

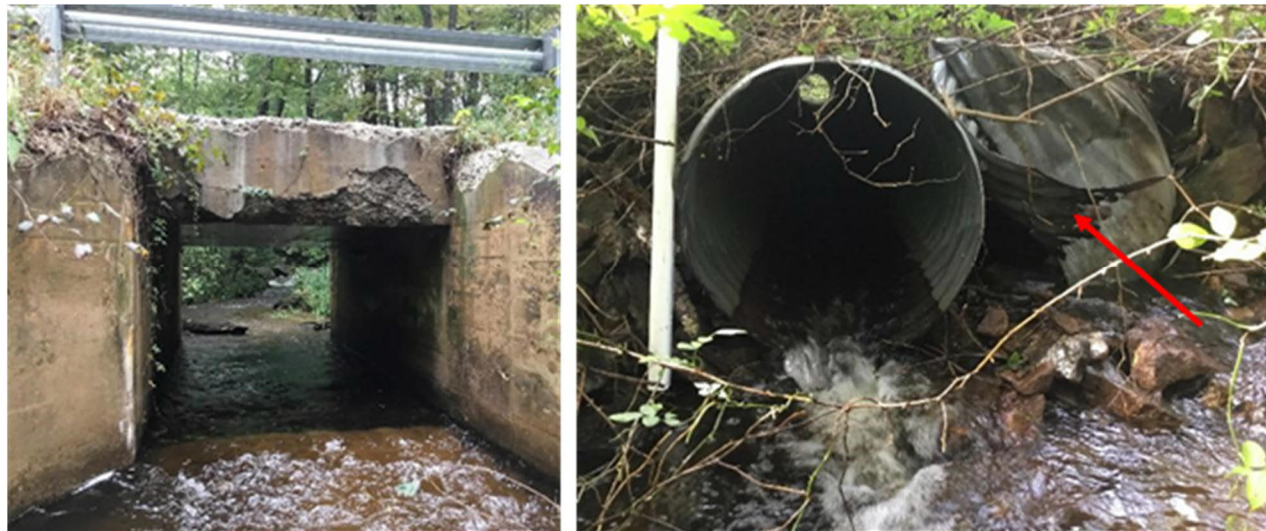
- **Poor Structural Condition:** Many of the crossings were observed to be in poor condition and in need of significant repairs or replacement. Significant erosion of the crossing embankment and unstable or deteriorating headwalls or wingwalls were common at many of these crossings. Corrugated metal pipes with rusted out bottoms were also relatively common throughout the Town.

Figure 3. Examples of crossing structures in poor structural condition observed at various locations during field assessments.

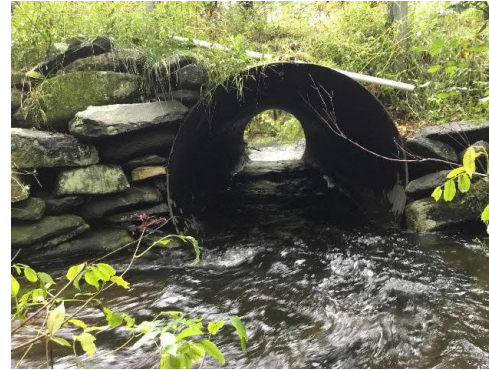
Ludlow Street crosses Roaring Brook several hundred feet north of Granby Road. The crossing consists of a single 5-foot diameter corrugated metal pipe, making the crossing width less than one third of Roaring Brook's bankfull width. Due to the severe constriction at the crossing, flow velocities in the culvert are significantly faster than the surrounding stream. These conditions pose a barrier to aquatic passage and have also resulted in creation of a large scour pool at the outlet and downstream deposition of displaced sediment. The outlet has been extensively armored in an attempt to prevent erosion, but the severity of the stream's constriction and high-velocity flows will continue to cause scour. The crossing can pass the existing 10-year peak flow, but is undersized for larger recurrence interval peak flows that were analyzed (25-year, 50-year, and 100-year) and estimated peak flows given future climate change projections.

Image 1: View of current crossing inlet taken during field assessment on October 3, 2018.

- Replace the existing undersized culvert with a bridge of approximately 22 foot span to accommodate the 1.2 times bankfull width design standard of the Massachusetts River and Stream Crossing Standards.
- Restore the stream banks and streambed to repair the existing scour pool and erosion, and match the substrate characteristics of the natural stream channel.
- The proposed culvert replacement design concept will:
 - Improve the alignment of the stream to the crossing structure
 - Provide increased hydraulic capacity to reduce flooding risk
 - Reduce erosion and scour by decreasing flow velocity through the crossing

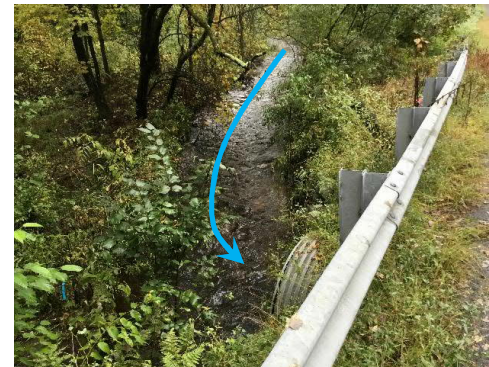
Image 2: Stream alignment relative to culvert inlet. Arrow indicates flow path entering culvert.

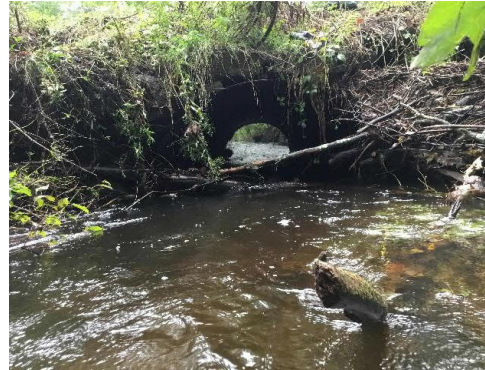
Granby Road crosses Roaring Brook a few hundred feet east of Ludlow Street. The crossing consists of a single corrugated metal pipe of approximately 6 feet in diameter, making the crossing width less than one third of Roaring Brook's bankfull width. Due to the severe constriction at the crossing, flow velocities in the culvert are significantly faster than the surrounding stream. These conditions pose a barrier to aquatic passage and have also resulted in creation of a large scour pool at the outlet and downstream deposition of displaced sediment. The crossing is significantly undersized for all of the recurrence interval peak flows that were analyzed (10-year, 25-year, 50-year, and 100-year), as well as the estimated peak flows given future climate change projections. Several crayfish were noted at the crossing during the field assessment, indicating that the stream provides important wildlife habitat and underscoring the relevance of aquatic organism passage at this site. The crossing is also scored as among the top 15% of culverts identified for replacement in the Massachusetts Wildlife Climate Action Tool.

Image 1: View of current crossing inlet taken during field assessment on October 3, 2018.

- Replace the existing undersized culvert with a bridge of approximately 22 foot span to accommodate the 1.2 times bankfull width design standard of the Massachusetts River and Stream Crossing Standards.
- Reconstruct stream banks at the crossing to match the existing stream channel up and downstream of the crossing, and match the substrate characteristics of the natural stream channel.
- The proposed culvert replacement design concept will:
 - Provide increased hydraulic capacity to reduce flooding risk
 - Reduce erosion and scour by decreasing flow velocity through the crossing

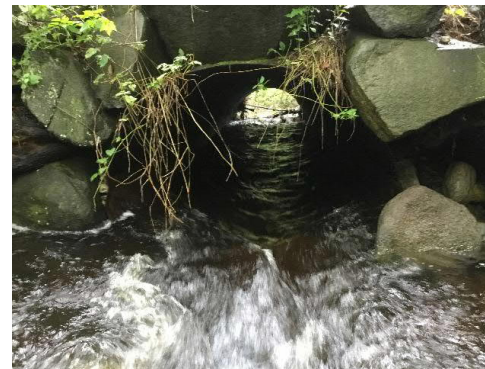
Image 2: View of current crossing outlet taken during field assessment on October 3, 2018.

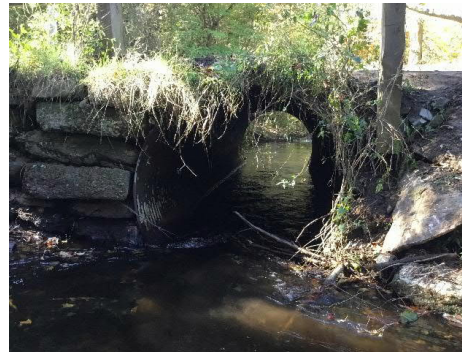
Image 1: View of current structure inlet taken during field assessment on October 5, 2018

Armoring in critical condition
Severe constriction
Large scour pool

- Replace the existing corrugated metal pipe culvert with a bridge, reconstructing the crossing to meet the Massachusetts River and Stream Crossing standards, including a design span of at least 19.2 feet to span 1.2 times the stream's bankfull width.
- Restore the downstream banks and streambed to repair existing scour pool and erosion, and match the substrate characteristics of the natural stream channel.
- The proposed culvert replacement design concept will:
 - Provide increased hydraulic capacity to reduce flooding risk and allow water and debris associated with larger storms to pass.
 - Reduce geomorphic risk associated with erosion and scour
 - Decrease attractiveness to beaver by reducing sounds of flowing water associated with the current constriction condition
 - Decrease potential for backwatering above the crossing inlet

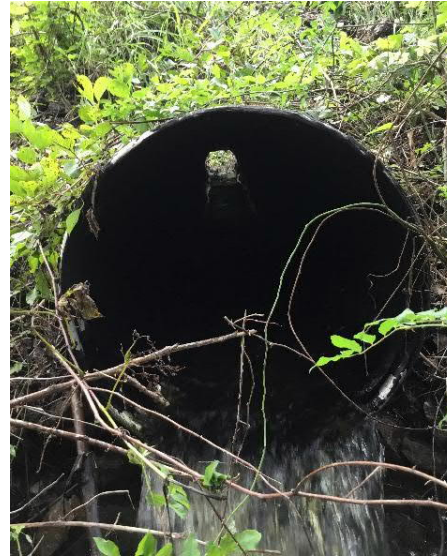
Image 1: View of current structure outlet taken during field assessment on September 27, 2018. Note that outlet has a freefall onto cascade condition which contributes to scour and geomorphic risk.

- Replace the existing corrugated metal pipe culvert with an embedded box culvert, reconstructing the crossing to meet the Massachusetts River and Stream Crossing Standards, including a design span of at least 10 feet to span 1.2 times the stream's bankfull width.
- Realign the crossing to better match the natural path of the stream and reduce potential for accumulated debris to block flows, and match the substrate characteristics of the natural stream channel.
- The proposed culvert replacement design concept will:
 - Provide increased hydraulic capacity to reduce flooding risk and allow water and debris associated with larger storms to pass
 - Reduce geomorphic risk associated with erosion and scour by eliminating freefall condition
 - Improve alignment of crossing with stream path to improve passage of woody material through structure and prevent accumulation of debris

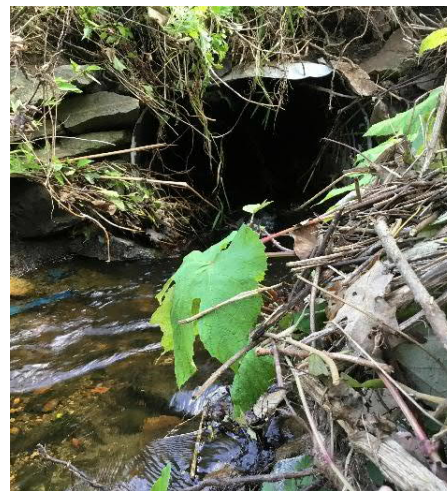
Image 2: View of inlet to current structure. The existing inlet is below the grade of the streambed, creating an inlet drop condition.

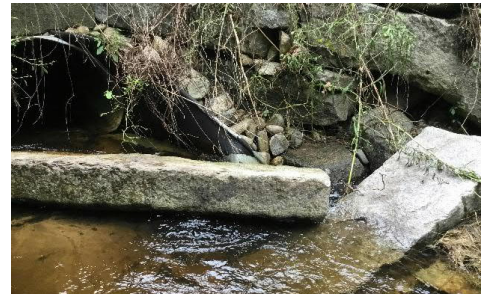
Montague Brook crosses North Street at a bend in the road approximately 400 feet west of Route 9. The crossing consists of two corrugated metal elliptical pipes, each approximately 3.5 feet wide, severely constricting Montague Brook's 14-foot bankfull width. The headwall at the outlet is in critical condition; several of the large headwall stones have fallen into the stream and partially block the outlet of one of the two structures. The crossing is hydraulically undersized, with total capacity only about a quarter of the estimated 10-year peak flow. A large outlet scour pool indicates that water is forced through the culverts at high velocity during storm events. This has led to significant bank erosion and is likely responsible for the failure of the outlet headwall.

Image 2: View of critical headwall condition at outlet, September 21, 2018.

Outlet headwall in critical condition
High bank erosion
Severe constriction
Large scour pool
Inlet drop at one structure

- Replace the existing undersized culvert with an open-bottom arch with an approximately 17-foot span to accommodate the 1.2 times bankfull width design standard of the Massachusetts River and Stream Crossing Standards.
- The proposed culvert replacement design concept will:
 - Provide increased hydraulic capacity to reduce flooding risk
 - Reduce erosion and scour by decreasing flow velocity through the crossing
 - Protect North Street from undermining and failure risk

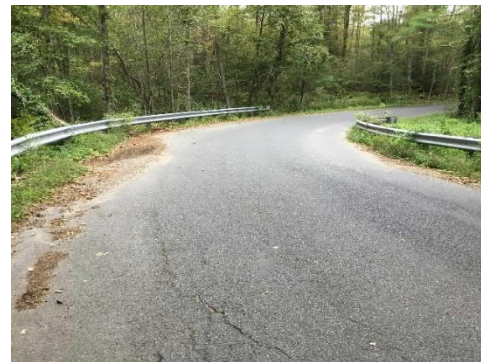
Image 3: Location of the crossing at a bend in the road on North Street.

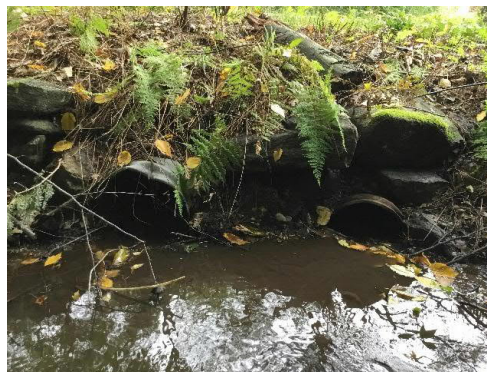
Image 1: View of current Forest Road crossing inlet taken during field assessment on October 4, 2018.

- Replace the existing undersized and deteriorated crossings at Forest Road and Ledgewood Circle with embedded box culverts approximately 6 feet wide by 4 feet high, designed to meet the Massachusetts River and Stream Crossing Standards.
- Refine bankfull width measurement and realign and enlarge the Ledgewood Drive crossing with an approximately 12-foot wide open bottom arch to provide direct connection between the stream inlet and outlet and improve flow conveyance and wildlife passage.
- The proposed culvert replacement design concept will:
 - Provide increased hydraulic capacity to reduce flooding risk
 - Remedy the current potential for structural failure at all crossings
 - Reduce sediment deposition and associated blockages
 - Improve terrestrial and aquatic passage conditions to connect forested wetlands throughout the neighborhood

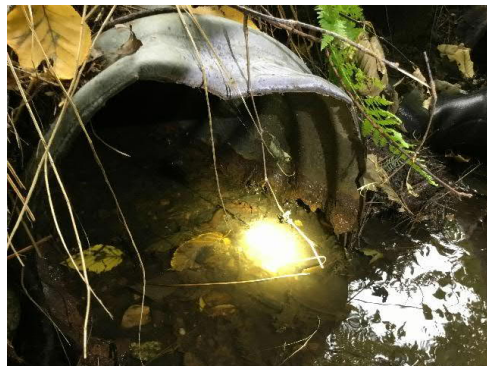
Image 3: View of deteriorated invert condition.

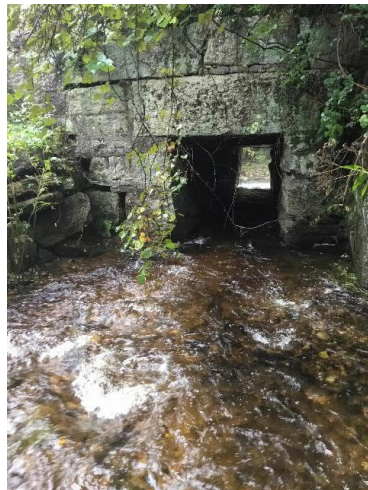
Image 3: Secondary, privately-owned crossing downstream of assessed crossing.

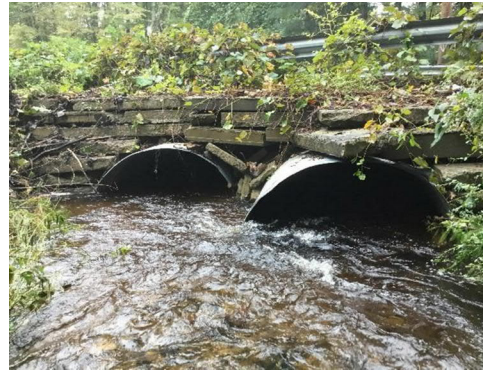
Image 1: View of current crossing inlet taken during field assessment on September 26, 2018. Note deteriorating headwall condition.

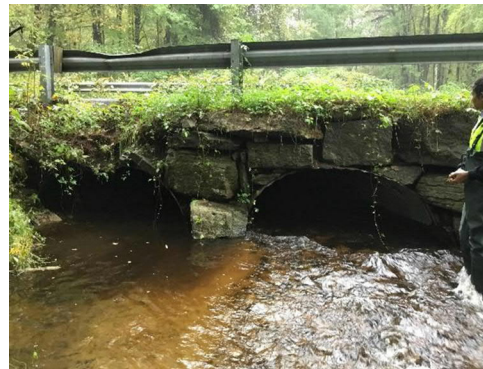
Image 2: View of crossing outlet on September 26, 2018. Note the different flow velocities between the structures.

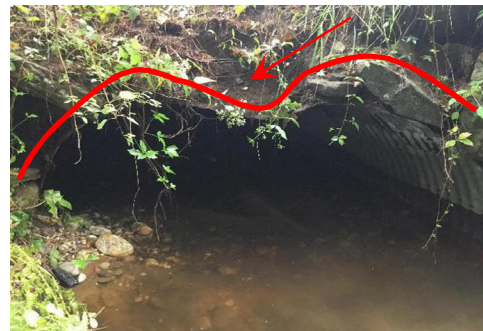
Image 4: View of structure deformation/crushing and poor headwall condition.

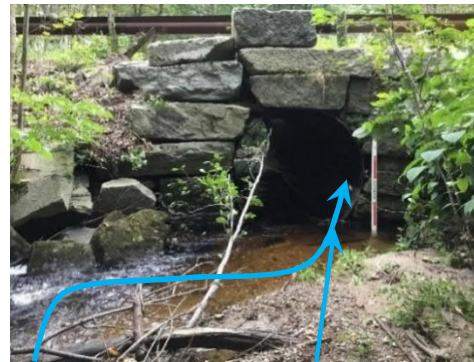
Image 1: View of current structure inlet taken during field assessment on September 21, 2018. Arrows indicate flow paths of Scarboro Brook during low and high flows.

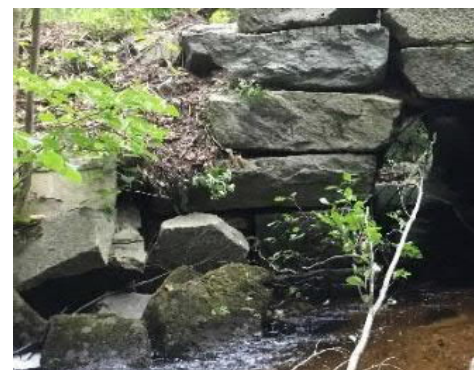
Image 3: Poor headwall condition at inlet.

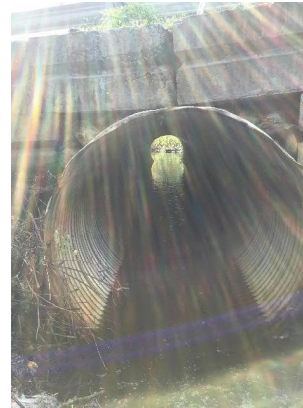
Image 1: View of current structure inlet taken from within the beaver deceiver fencing during field assessment on October 10, 2018.
