PREPARED FOR:  
NEW BEDFORD PORT AUTHORITY

**ROUTINE INSPECTION REPORT UPDATE  
PORT OF NEW BEDFORD  
POPE'S ISLAND MARINA**

JULY 2020

**ROUTINE INSPECTION REPORT UPDATE  
POPE'S ISLAND MARINA  
NEW BEDFORD, MASSACHUSETTS**

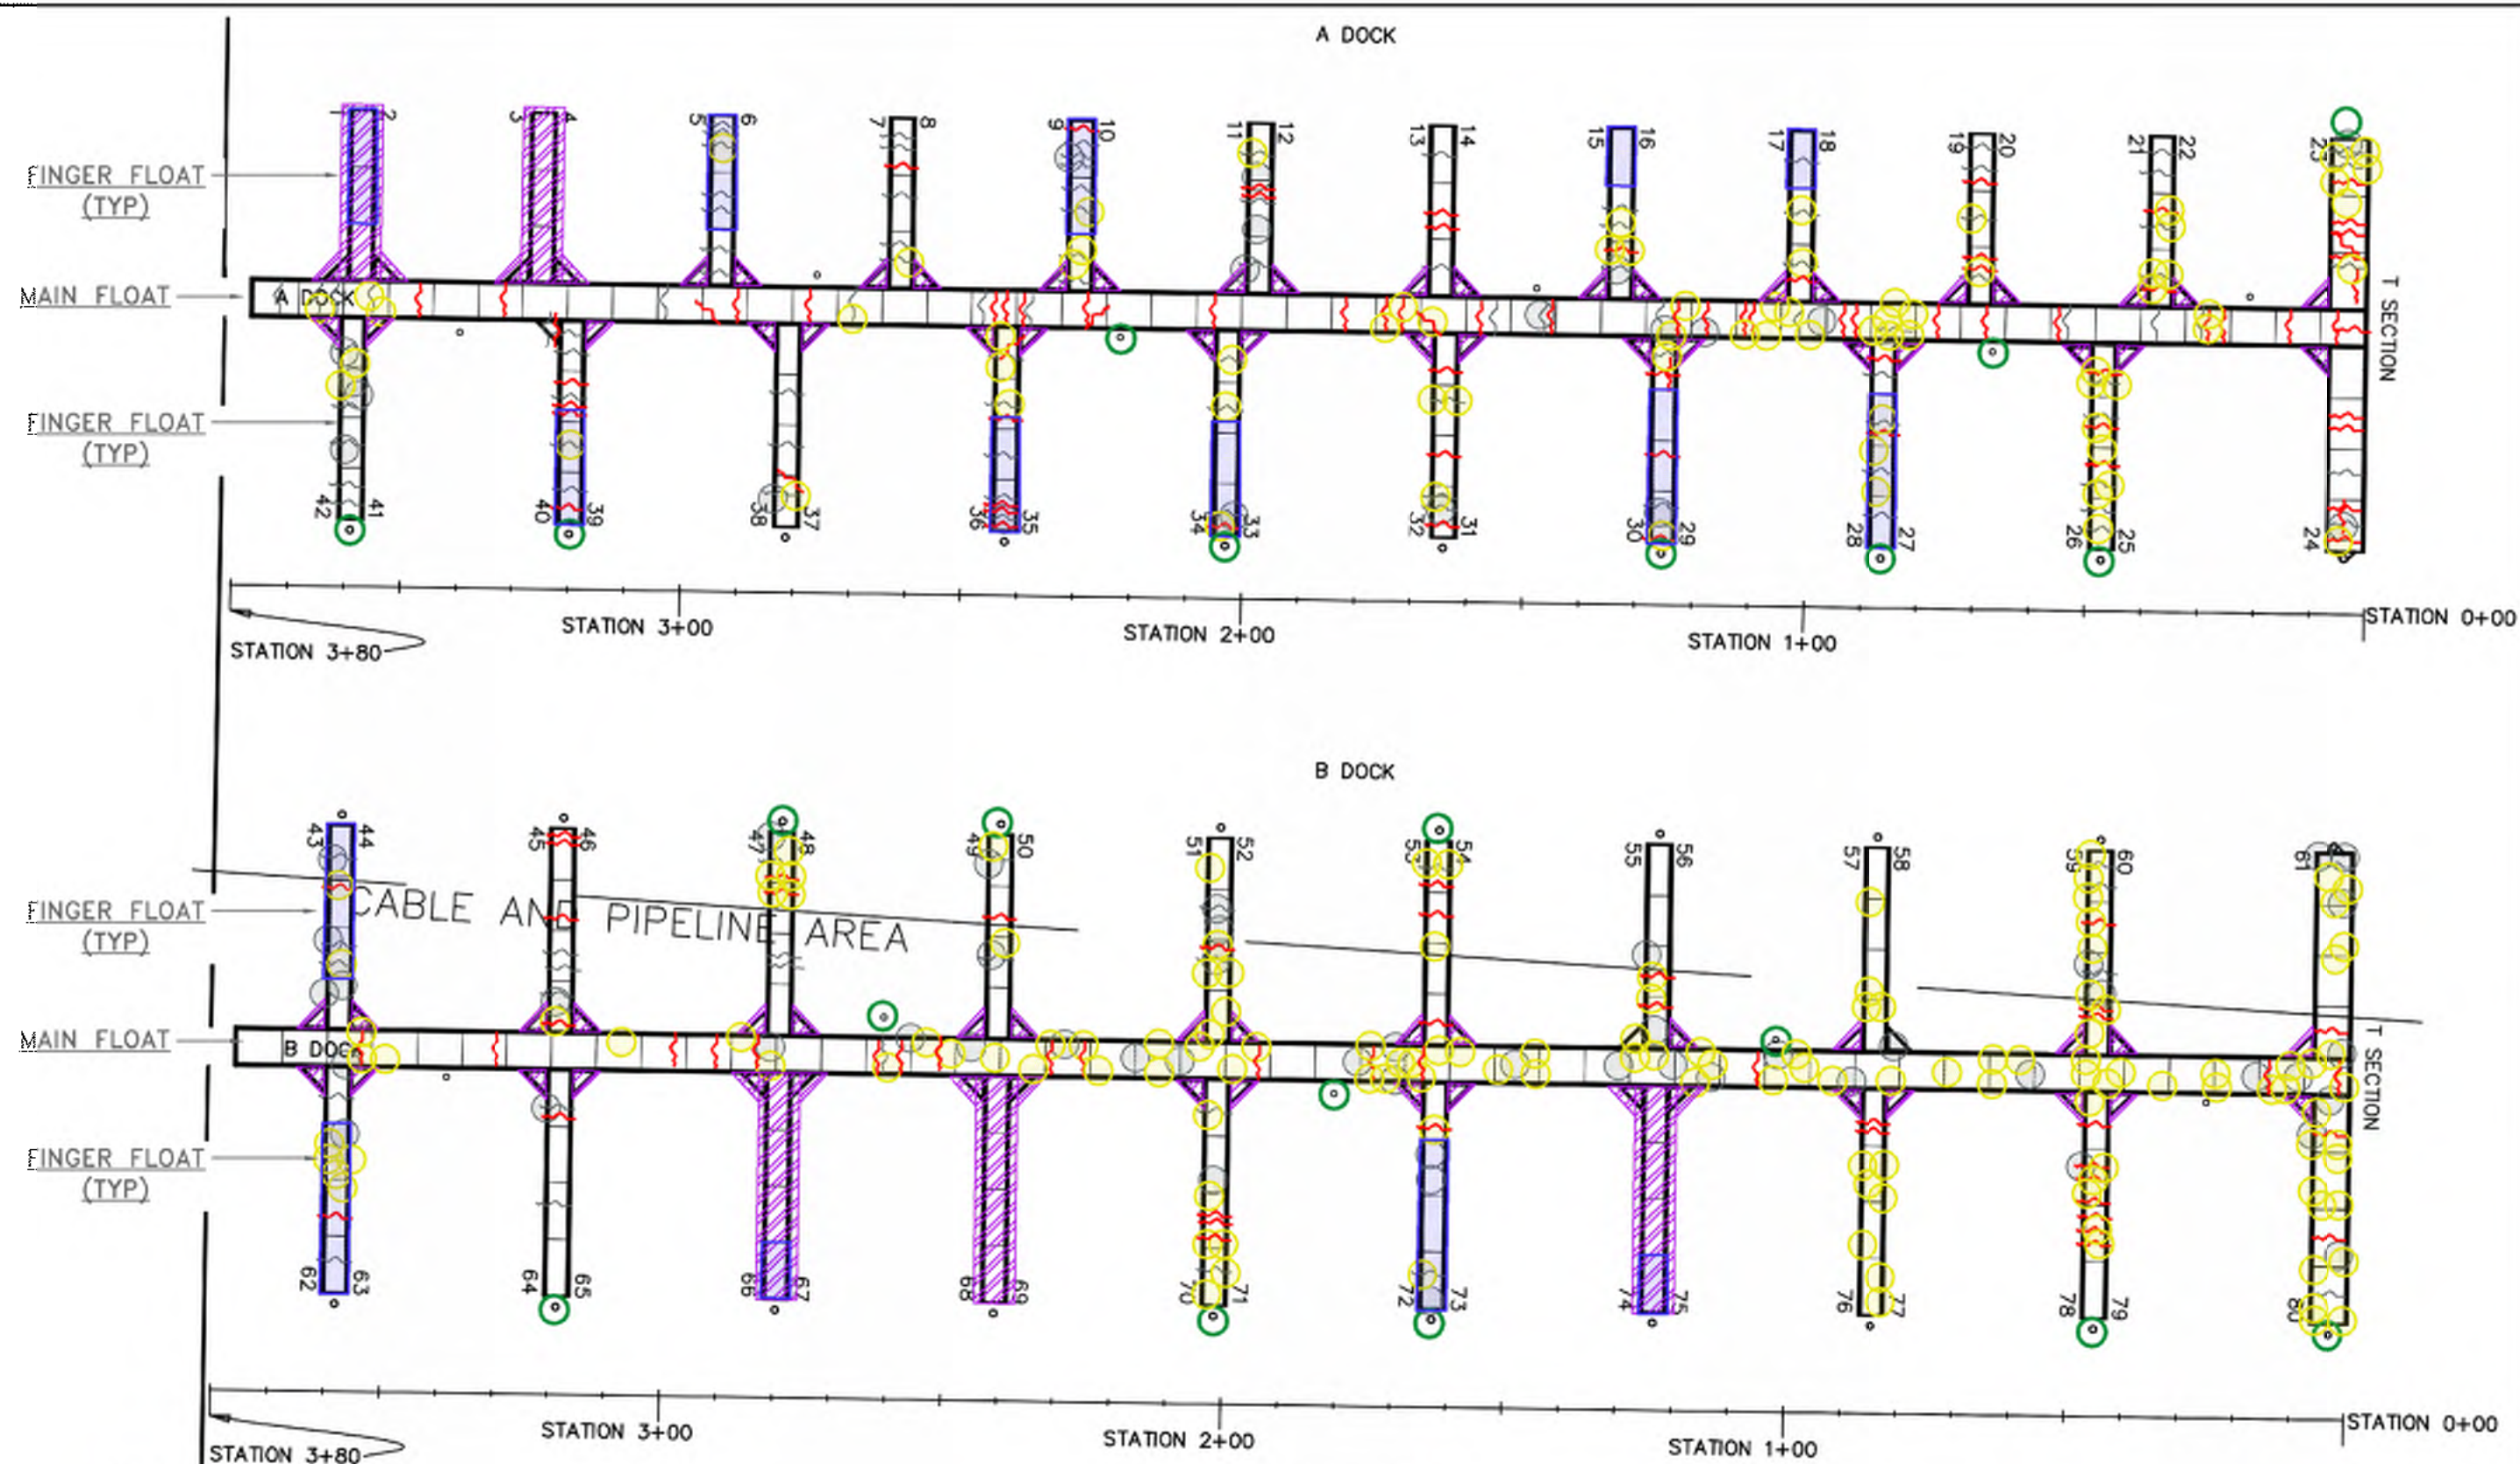
DRAWING NO.:  
**1.0**  
SHEET NO.: 1 OF 4

**EXISTING CONDITIONS PLAN**  
SCALE: 1"=30'

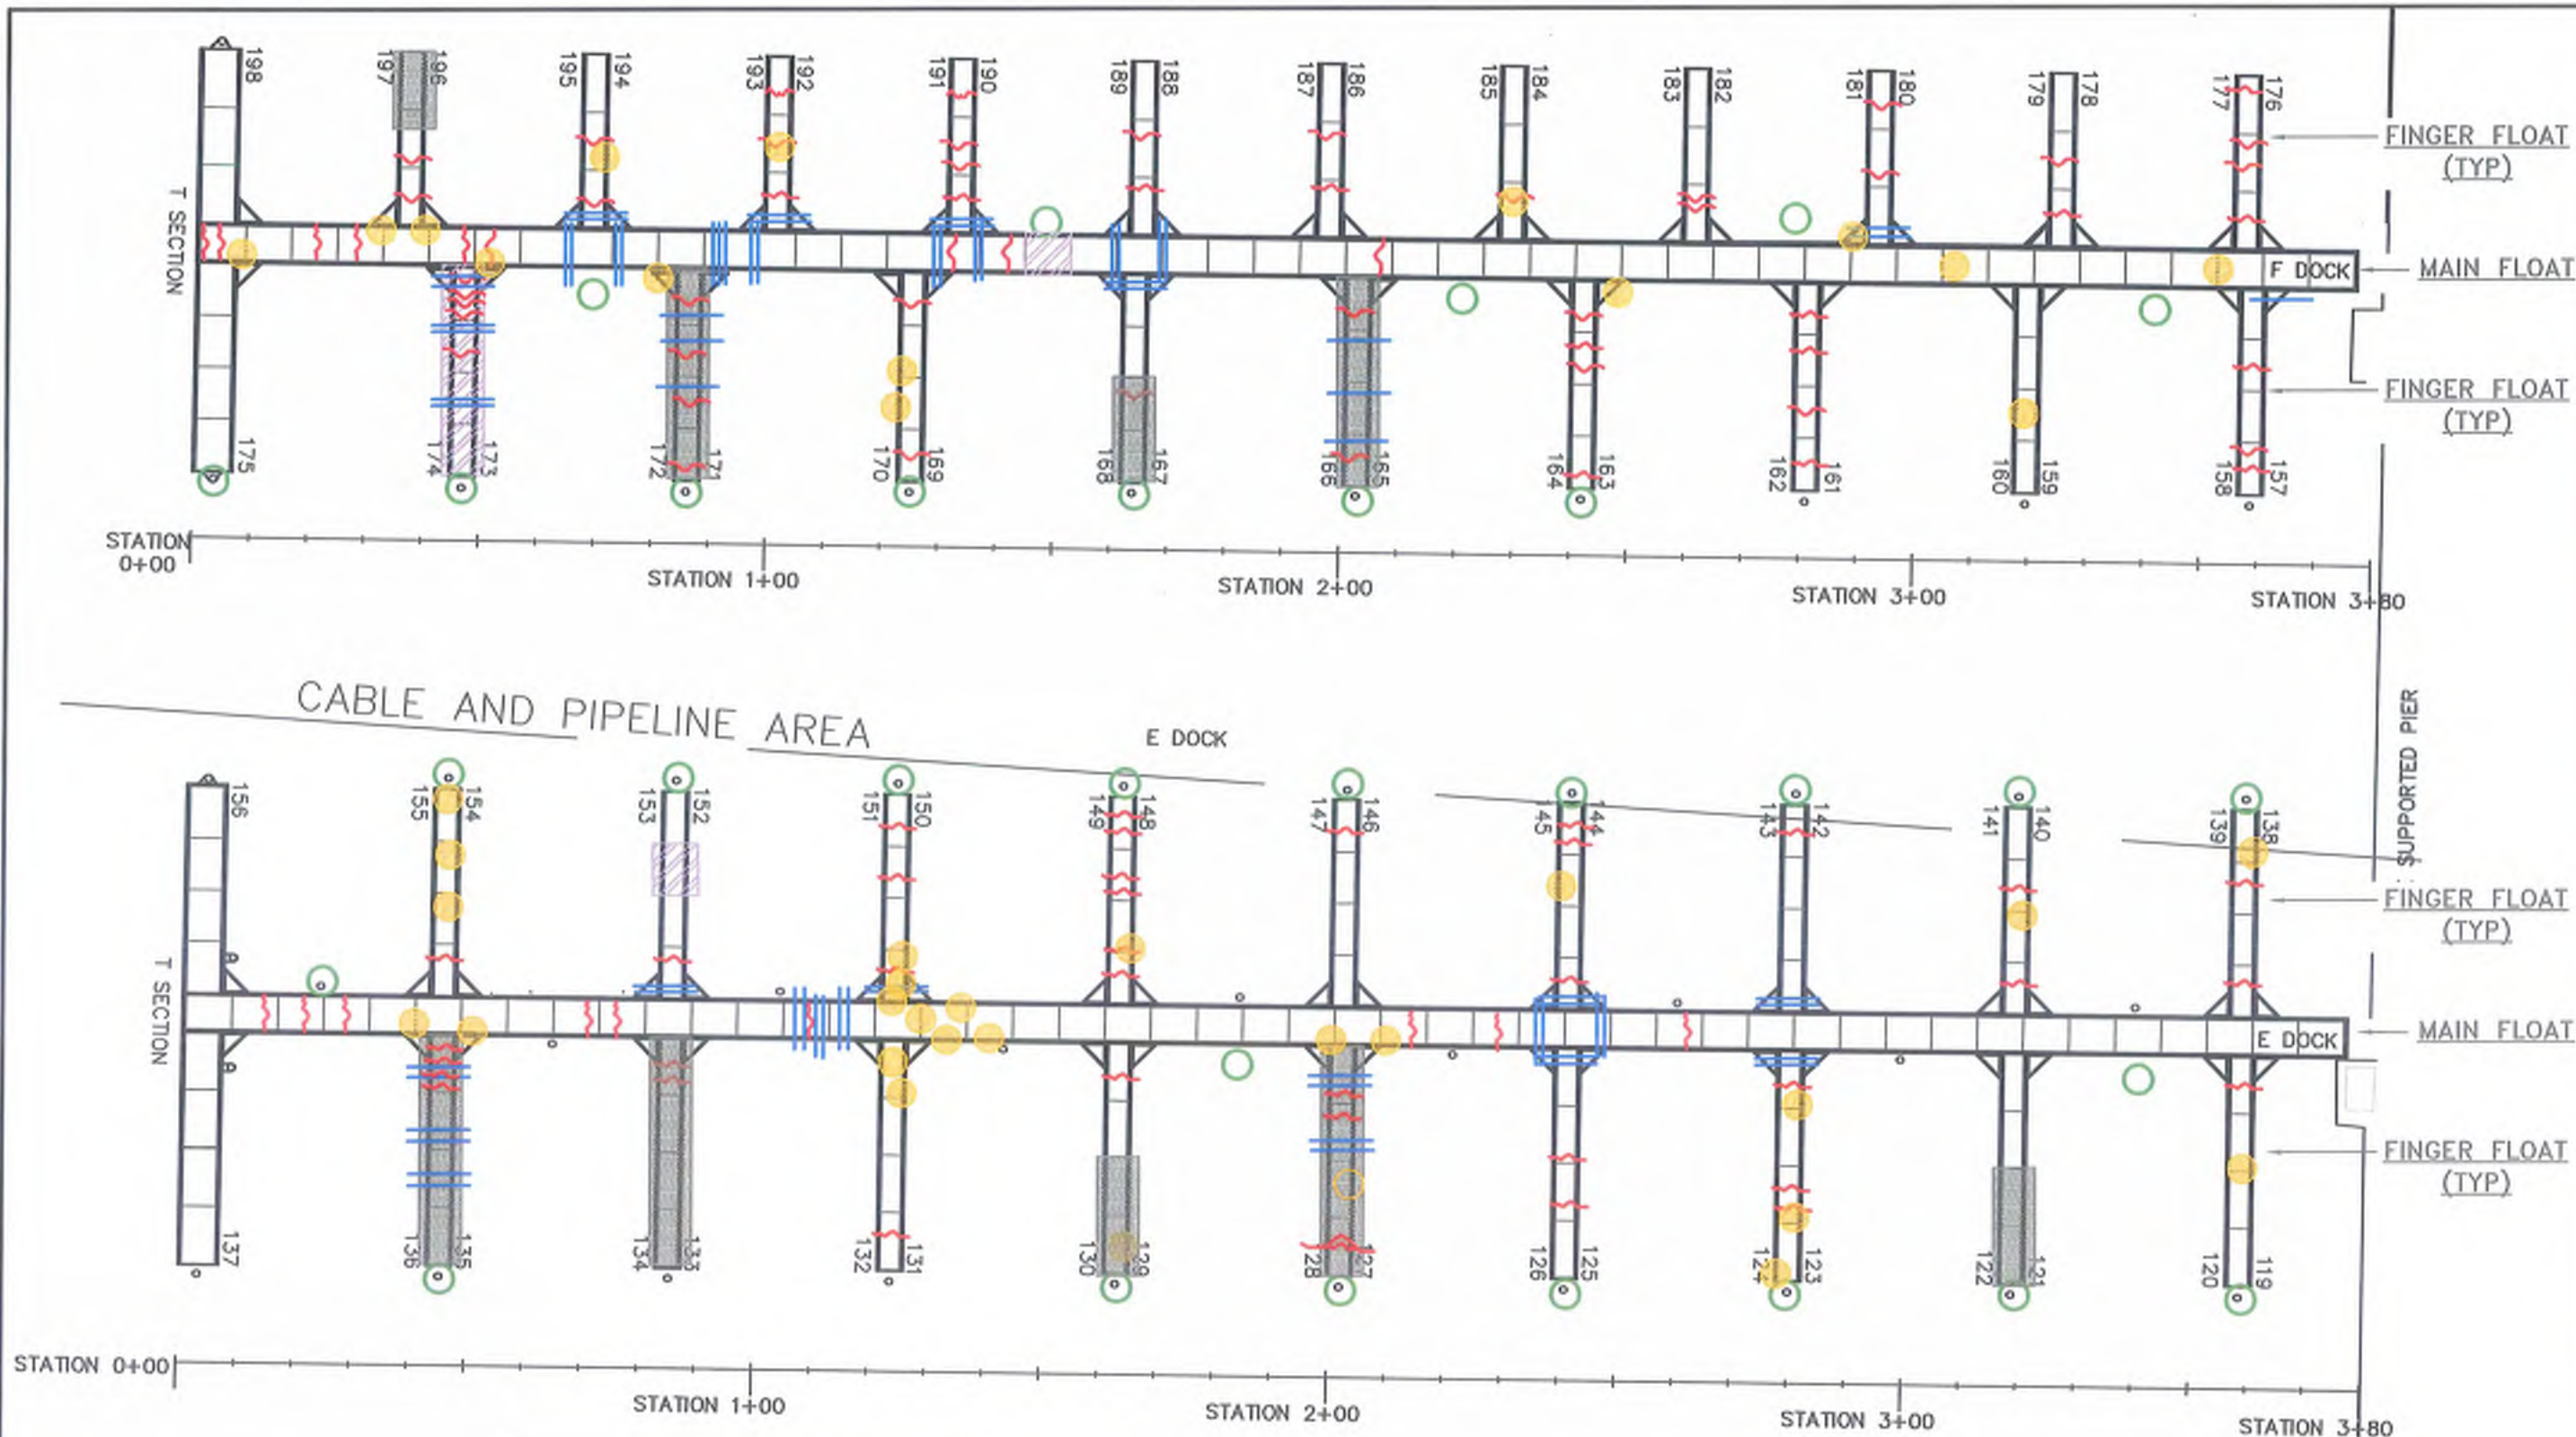
DRAWING NO.:  
**4.0**  
SHEET NO.: 4 OF 4

**E-DOCK & F-DOCK PLAN**

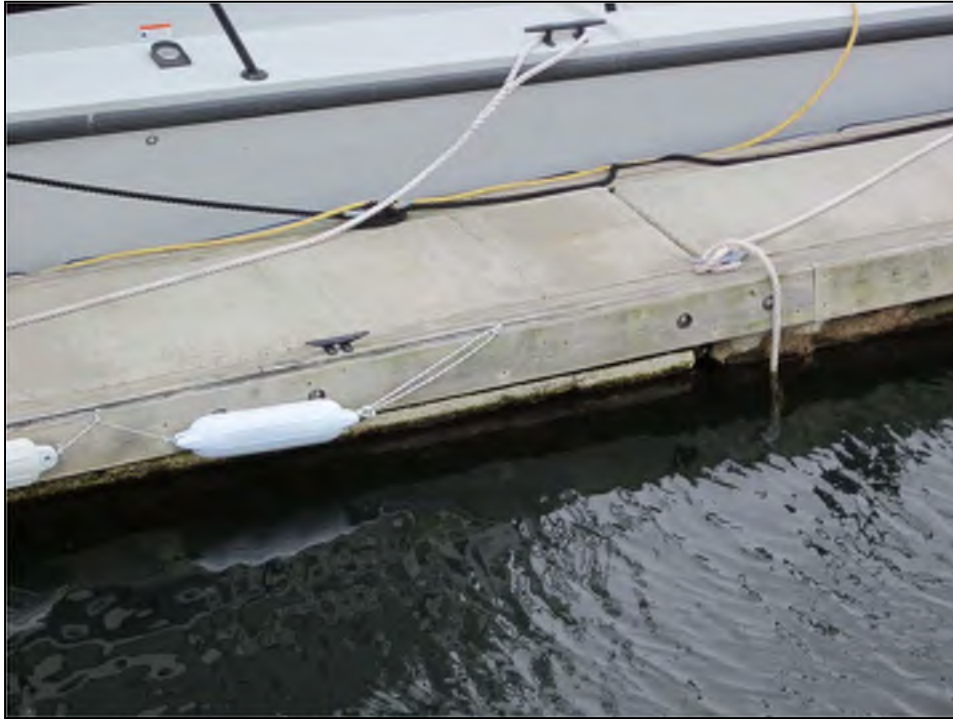
Photo No. 1: Deteriorated concrete encapsulation with exposed polystyrene floatation units.

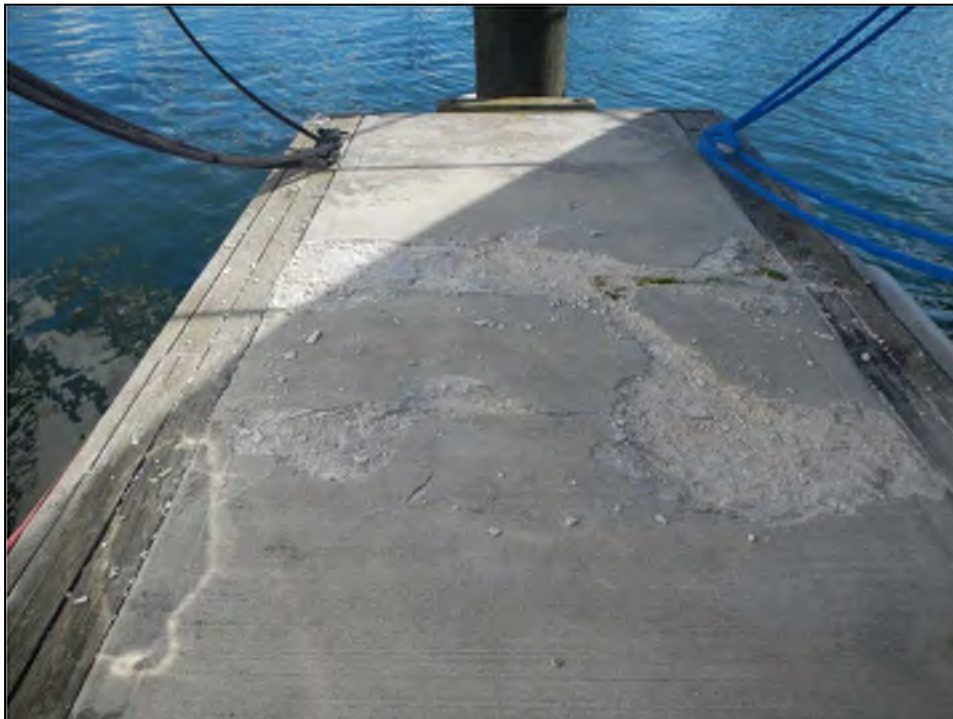
Photo No. 2: Typical spalling, cracking, and deterioration of the fiber reinforced concrete modules.

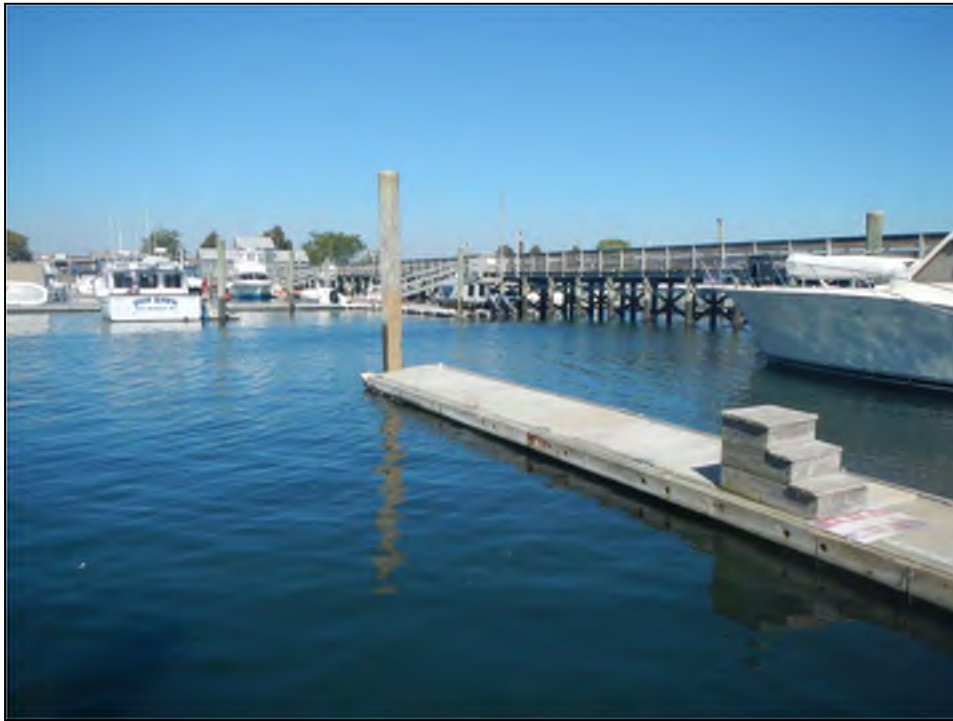
Photo No. 3: View of listed float along D-dock.

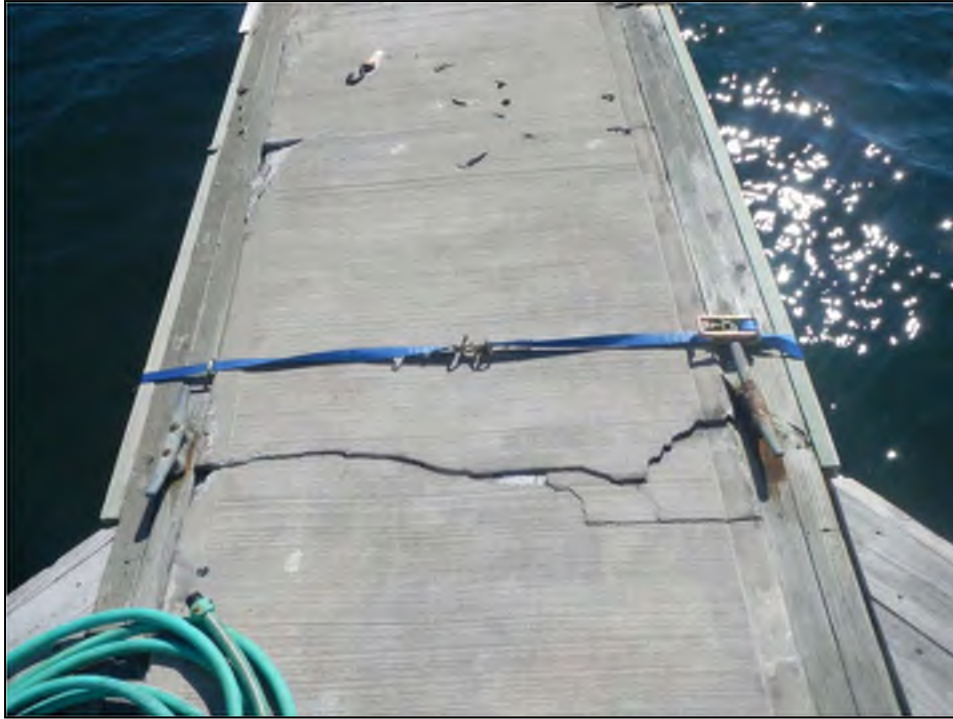
Photo No. 7: Cracking and deterioration of the concrete deck with a trip hazard.

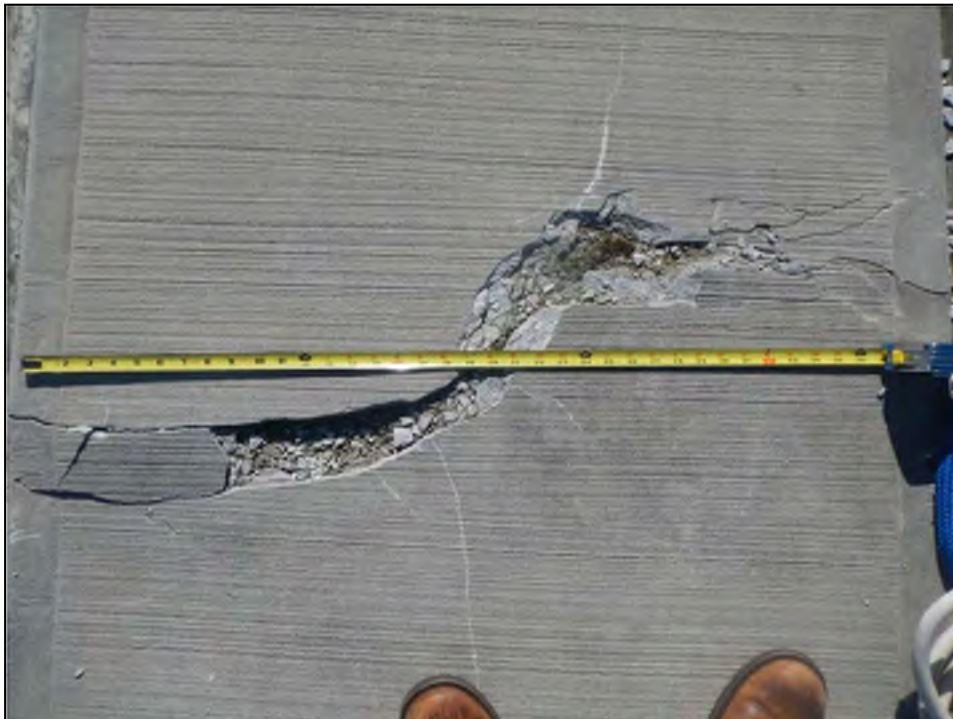
Photo No. 8: Cracking and deterioration of the concrete deck.

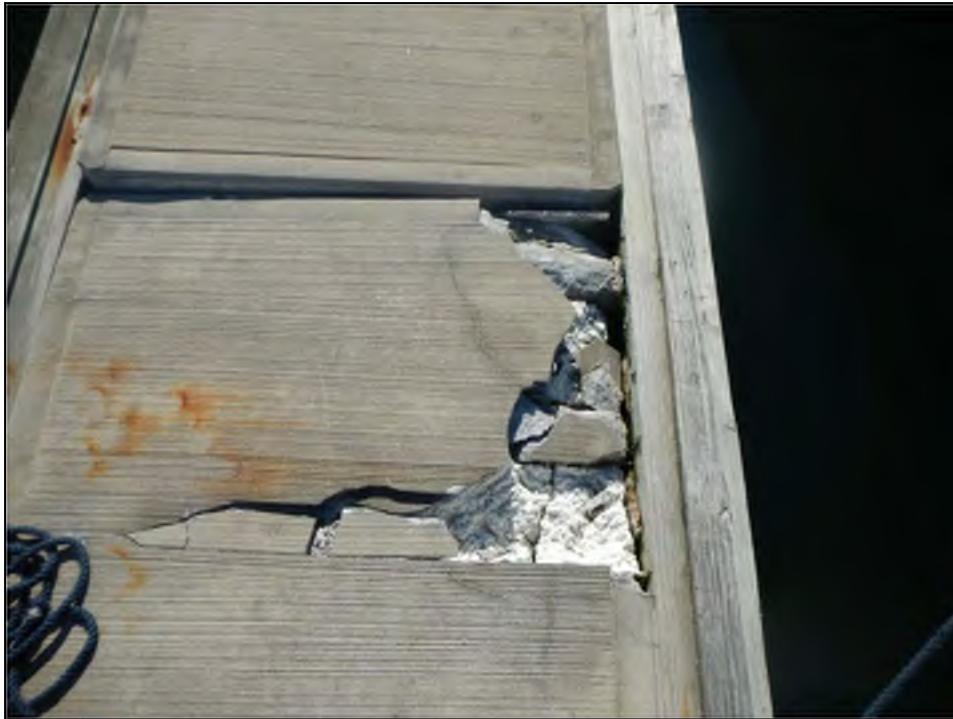
Photo No. 11: Concrete deck deterioration.

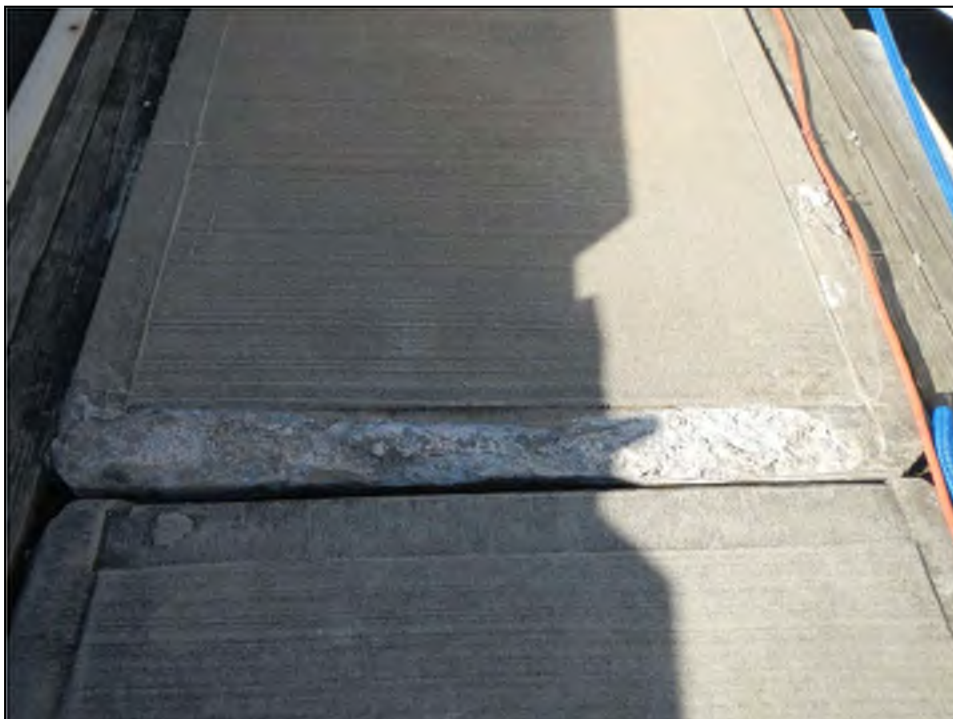
Photo No. 12: Deterioration at the edge of a concrete deck panel with a trip hazard.

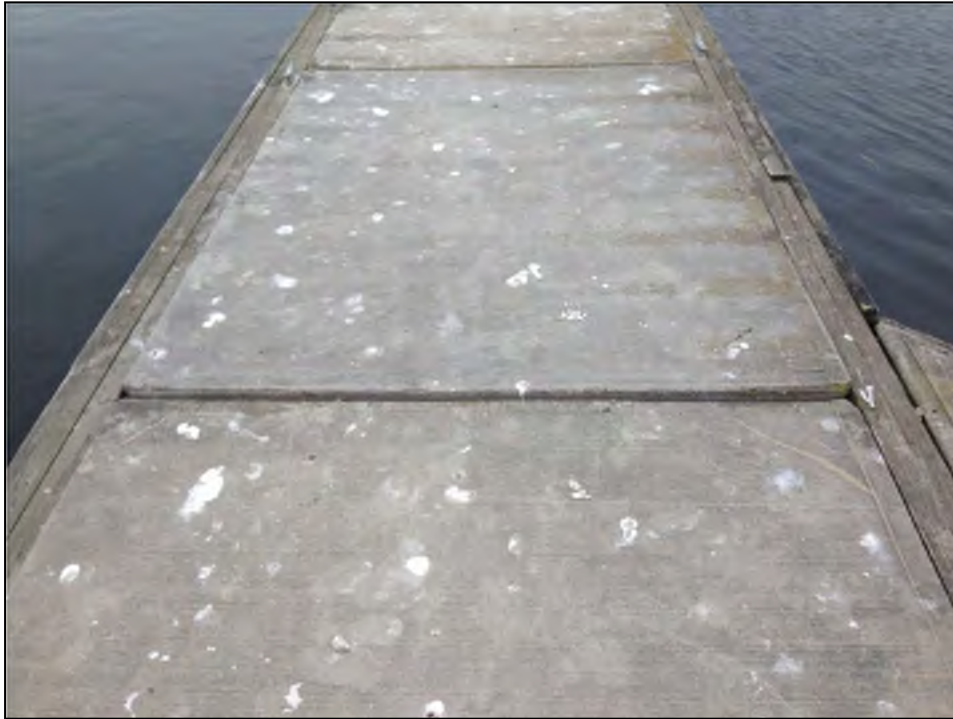
Photo No. 13: Typical trip hazard at the joints between adjacent concrete modules along the main floats.

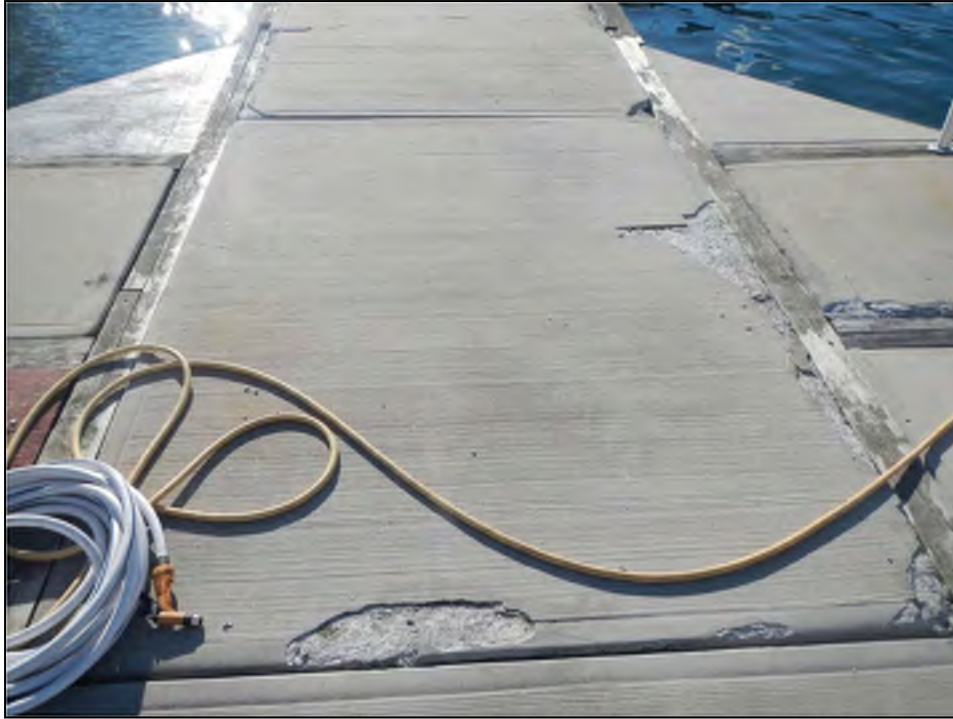
Photo No. 15: Deterioration of the edges of the concrete deck panels creating trip hazards.

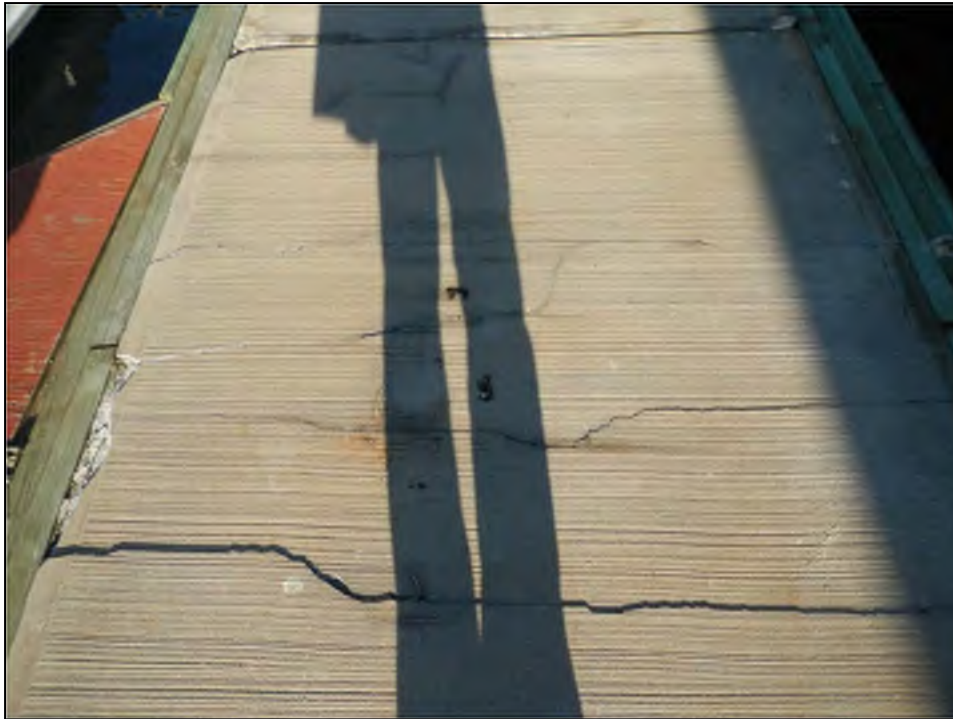
Photo No. 16: Cracking and trip hazards along the concrete deck panels.

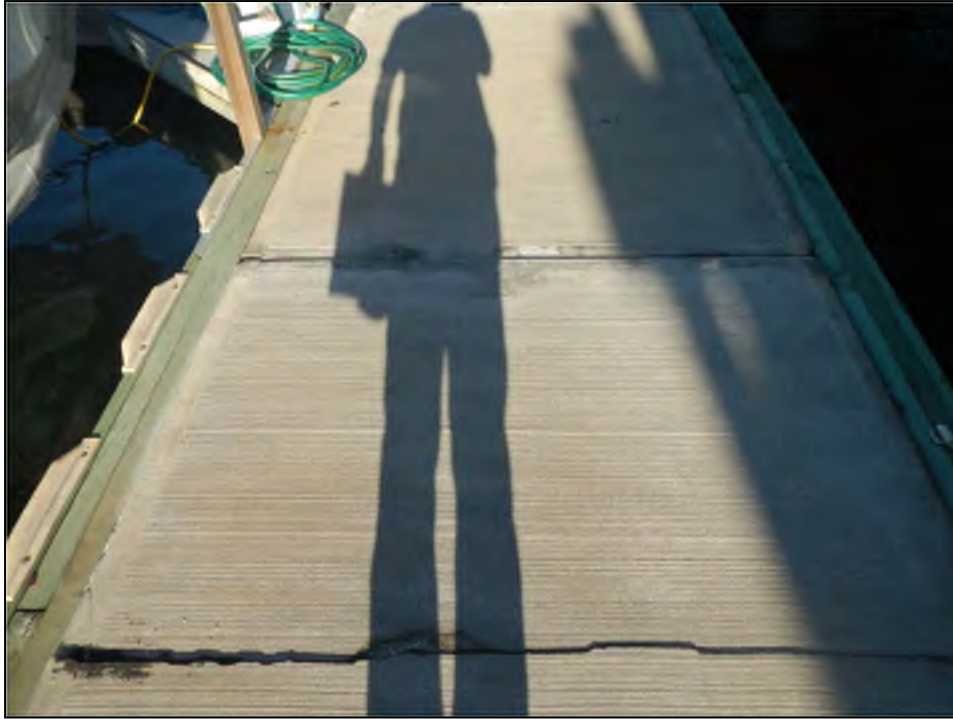
Photo No. 17: Cracking and trip hazards along the concrete deck panels.

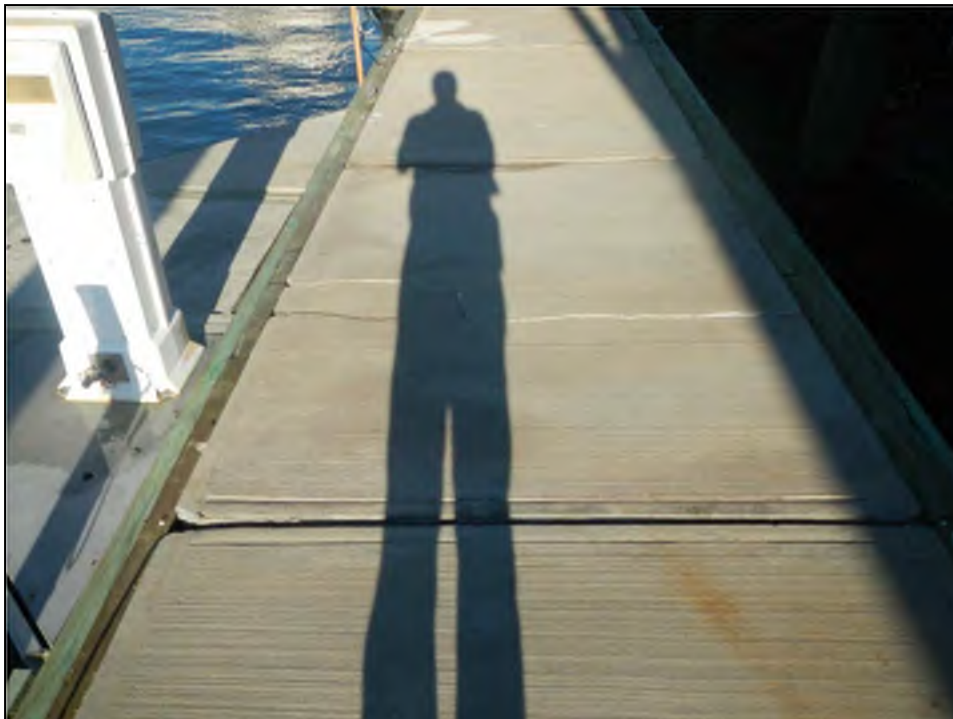
Photo No. 18: Cracking and trip hazards along the concrete deck panels.

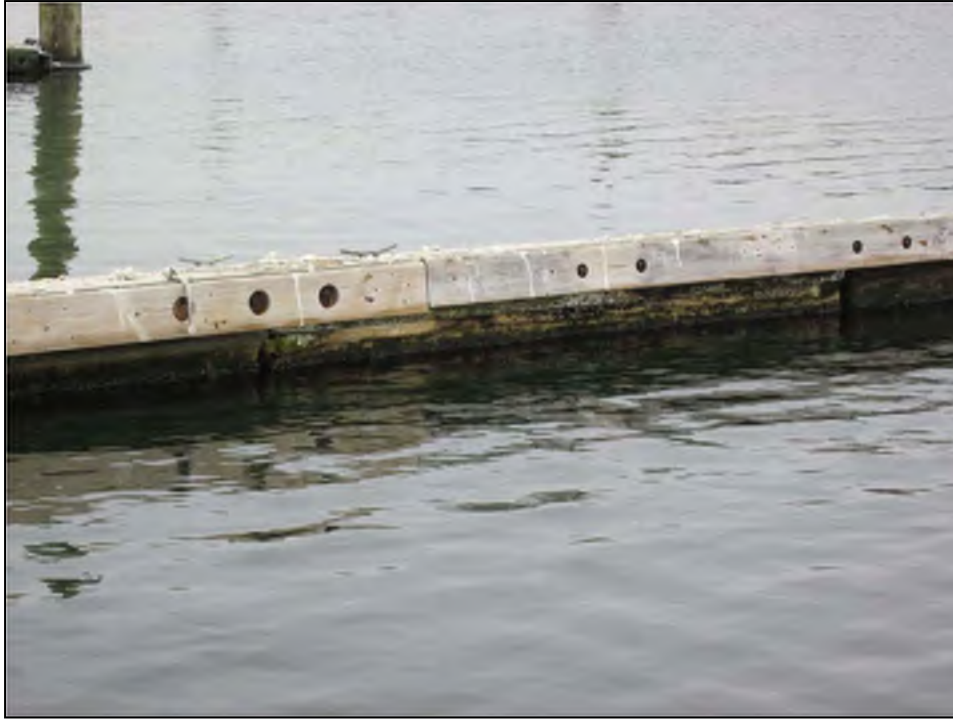
Photo No. 19: Deterioration of the concrete modules with exposed polystyrene at a finger float.

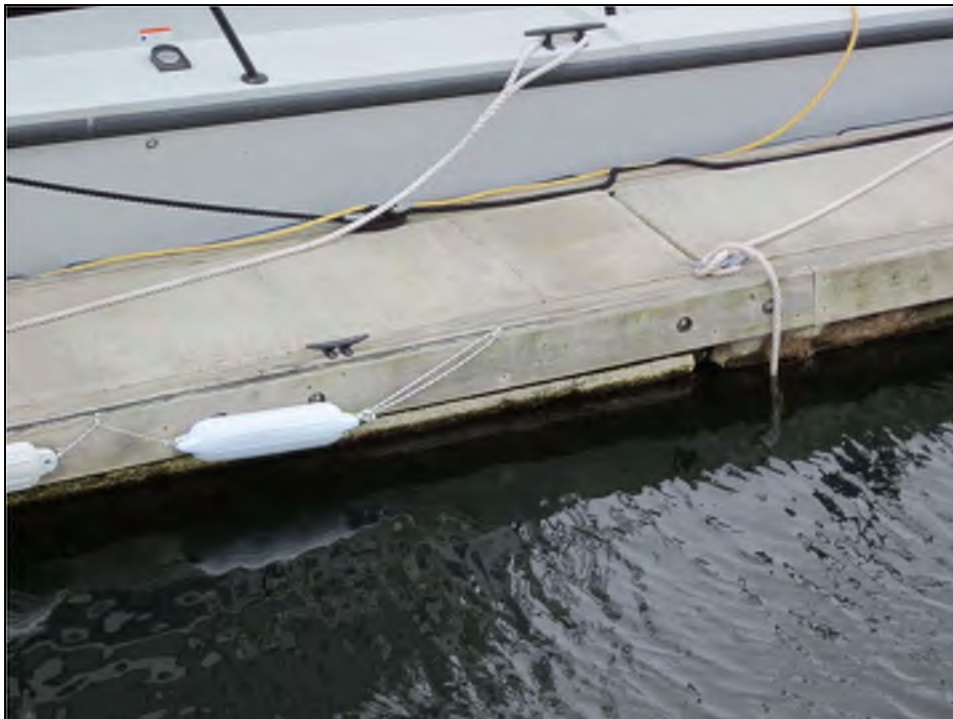
Photo No. 20: Deterioration of the concrete modules with exposed polystyrene at a finger float.

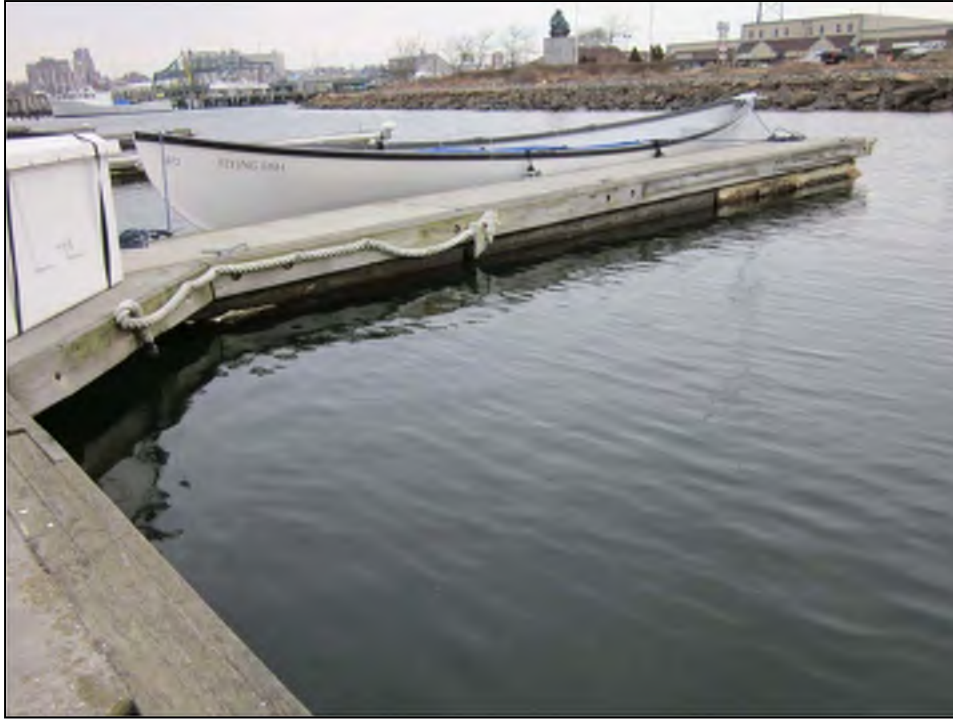
Photo No. 21: Deterioration of the concrete modules with exposed polystyrene at a finger float.

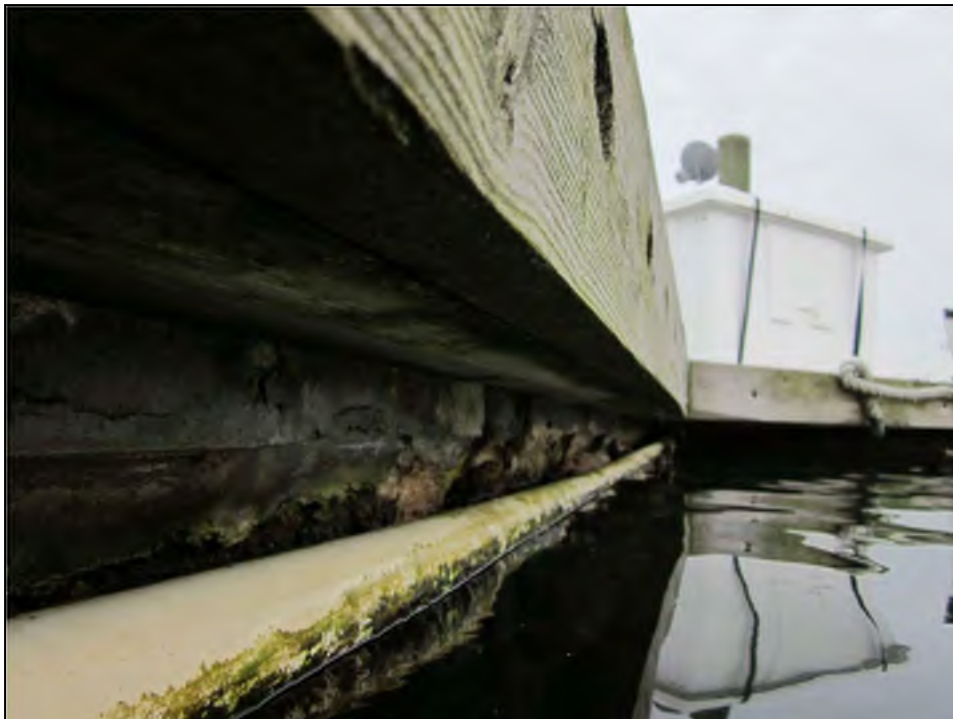
Photo No. 22: Deterioration of the concrete modules near the waterline.

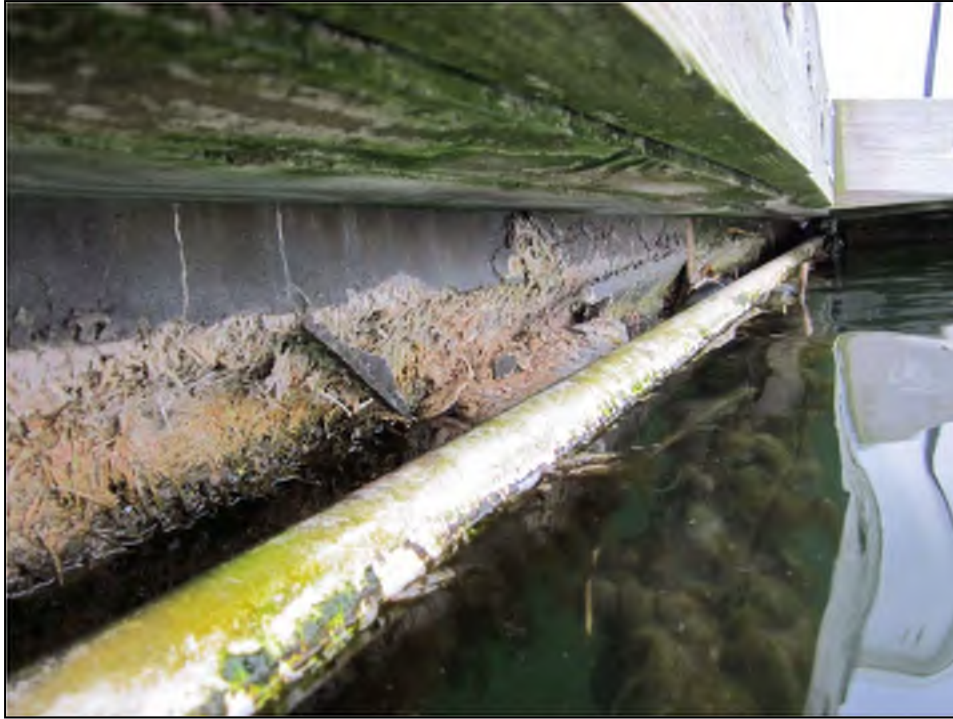
Photo No. 23: Deterioration of the concrete modules near the waterline. Note fiber reinforcement.

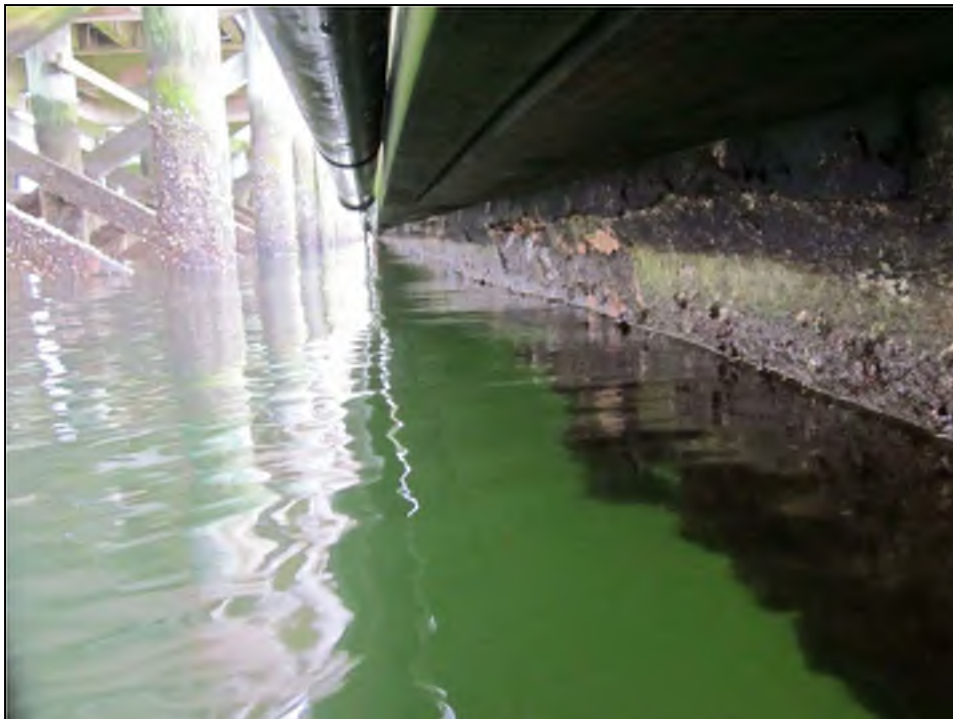
Photo No. 24: Deterioration of the concrete modules near the waterline.

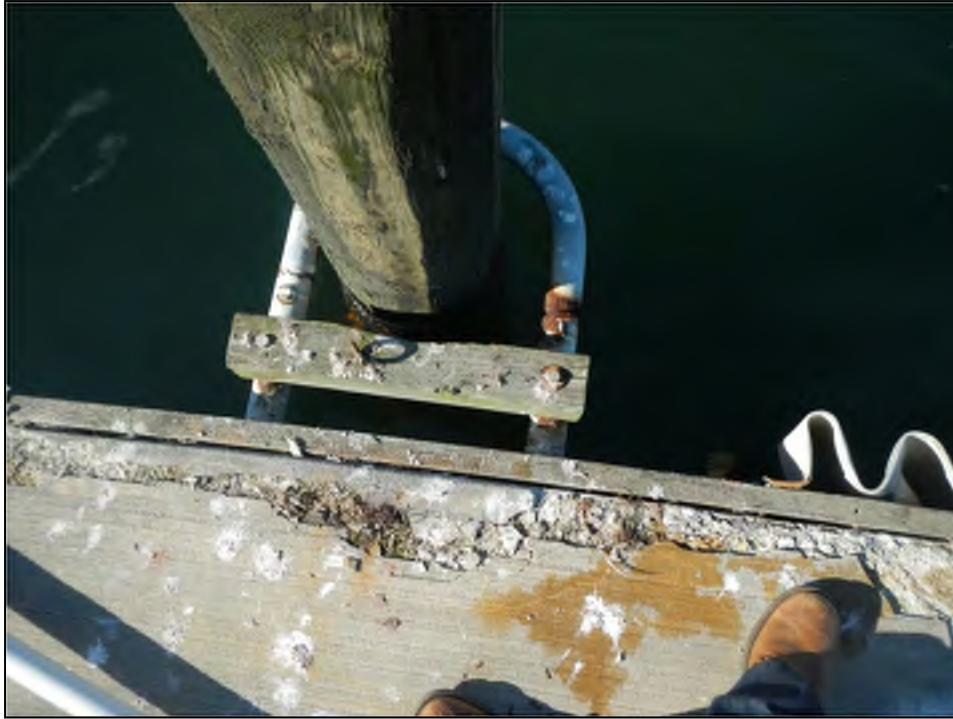
Photo No. 29: Typical existing pile hoop. Note corroded connection hardware.

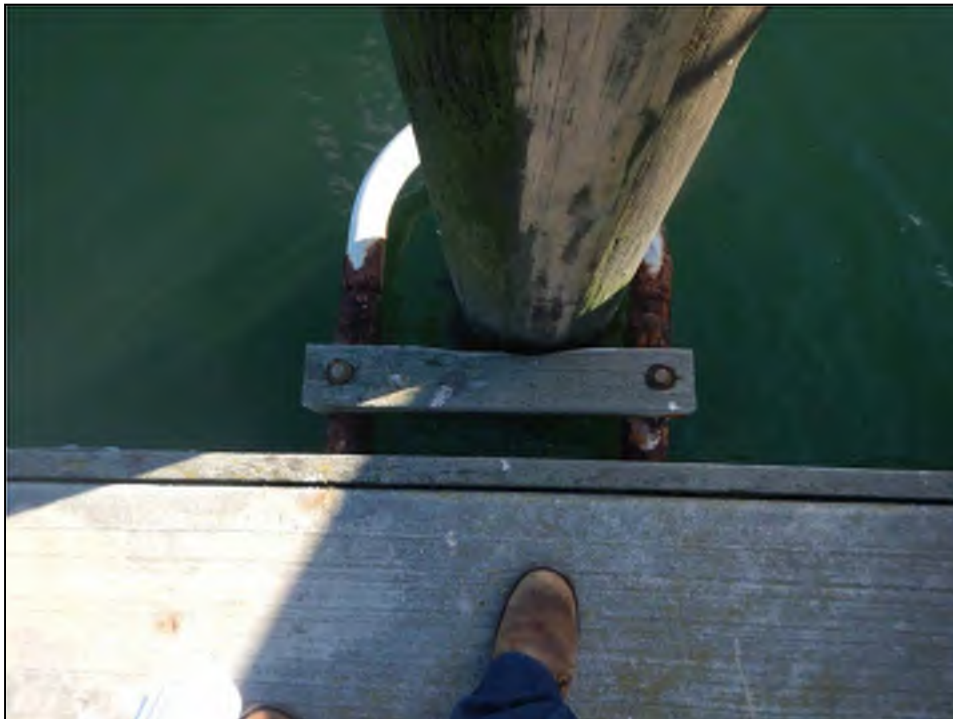
Photo No. 30: Significantly deteriorated steel pile hoop.

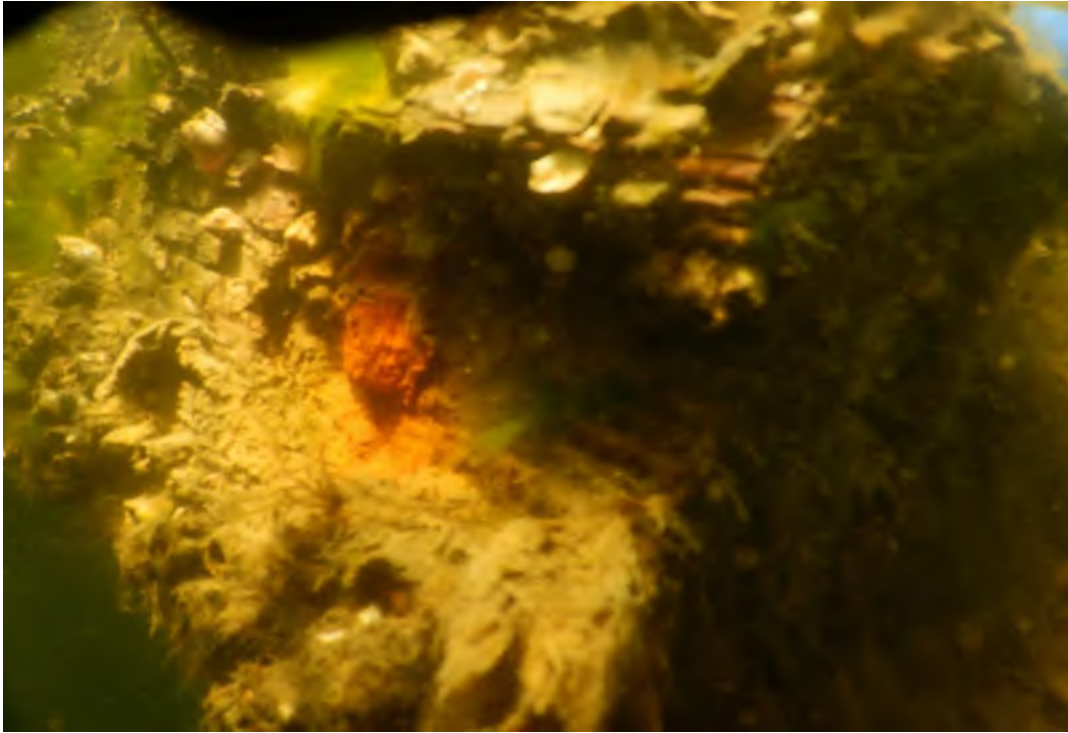
PHOTO #3 Photo of a fractured brace end and deteriorated fastener.
