PREPARED FOR:  
NEW BEDFORD PORT AUTHORITY

**ROUTINE INSPECTION REPORT UPDATE  
PORT OF NEW BEDFORD  
POPE'S ISLAND MARINA**

JULY 2020

**ROUTINE INSPECTION REPORT UPDATE  
POPE'S ISLAND MARINA  
NEW BEDFORD, MASSACHUSETTS**

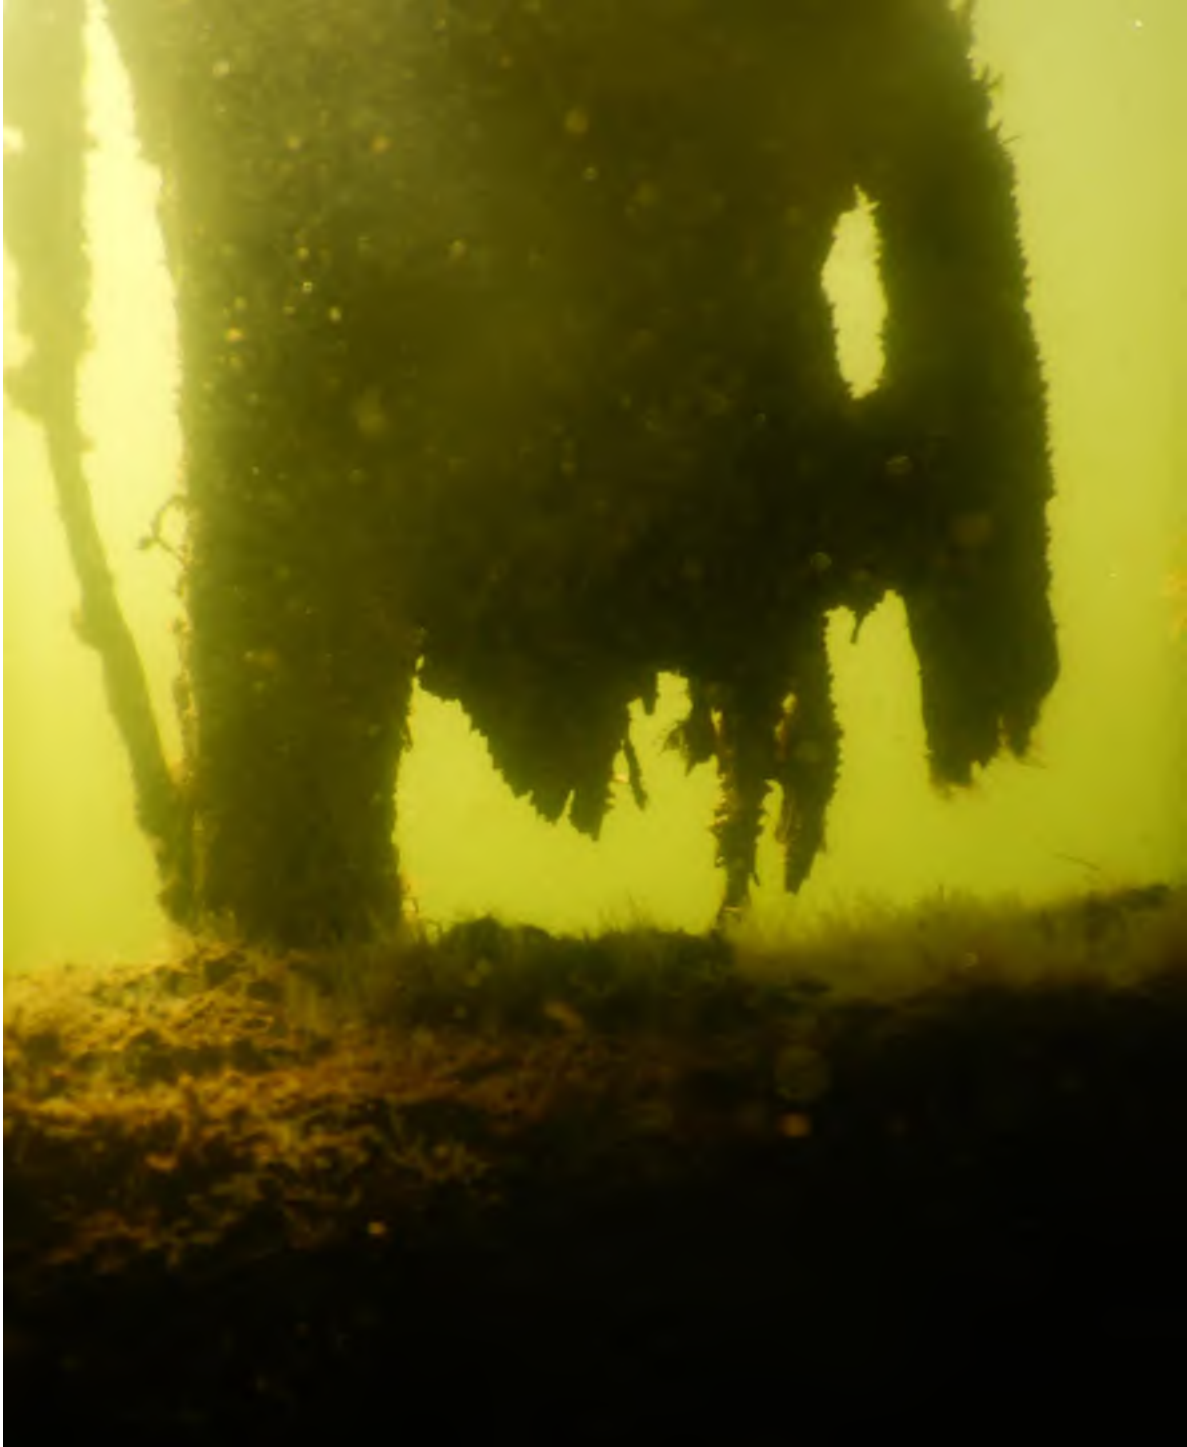
PHOTO #10, showing a wave plank underwater. Many of the planks were in this condition and the whaler-support timber below was rotted and falling down. Low water fasteners holding the planks were poor, fasteners holding the timbers to the piles were poor

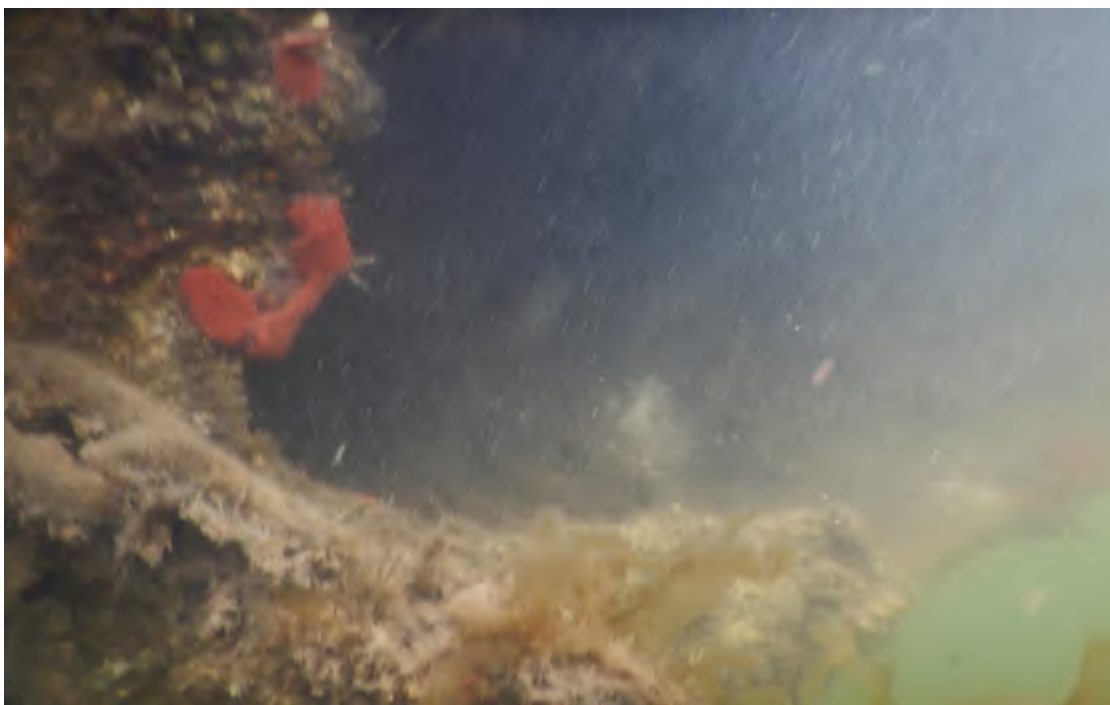
PHOTO #11, showing the deteriorated end of a float with the interior visible, many of the floats in this area were like this.

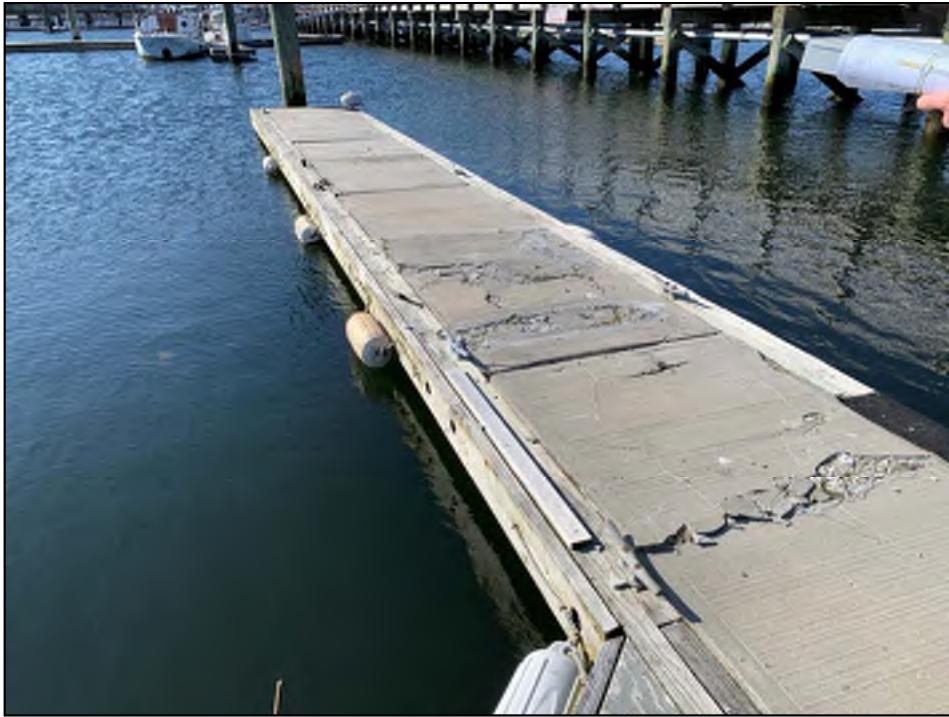
Photo No. 3: Typical spalling, cracking, and deterioration of fiber reinforced concrete modules.

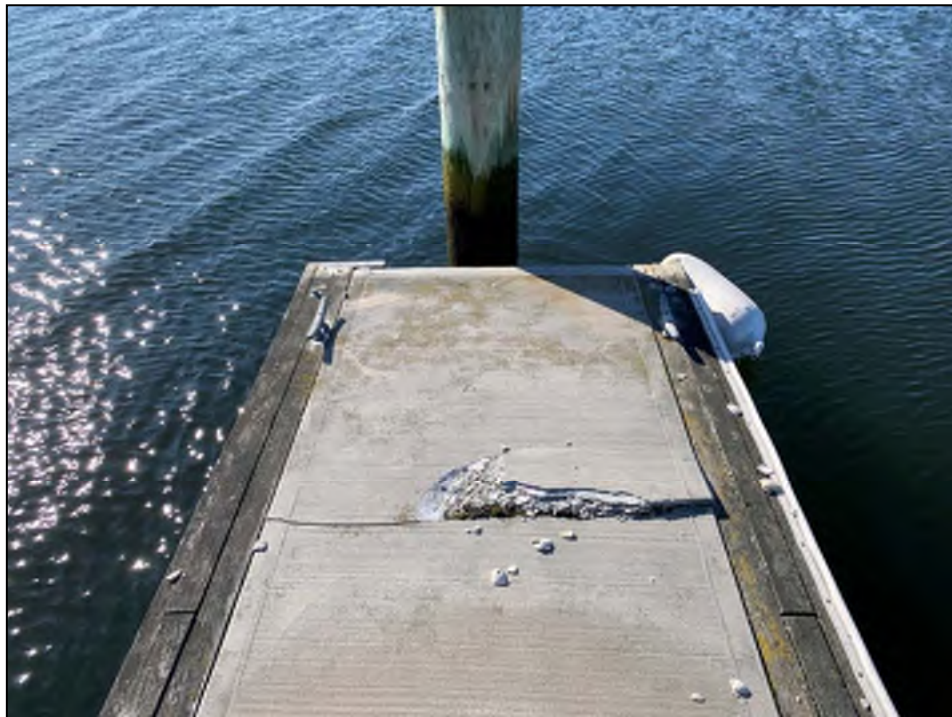
Photo No. 4: Cracking and deterioration of concrete with a trip hazard.

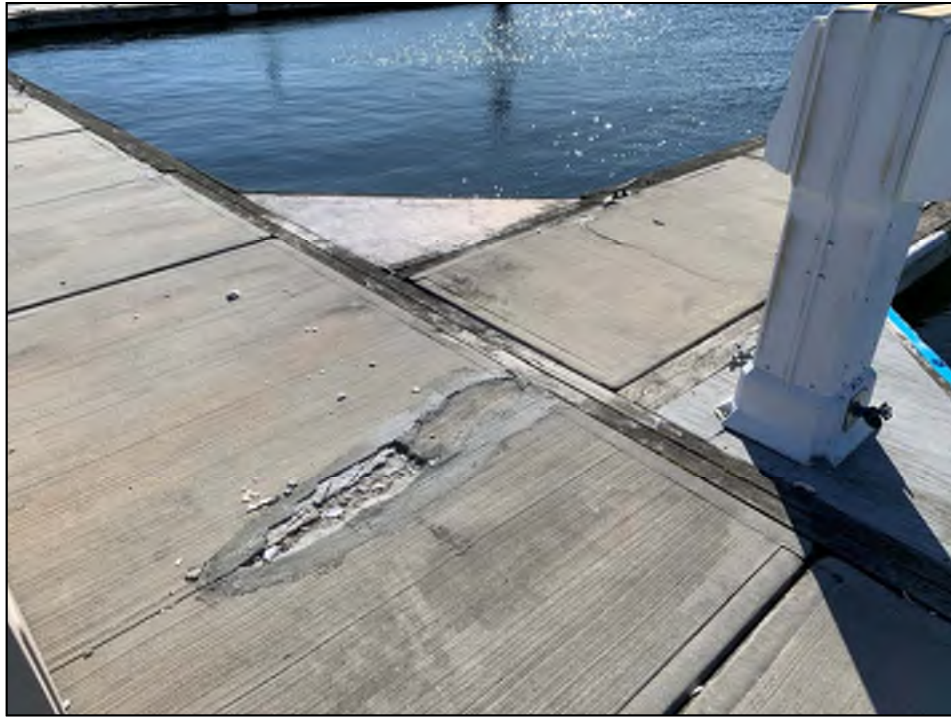
Photo No. 5: Typical deterioration of previously repaired spill

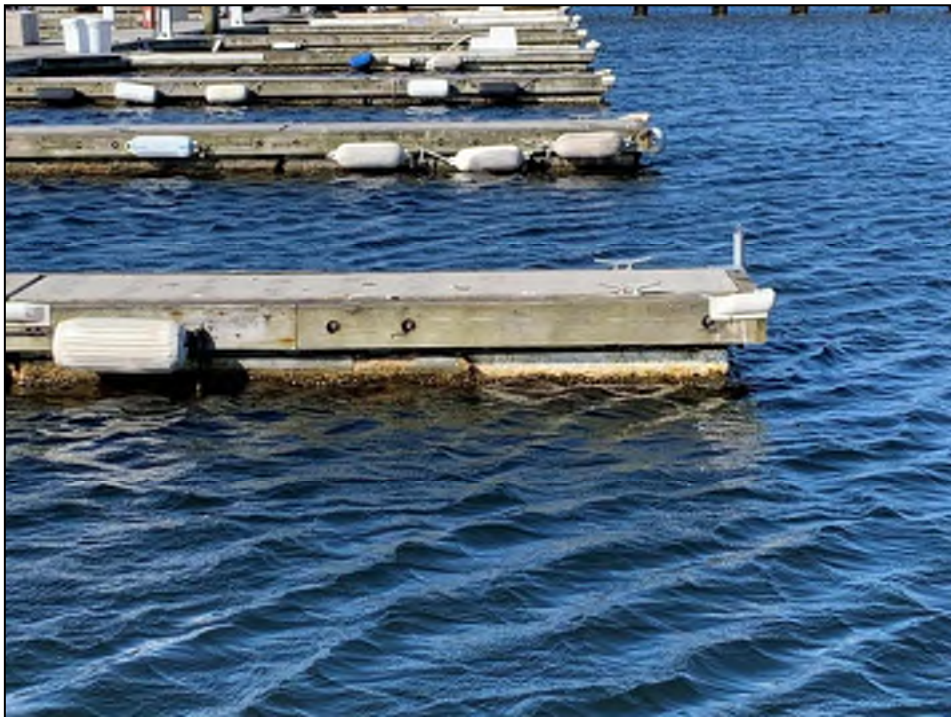
Photo No. 6: Deteriorated concrete encapsulation with exposed polystyrene flotation units.

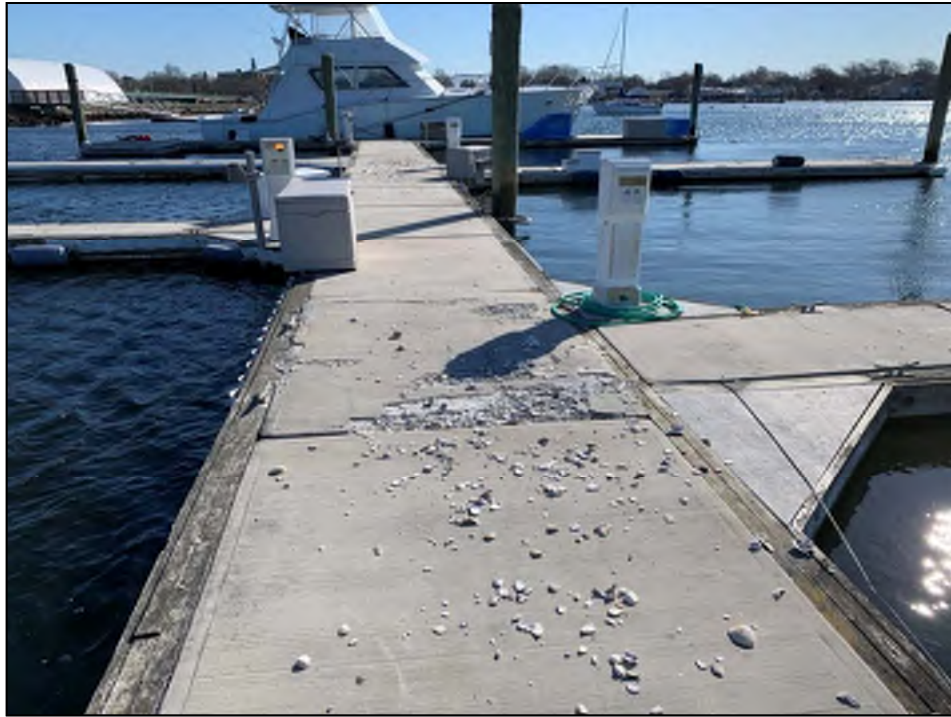
Photo No. 7: Cracking and deterioration of concrete deck with trip hazard.

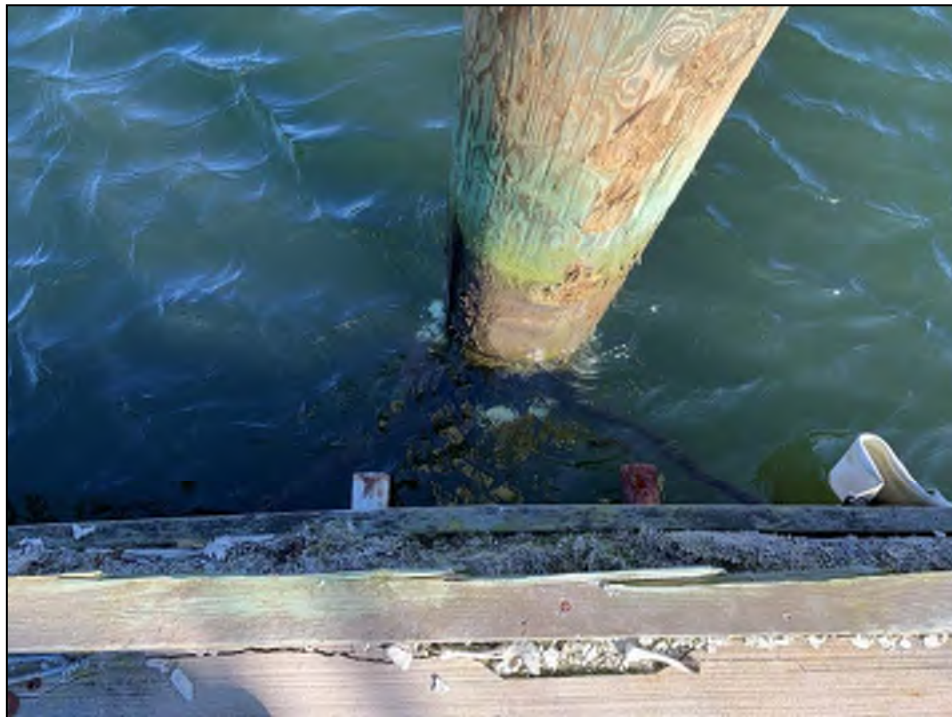
Photo No. 8: Deterioration at end of concrete module with exposed polystyrene flotation unit. Note absence of pile guide and replacement with rope.

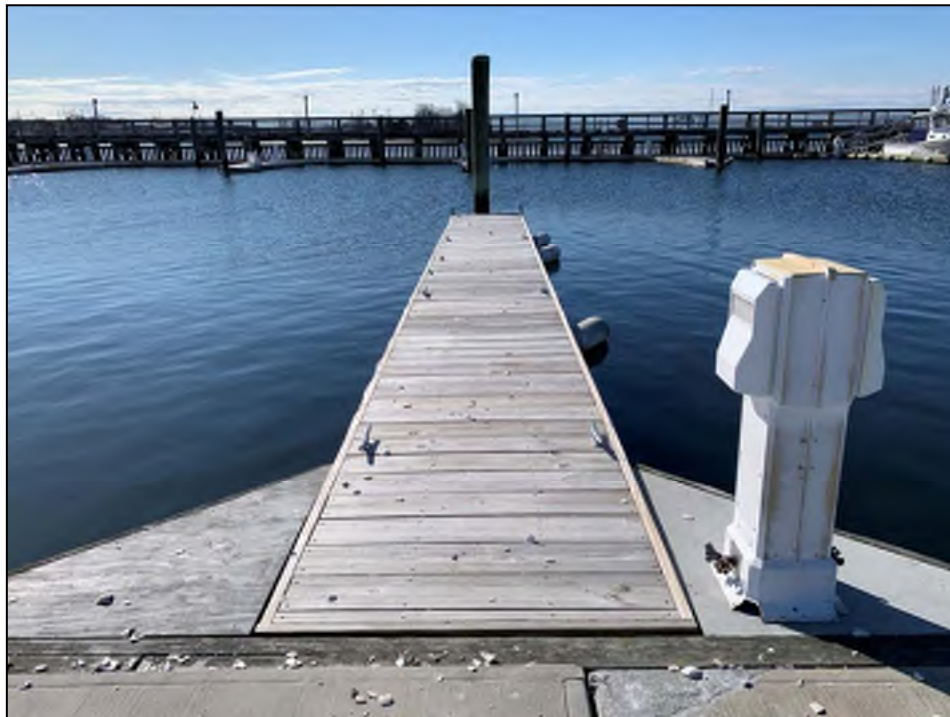
Photo No. 10: Replacement timber finger float.

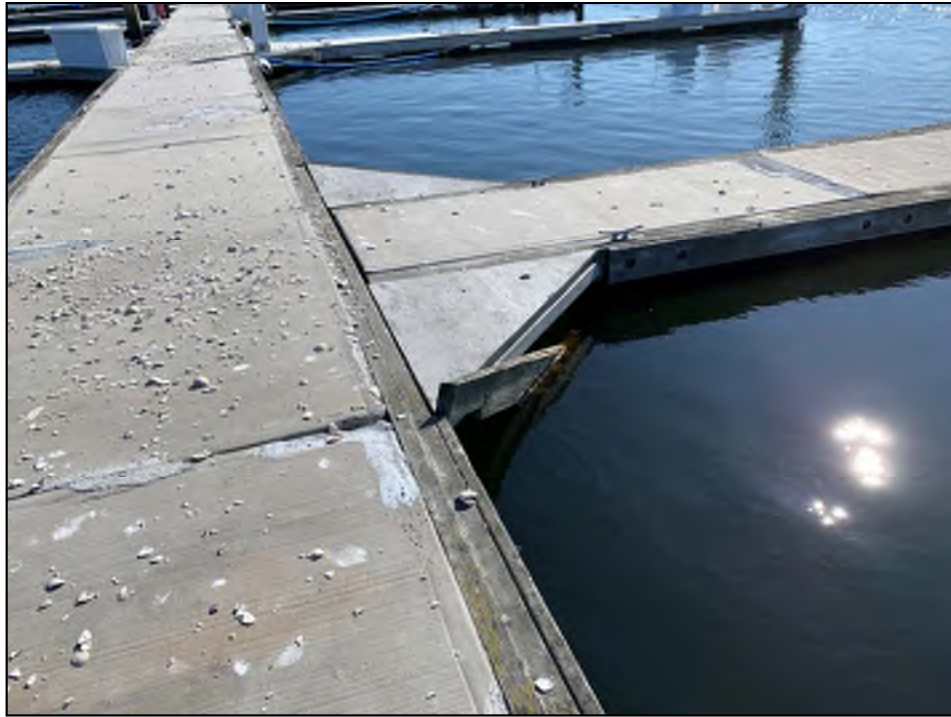
Photo No. 11: Displaced timber skirt board at Dock B.

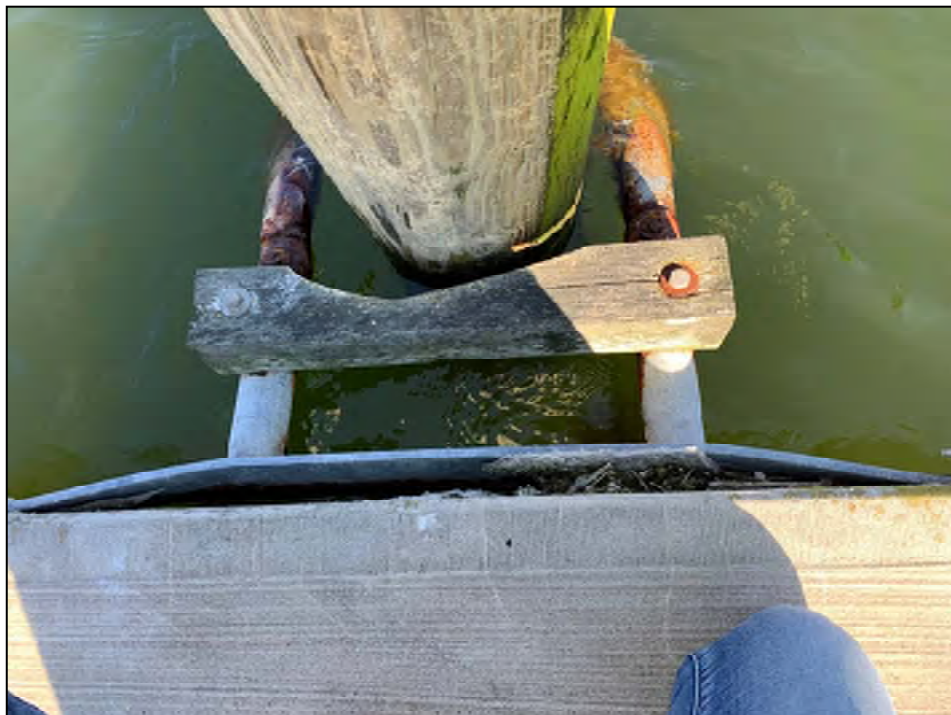
Photo No. 12: Deterioration at end of concrete module with exposed polystyrene flotation unit. Note displacement of pile guide hardware.

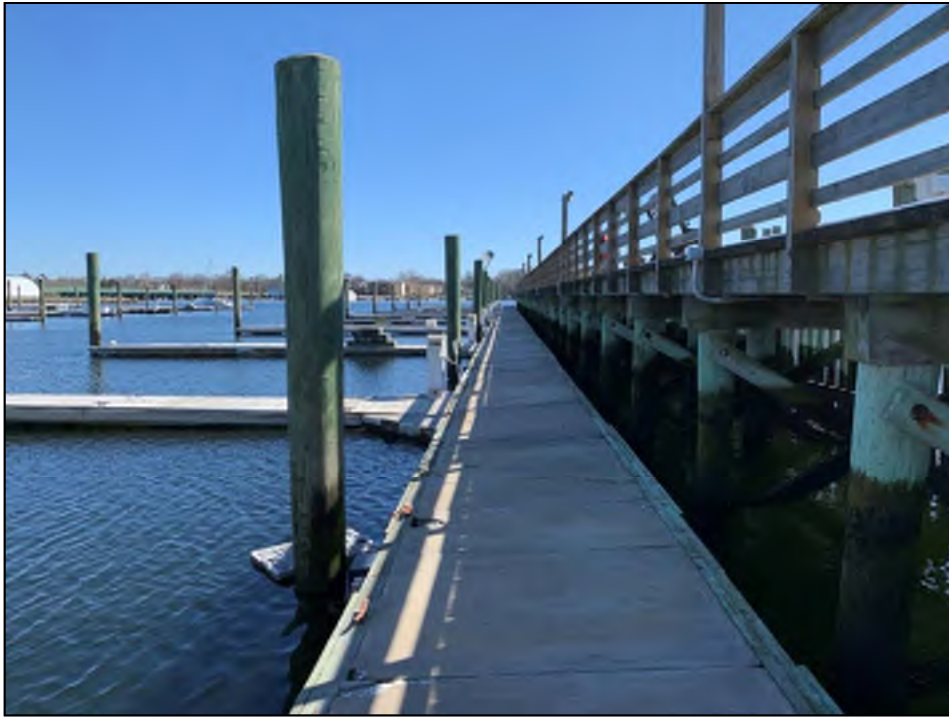
Photo No. 13: Listing of float units along majority of main floats at Dock B.

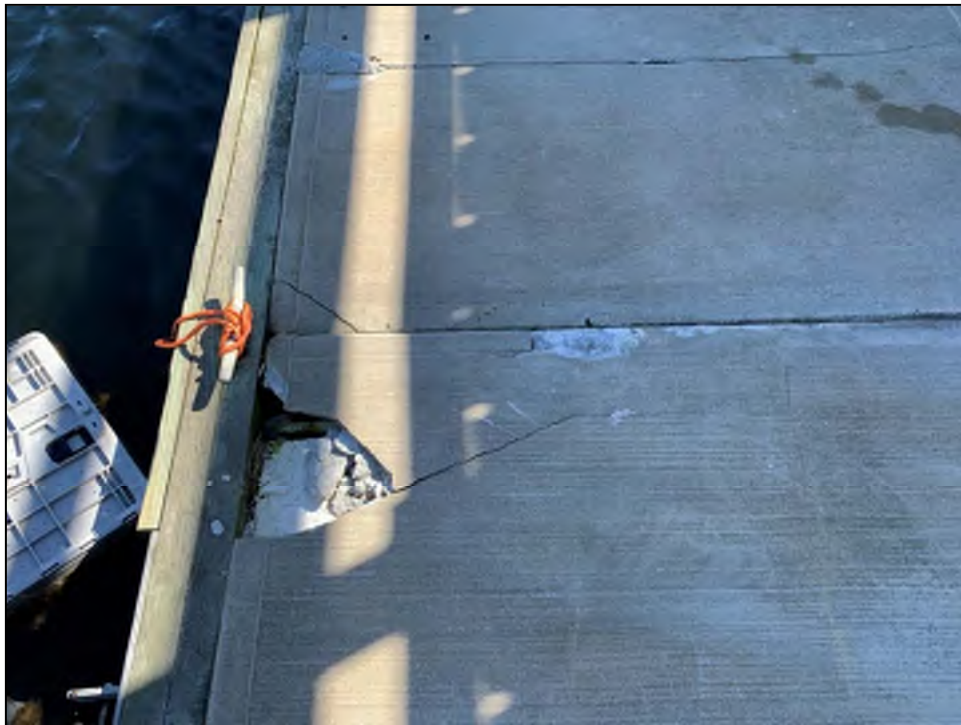
Photo No. 14: Deterioration of concrete with exposed polystyrene float unit.  
Note cracking at previously repaired spall.

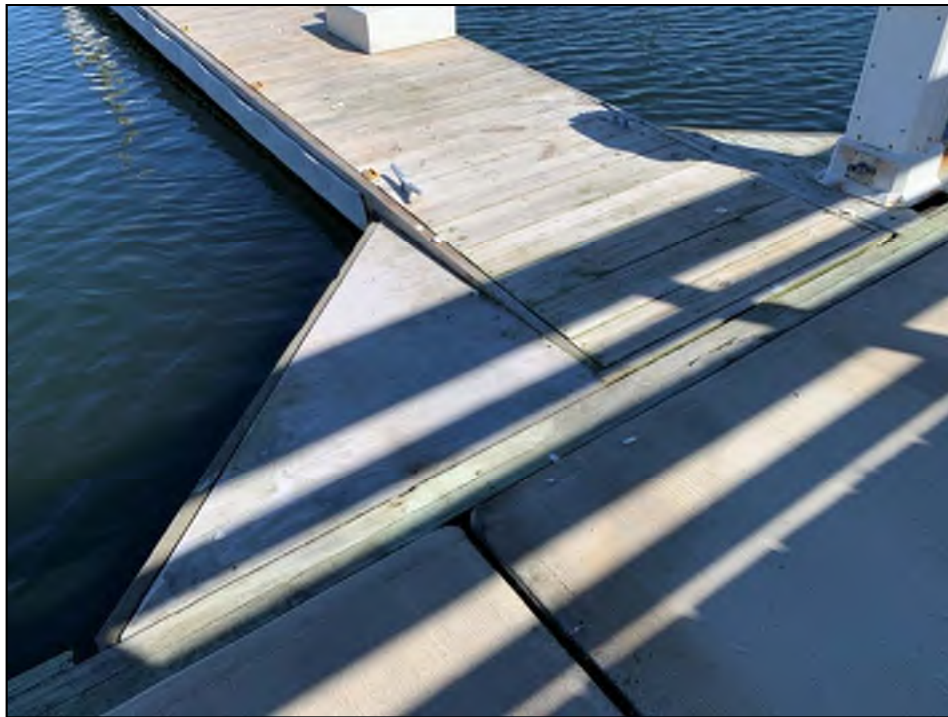
Photo No. 15: Typical uneven timber triangle for finger float connection.

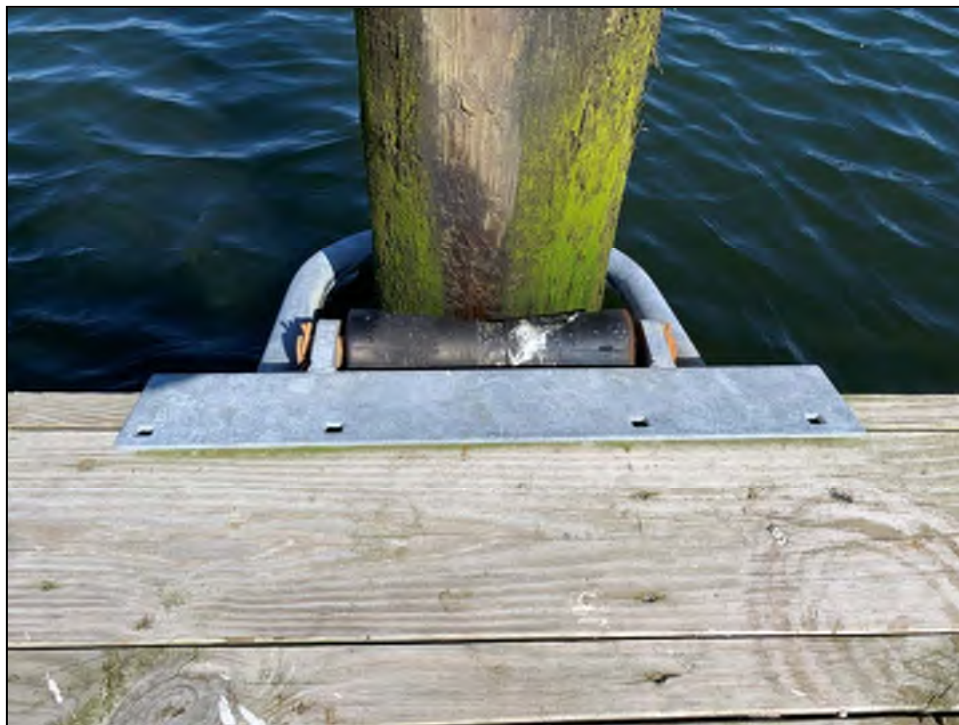
Photo No. 16: Typical top bolts missing on top of steel angle for guide pile.

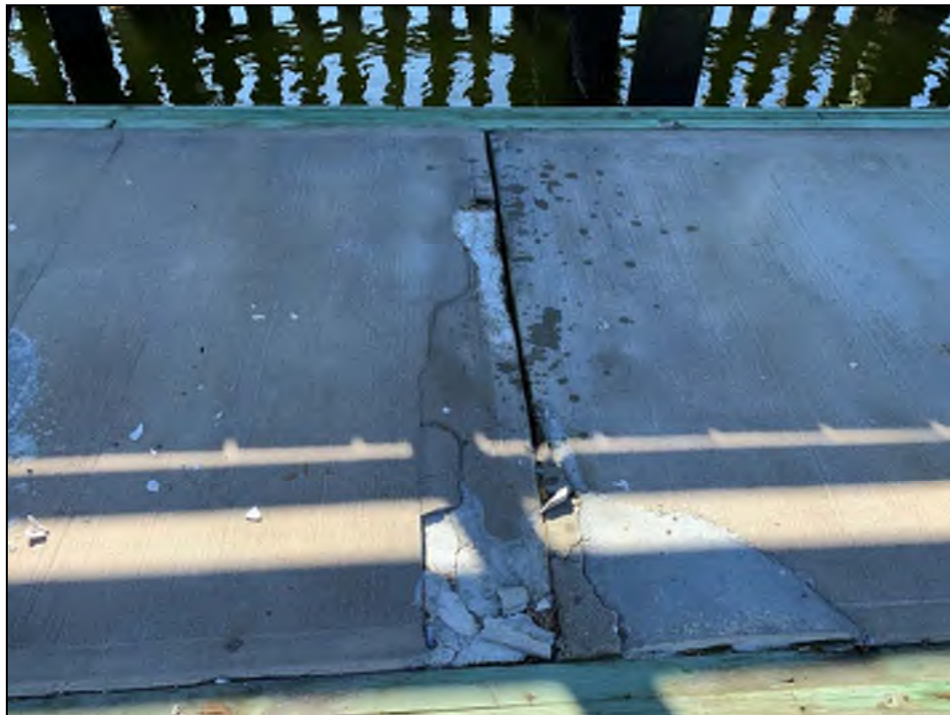
Photo No. 18: Cracking and deterioration of concrete deck with trip hazard and exposed polystyrene float unit. Note deterioration of previously repaired spall.

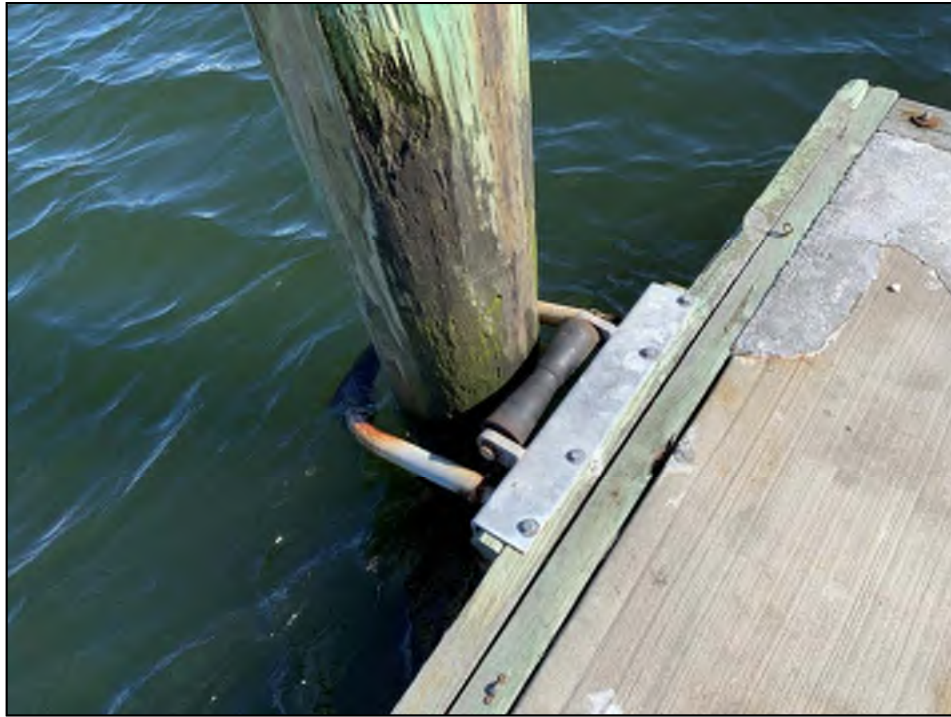
Photo No. 19: Guide pile hoop with loose connection.

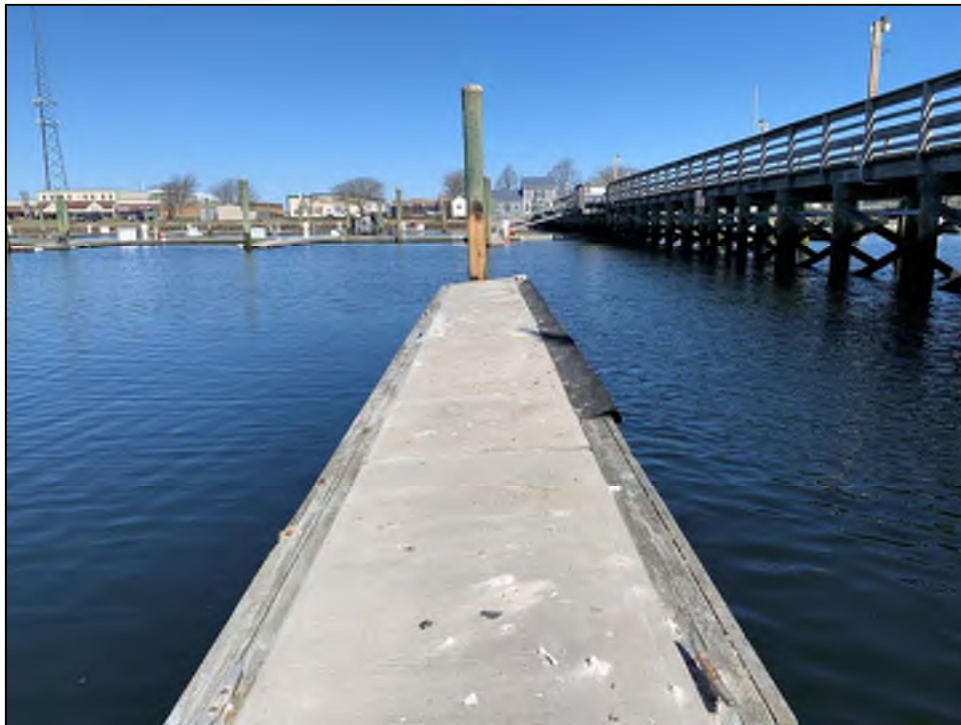
Photo No. 20: Listed finger float at Dock D

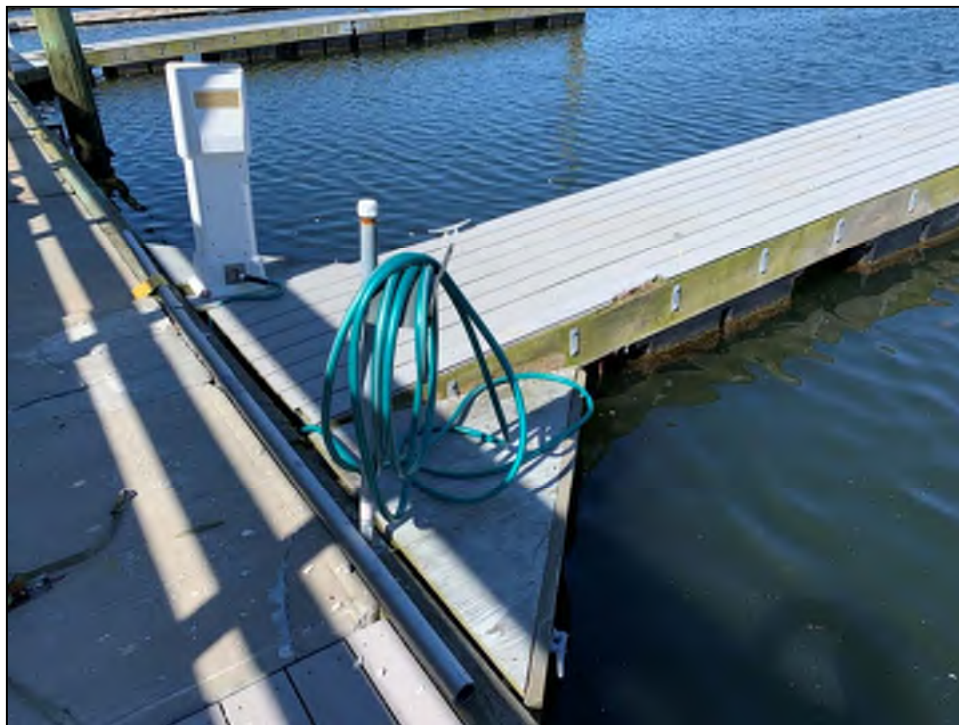
Photo No. 24: Failing timber triangle connection.

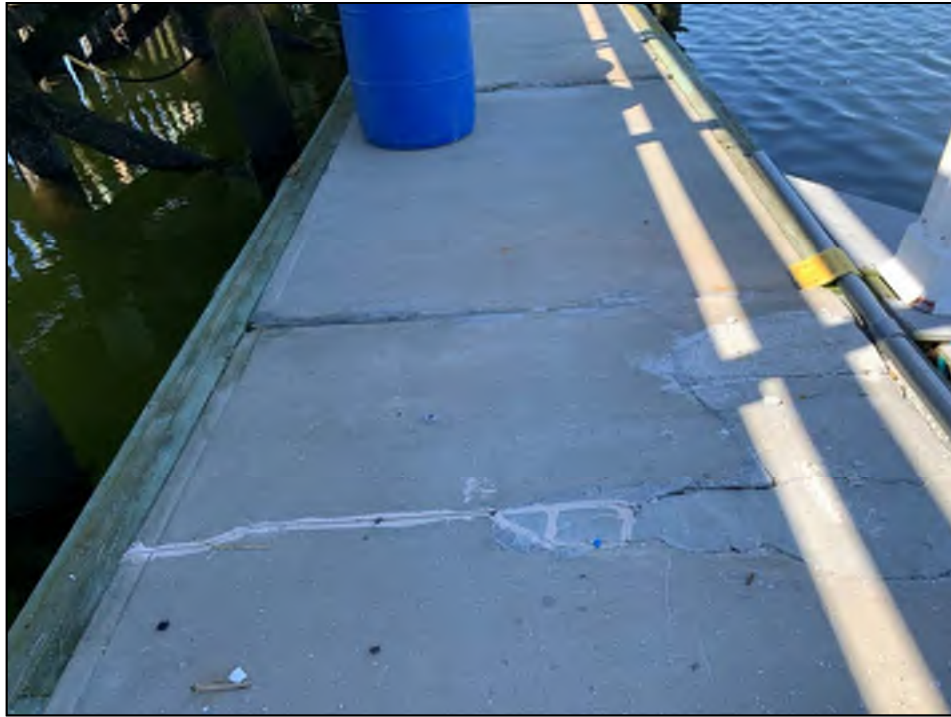
Photo No. 25: Previously repaired spill with trip hazard.

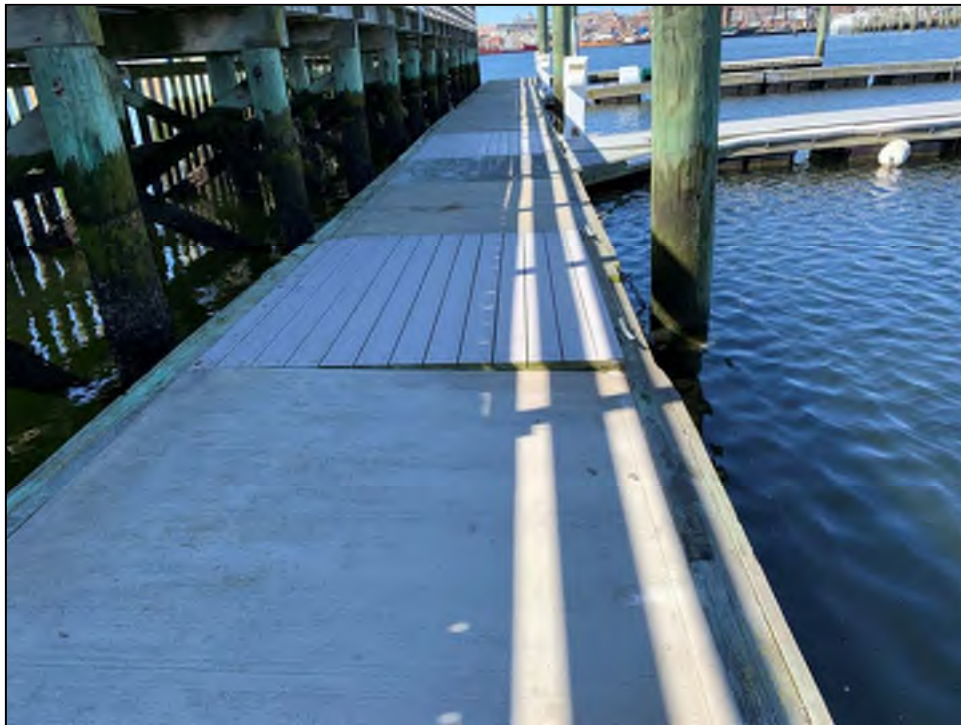
Photo No. 26: Listing of concrete main float and trip hazard.

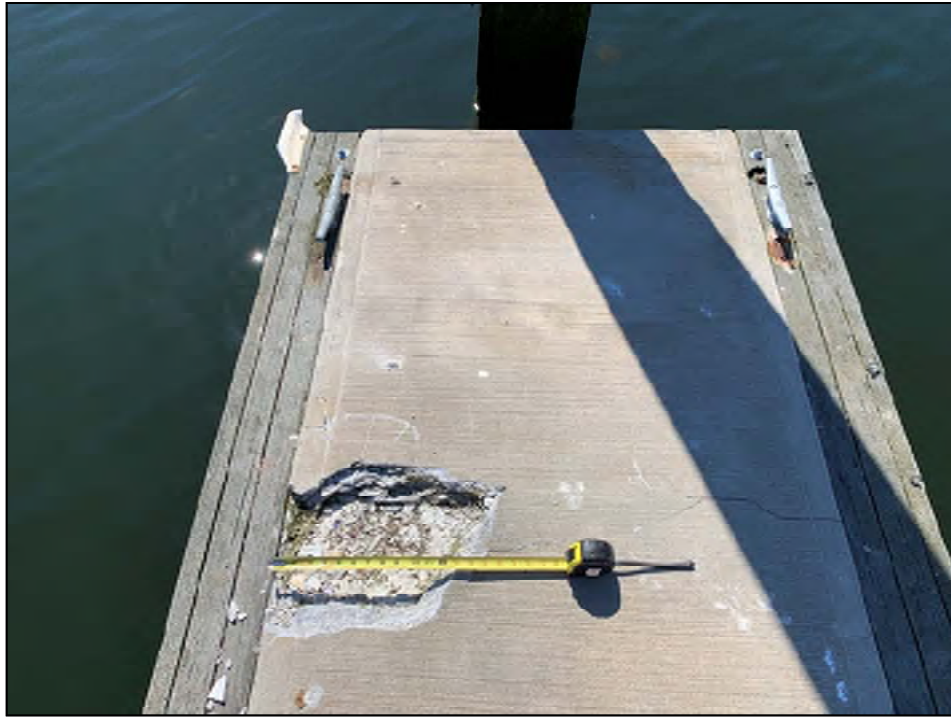
Photo No. 27: Concrete deterioration with exposed polystyrene float unit.

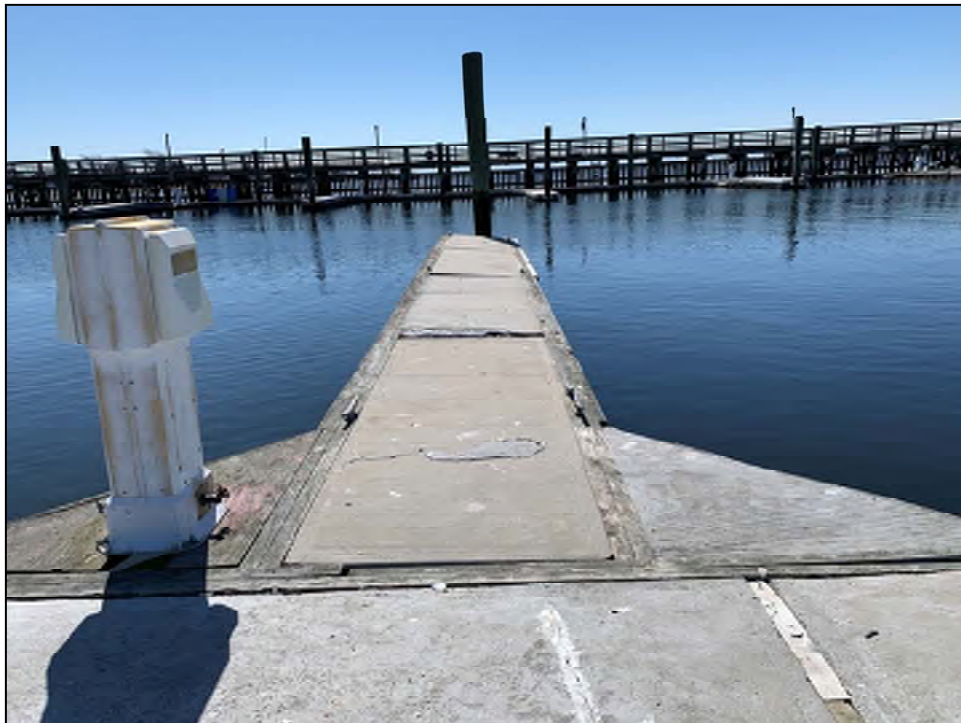
Photo No. 28: Listed and deteriorated concrete float modules with trip hazard.

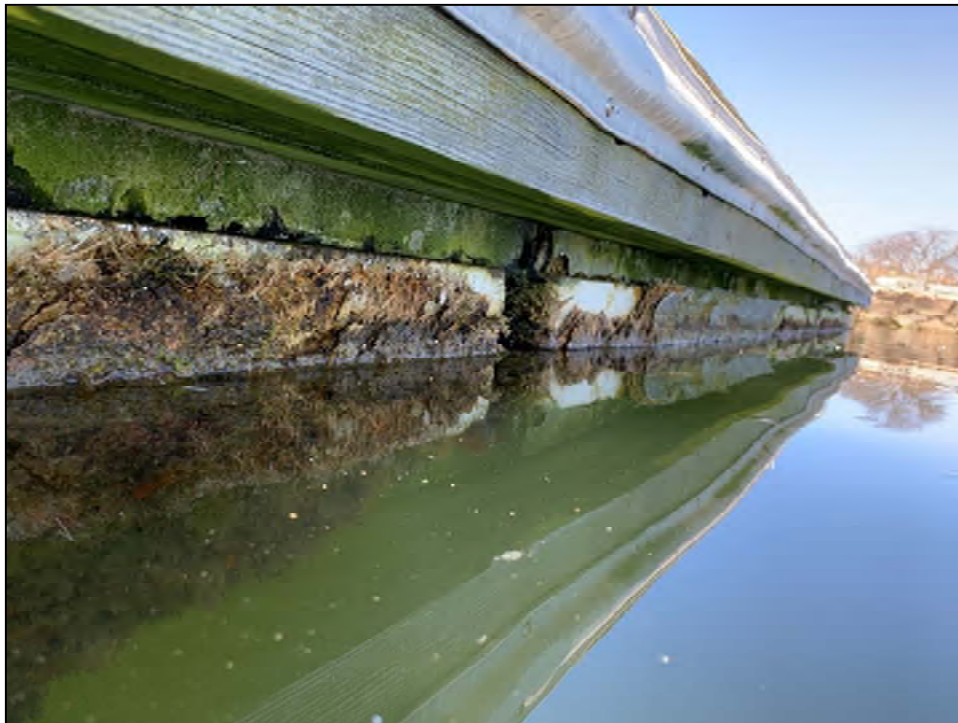
Photo No. 30: Deteriorated concrete encapsulation with exposed polystyrene flotation units.

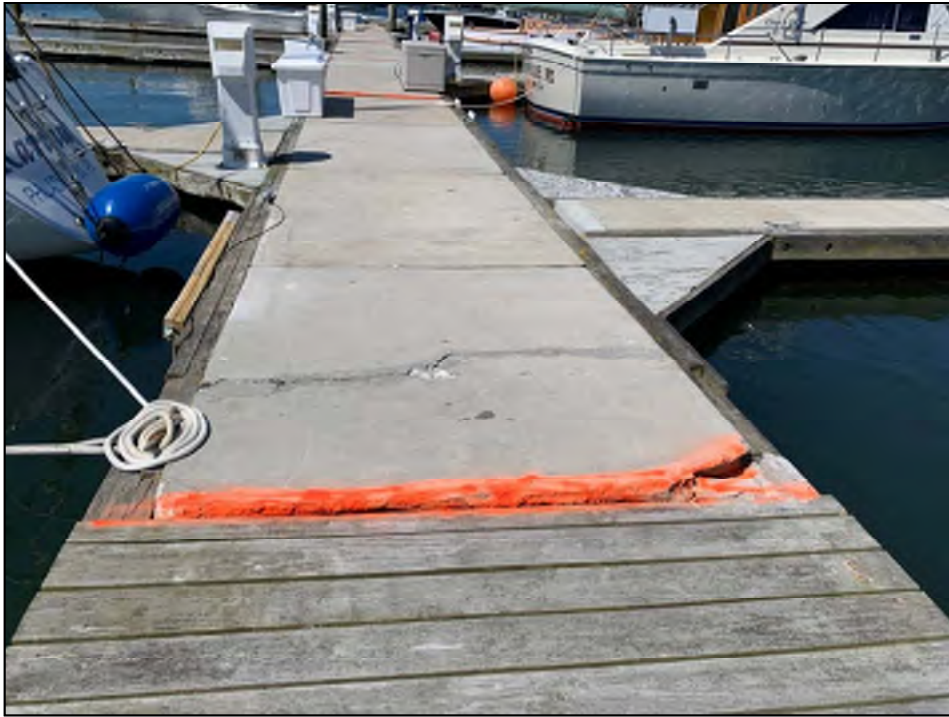
Photo No. 31: Concrete deterioration with trip hazard. Note previously repaired spill with continued deterioration..

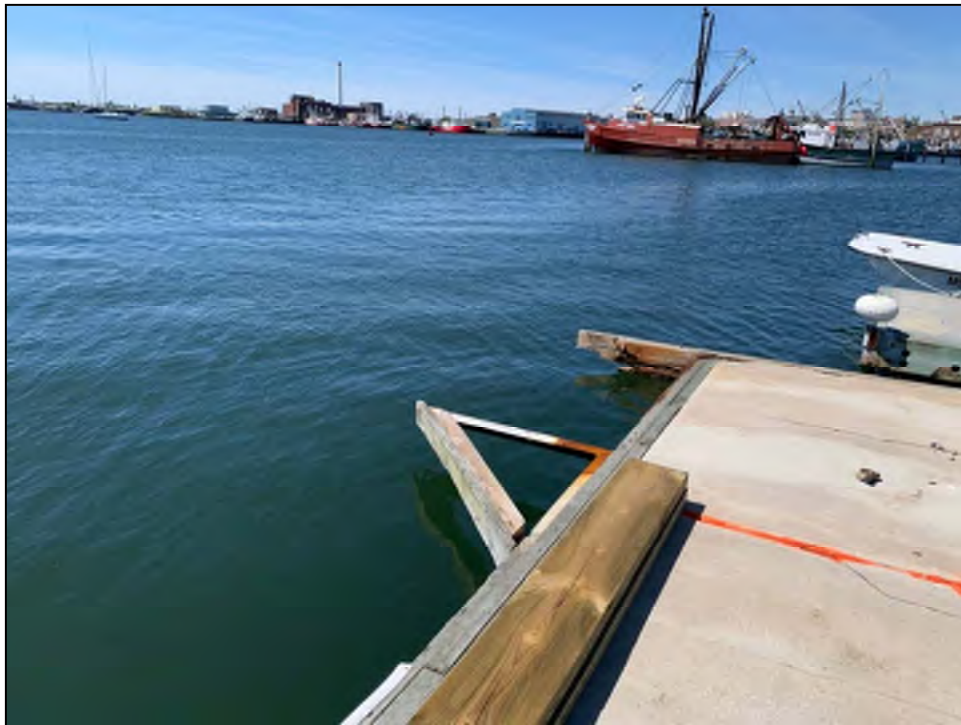
- The connection for one of the timber finger floats failed during a seasonal storm and the float is no longer attached to the main float. (Photo No. 32)

Photo No. 32: Float missing from failed connection after storm.

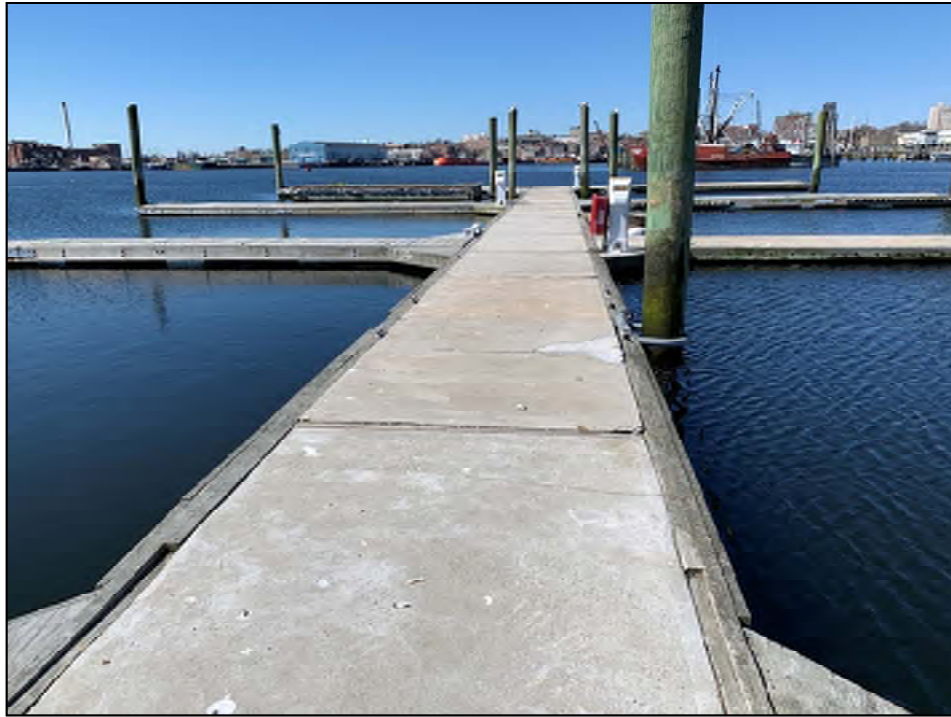
Photo No. 33: Concrete main float on Dock E before storm.

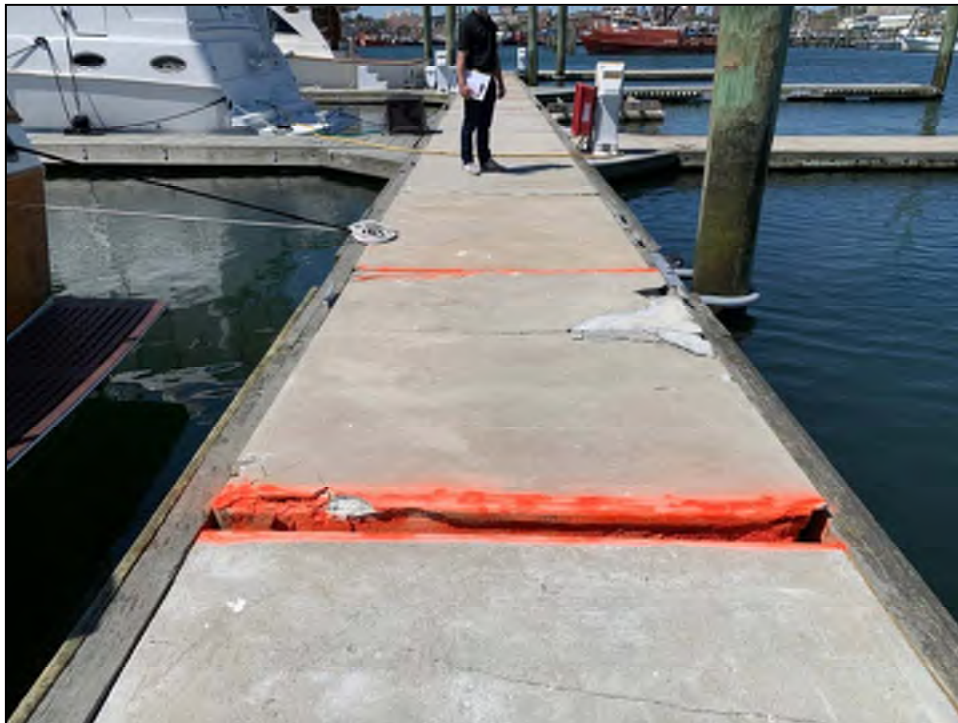
Photo No. 34: Concrete main float on Dock E after storm. Note displacement of float and trip hazard.

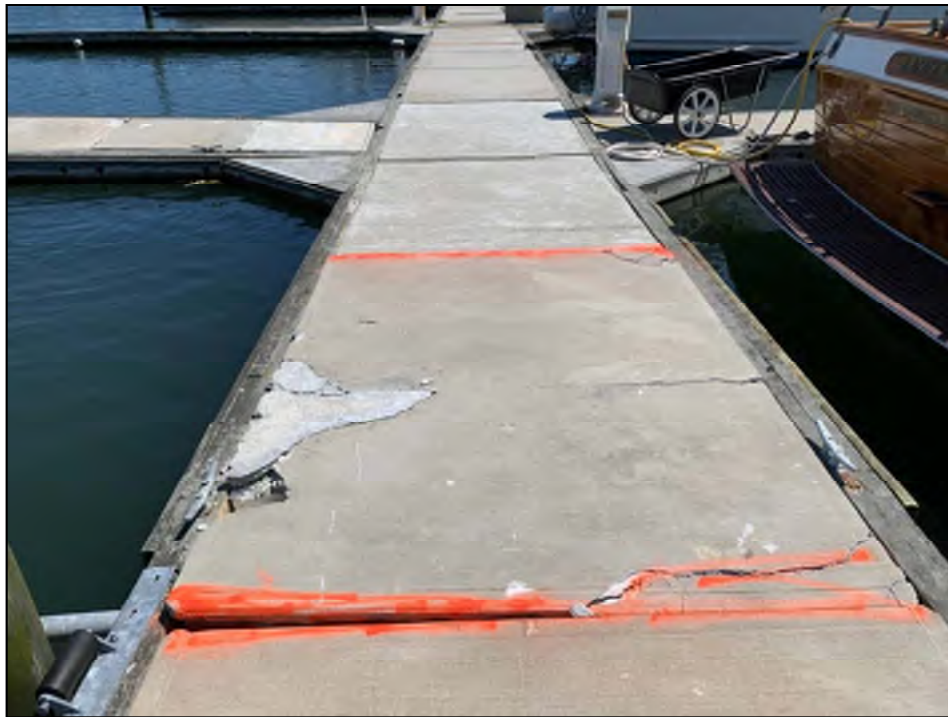
Photo No. 35: Additional damage to concrete after storm.

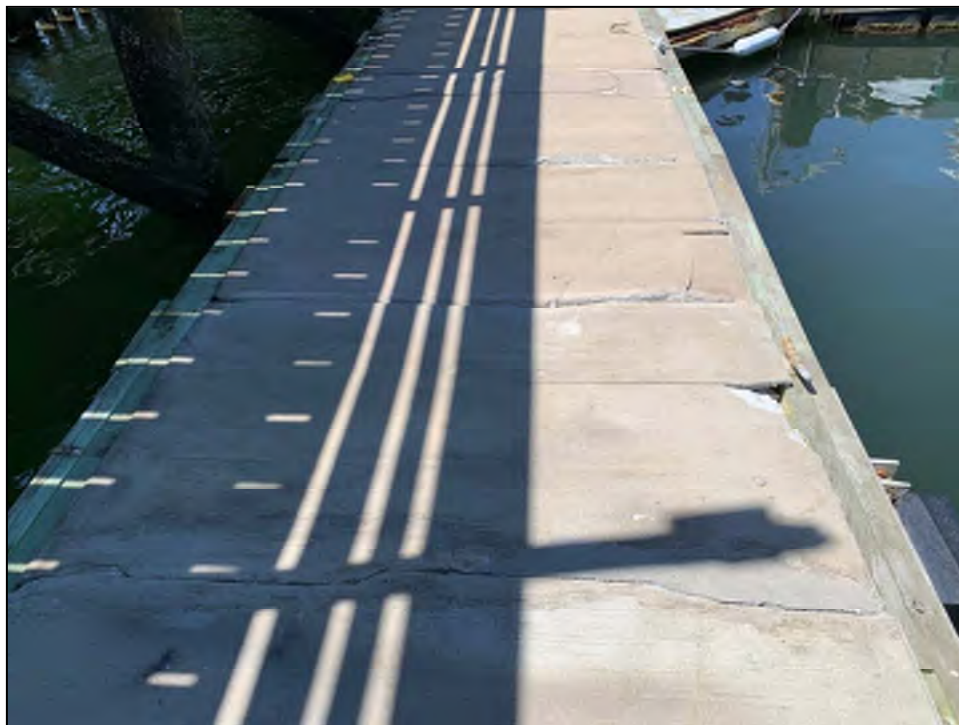
Photo No. 36: Damage to deteriorated concrete main floats on Dock D.

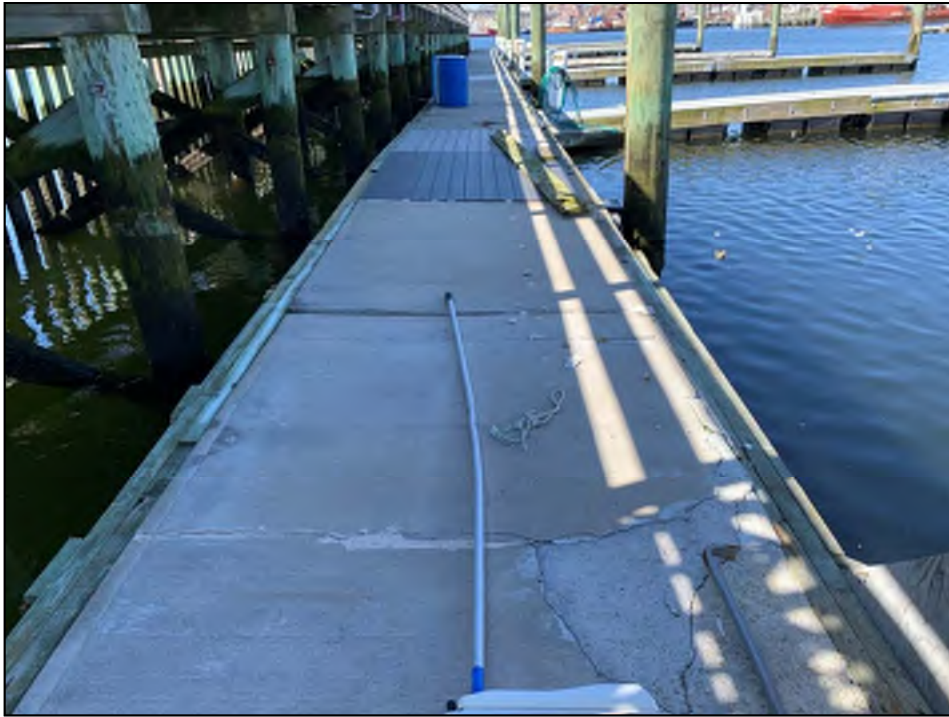
Photo No. 37: Deteriorated concrete main float along Dock D before storm.
