PREPARED FOR:  
NEW BEDFORD PORT AUTHORITY

**ROUTINE INSPECTION REPORT UPDATE  
PORT OF NEW BEDFORD  
POPE'S ISLAND MARINA**

JULY 2020

**ROUTINE INSPECTION REPORT UPDATE  
POPE'S ISLAND MARINA  
NEW BEDFORD, MASSACHUSETTS**

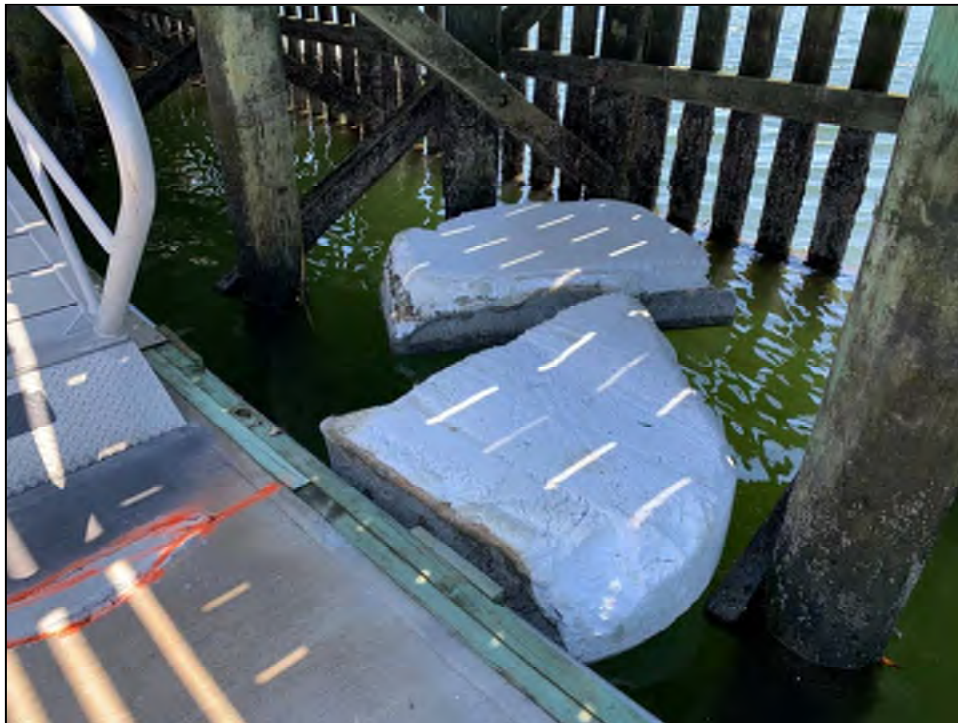
Photo No. 40: Displaced polystyrene float units after storm on Dock D.

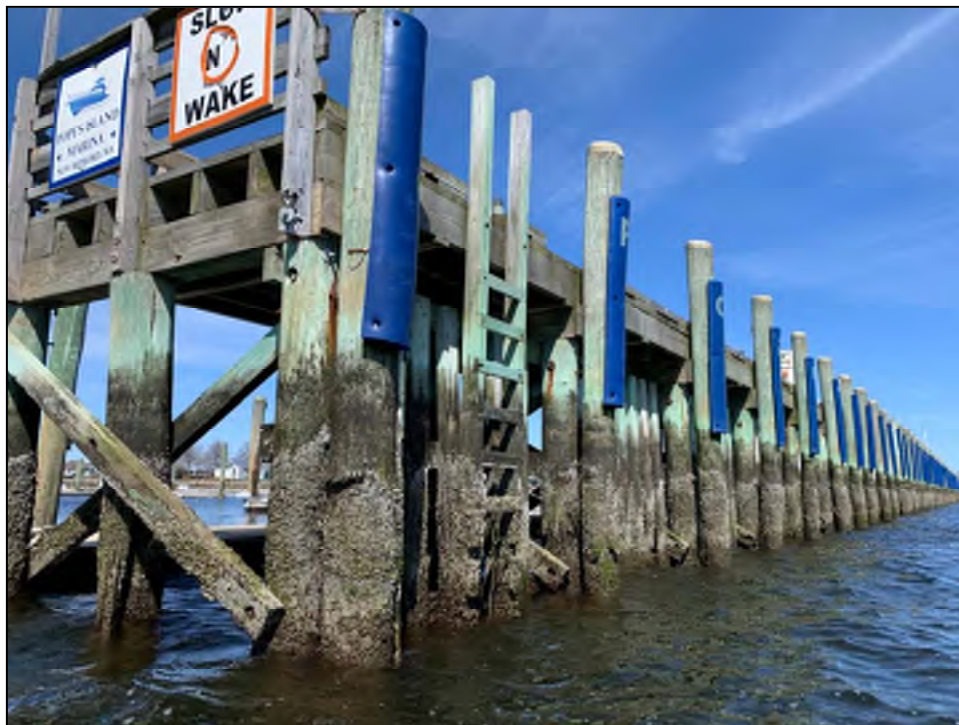
Photo No. 44: T-head of timber pile supported pier with cross bracing, fender piles, and timber wave fence.

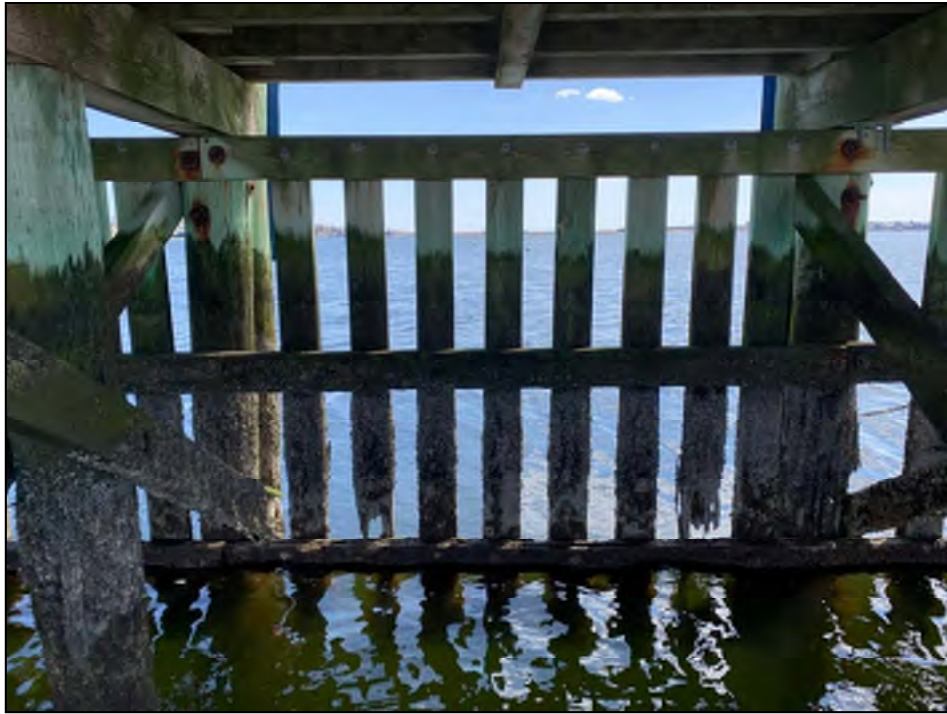
Photo No. 45: Deteriorated timber wave fence.

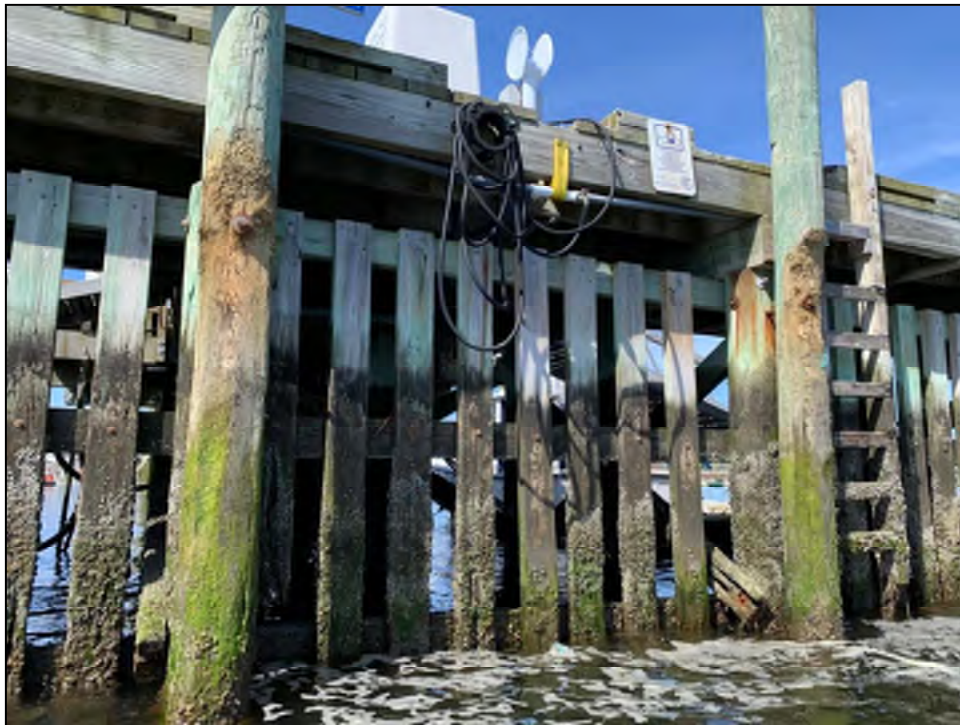
Photo No. 46: Timber fender piles with missing rub blocks and pile damage.

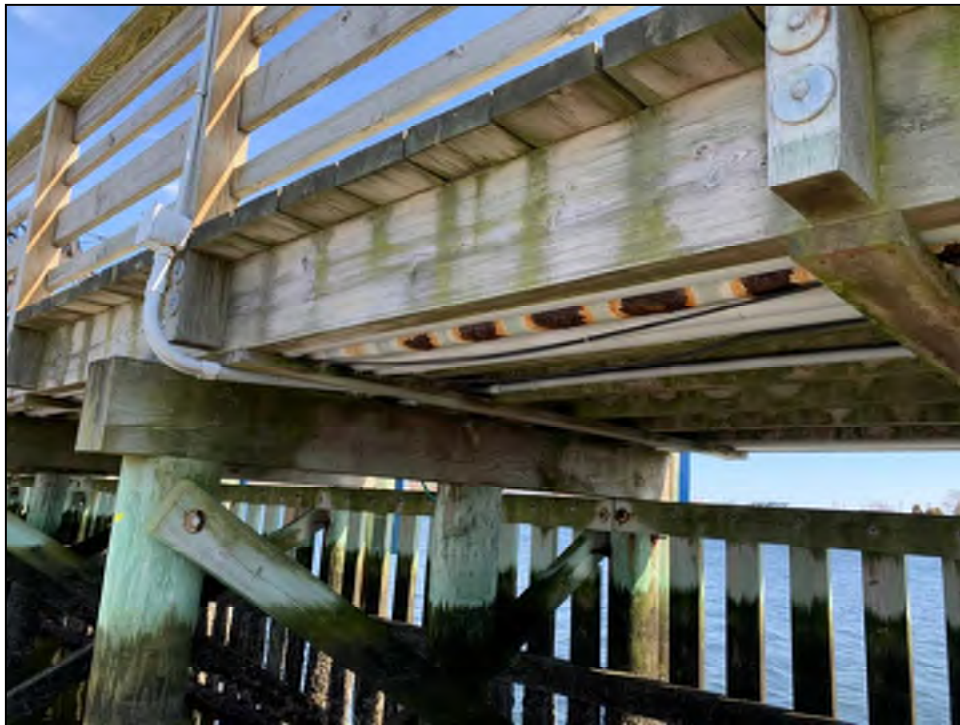
Photo No. 48: Corroded fire line along T-head.
