*Massachusetts Coastal Infrastructure
Inventory and Assessment Project
Massachusetts Department of Conservation and Recreation
Office of Waterways*

North Coastal

July 6, 2009

**Bourne Consulting Engineering
Franklin, Massachusetts**

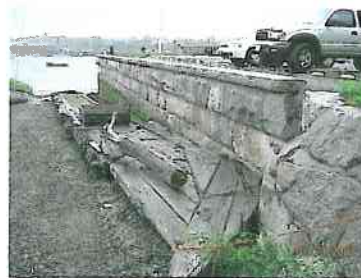
A mortared granite block seawall in generally good condition, though the top of the wall cantilevers out beyond toe of wall.

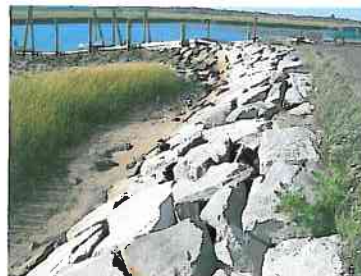
A stone revetment at a boat ramp in satisfactory condition. The geotextile is exposed between stones.

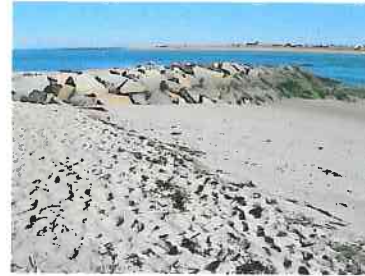
A stone groin unravelling inshore at the west side and at the offshore end. Both sides and crest underlayer stone are exposed but in fair condition.

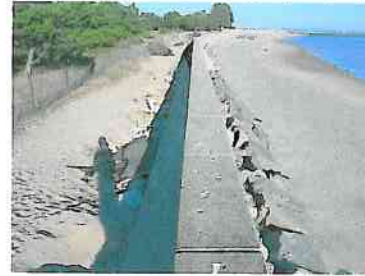
A precast concrete wave return face seawall set on top of stone revetment. Generally in satisfactory condition, except there is 300 linear feet of damaged revetment and loss of wall backfill along centered portion of wall. There are trees, shrubs and dune behind wall, and a campground roadway set back.

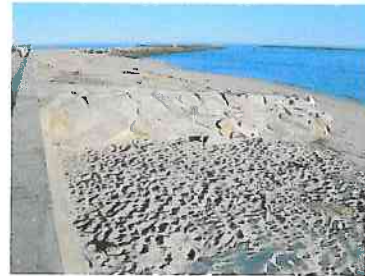
A mortared stone groin with minor mortar loss. The stones at the offshore end have shifted approximately 3 inches offshore, causing open joints. Generally satisfactory condition.

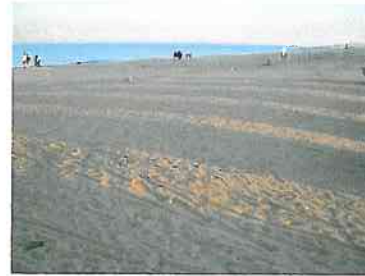
A beach nourishment area per the Harbor Master, good condition. Some nearby buildings elevated on piles.

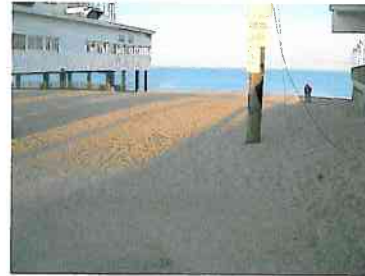
A beach nourishment area, per the Harbor Master, that is in good condition.

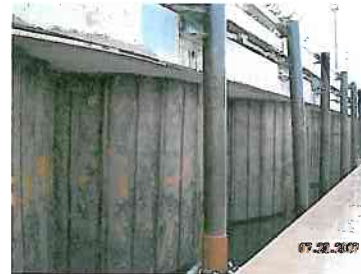
Steel sheetpile cells with a concrete cap with moderate sheetpile corrosion in splash and tidal zones. There are minor defects on the concrete cap. It is in fair condition for storm protection. The boardwalk and park are above.

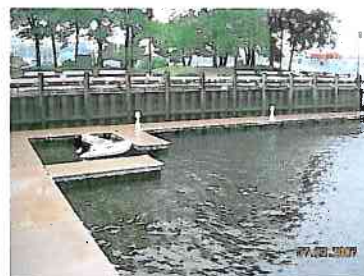
A steel sheetpile bulkhead with tie-backs and concrete cap with moderate steel corrosion in the splash and tidal zones. It is in satisfactory condition for storm protection.

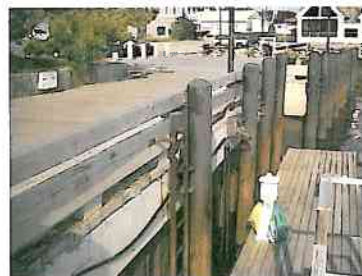
Steel sheetpile cells with a concrete cap. There is moderate corrosion in the splash and tidal zones and minor defects on concrete cap. It is in satisfactory condition for storm protection.

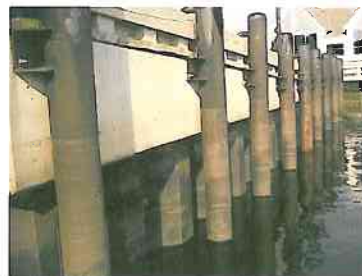
A coated steel sheet pile bulkhead with concrete cap in good condition. There is a park area behind the wall.

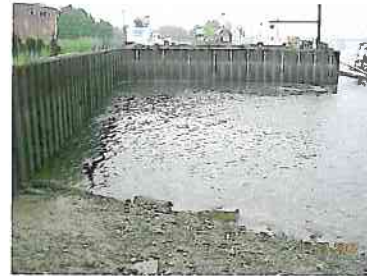
A steel sheetpile bulkhead with tie-backs in satisfactory condition with minor general corrosion. A portion of the area behind the bulkhead is a commercial boat loading/unloading area.

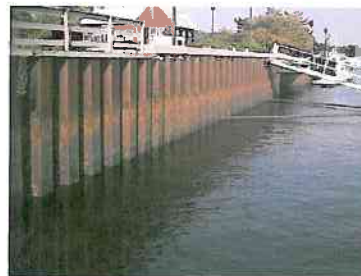
A steel sheetpile bulkhead with park boardwalk above, with general minor corrosion of sheet pile. In satisfactory condition.

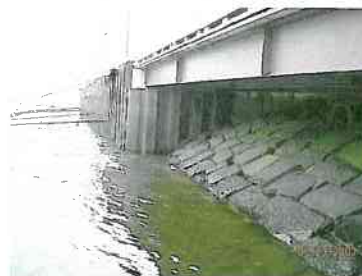
A steel framed deck spanning over placed stone block revetment and drainage outfall, in satisfactory condition. The Harbor Master building is set back.

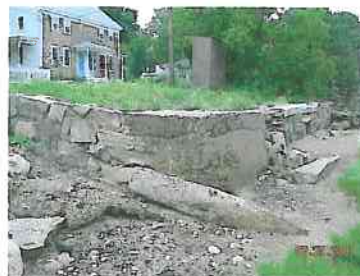
A mortared rubble stone wall with granite cap stones and some repair concrete cast in place. There is a collapsed area 8 feet long with overtopping erosion in fair condition. Located at the Bus Stop, adjacent to Water street.

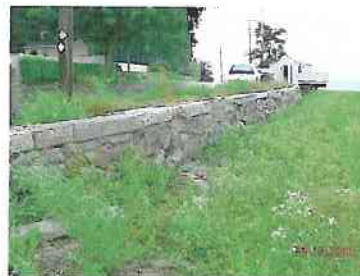
A stone seawall inshore of salt marsh along Water Street, in fair condition. It is mortared rubble with a granite block cap. There is some mortar missing and overtopping scour damage.

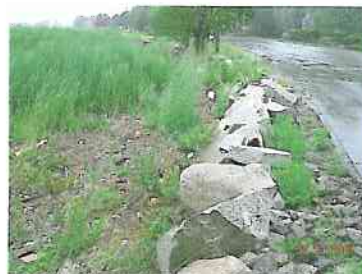
A dumped rubble stone revetment with random alignment in fair condition, along Water Street.

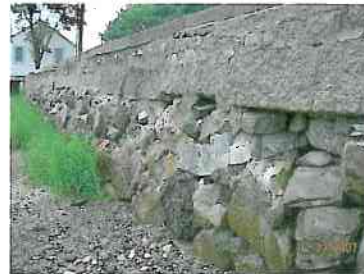
A mortared rubble stone wall with precast concrete cap, along Water Street at top of salt marsh. There are some joints missing mortar and a few missing stones. It is in fair condition.

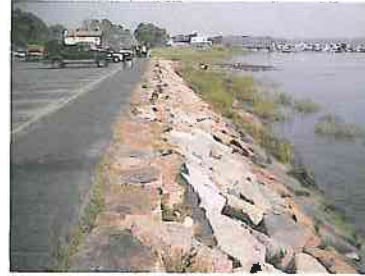
A medium size stone placed revetment parallel with slope that protects the parking lot and sidewalk including the apparently abandoned boat ramp. The revetment is in satisfactory condition.

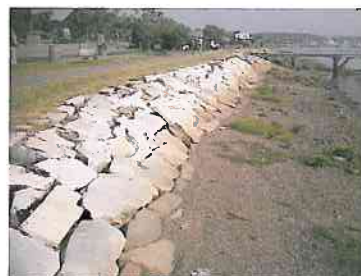
A medium size stone placed revetment parallel with slope, protecting sidewalk and parking lot, including active boat ramp. Some loss of undersized underlayer, but in satisfactory condition.

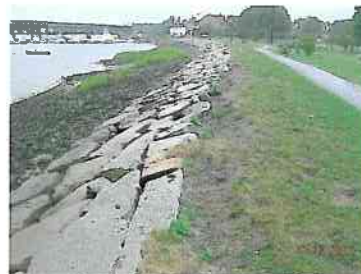
A medium size stone placed revetment parallel with slope, protecting sidewalk and lawn area. There is some loss of undersized underlayer and areas with wave over erosion and scour. It is in satisfactory condition.

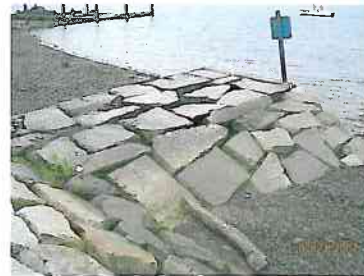
A placed stone groin with concrete end wall at drain outfall. There is some erosion of the undersized underlayer, and crest stones with poor interlocking and open joints. It is in fair condition.
