Carver Cotton Gin Dam Removal Photograph Summary

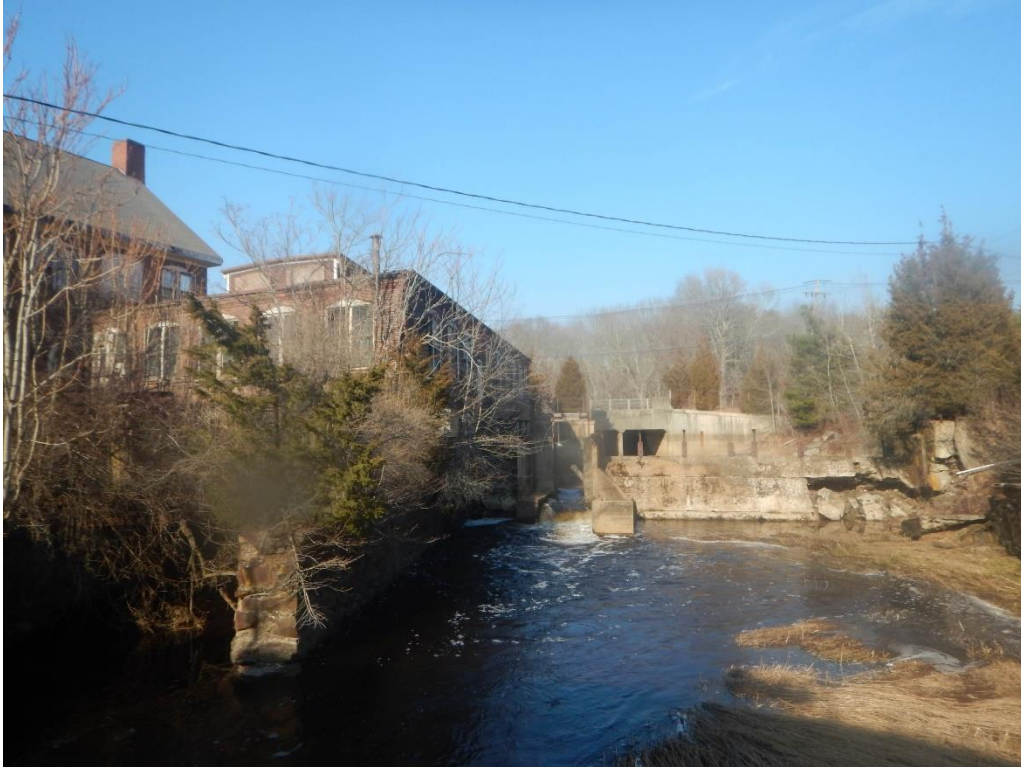
Photo 1: Downstream face of dam looking upstream (pre-construction)
(Gomez and Sullivan, 3/18/16)

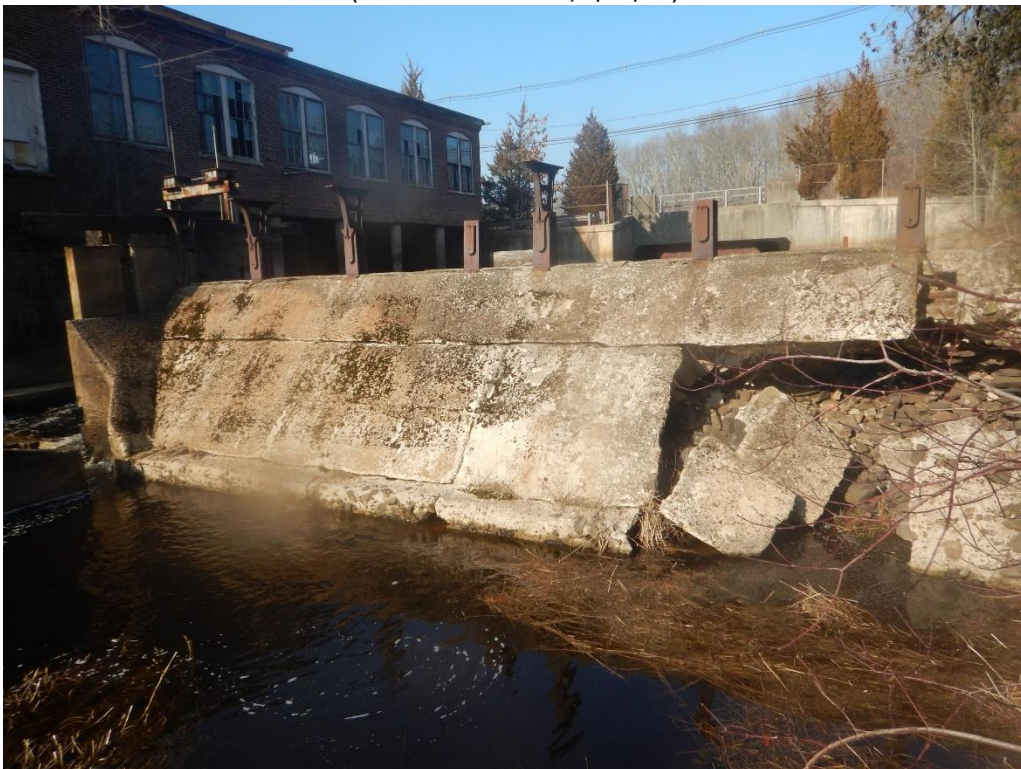
Photo 2: Downstream face of dam looking at rubble fill exposed on right (pre-construction)
(Gomez and Sullivan, 3/18/16)

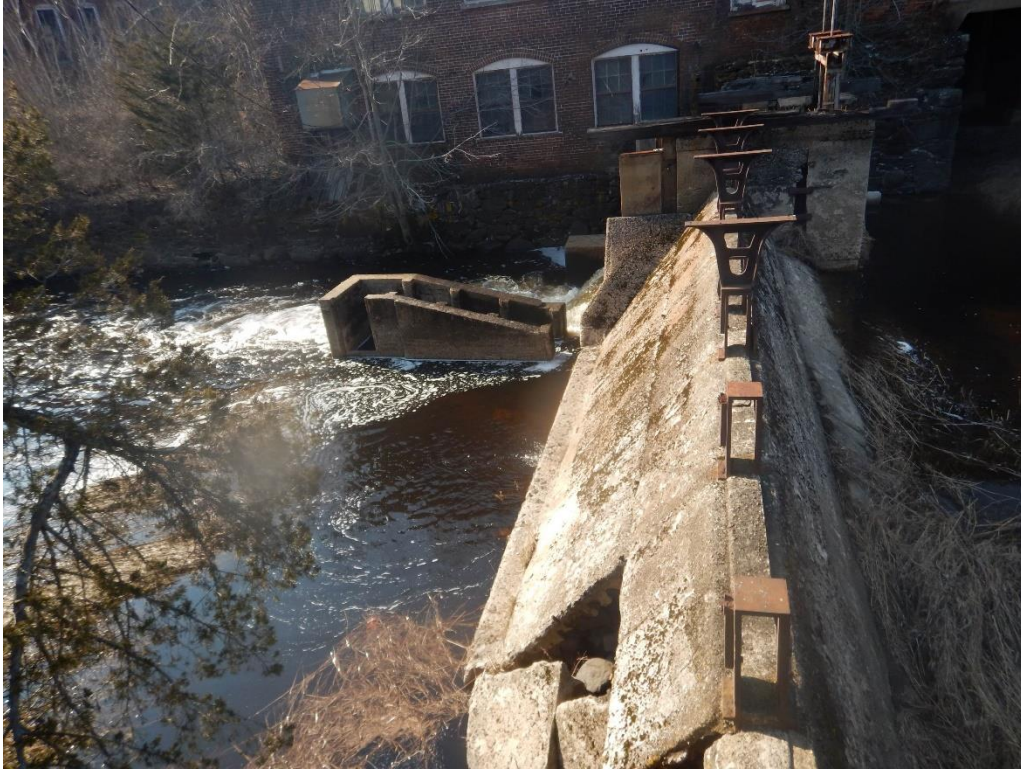
Photo 3: Crest of dam looking at the right abutment (pre-construction)
(Gomez and Sullivan, 3/18/16)

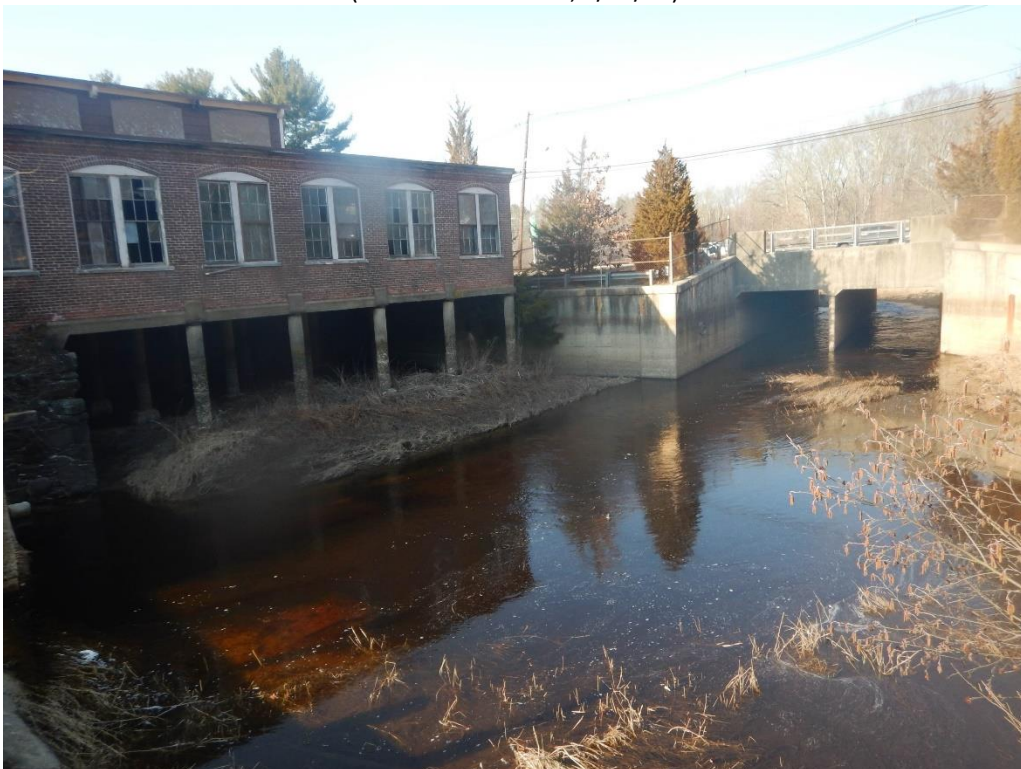
Photo 4: Looking upstream at mill building piers on river left and Route 106 Bridge (pre-construction)
(Gomez and Sullivan, 3/18/16)

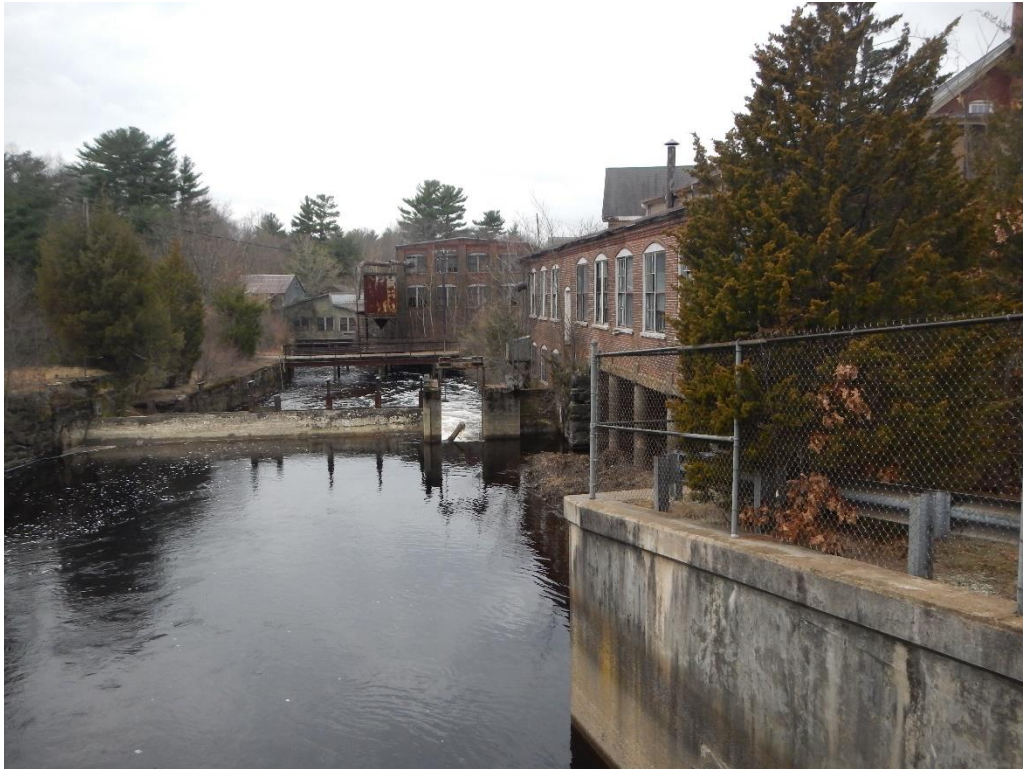
Photo 5: Looking Downstream from Route 106 bridge (pre-construction)
(Gomez and Sullivan, 4/14/15)

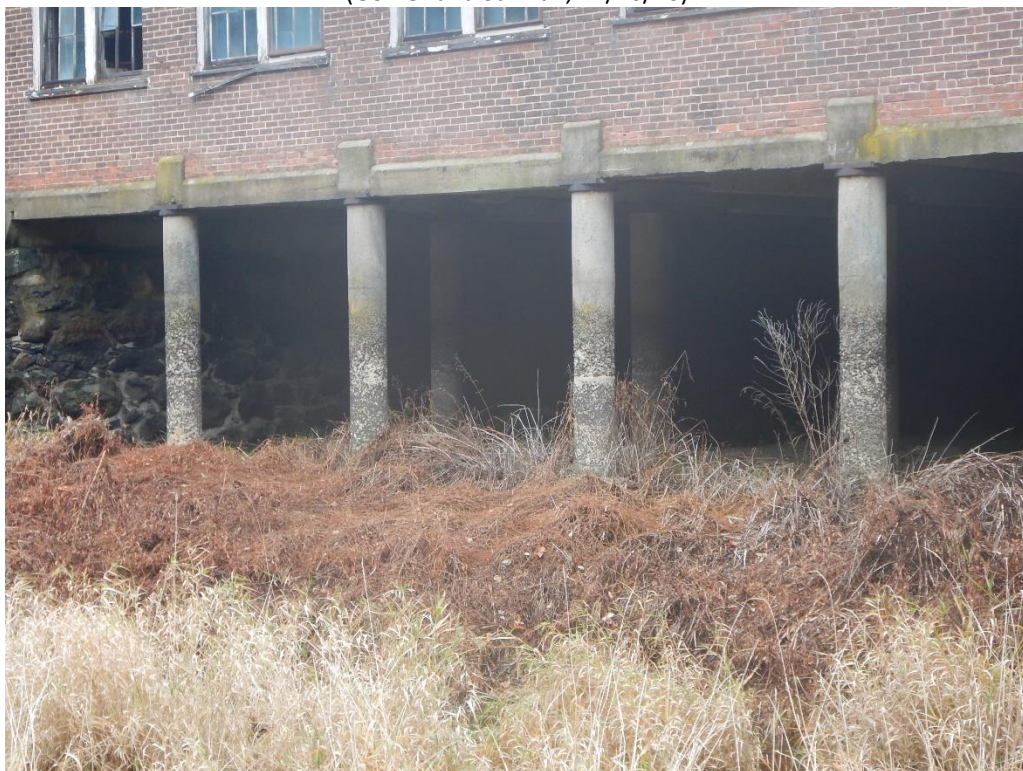
Photo 6: Piers of mill building on river right (pre-construction)
(Gomez and Sullivan, 11/16/16)

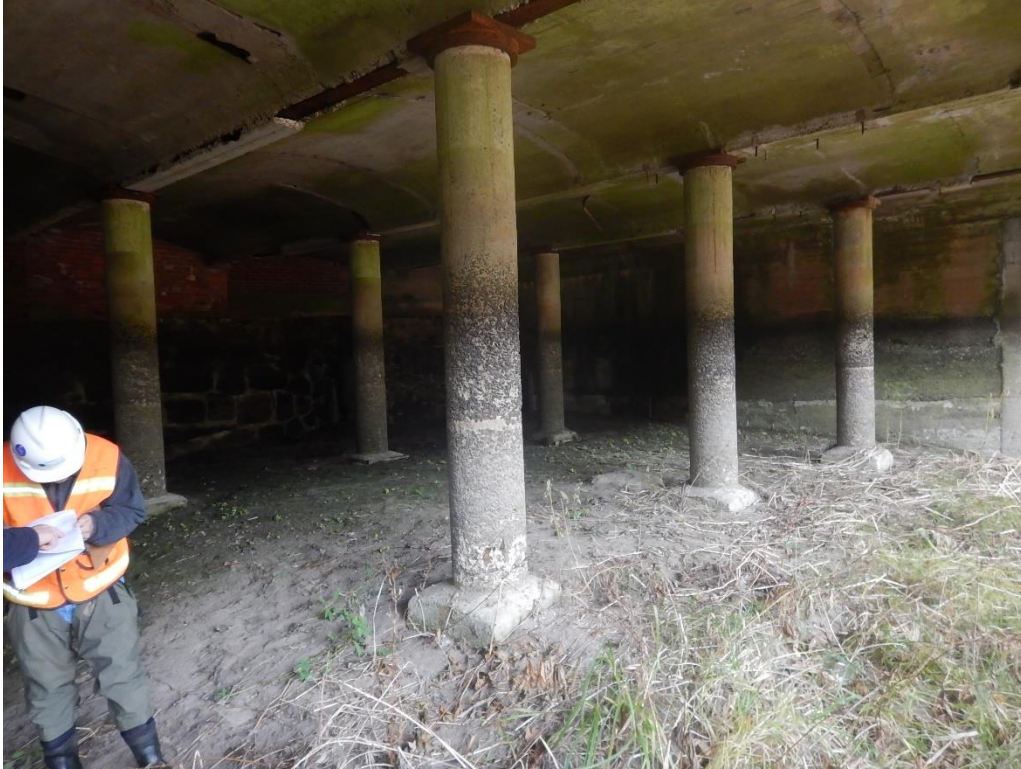
Photo 7: Piers and pier foundations of mill building(pre-construction)
(Gomez and Sullivan, 11/16/16)

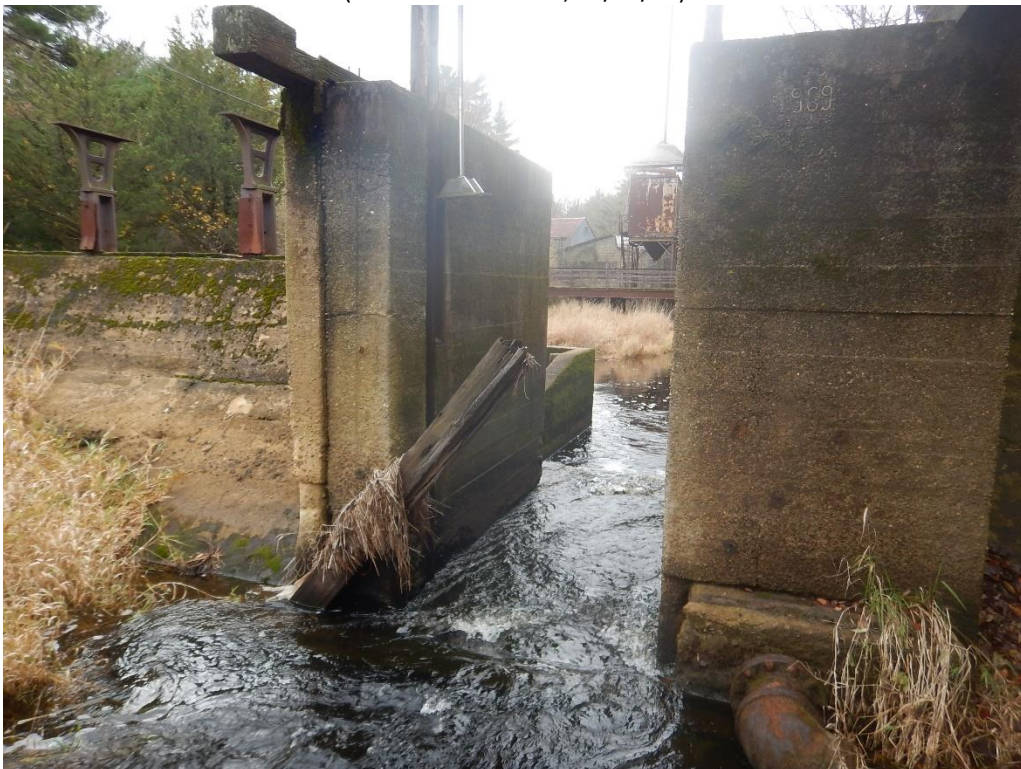
Photo 8: Looking downstream at open gate and right dam abutment (pre-construction)
(Gomez and Sullivan, 11/16/16)

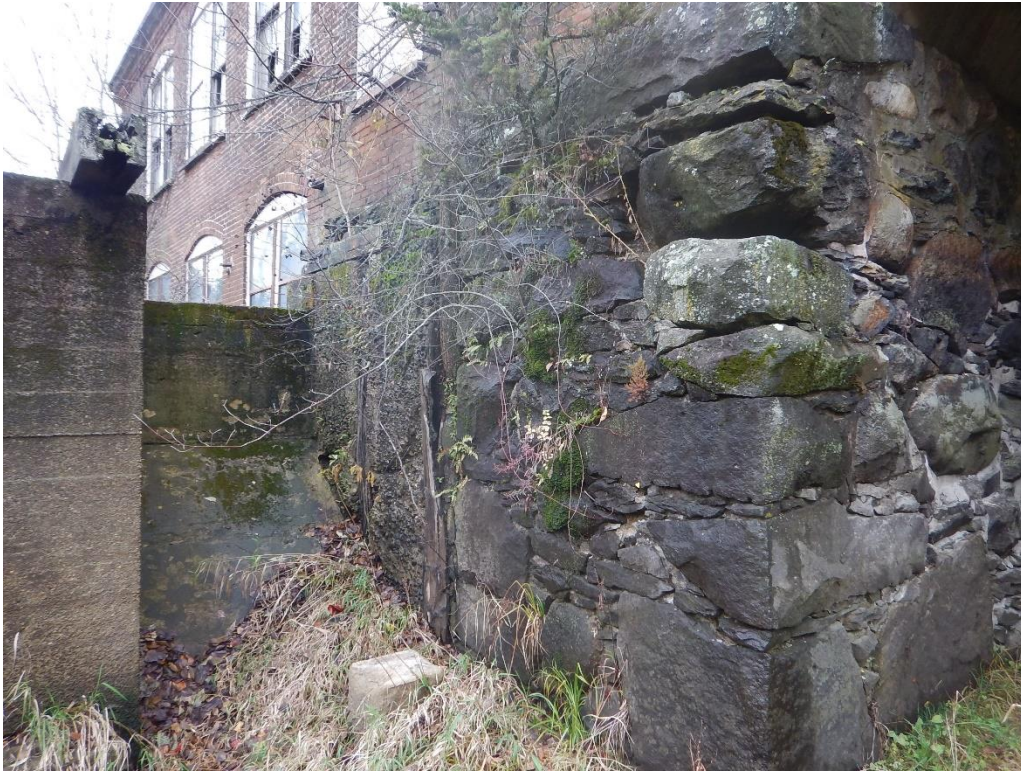
Photo 9: Looking downstream at Dam right abutment with emergency overflow spillway (pre-construction)
(Gomez and Sullivan, 11/16/16)

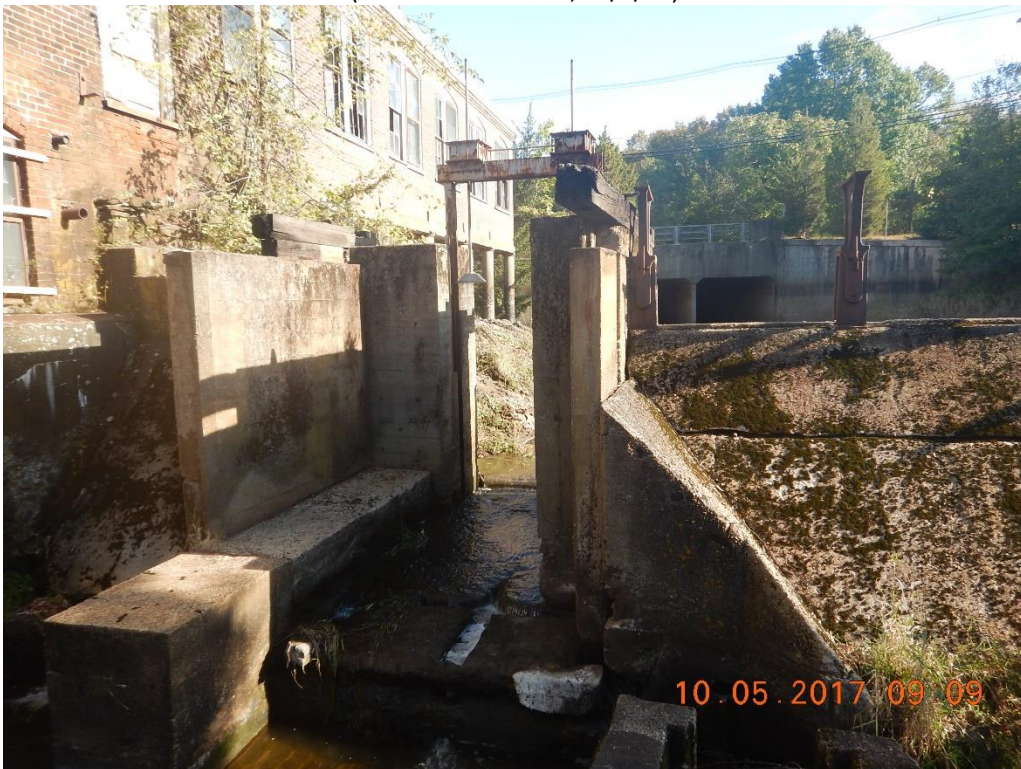
Photo 10: Looking upstream at open gate and right dam abutment (pre-construction)
(Gomez and Sullivan, 10/5/17)

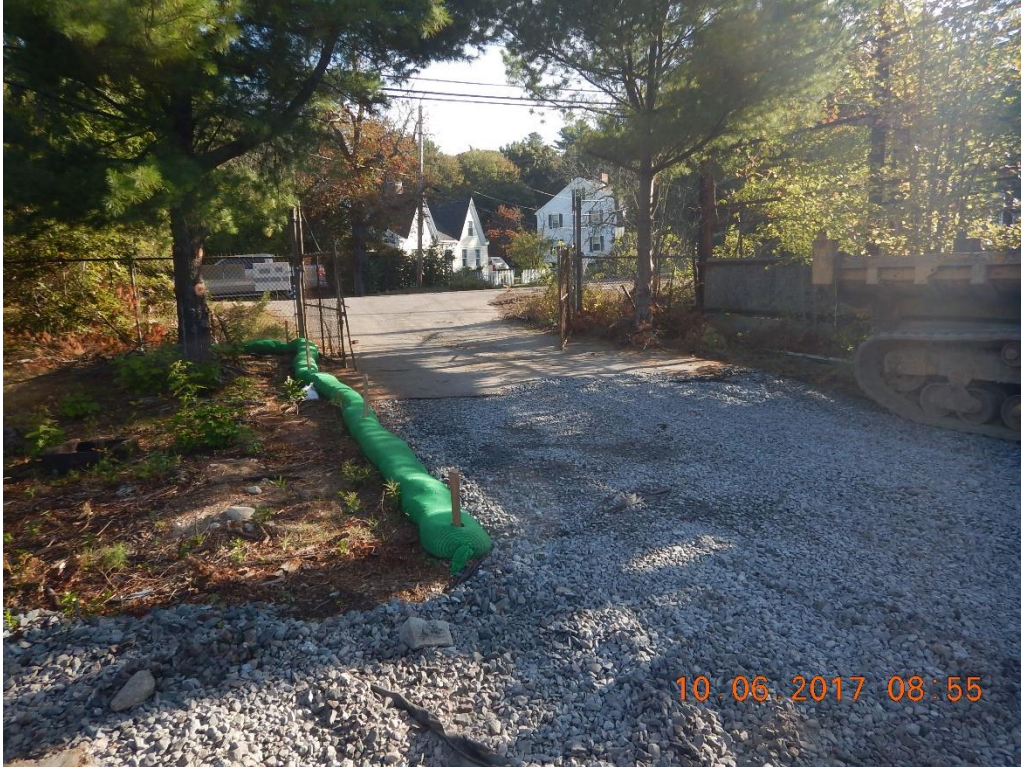
Photo 11: Stabilized Construction Entrance (mid-construction)
(Gomez and Sullivan, 10/6/17)

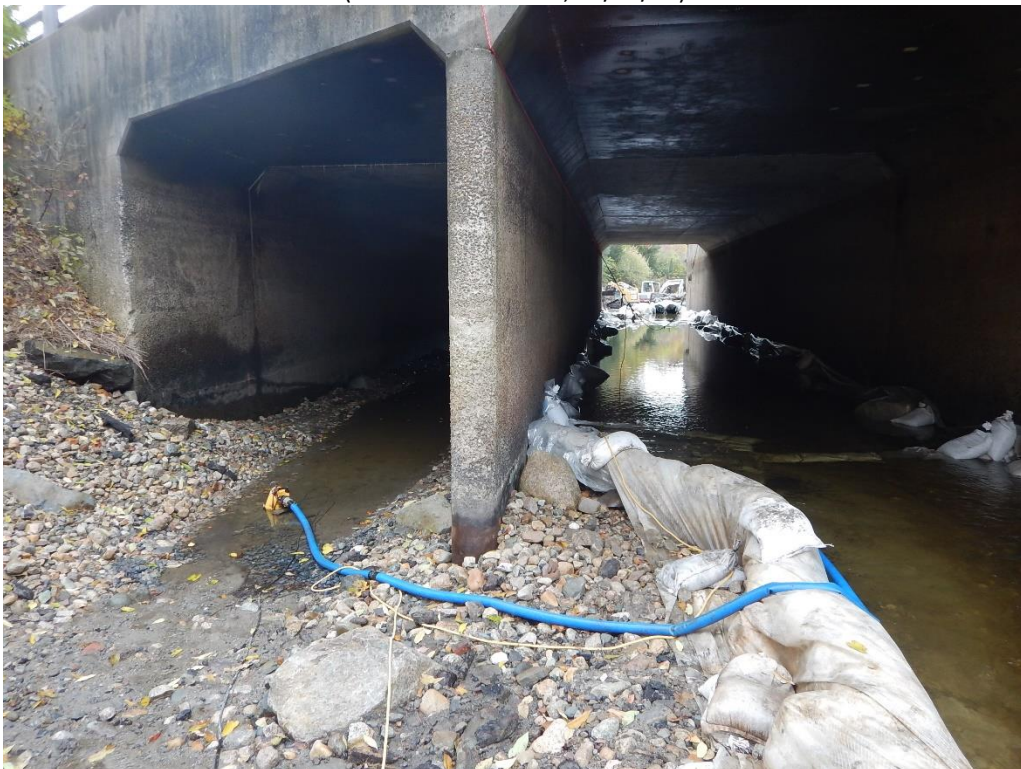
Photo 12: Looking downstream through route 106 bridge culvert (mid-construction)
(Gomez and Sullivan, 10/24/17)

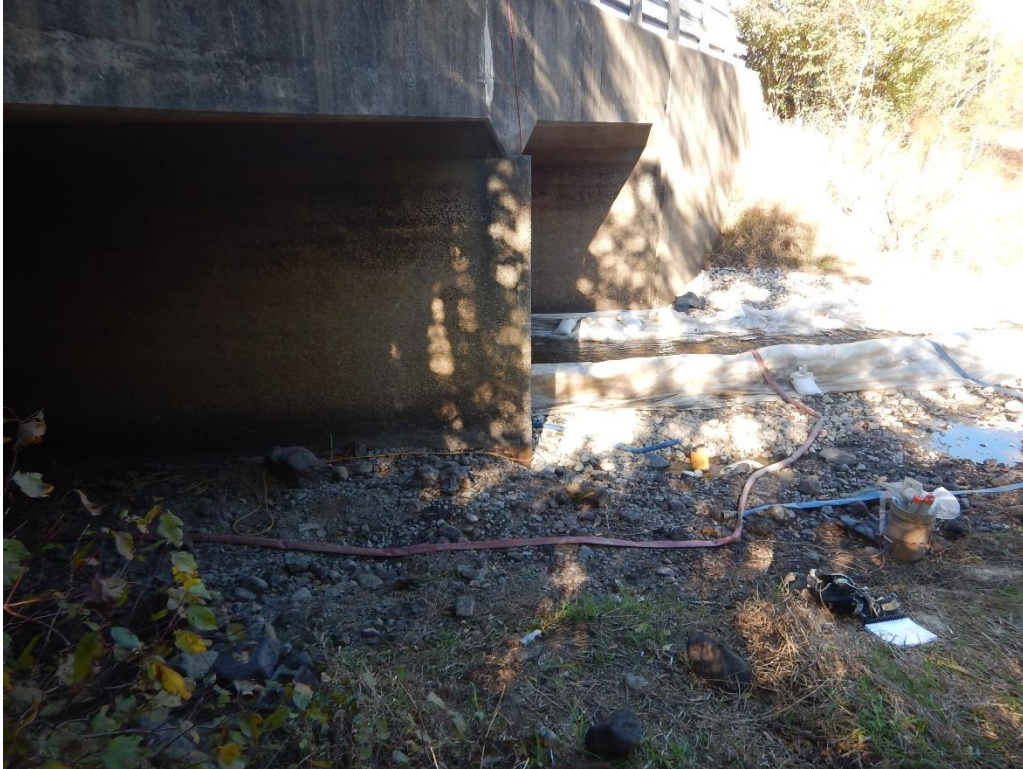
Photo 13: Scour countermeasure construction upstream of Route 106 (mid-construction)
(Gomez and Sullivan, 10/17/17)

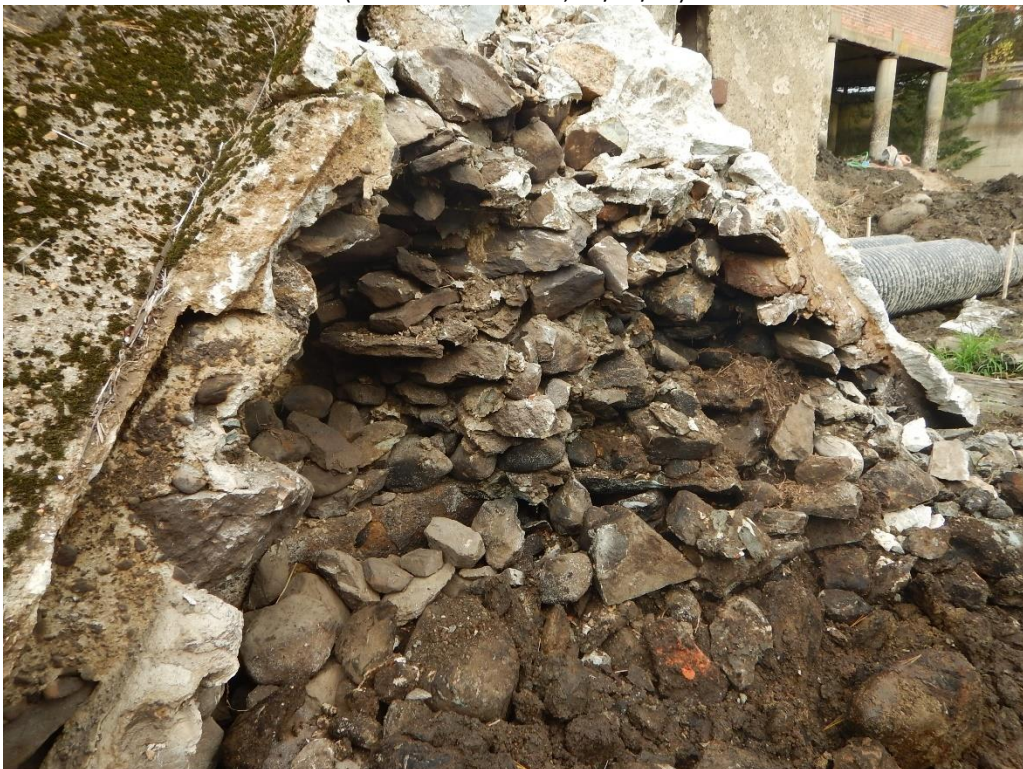
Photo 14: Partially removed dam with exposed material (mid-construction)
(Gomez and Sullivan, 10/24/17)

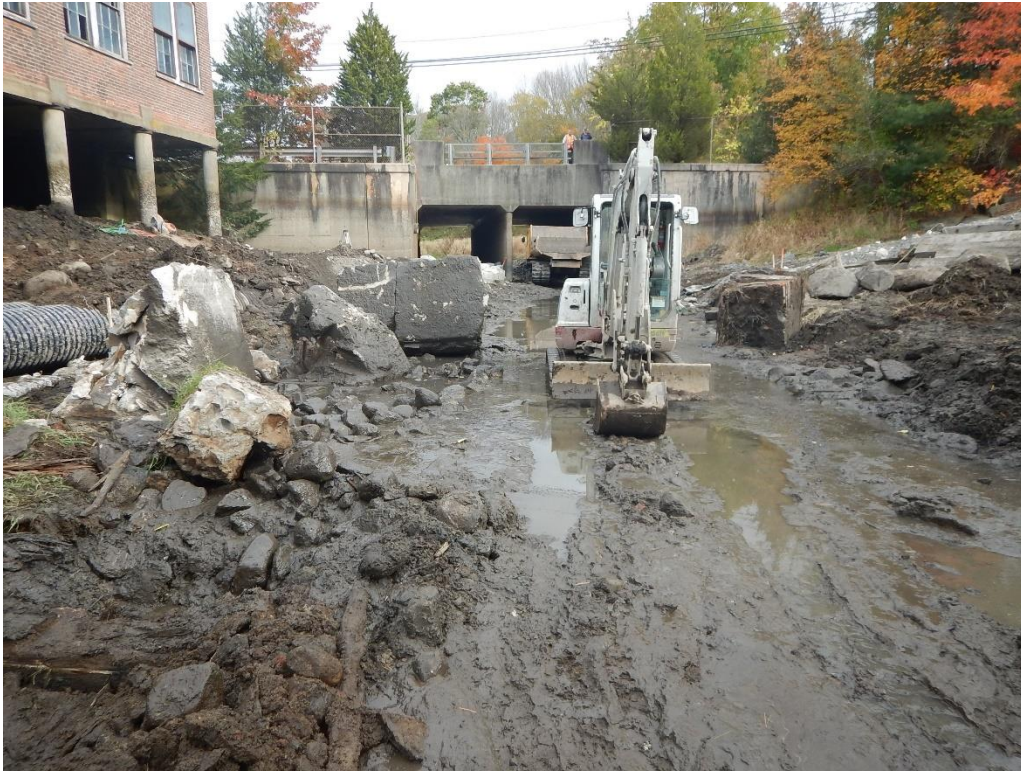
Photo 15: Looking upstream at channel excavation (mid-construction)
(Gomez and Sullivan, 10/24/17)

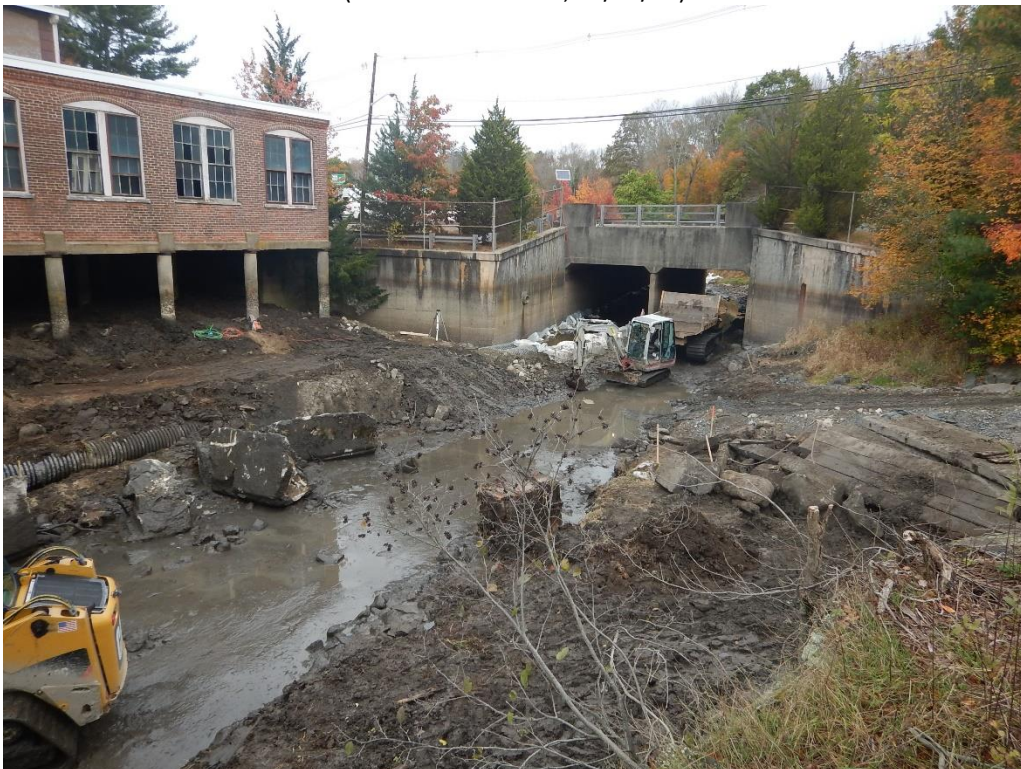
Photo 16: Looking upstream at channel excavation (mid-construction)
(Gomez and Sullivan, 10/24/17)

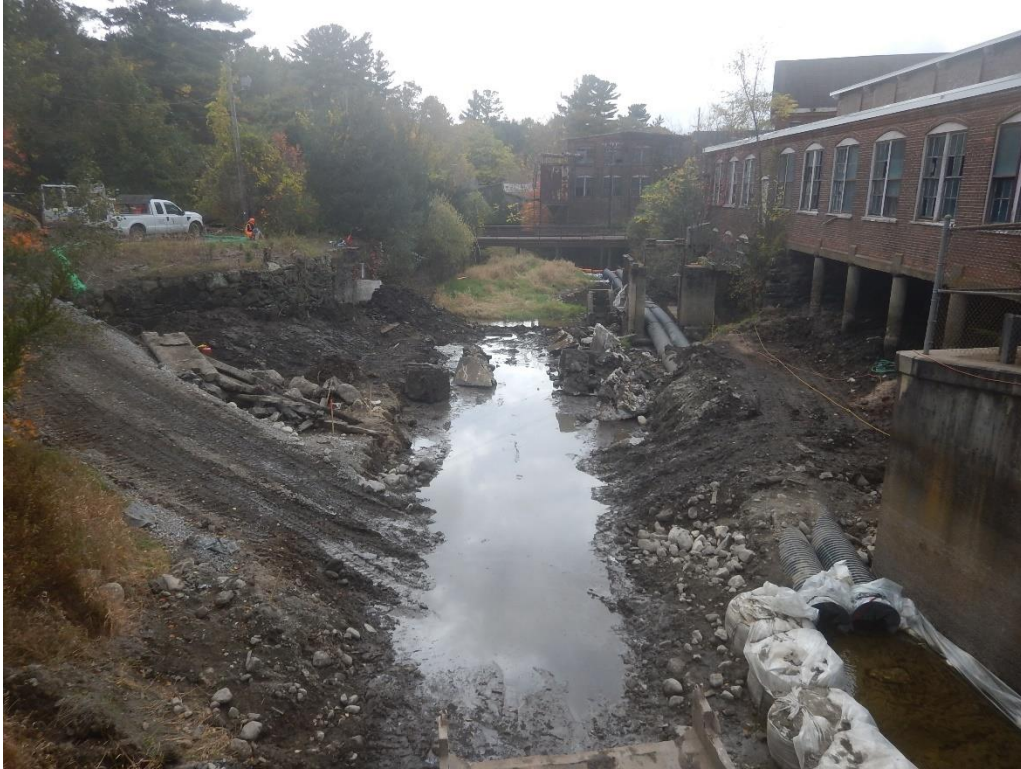
Photo 17: Looking downstream from route 106 bridge (mid-construction)
(Gomez and Sullivan, 10/24/17)

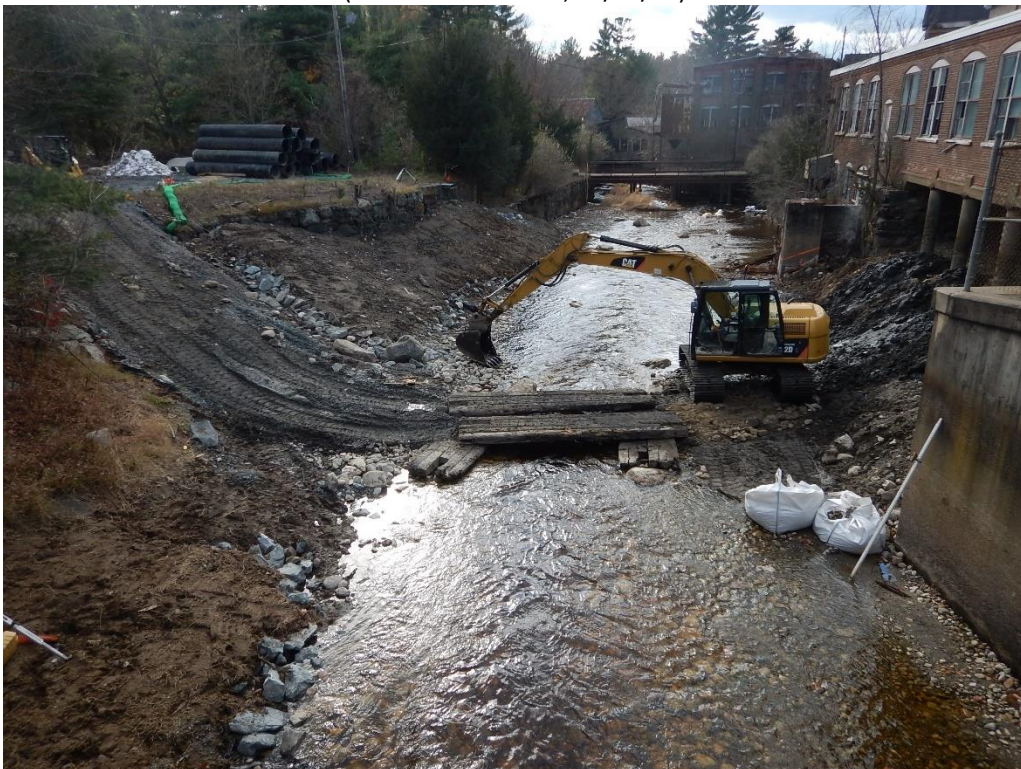
Photo 18: Looking downstream from route 106 bridge (mid-construction)
(Gomez and Sullivan, 10/24/17)

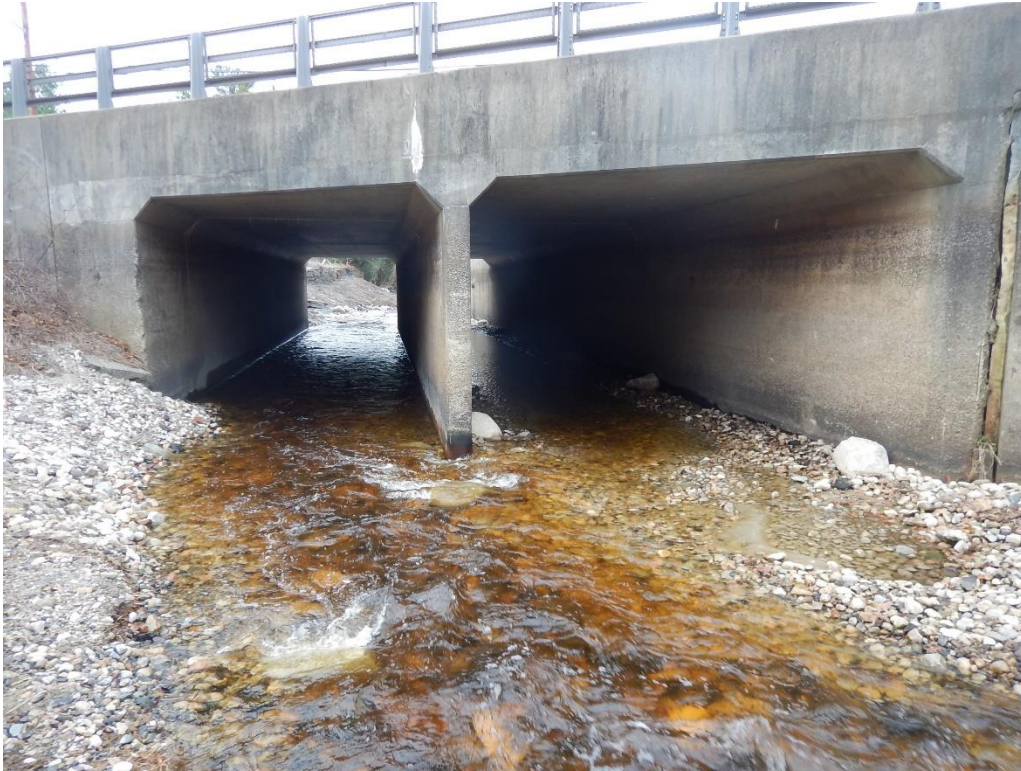
Photo 19: Looking downstream at route 106 bridge (post-construction)
(Gomez and Sullivan, 11/27/17)

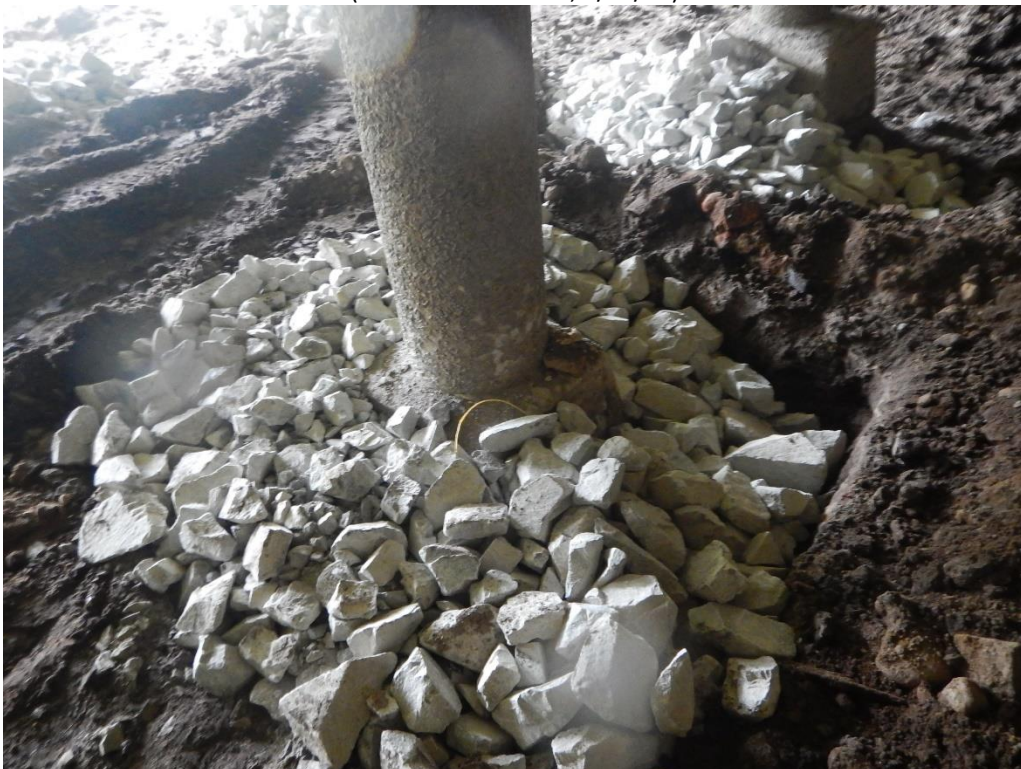
Photo 20: Mill building pier foundation protection (mid-construction)
(Gomez and Sullivan, 9/22/17)

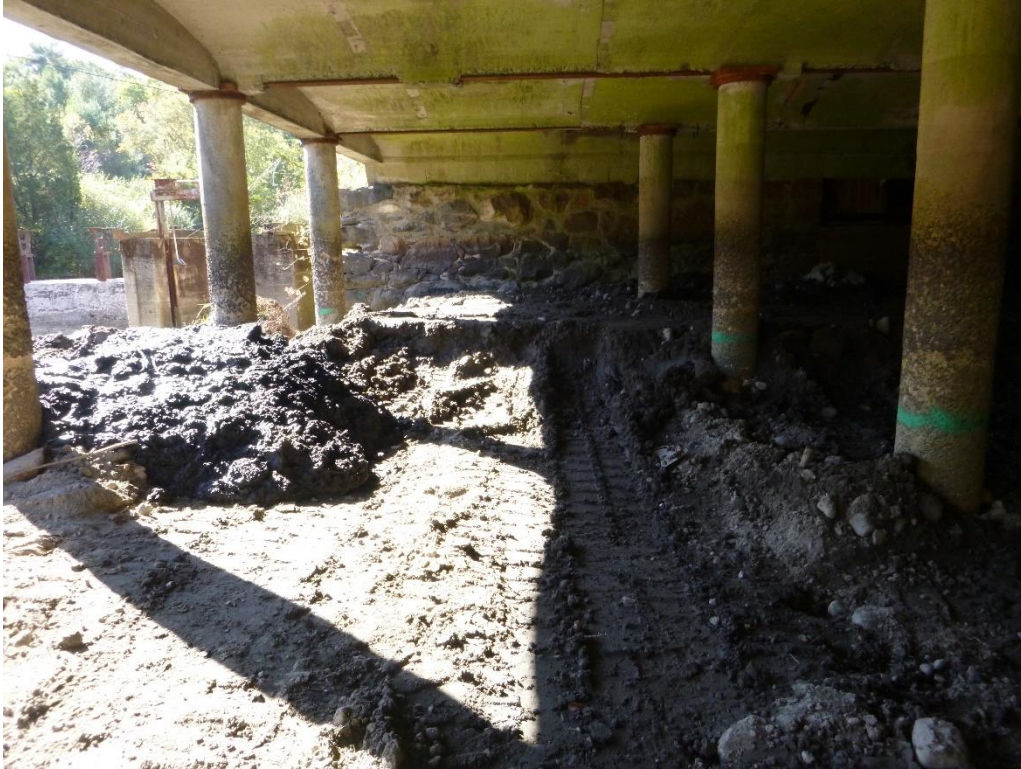
Photo 21: Mill building piers (mid-construction)
(Gomez and Sullivan, 10/20/17)

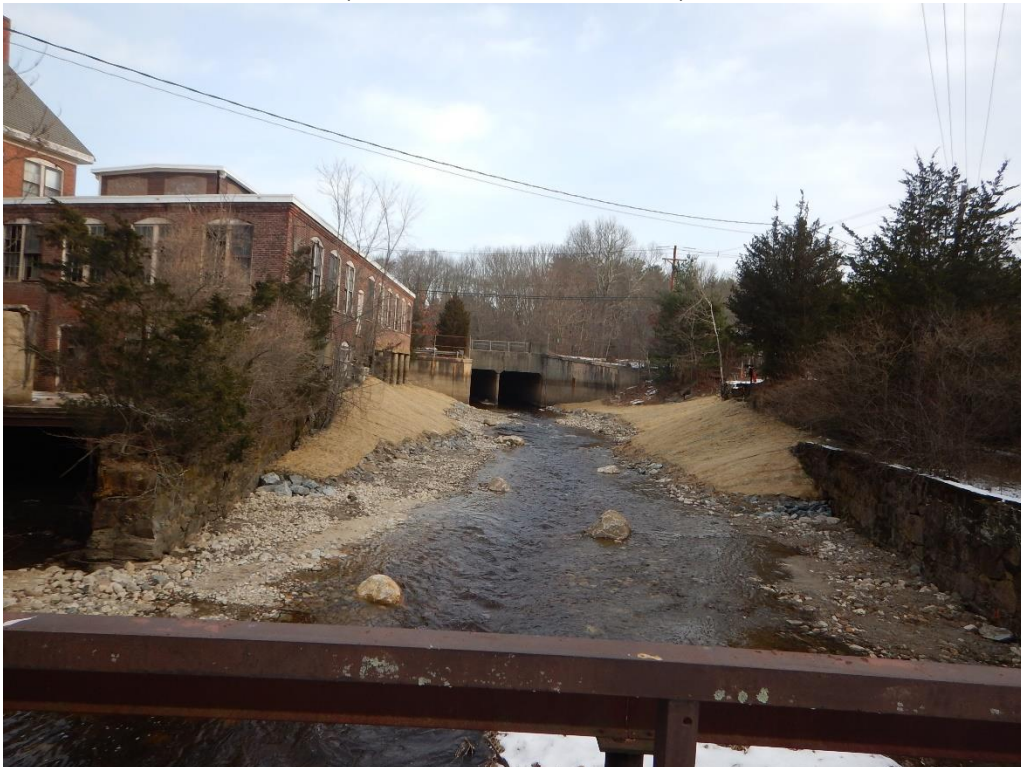
Photo 22: Looking upstream at constructed channel and removed dam (post-construction)
(Gomez and Sullivan, 12/13/17)

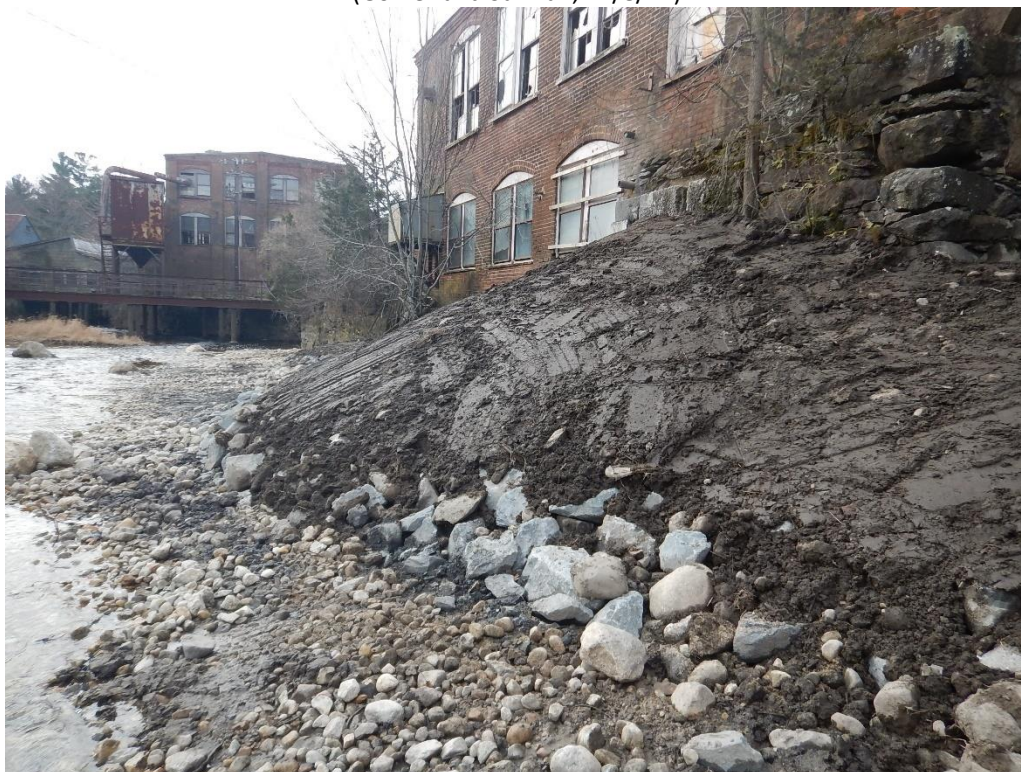
Photo 23: Looking downstream at river right stabilized abutment (mid-construction)
(Gomez and Sullivan, 12/8/17)

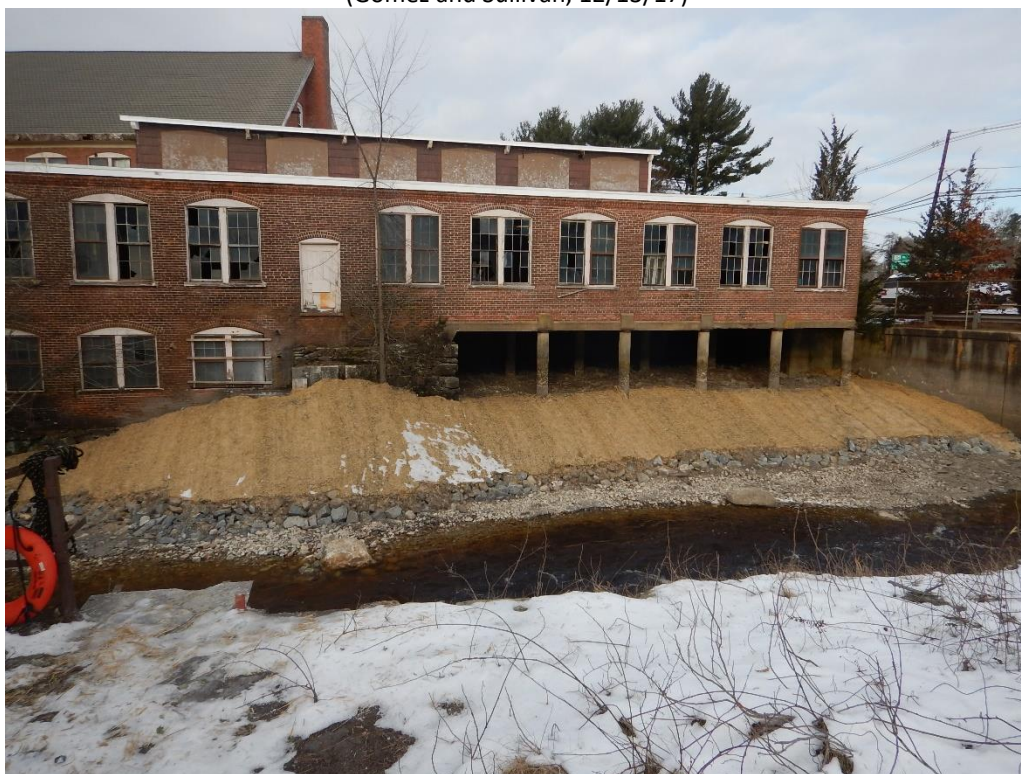
Photo 24: Looking downstream from route 106 bridge (post-construction)
(Gomez and Sullivan, 12/13/17)

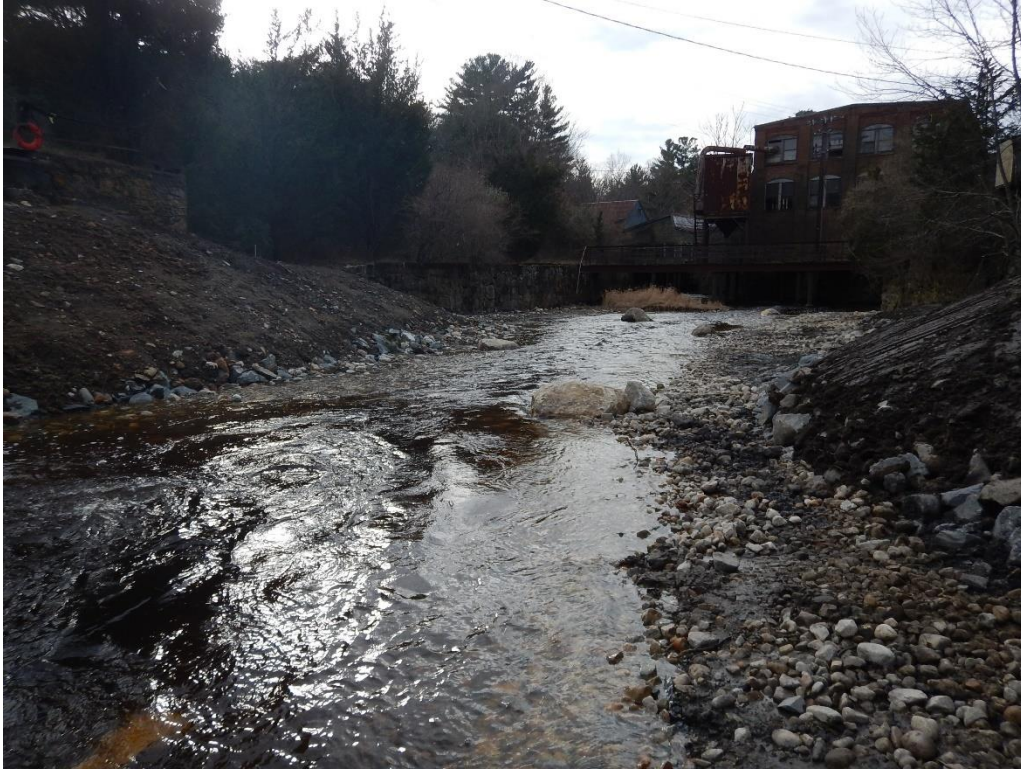
Photo 25: Looking downstream at river channel through removed dam (mid-construction)
(Gomez and Sullivan, 12/8/17)

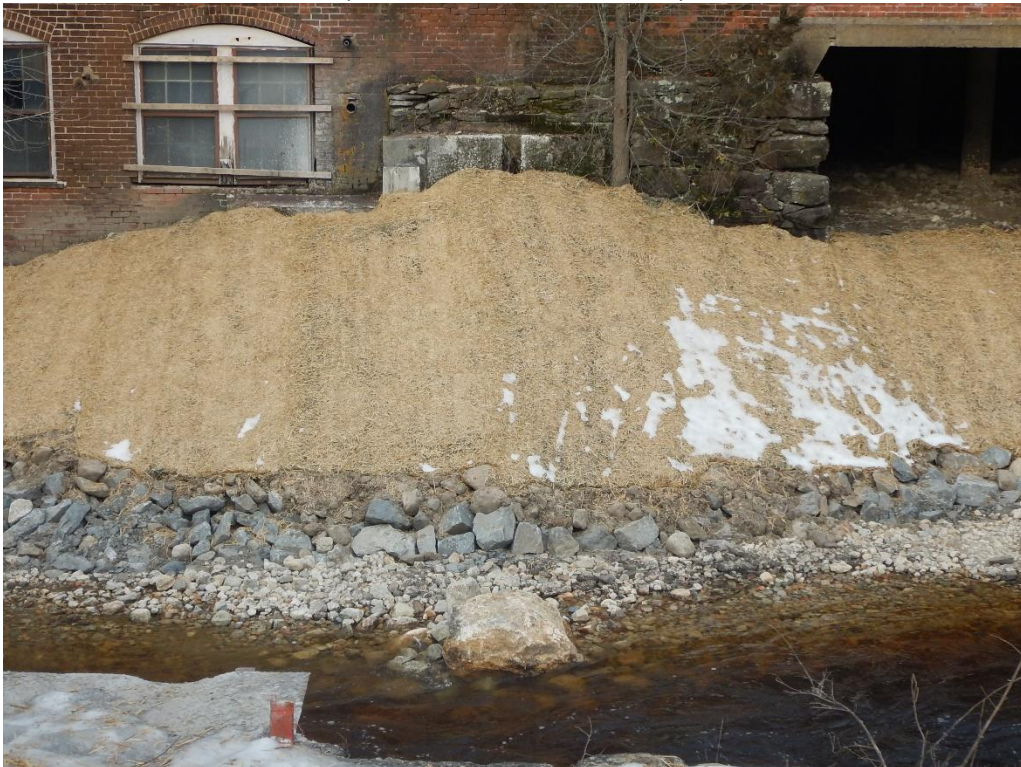
Photo 26: River right stabilized abutment, loamed, and seeded with loam (post-construction)
(Gomez and Sullivan, 12/13/17)

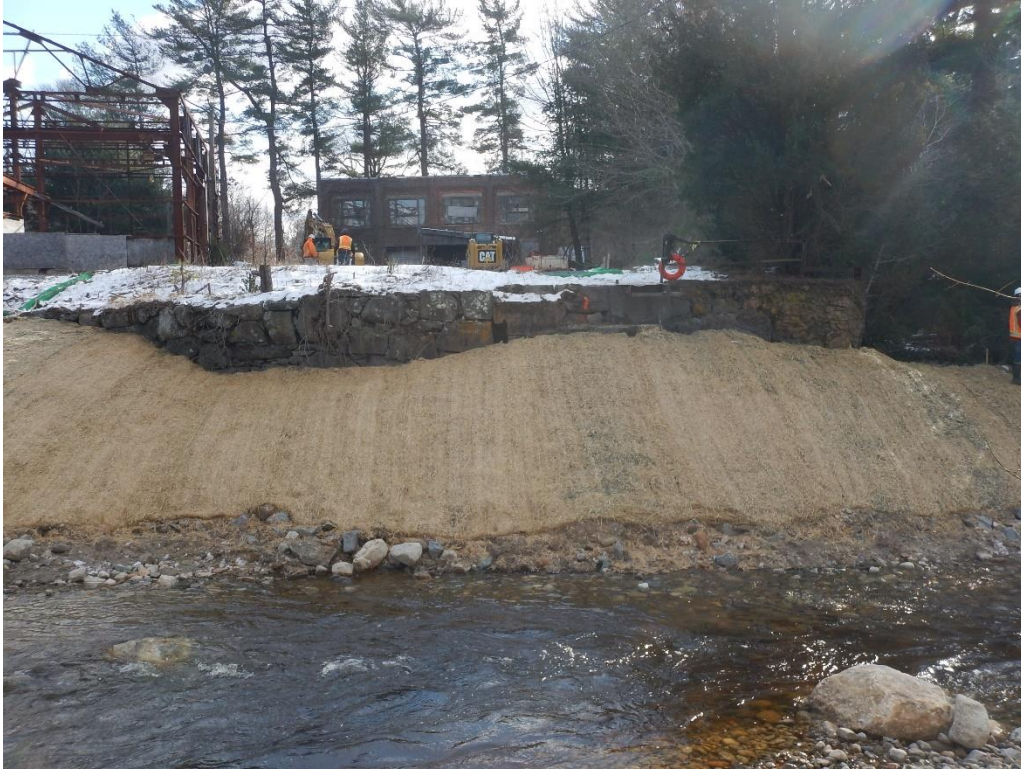
Photo 27: River left retaining wall stabilized, loamed, and seeded (post-construction)
(Gomez and Sullivan, 12/13/17)

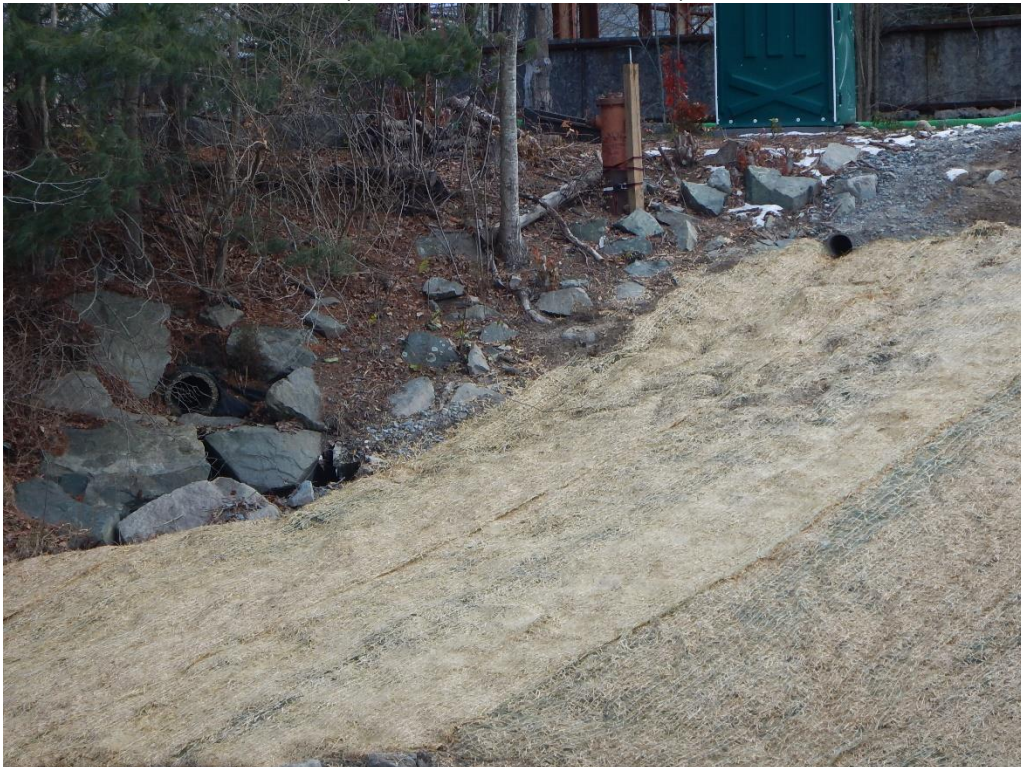
Photo 28: River left pipe outfalls and slope loamed and seeded (post-construction)
(Gomez and Sullivan, 12/13/17)
