Carver Cotton Dam Removal and Satucket River Restoration Project Monitoring Plan:

Carver Cotton Gin Dam Removal, East Bridgewater, MA – Post Removal Photo Monitoring

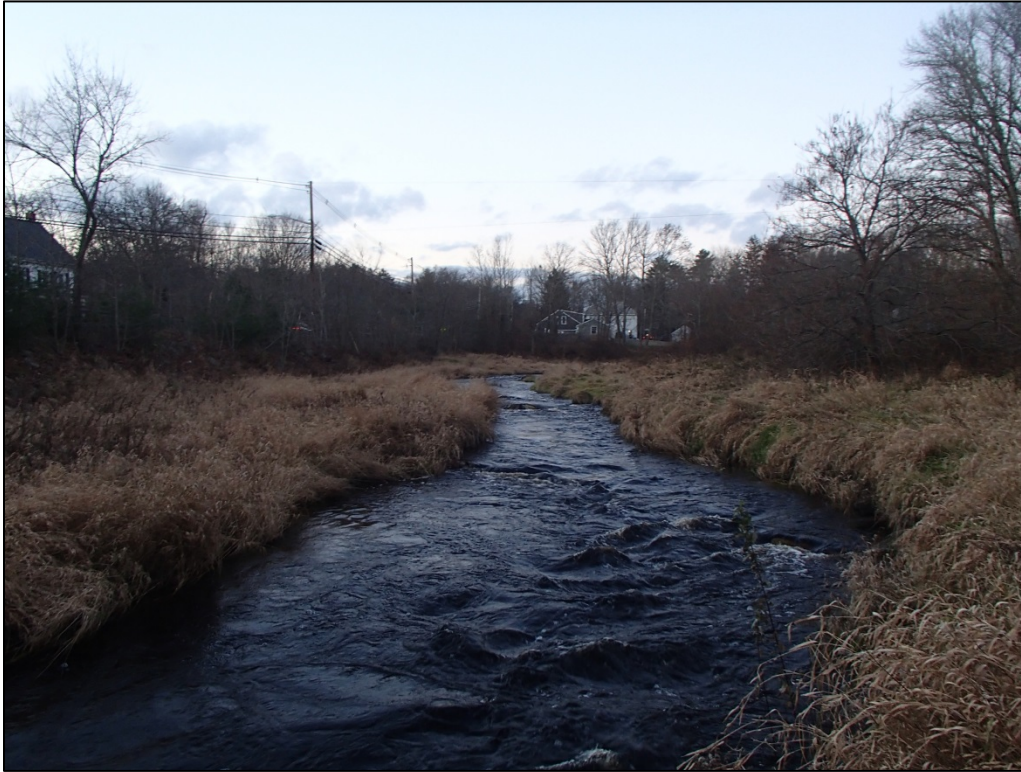
Photo 1: Station A1 – Impoundment (looking upstream) (11/21/18)

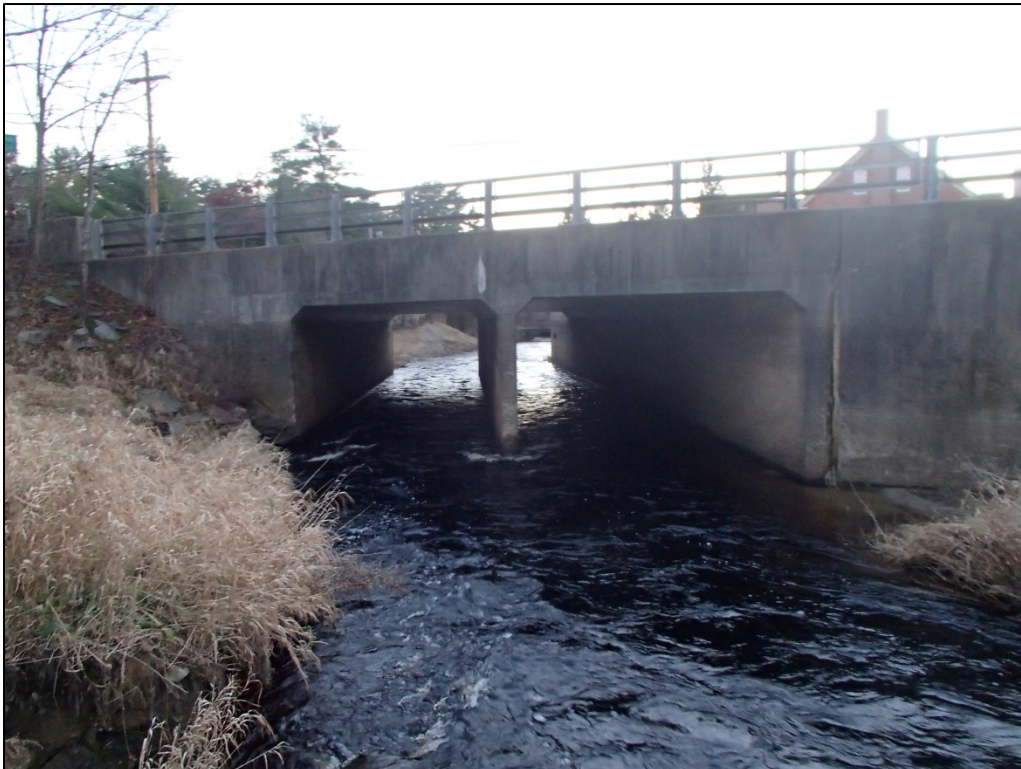
Photo 2: Station A2 – Bridge barrels (looking downstream) (11/21/18)

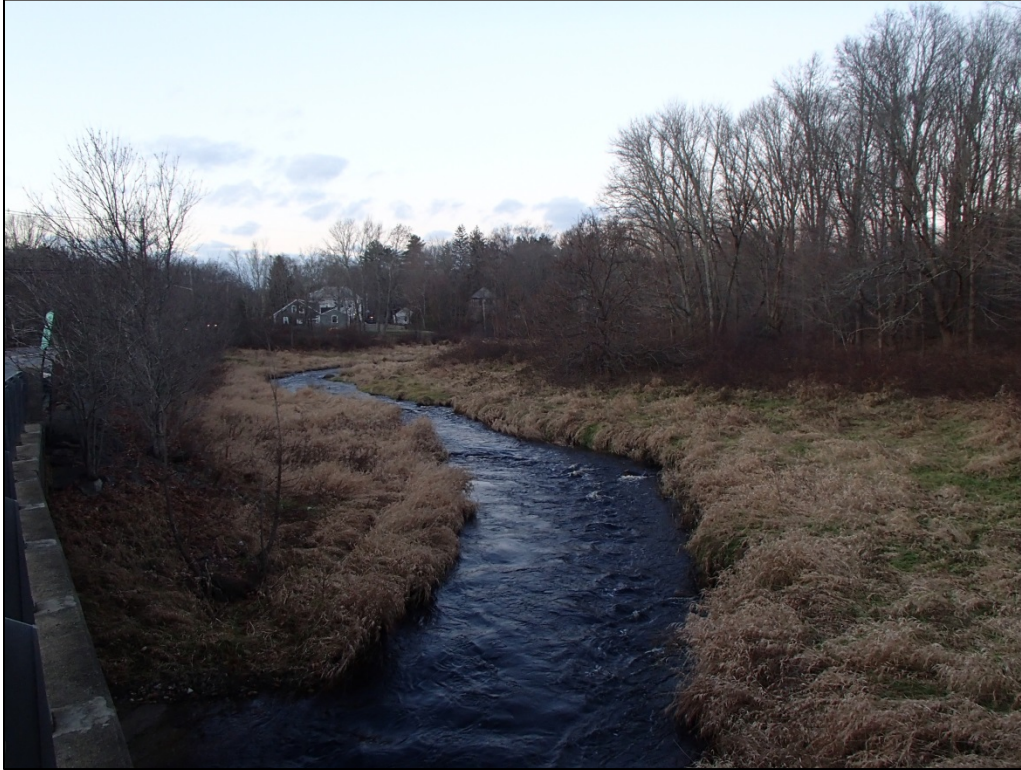
Photo 3: Station B1 – Impoundment (looking upstream) (11/21/18)

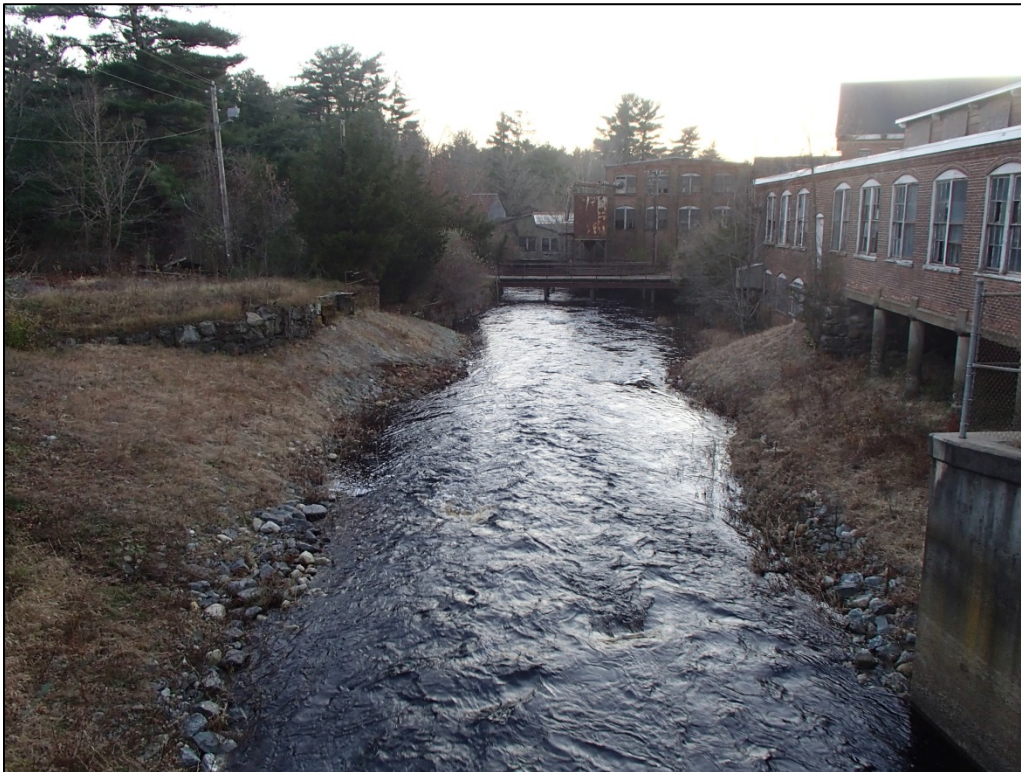
Photo 4: Station C1 – Restored Channel (looking downstream) (11/21/18)

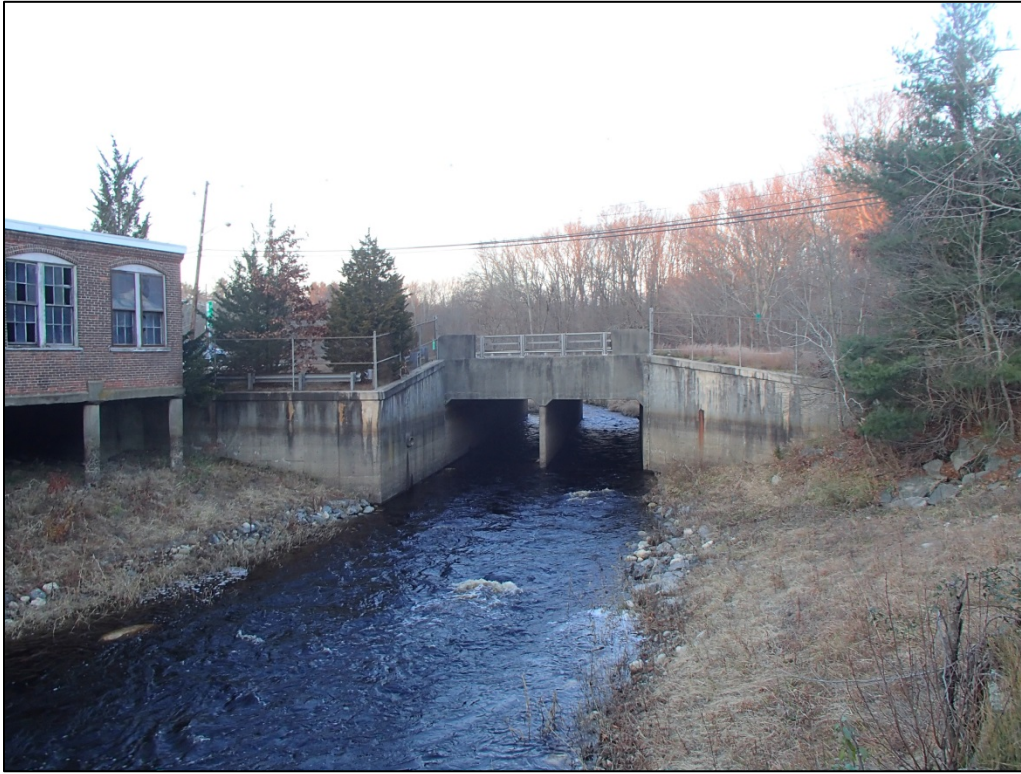
Photo 5: Station D1 – Bridge barrels (looking upstream) (11/21/18)

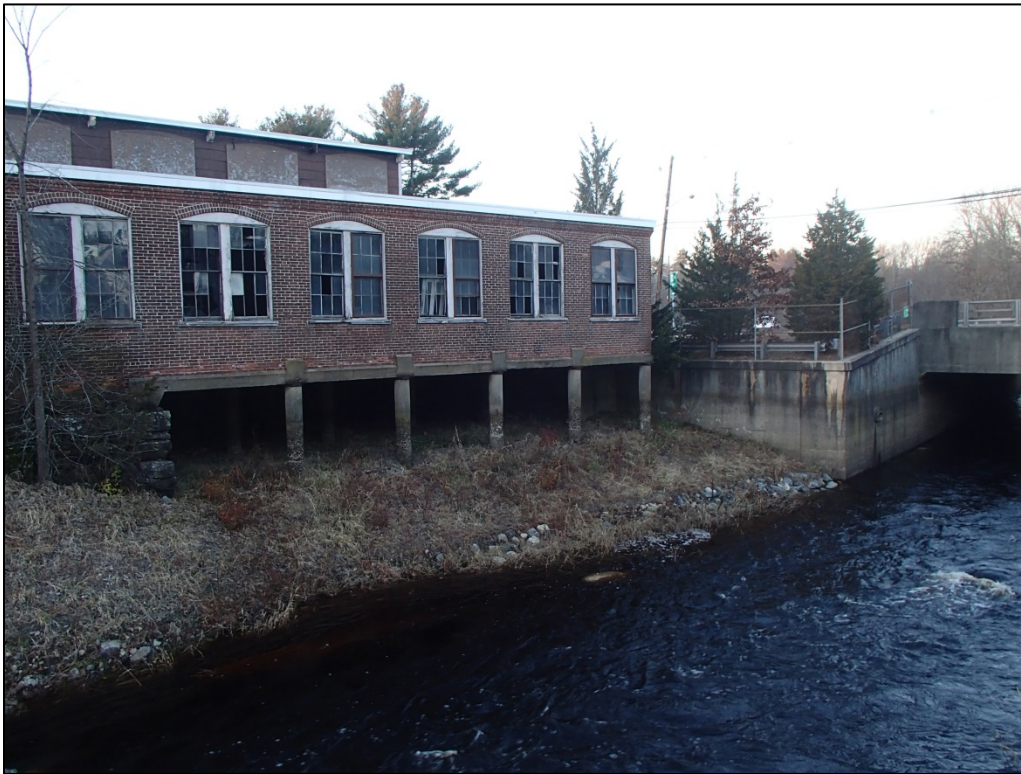
Photo 6: Station D2 – Building pier protection (11/21/18)

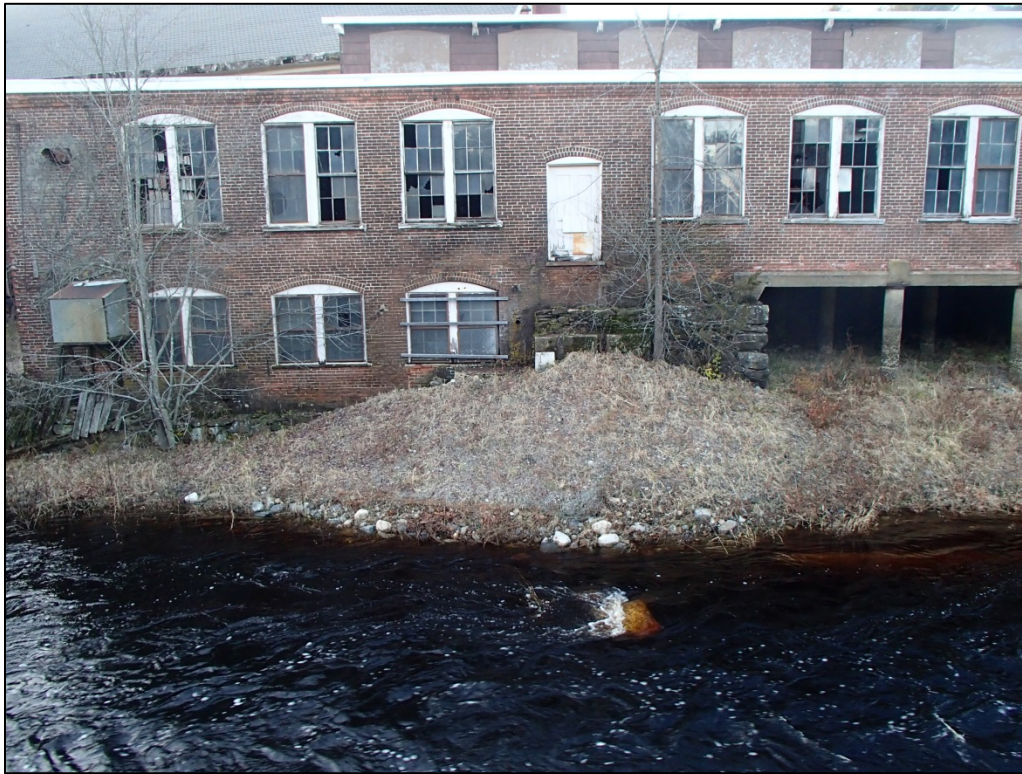
Photo 7: Station D3 – Building protection (right bank) (11/21/18)

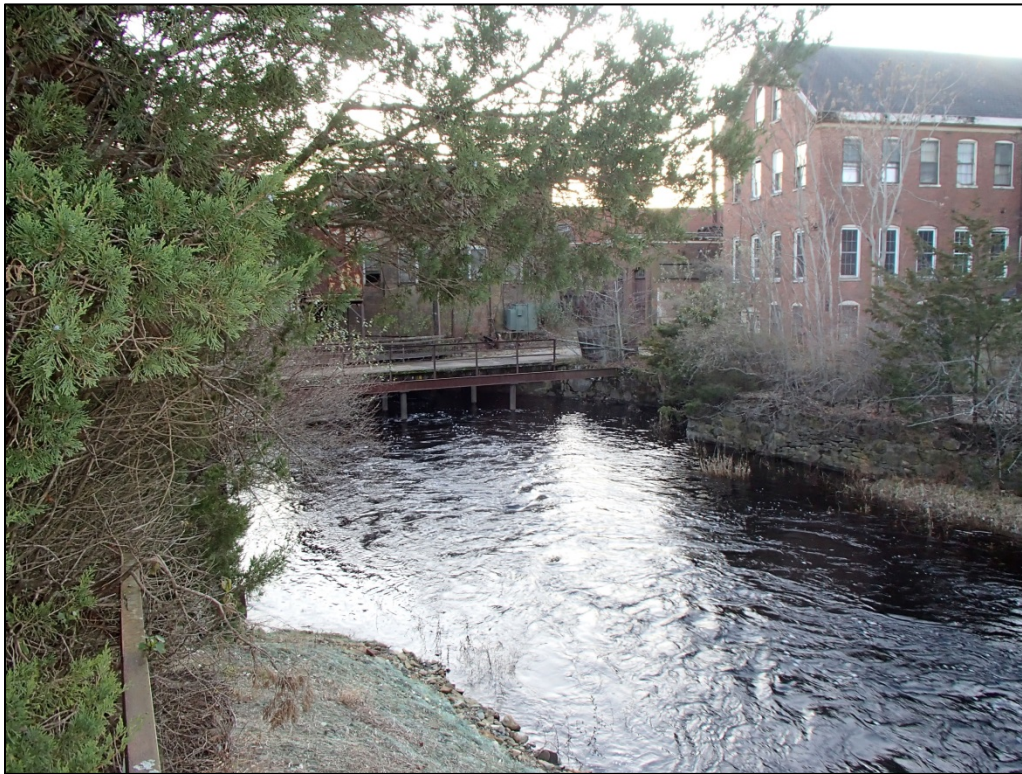
Photo 8: Station D4 – Restored channel (looking downstream) (11/21/18)

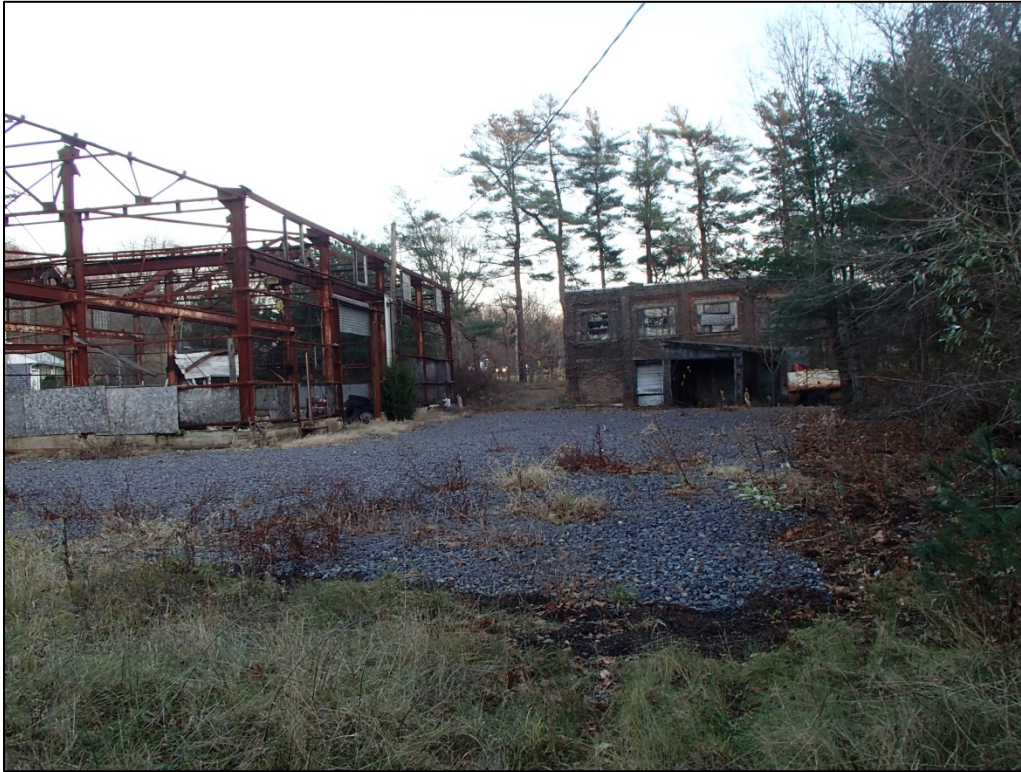
Photo 9: Station D5 – Staging area (11/21/18)

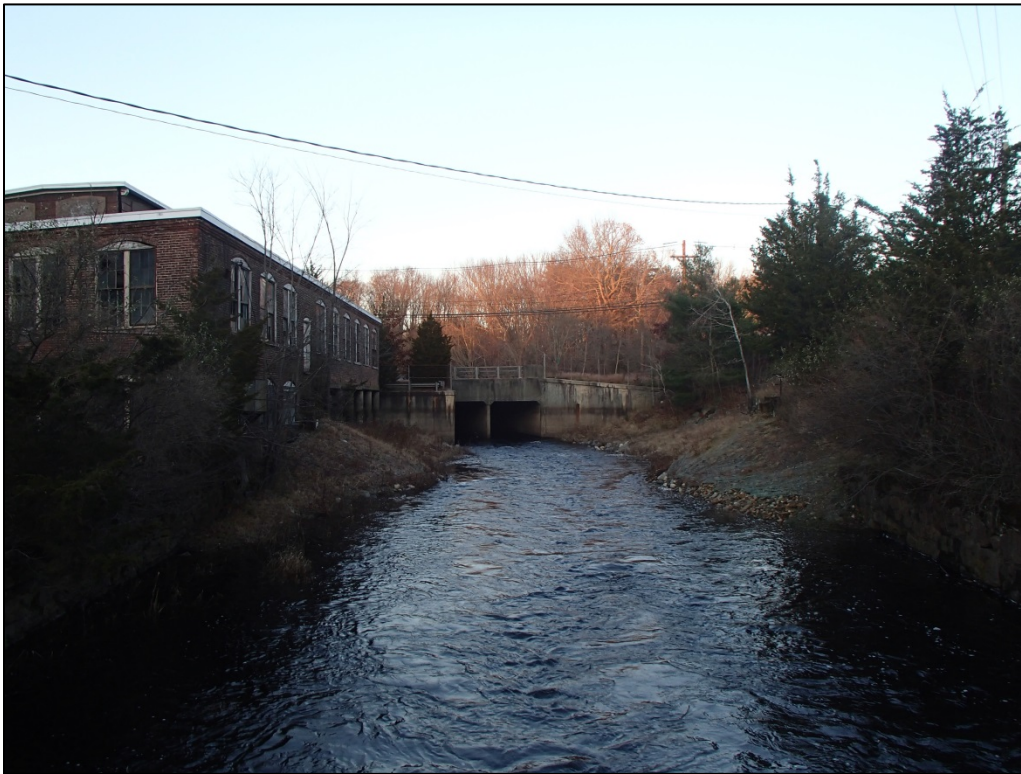
Photo 10: Station E1 – Restored channel (looking upstream) (11/21/18)

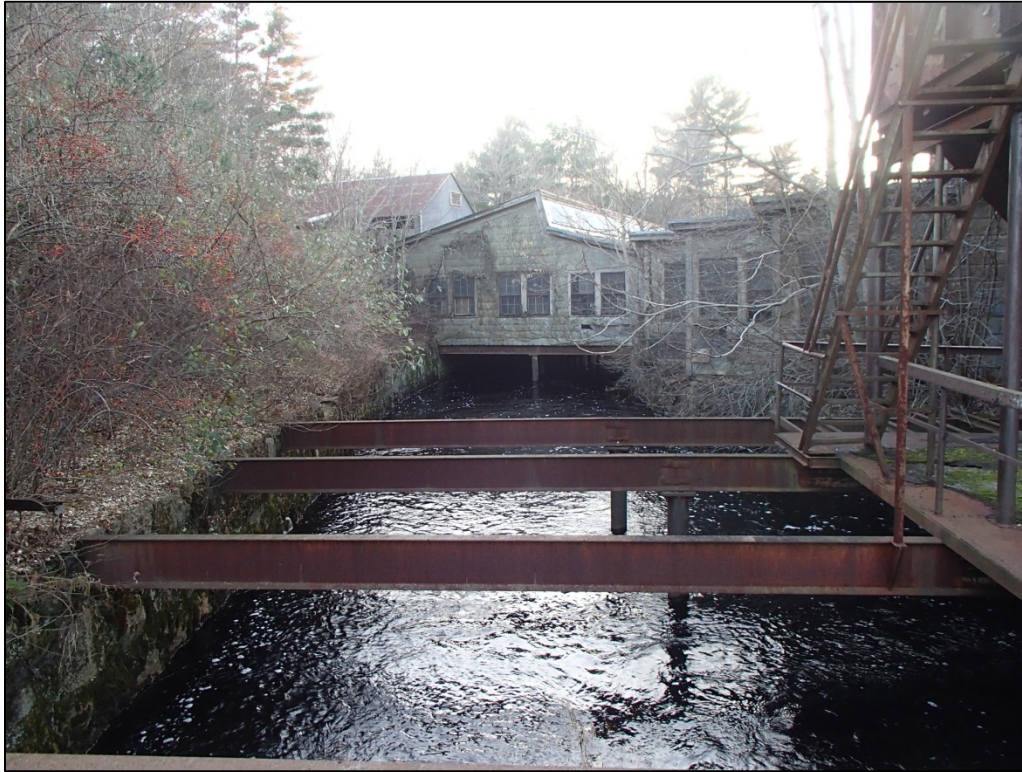
Photo 11: Station E2 – Channel (looking downstream) (11/21/18)

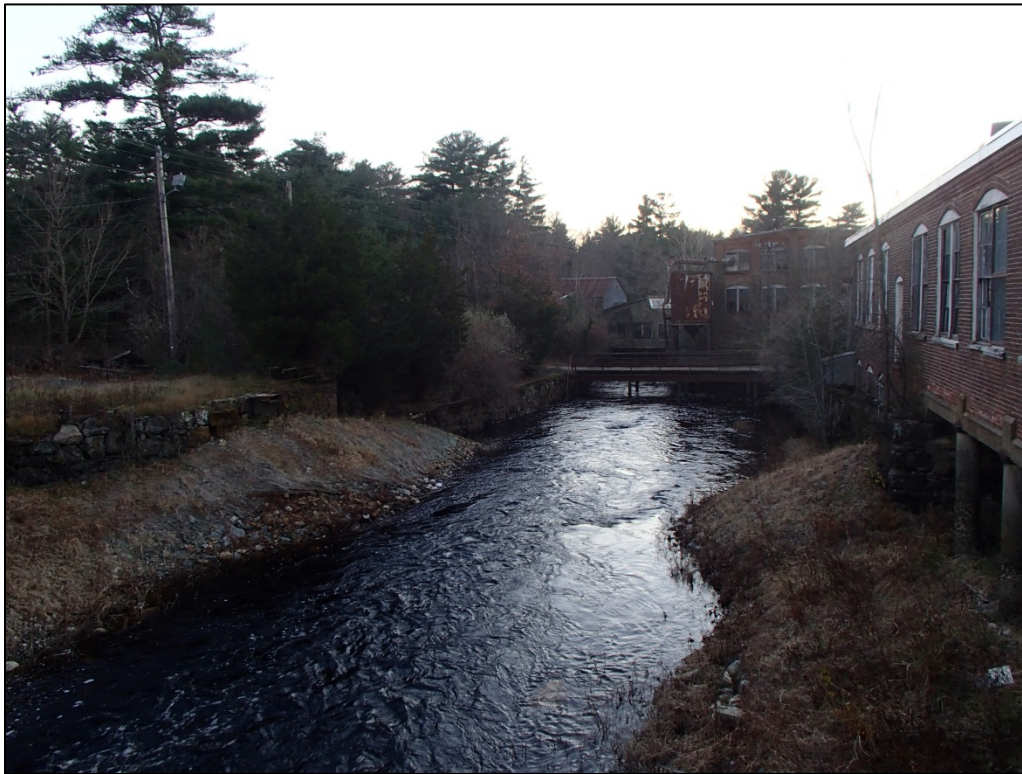
Photo 12: Station F1 – Restored channel (looking downstream) (11/21/18)

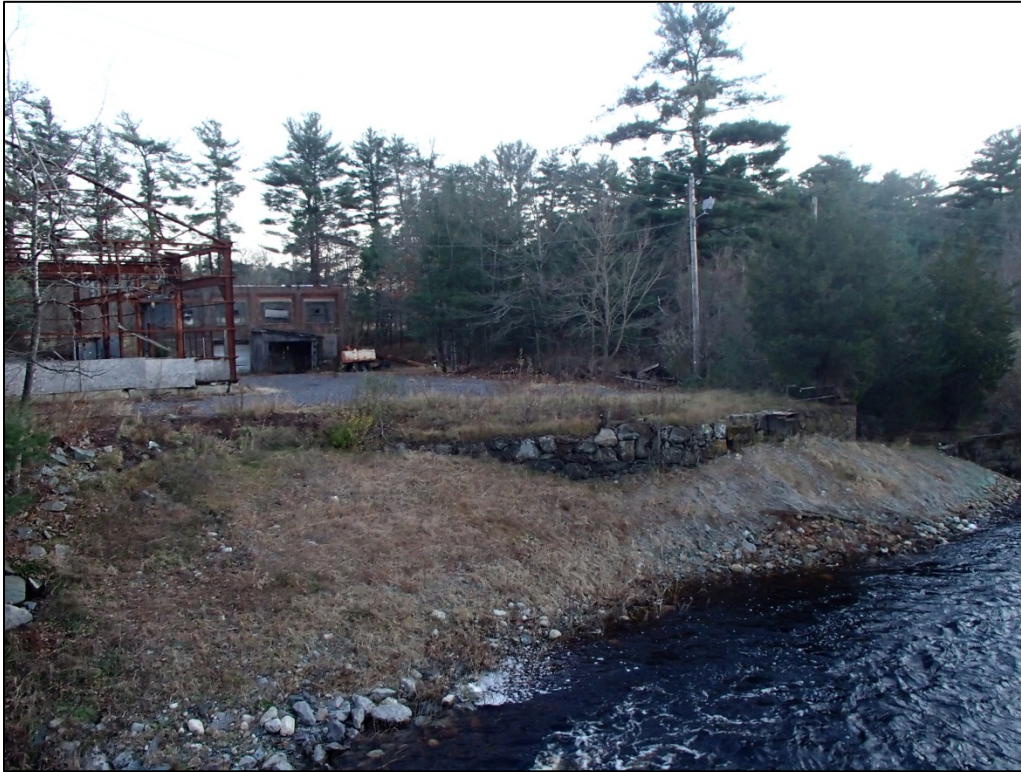
Photo 13: Station F2 – Wall protection (left bank) (11/21/18)

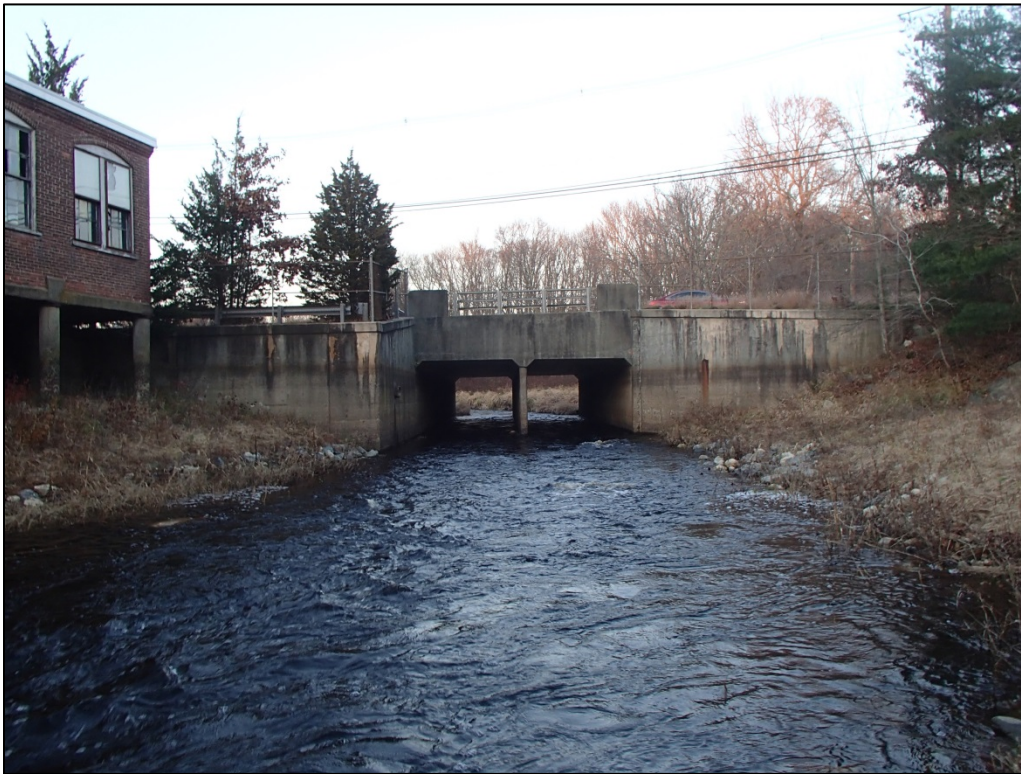
Photo 14: Station G1 – Riffle (looking upstream) (11/21/18)

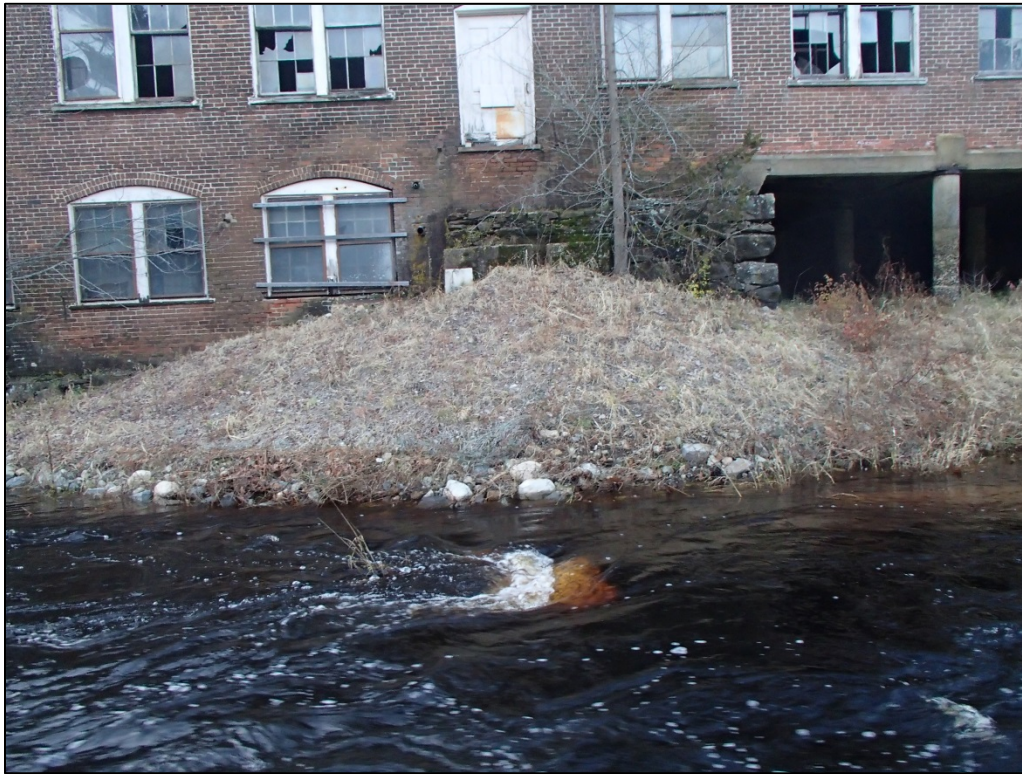
Photo 15: Station G2 – Building protection (right bank) (11/21/18)

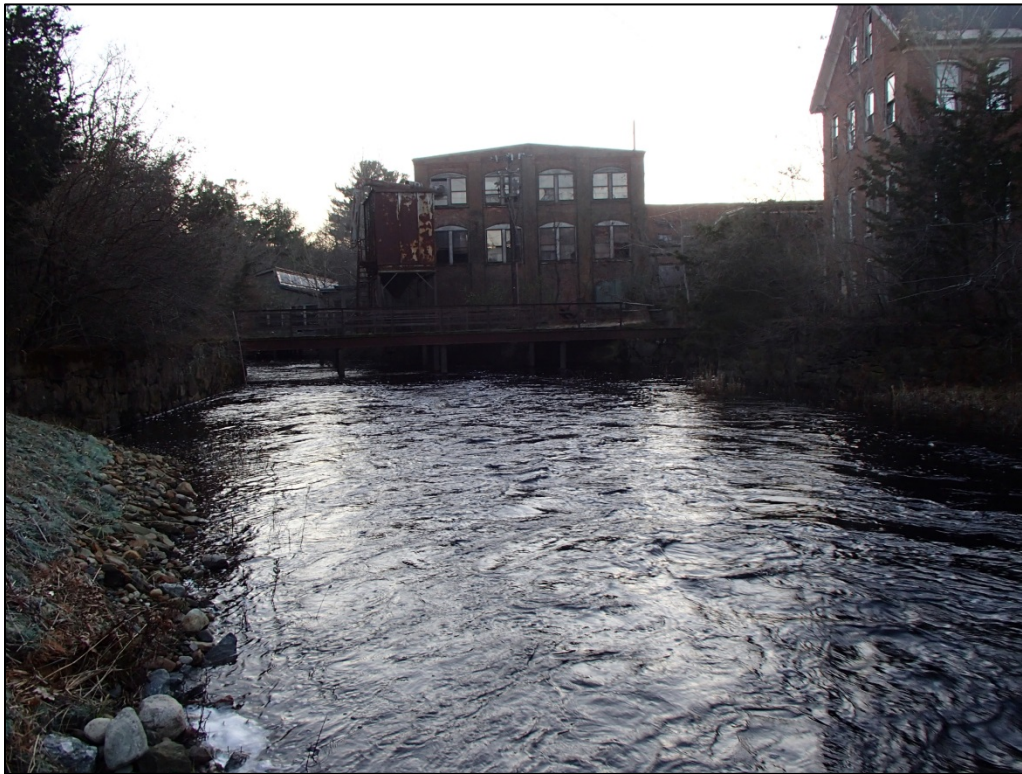
Photo 16: Station G3 – Riffle (looking downstream) (11/21/18)

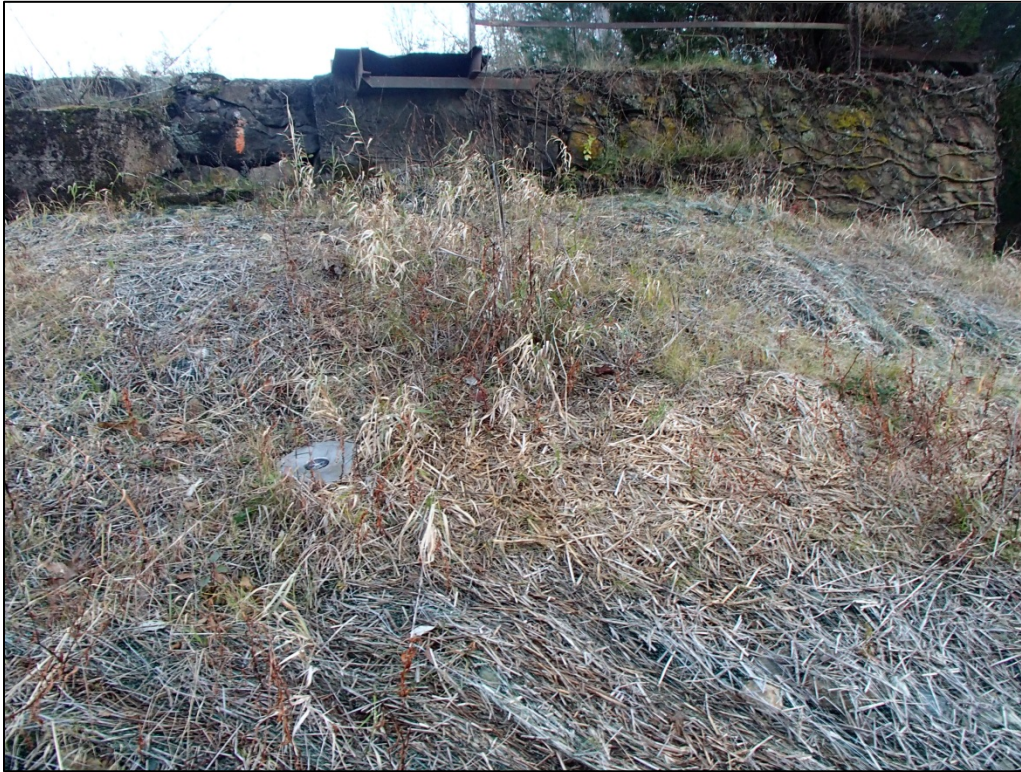
Photo 17: Station G4 – Wall protection (left bank) (11/21/18)

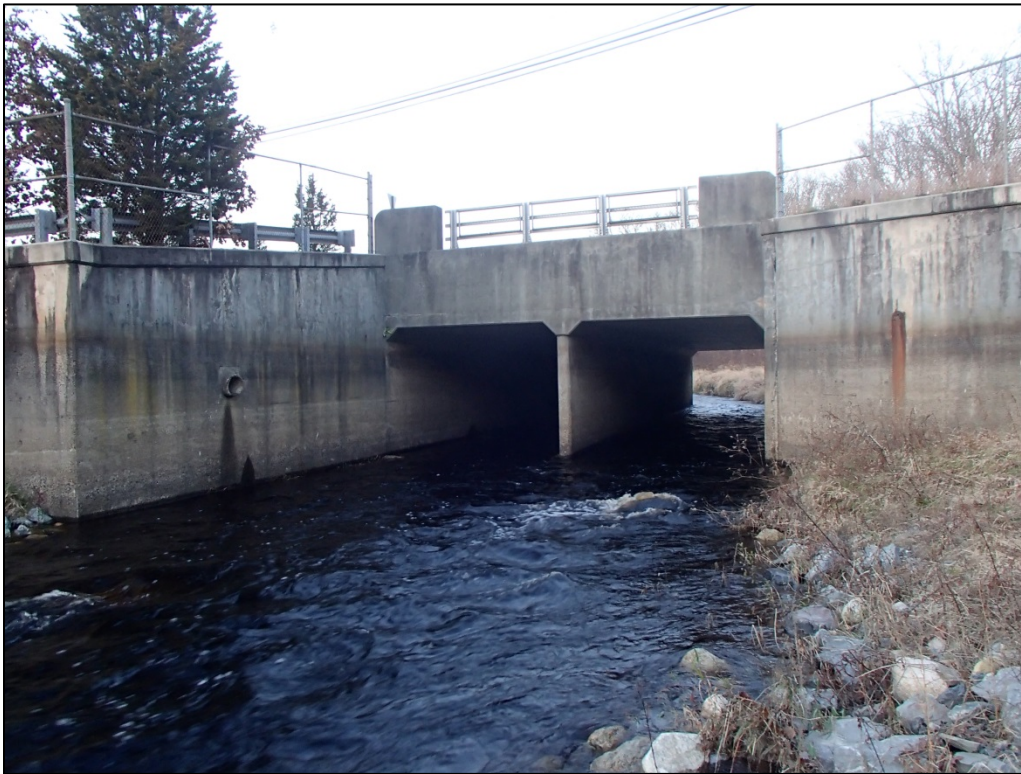
Photo 18: Station H1 – Pool (looking upstream) (11/21/18)

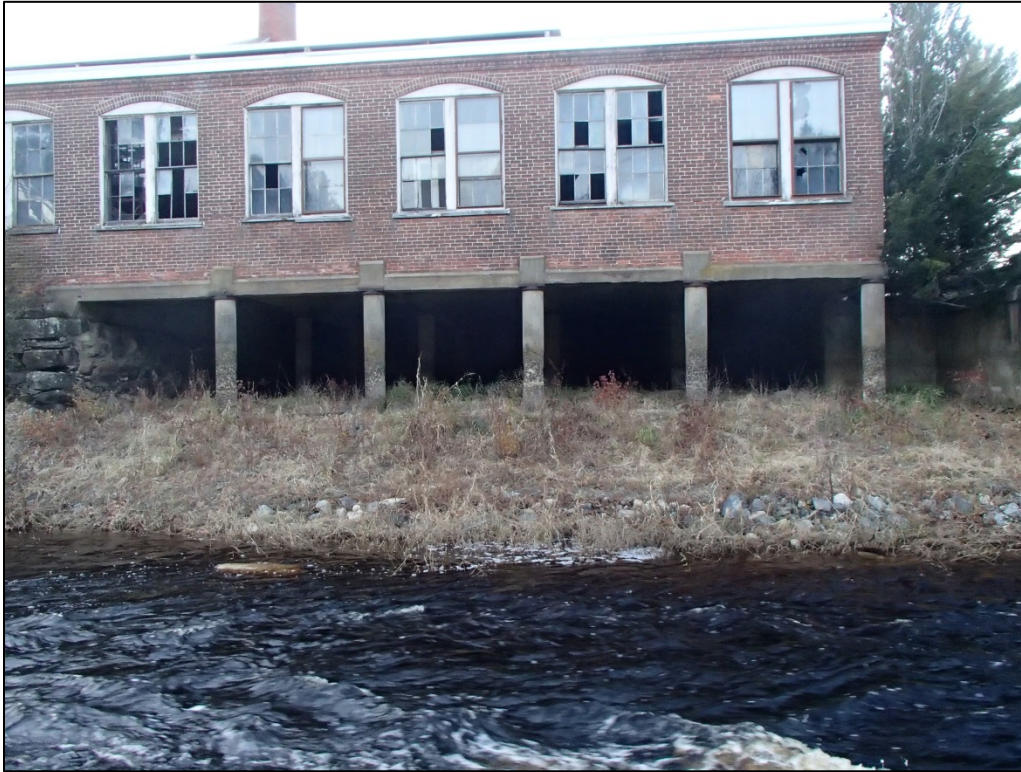
Photo 19: Station H2 – Building protection (right bank) (11/21/18)

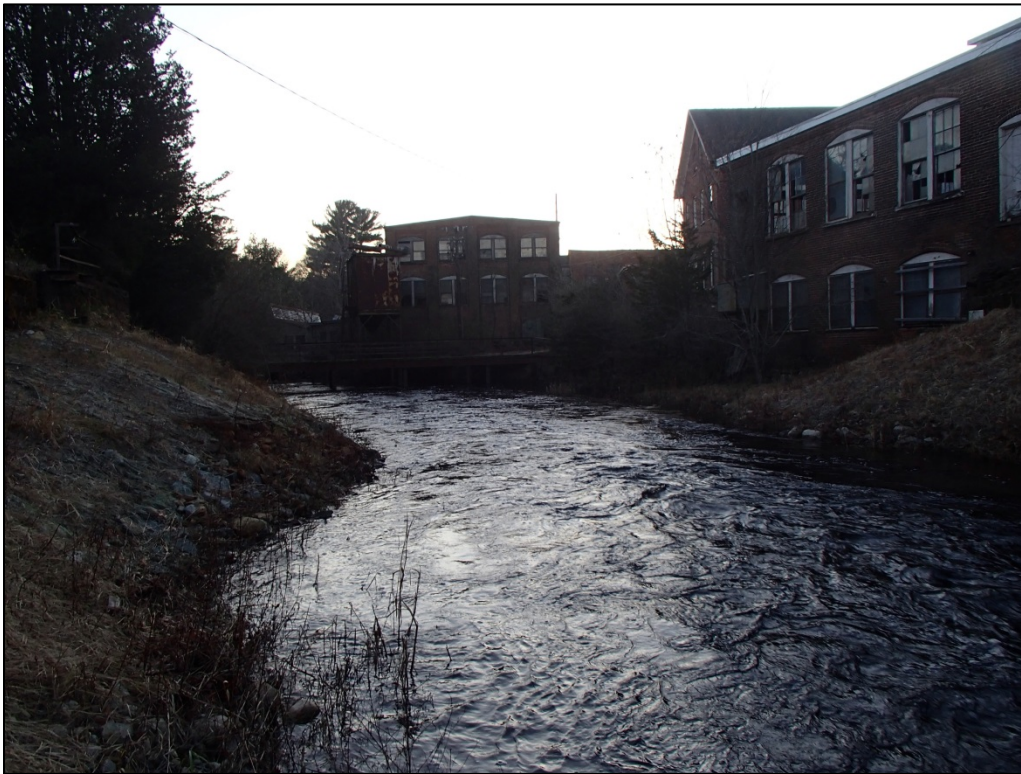
Photo 20: Station H3 – Pool (looking downstream) (11/21/18)

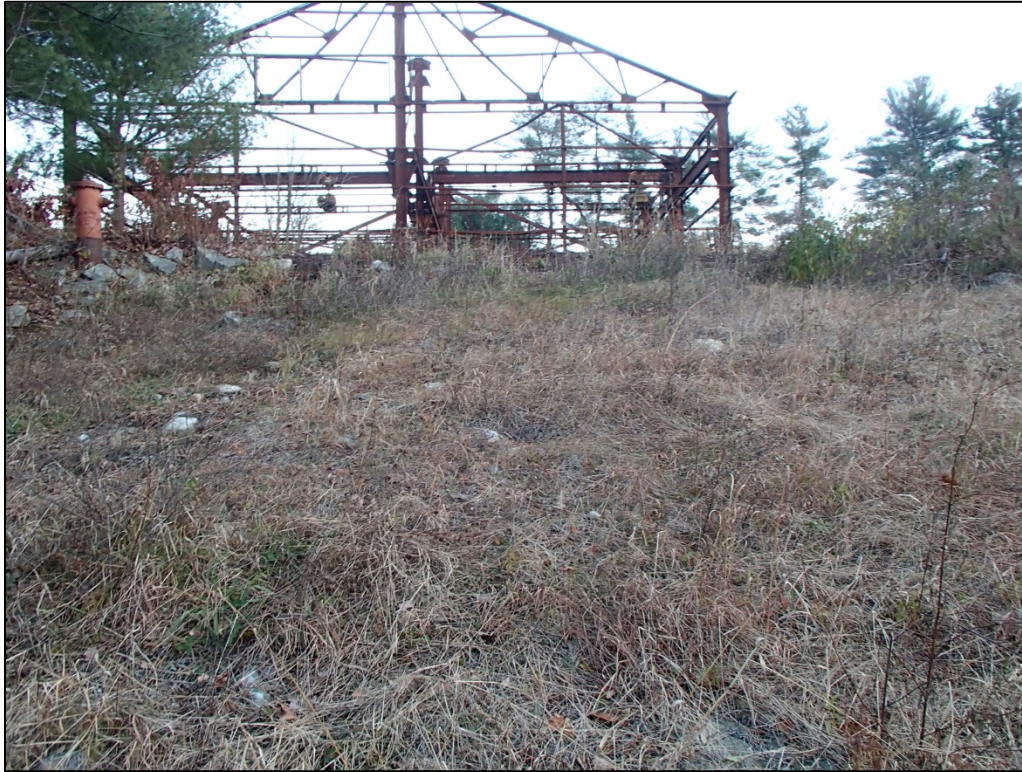
Photo 21: Station H4 – Wall protection (left bank) (11/21/18)
