***South Shore Coastal Infrastructure Inventory
and Assessment Demonstration Project
Coastal Hazards Commission***

Town of Scituate

February 28, 2007

**Presented by:
Bourne Consulting Engineering
Franklin, Massachusetts**

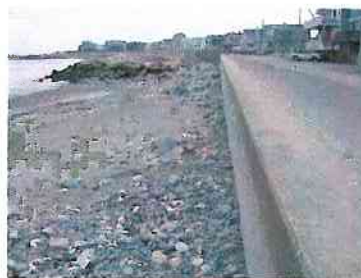
This structure is a vertical concrete seawall with a wave return face. Some sections of the wall have rubble located along the toe. The wall is weathered and exhibits minor cracking and spalling.

Structure observed to exhibit very minor problems, superficial in nature. Minor erosion to landform is present. Structure / landform adequate to provide protection from a major coastal storm with no damage. Actions taken to prevent / limit future deterioration and extend life of structure.

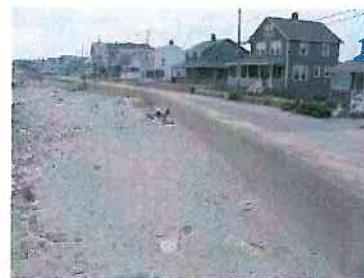
This structure is a low vertical seawall made of concrete. It is fronted by a bedrock outcropping just offshore. Minor cracks and spalling is evident. The northern end has a small section missing at its base.

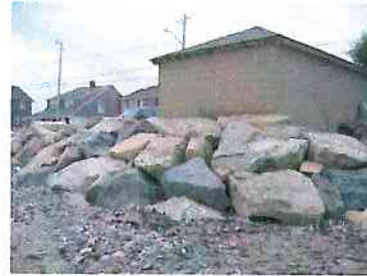
This structure is a stone revetment fronting a small private structure which appears to be a garage. The single layer of armor stone shows normal weathering and is generally in good condition and functional.

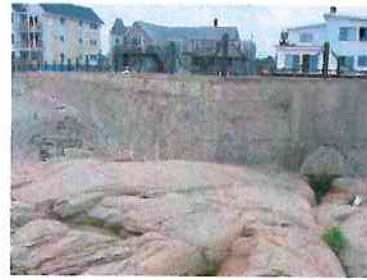
This structure is a vertical masonry wall with a concrete veneer. Weathering is evident and there is minor cracking along the concrete cap.

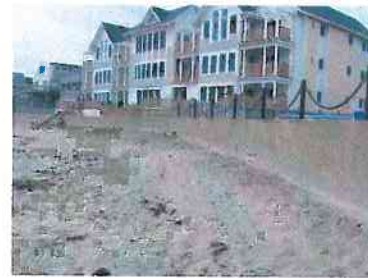
This structure is a vertical concrete seawall. Minor cracking and spalling is present.

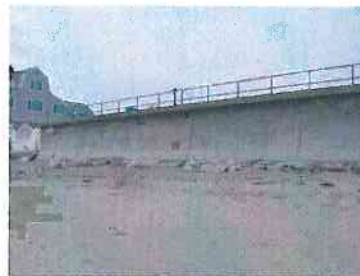
This structure is a vertical concrete seawall with a recurved cap. The toe is fronted by riprap which is mostly buried in the beach. The wall exhibits cracking and spalling of the concrete consistent with normal weathering.

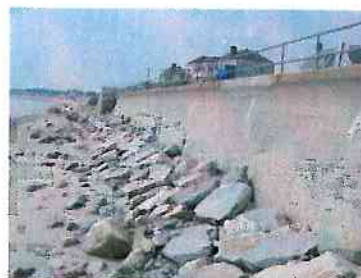
This is a vertical seawall with a stone revetment placed at the toe of the wall. The wall shows cracking and spalling with some larger cracks evident on the face of the wall. Some undermining of the toe apparent at the south end near the junction with the stairs.

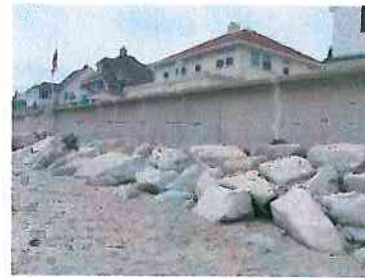
This structure is a concrete seawall with a wave return face and rip rap at the toe. Minor cracking and spalling is evident along the wall. Some of the cracking looks to have been repaired/filled.

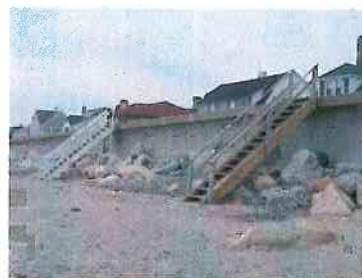
This structure is a concrete seawall with riprap placed at the toe. The concrete shows minor cracking and spalling but is generally in good condition.

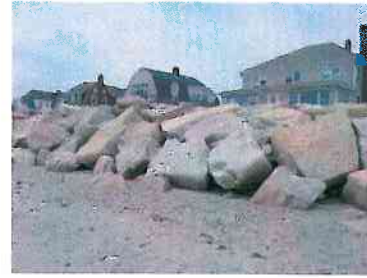
This is a stone revetment which is fronting/covering an old concrete seawall which is in poor condition. The central portion of the revetment shows minor slumping and loss of crest elevation.

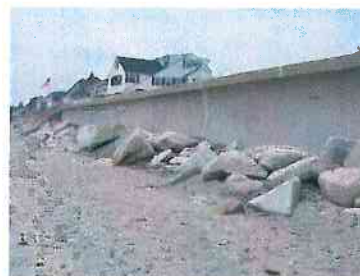
This structure is a recurved concrete seawall with riprap placed along the toe. Minor cracking and spalling is evident along the wall.

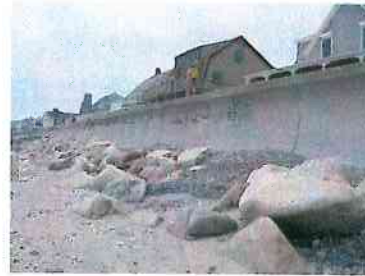
This structure is a wave return face concrete seawall with stone placed at the toe. The concrete shows cracking and spalling along the face of the wall, especially just below the top of the return face area. There is a large 20'-30' horizontal crack along the front of the wall which has been repaired.

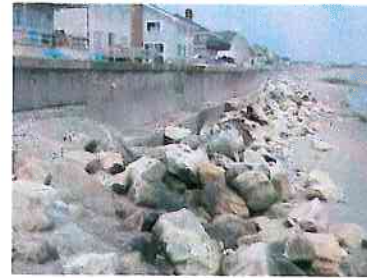
This structure is a wave return face concrete seawall with a concrete toe wall and stone riprap along the toe. Cracking and spalling is evident throughout along with severe discoloration of the concrete due to weathering. The wall appears to have rotated slightly with the crest tipping forward by a few inches in sections, relative to the neighboring sections. An inspection of the toe/foundation of the wall is merited.

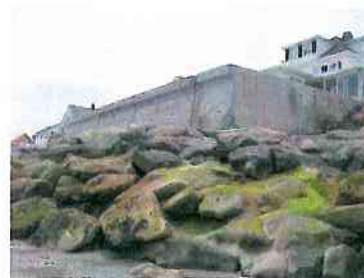
This structure is a concrete seawall with rip rap along the toe of the wall. This section of the wall jutting out from the adjacent seawalls and protects a single house behind it. The stone along the toe at the north corner has been grouted and this north corner of the wall itself is the most worn. There is severe cracking and spalling along the face of the seawall, along the crest and at the section joints. The material behind

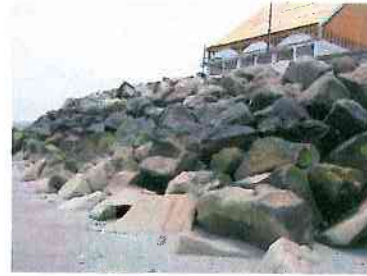
This structure is a stone revetment fronting a seawall/foundation of the single home behind it. The stone is weathered and displaced in some areas, espically at the south end due to possible end effects of being the end of this very long section of armored coastline.

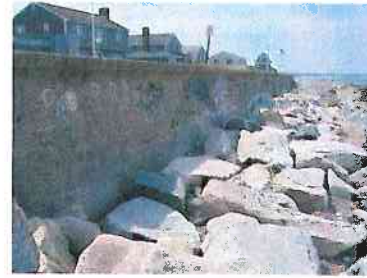
This structure is a concrete seawall with riprap at the toe. There is severe cracking and spalling along the face and crest of the wall. The rebar is exposed and rusted in some areas. The toe of the wall is almost exposed in some areas.

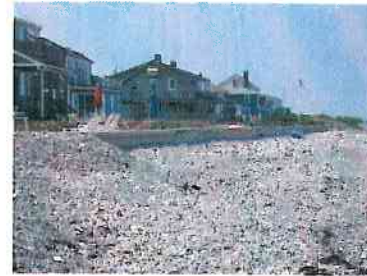
This structure is a small concrete seawall. The cobble beach fronting the wall has been pushed up against the wall, covering the crest in certain sections. Cobble is evident behind the wall. The wall itself shows moderate cracking and spalling throughout.

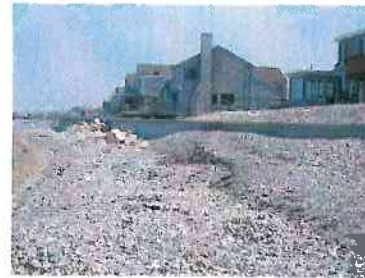
This is a concrete seawall with some random placed stone in front along certain sections. There is cracking and spalling evident and many portions of the wall face and the crest has been resurfaced and repaired.

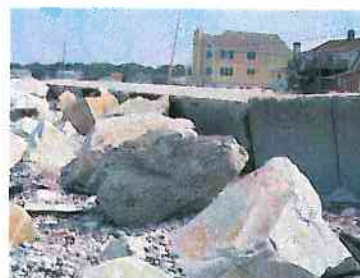
This is a concrete seawall with armor stone placed in front of it. The majority of the structure is broken, falling forward and generally failing

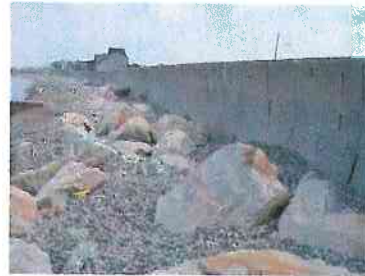
This is a concrete seawall with some armor stone placed in front of it. This section of the wall shows severe cracking and spalling with the rebar having been exposed in some areas.

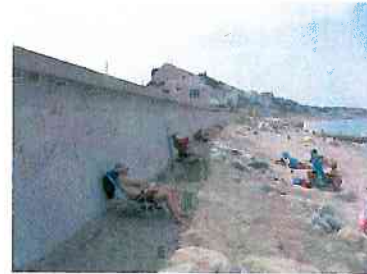
This structure is a concrete seawall with riprap placed at the toe. The armor stone along the toe is partially buried by the sand beach. The concrete shows normal weathering. The eastern terminus is a beach accessway and some spalling is evident here.

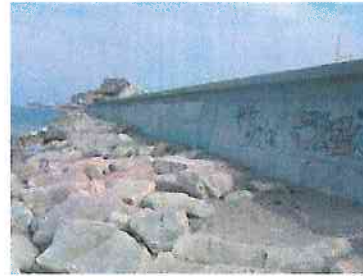
This structure is a concrete seawall with a stone revetment along the toe. Minor cracking and spalling are occurring but the structure is generally in good condition.

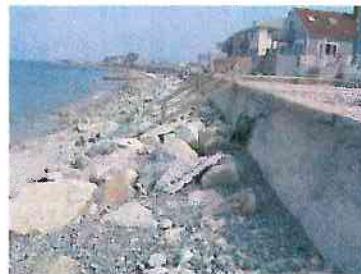
This is a vertical concrete seawall with riprap placed along the toe. The surface of the wall is heavily spalled and there are frequent large cracks on the wall's surface. Some other areas have been resurfaced and patched.

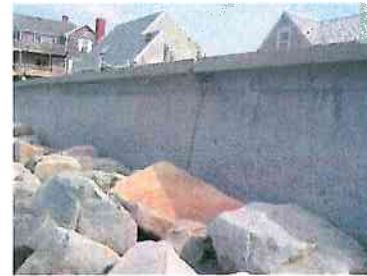
This is a concrete seawall with a wave return face and riprap along the toe. The armor stone along the base of the wall shows some breakage. The wall is in good condition.

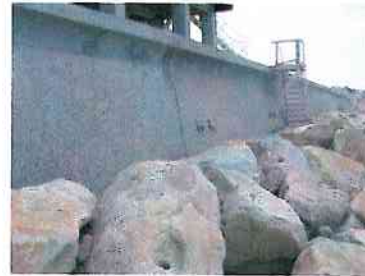
This structure is a vertical seawall with riprap placed along the toe. The wall shows some cracking and spalling along the surface but is generally in good condition.

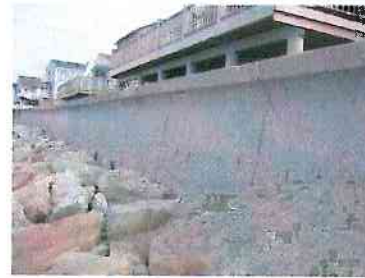
This structure is a concrete seawall with armor stone placed along the toe. Heavy cracking and spalling is evident along the surface of the wall.

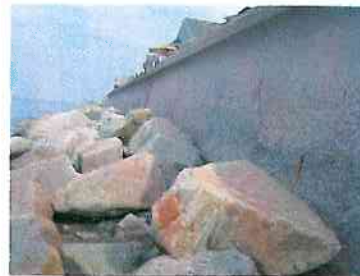
This structure is a concrete seawall with a wave return face and riprap along the toe. Approximately 75% of the armor stone at the base of the wall has been grouted. The wall and stone are generally in good condition.

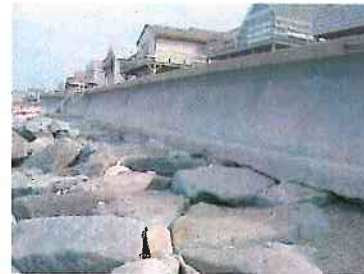
This structure is a concrete seawall with a wave return face cap and grouted armor stone along the base. There is also a small concrete toewall at the base which has become exposed. The main wall shows some cracking and spalling. The undermining of the toe wall is cause for concern.

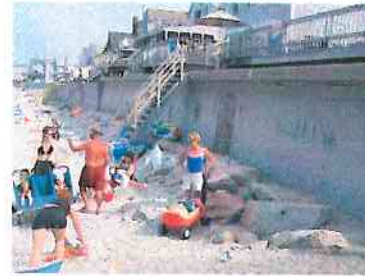
This structure is a concrete seawall with a recurved cap and riprap along the toe. Surface cracking and spalling is seen along the concrete wall.

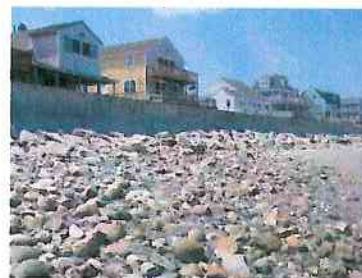
This structure is a concrete seawall with a wave return face cap and riprap along the toe. The wall shows cracking and spalling along greater than 50% of the crest. The stone at the base of the wall is unraveled for most of the length.

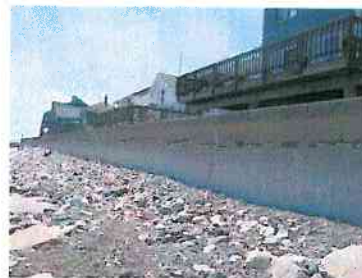
This structure is a concrete seawall with a wave return face. Minor cracking and weathering is seen. There are signs of an old revetment fronting the wall which is now buried by the cobble beach. The final 100 feet or so at the south end of the structure shows marked wear at the base of the wall, where much of the surface of the wall has been worn away. This worn section at the base of the wall needs to be addressed

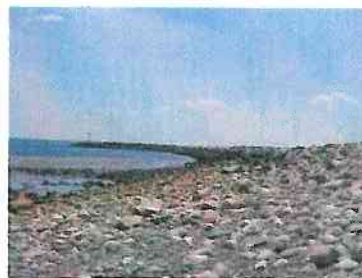
This structure is the main rubble mound jetty at the entrance to Scituate harbor. The crest and sideslopes are level and sharp. There is some unraveling of the armor stone at the head of the jetty and a few isolated cases of broken armor stones. In general the structure is in good shape.

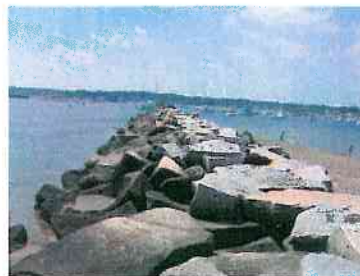
This structure is a rubble mound spur jetty just inside the entrance to Scituate Harbor. The armor stones are in good condition and the crest and sideslopes are intact.

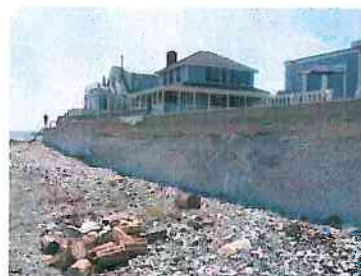
This structure is a concrete seawall. There is cracking and spalling evident throughout, some sections are showing quite heavy damage.

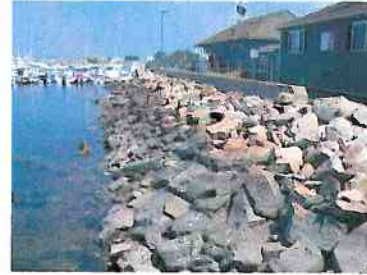
This structure is a stone revetment fronting a concrete seawall with railing. The wall and railing show some cracking and rusting. The stone slope is beginning to unravel and slump at the northeast corner.
