Plainville, MA
Turtle Brook Culvert at Shepard St
In Turnpike Lake
June 2021

CULVERT EVALUATION REPORT

Prepared by: BETA GROUP, INC.

Prepared for: Town of Plainville

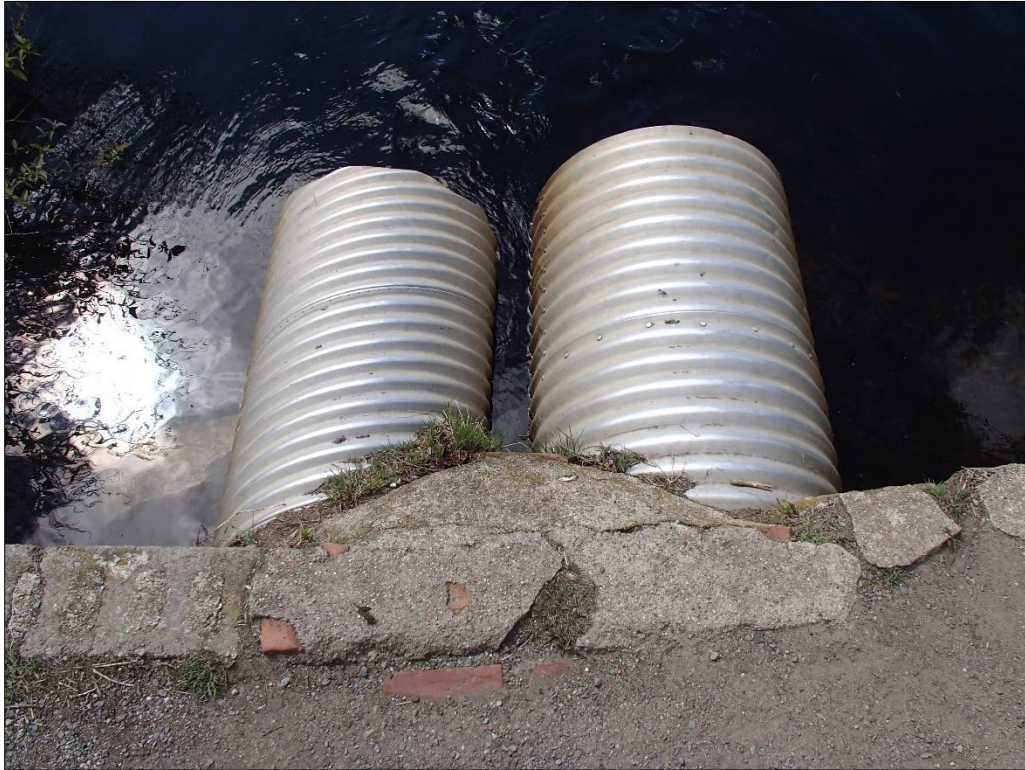
Photo 9 South Side of CMPs

to be a scour hole present just outside the south entrance to the CMPs. The flow elevation rapidly drops off at this location, approximately 18" out from the CMPs.

Scour: Approx. 3.7' of Scour noted at downstrDebris: NA

- Address undermining and fill in scour void on the south side with rip rap. This should be considered a High Priority to protect against future deterioration.
- Rebuild stone masonry walls to avoid washout and protect roadway surface.
- Clear vegetation around masonry walls.

South Headwall Scour Length =	10.00 ft	
Assumed Height of Scour =	3.70 ft	
Approximate Depth of Scour =	0.50 ft	
Area of Repairs in CF =	18.50 cf	
Conc.Filled Grout Bags for Scour (Item 920.9901.) =	\$1,100.00 Per CF	Scour Repairs = \$20,350

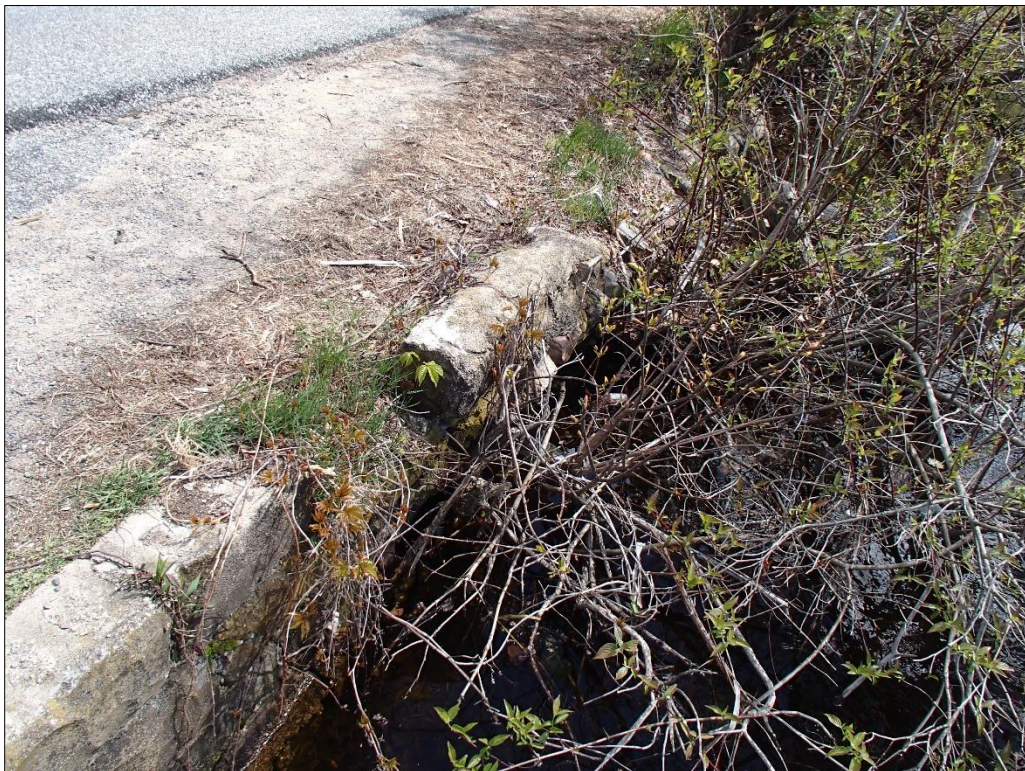
Photo 14 Looking East: Southeast Masonry Wall

The overall condition of the structure is fair with a few deficiencies noted. The condition of the CMPs were good, with no deficiencies noted. Both headwalls have some areas of hairline cracks and loose/missing mortar. The north headwall is displaced up to 5" and has several cracks (See Photos 5 and 6). The south headwall is also displaced about 6" and has several cracks (See Photos 12 and 13). The south headwall was found to have undermining of at least 6" in depth. The south headwall continues to a stone masonry wall to the southeast. This southeast wall has heavy vegetation and is displaced (Photo 14). There appears

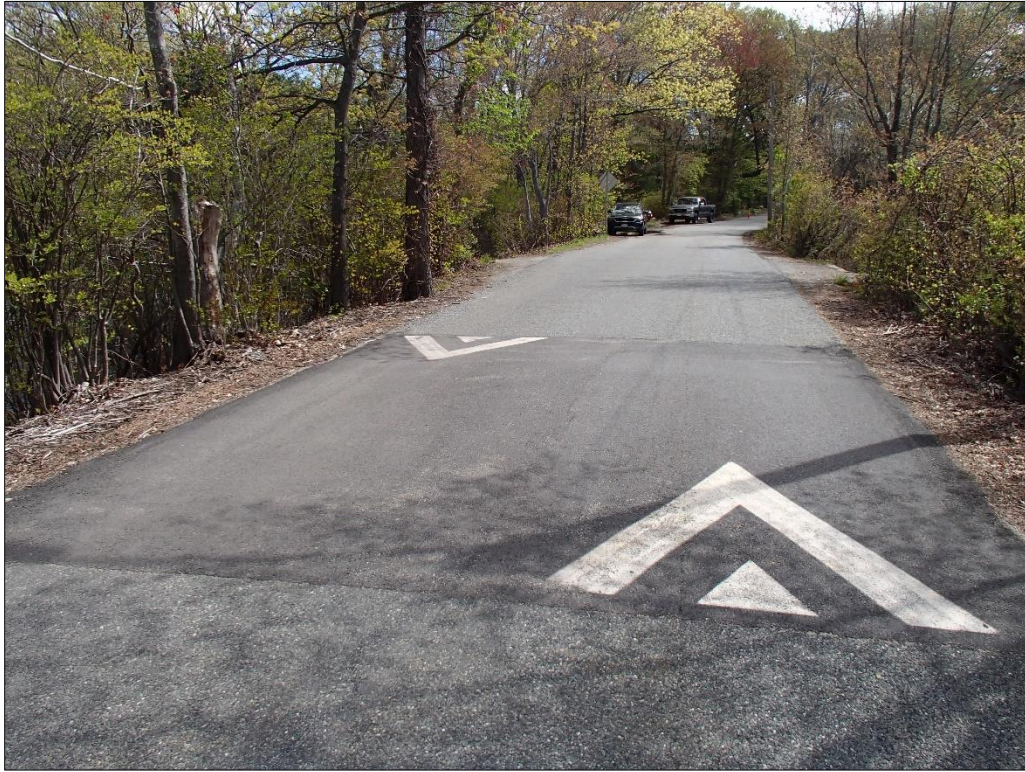
Photo 15 Looking East: West Approach

The roadway over the culvert and at each approach is in good condition. There is an area of heavy ponding on the north side of the east approach (Photo 16). There is a newly installed speed bump on the west approach (Photo 15).
