SOUTH SHORE WATERSHEDS

South Shore Watersheds

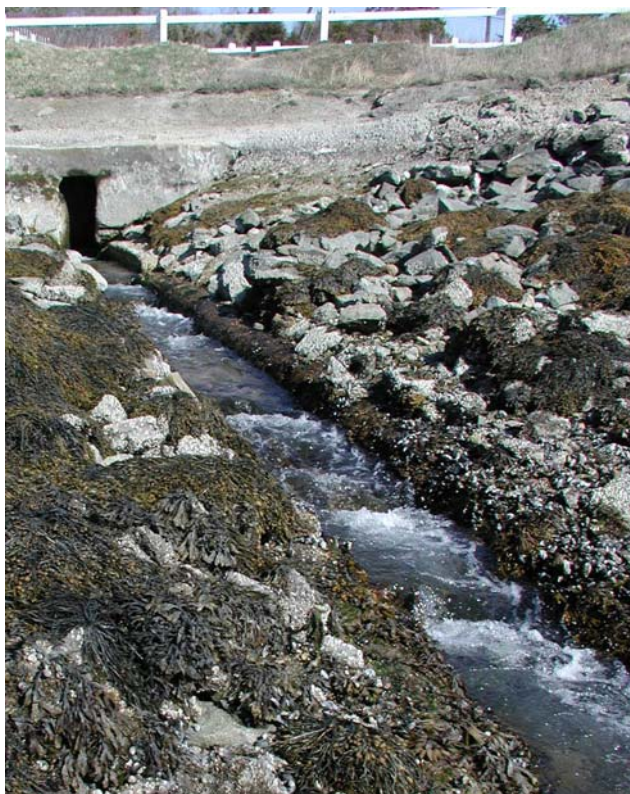
Obstruction # 1

Cape Cod Canal culvert at low tide

The first obstruction on the stream is actually the Cape Cod Canal and the elevation change it caused when the canal's construction intercepted the stream's natural channel. This is overcome by a series of weir-pool and notched weir-pool fishways which are integrated within the stream's artificial channel. The fishway structures have begun to show some deterioration and this in combination with the difficulties caused by the tidal fluctuations in the canal causes less than efficient fish passage through this section.

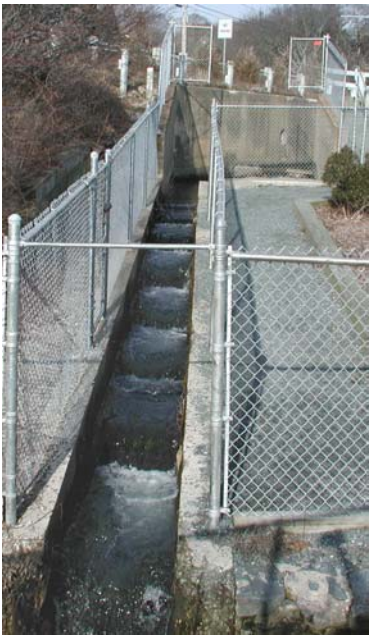
Lower section of fishway to Herring Run Motel Pool

| Notched weir-pool | Concrete with metal slots and wooden baffles | 364.0 | 8.1 | 10 | 7 | 1.4 | ~2.5 | 59.5 | Fair Passable |

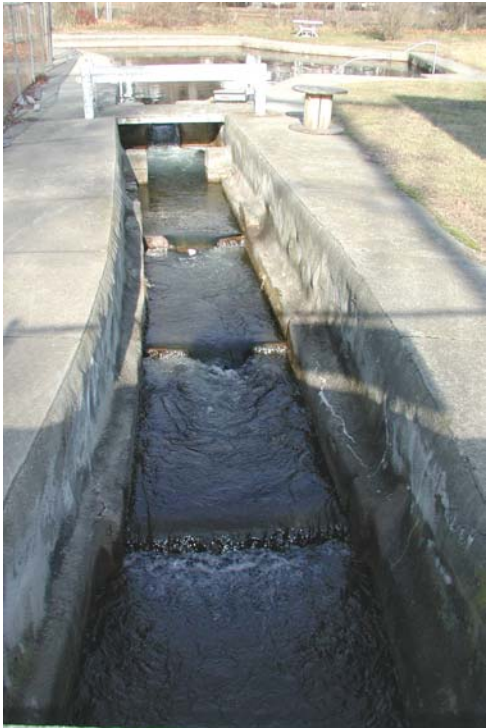
| Design (ft) | Material W (ft) | Length W (ft) | Inside Baffles | Outside H (ft) | # of W (ft) | Baffle L (ft) | Notch Function | Pool | Condition/ |
|---|---|---|---|---|---|---|---|---|---|
| Notched weir-pool | Concrete and wood | 171.0 | 4.0 | 6.3 | 8 | 1.0 | Varied (3.4, 4.6) | Varied ~(9-10) | Poor Passable |

End of fishway and pool at Herring Run Motel

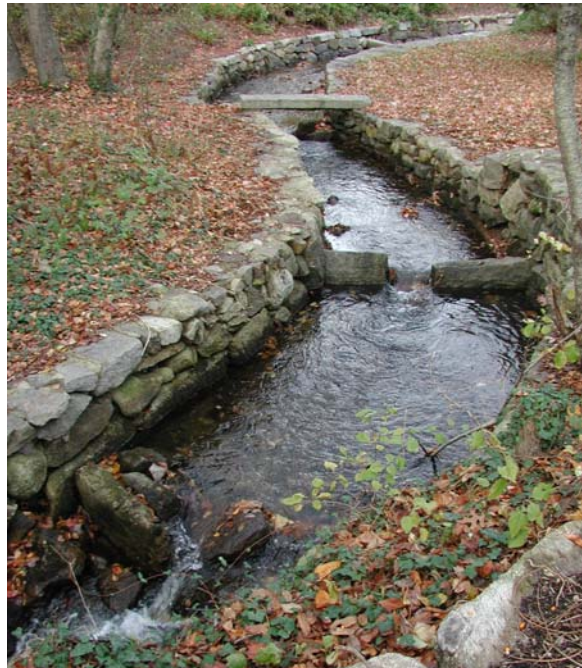
| Design | Material | Length (ft) | Inside W (ft) | Outside W (ft) | # of Baffles | Baffle H (ft) | Notch W (ft) | Pool L (ft) | Condition/Function |
|---|---|---|---|---|---|---|---|---|---|
| Notched weir-pool | Stone, concrete and wood | 357.0 | 8.0 | 14.0 | 18 | Varied (1.3-2.4) | Varied. ~1-3 | Varied (20.0-41.3) | Poor Inefficient passage |

Fishway at Beal's Pond Dam

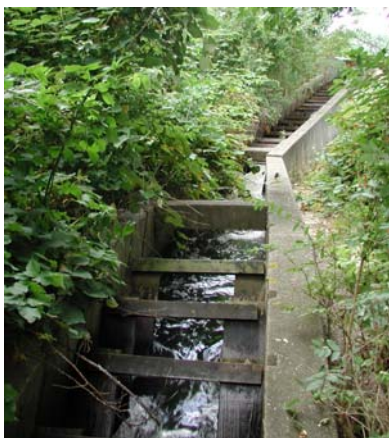
| Design | Material | Length (ft) | Inside W (ft) | Outside W (ft) | # of Baffles | Baffle H (ft) | Notch W (ft) | Pool L (ft) | Condition/Function |
|---|---|---|---|---|---|---|---|---|---|
| Denil | Concrete with wooden baffles | 126.0 | 3.0 | 4.6 | 39 | 1.3 | - | - | Good Passable |

Fishway at Hayden Mill Pond

The primary spawning habitats on this stream are 20.5 acre Hayden Pond and 42.2 acre Russell Millpond. In 1980 a dilapidated fishway at Hayden Pond was replaced by DMF with a concrete and wooden Denil ladder. This ladder is in good condition and functions well. At Russell Millpond, however, a weir-pool fishway was allowed to be shut down at the request of the dam owner due to the possibility of further damage to the already unsafe dam. Since that time, the Town of Plymouth has planned repair work to both dams and has agreed to include fishway restoration in the plans. At this writing funds are being sought to construct a new ladder and provide access to the larger of the two impoundments.

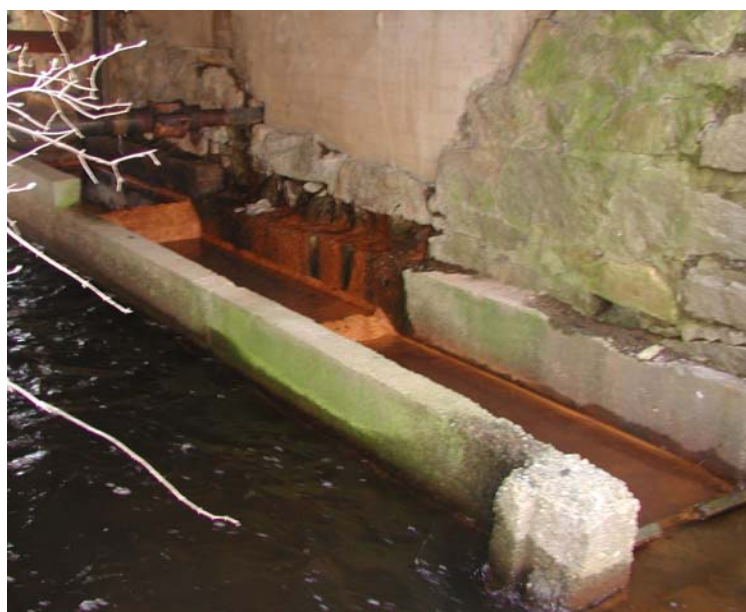
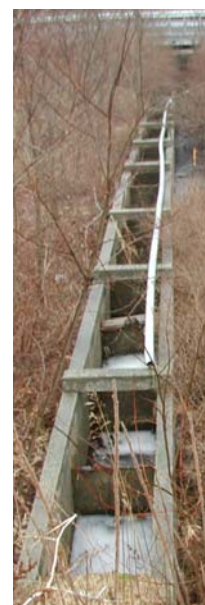
| Design | Material | Length (ft) | Inside W (ft) | Outside W (ft) | # of Baffles | Baffle H (ft) | Notch W (ft) | Pool L (ft) | Condition/Function |
|---|---|---|---|---|---|---|---|---|---|
| Weir-pool | Concrete with wooden baffles | 272 | 3.0 | 4.3 | 24 | Varied (0.4-4.2) | - | 8 | Poor Not passable |

Russell Mill Pond fishway entrance (left) and fishway (right)

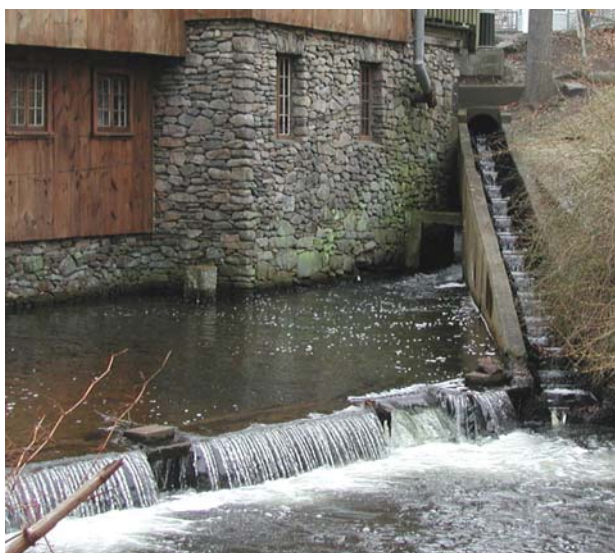
| Design | Material | Length (ft) | Inside W (ft) | Outside W (ft) | # of Baffles | Baffle H (ft) | Notch W (ft) | Pool L (ft) | Condition/Function |
|---|---|---|---|---|---|---|---|---|---|
| Notched weir-pool | Concrete | 65.0 | 2.0 | 3.0 | 15 | 1.2 | 0.6 | 4.0 | Fair Inefficient passage |

Fishway at Jenny Grist Mill

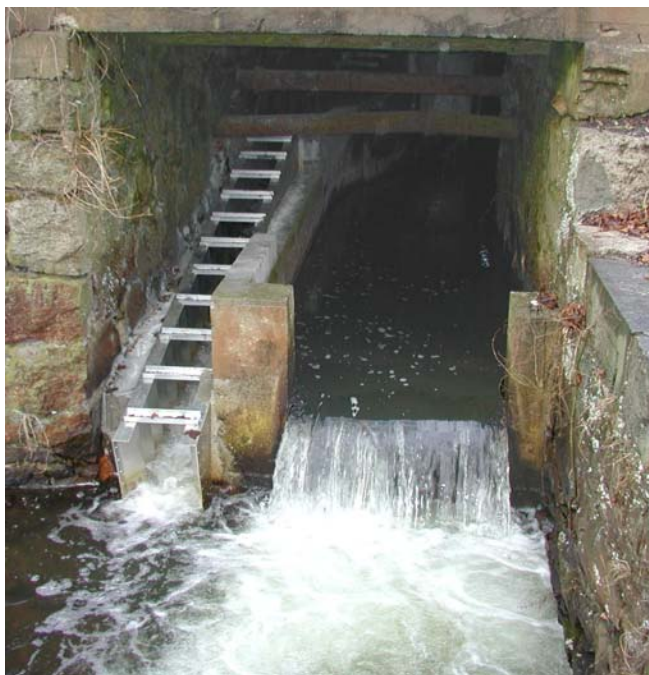
| Design | Material | Length (ft) | Inside W (ft) | Outside W (ft) | # of Baffles | Baffle H (ft) | Notch W (ft) | Pool L (ft) | Condition/Function |
|---|---|---|---|---|---|---|---|---|---|
| Alaskan Steeppass | Aluminum | 30 | 2 | 2 | - | - | - | - | Good Passable |

Newfield Street Dam and steeppass

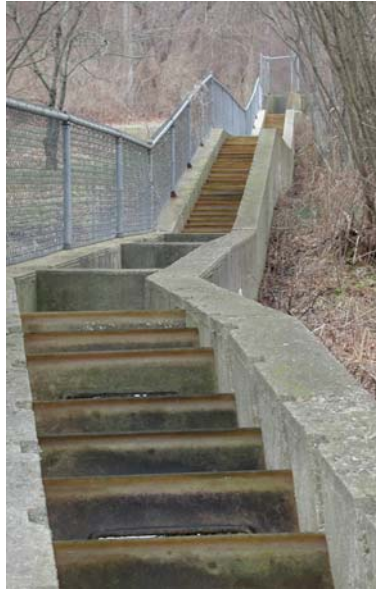
| Design | Material | Length (ft) | Inside W (ft) | Outside W (ft) | # of Baffles | Baffle H (ft) | Notch W (ft) | Pool L (ft) | Condition/ Function |
|---|---|---|---|---|---|---|---|---|---|
| Denil | Concrete with fiberglass baffles | 202.0 | 2.0 | 3.8 | 75 | 0.8 | - | - | Good Passable |

Mid-section of Newfield St. Denil fishway

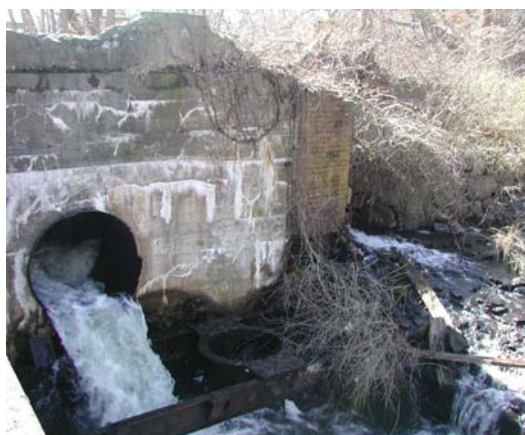
Plymco Dam, spillway and leak

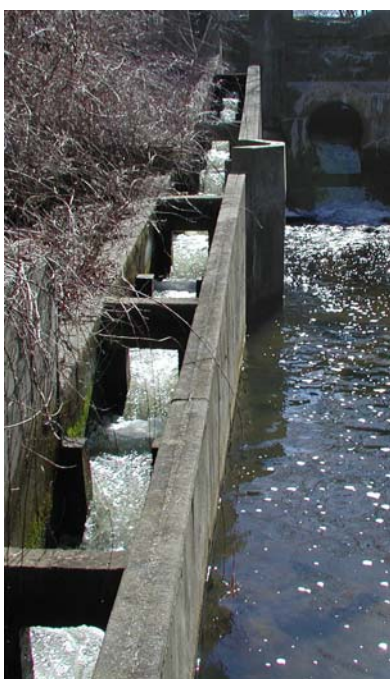
| Design | Material | Length (ft) | Inside W (ft) | Outside W (ft) | # of Baffles | Baffle H (ft) | Notch W (ft) | Pool L (ft) | Condition/Function |
|---|---|---|---|---|---|---|---|---|---|
| Notched weir-pool | Concrete | 116.0 | 2.2 | 3.7 | 14 | 3.2 (2.0 notch H.) | 1.1 | 4.3 | Fair Inefficient passage |

Fishway at Plymco Dam

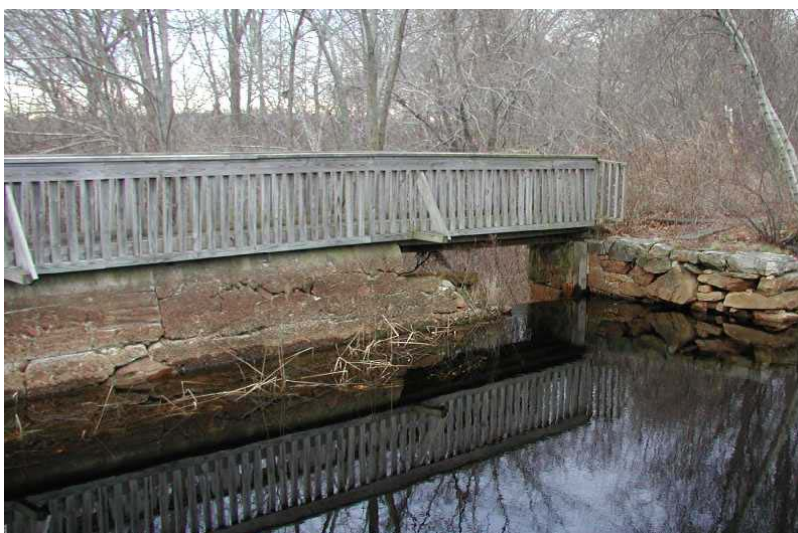
Dam at Mill Pond

Halls Brook has its source in 7.6 acre Blackwater Pond. The stream is impounded by an 8.5 foot dam at its mouth. Fishway facilities or removal of the dam would allow fish to access the headwaters. The expense of this work must be weighed against the amount of habitat to be gained. Moderate densities of smelt eggs have been observed below the dam.

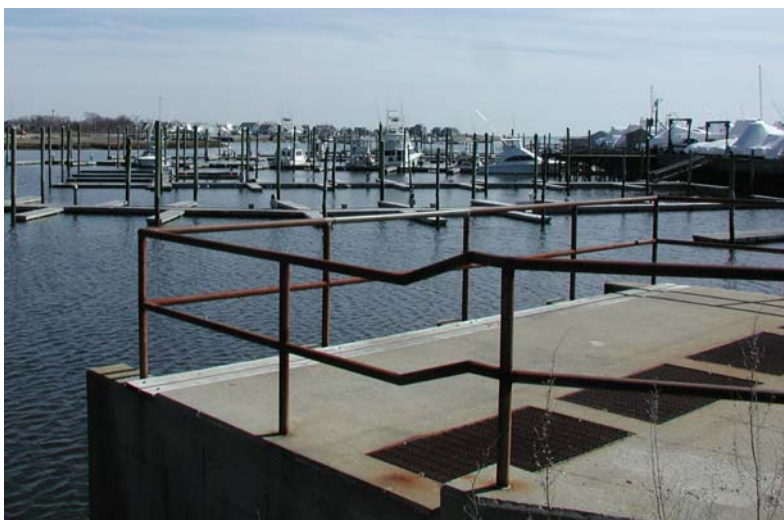
Tide gate at Green Harbor

River herring passage into this system through a set of tide gates was possible though restricted in the past. Although some herring have been observed in the upper river in recent years, the installation of a new set of gates appears to have further inhibited off fish migration. The difficulty in modifying the gates to improve fish passage and the lack of substantial freshwater habitat make this work a low priority.

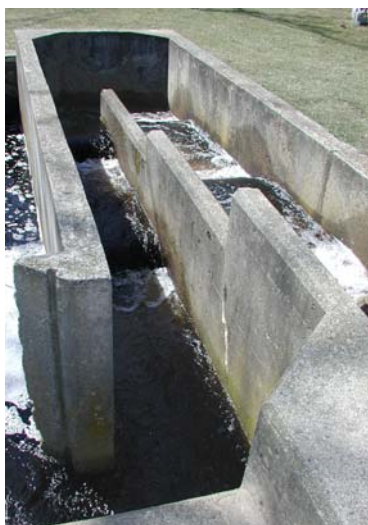
| Design | Material | Length (ft) | Inside W (ft) | Outside W (ft) | # of Baffles | Baffle H (ft) | Notch W (ft) | Pool L (ft) | Condition/Function |
|---|---|---|---|---|---|---|---|---|---|
| Weir-pool | Concrete, top baffle wood | 124.5 | 3.0 | 4.4 | 8 | Varied (1.6-3.8) | - | Varied (6.0-8.0) | Good Passable |

Fishway at Old Oaken Bucket Pond

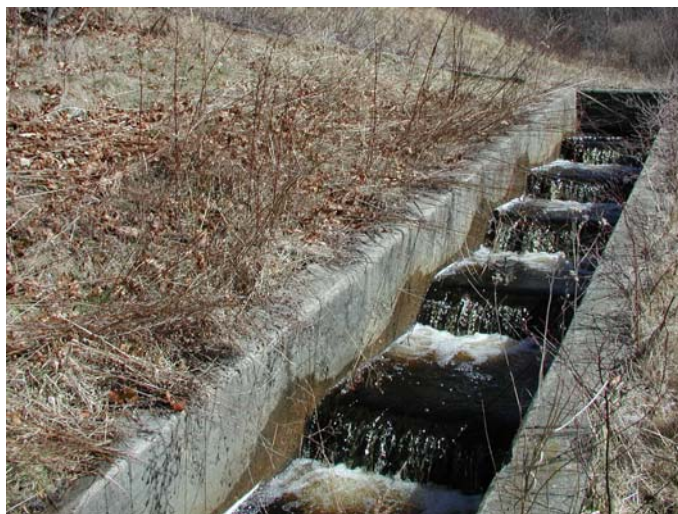
| Design | Material | Length (ft) | Inside W (ft) | Outside W (ft) | # of Baffles | Baffle H (ft) | Notch W (ft) | Pool L (ft) | Condition/Function |
|---|---|---|---|---|---|---|---|---|---|
| Weir-pool | Concrete | 110.0 | 3.2 | 4.7 | 19 | 2.0 | - | 3.8 | Good Inefficient passage |

Lower section of Brushy Hill Pond fishway

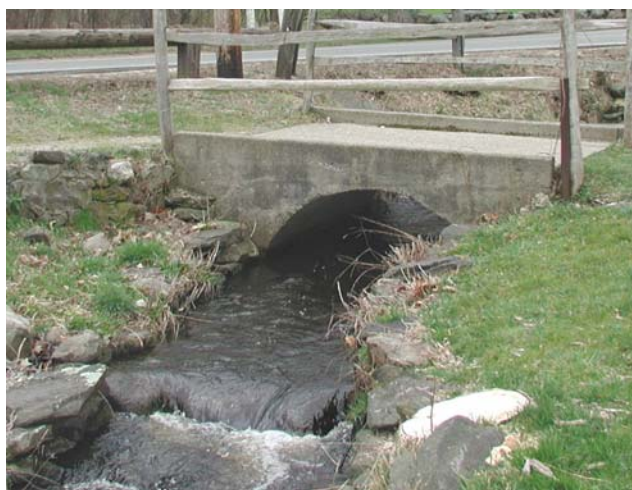
| Design | Material | Length (ft) | Inside W (ft) | Outside W (ft) | # of Baffles | Baffle H (ft) | Notch W (ft) | Pool L (ft) | Condition/Function |
|---|---|---|---|---|---|---|---|---|---|
| Stream baffle | Stone | 338.0 | Varied (3-5, 12) | Varied (3-12) | 3 | Varied (1.0-1.3) | - | Varied (19-166) | Fair Inefficient |

Pembroke Herring Run

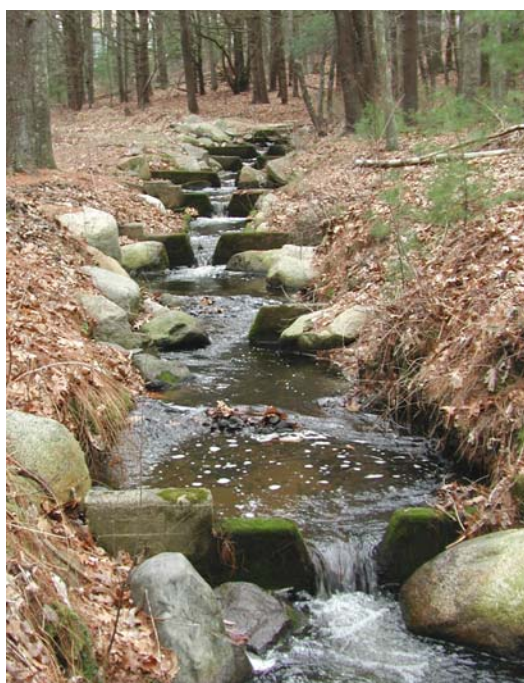
| Design | Material | Length (ft) | Inside W (ft) | Outside W (ft) | # of Baffles | Baffle H (ft) | Notch W (ft) | Pool L (ft) | Condition/Function |
|---|---|---|---|---|---|---|---|---|---|
| Notched weir-pool | Concrete | 336.0 | Varied (3.0-8.0) | Stream Edge | 15 | 1.9 | 1.4 | Varied (16, 17) | Poor Inefficient passage |

First Mill Ponds fishway

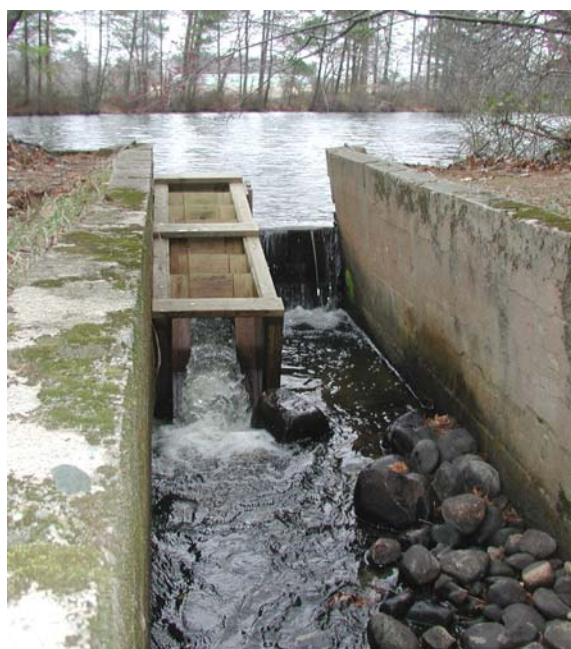
| Design | Material | Length (ft) | Inside W (ft) | Outside W (ft) | # of Baffles | Baffle H (ft) | Notch W (ft) | Pool L (ft) | Condition/ Function |
|---|---|---|---|---|---|---|---|---|---|
| Denil | Wood | 8.0 | 1.5 | 2.2 | 8 | 2.4 | - | - | Good Passable |

2nd Mill Ponds fishway

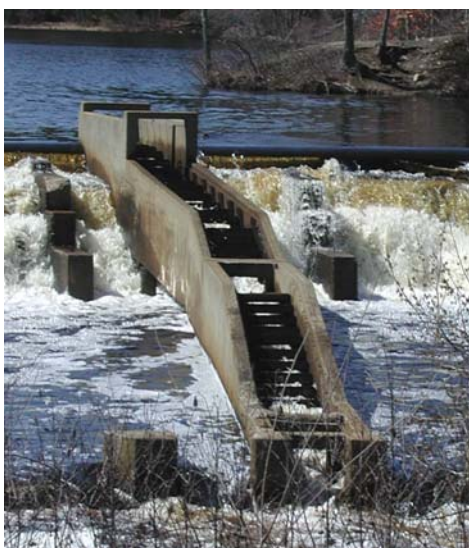
| Design | Material | Length (ft) | Inside W (ft) | Outside W (ft) | # of Baffles | Baffle H (ft) | Notch W (ft) | Pool L (ft) | Condition/Function |
|---|---|---|---|---|---|---|---|---|---|
| Denil | Concrete and wood | 109 | 2.6 | 4.4 | 33 | Varied (5.0-5.8) | - | - | Good Inefficient passage |

Fishway at Elm Street Dam

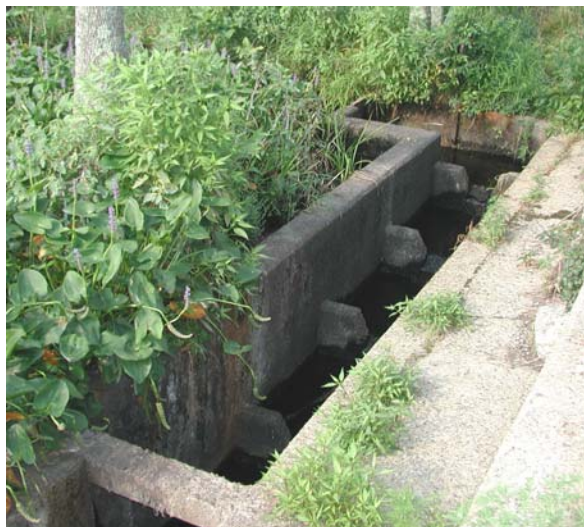
| Design | Material | Length (ft) | Inside W (ft) | Outside W (ft) | # of Baffles | Baffle H (ft) | Notch W (ft) | Pool L (ft) | Condition/Function |
|---|---|---|---|---|---|---|---|---|---|
| Notched weir-pool | Concrete | 27.0 | 3.0 | 4.5 | 6 | 3.0 | 1.0 | 4.0 | Poor Not passable |

Fishway at Hunters Pond Dam

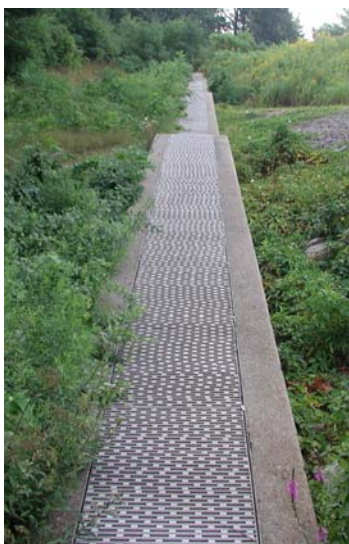
| Design | Material | Length (ft) | Inside W (ft) | Outside W (ft) | # of Baffles | Baffle H (ft) | Notch W (ft) | Pool L (ft) | Condition/Function |
|---|---|---|---|---|---|---|---|---|---|
| Denil | Concrete and aluminum | 231.0 | 2.0 | 4.0 | | unknown | - | Unknown | Excellent Passable |

Aaron River Reservoir ladder (covered)
