Release Date: February 24, 2022

**HVAC Repairs
Springfield Court Complex
50 & 80 State Street
Springfield, Massachusetts**

Mass. State Project No. TRC 2111

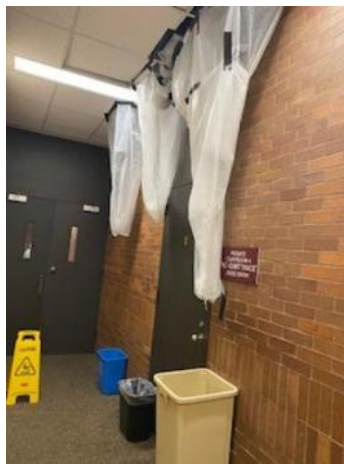
One notable operational issue is that the building users reported that the condensate drain pan for AC-1 recently failed, which caused water to leak into Probate and Family Courtroom 4 as well as the adjacent hallway. Refer to the photo below for an image of the containment efforts taken to address this.

Hall of Justice – AC-1 Failed Drain Pan – Leaking Above Hallway

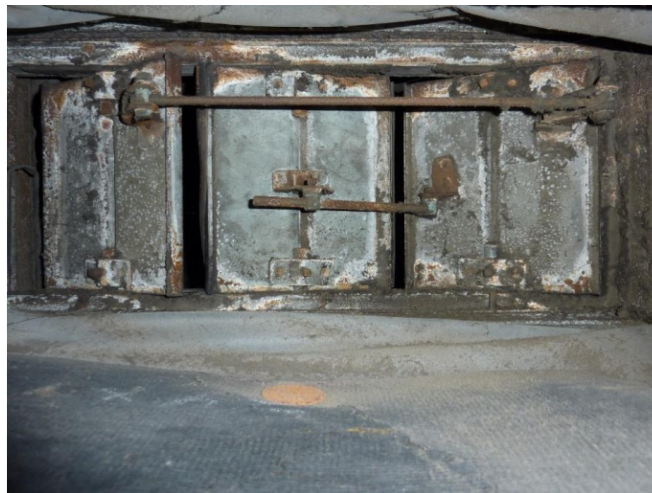
Housing & Juvenile Court – Rusted Outside Air Damper

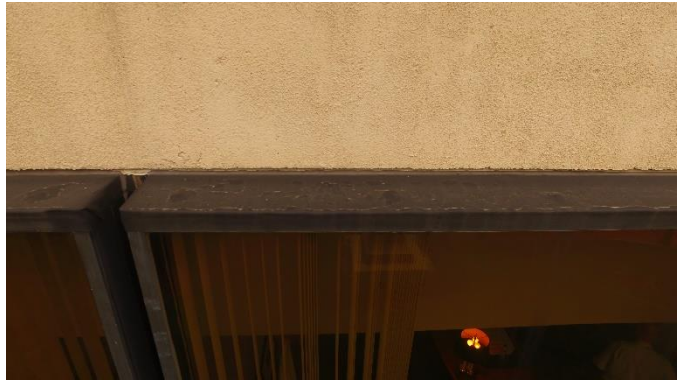
Photo 5: Sealant failure at window.

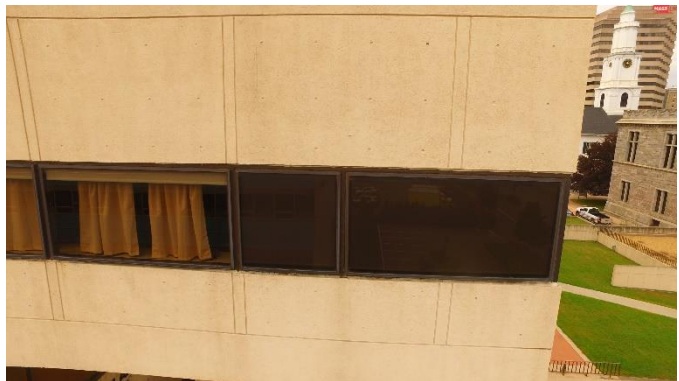
Photo 6: Sealant failure at window.

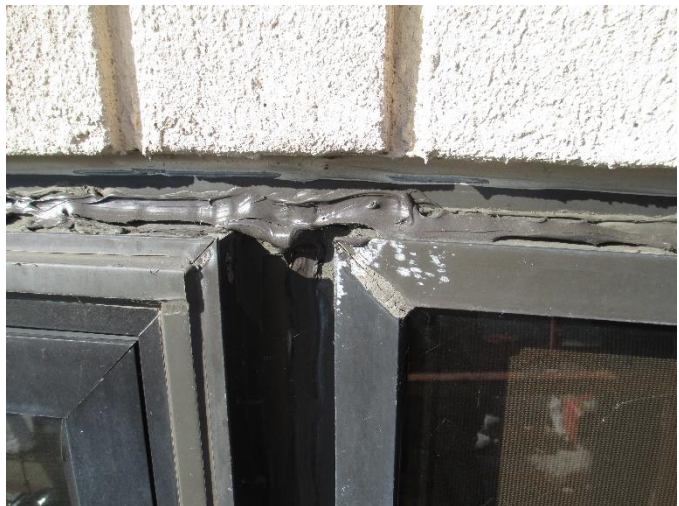
Photo 7: Sealant failure at window.

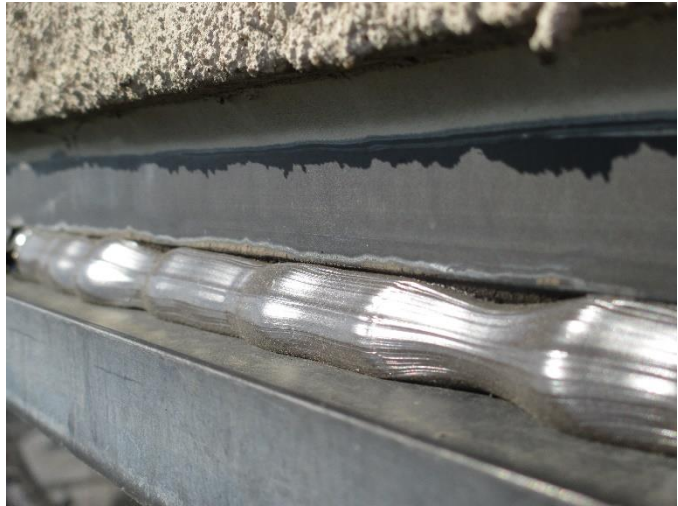
Photo 8: Hole in window sealant.

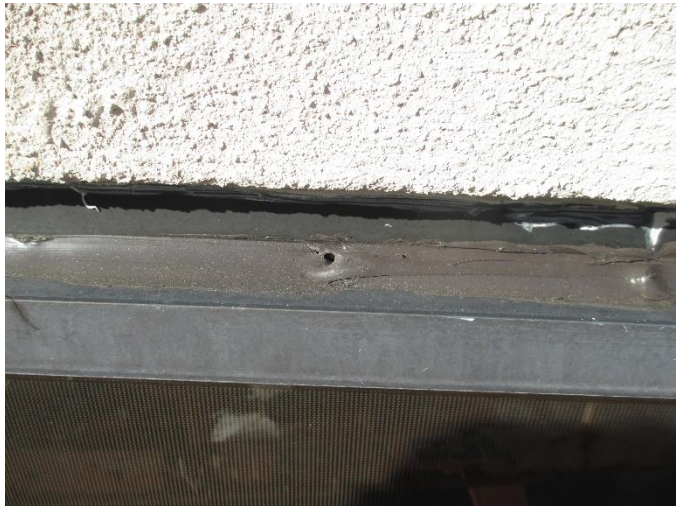
Photo 9: Deteriorated sealant at window.

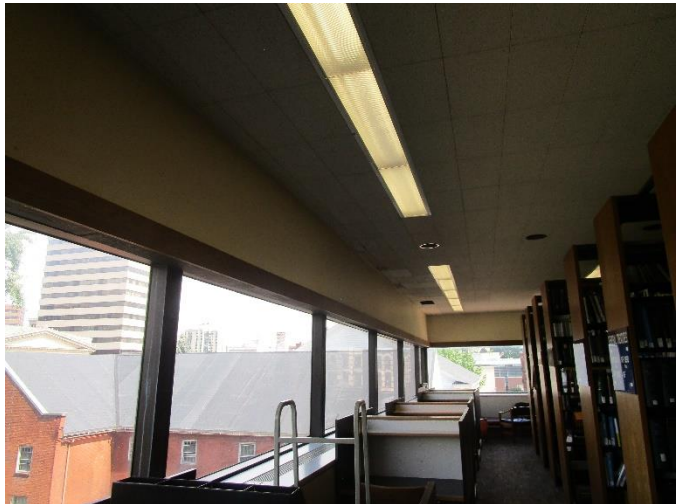
Photo 2: Ceiling damage in Law Library.

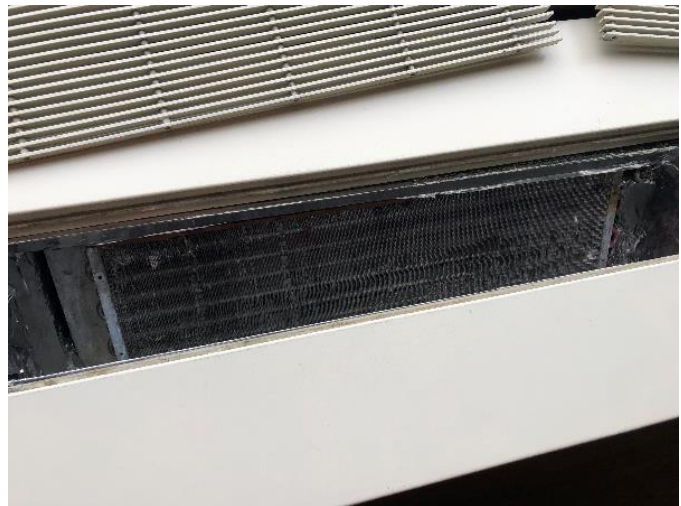
Photo 12: Perimeter Fan Coil Internal Condition.

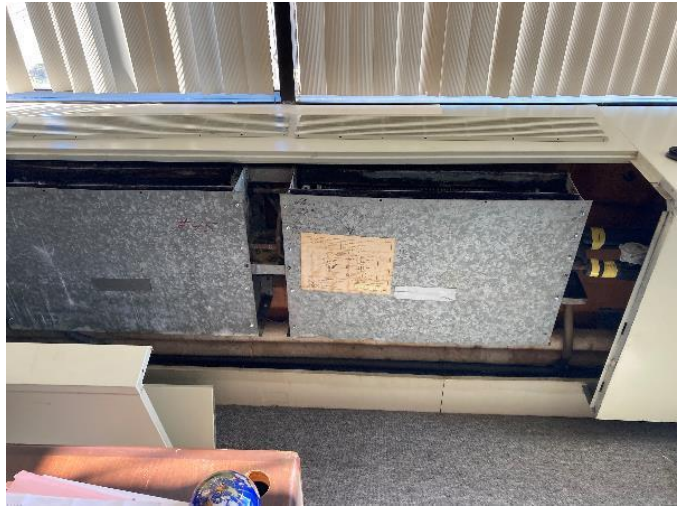
Photo 13: Perimeter Fan Coil Internal Condition.

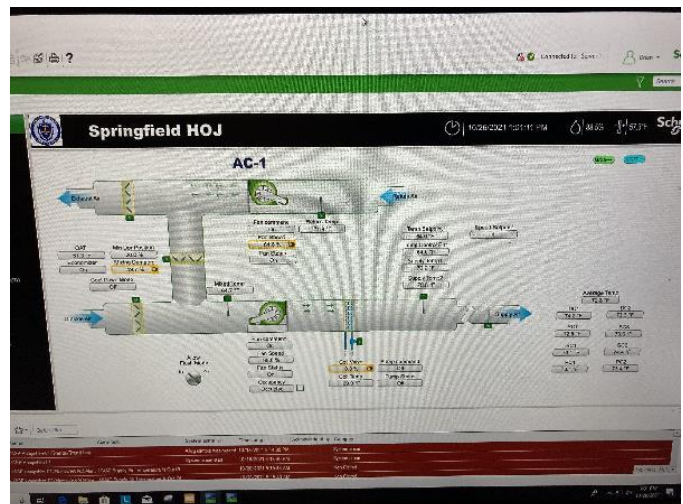
Photo 21: AC-1 Failed Drain Pan – Leaking
Above Hallway.

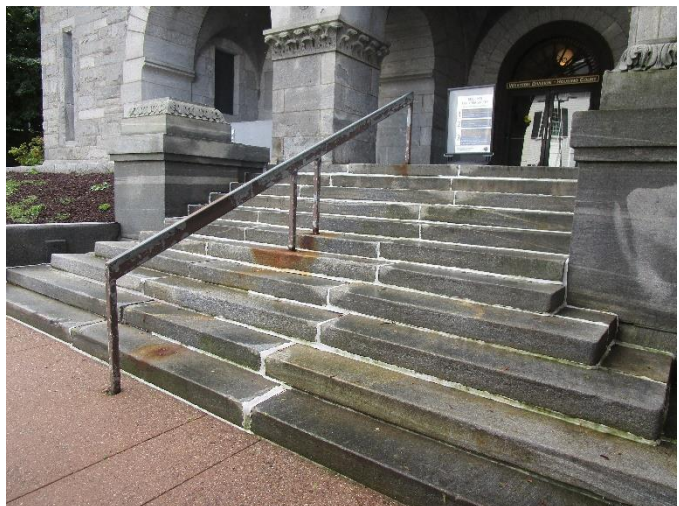
Photo 4: Granite spall at North Entry.

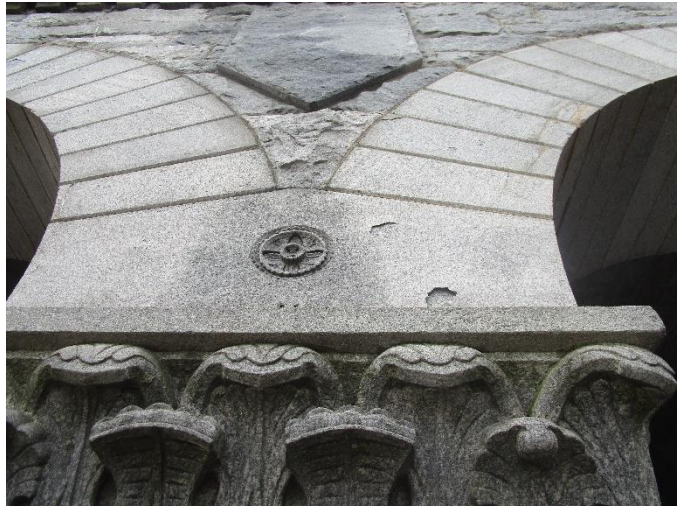
Photo 5: Granite spall at South Entry.

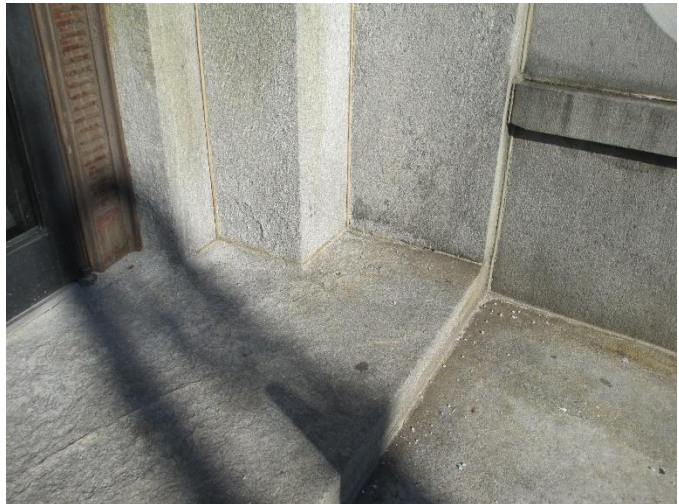
Photo 6: Deteriorated sealant at South Entry Stairs.

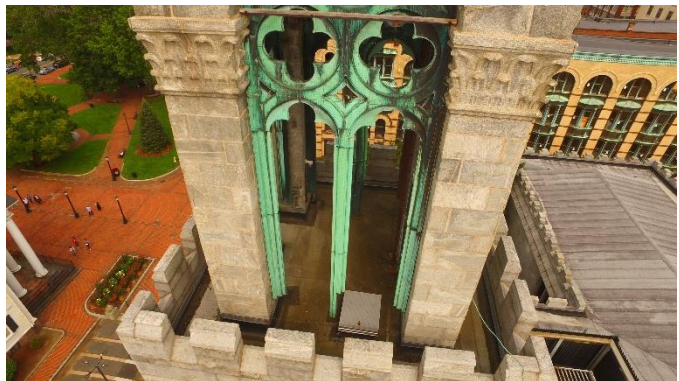
Photo 10: Damage to support of arch in tower.

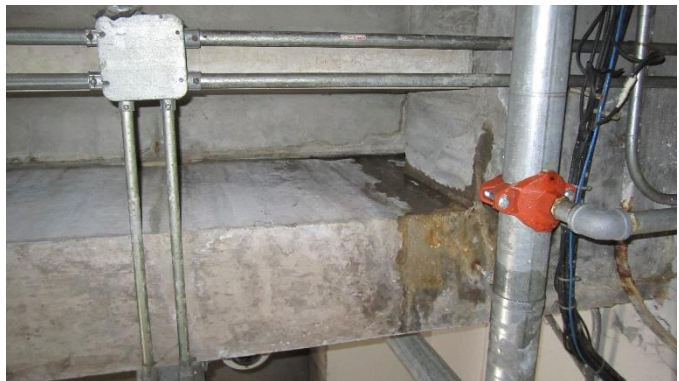
Photo 12: Evidence of water infiltration at parking garage.

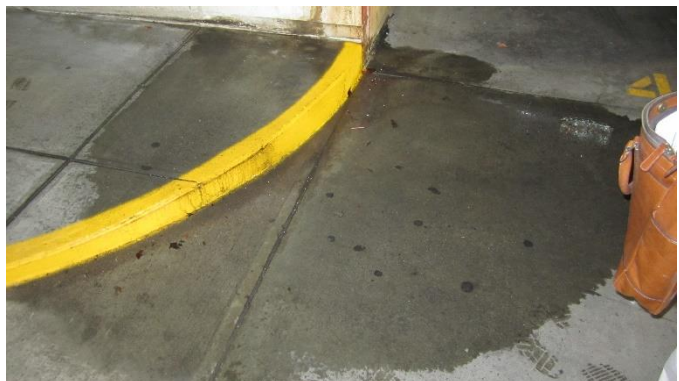
Photo 13: No waterproofing at below grade scuppers

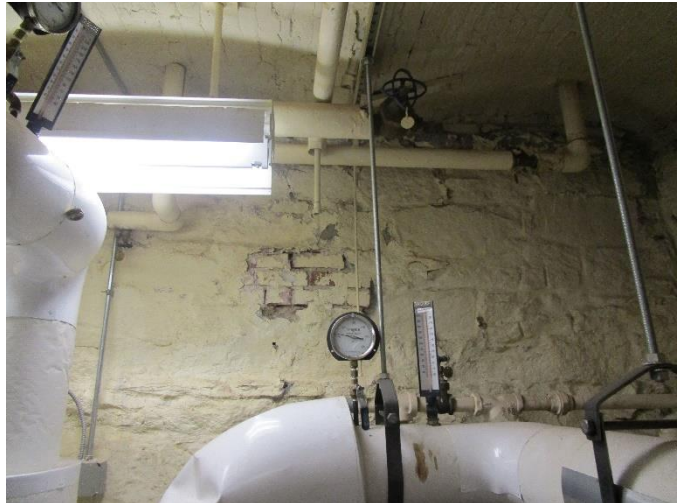
Photo 2: Water infiltration on walls in basement

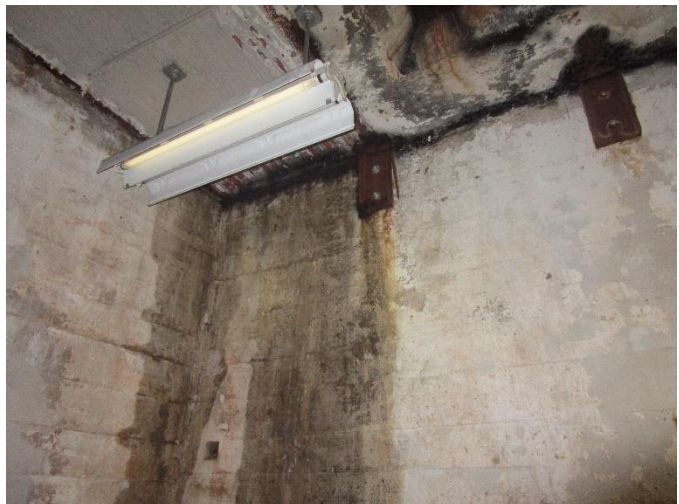
Photo 3: Moisture damaged walls in basement. Note vents added in wall assembly as attempted repair to reduce moisture buildup and peeling paint.

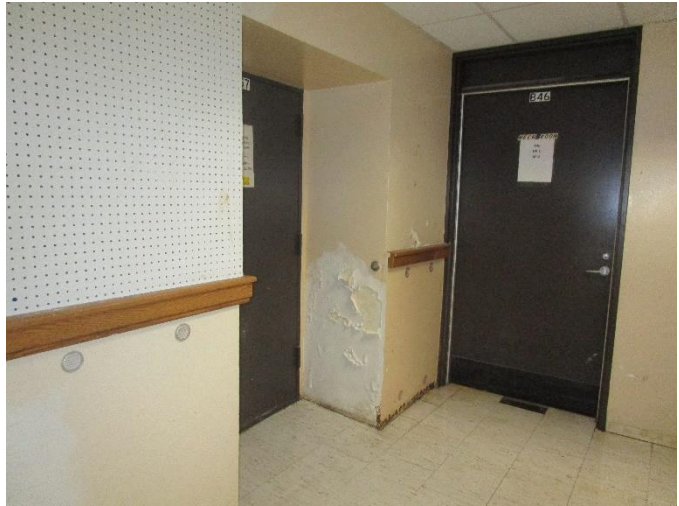
Photo 4: Water infiltration in basement after rainstorm.

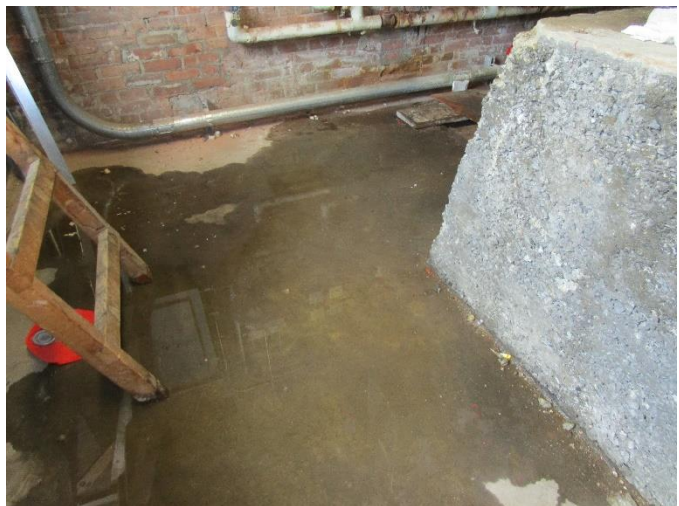
Photo 5: Water infiltration at tower after rainstorm.

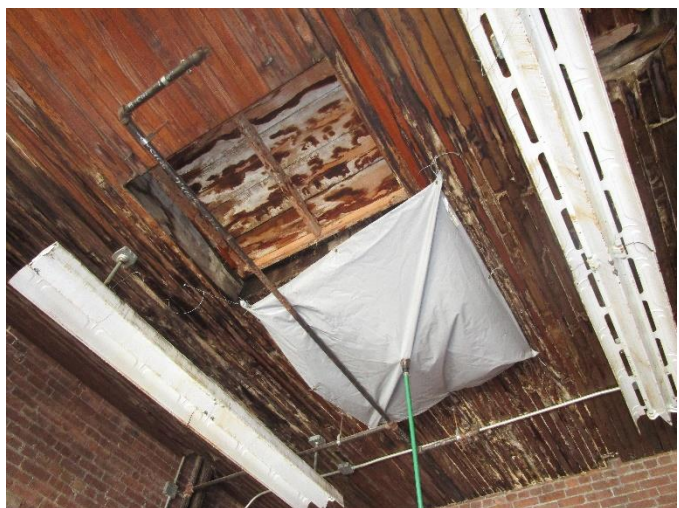
Photo 6: Damaged ceiling in Room 301, which is the room below the tower.

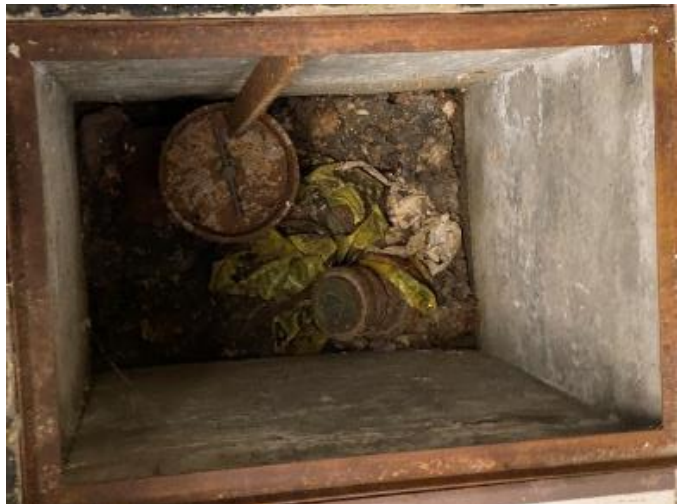
Photo 5: Mechanical Floor Drain Overflow.

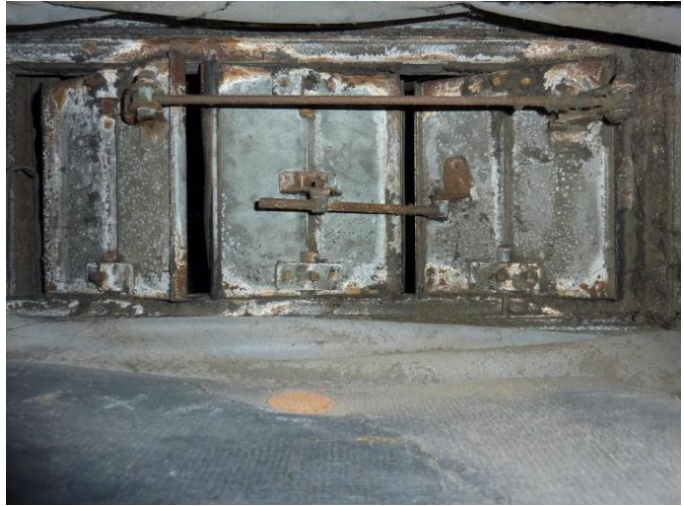
Photo 12: Rusted Outside Air Damper.

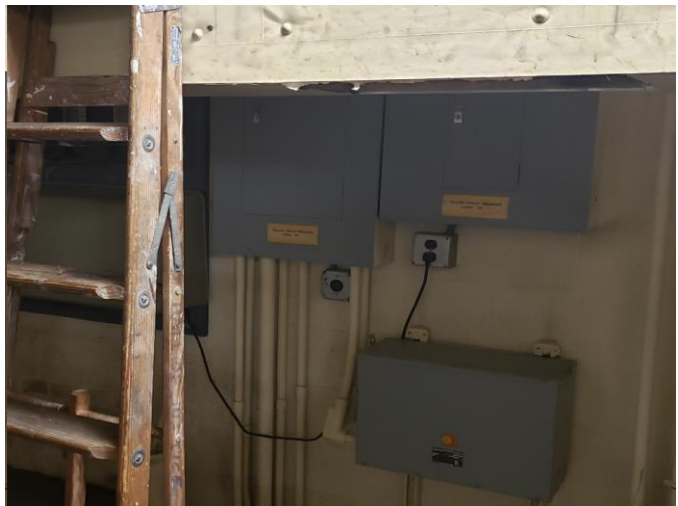
Photo 1: Ductwork intruding on clear working space of power panels.

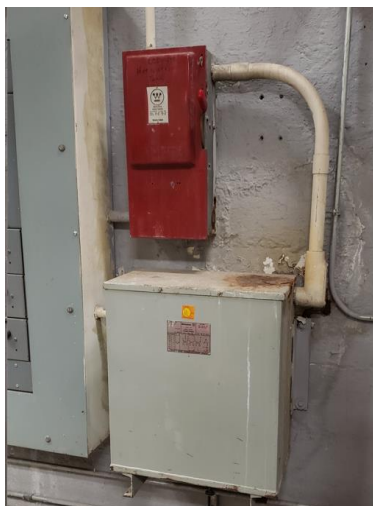
Photo 2: Rusted transformer enclosure under leaky spot in mech room.

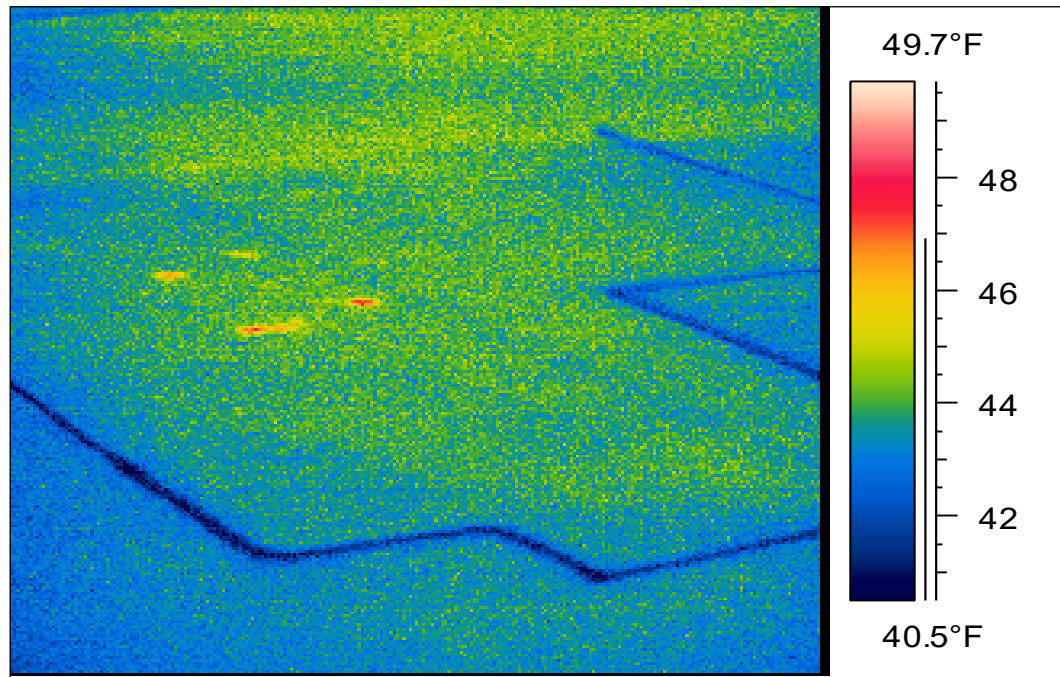
1

The above thermal image is of Area A1 along the west wall of the main roof (Roof A). *Blue* areas in this and the following images are dry, while objects such as drains, mechanical equipment and masonry may appear warmer without containing moisture. The boundaries of wet areas are marked with orange spray paint, shown in the photo below.

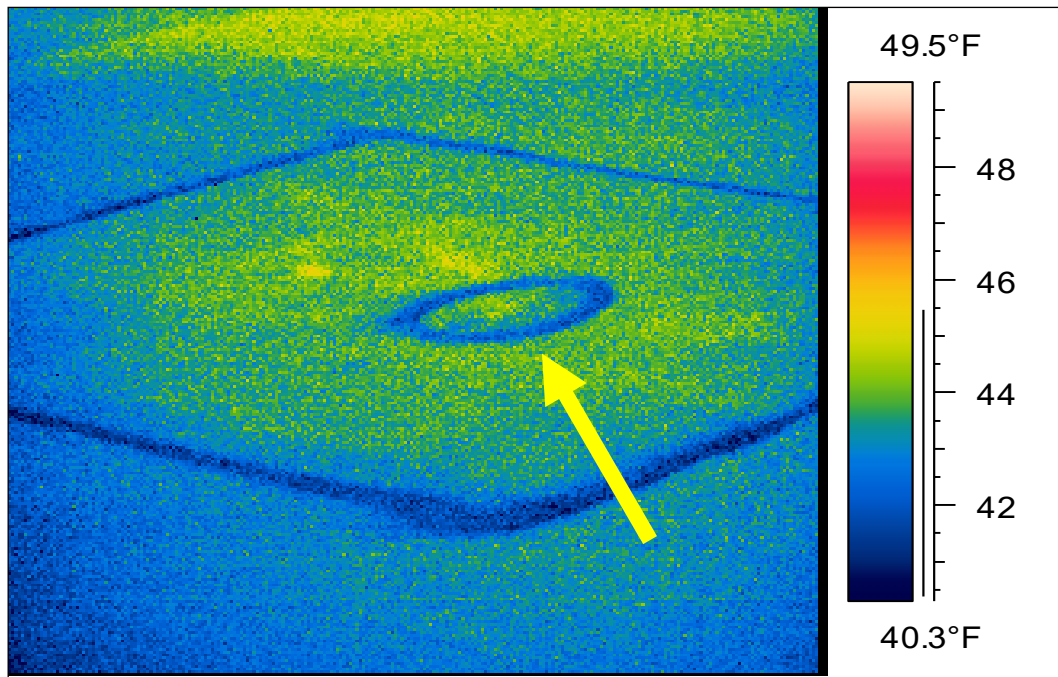
8

Thermal image of Area A9 by the stairwell penthouse on the NE side of the main roof.
An open seam was found and circled within the area, shown in the photo below.
