Manhole Inspection Report

MH# S2-2767

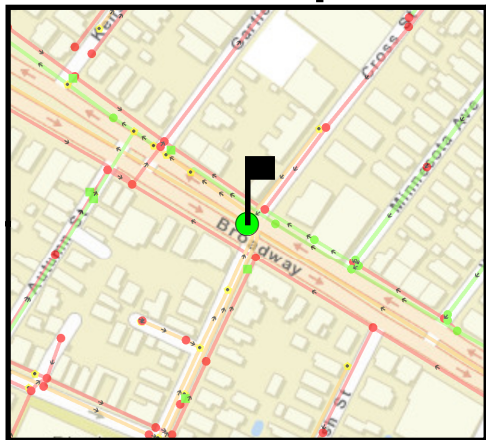
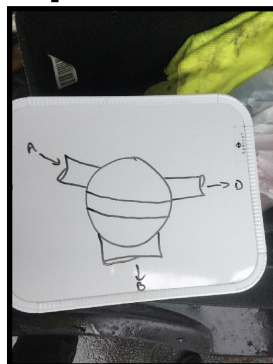
General Comments: Additional inspection on 12/20/18. Confirmed cross connect between S2-2767 (US) and S2-2141 (DS). On US side, weir is 5.1'Wx1.4'H; on DS side, weir is 5'Wx2.3'H. Observed inline connection upstream into 36" brick cs.

Recommendations- No Action

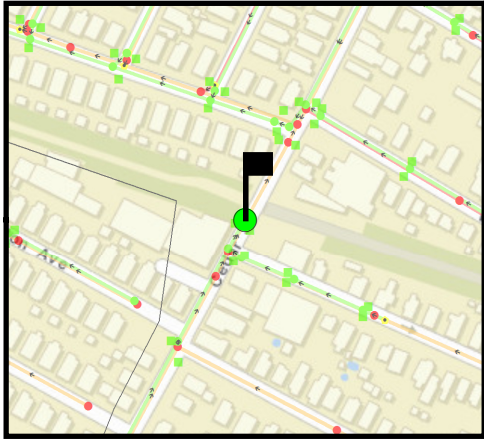
CA-2752

General Comments: Flap Gate in poor condition

Recommendations- Rebuild

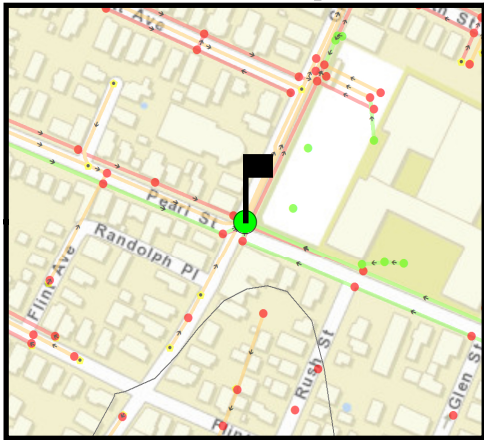
S2-1577

General Comments: No pipe observed from Pearl St (South) but could be weir; recommend CSE

Recommendations- No Action

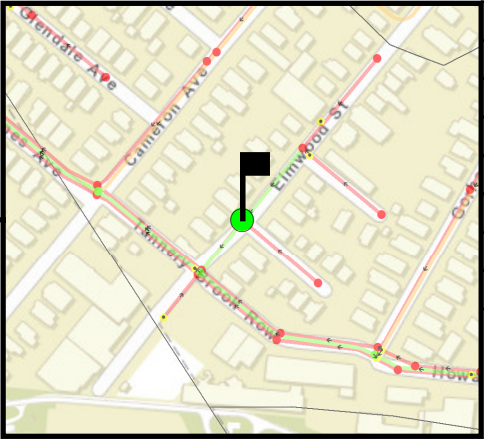
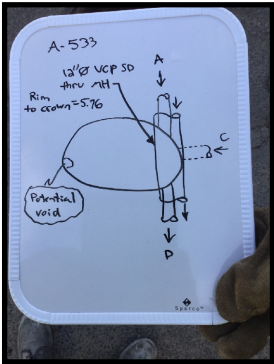
General Comments: Pipe through MH; suspect SD; potential void with infiltration or buried lateral

MH Condition:
Poor

Pipe Size	Material	From / To MH#	Invert Depth (from rim)	Flow Depth (from invert)	Debris Depth (from invert)	Condition
A.	8"	VCP	A-532	8.63'	7"	2"	Poor
B.							
C.		Unknown	A-537	8.63'	7"	2"	Poor
D.	8"	VCP	A-534	8.65'	7"	2"	Poor
E.							
F.							
G.							
H.

Recommendations- Clean/Remove Depris from invert

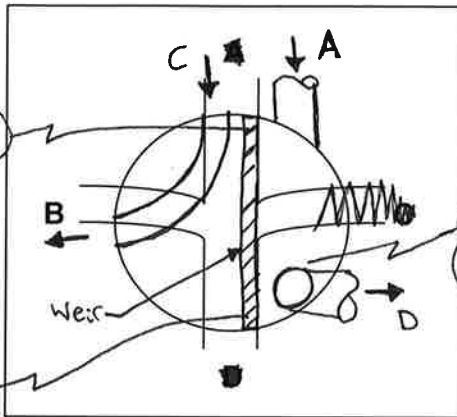
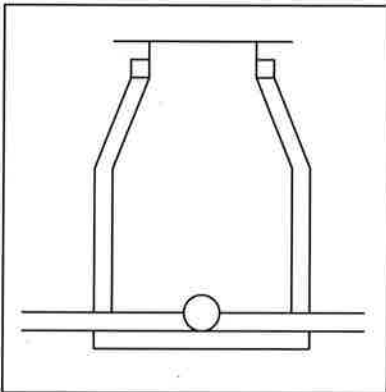
MH# 52-3215

- Weir is tapered
- Steady Flow observed within channel that "D" pipe drops into

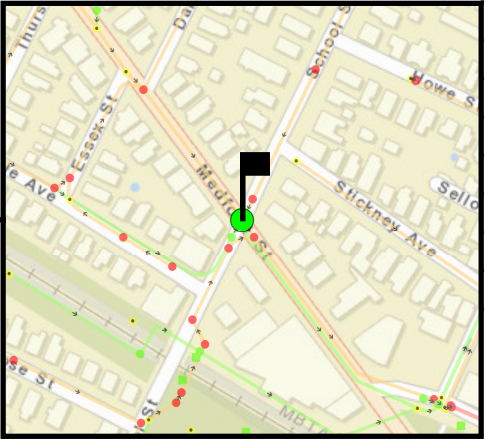
MH#S2-2686

General Comments: Crack in manhole, 1.3' from top of weir to invert on other side of weir

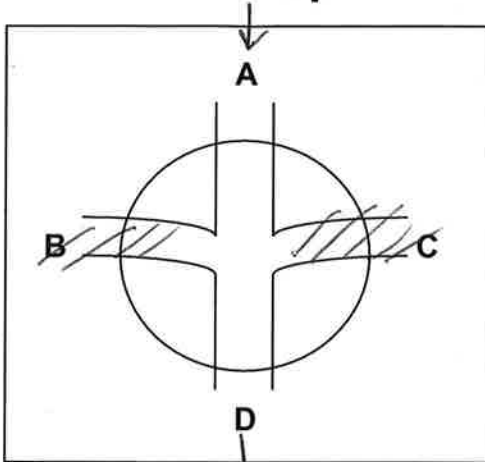
MH# C1-5679 B

Located
in the
b'ball ct.

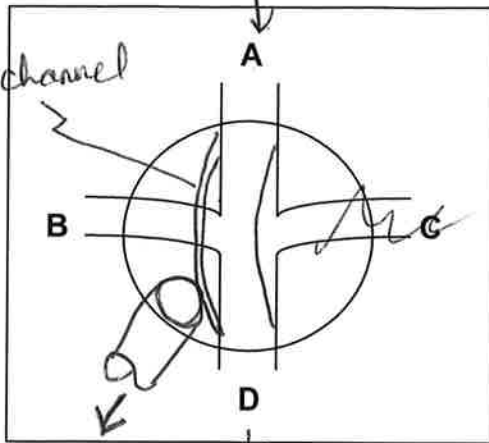
MH# 52-1848

raised channel
Weir

Rim to top
of channel
weir
= 5.49'
