Manhole Inspection Report	MH# C2-1337
Image: Sector	Catchment Area: Inspector: Greg Frazier Date: 11/21/2018 8:19:03 AM Temp: 30s Weather: Cloudy/Overcast Street: Somerville Ave
General Comments:	Cover Size: 24" Other: Manhole Size: Other: Drop: N Depth to Wet Ring from Rim or Invert:
Location of MH - Roadway Comment - Brick Manhole Material - Brick Comment - Stagnant Flow - Stagnant Comment - Normal Sewer Appearance	Weir- (Y/N):YRim to top of weir:8.05'MH Channel- (Y/N):YMH Channel Condition:FairArea Around MH Condition:Paved- CrackedMH Condition:
Recommendations- Clean/Remove Depris from invert	Fair

Somerville MVP - Fieldwork Planning

Somerville, MA

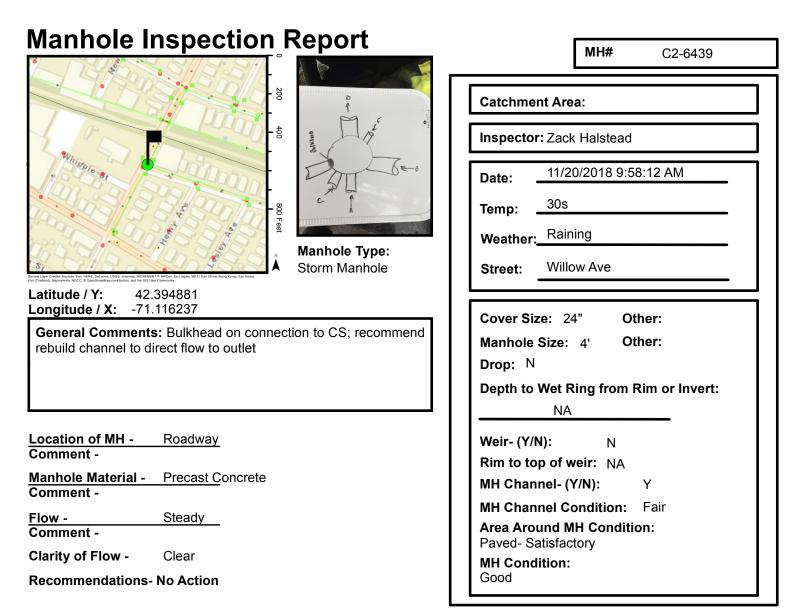
Pipe Size	Material	From / To MH#	Invert Depth (from rim)	Flow Depth (from invert)	Debris Depth (from invert)	Condition
Α.	8"	VCP	CB?	6.71'	1"	0"	Good
в.	20"?	RCP	<u>C2-5419</u>	7.42'	2"	0"	Good
C.	12"	RCP	Unk	4.64'	0"	0"	Good
D.	21"	RCP	1-5431	7.47'	2"	0"	Good
Ε.	20"	VCP	Bulkheaded	7.37'	0"	0"	N/A
F.	8"	PVC	CB?	5.68'	1"	0"	Good
G.							
Н.

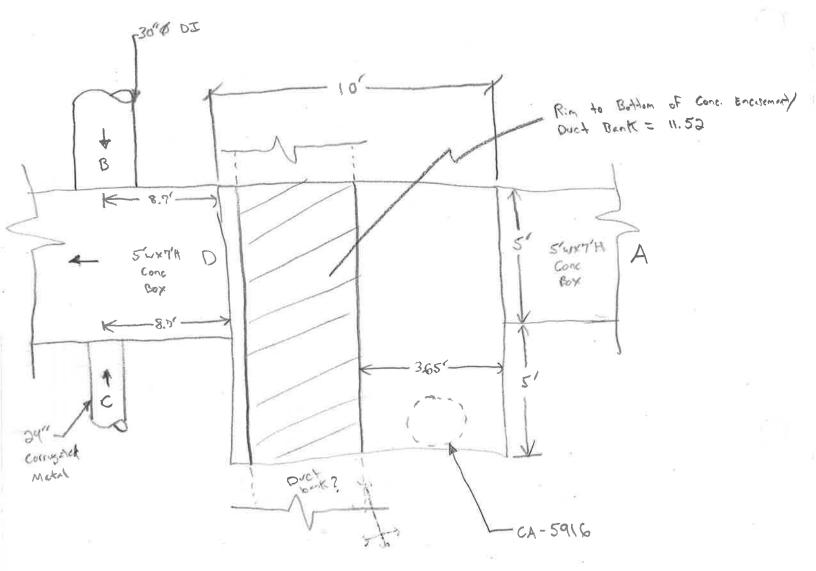
Size	Maderiel	From RIM
A	SWX7'H	CONC	15.27
B	30"Ø	ID	9.77
С	24" Ø	Corrugated Met	4. 9.07'

D SWX7'H CONC 15.27"
