Structural Condition Assessment

Town of Swansea

Palmer River Pump Station
Raw Water Pump Station
Old Providence Road Bridge
Swansea, MA 02777

April 23, 2019

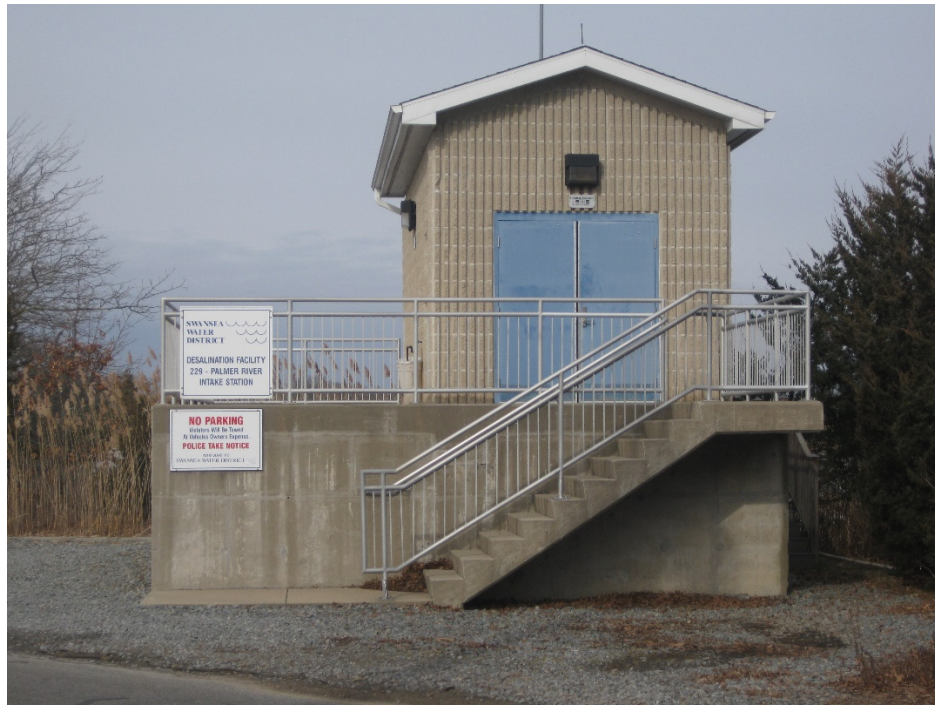
Photo #1 – Palmer River Pump Station south elevation

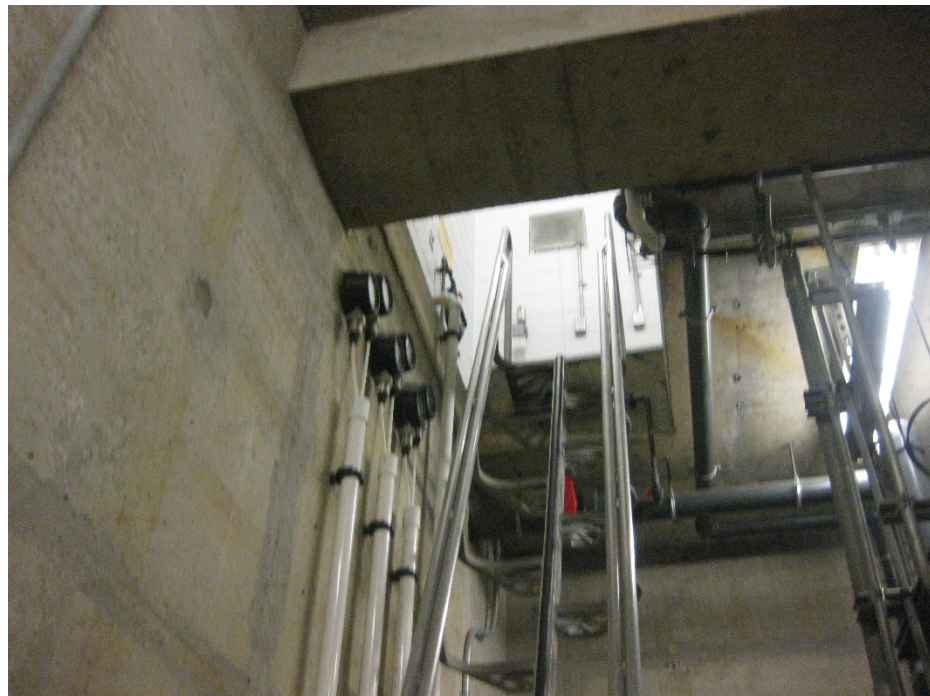
Photo #2 – Ship's ladder to lower level

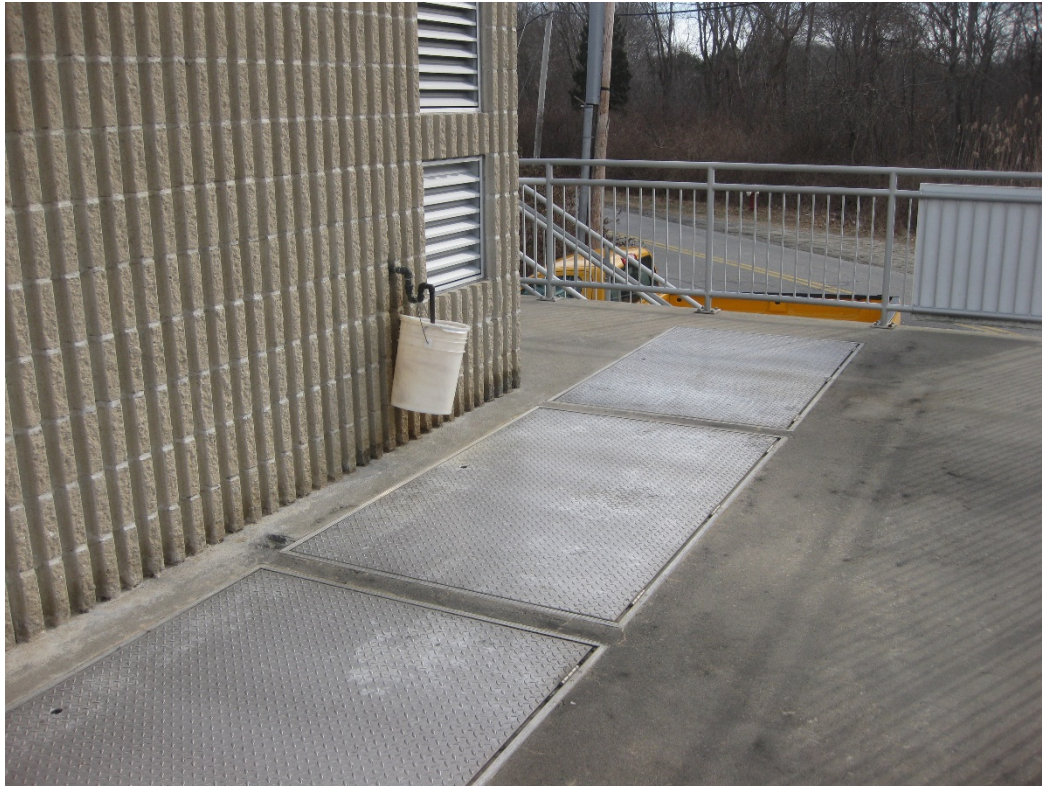
Photo #3 – Equipment hatches at main slab exterior

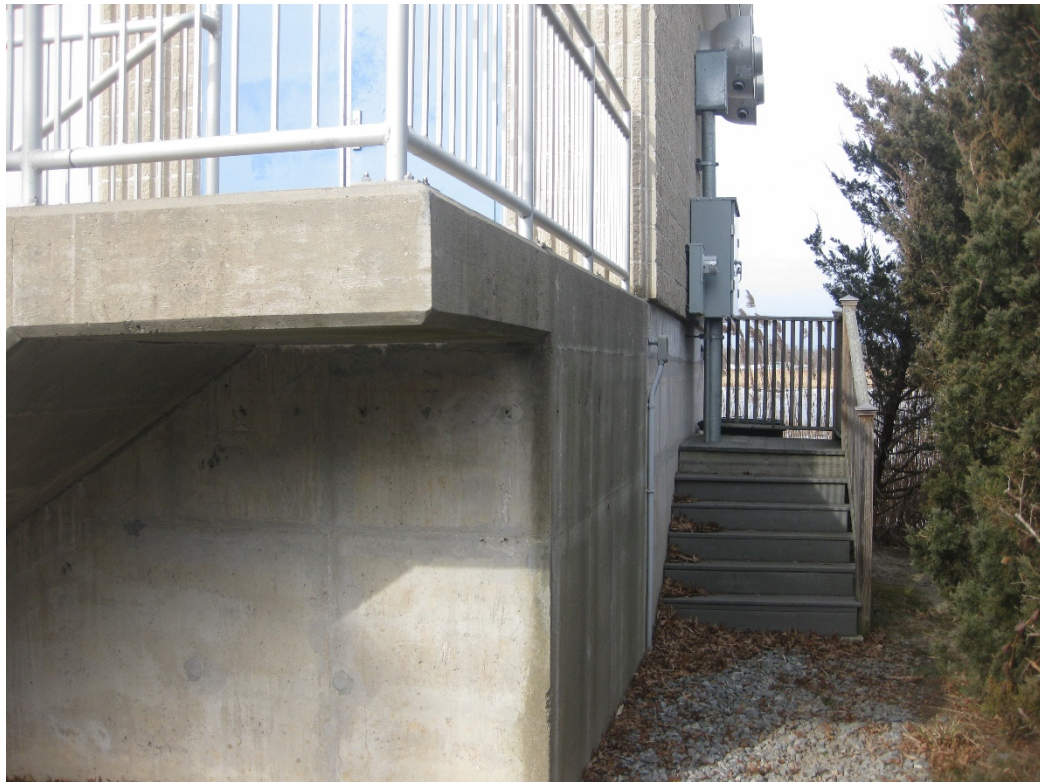
A small wood stair on the east side of the building appears to have been added to provide access to elevated meters and electrical boxes on that side of the building (see photo #4). This stair does not appear on the original construction drawings.

Photo #4 – Wood stair at east elevation

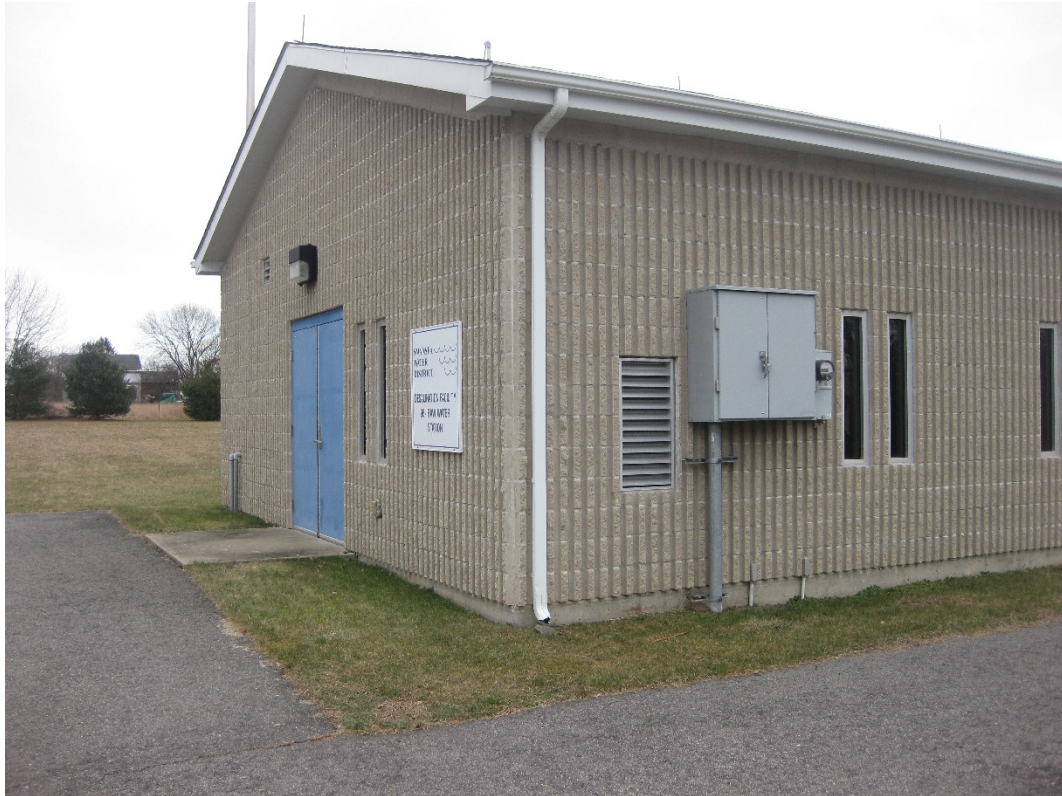
The Raw Water Pump Station is a single-story split rib concrete masonry bearing wall structure supporting a gable formed wood truss roof (see photo #5). The floor of the building is at elevation 23.0 feet, just above the surrounding grade elevation and well above the current base flood elevation. There are two 5'-0" deep pits covered with steel grating on the east and west sides of the building. The building is accessed through a double door on the street side and a single door on the side.

Photo #5 – Raw Water Pump Station

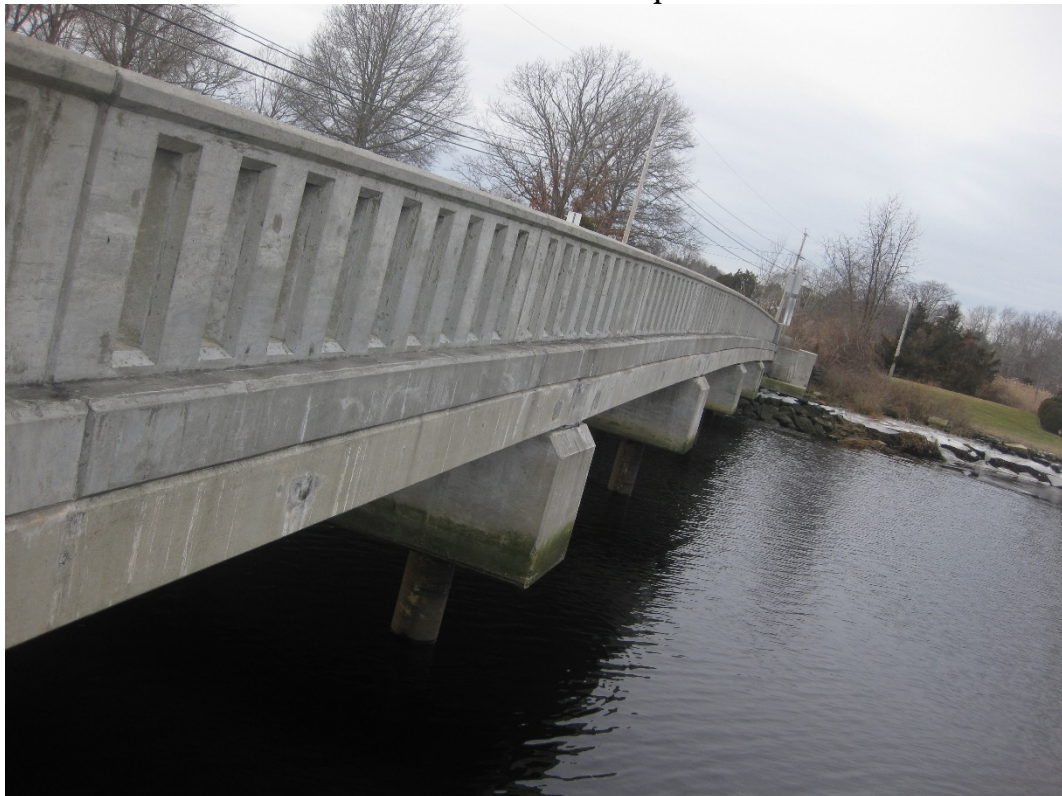
The Old Providence Road Bridge is a precast concrete structure spanning approximately 150 feet across the Palmer River. A cornerstone indicates the bridge was constructed in 2007. The structure consists of precast concrete hollow core planks spanning 30 feet between concrete abutments and a series of four interior concrete piers, each supported on five 16" diameter steel pipe piles (see photo #6). Steel H-piles support the abutments.

Photo #6 – Old Providence Road Bridge

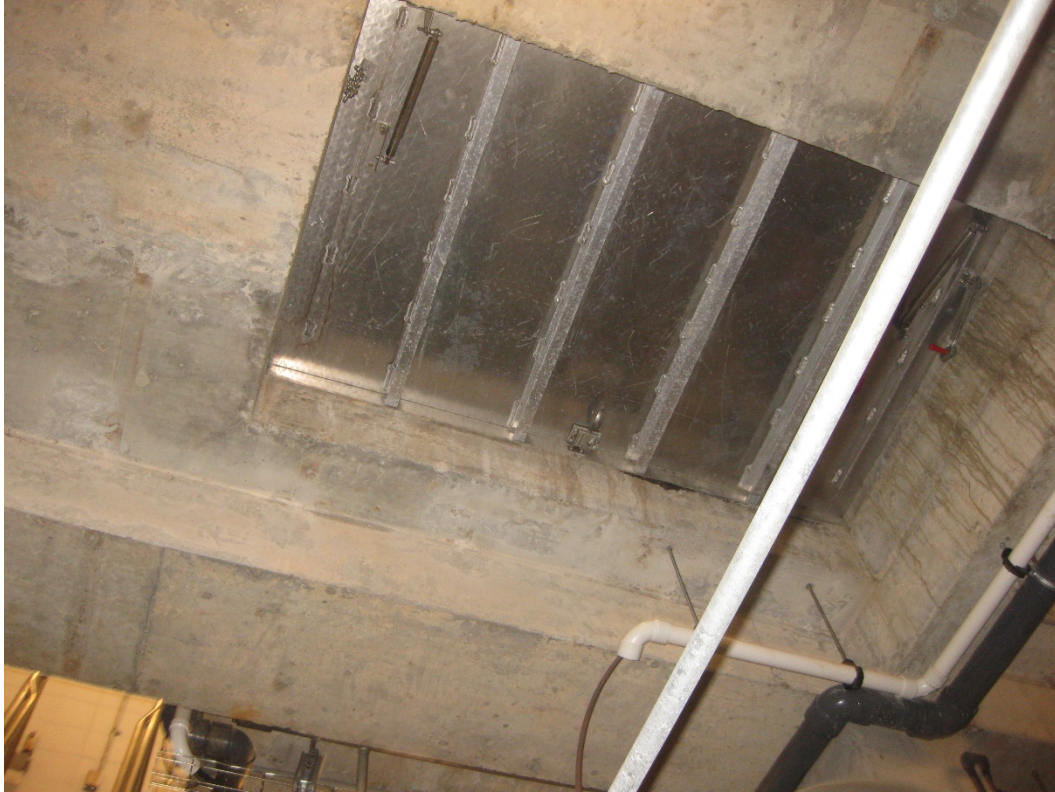
2. The three exterior hatches are already exposed to surface rainwater, and would likely provide some protection from flood water, but it is unclear whether they would remain watertight under 13.68" of water. Some staining from water infiltration was evident (see photo #7). Similarly, the double door entrance into the masonry enclosure likely cannot prevent flood water from entering the building and ultimately filling the basement level.

Photo #7 – Water stains at underside of equipment hatches

1. Construct a 2'-3" high bulkhead around the perimeter of the main level slab.
2. Install a water-tight door at the double door entrance to the masonry enclosure and water-tight equipment hatches, and construct a 2'-3" high bulkhead around the interior opening to the basement.

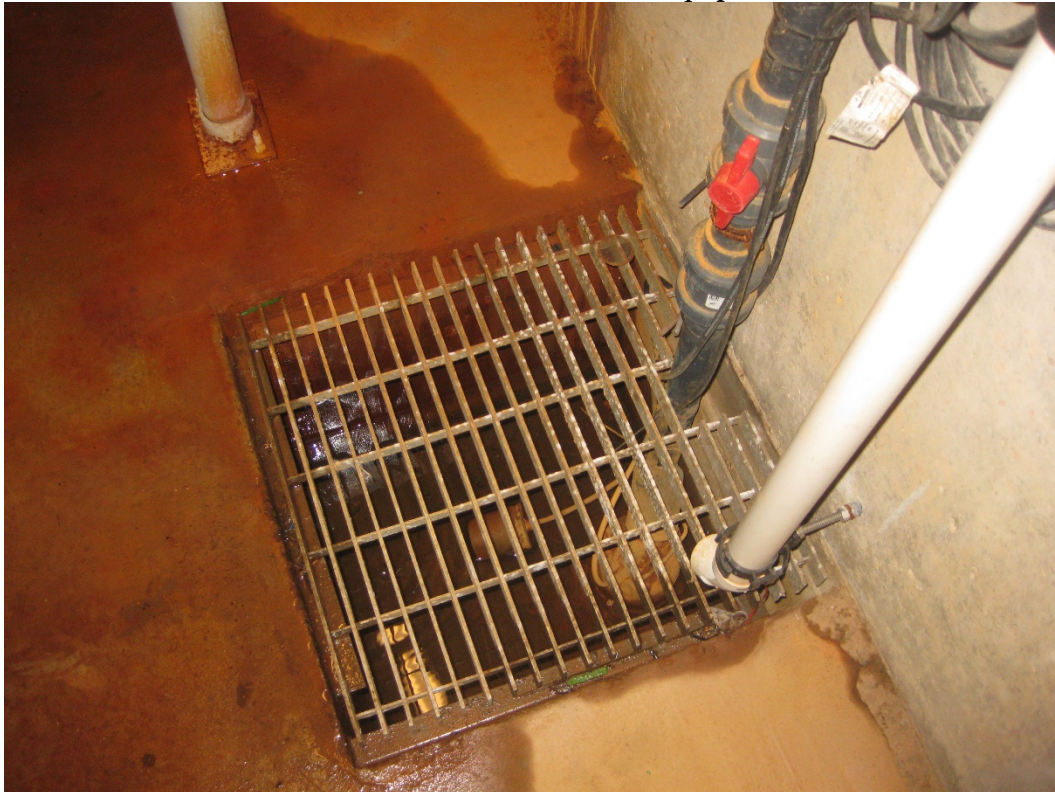
3. A 2'-0" deep sump pit lies at the center of the west side of the basement (see photo #8). Some standing water was evident near the pit and at other locations at the basement level.

Photo #8 – Sump pit in basement level

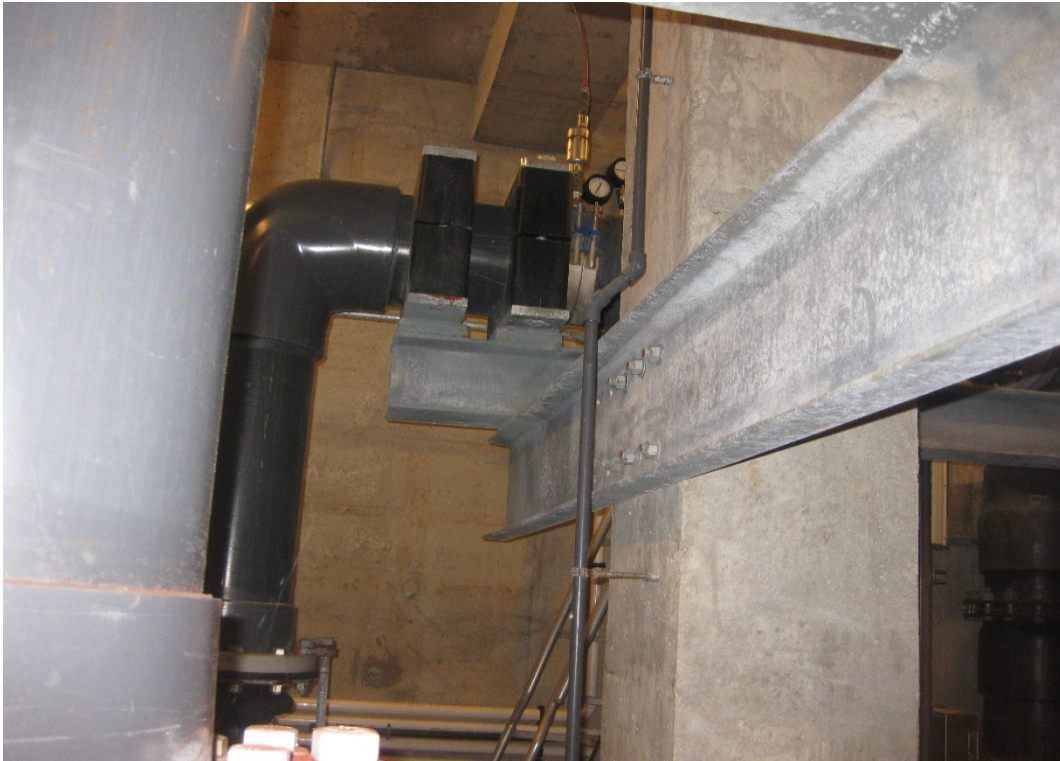
4. Pipe supports within the building are generally constructed with galvanized steel, but several supports were found that consist of painted steel (see photos #9 and 10). These were reportedly replaced or modified following the original construction. No pipe support details are indicated on the original structural drawings.

Photo #9 – Galvanized steel pipe supports

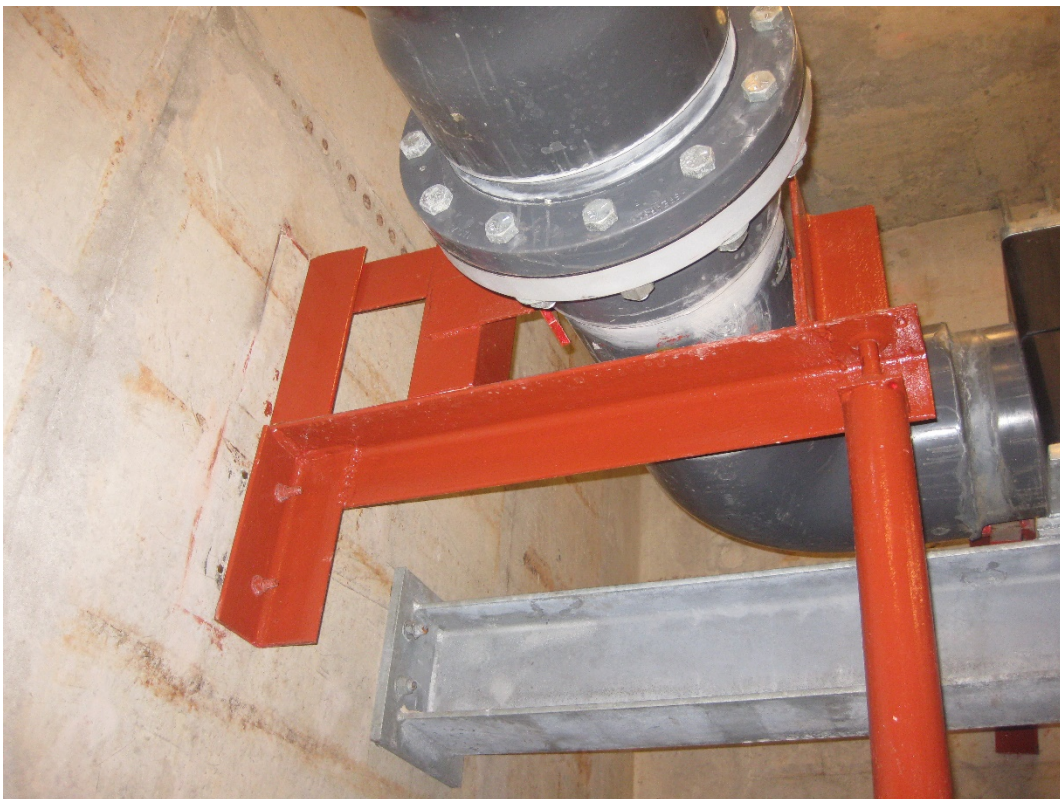
Photo #10 – Painted steel pipe supports

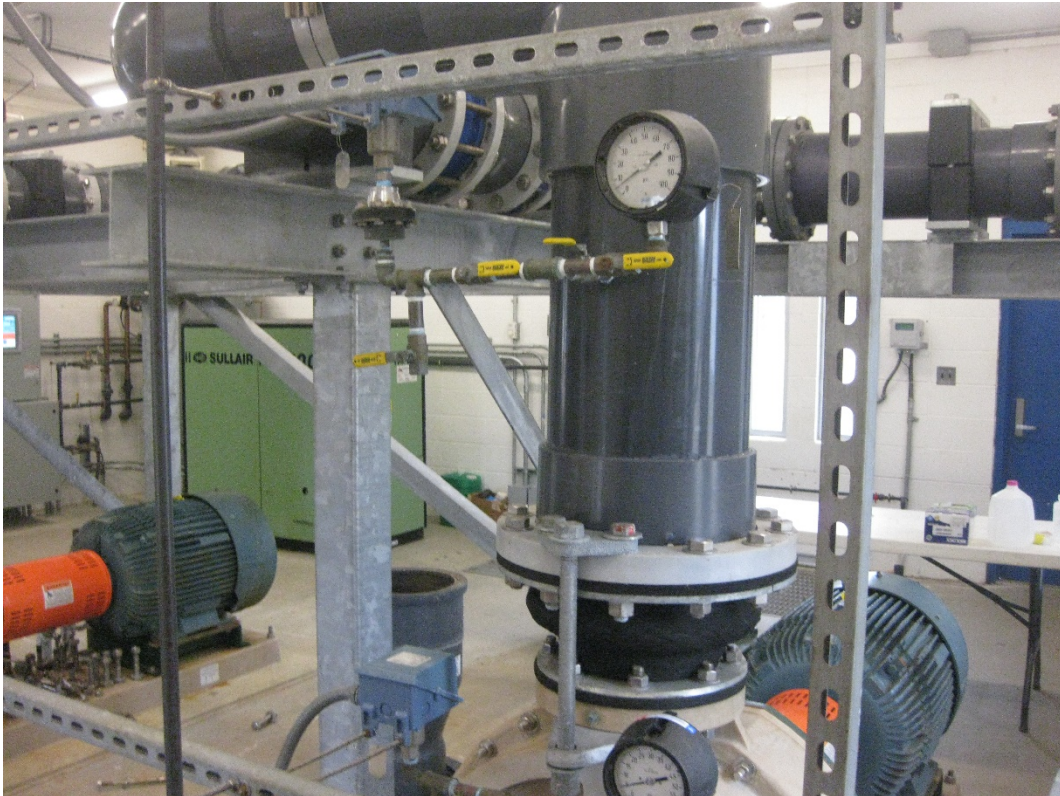
1. The equipment and pipes inside the building are supported with galvanized steel frames and Unistrut framing (see photo #11).
2. Several minor random cracks were noted in the slab on grade (see photo #12).
3. Some discoloration was noted on the exterior face of the split rib block at the rear (see photo #13). This is likely the result of exposure to surface water.

Photo #11 – Equipment and pipe supports at Raw Water Pump Station

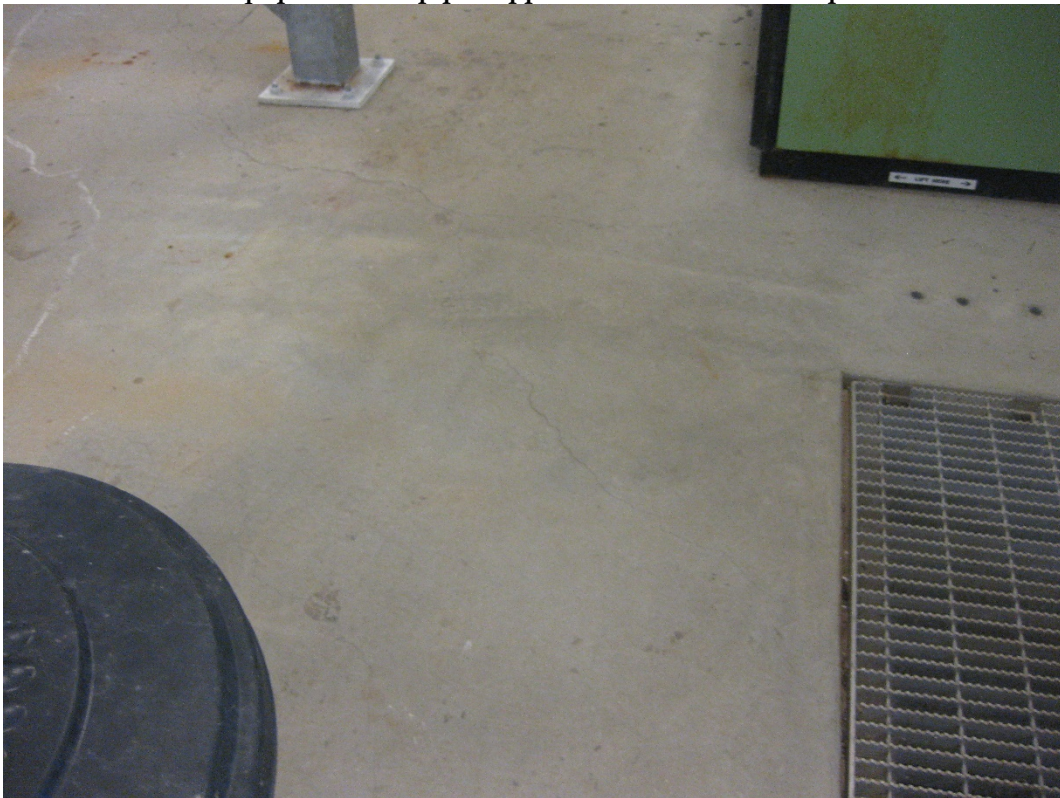
Photo #12 – Cracks at the slab on grade

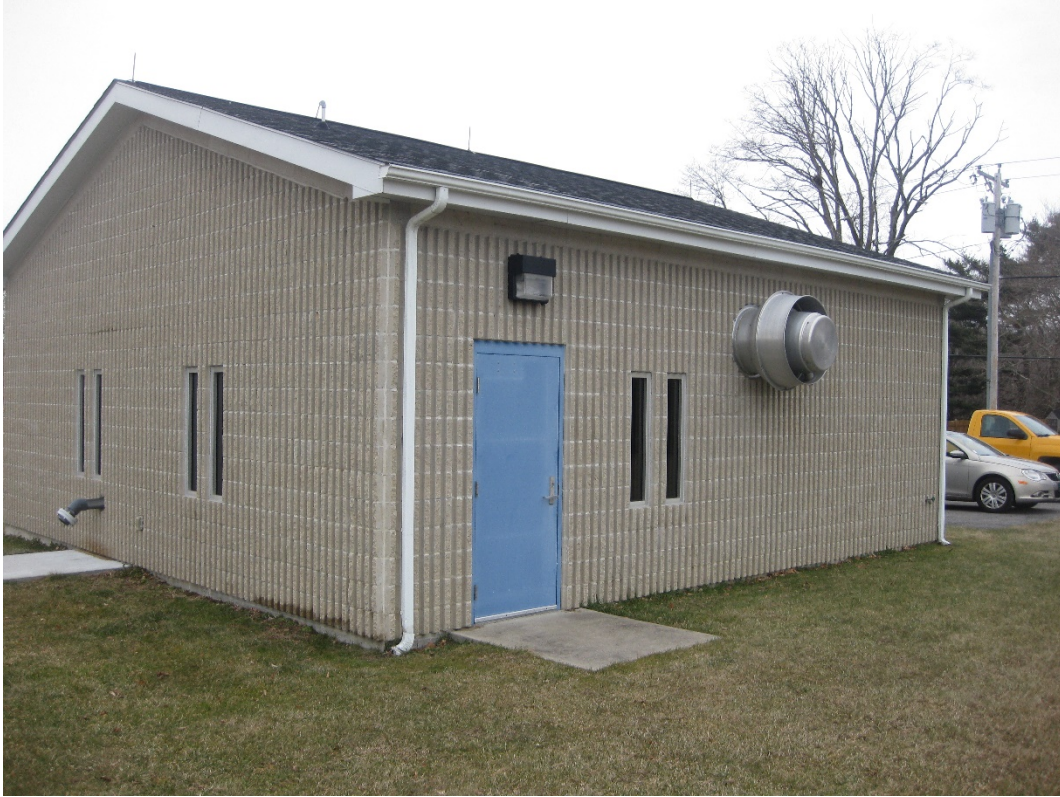
Photo #13 – Discoloration at rear exterior wall

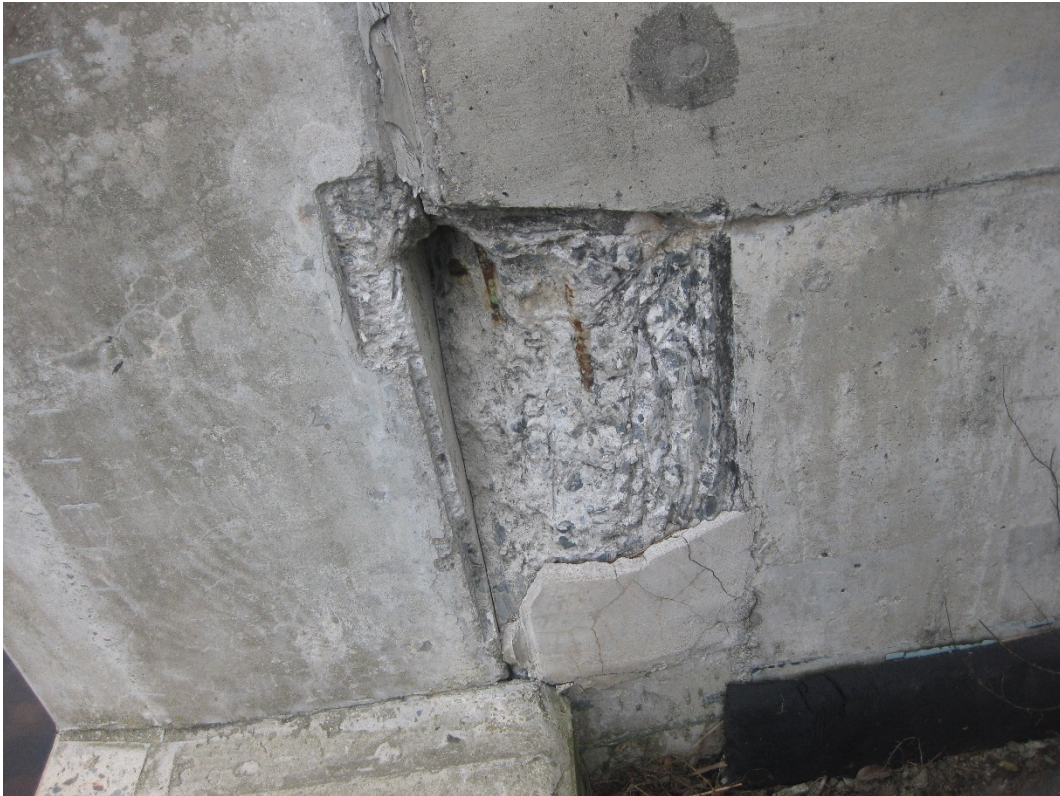
2. All bridge elements appear to be in good condition, but a spalled area with some exposed, moderately rusted reinforcing was found at the joint at the north side of east abutment (see photo #14). It appears the spall was patched previously, but further spalling has occurred.
3. Evidence of water infiltration was found at the joint between the east abutment and the deck planks from below (see photo #15).

Photo #14 – Spalling at bridge abutment

Recommendations for bridge repairs are limited to deck joint and spall repairs at the abutments. No remedial measures are required for the Raw Water Pump Station.

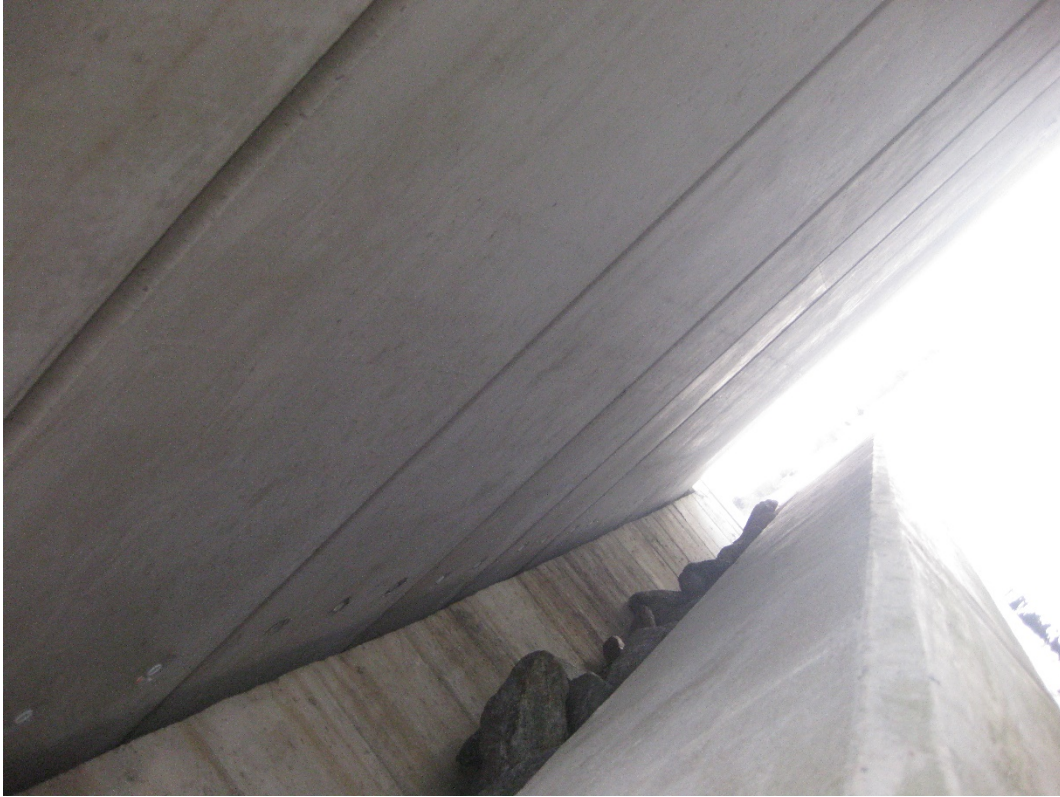
Photo #15 – Signs of water infiltration at abutment
