TAUNTON RIVER WATERSHED

Taunton River Watershed

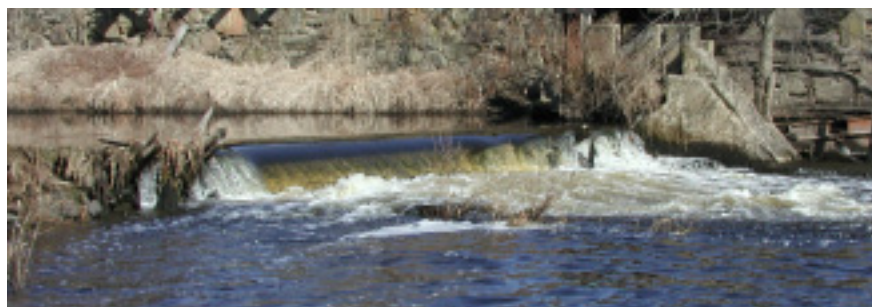
Plymouth Street Dam

River Mile	Type	Material	Spillway W (ft)	Spillway H (ft)	Impoundment Acreage	Year Built	Owner	GPS
38.2	Dam	Steel and wood	75	1.8	0.0	1900	Private	41° 59' 31.909" N 70° 56' 19.963" W

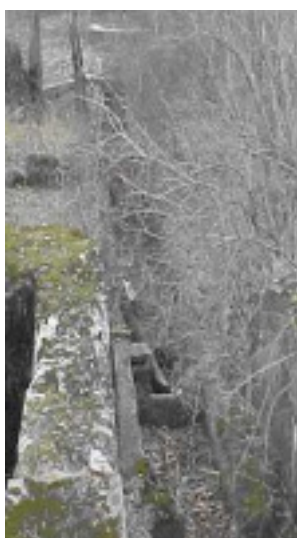
Design	Material	Length (ft)	Inside W (ft)	Outside W (ft)	# of Baffles	Baffle H (ft)	Notch W (ft)	Pool L (ft)	Condition/Function
Notched weir-pool	Concrete	122	3.5	6.0	12	-	-	-	Poor Not passable

Remnants of Plymouth Street Fishway

The Taunton River is formed by the confluence of Town River and the Matfield River in Bridgewater. The only obstruction on the main stem river is immediately downstream of this point. A partially breached dam at Plymouth Street creates an impediment to fish migration during low spring flows. Under most flow conditions, however, river herring are able to pass upstream. Complete removal or further breaching of the remaining dam would insure unencumbered passage to the upper river.

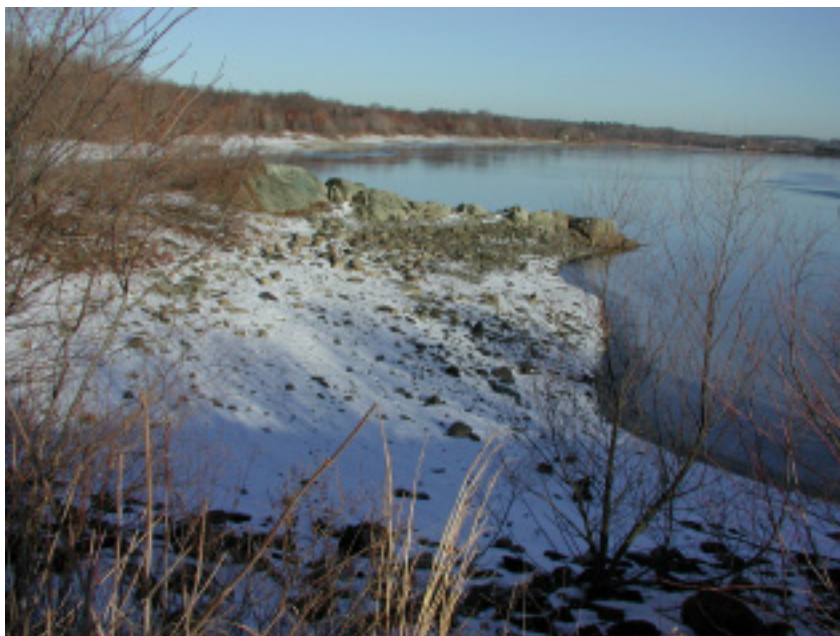
Dry Outlet of Somerset Reservoir

The source of this small stream is a public water supply for the Town of Somerset. Widely fluctuating water level in the impoundment, inconsistent flows and lack of access eliminate any potential for development as a river herring run.

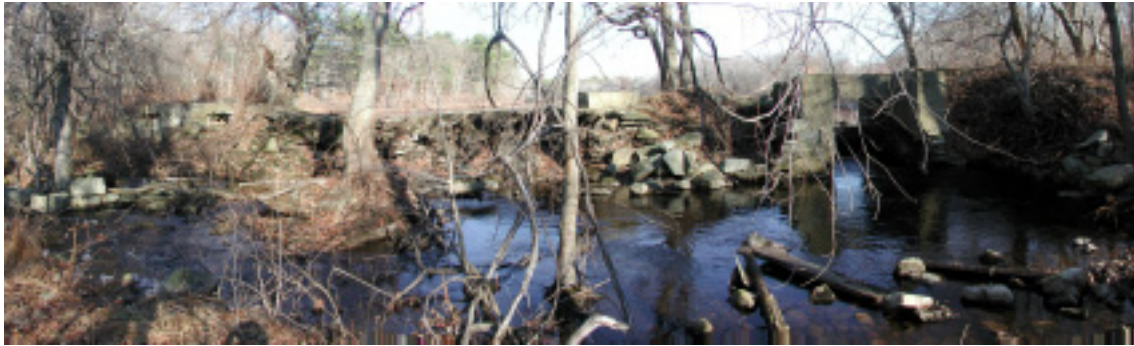
Forge Pond Dam

The Assonet River has 3 dams which obstruct fish passage. The first is at the head of the tide and the last forms the only significant potential spawning area, Forge Pond. The Forge Pond dam is in poor condition and leaks badly resulting in the loss of most of the impounded acreage. The cost of extensive repairs to the dams and fishway construction at all three sites gives this stream a low priority for development. River herring and smelt currently spawn immediately below the first dam and an active white perch fishery is carried on in the estuary. Consideration should be given to protection of existing spawning habitat and removal or breaching of the dams in order to create a free flowing stream habitat.

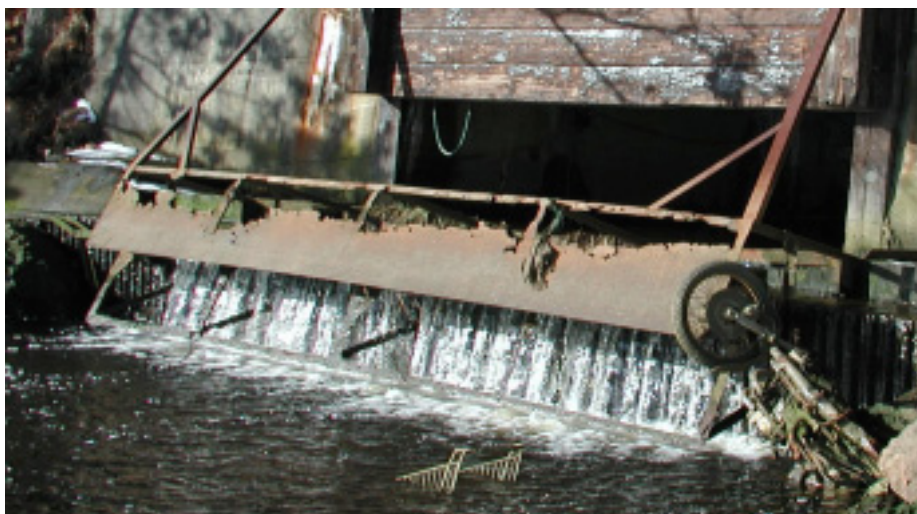
Gate under Railroad Tracks

Muddy Cove Brook is a small tributary to the main stem Taunton River in Dighton. Several obstructions exist, two of which are passable at some tidal stages. The first, a tide gate at the stream mouth has deteriorated and allows fish to get by at higher tidal stages. The second is a concrete dam which has had its wooden stop logs removed and is passable under current water levels. A 17 foot dam blocks fish passage to a 23 acre impoundment. River herring have been reported to ascend to the base of that dam. The habitat available in the impoundment and the fact that the owner has expressed interest in installing fish passage facilities makes this system a good candidate for development.

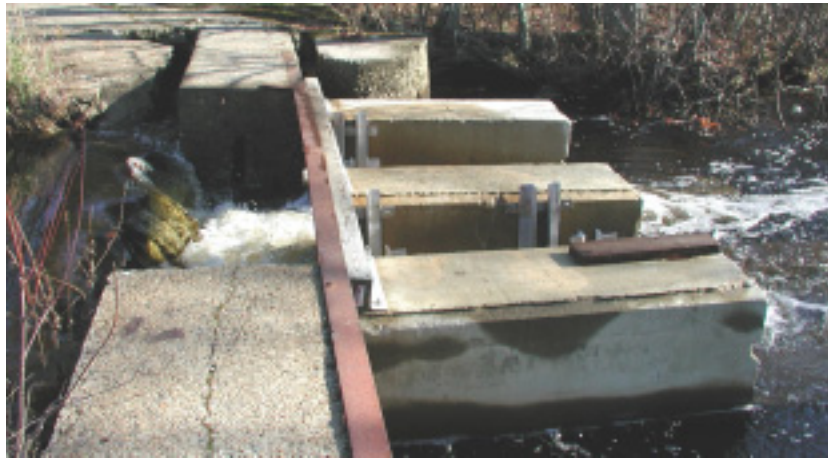
First unnamed dam and fishway on the Segreganset

Design	Material	Length (ft)	Inside W (ft)	Outside W (ft)	# of Baffles	Baffle H (ft)	Notch W (ft)	Pool L (ft)	Condition/ Function
Weir-pool	Concrete with aluminum slots and wooden baffles	5.5	3.0	7.3	2	N/A (none in at time of survey)	-	3.3	Excellent Passable

The Segreganset River has two obstructions to passage in its lower reaches. The first, a low head concrete and steel structure, was equipped with a steel plate weir-pool fishway which became badly deteriorated and was removed in 2000. A new ladder has been constructed by the Town of Dighton along with volunteer help and appears to be functional. Although this dam creates a spawning habitat of only 2.8 acres, a small population of river herring appears to be maintaining itself with some success. Also, smelt eggs have been observed in the stream below the dam in past years.

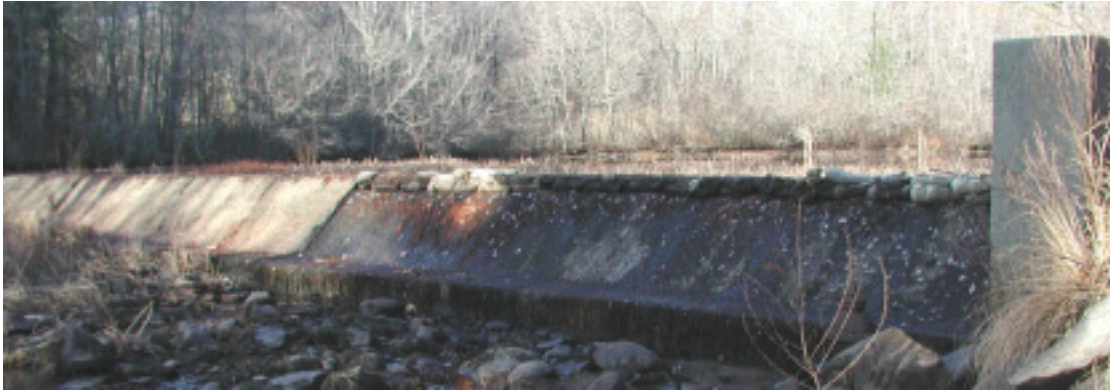
Segreganset River Dam

A second dam, immediately upstream, blocks further passage. This obstruction creates an impoundment of only 1.2 acres which does not justify construction of fish passage facilities.

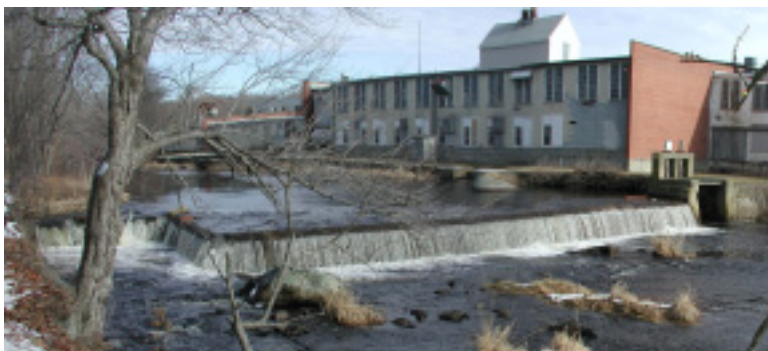
Dam below Harodite Factory

This tributary to the Taunton River forms the boundary between Dighton and the City of Taunton. The lower course is impounded by two currently impassable dams. The first, at the Harodite Company was equipped with a prefabricated, wooden Denil ladder. This structure was washed away by high water during the spring of 1998. The upstream impoundment has been stocked by DMF with blueback herring in anticipation of a replacement being installed. A more permanent structure has been designed for the site and is awaiting funding. A second dam at the Harodite location appears to be avoidable by way of a bypass channel a few yards from the spillway. A railroad trestle over the bypass channel, while not forming an obstruction itself, collects a large amount of debris which could impede passage and must be cleaned annually.

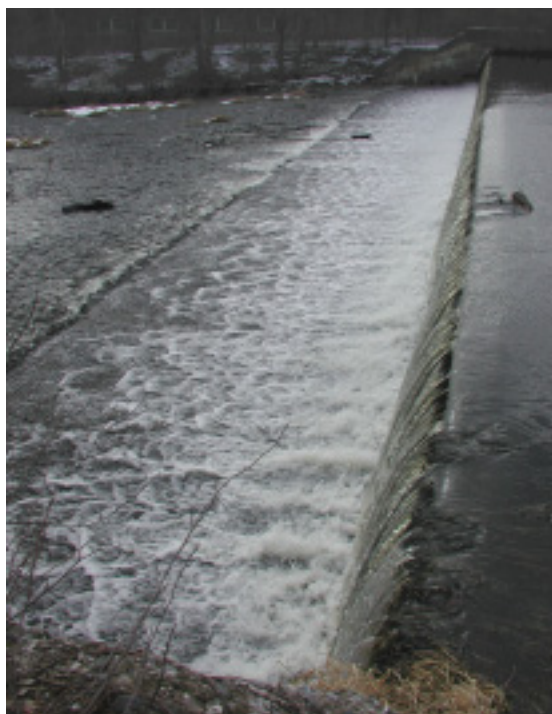
Dam at Draka Factory

A fishway has also been designed for the third obstruction, a dam at the Draka factory. This structure, a concrete and wood Denil style ladder, if funded, would make a significant amount of riverine impoundment and slow flowing river habitat available to anadromous species.

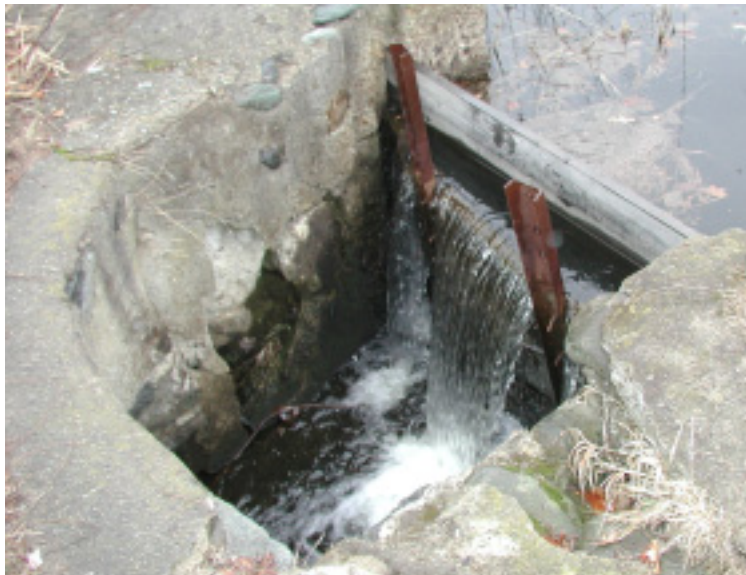
Unnamed dam above Berkley Street

Due to the difficulty of providing fish passage and the small impoundment size, anadromous fish development is not warranted.

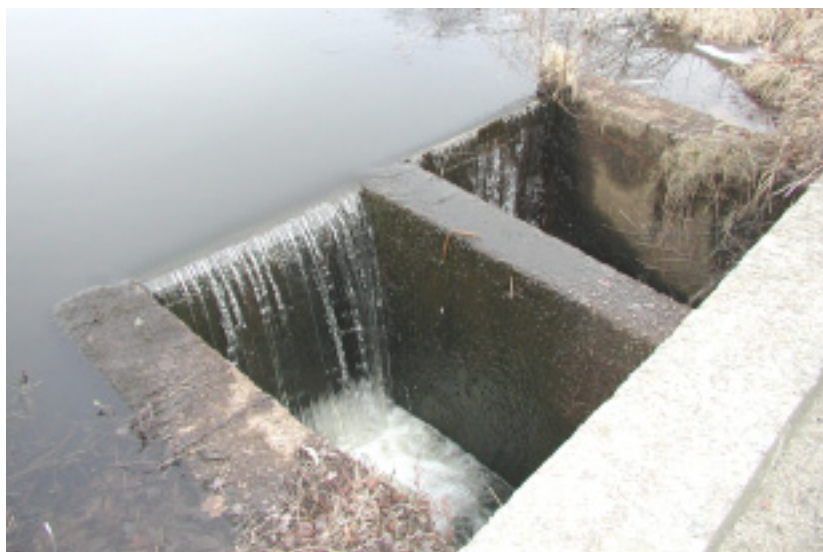
Richmond Pond Dam

Richmond Pond drains into the Taunton River by way of a small unnamed intermittent stream. The difficulty of providing fish passage caused by the spillway/culvert configuration and the small impoundment size give this site a low priority for development.

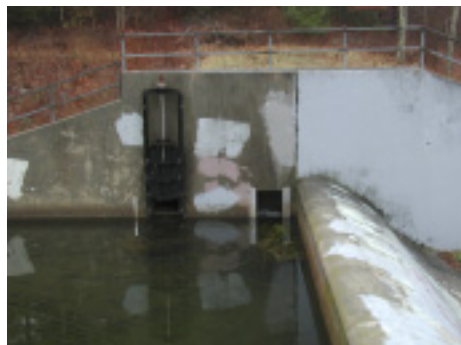
Design	Material	Length (ft)	Inside W (ft)	Outside W (ft)	# of Baffles	Baffle H (ft)	Notch W (ft)	Pool L (ft)	Condition/Function
Weir-pool	Concrete	170.0	2.0	4.0	20	Varied	-	Varied (6 – 8)	Good Passable

Exit of Lake Rico Fishway

This stream flows for approximately one mile from Lake Rico to the Taunton River. The dam that creates Lake Rico was constructed by the Commonwealth's Department of Environmental Management in 1969. A fishway was installed at the time of construction but the inability to fill the impoundment to its design elevation caused the ladder to be nonfunctional. In 2000, DMF developed a design to retrofit the fishway with a new exit at the existing lake elevation. DEM funded the modifications and the fishway now passes river herring successfully. With proper maintenance and flow regulation, Lake Rico's 215 acres should support a sizeable population. Due to the low stream gradient, channel maintenance below the ladder and to the brook mouth is also an important priority.

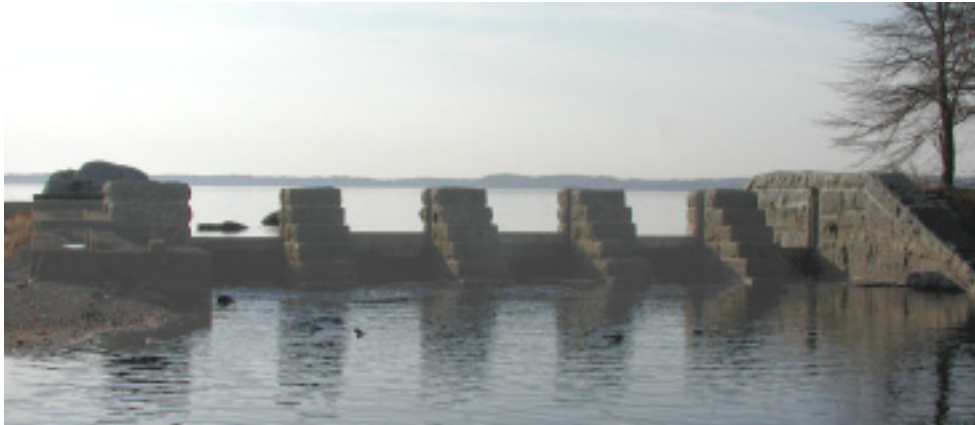
Assawompset Pond Dam (with Fishway along left edge of the dam)

Design	Material	Length (ft)	Inside W (ft)	Outside W (ft)	# of Baffles	Baffle H (ft)	Notch W (ft)	Pool L (ft)	Condition/Function
Denil	Concrete with wooden baffles	29.5	2.0	4.0	9	4.5	-	-	Good Inefficient passage

The dam at Assawompsett is, in fact, passable for most of the early spring flows since the tailwater pool level rises sufficiently to allow herring to swim over it. When the pool level drops, the migrating herring are able to utilize the fishway. This is an important point since the dam is in poor condition and may be replaced. A dam design that would not allow fish to ascend it could have a dramatic impact on the population because the small Denil ladder is incapable of passing such a large number of fish efficiently. Emergent aquatic vegetation in the impoundment above Wareham Street and other slow moving sections of the river has caused problems for migrating fish in the past and a channel should be maintained through this growth.

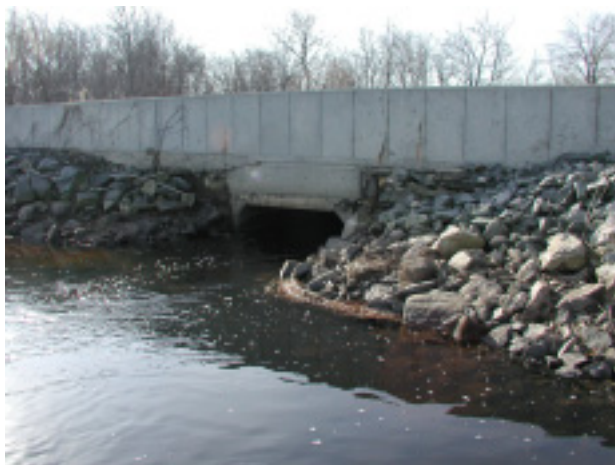
Larger culvert under Route 18

Two other potential obstructions to passage may be encountered once fish have entered the lake system. A culvert at Route 18 which accommodates the connector stream between Assawompsett and Long Pond was replaced in 1993. The invert elevation of the culvert was too high for downstream migration of juvenile herring and as a result a second smaller culvert was added at a lower elevation. The effectiveness of both these culverts in passing fish has never been assessed. Since Long Pond represents a substantial portion of the total spawning habitat, such an assessment should be conducted.

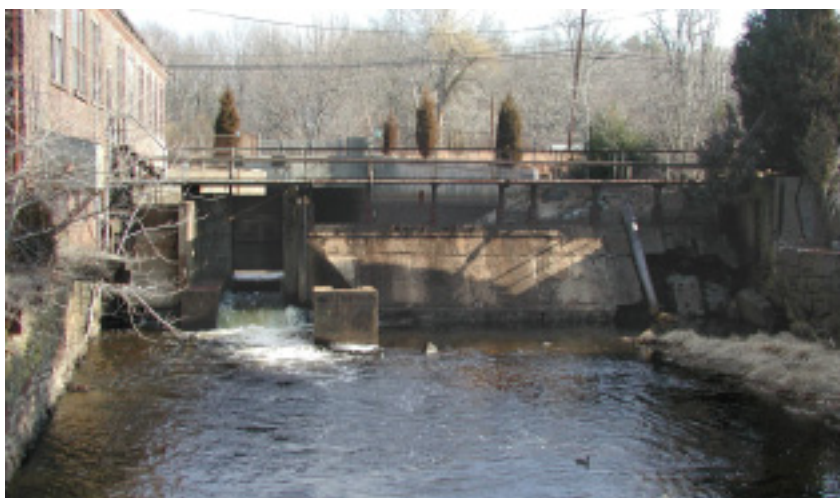
Dam at Route 106

The Satucket River flows from 124 acre Robbins Pond for 5.6 miles to the Matfield River. One obstruction, a dam at Route 106, blocks fish passage to this significant habitat. The dam is in poor condition and has been partially breached for safety reasons thereby draining its impoundment. Fish may be able to surmount the remaining elevation but such passage would be less than adequate for the potential population that this system can produce. The current owner is faced with the options of dam repair or removal. If repair is chosen, a fishway should be included in the design. If the removal option is selected, it should be complete and leave no obstruction for migrating fish. Stream channel reconstruction and design should be performed to ensure no elevation differences create blockage at the Route 106 culvert or further upstream.

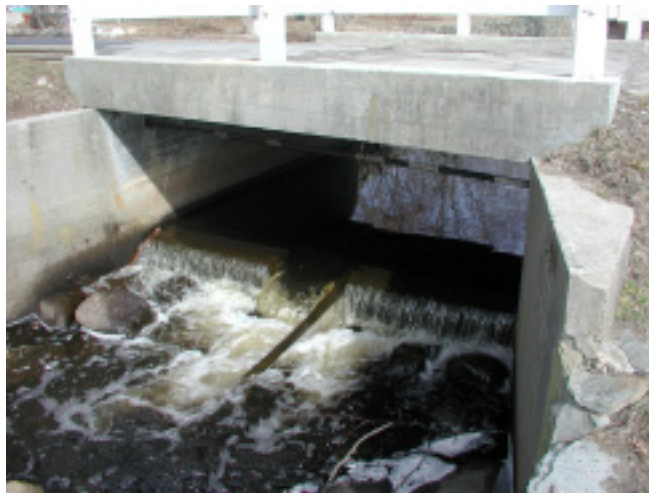
Willow Avenue Dam

Before it enters the Matfield River, this stream forms a 3 acre impoundment called Forge Pond. Immediately below the pond is a small dam at Willow Avenue. This 2 foot drop may be passable during spring flows with some adjustment to the notch in the crest. The dam at Forge Pond has a deteriorated fishway which is not currently functional. A population could be restored here if the ladder was repaired, although only a small spawning area would be gained.

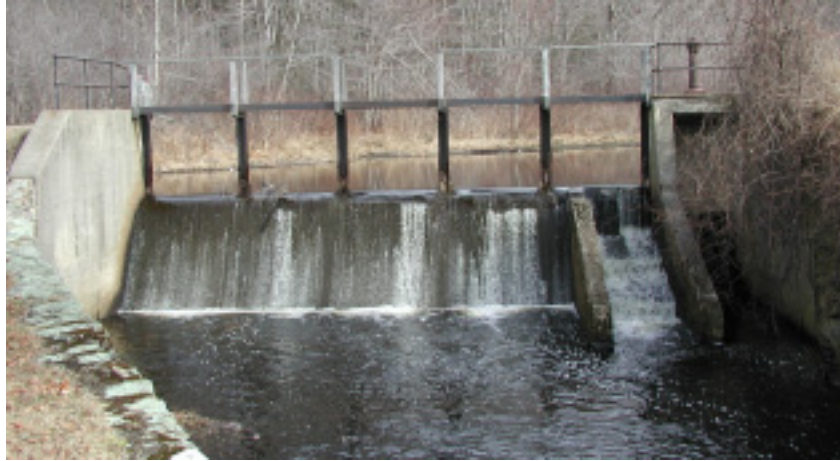
Forge Pond Dam, with fishway along right edge of the dam

Design	Material	Length (ft)	Inside W (ft)	Outside W (ft)	# of Baffles	Baffle H (ft)	Notch W (ft)	Pool L (ft)	Condition/ Function
Weir-pool	Concrete with wood baffles	18.0	4.0	6.0	4	N/A (none in at time of survey)	-	Varied (3-6)	Poor Not passable

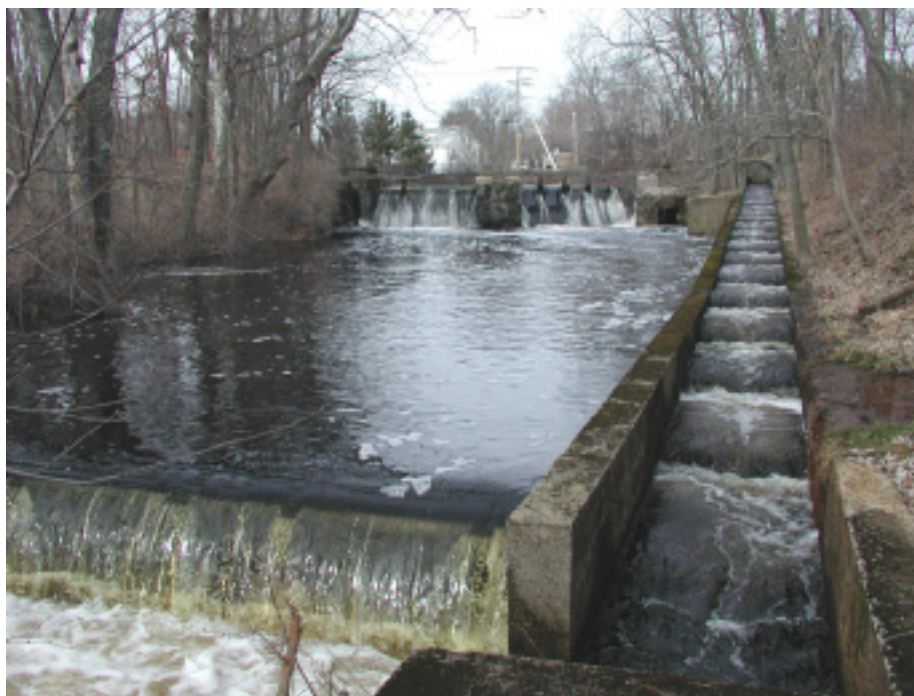
Fishway at High Street, with dam in background

Design	Material	Length (ft)	Inside W (ft)	Outside W (ft)	# of Baffles	Baffle H (ft)	Notch W (ft)	Pool L (ft)	Condition/Function
Notched weir-pool	Concrete	212.0	4.0	6.0	21	3.0	1.0	6.0	Fair Passable

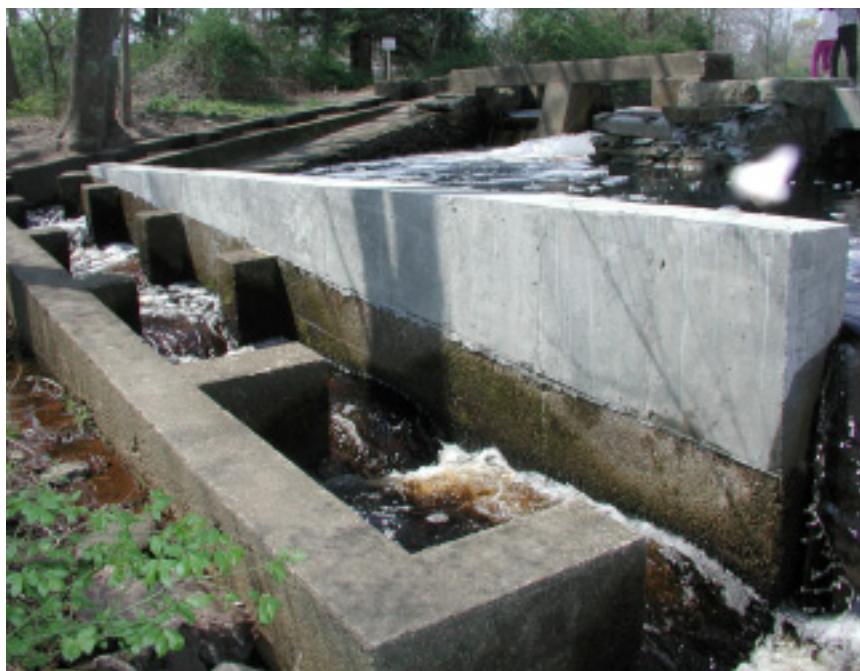
Fishway at War Memorial Park with dam in background

Design	Material	Length (ft)	Inside W (ft)	Outside W (ft)	# of Baffles	Baffle H (ft)	Notch W (ft)	Pool L (ft)	Condition/Function
Notched weir-pool	Concrete	66.0	4.0	6.0	12	1.3	2.0	Varied (3.8-6.2)	Fair Inefficient passage

The second dam received extensive repairs in 2001 and, as part of that work a barrier dam was added to direct fish to the fishway entrance. The effect of the barrier dam on passage efficiency hasn't been assessed as of this writing but the fishway itself, an early notched weir-pool design is inadequate for the population this system should be producing. Consideration should be given to replacement or modification with an aluminum steeppass insert.
