# **Sawmill Brook Culvert at Taunton St**

*Southern Outlet from Turnpike Lake*

## **CULVERT EVALUATION REPORT**

Prepared by: **BETA GROUP, INC.**

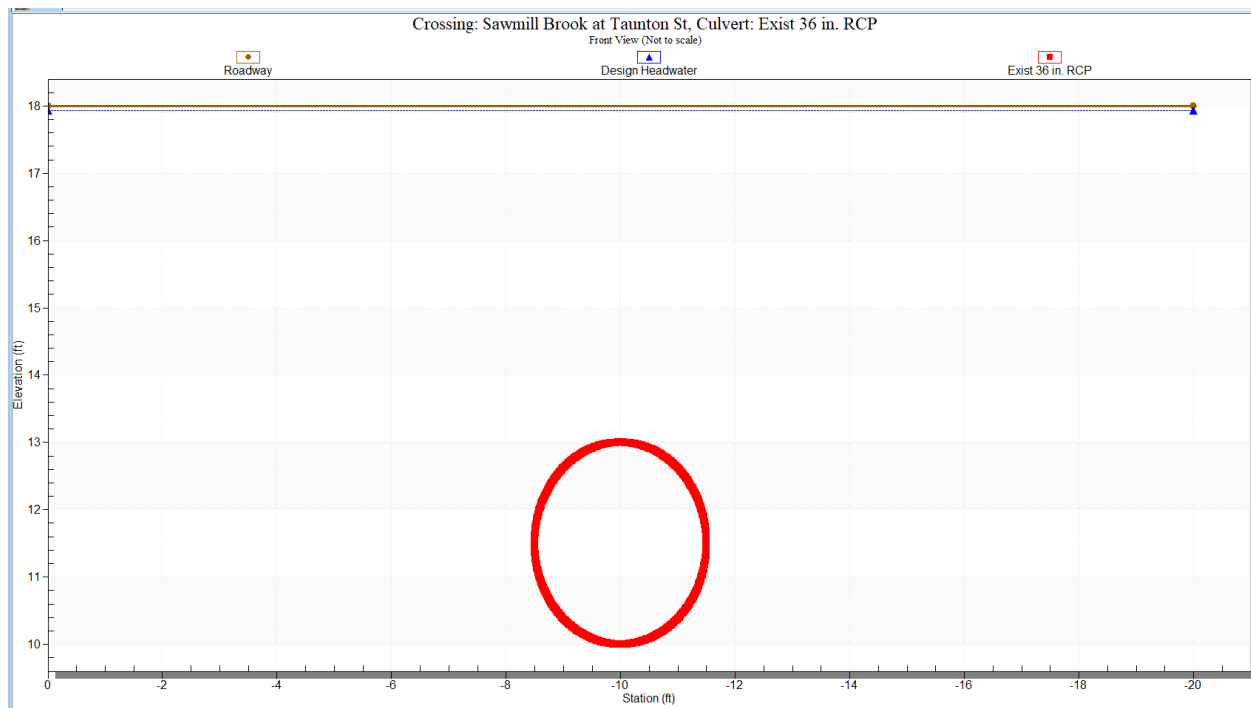
**Figure 7-1 HY-8 Existing Model Overview**

The results indicate that the culvert is sufficient to convey the 25-year storm flows (96 cfs – Streamstats data modified for climate change and proportioned based on culvert size with the Turtle Book outlet). The following figures and table show that the road is not overtopped during the design (25-year storm).

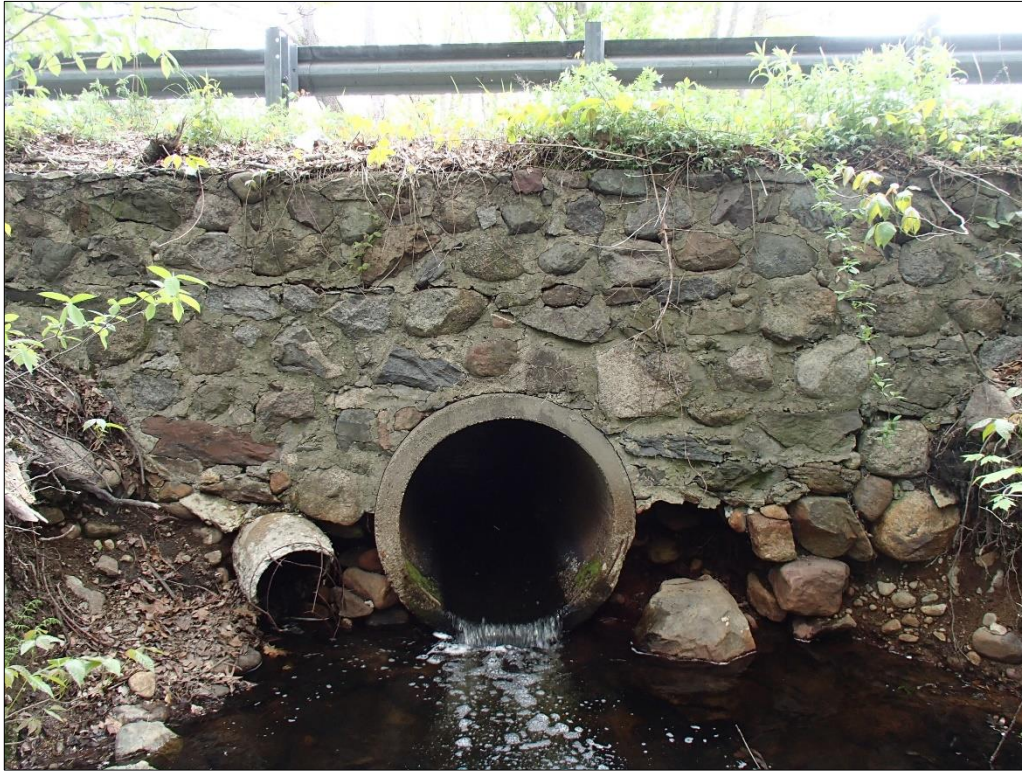
The stone masonry wall on the east side is in poor condition. There are several boulders that have fallen off into the water at the base and there are areas of loose stones and missing mortar throughout. There is also a horizontal crack that runs the full length of the wall, approximately 16" above the top of the pipe (Photo 1). Vegetation and debris are present on the east side (Photo 8). The stone masonry wall on the west side is in fair condition with a few deficiencies noted. There is some missing mortar and an area of potential washout on the northwest embankment (Photo 10). On the west side, there is heavy vegetation on the embankments and over the waterway (Photo 3 and 9).

Photo 1 Looking West: East Elevation

The overall condition of the structure is fair, while the east masonry wall is poor. Based on recent inspection findings, BETA recommends a full replacement of the east wall. Considering the condition of the wall, with cracking and voids at the base, replacing the wall with a C.I.P. concrete wall is the best long-term solution. In order to prevent further deterioration, the following items should be addressed in the interim:

- Replace all missing and/or loose stones in the stone masonry walls, especially at the base of the east wall.
- Repoint all masonry joints to the stone masonry walls on both sides.

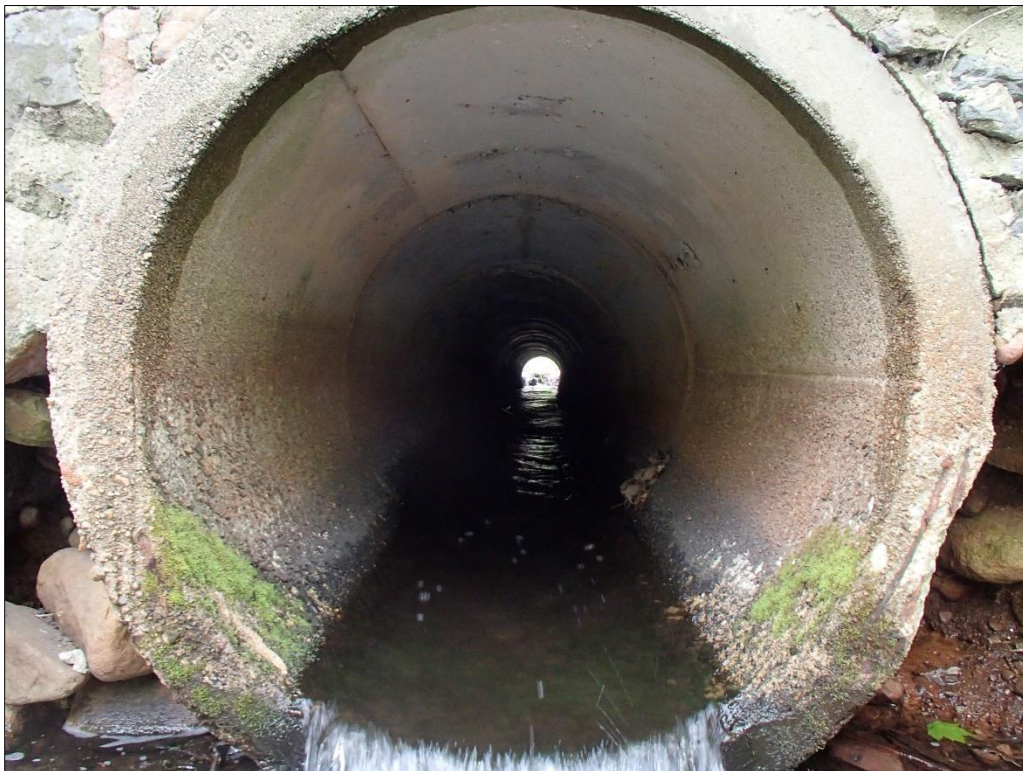
The overall condition of the structure is fair with several deficiencies noted. The concrete pipe through the culvert is in fair condition. Abrasion is present across the pipe, continuing approximately to the center. There is spalling with exposed rebar on the outside of the concrete pipe on the east side, measuring 10' long and 1" deep (Photo 2). There is a drainpipe present on the east side, potentially from the catch basin on the west side. The drainpipe is in poor condition, showing heavy deterioration up to 2' deep into the pipe (Photo 5).

Photo 2 Looking West: East View of Pipe

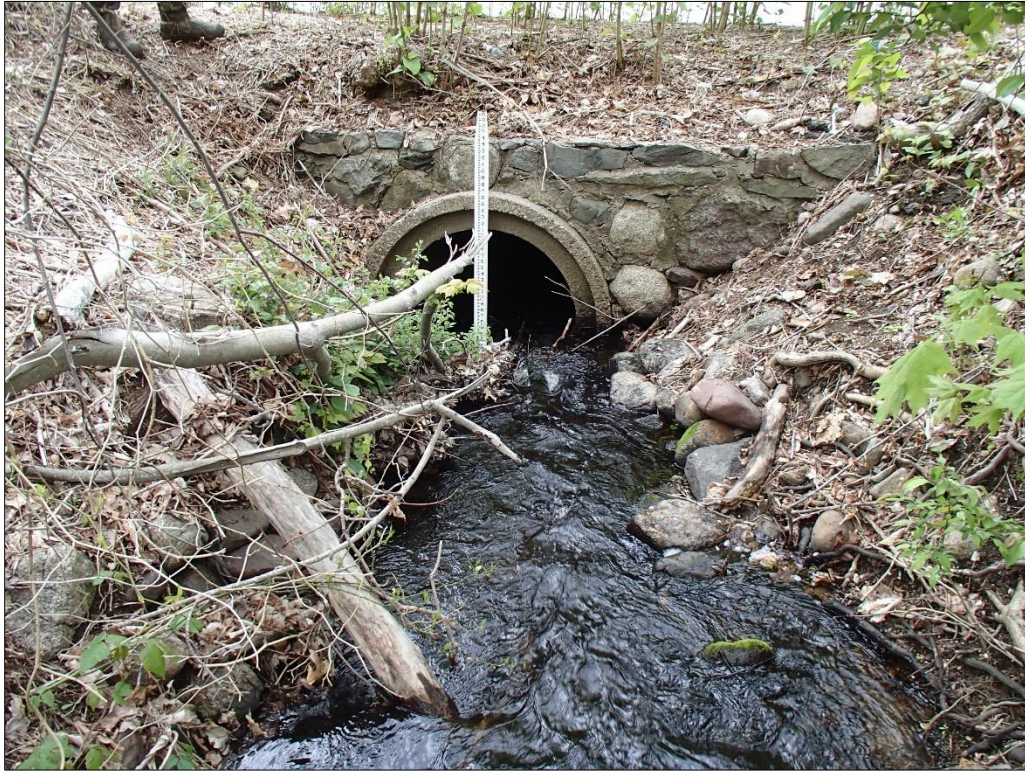
Photo 3 Looking East: West Elevation

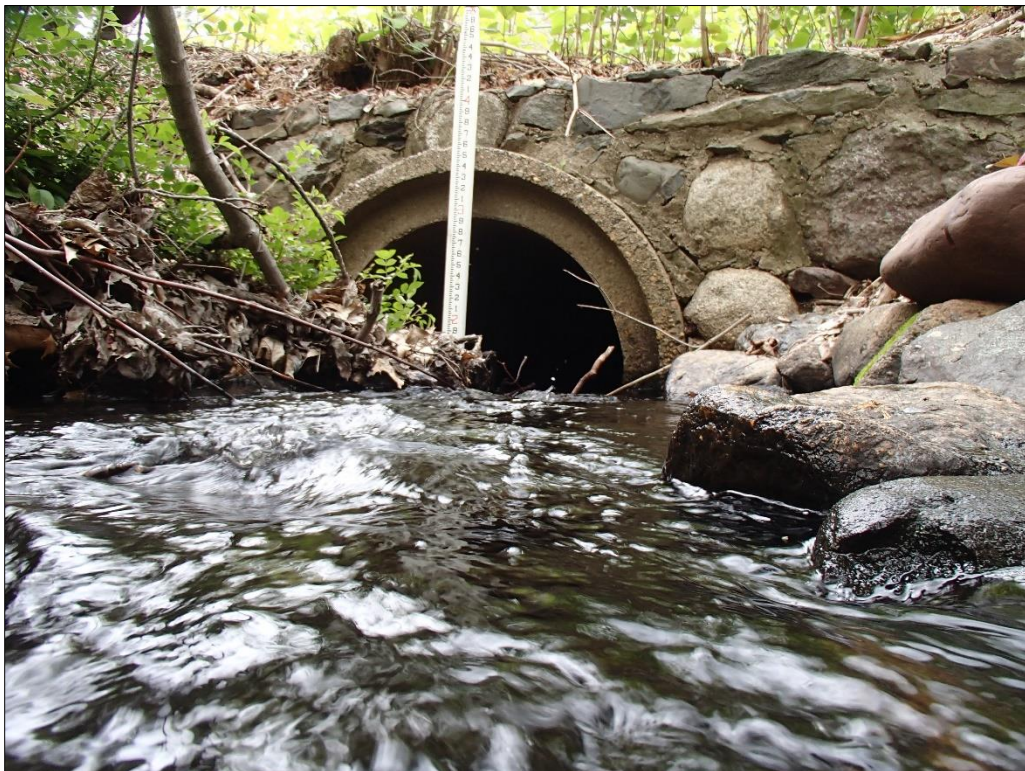
Photo 4 Looking East: Water Through Pipe

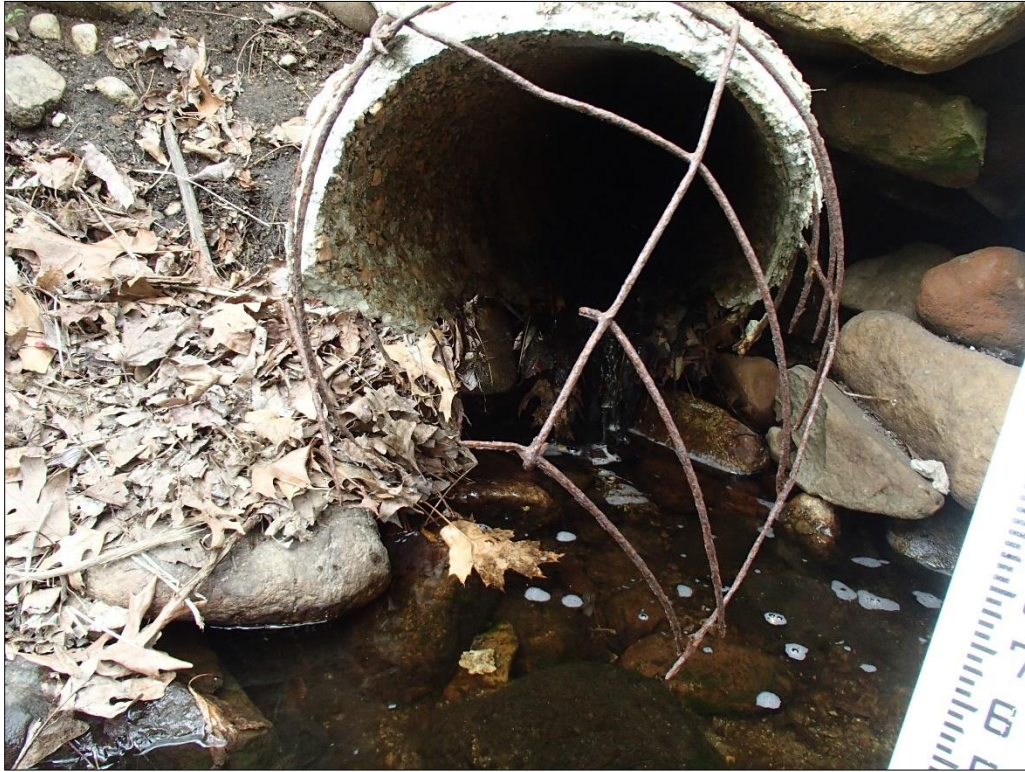
Photo 5 Looking East: Secondary Pipe Deteriorated

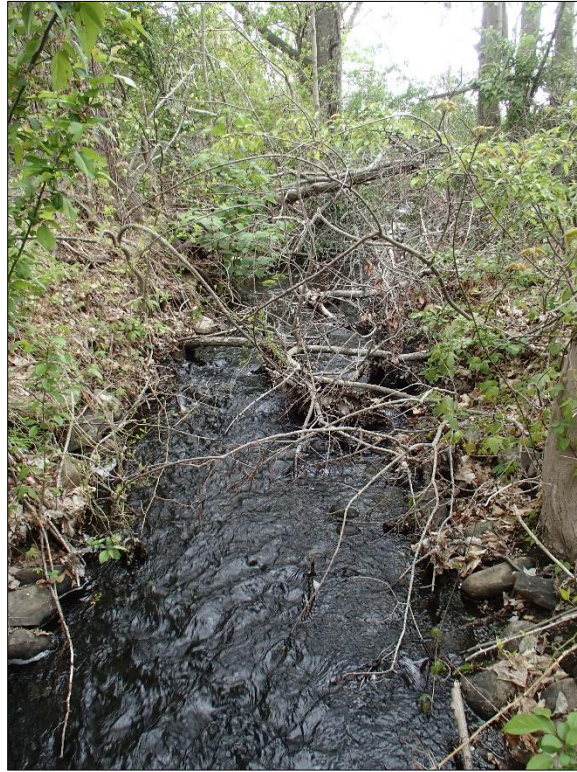
Photo 9 Looking West: Water Flow
