**AGRICULTURAL INSPECTION AND ASSESSMENT OF
EIGHT AGRICULTURAL BUILDINGS AT THE
TEMPLETON DEVELOPMENTAL CENTER
STRUCTURAL ASSESSMENT BASIS AND METHODOLOGY**

August 4, 2019

**AGRICULTURAL INSPECTION AND ASSESSMENT OF
EIGHT AGRICULTURAL BUILDINGS AT THE
TEMPLETON DEVELOPMENTAL CENTER
STRUCTURAL ASSESSMENT
ELLIOT UPPER BARN**

**AGRICULTURAL INSPECTION AND ASSESSMENT OF
EIGHT AGRICULTURAL BUILDINGS AT THE
TEMPLETON DEVELOPMENTAL CENTER
STRUCTURAL ASSESSMENT
BROOK HOUSE BARN**

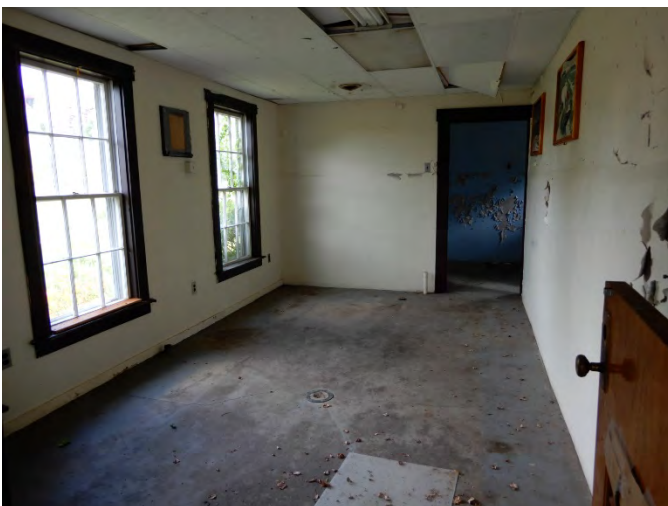
2. Rafters supported on exterior wall at eave and central wall along ridge. Tie joists serve to support hung ceiling tile.

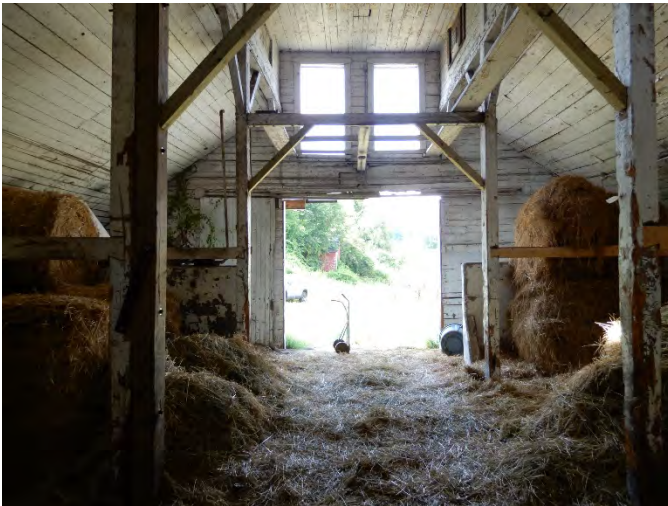
Sighting along the rear wall, it appears that the rear side wall is bowed outward along the floor sill level. It is likely that hay bales piled against the wall are pushing the sill outward. Another possibility is that the foundation side wall is tipping outward from unbalanced earth fill pressures.

4. The rear side wall appears bowed out in areas along the sill line.

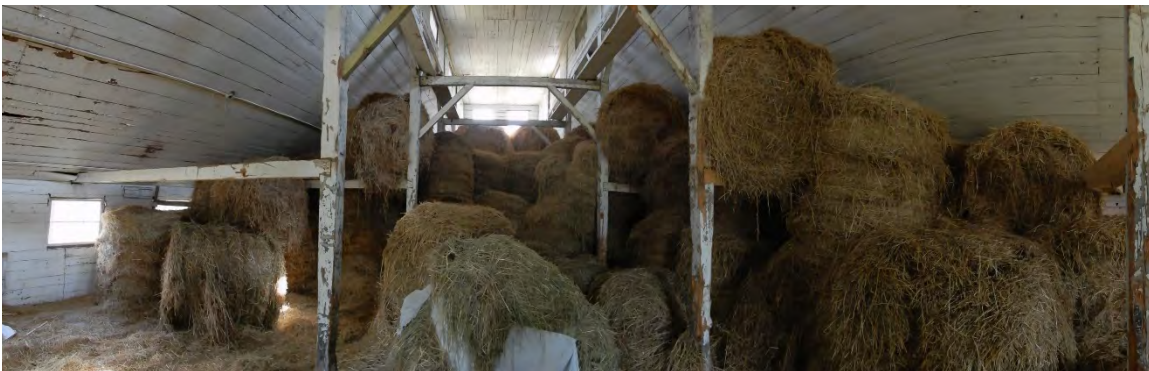
6. The end of the barn nearest the Elliot Office is filled with hay bales. Bales are applying loads against the side walls and the tie beams connecting side walls to the center bay.

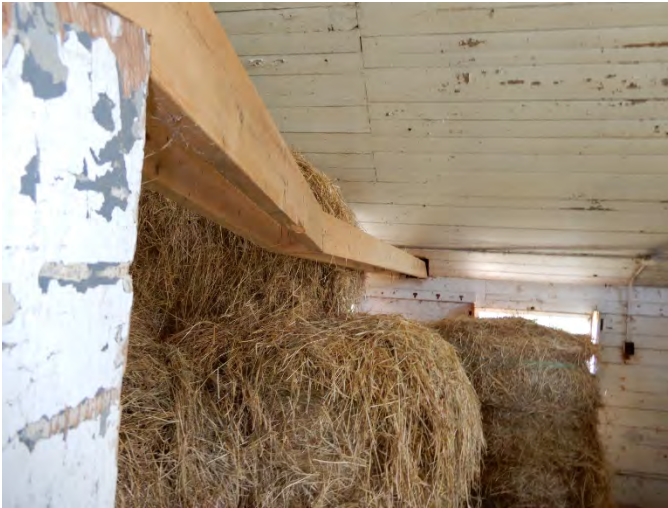
The eave ties between the side walls and monitor posts are broken in two locations from tractors crashing into them.

7. Replacement 6-2x6 eave tie broken by equipment moving hay bales.

3. Add 2x6 or 2x8 cover plate to gouged posts stitched with two rows 16d nails.
4. Replace two broken eave ties.
5. Patch miscellaneous holes in soffit. Allow for 100 square feet total.

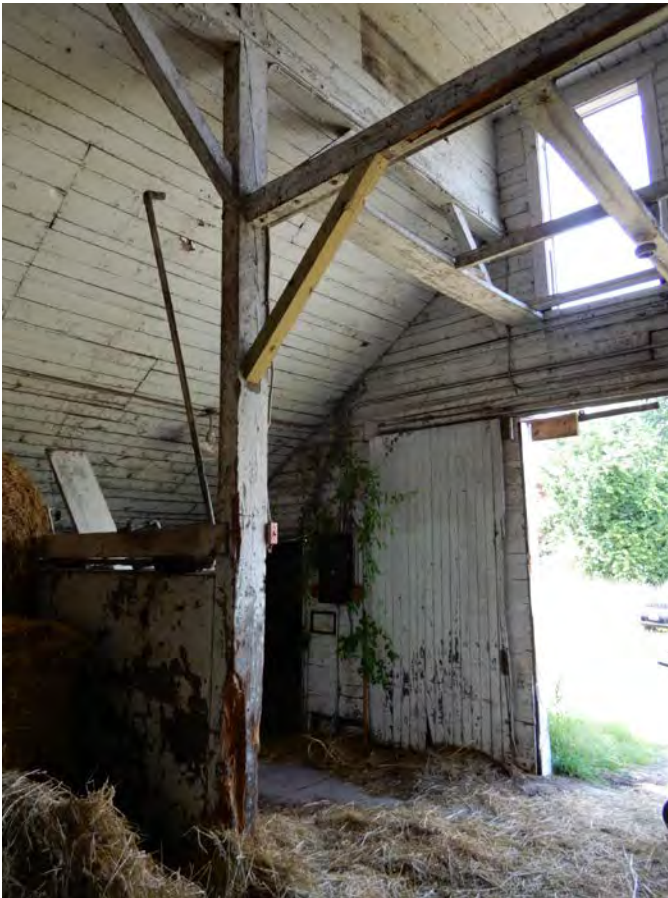
8. Closer view of door opening. Monitor frames into end wall. Post framing in line with the monitor wall is missing inside the end wall. Knee braces here serve to shorten column unbraced lengths and are needed.

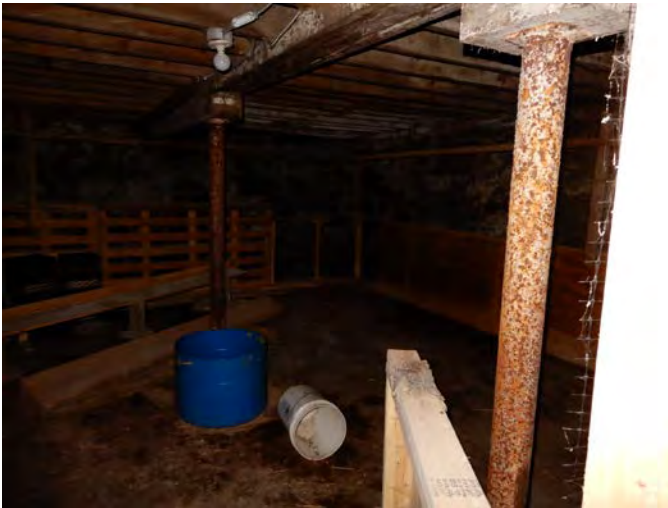
9. View of reinforcement under beam at first floor. The reinforcement is not consistent throughout the floor.

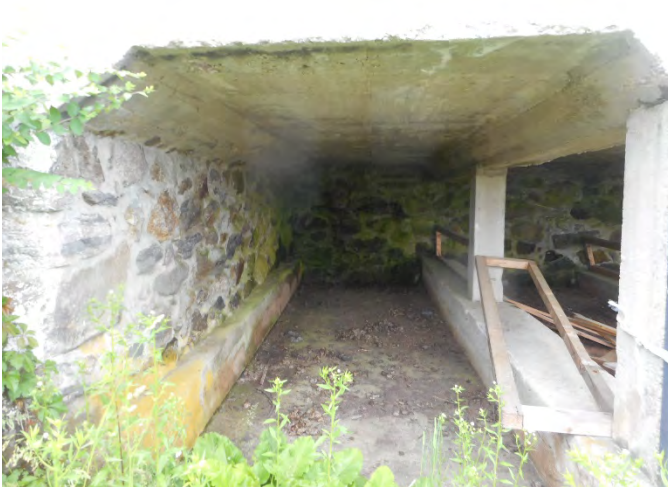
4. End wall to left of front. Left half of foundation wall is cracked and spalled. The upper portion of the wall is wood framed.

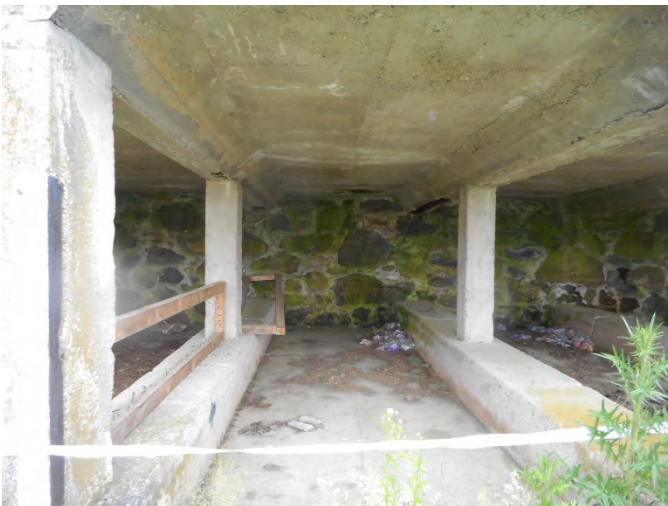
5. End bay of lower level stall. Foundation is rubble stone. Support sleeper and piers are concrete.

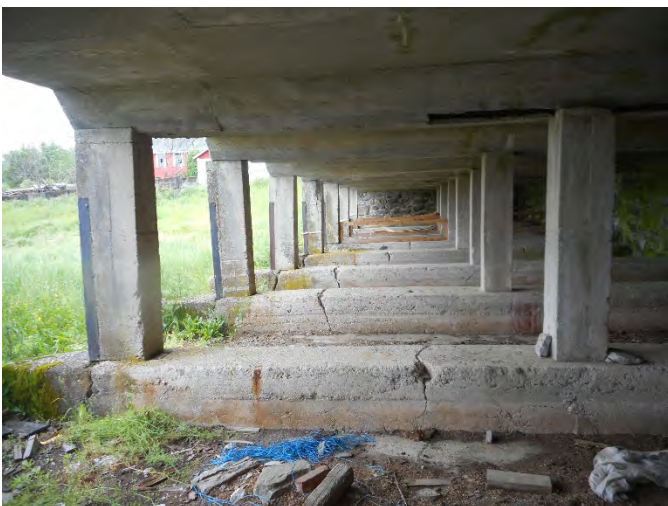
8. Casing falling off one beam exposing the bottom flange of a rusting steel beam.

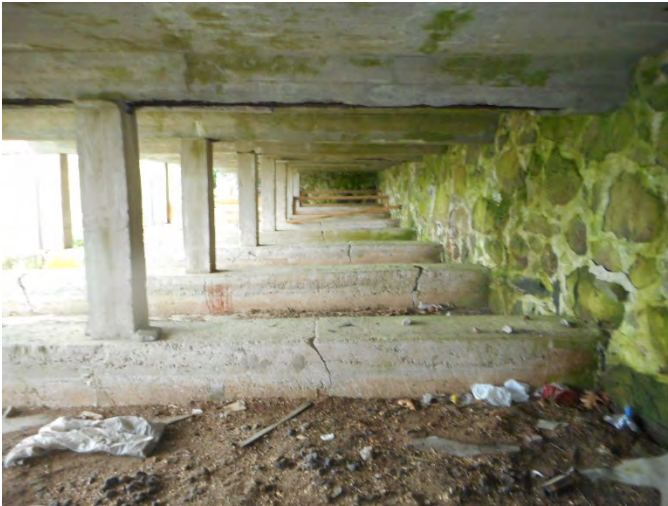
9. Multiple bays viewed down outer rows of piers. Note the cracked sleepers.

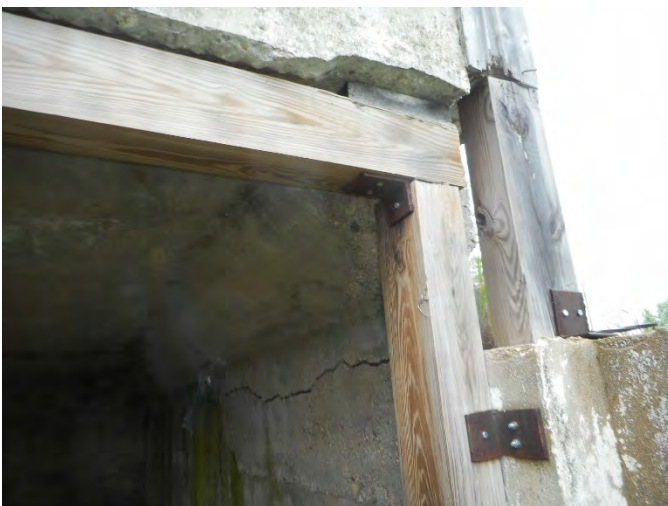
11. Shoring at end bay.

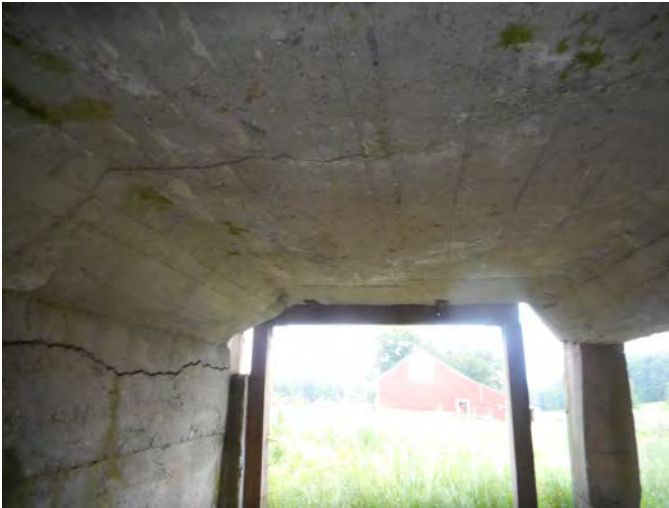
12. Another view of the shoring at the other end. This end foundation wall is made of concrete.
