TIDE Gateway

Tidegate Inventory and Data Evaluation Gateway

Final Report

April
2016

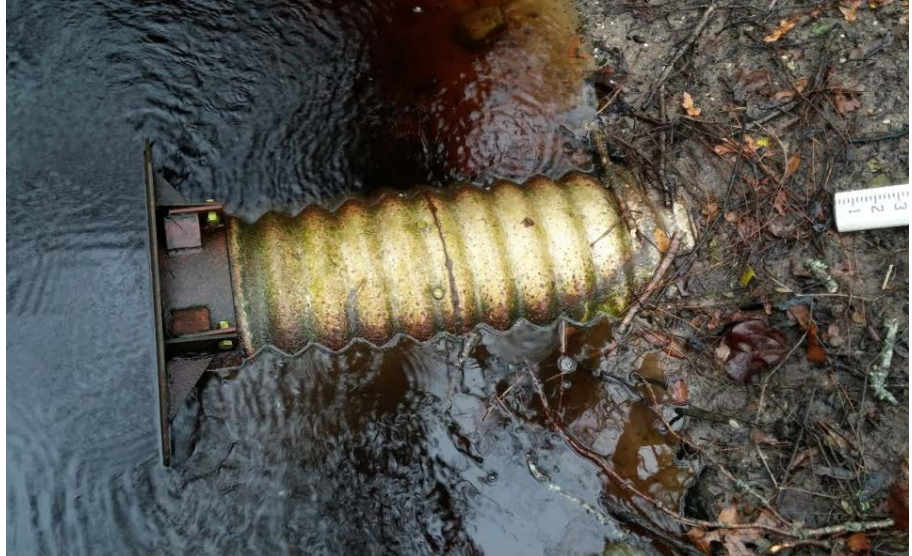
Comments: At the time of the site visit (12/18/2015), the tide gate was inoperable and was sealed completely shut by fine grained sediment deposited in the channel. Dredging was required to restore proper functionality of the tide gate and to allow passage of upstream flow.

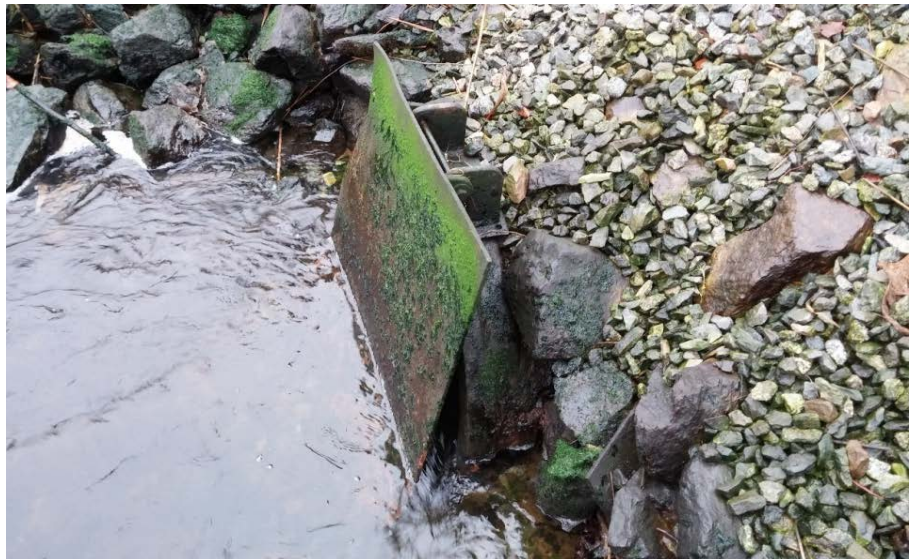
Photo ID: 1218150907_14_1

Comments: The metal comprising the flap gate was deformed and did not appear to form a tight seal against the culvert opening. A 3-5" gap was observed from which tidal exchange could occur. In addition, the bottom half of the tide gate was corroded and its operation was impeded by heavy algae growth. It was unclear if the tide gate would be able to fully open in the event of a storm event to pass heavy upstream flows.

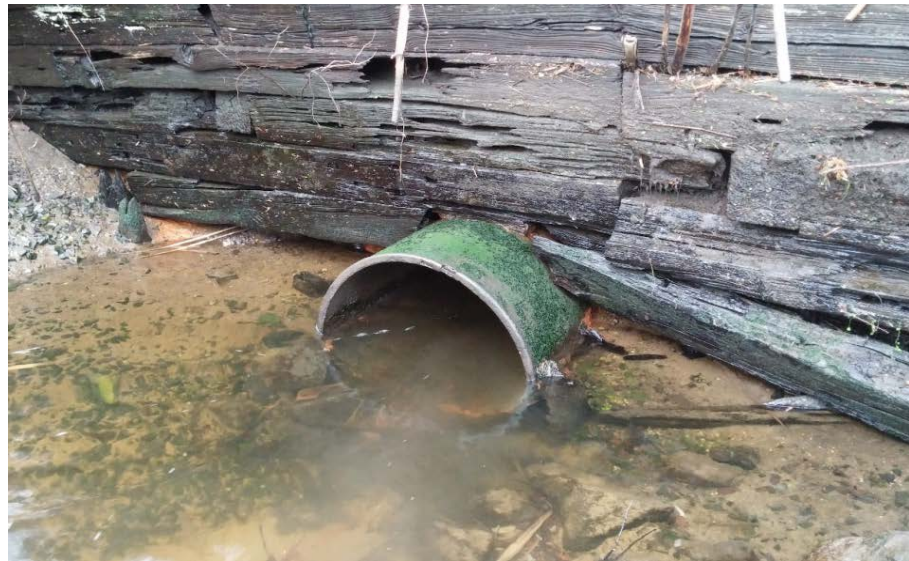
Comments: The upstream end of the culvert was located at the bottom of a wooden retaining wall in poor condition. The retaining wall was beginning to collapse at multiple locations, excessive wood rot was observed, and upland vegetation was observed growing through the retaining wall - further compromising its structural integrity.

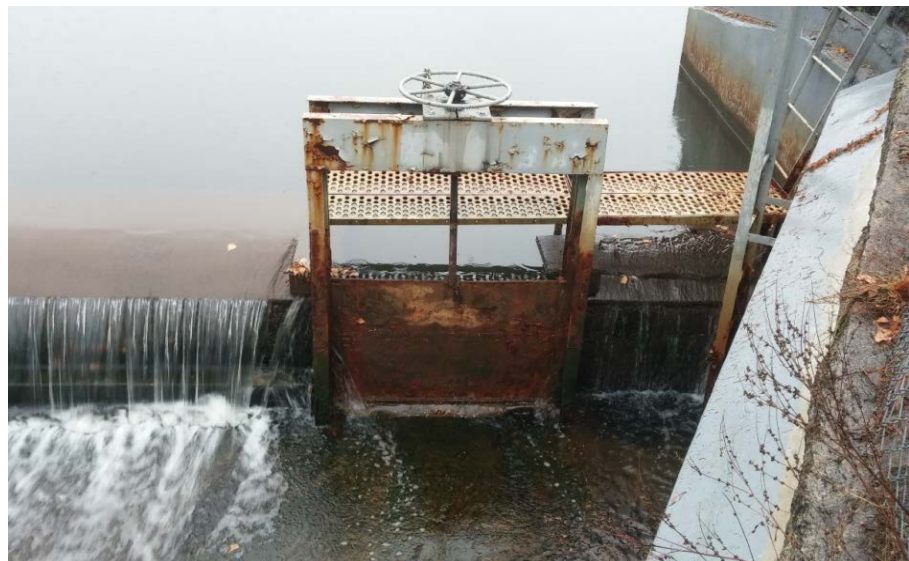
Photo ID: 1202150858g_22_6

| UNIQUE ID | TIDEGATE ID | REGION | TIDE GATE CONDITION | TIDE GATE COMMENTS | CULVERT CONDITION | CULVERT COMMENTS |
|---|---|---|---|---|---|---|
| 132 | Beverly-01B | LOWER NORTH SHORE | Fair | Beverly-01B was located on the eastern end of the spillway and was a steel sluice gate operated by a handwheel. Grease was observed on the handwheel, so it appeared that the gate was periodically operated. The tide gate was in fair condition; the metal sluice gate was badly corroded and was leaking. | Good | There was no culvert at this location, the restriction was a concrete dam built in 1904. The approximate spillway dimensions were as follows: width 31'; height 5.5'. The spillway appeared to be in good condition with no visible signs of deterioration. |

Comments: Beverly-01B was located on the eastern end of the spillway and was a steel sluice gate operated by a handwheel. Grease was observed on the handwheel, so it appeared that the gate was periodically operated. The tide gate was in fair condition; the metal sluice gate was badly corroded and was leaking.

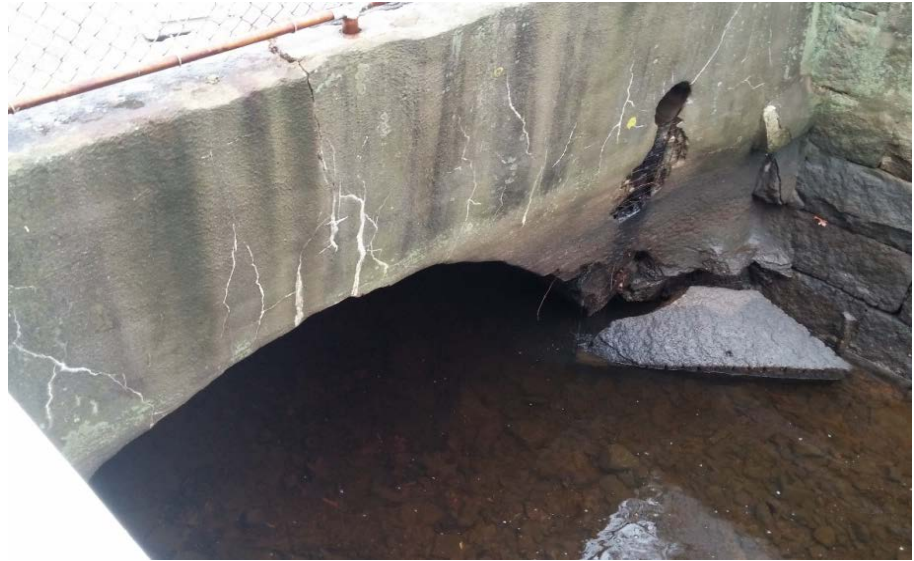
Comments: The upstream headwall was in poor condition. A chunk of the headwall had fallen into the channel, exposed rebar was observed, and a vertical crack was forming in the top middle of the headwall that extended almost down to the top of the culvert opening.

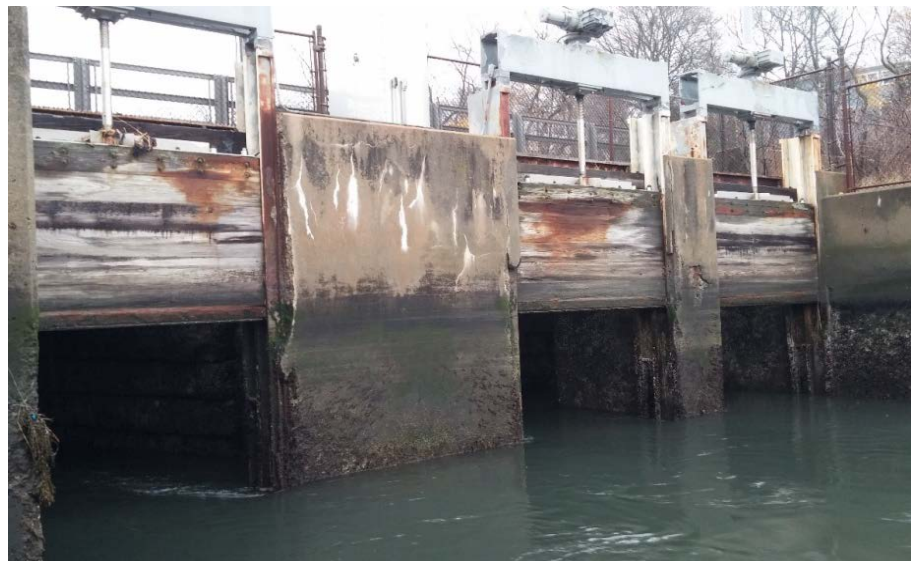
Photo ID: 1202150754_25_2

Comments: Spalling and general deterioration of the upstream headwall was observed.

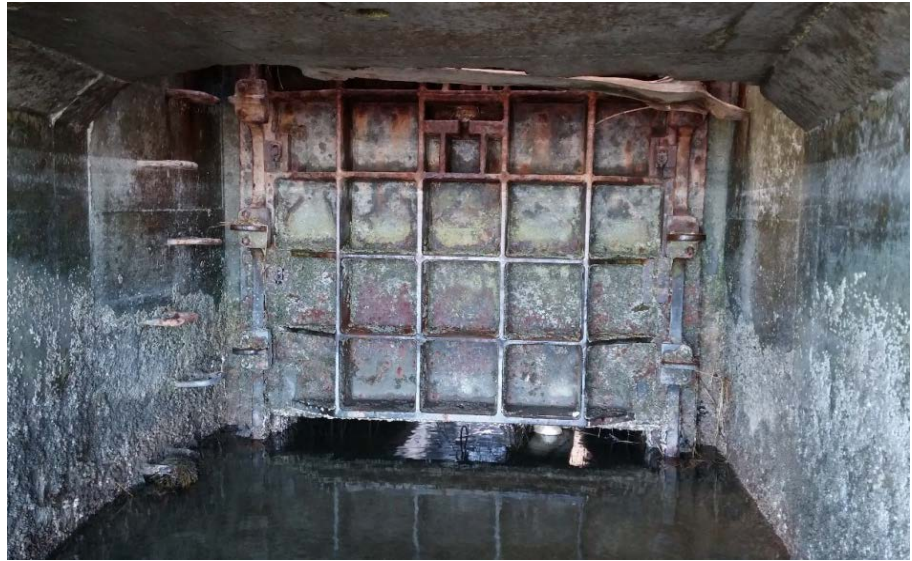
| UNIQUE ID | TIDEGATE ID | REGION | TIDE GATE CONDITION | TIDE GATE COMMENTS | CULVERT CONDITION | CULVERT COMMENTS |
|---|---|---|---|---|---|---|
| 36 | Hull-02A | METRO BOSTON | Fair | Tide gate was a metal sluice gate operated by a manual jack screw. The tide gate appeared to be in fair condition; however, it appeared that it was inoperable and rusted in place. Significant rusting of the hinges and main structure of the tide gate was observed. | Fair | There were no apparent structural issues observed at the concrete box culvert; however, the headwalls on both the upstream and downstream end of the culvert were in poor condition. Significant spalling and exposed rebar was observed on both the upstream and downstream headwalls. Further, the access rungs leading from the top of the headwall down to the tide gate were corroded. |

Comments: Tide gate was a metal sluice gate operated by a manual jack screw. The tide gate appeared to be in fair condition; however, it appeared that it was inoperable and rusted in place. Significant rusting of the hinges and main structure of the tide gate was observed.

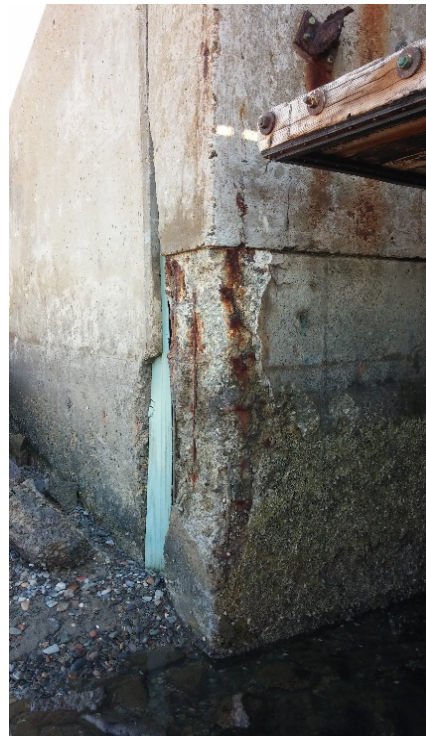
Photo ID: 1103151108_36_5

Comments: There were no apparent structural issues observed at the concrete box culvert; however, the headwalls on both the upstream and downstream end of the culvert were in poor condition. Significant spalling and exposed rebar was observed on both the upstream and downstream headwalls. Further, the access rungs leading from the top of the headwall down to the tide gate were corroded.

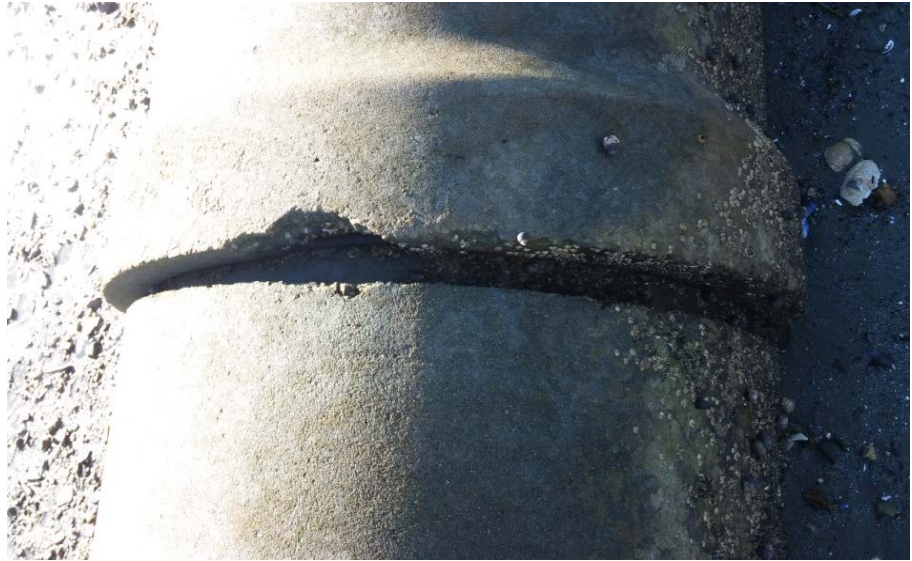
Comments: Outfall to culvert was located below high water mark approximately 150' downstream of the tide gate. A metal (rebar) trash grate was installed at the outlet. The culvert was in fair condition - the culvert bell/segments were beginning to decouple and gaps were observed in the joints. It appeared that the cause of the decoupling was lowering of the beach profile (i.e. longshore sediment transport).

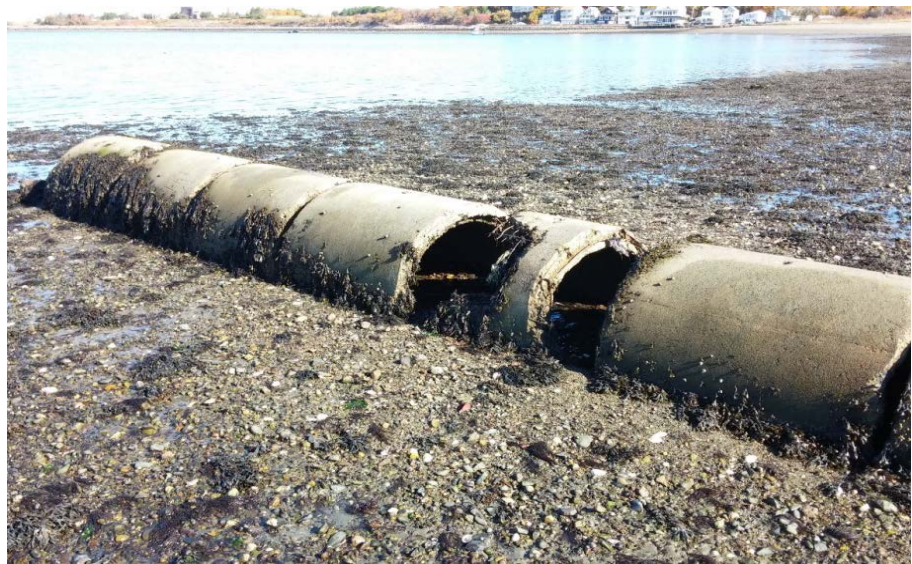
Photo ID: 1102151010a_42_6

Comments: Outfall was located approximately 100' feet north of Bayswater Road on the beach and was partially exposed at low tide. Downstream end of culvert was severely deteriorated: most of the joints had separated and large 1'-2' gaps were observed in the pipe.

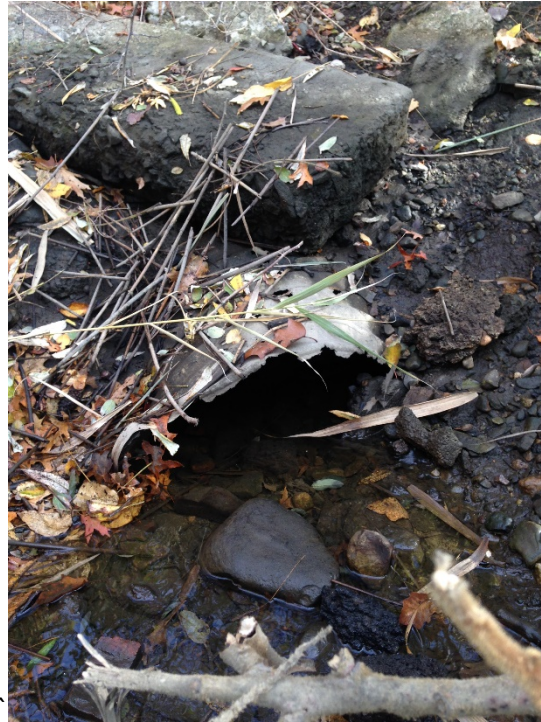
| UNIQUE ID | TIDEGATE ID | REGION | TIDE GATE CONDITION | TIDE GATE COMMENTS | CULVERT CONDITION | CULVERT COMMENTS |
|---|---|---|---|---|---|---|
| 84 | Quincy-06 | METRO BOSTON | Good | Tide gate was recently installed and appeared to be in good condition and operable. | Fair | Downstream end of culvert was plastic (HDPE) and upstream end of culvert was corrugated metal. Downstream end of culvert appeared to be in good condition; however, upstream end was partially buried, thereby potentially limiting stormwater conveyance capacity. |

Comments: Downstream end of culvert was plastic (HDPE) and upstream end of culvert was corrugated metal. Downstream end of culvert appeared to be in good condition; however, upstream end was partially buried, thereby potentially limiting stormwater conveyance capacity.

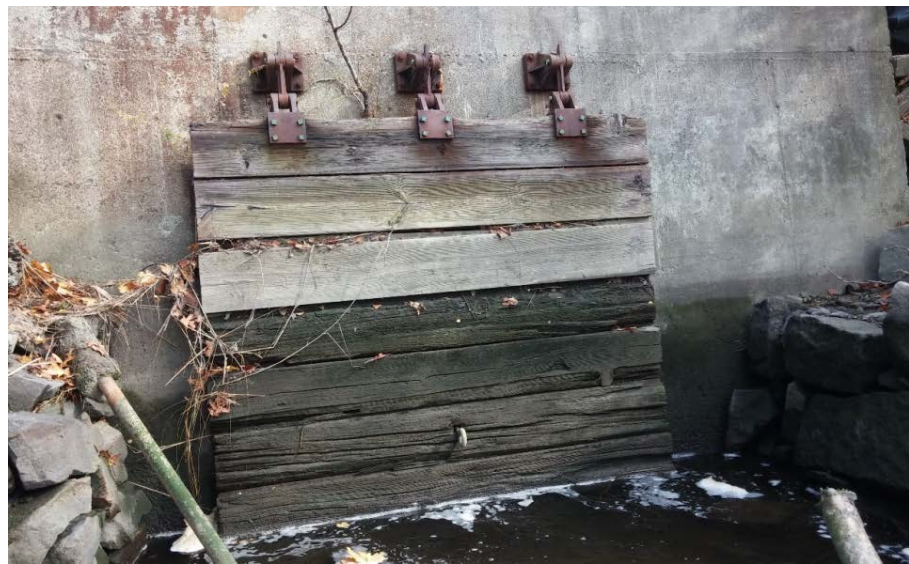
Photo ID: 1102151114a_58_1

| UNIQUE ID | TIDEGATE ID | REGION | TIDE GATE CONDITION | TIDE GATE COMMENTS | CULVERT CONDITION | CULVERT COMMENTS |
|---|---|---|---|---|---|---|
| 58 | Weymouth-02 | METRO BOSTON | Poor | Large wooden flap gate was in poor condition. The bottom half of the tide gate was rotting. The tide gate was installed in such a way that a seal was not created against the headwall thereby allowing some level of tidal exchange at all tidal levels. The tide gate hinges appeared to be operable; however, the tide gate was so waterlogged that it was not possible to fully open. | Fair | Stone culvert appeared to be in fair condition. Longitudinal cracks were observed on upstream end of the headwall. Upstream end of the headwall had a steel trash screen installed across the culvert mouth. The bottom portion of the trash rack was corroded. |

Comments: Large wooden flap gate was in poor condition. The bottom half of the tide gate was rotting. The tide gate was installed in such a way that a seal was not created against the headwall thereby allowing some level of tidal exchange at all tidal levels. The tide gate hinges appeared to be operable; however, the tide gate was so waterlogged that it was not possible to fully open.

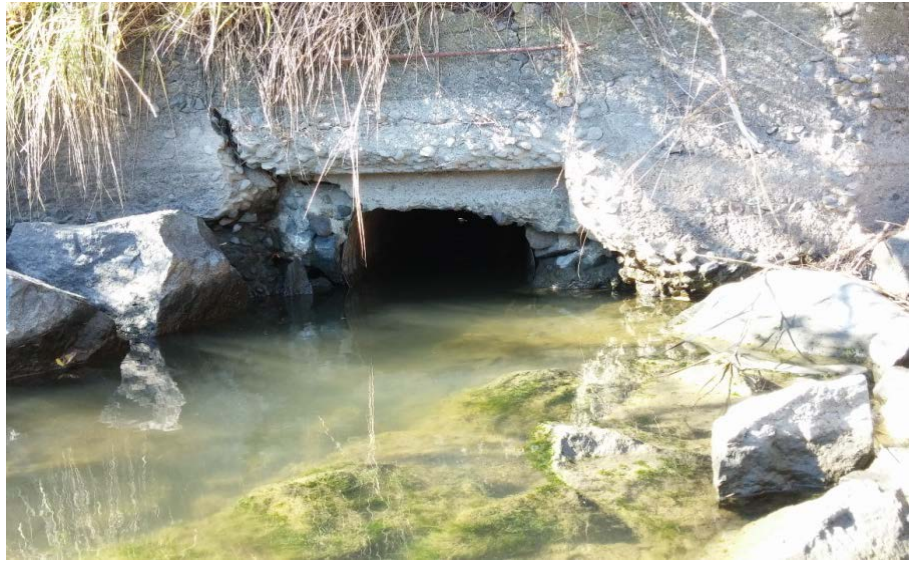
Comments: Deformation of the corrugated metal culvert was observed on its downstream end indicating that it was potentially beginning to collapse. Significant spalling and cracking was also observed on the downstream concrete headwall.

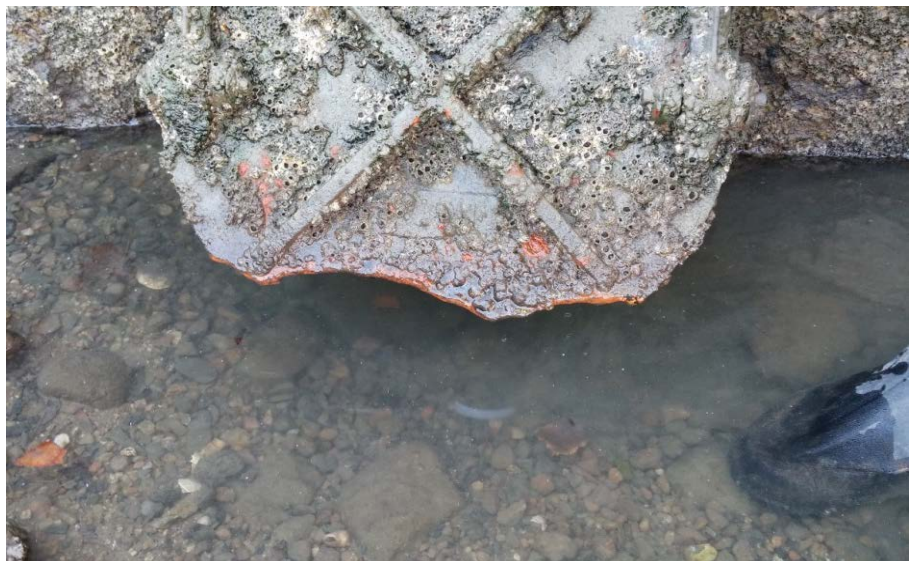
Photo ID: 1104151236_28_6

| UNIQUE ID | TIDEGATE ID | REGION | TIDE GATE CONDITION | TIDE GATE COMMENTS | CULVERT CONDITION | CULVERT COMMENTS |
|---|---|---|---|---|---|---|
| 28 | Duxbury-01 | SOUTH SHORE | Fair | The metal circular flap gate was operational; however, the bottom 10% of the flapper was beginning to corrode away. | Fair | The culvert ran through a rip rap seawall. The culvert was cast iron, covered in barnacles, and appeared to be in fair condition. The upstream end of the culvert was unable to be assessed as it was obstructed by collapsing riprap. A vertical crack was forming on the face of the downstream concrete headwall which extended appx. 3 foot down to the tide gate. In addition, the concrete wing walls were beginning to crack. |

Comments: The metal circular flap gate was operational; however, the bottom 10% of the flapper was beginning to corrode away.

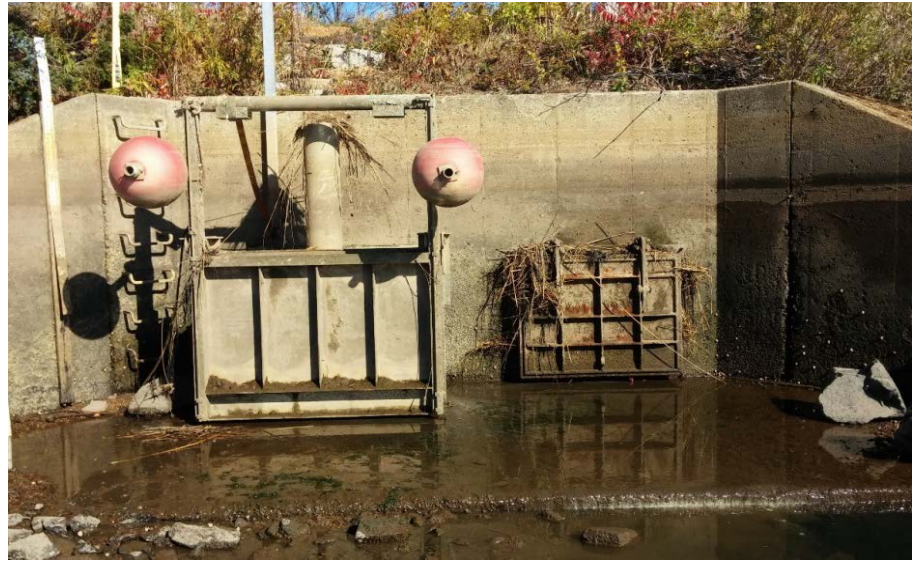
Comments: The self-regulating tide gate was in fair condition and was inoperable; the bottom float which allows the tide gate to open was missing. As a result, it appeared that the gate was currently operating as a flap gate and limiting upstream tidal exchange. A hand operated winch and strap had been installed to operate the SRT and the strap was weathered. Additionally, the SRT's breather was clogged with debris and some leakage was observed around the flange connection to the headwall.

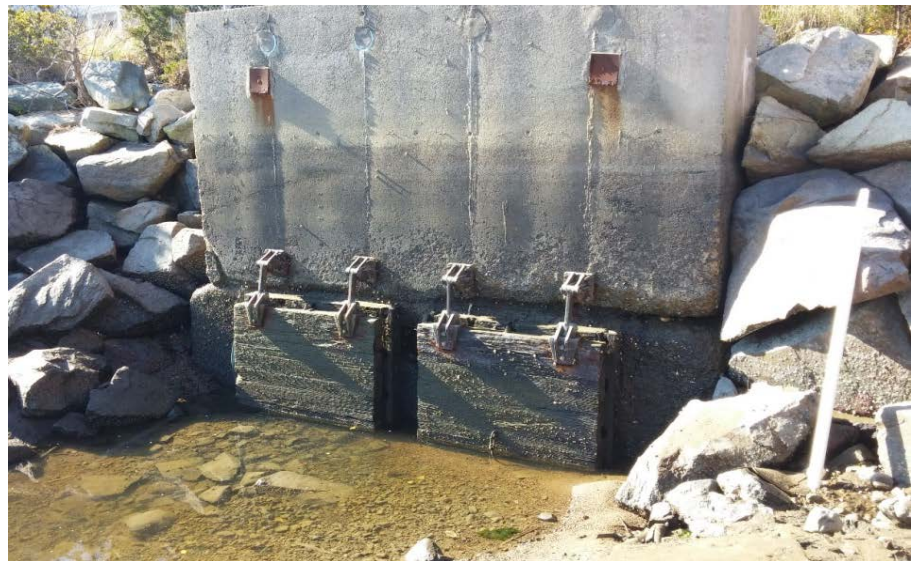
Photo ID: 1104151019_72_1

| UNIQUE ID | TIDEGATE ID | REGION | TIDE GATE CONDITION | TIDE GATE COMMENTS | CULVERT CONDITION | CULVERT COMMENTS |
|---|---|---|---|---|---|---|
| 72 | Marshfield-05A | SOUTH SHORE | Poor | There were two wooden flap gates at this location. Marshfield-05A was located to the north and Marshfield-05B was located to the south. The wood on both tide gates was heavily rotted and waterlogged with rusty wooden hinges. The northern tide gate was inoperable and was stuck shut; it appeared that the hinges were corroded shut. Additionally, the bolts securing the tide gate to the headwall were wearing through the wood. The southern tide gate was operable. Gaps were observed in the wooden backing behind each tide gate and it appeared that both tide gates did not create a watertight seal at high tide, thus enabling some level of upstream tidal flushing. | Poor | There were two identical oval CMP culverts for each tide gate. Both culverts appeared to be in poor condition. The culverts were separating from the concrete headwall and significant deterioration and rust was observed. The northern culvert (downgradient of the inoperable tide gate) was approximately half full of sediment presumably since the tide gate was rusted shut; presumably not letting sediment from upstream stormwater flows out. Both the upstream and downstream headwalls were also in poor condition and deterioration / spalling was observed in multiple areas. Finally, it appeared that the downstream headwall's weep holes had been filled with concrete. |

Comments: There were two wooden flap gates at this location. The wood on both tide gates was heavily rotted and waterlogged with rusty wooden hinges. The northern tide gate was inoperable and was stuck shut; it appeared that the hinges were corroded shut. Additionally, the bolts securing the tide gate to the headwall were wearing through the wood. Gaps were observed in the wooden backing behind each tide gate and it appeared that both tide gates did not create a watertight seal at high tide, thus enabling some level of upstream tidal flushing.

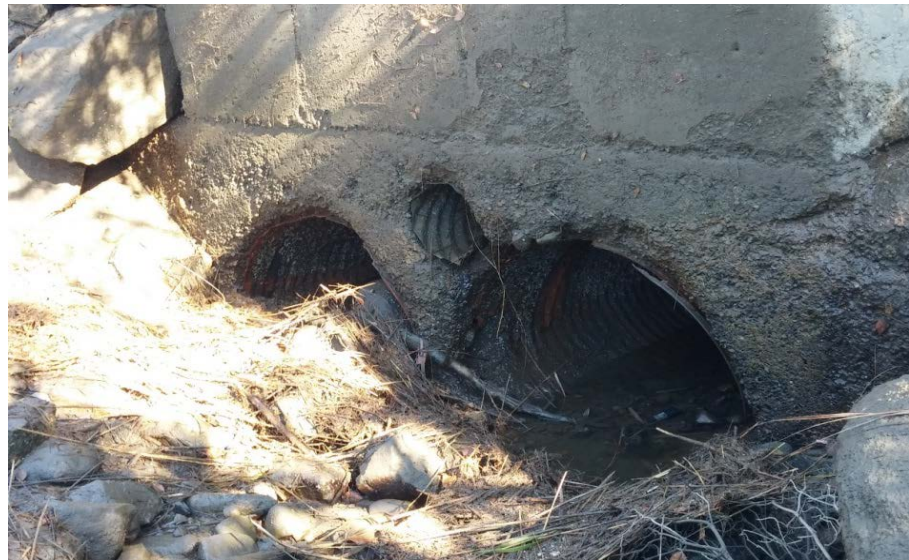
Comments: There were two identical oval CMP culverts for each tide gate. Both culverts appeared to be in poor condition. The culverts were separating from the concrete headwall and significant deterioration and rust was observed. The northern culvert (downgradient of the inoperable tide gate) was approximately half full of sediment presumably since the tide gate was rusted shut; presumably not letting sediment from upstream stormwater flows out. Both the upstream and downstream headwalls were also in poor condition and deterioration / spalling was observed in multiple areas.

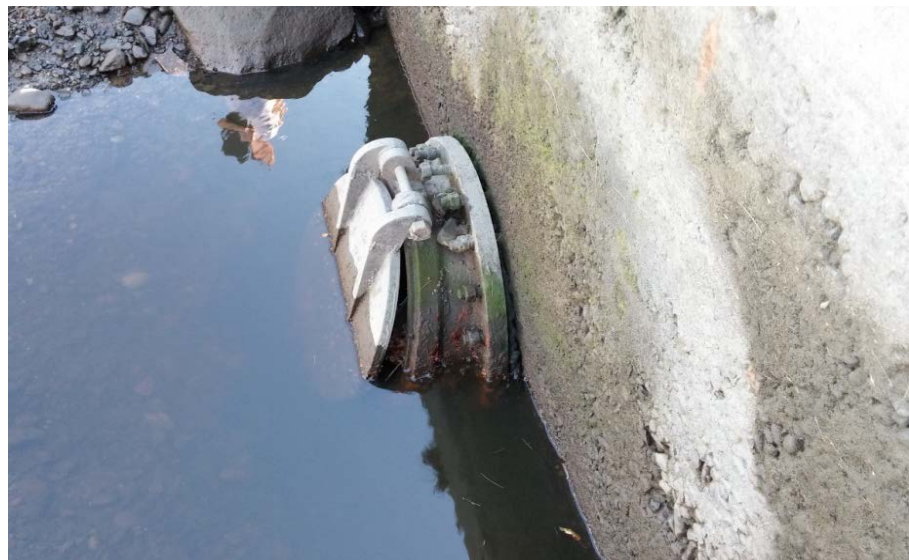
Photo ID: 1103151347_74_7

| UNIQUE ID | TIDEGATE ID | REGION | TIDE GATE CONDITION | TIDE GATE COMMENTS | CULVERT CONDITION | CULVERT COMMENTS |
|---|---|---|---|---|---|---|
| 74 | Scituate-01A | SOUTH SHORE | Poor | There were two tidal control structures at the site. A metal flap gate was installed on the downstream portion of the culvert (Scituate-01A). The downstream metal flap gate was in poor condition. It was rusted open approximately 3 to 4 inches, the bolts affixing it to the concrete headwall were corroded, and it appeared that someone had attempted to remove the tide gate as evidenced by loosened nuts (i.e., the nuts had been backed off the bolts). | Fair | The reinforced concrete pipe was in fair condition. It appeared that the mouth of the pipe was beginning to separate from the weir wall on the upstream side of the restriction. In addition, erosion was observed around the upstream concrete weir, presumably from stormwater runoff from the adjacent road, tidal influence, or some combination thereof. Erosion was also observed around the downstream headwall. The downstream headwall was in poor condition and appeared to "leaning" towards the channel towards the top, indicating mobilization of soils behind it. Additionally, spalling of the headwall was observed. |

Comments: The downstream metal flap gate was in poor condition. It was rusted open approximately 3 to 4 inches, the bolts affixing it to the concrete headwall were corroded, and it appeared that someone had attempted to remove the tide gate as evidenced by loosened nuts (i.e., the nuts had been backed off the bolts).

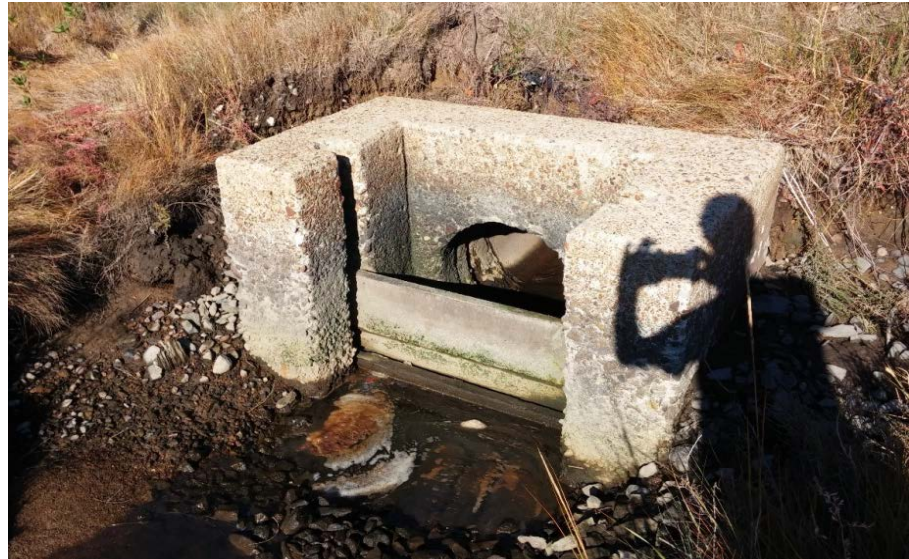
Comments: The reinforced concrete pipe was in fair condition. It appeared that the mouth of the pipe was beginning to separate from the weir wall on the upstream side of the restriction. In addition, erosion was observed around the upstream concrete weir, presumably from stormwater runoff from the adjacent road, tidal influence, or some combination thereof.

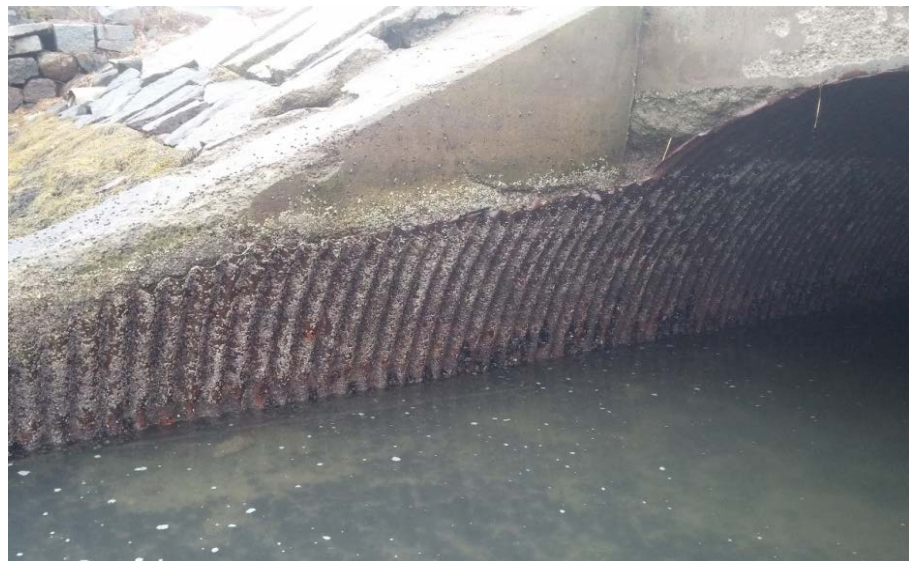
Photo ID: 1202151017a_79_5

Comments: The upstream portion of the culvert appeared to be in good condition with no apparent deterioration; however, the downstream portion was slightly separating from the headwall in places. Additionally, portions of the downstream culvert were jagged and appeared to pose a potential safety hazard.
