## Occupational Fatality Report

### Truck Driver Dies while Rotating Tires Mounted on Demountable Multi-piece Rim Wheels - Massachusetts

Release Date: March 1, 2013  
Investigation: # 11-MA-044-01

Massachusetts Department of Public Health  
Occupational Health Surveillance Program

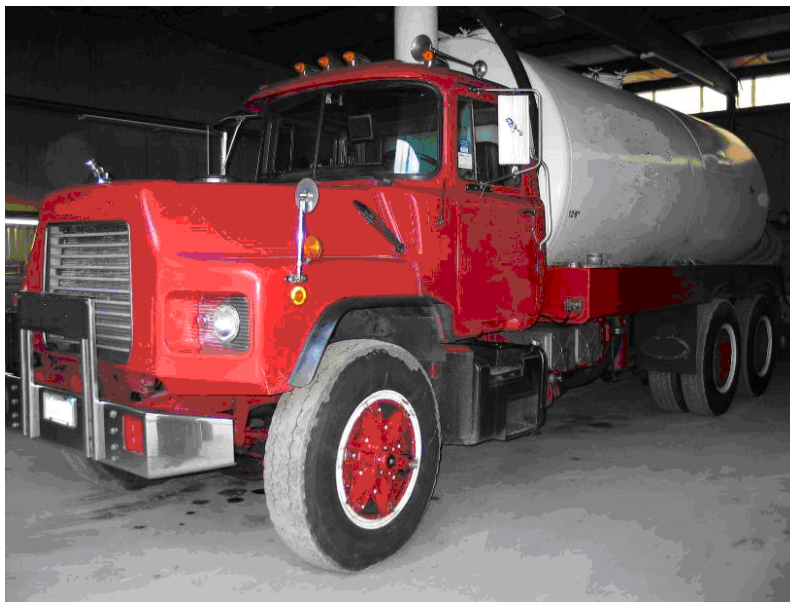
**Figure 1 – Truck involved in the incident**

The truck involved in the incident is a 10-wheel septic system pump truck. Both the truck chassis and tank were manufactured in 2001 (Figure #1). The truck has a diesel engine and rear tandem axle dual wheels with demountable rims and tubeless 1100 R24 tires. The tires were reported to be approximately one year old at the time of the incident. The truck's rear wheels are three-piece demountable rims. The three pieces are a rim base, a split locking ring, and a continuous side ring. The rim parts are designed so the locking ring fits into a gutter on the base rim, locking the continuous side ring in place on the rim when the tire is inflated. These demountable rims also have a cast spoke hub, a component of the axle, to which the demountable rim is clamped. In this case, the spoke hub consisted of six spokes (six bolt pattern) and six clamps to hold the rim in place on the spokes. Since the spoke hub is attached to the truck's axle, when the rims are removed from the truck the spoke hub section remains attached to the truck (Figure #2).

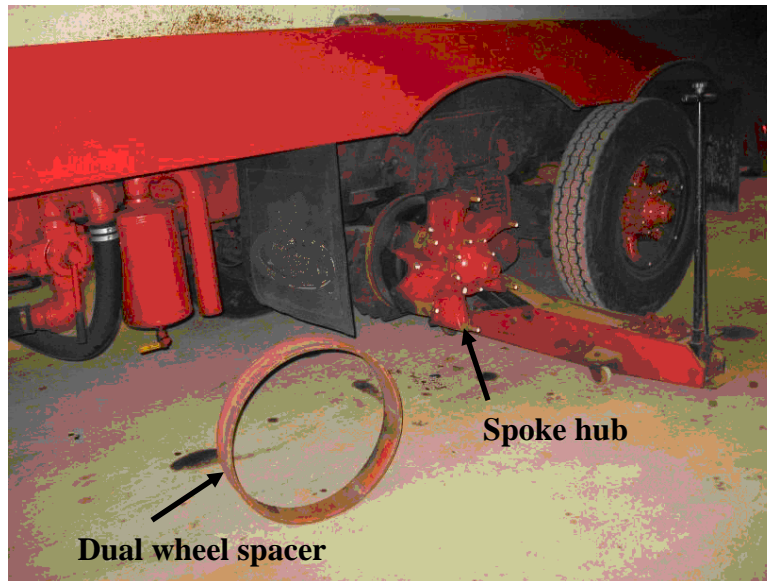
**Figure 2 – Truck involved in the incident with three of the four driver's side rear wheels removed**

To begin the task, the victim backed the truck into one of the company's garage bays. The garage door was left open and the truck was positioned so the truck's cab remained outdoors. It appears that prior to starting the task of rotating the tires, all of the truck's tires remained fully inflated on their rims. A hydraulic floor jack was positioned under the left rear axle to raise the truck's left rear tires off the ground. Once the left rear tires were lifted off the ground, the victim removed both the outer and inner wheels on the forward rear axle.

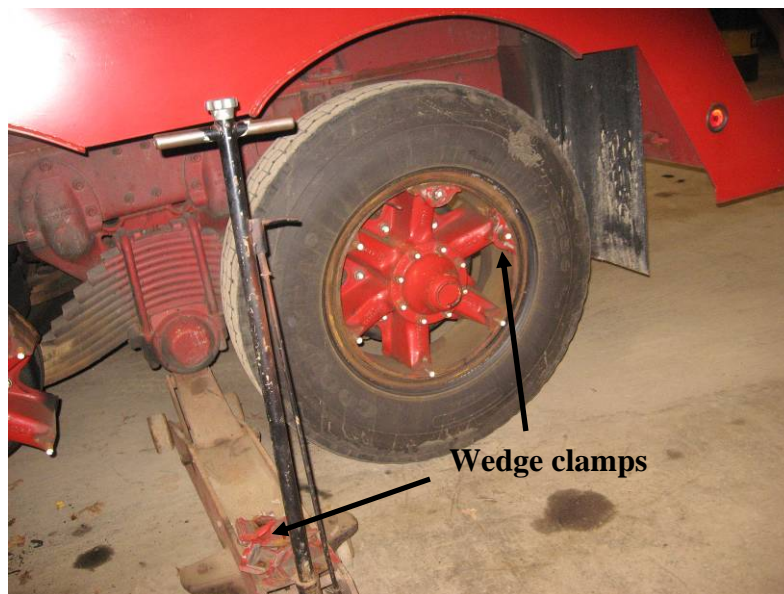
**Figure 3 – Demountable rim wheel with wedge clamp**

When placing tires mounted on demountable rims onto a truck, the rim is positioned onto the spoke hub and then wedge clamps are used to hold the rim in place on the spokes. The wedge clamps prevent the rim from spinning on the spokes and are positioned onto the studs. Lug nuts fasten the wedge clamps onto the spoke's studs and secure the wheel in place (Figure #3). For dual wheel setups, the outer tire and rim mounts onto the same spoke hub as the inner rim, and the rims are separated by a spacer.

Since the victim was working alone and the incident was un-witnessed it is difficult to know exactly what happened and what the victim was doing when the incident occurred. It appears that the victim had just removed the outer rear wheel on the rear most axle by loosening and removing most of the six lug nuts and wedges (Figure #2). The victim then moved this wheel away from his immediate work area. Evidence suggests that the victim was standing in front of the inner left rear wheel and was starting to remove the wheel from the axle when its rim suddenly released. It would appear that when the rim released, this caused the victim to be blown back. Both the split locking ring and continuous side ring and at least one of the wedges were propelled out from the wheel with great force. The victim was struck in the forehead by one of the wedges.

**Discussion:** In this case it appears that most of the lug nuts may have been completely removed prior to ensuring that all of the rim's wedge clamps were loose. This possibly contributed to the incident. Demountable rim wheel wedge clamps are likely to be under pressure when in place. When the lug nuts have been completely removed from the studs and the pressure releases, the wedges can be forcefully release through the air.

To prevent the wedges from releasing into the air, first loosen all of the lug nuts leaving them threaded on the wheel studs a few turns; do not totally remove the lug nuts from the studs. Next use a hammer to loosen the wedges by tapping on them. When the wedges become loose they may move away from the rim with a "pop". Leaving the lug nuts threaded multiple turns on the wheel studs will stop the movement of the wedges and prevent their release into the air. Once all of the wedges are loose, the lug nuts and wedges can be totally removed from the wheel's studs.

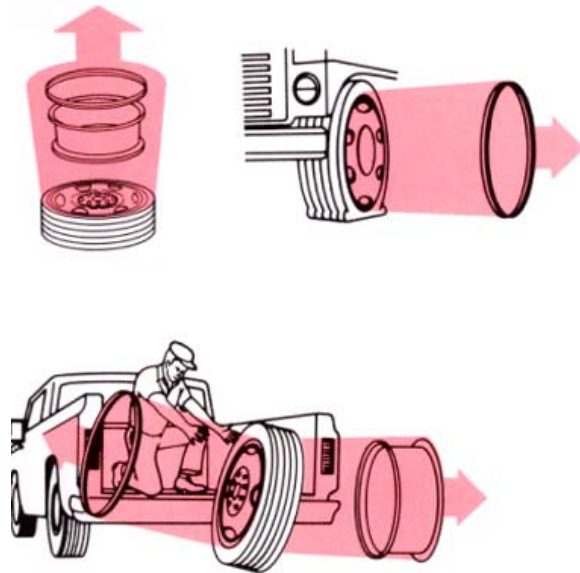
**Figure 4 - Trajectory of multi-piece rim parts in different scenarios.**

**Discussion:** When multi-piece rim wheels are inflated, they are under great air pressure. It is this air pressure that holds the multiple components of the multi-piece rim wheel together. When there is an uncontrolled release of the air pressure from the tire, this causes the rim wheel components to separate. When the rim wheel components separate, they are usually dislodged causing them to be thrown at extreme speeds and violent force (Figure # 4).

**Discussion:** OSHA's definition of trajectory is any potential path or route that a rim wheel component may travel during an explosive separation or sudden release of the pressurized air (Figure #4). When a rim wheel with an inflated tire is mounted on a vehicle, the hazard of being struck by a wheel component during an explosive separation or sudden release when working on the wheel exists. Therefore, to minimize this hazard it is extremely important for employees to always stay outside of the trajectory by never positioning themselves in front of or over inflated tires.

In this incident, the wheels that were being rotated reportedly appeared to be in good condition with no noticeable damage. Therefore, this case underscores the importance of always deflating multi-piece rim wheels, releasing the air pressure in a controlled fashion, prior to maintenance or removal from a vehicle. Deflating multi-piece rim wheel tires can be accomplished by removing the wheel's core valve.

**Recommendation #3: Employers should ensure that employees never position themselves in the trajectory of (in front of or over) inflated tires mounted on multi-piece rims while servicing any wheel or tire component.**
