# DEPARTMENT OF TELECOMMUNICATIONS & ENERGY

## INCIDENT REPORT

9 Rockwood Street, Walpole, Massachusetts April 13, 2004

Report Issued - June 2006

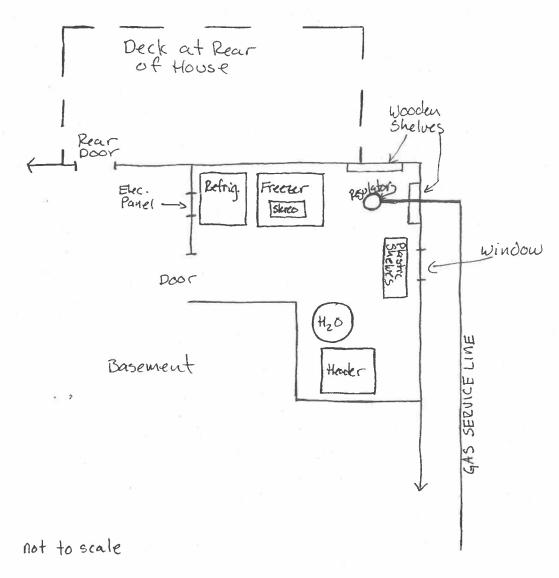
Schematic of Utility Room

Schematic of utility room in basement.

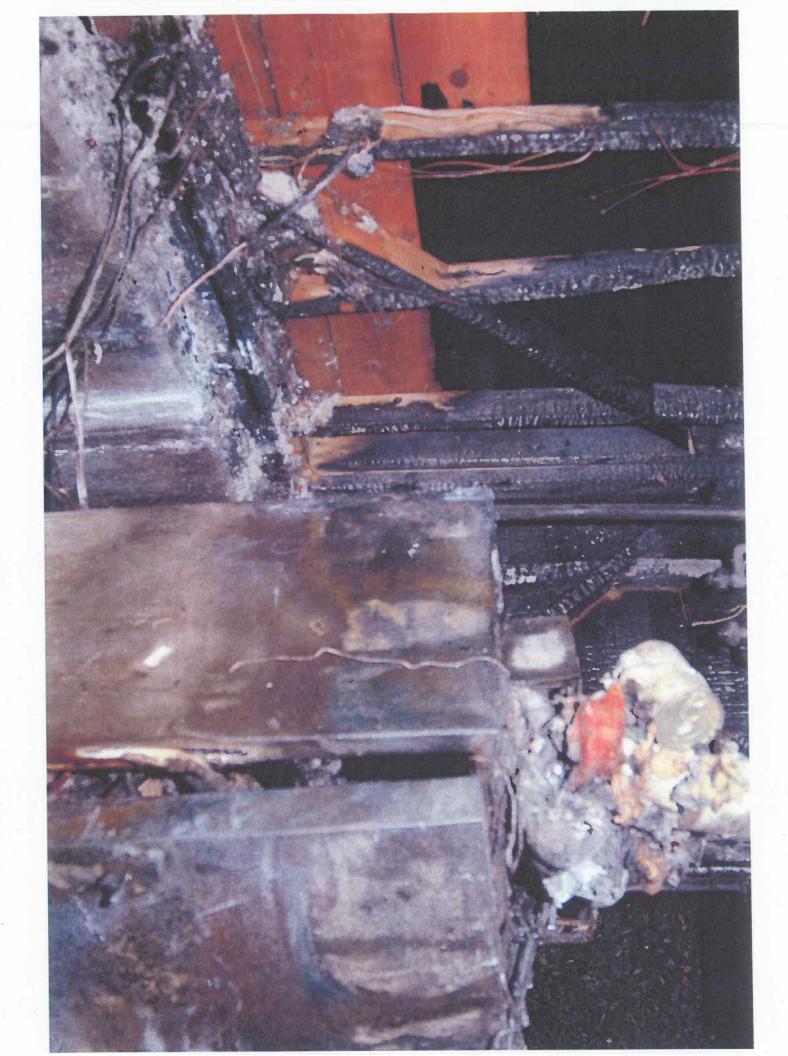
Utility Room

The house had extensive fire damage in the utility room and the surrounding area (Exh. 4). The electric panel and wiring had been completely burned. The gas meter had melted and the service regulator was partially melted (Exhs. 5,6). Most of the basement windows and the garage door had been blown out (Exh. 7). The rear house wall was off the foundation (Exh. 8).

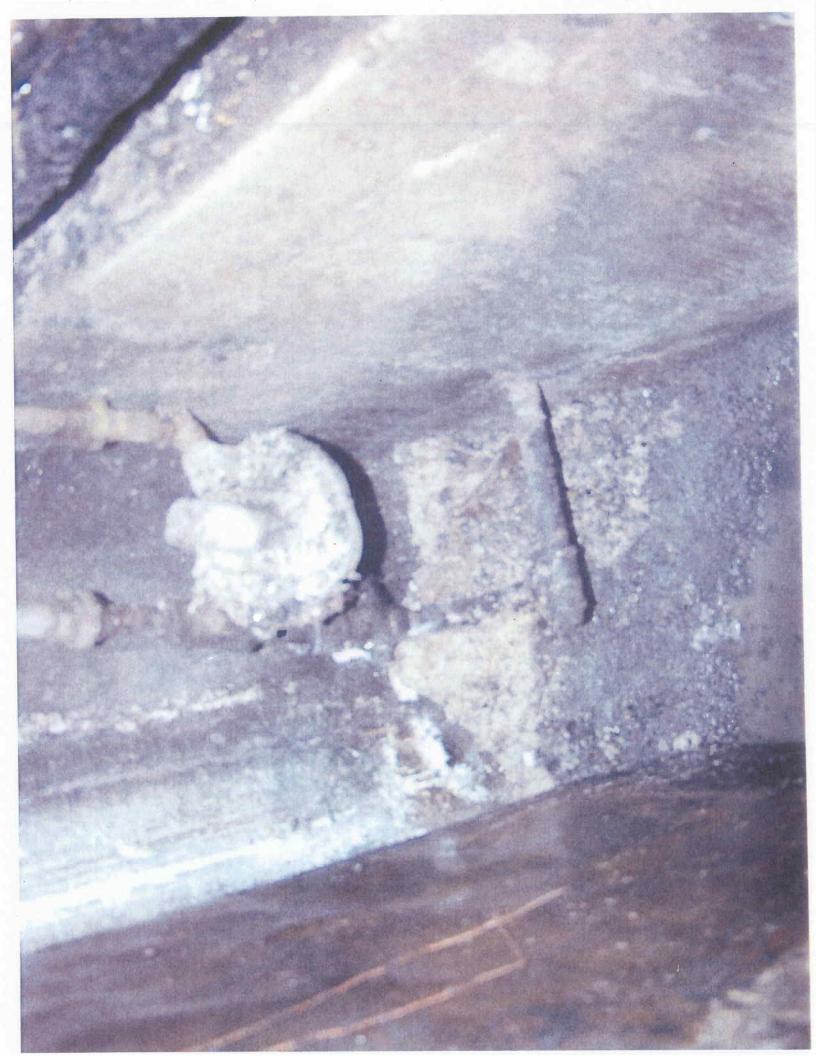
The Gas Regulator

- Examination of fractures located on the incident regulator revealed that substance containing these aliphatic compounds that had spilled onto the regulator was not present on the fractures. In fact, this spilled substance was present on the regulator vent side rim surface on both sides of two regions of the vent fracture, but did not spill onto the fracture at either region. This indicates that the substance spilled prior to the vent-side fracture occurring.

- Scene photographs taken by the Walpole Fire Department show the charred remains of wooden shelving and a large can under the regulator after the fire. The can appears large enough to have caused the dent on the vent side of the regulator. This indicates that the dent was caused as a result of the shelving collapse after the fire was already in progress.

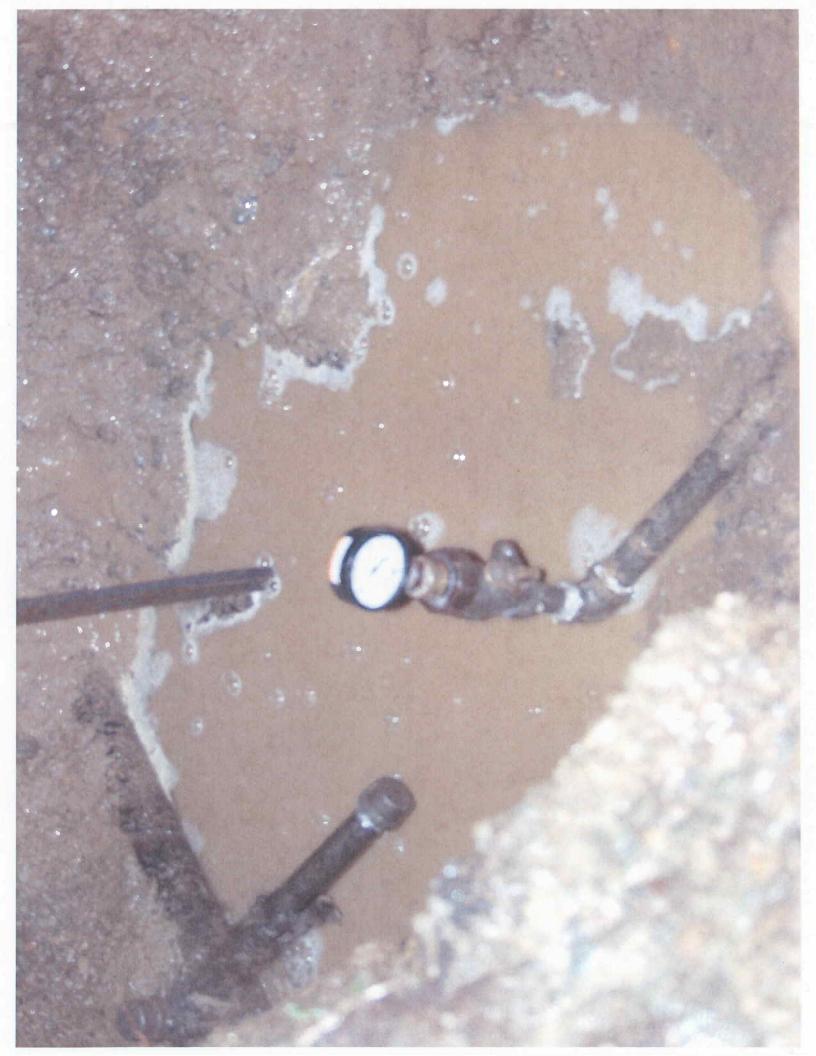
Pressure Gauge of Pressure Test

The Division investigator requested that the gas service line be pressure tested from the street area to inside the house. The gas meter, regulator, and piping inside the house could not be part of the test due to their damaged condition. The service line was sealed inside the house and disconnected from the main. The pressure test was conducted at 50 psig for 16 minutes (Exh. 10 & 11). There was no pressure drop observed, indicating no leakage.
