**West Roxbury Municipal Court
Jamaica Plain, MA**

HVAC SYSTEM EVALUATIONS COVID-19

Office of Court Management

December 14, 2021

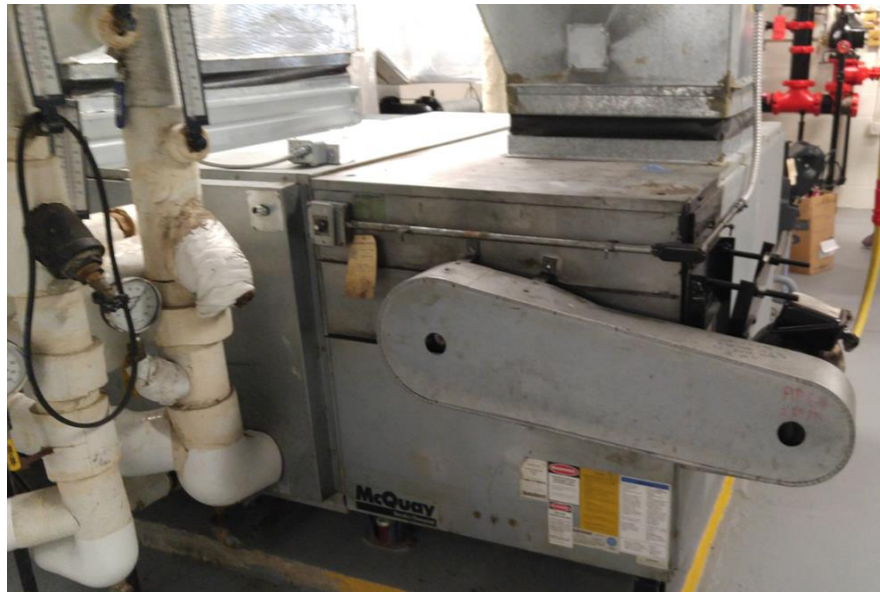
All air handlers have a hot water coil, chilled water coil, supply fan, return air and outside air dampers. Each AHU has an associated external return air fan and exhaust air damper. The air handling units are in fair condition. We observed that several of the freeze stats do not adequately cover the hot water coil, which could result in coil freezing.

Photo 1 – Representative Air Handler

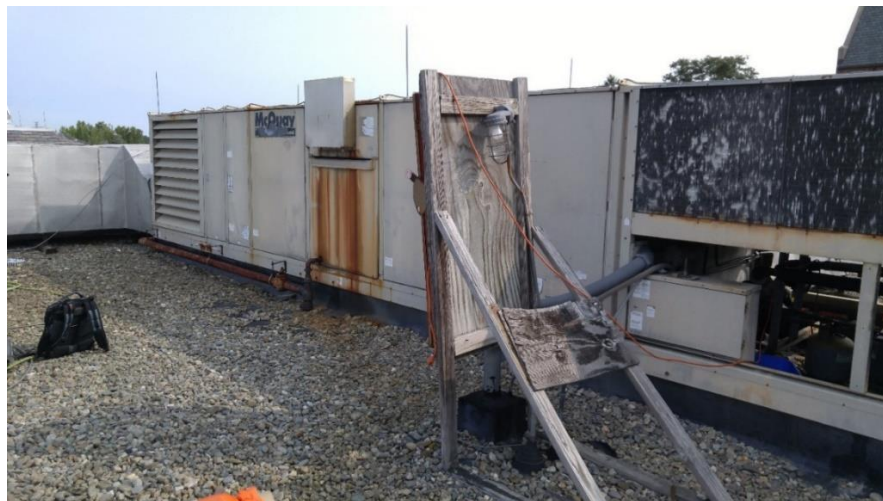
RTU-1 has natural gas heating, DX cooling, a supply and return fan, as well as return, outside, and exhaust air dampers. The RTU is in poor condition. The unit did not have a trap on the cooling coil condensate drain, and the tray was flooded at the time of the visit.

Photo 2 – RTU-1 Rooftop Air Handler.

While most air handler coils were in good condition, several showed some signs of corrosion or buildup. These should be cleaned to ensure the airflow and heating/cooling capacity can be maintained. In addition, the RTU-1 drain pan was in poor condition due to the lack of a condensate trap.

2.7.2 Add a Condensate Trap to the RTU-1 Condensate Piping

The addition of a trap allows water to drain out of the condensate pan and, prevents stagnant water from accumulating in the cooling coil tray, and reduces unfiltered air leakage into the supply air stream.

2.7.4 Replace RTU-1

While operational, RTU-1 is in poor condition, and at the end of its expected useful life. It should be replaced within the next three to five years. The indoor AHU's may have another five to ten years of useful life.
