LAMPSON BROOK FARM BELCHERTOWN, MA

DEBRIS REMOVAL, REPAIR AND REMEDIATION

ASSESSMENT REPORT - JUNE 2022

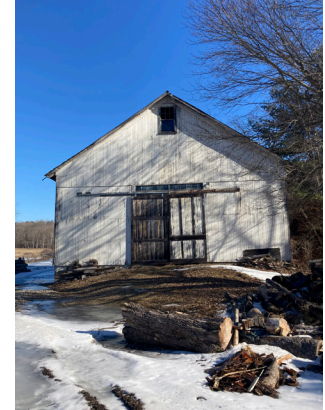
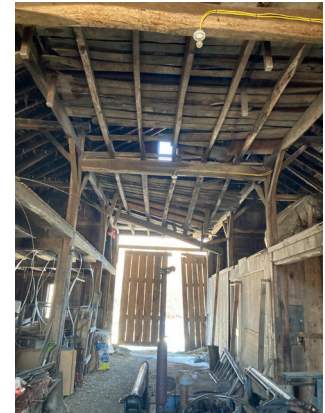
The main barn door facing North does not close fully and the window glazing is broken (left).

The building overall is in usable condition. The siding should be prepared and painted appropriately. The windows should be replaced throughout. And the sliding doors should be adjusted so they can close properly. The roof should be replaced and when it is, repair the roof sheathing as required. See below regarding structural repairs and information.

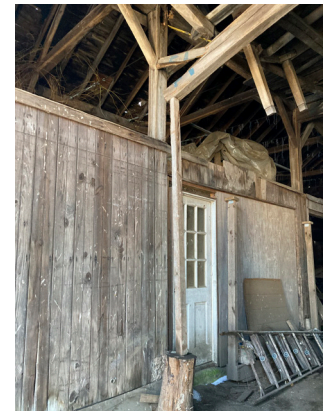
Wood post-and-beam framing is mostly sound and will require minimal restoration.

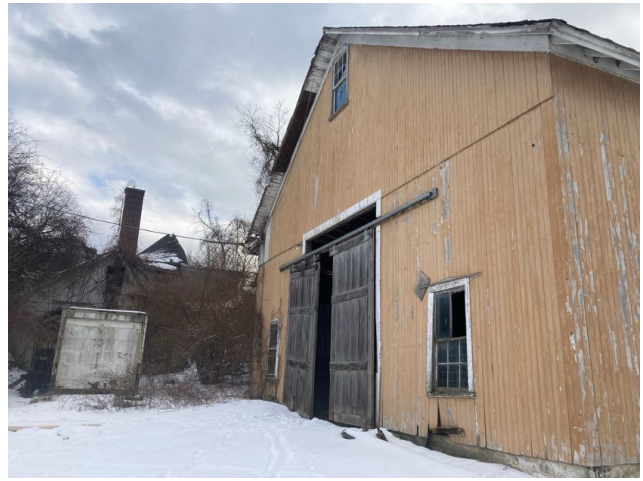
The asphalt shingle roof has holes in the plywood decking and is leaking (left). One of the central beams have split and collapsed (right).

Some rot was observed in localized areas in the roof and roof framing. No more than 20% of the existing framing should need to be replaced. Mezzanines appeared to be in adequate condition, as there were no signs of failure. Localized areas of deterioration were observed in the underside of the mezzanine deck, existing deteriorated boards should be replaced. High central storage mezzanine appeared to be failing and should be demolished. Some repairs to exterior paneling may be required as multiple areas of deterioration were observed. The roof will likely need to be replaced.

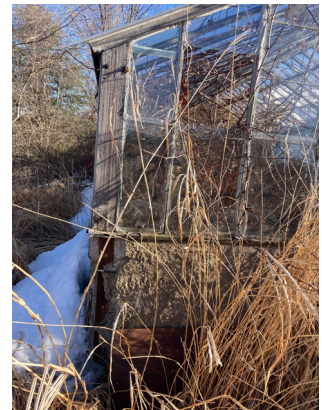
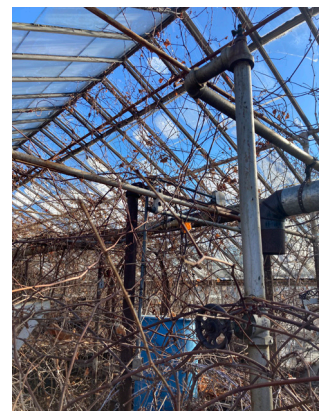
The greenhouse is composed of metal framing, glass panels, concrete curbing and a slab on grade. A majority of wall and roof glass panels are broken and exposing the interiors to climate vulnerabilities, accelerating degradation. The concrete curbing foundation walls are crumbling and rebar is exposed in multiple areas.

Based on the condition of the greenhouse, it is recommended that this structure should be demolished.

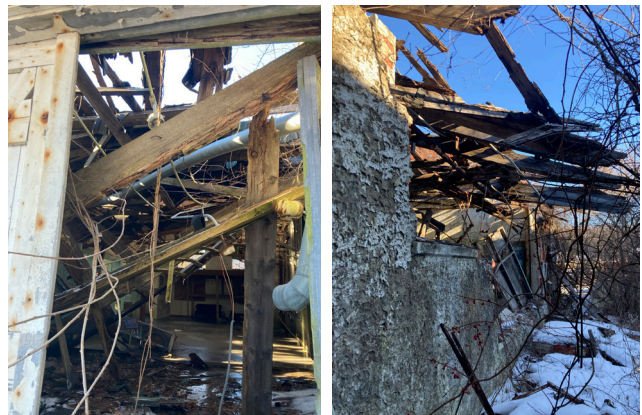
Looking through the front door (left) and along the side of the building (right), it is clear that the roof and wall framing are compromised and beyond repair.

Based on the conditions of the Milk Room, it is recommended that this structure should be demolished.

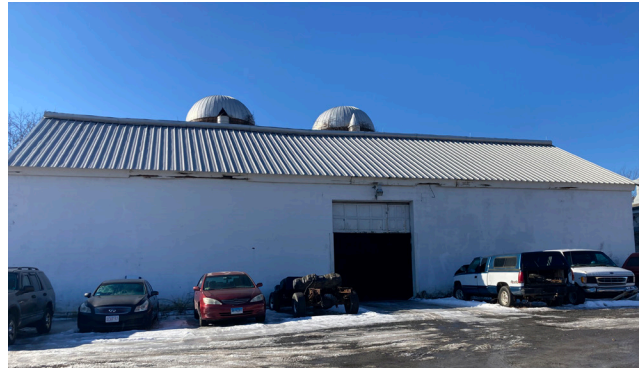
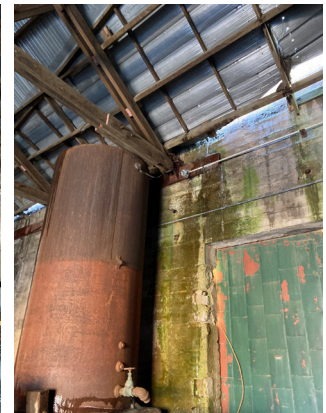
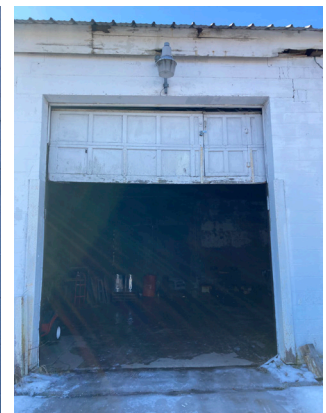
The molasses shed is a load bearing masonry wall building with a sectional door in the center. There are interior trusses with a metal sheet panel roofing assembly. There was an existing building on the south west wall that was demolished. There are areas that have visible daylight coming through from the demolished portion of the building. The building is in relatively good shape with minor cracking of the CMU throughout. The sectional doors are in poor shape.

The metal roof deck appeared to be severely damaged in certain locations and will likely need to be completely replaced. The trusses bearing along the back wall at the steel ledger plate connection were observed to be failing in multiple locations. The steel ledger and truss bearing ends will need to be repaired and/or replaced. Several rafters spanning from the back wall to the roof purlins were observed to be deteriorated and will likely need to be replaced. Cracking was observed in both the masonry walls and the concrete back wall. Differential settlement was observed in the concrete floor causing significant cracking in multiple locations. Exterior roof edge beam was observed to be rotted/deteriorated in multiple locations. The concrete back wall is a shared wall with dairy barns 1 & 2. It is recommended that both dairy barns be demolished (refer to sections 9/10 in this report). Concrete wall shall be shored prior to demolition. Shoring shall remain throughout the life of the structure.

The metal roof deck should be replaced as daylight is showing where the previous demolished building was located. See below regarding the truss work that should occur prior to the roof replacement. There should be repointing work throughout. Replacement of the sectional and sliding barn doors scheduled. into the cost and repairs.

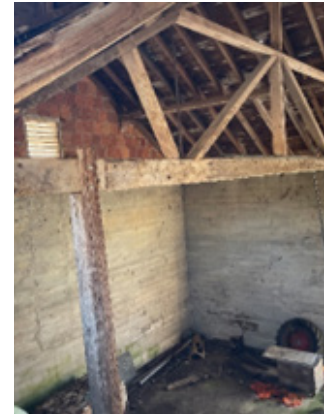
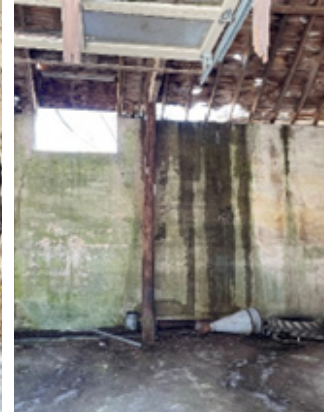
The existing plywood deck appears to be failing in multiple locations. Each hip truss appears to be completely failing. Truss #1 failed at the bearing end and was temporarily shored by a telephone pole. Trusses 2 and 4 appear to be failing at their splice connections, and truss 3 collapsed and is resting on the concrete slab. The concrete walls appear to be in reasonable condition, except at the overhead doors where significant spalling and cracking were observed, likely due to the failure of the overhead doors. Cracking in the masonry walls was observed at window openings as well. The concrete slab could not be fully inspected due to concerns about the stability of the roof. It appeared unsafe to enter the building.

We'd recommend replacing the roof after the truss and shoring recommendations provided below are completed. There will be sheathing / plank replacement once the demolition of the roof exposes the sheathing. The concrete openings at the sectional doors should be repaired prior to replacing the sectional doors. Once that work is completed, the sectional doors should be replaced.
