MassDEP Field Assessment and Support Team (FAST)

After Incident Report

DEP RTN 4-22,140

WESTPORT – 81 Robert Street

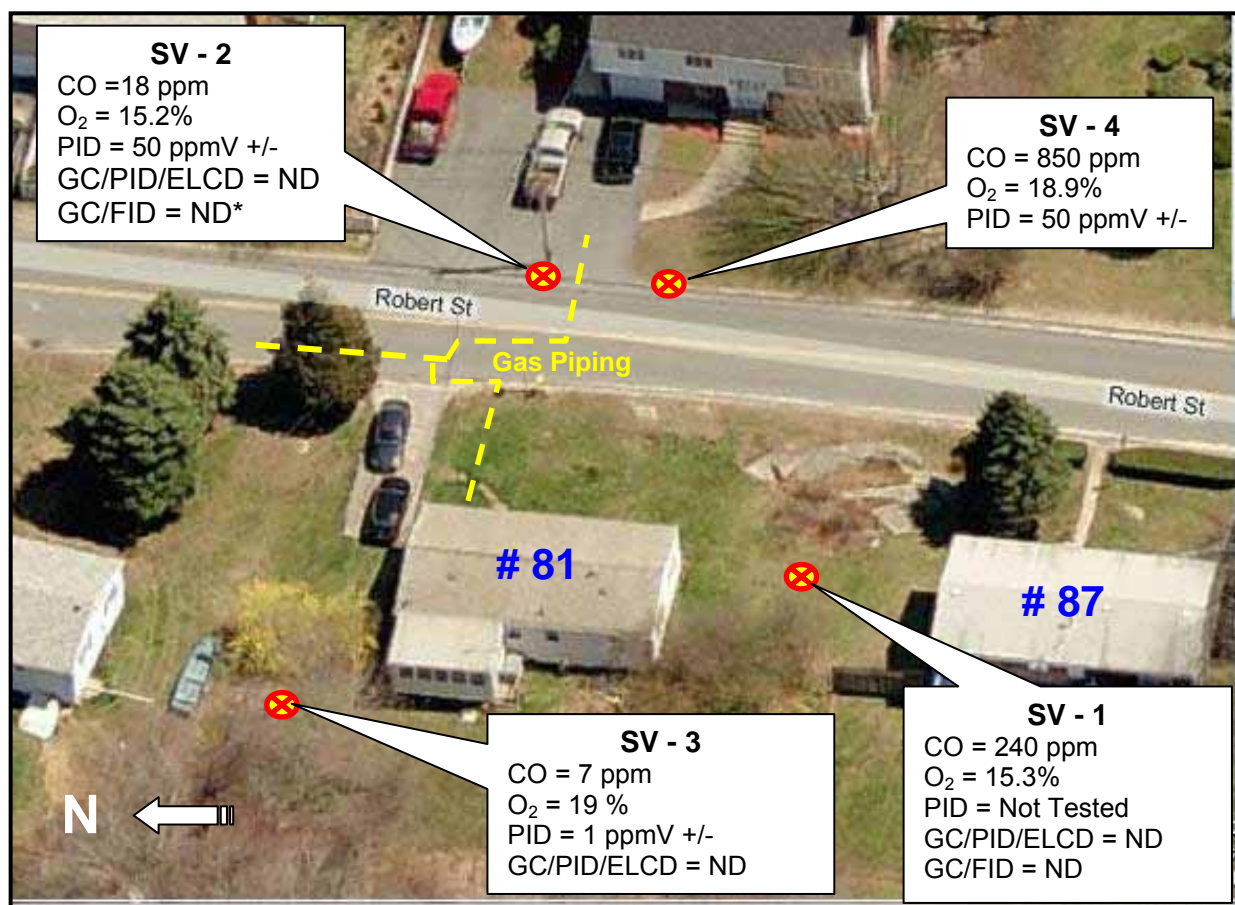
To further explore the reported high levels of CO identified in the subsurface by gas company personnel, following an emergency Dig Safe notification, FAST personnel installed and sampled 4 soil vapor probes (KVA Temporary Probe apparatus). All probes were advanced approximately 2-3 feet below grade, in the locations indicated on the map below. Except for SV-1, the probes were sampled with a VX 500 PID unit, with measured (and metered) flowrates of less than 300 cc/minute. 40 mL soil gas samples obtained from SV-1, 2, and 3 were also analyzed on the GC/PID/ELCD and/or GC/FID units in the FAST vehicle. The results are depicted below:

Similar to the results for the basement air sample in #81 Robert Street, an unidentified early-eluting ($< C_5$) peak was observed on the GC/FID chromatogram for SV-1 and SV-2. This peak was much larger (i.e., $>> 20$ ppmV) on the sample from SV-2, which was near the gas piping. It is possible that this peak is a component of natural gas (e.g., butane).
