# Whiting Pond Bypass Culvert at West Bacon St

*MassDOT P12007-973-MUN-BRI*

*June 2021*

## CULVERT EVALUATION REPORT

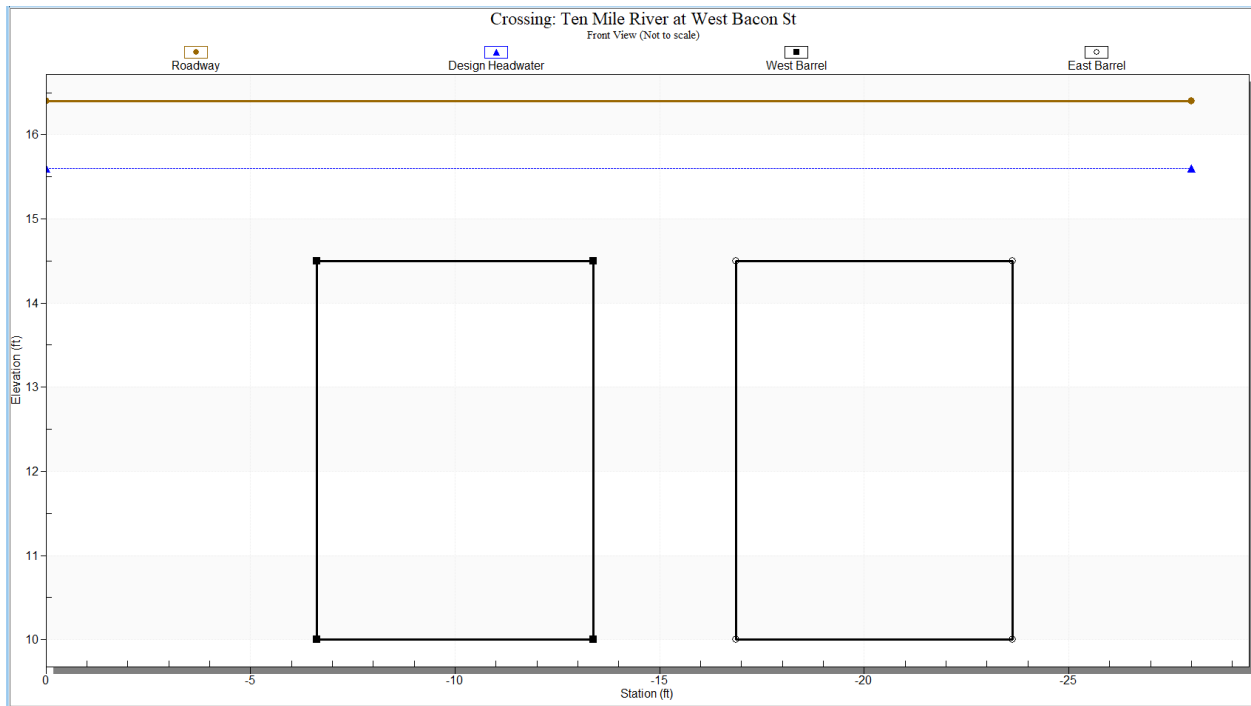
Figure 7-2 HY-8 Existing Model Overview

Field measurements were taken to develop a basic hydraulic model using HY-8 program. The results indicate that the combination of the two culverts is insufficient to convey the 25-year storm flows (384 cfs – Streamstats data modified for climate change). The following figures and table show that the road overtops during the design (25-year storm).

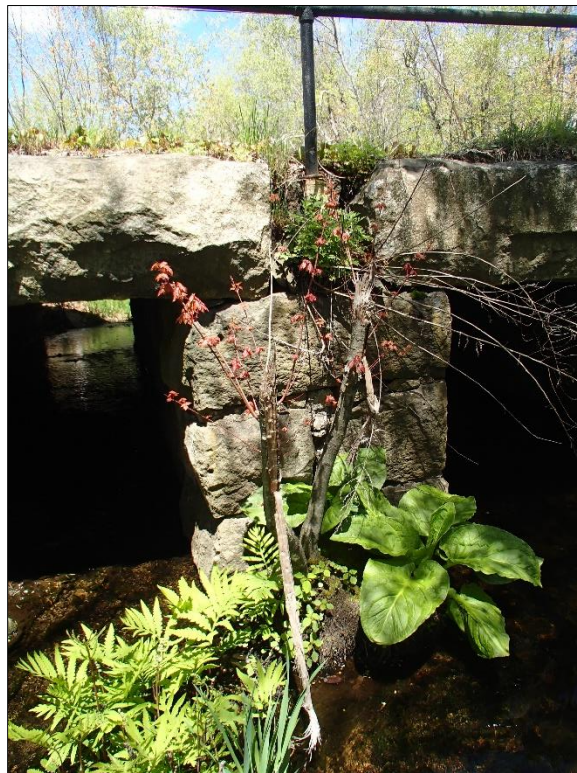
The embankments on both sides have overgrowth into the channel. There is debris present throughout, which is worse in the west span (See Photo 9). At the south end of the pier there is a tree growing with vegetation blocking flow (See Photo 8).

Photo 8 Looking South: Center Pier at South Side

- Replace the roof slab to lower the roadway elevation over the structure to align with the approach roadway elevations. The existing hydraulic opening should remain.
- Replace the north sidewalk as it is heavily fragmented and allows water to leak into the structure. This should be done to preserve the integrity of the substructure.
- The north guardrail and the south fence should be replaced with a crash tested guardrail to maintain safety conditions.
- Fill in all voids in the masonry abutments, pier, and wingwalls.
- Replace all missing and/or loose chinking stones in the masonry abutments, pier, and wingwalls.
- Repoint all masonry joints to the masonry abutments, pier, and wingwalls.
- Scale back vegetation and remove debris in river on both sides to focus and control water flow.

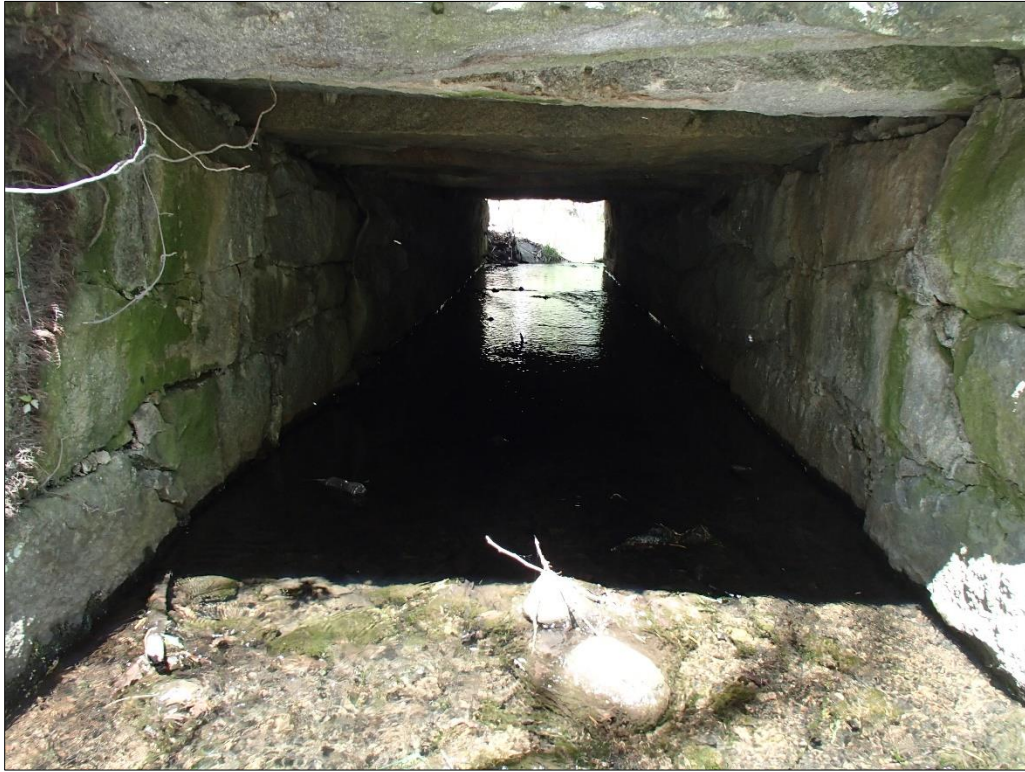
Photo 9 Looking North: West Barrel

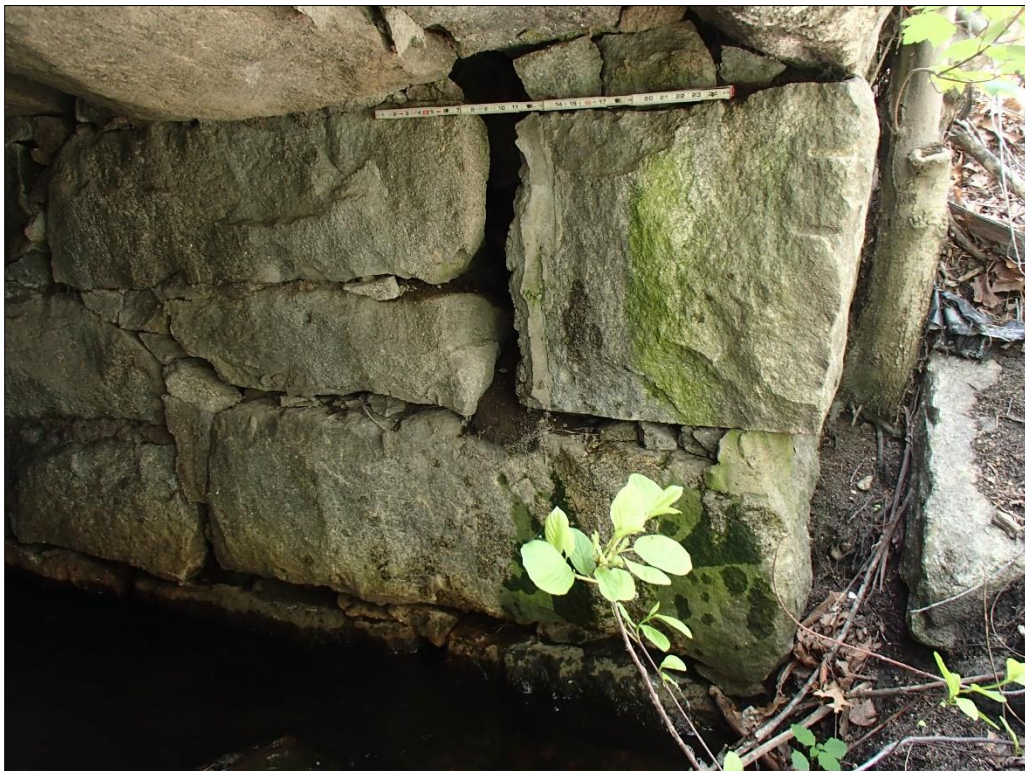
The overall condition of the structure is fair with some deficiencies noted. There are voids, loose and/or missing mortar joints, and loose and/or missing chinking stones typical throughout. There is cracking and active leakage on the roof of the masonry slab, present in each span. The south side of the west span has a 1/8" wide crack that is fully through the clapper (Photo 12). There are voids along the water line at each abutment, with a 29" deep void at the northeast abutment corner (Photo 11). The northwest abutment corner has voids up to 27" deep and is slightly displaced up to 4" (Photo 10).

Channel Walls: Typ. Voids at waterline; Missing and loose chinking stone (typical); 27" deep void @ NW corner

Photo 10 Looking West: Northwest Corner Voids

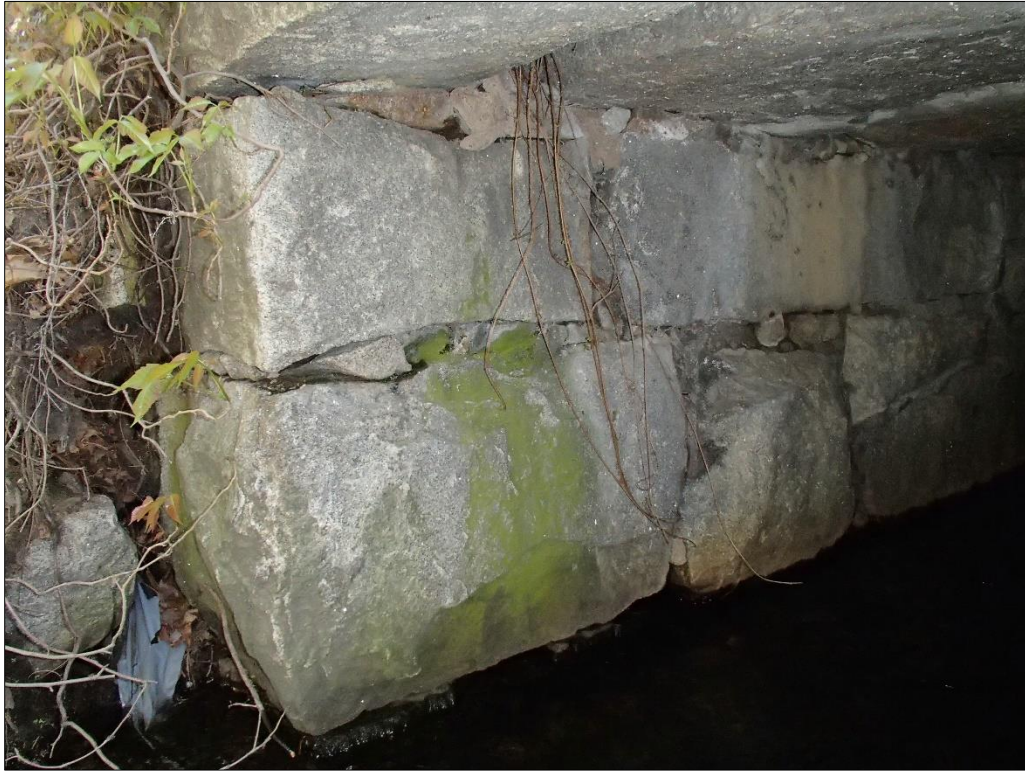
Center Pier: Typ. Voids at waterline; Missing and loose chinking stone (typical); 29" deep void @ NE corner

Photo 11 Looking East: Northeast Corner Voids

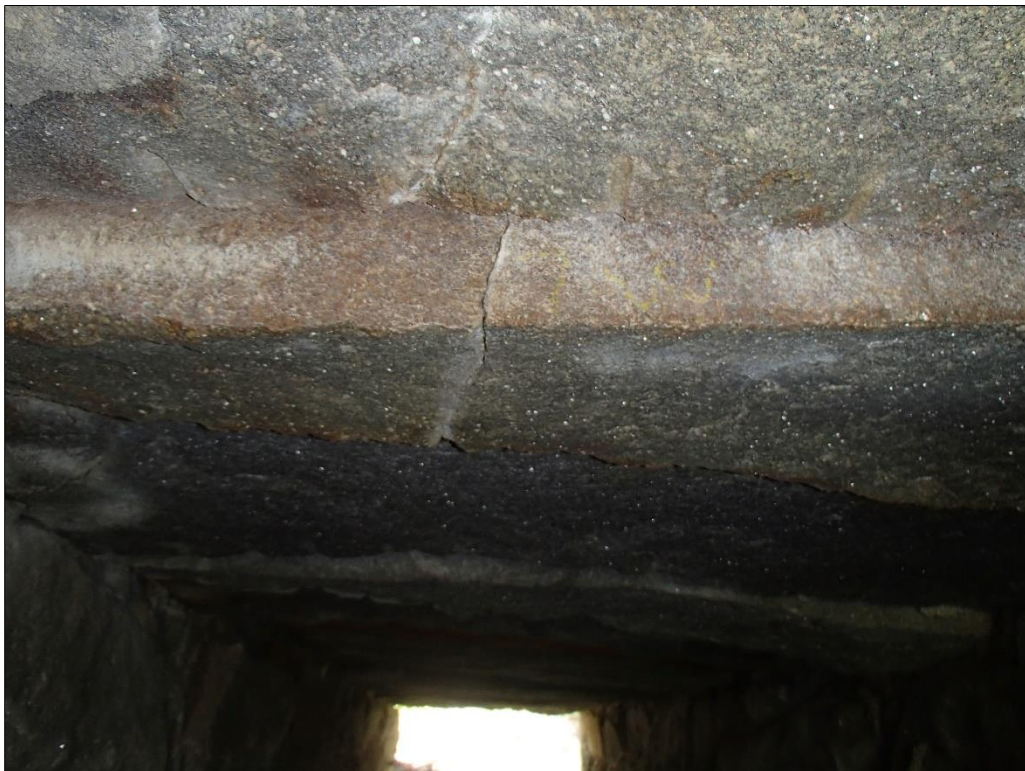
Condition Notes: Active water leakage & staining typical in both barrels; full width crack in west barrel (no stone movement)

Photo 12 Looking North: Crack in Roof on South Side of West Span

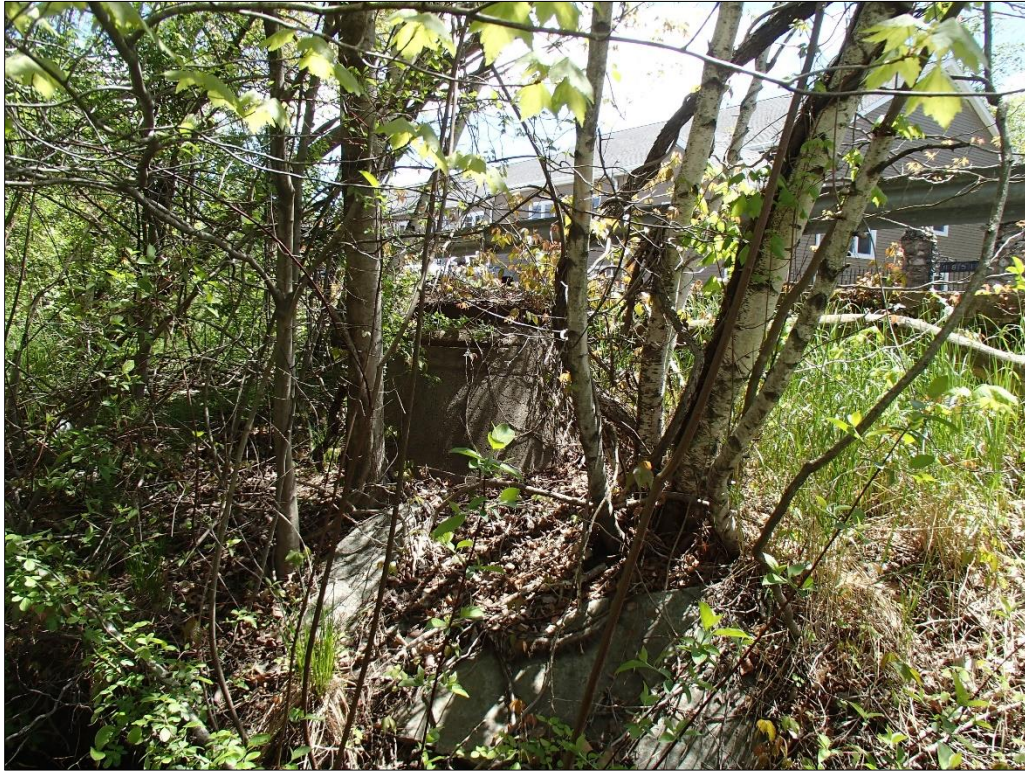
There are overhead wires on the north side. There is an elevated manhole present in the brush to the northeast side of the culvert (See Photo 13). Guardrail is present on the north side, while the south side

Photo 13 Looking Southeast: Elevated Manhole

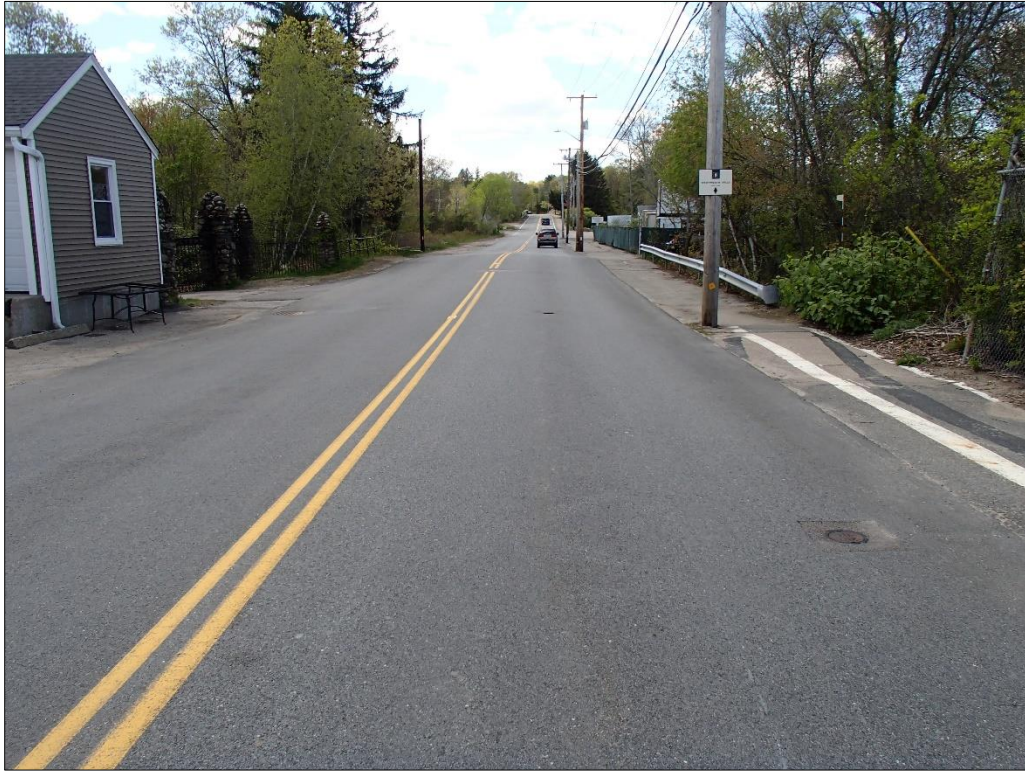
The roadways at either approach are in good condition, but the roadway over the culvert is in poor condition. The roadway over the culvert is at a higher elevation than the approaches (Photo 15 and 16). This change in elevation creates a speed bump for travel over the structure. The north sidewalk is in poor condition with numerous cracks and settlement (Photo 16). The south shoulder area also has settlement (Photo 18). The safety rails over the structure are in poor condition. The guardrail on the north side is not secure throughout and exhibits corrosion at the base of the posts. The metal fence on the south side is heavily corroded and is leaning off towards the river.

Photo 15 Looking West: East Approach

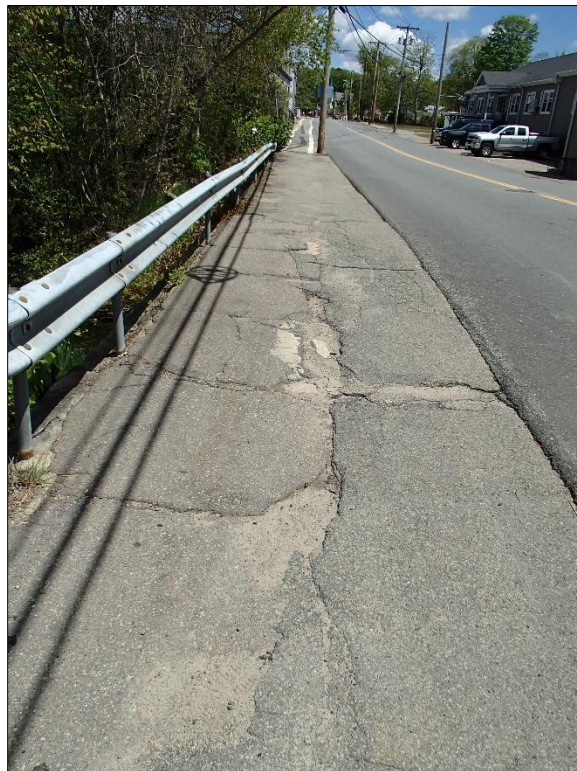
Culvert/Bridge Roadway Condition:	N. Sidewalk widespread cracking; Minor cracking	Culvert/Roadway (Feet):	29.0'
Culvert/Bridge Roadway Settlement:	Raised over structure; N. Sdwk settlement	Culvert/Roadway Rating:	4
Culvert/Bridge Roadway Alignment:	Straight		
North Roadway Approach Condition:	NA	North Roadway (Feet):	NA
North Roadway Approach Settlement:	NA	North Roadway Rating:	NA
North Roadway Approach Alignment:	NA		
South Roadway Approach Condition:	NA	South Roadway (Feet):	NA
South Roadway Approach Settlement:	NA	South Roadway Rating:	NA
South Roadway Approach Alignment:	NA		
East Roadway Approach Condition:	Good - Newly Paved	East Roadway (Feet):	29.0'
East Roadway Approach Settlement:	NA - newly paved	East Roadway Rating:	7
East Roadway Approach Alignment:	Entrance to cemetary		
West Roadway Approach Condition:	Good - Newly Paved	West Roadway (Feet):	29.0'
West Roadway Approach Settlement:	NA - Newly Paved	West Roadway Rating:	7

Photo 16 Looking East: North Sidewalk Area

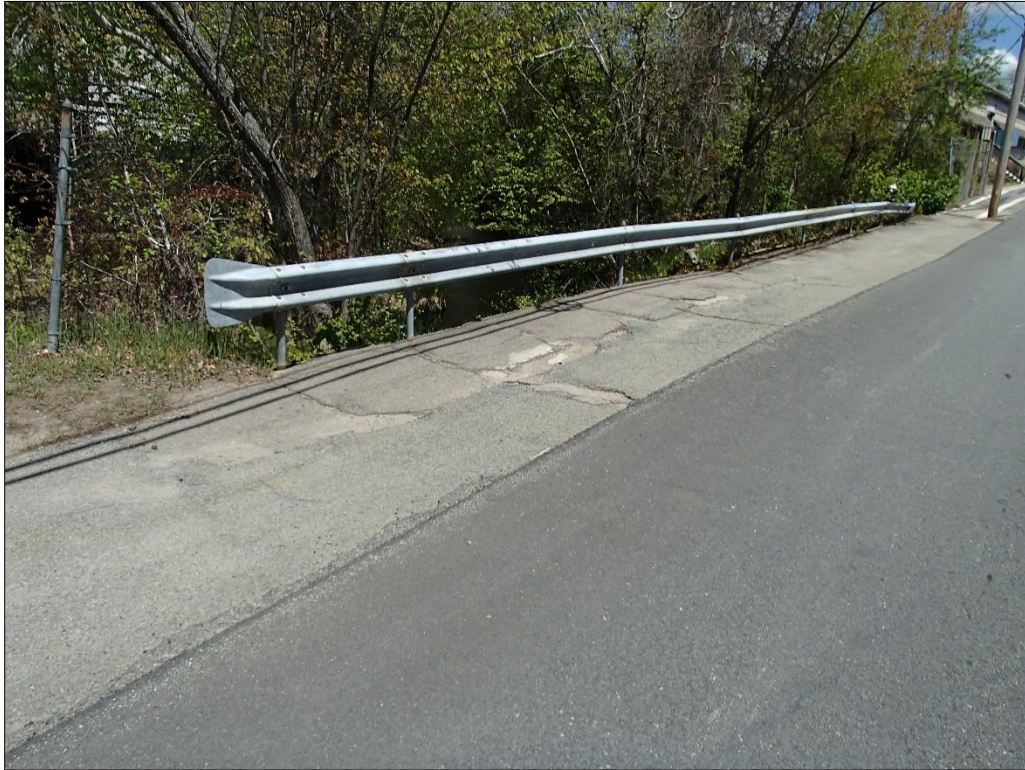
Bridge Rail Type:	Metal Pipe
Bridge Rail Condition:	Poor - Hvy corr. of bolts & Conn's.; S. rail leaning; Unstable
Bridge Rail Rating:	1
Approach Rail Notes:	No transitions; N. barrier non-standard & in poor condition

Photo 17 Looking Northeast: North Railing

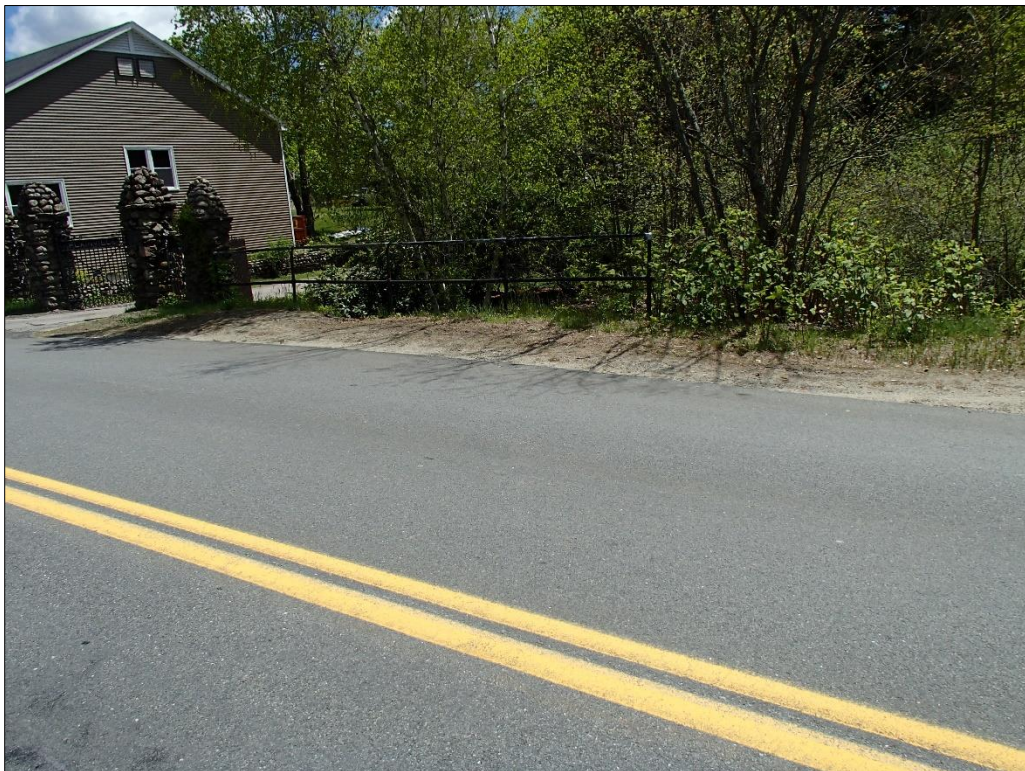
Photo 18 Looking South: South Railing
