DEPARTMENT OF PUBLIC UTILITIES

PIPELINE ENGINEERING AND SAFETY DIVISION

INCIDENT REPORT

627 Pleasant Street, Winthrop, Massachusetts

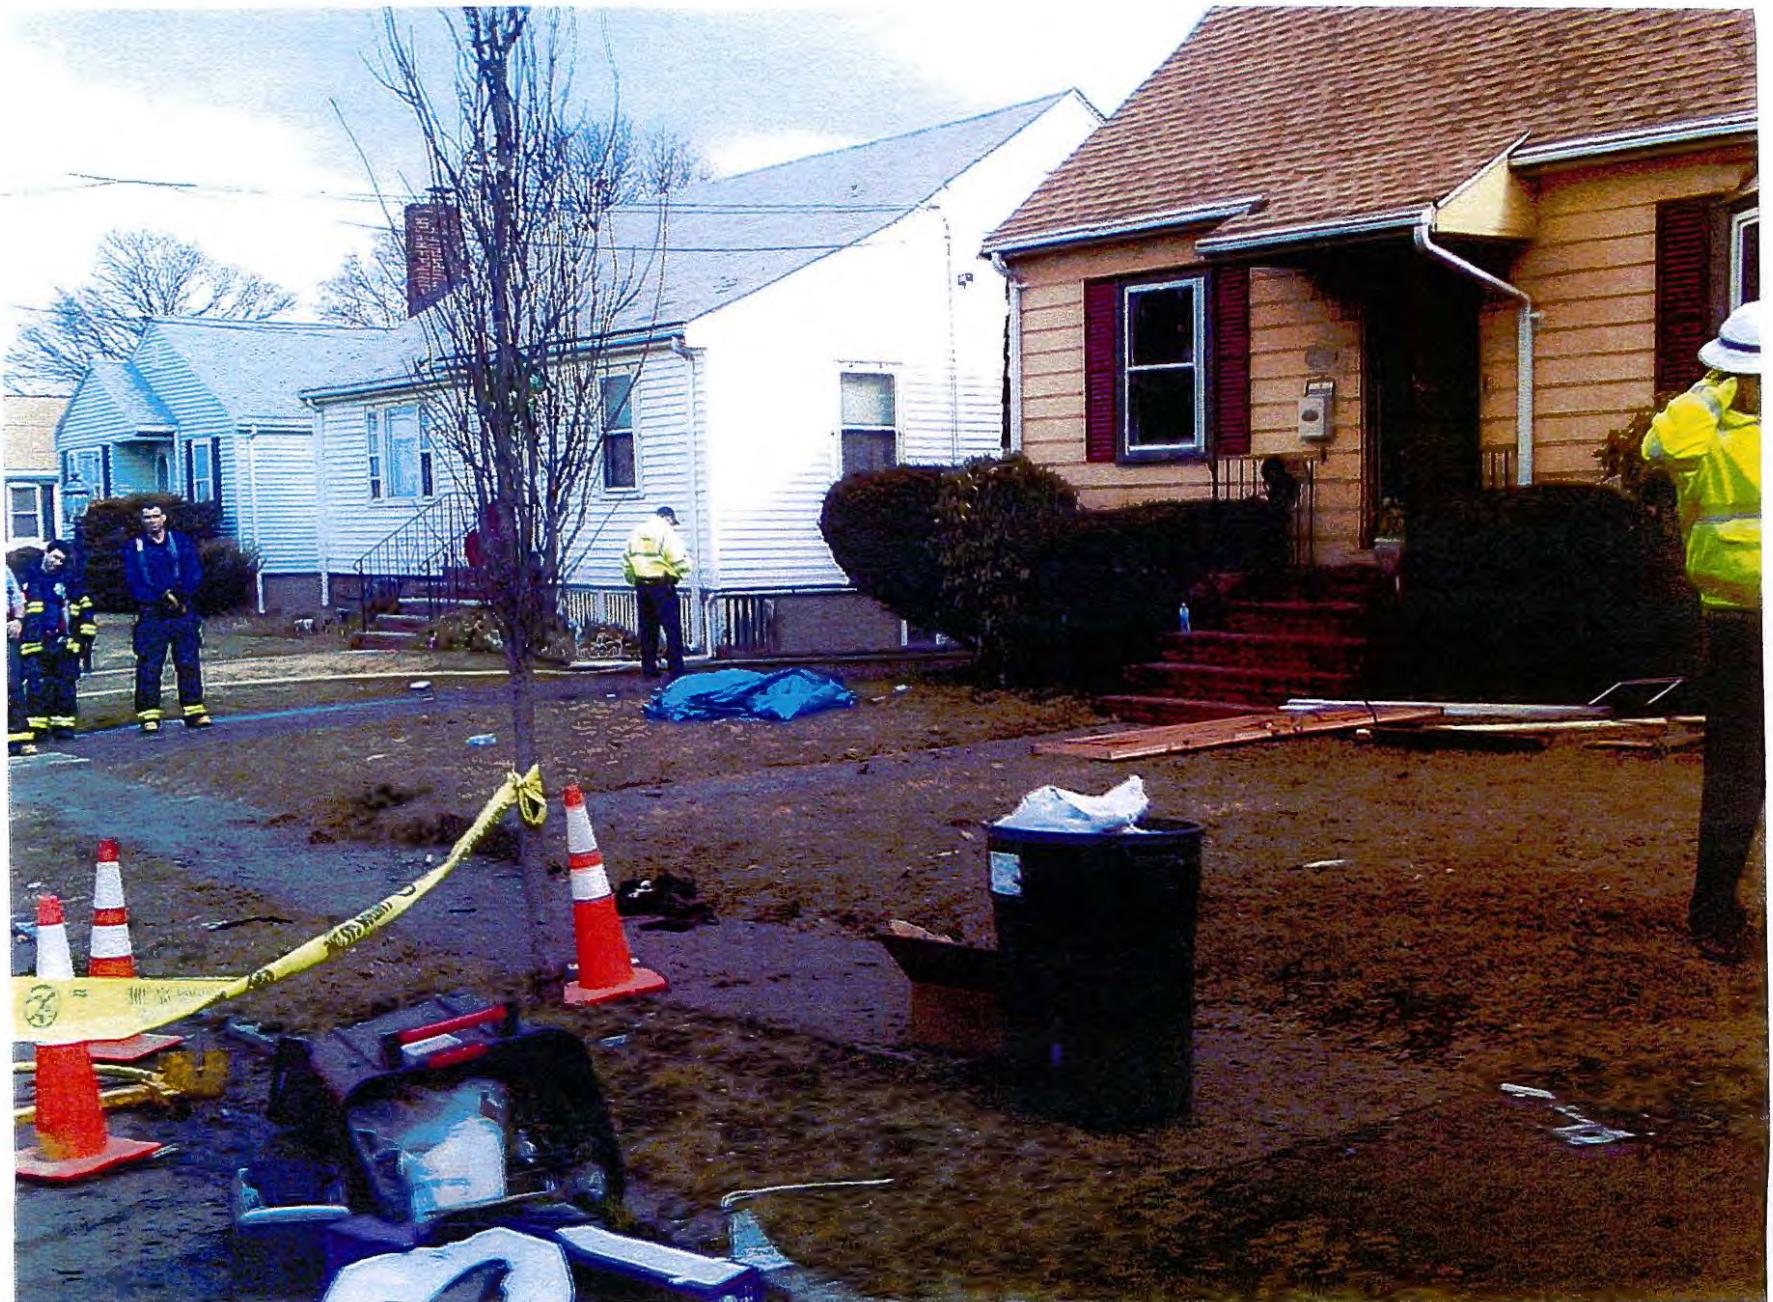
4(a) - 627 Pleasant Street, Winthrop – Residential Area

Pleasant Street, Winthrop is located in a residential area comprised of single family homes (Exh. 4(a)). The structure at 627 Pleasant Street was a two-story wood frame house with a basement. The house was constructed in 1850. The Division investigator observed that the natural gas service line entered through the right front basement wall. The gas furnace, hot water heater and dryer were located in the basement (Exh. 4(b)). A gas stove was located on the first floor of the house (Exh. 4(c)).

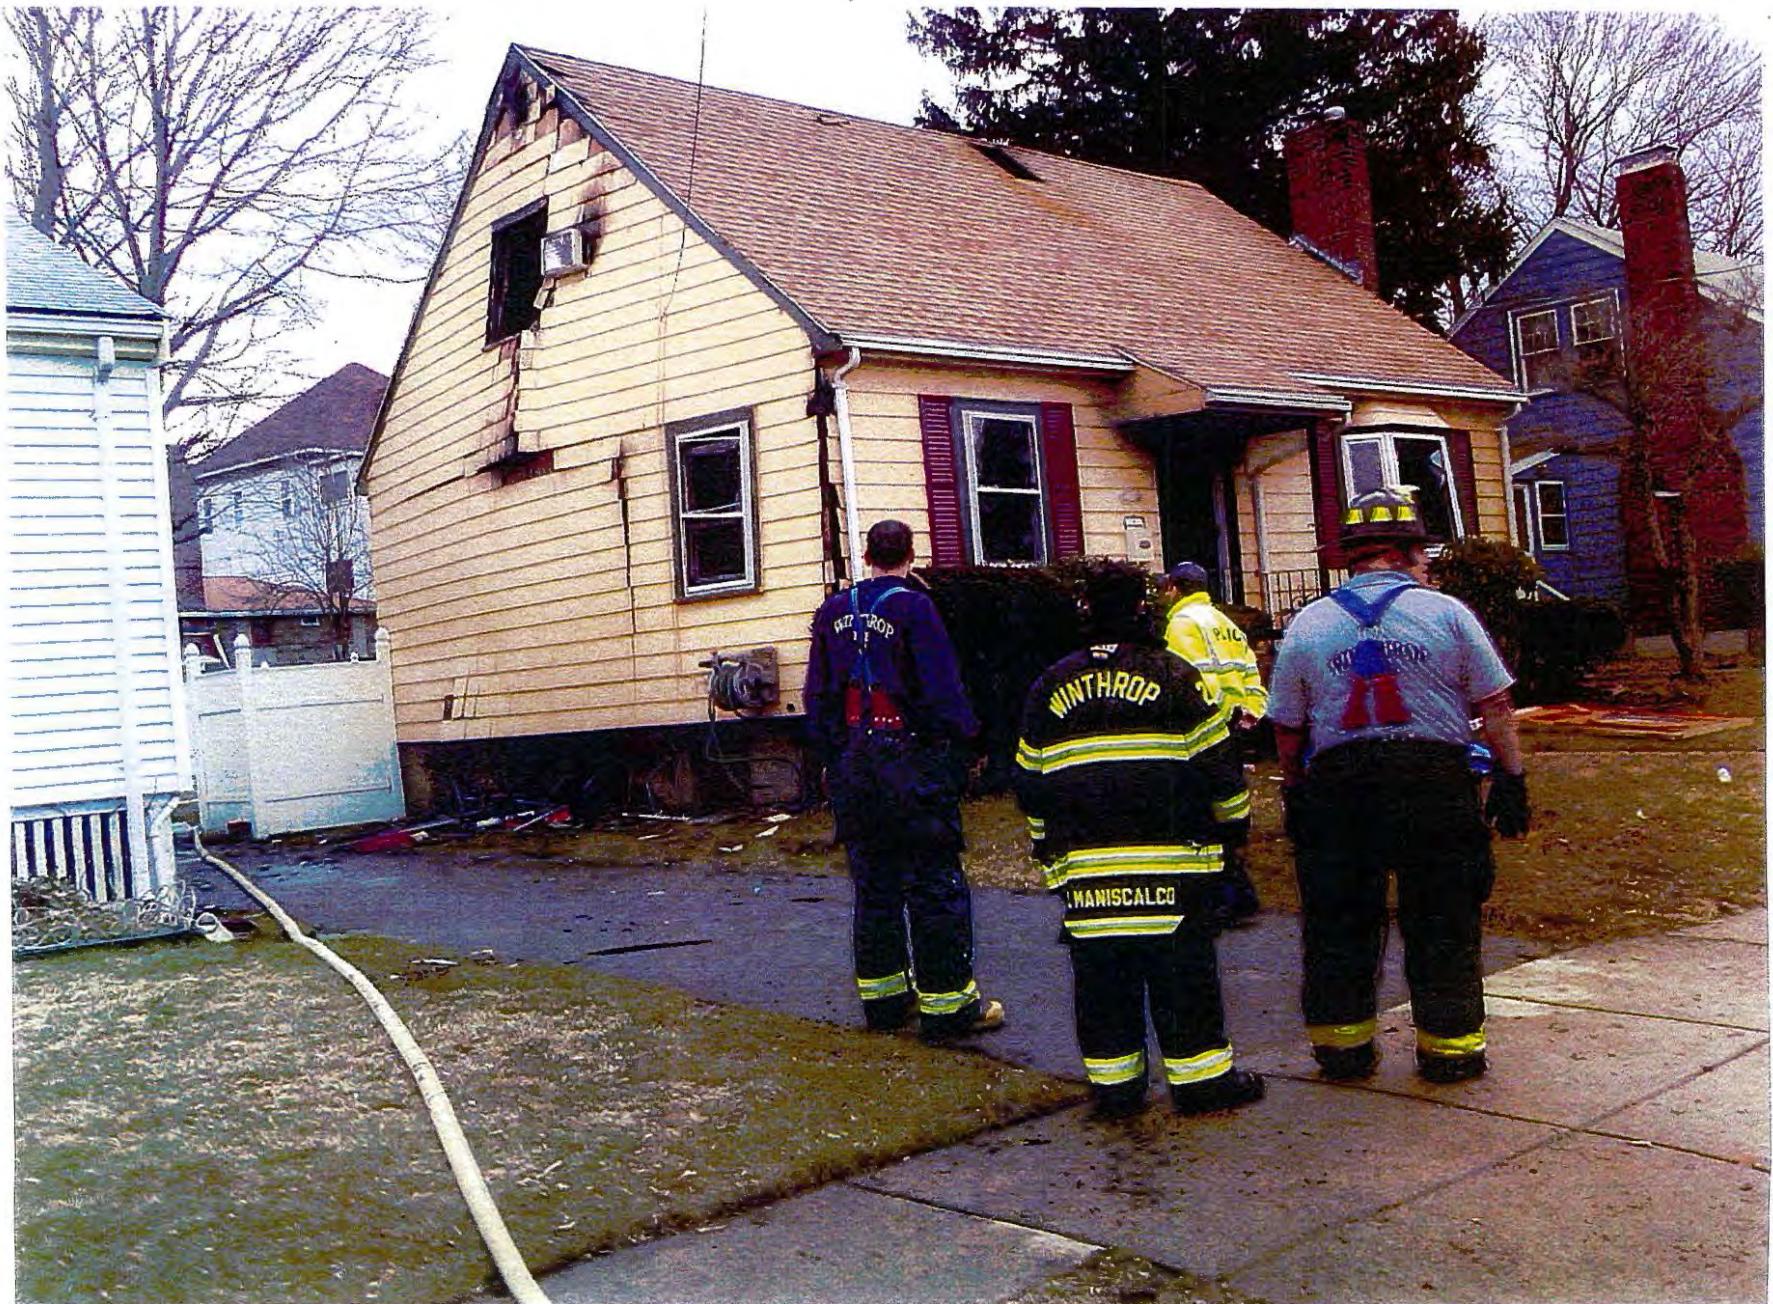
The building had been severely damaged by an apparent explosion and subsequent fire (Exhs. 4(d), 4(e)). Debris was blown onto the lawn of 627 Pleasant Street, and adjacent properties (Exh. 4(e)). In addition, the windows and walls were displaced.

4(d) - 627 Pleasant Street, Winthrop - Fire Damage

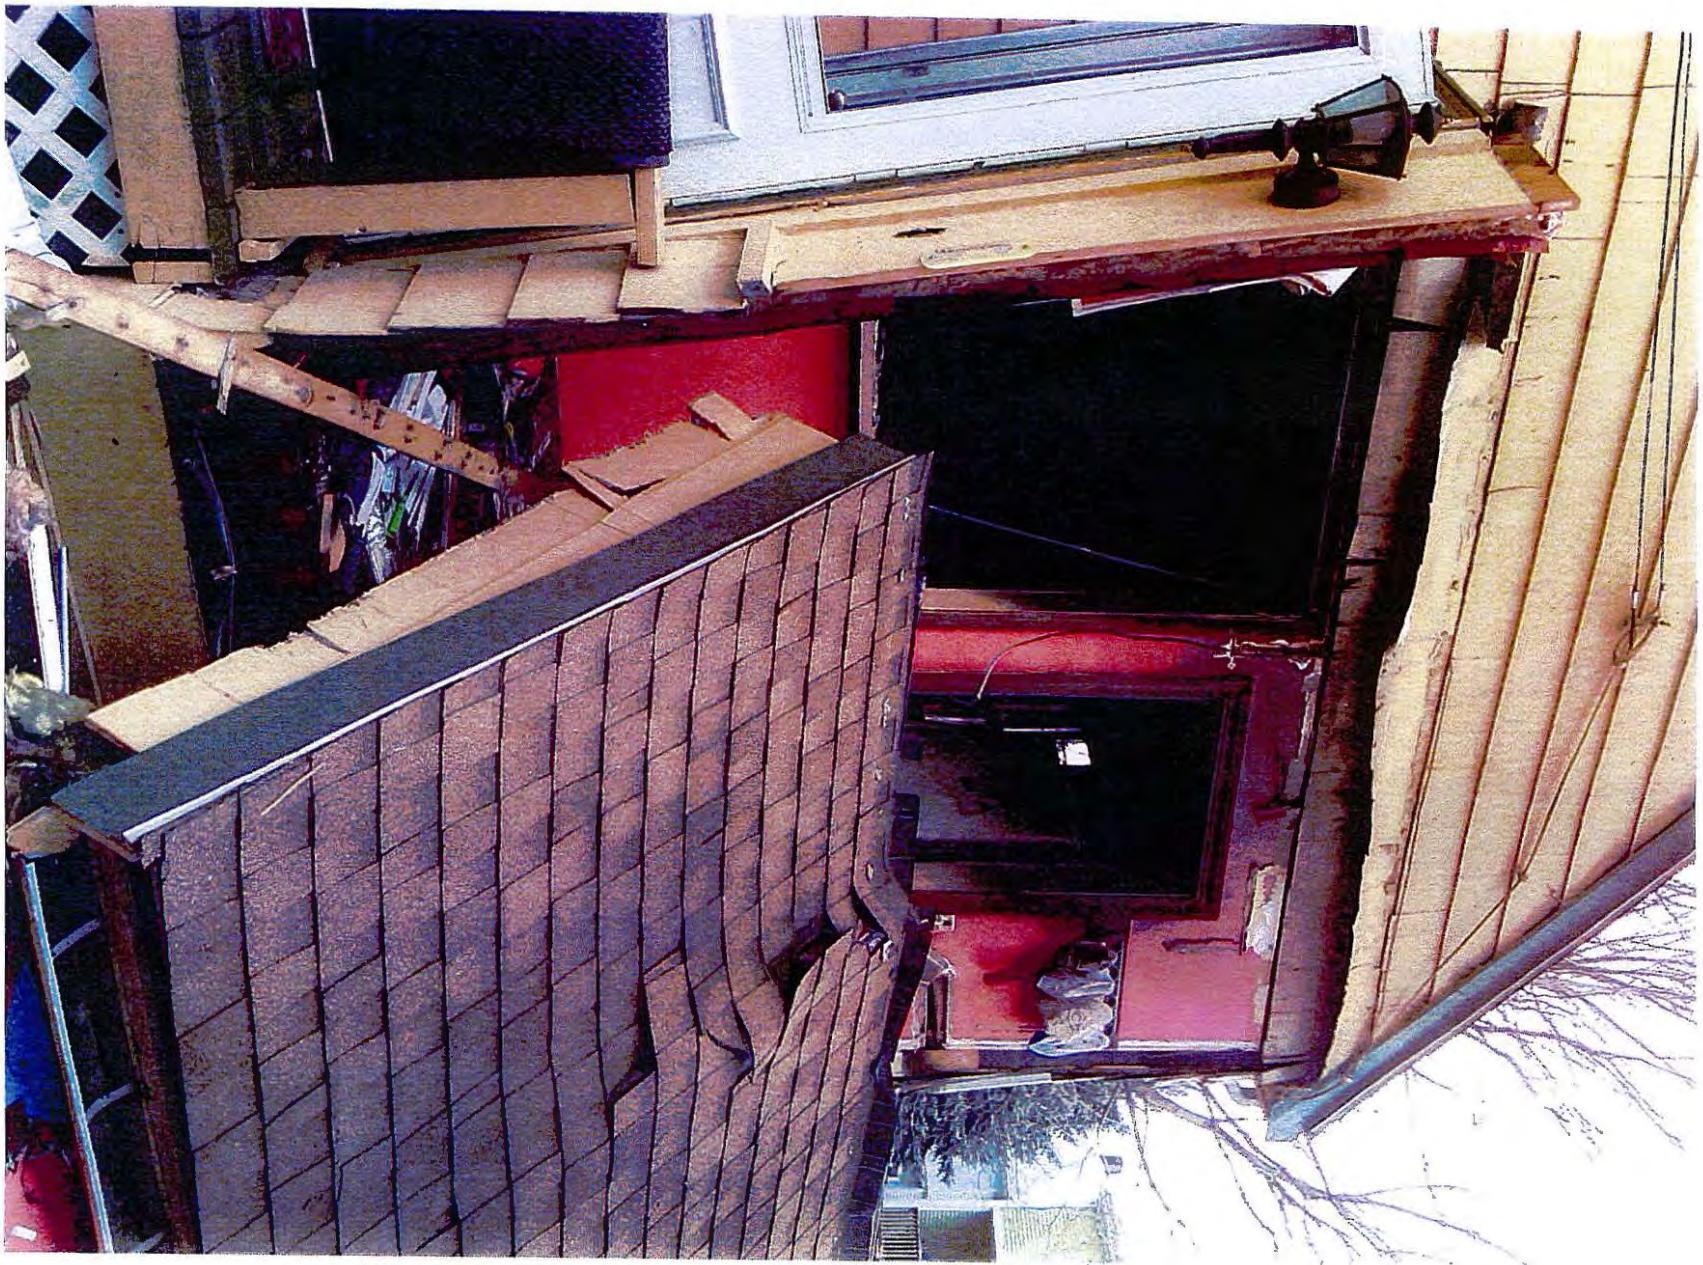
4(e) - 627 Pleasant Street, Winthrop - Debris on right side of structure

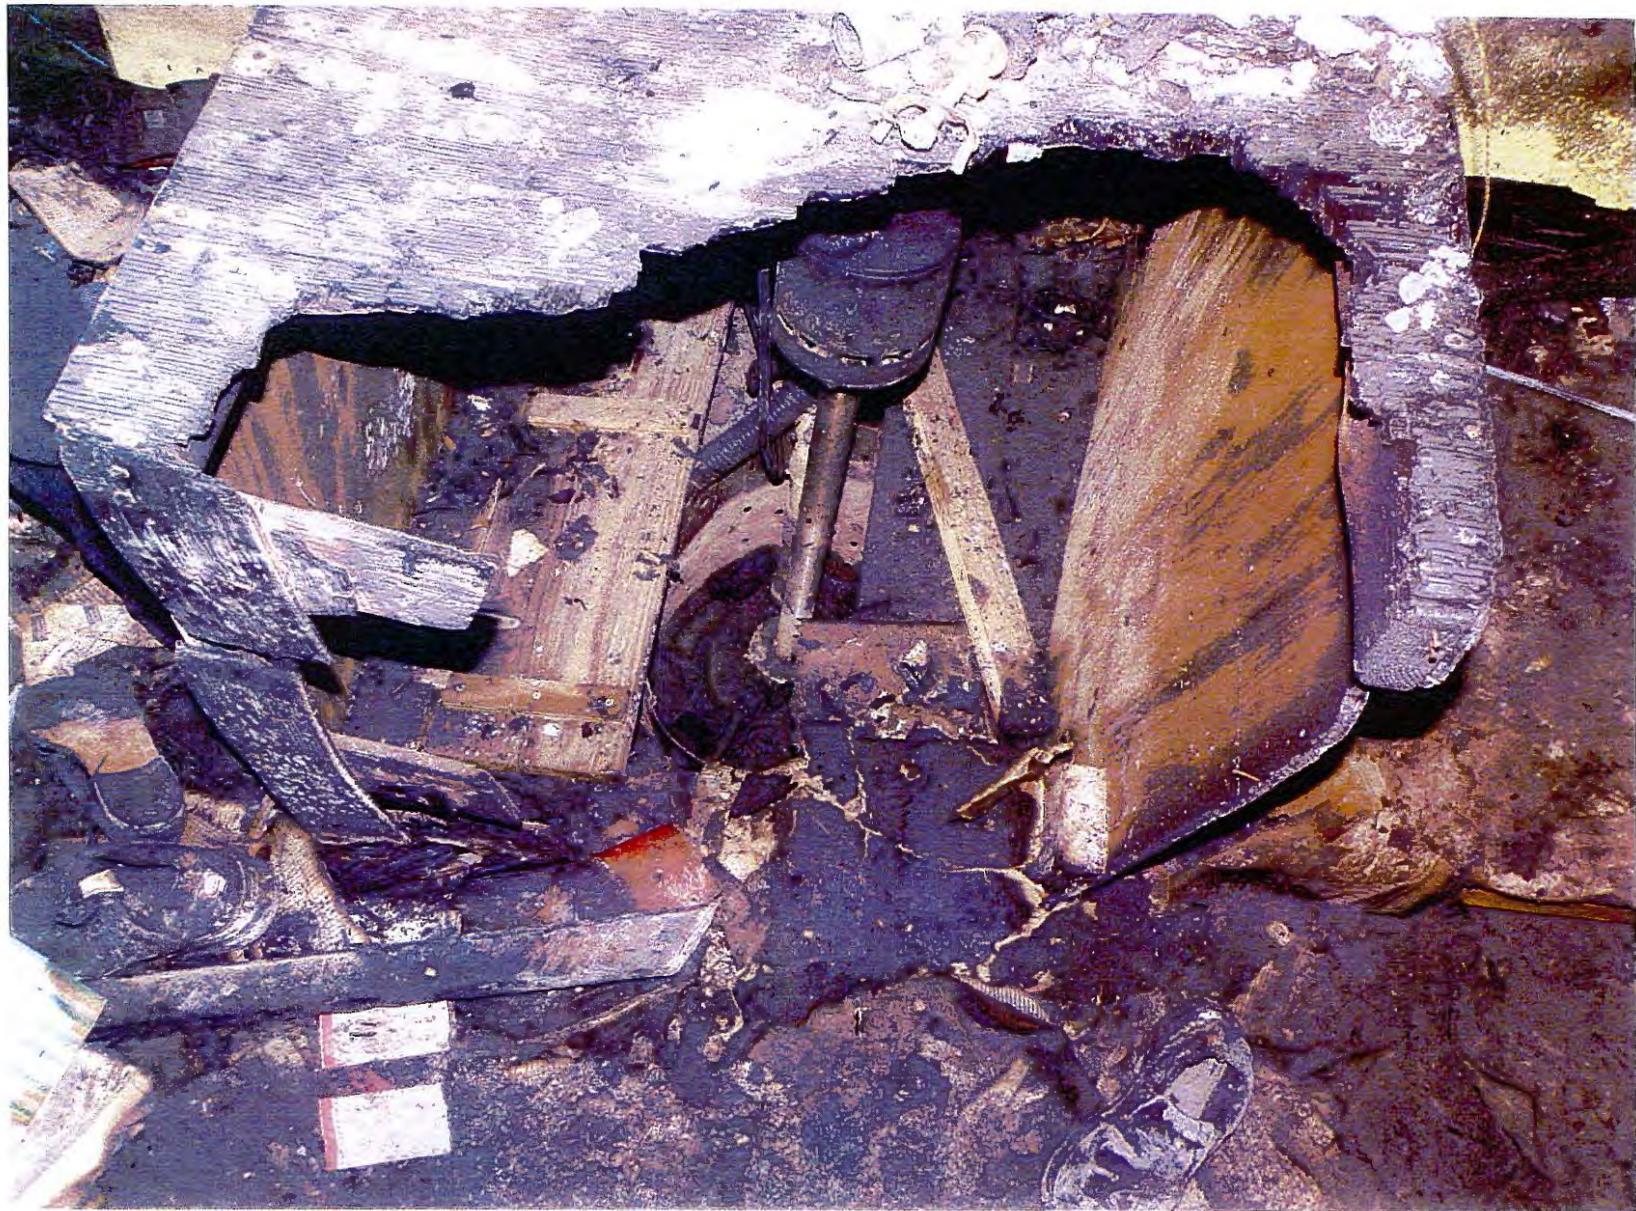
The Division inspector observed the Operator conduct an internal inspection of the sewer line, from the sump pump area inside of 627 Pleasant Street, to the main sewer line located in the street. The sump pump was located at the center of the inside front foundation wall of the house in a covered box in the basement floor; the box also contained the water line (Exhs. 4(f), 4(g)). During the inspection, the Division inspector noted the following:

4(f) - 627 Pleasant Street, Winthrop - Sump pump in basement floor

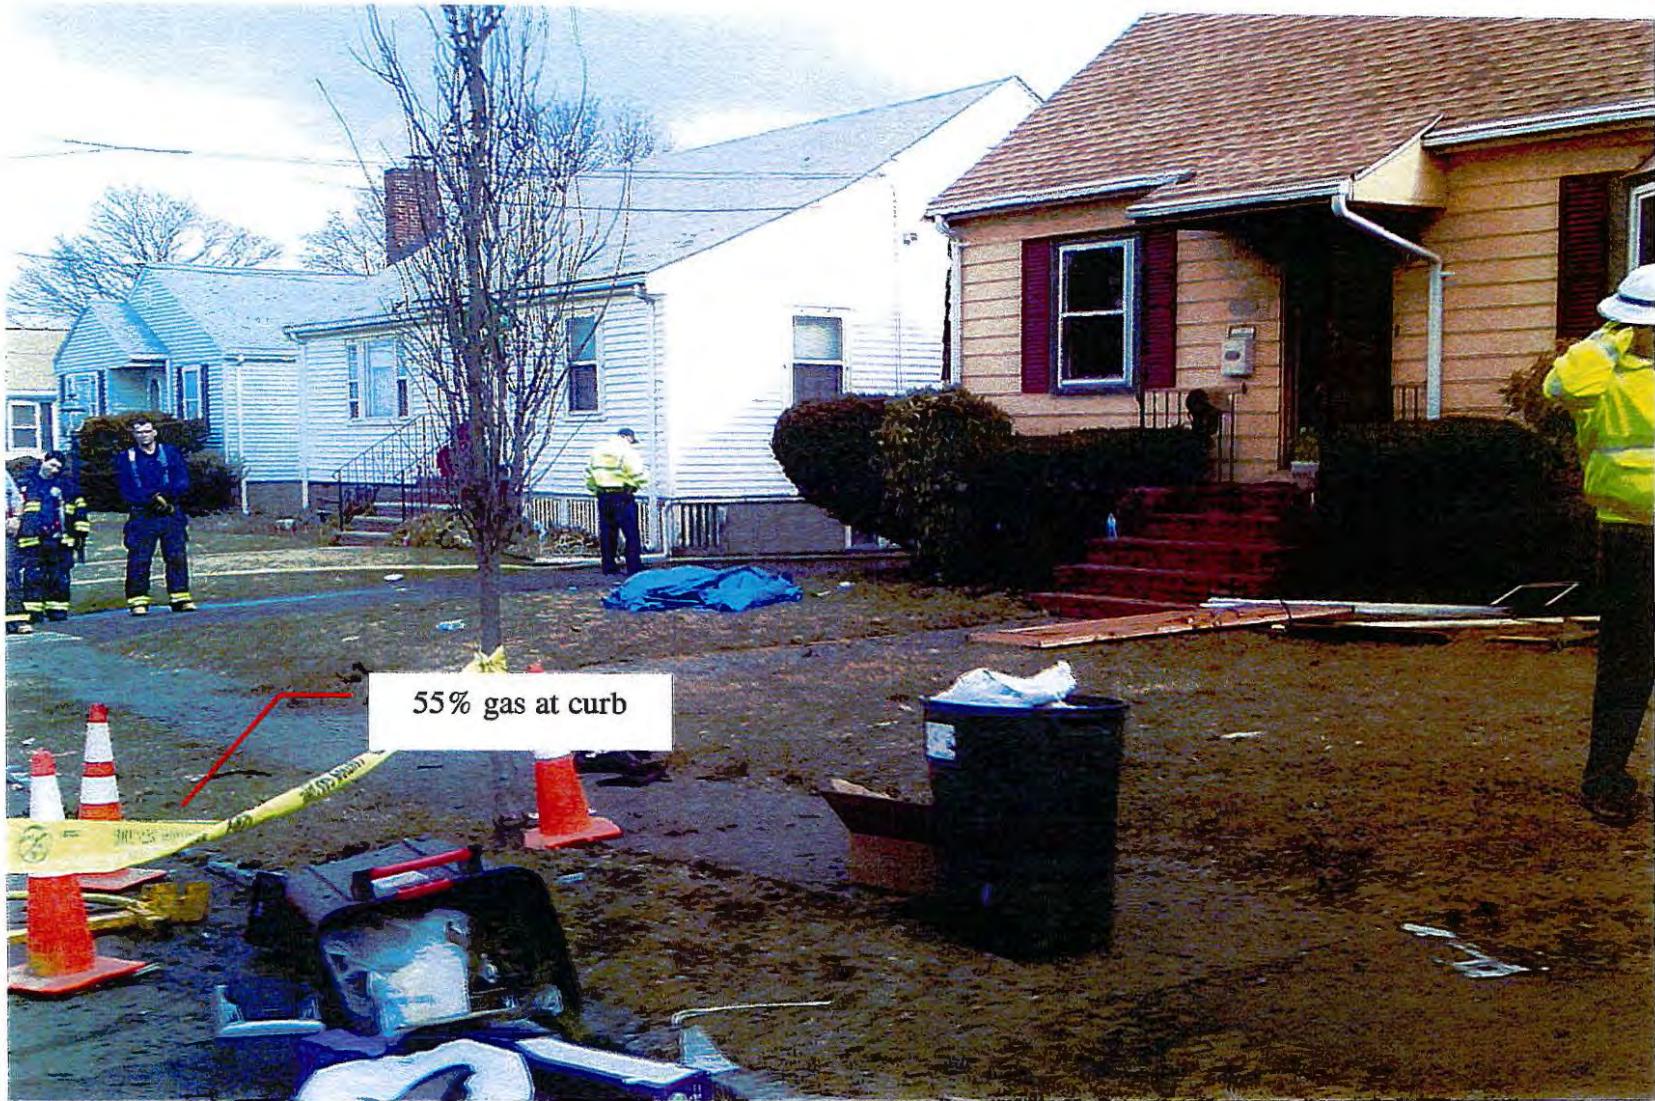
7(c) – Gas reading at curb

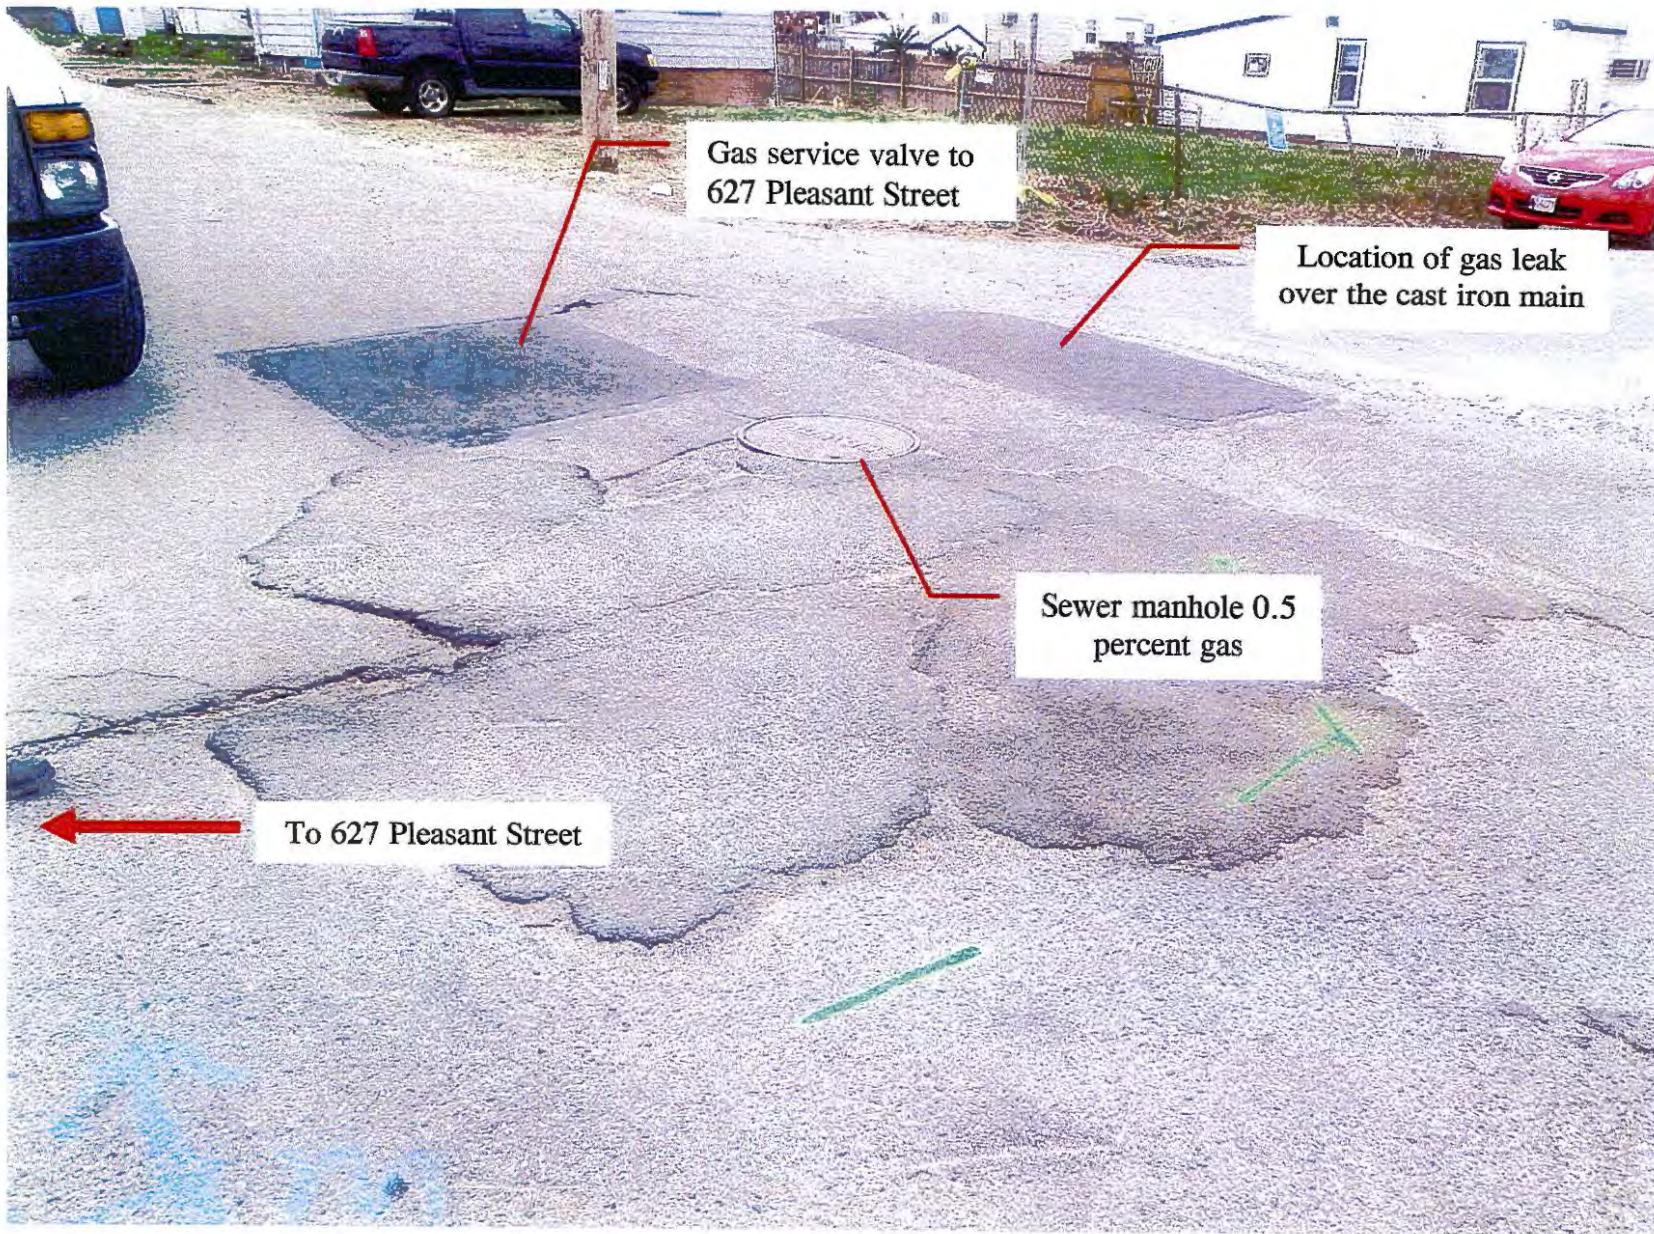
7(d) – Street typography

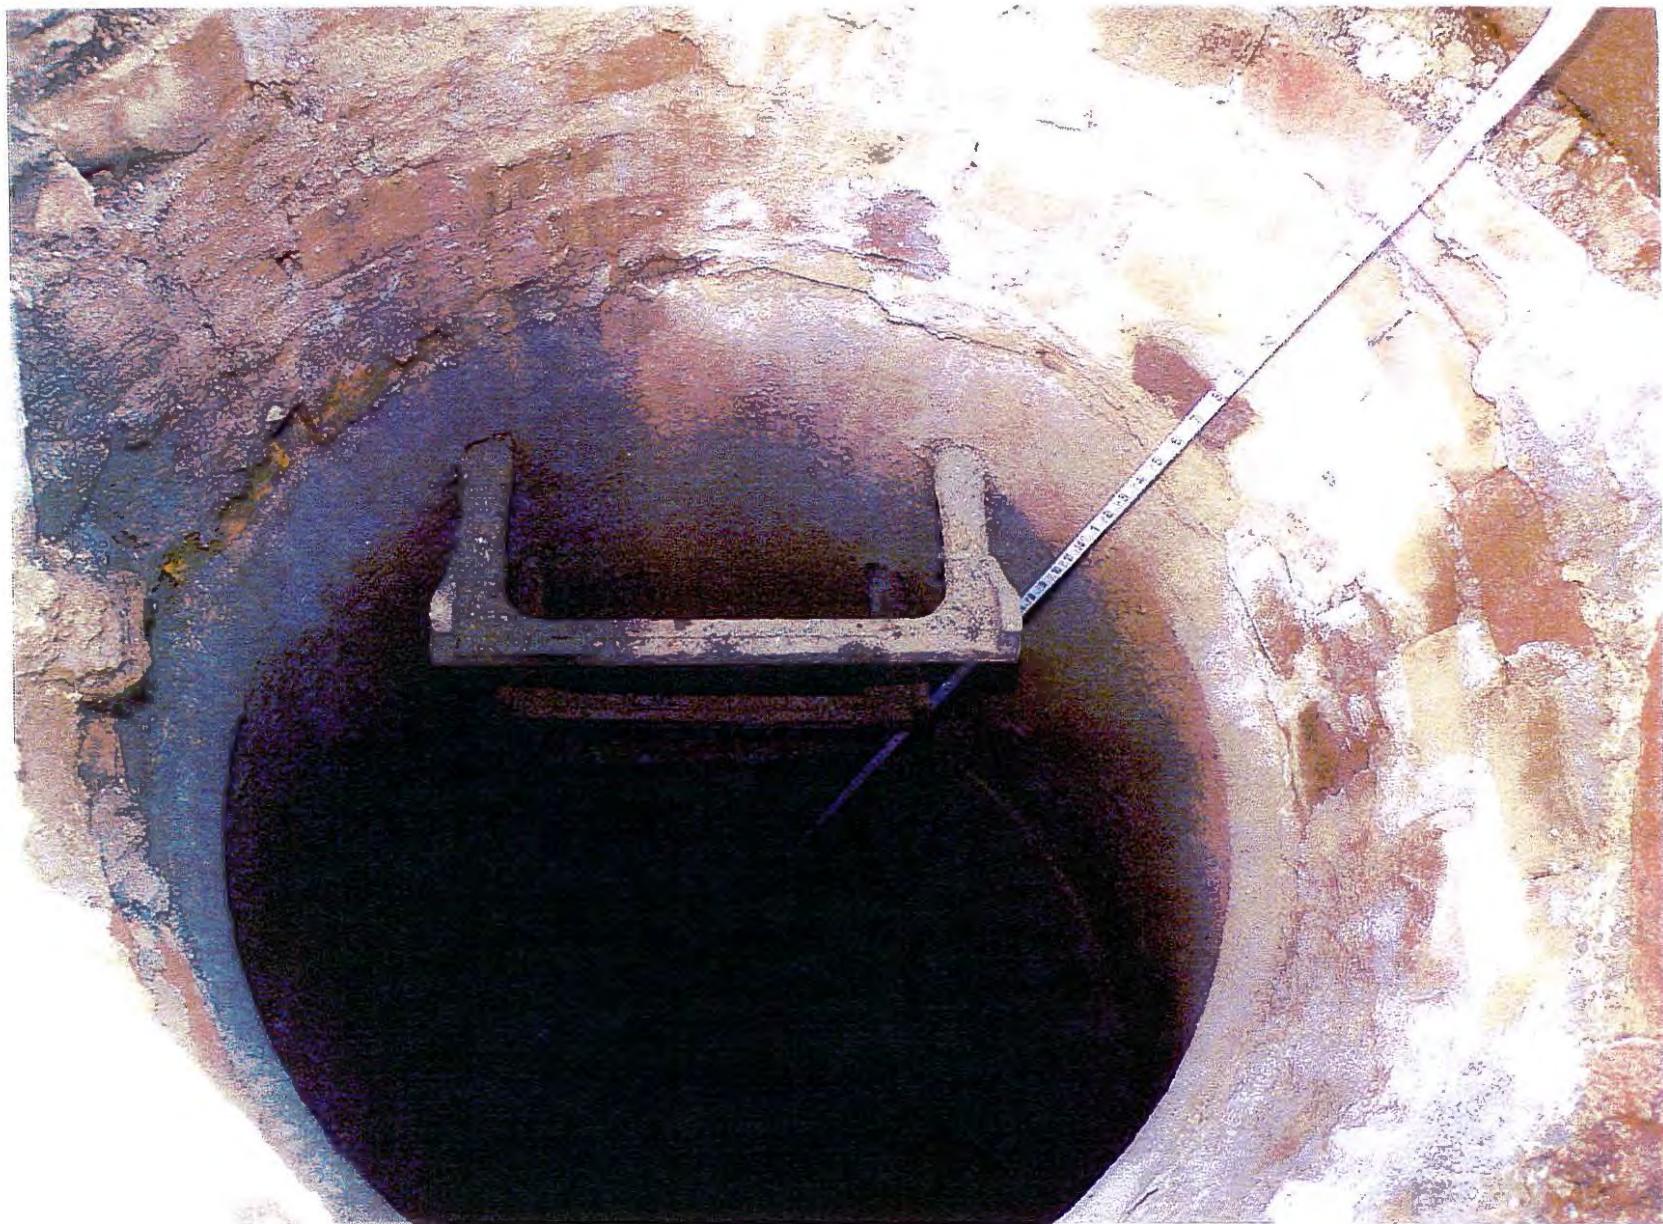
7(e) – Sewer Manhole

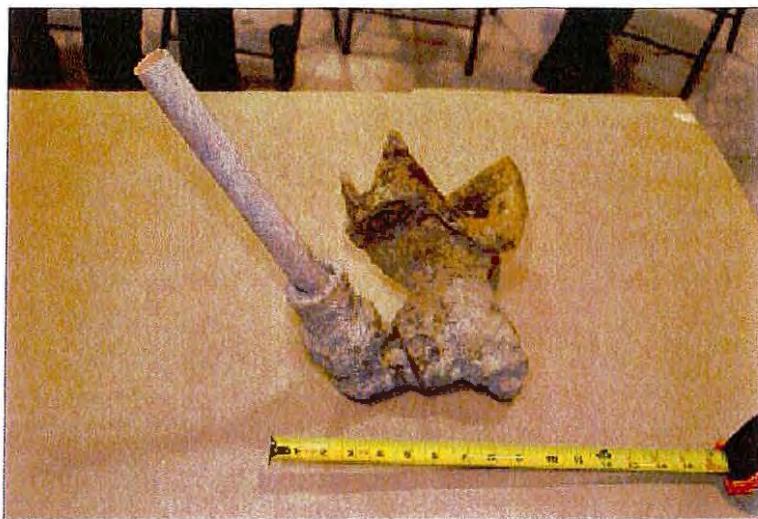
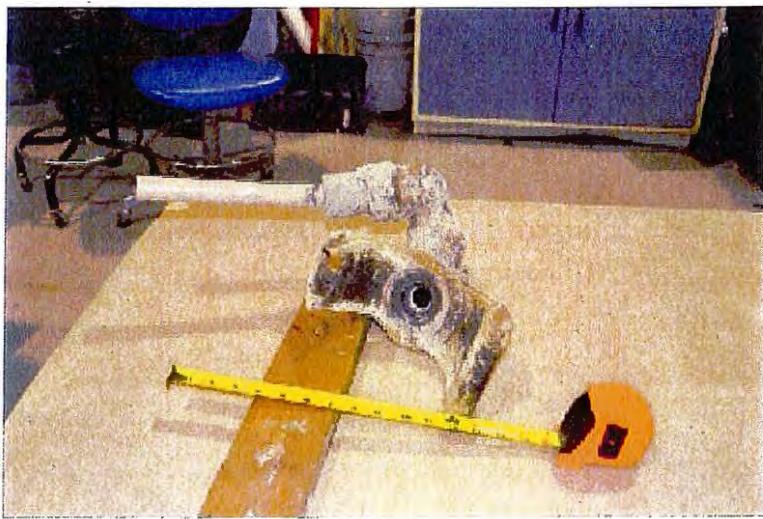
dense clay material. The Operator removed, and the Department secured, the service saddle, transition fitting, and approximately one foot of pipe that included the leak location (Exh. 8(b)).

Figure 10: The saddle fitting assembly, top view.

Figure 11: The saddle fitting assembly, bottom view. Note plastic service pipe is askew.

8(b) – Service saddle transition fitting and plastic pipe that was attached to the six inch cast iron gas main

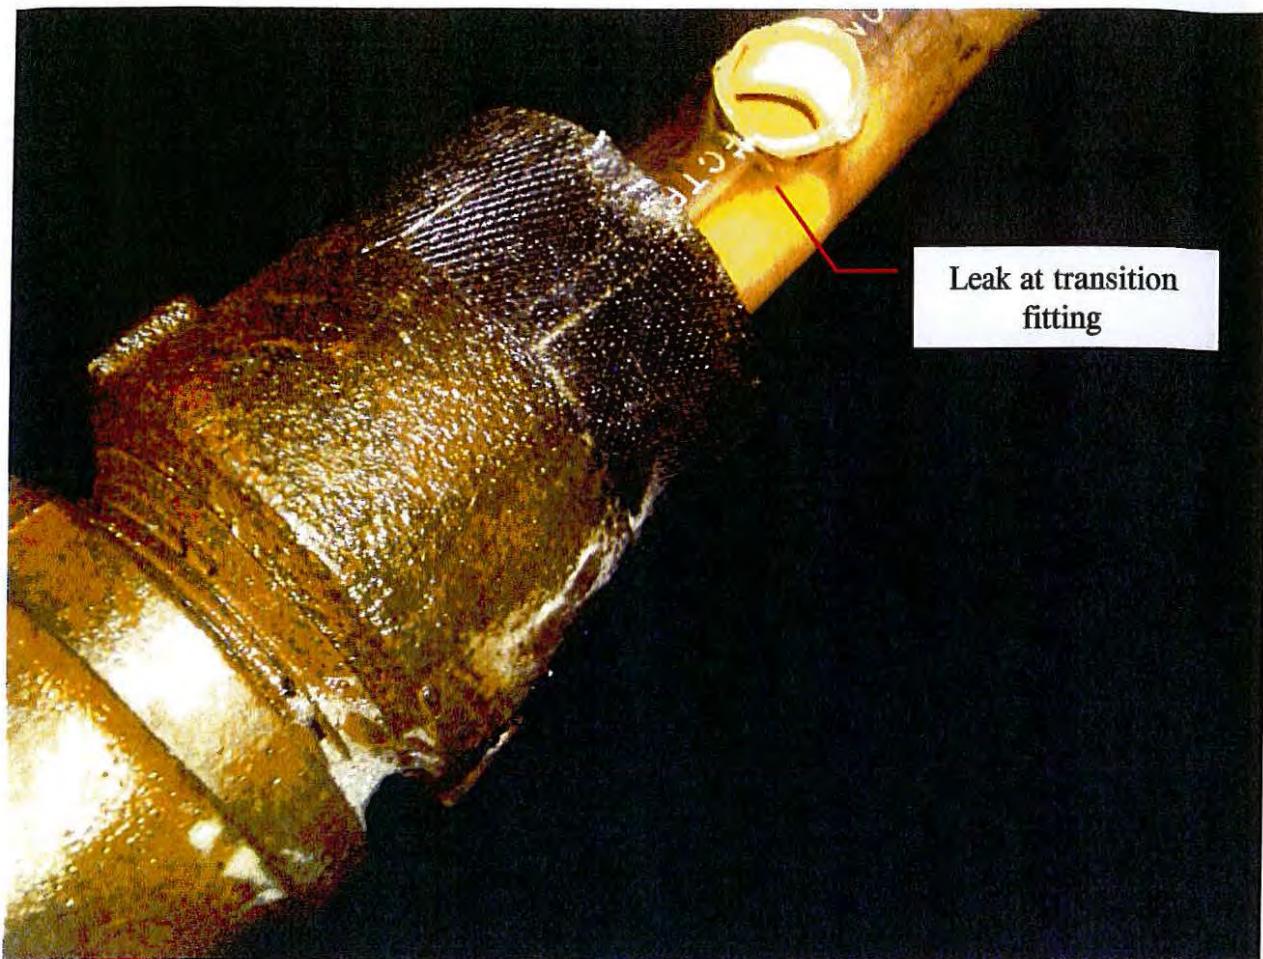
The Operator excavated in the front lawn of 627 Pleasant Street, and uncovered the plastic service line inside a steel sleeve. The line extended from inside the house foundation wall to the area in the sidewalk where the Operator detected a fifty five (55%) percent gas reading (Exhs. 7(a), 7(c)). When the Operator exposed the gas service inside the house they found a half (1/2) inch hole in the plastic pipe at the transition point of the internal stiffener located inside the foundation wall (Exhs. 8(c), 8(d), 8(e)).

8(c) – Leak at transition fitting inside the basement at the foundation wall

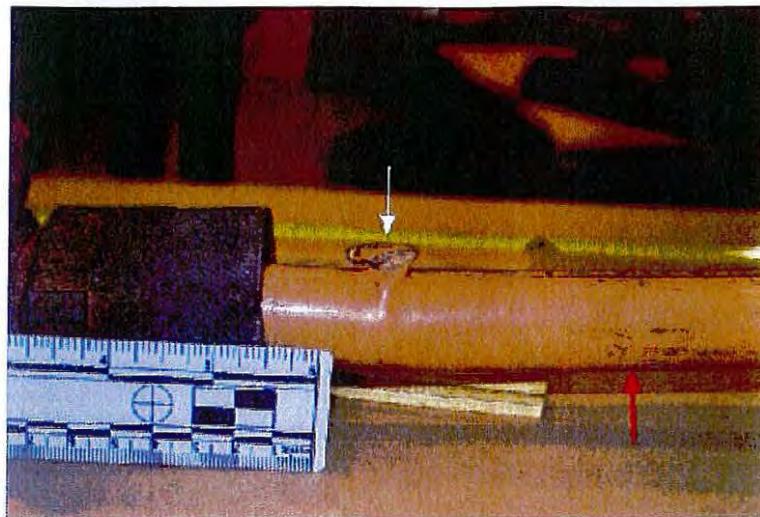
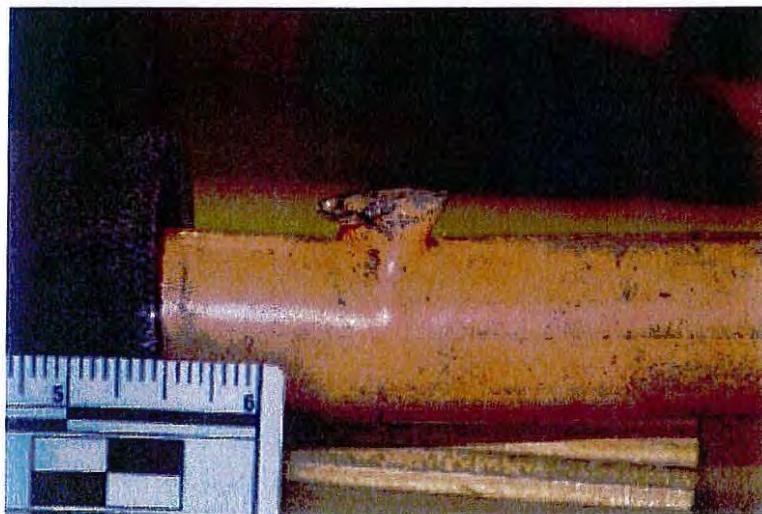
The service line hole possessed the thinning and general morphology of a blow-out type hole. This is consistent with heat exposure and is a result of the incident. The service line within the transition fitting also exhibited obvious heat damage. The service line 180-degrees to the blow hole was unremarkable, (MMR Project No. 92941 - Page 3 See Exh. 8(d)).

21. The MMR conclusion that the leak in the service line at the transition fitting in the foundation wall of 627 Pleasant Street is consistent with heat exposure, and a result of the Incident, is reasonable and supported by substantial evidence.

Figure 5: Service line blowhole adjacent to the foundation fitting, white arrow. The service line was bowed on this end, red arrow.

Figure 6: Detail of blowhole. This damage was heat related.

8(d) – Leak at transition fitting inside the basement at the foundation wall

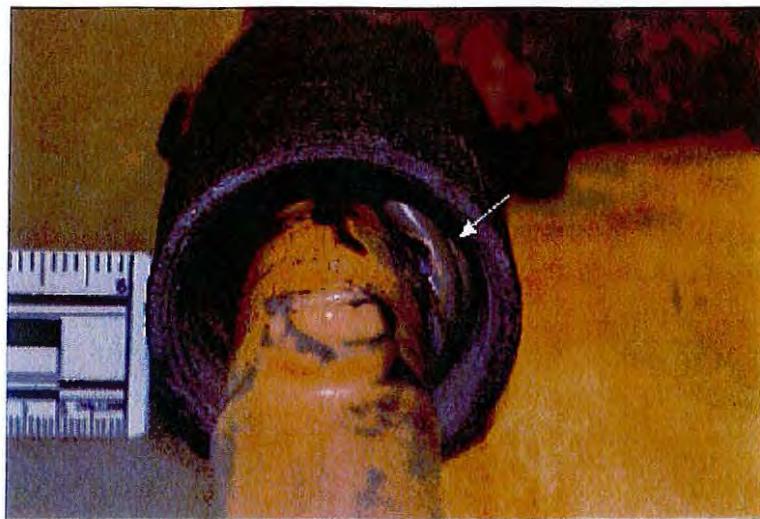
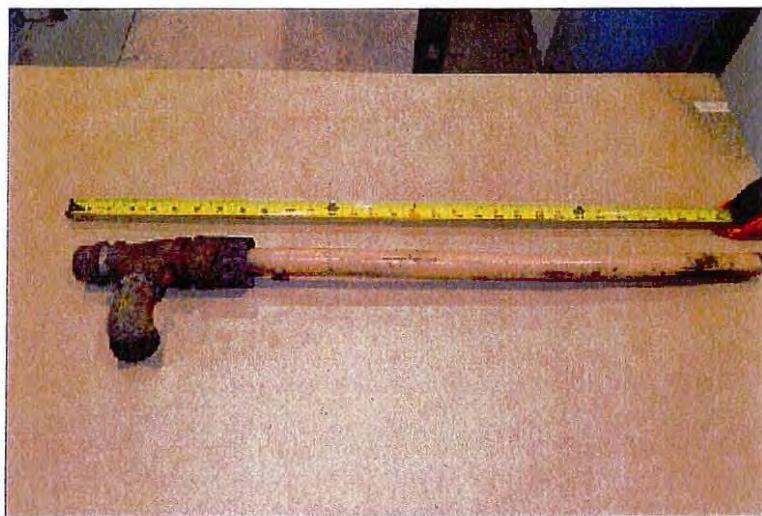
Figure 7: Melted plastic was visible within the foundation fitting, arrow. This was heat related.

Figure 8: The underside of the foundation fitting assembly and service pipe were unremarkable.

8(e) – Leak at transition fitting inside the basement at the foundation wall

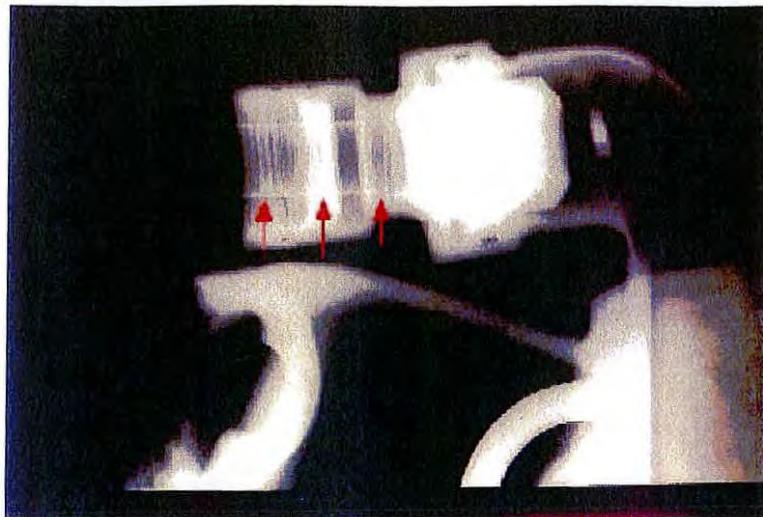
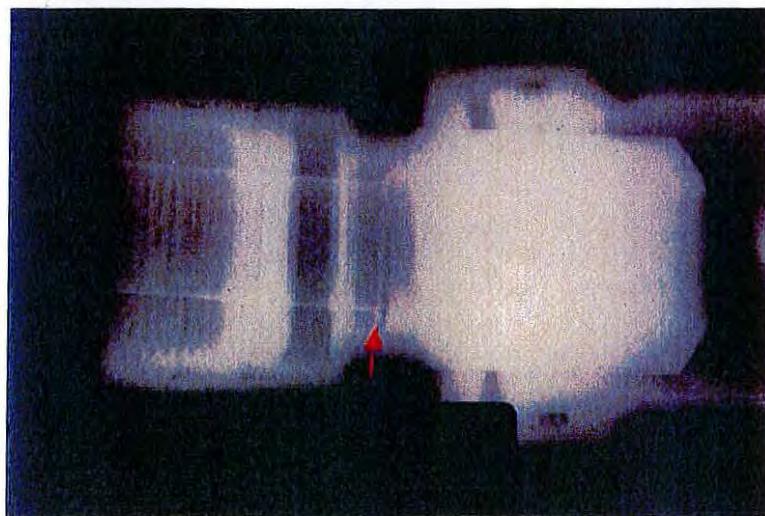
With respect to the saddle transition fitting mounted on the gas main. MMR noted that[t]he saddle fitting stiffener was askew in the joint (Exh. 8(f)). MMR concluded that:

Putting enough bending force on a plastic service line to angle a stiffener in a transition fitting creates a severe situation for the plastic component. This is a condition created at assembly of this transition fitting during the 1986 steel service replacement (MMR Project No. 92941, at 4).

Figure 21: The stiffener in the saddle fitting was obviously askew, arrows.

Figure 22: Saddle fitting stiffener detail, arrow.

8(f) -Transition fitting attached to the six inch cast iron main saddle

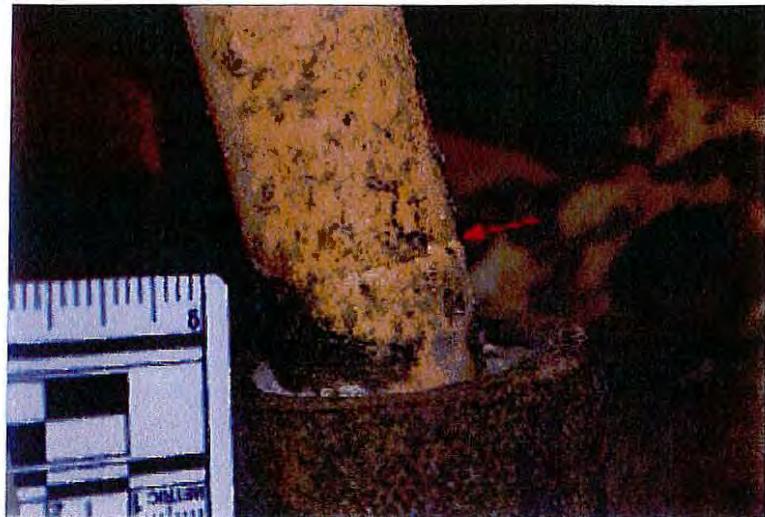
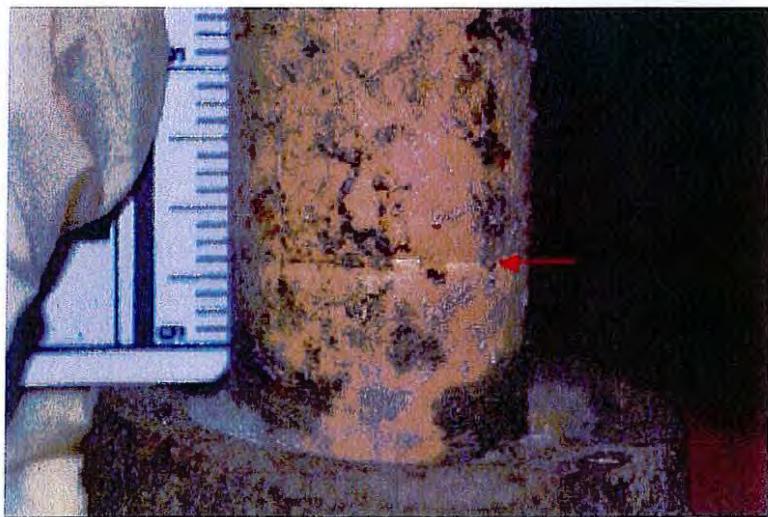
A crack was present in the plastic service pipe at the edge of the saddle transition fitting stiffener. The saddle fitting stiffener was askew in its joint and the pipe was angled exiting the transition fitting. The crack was caused by the bending and other forces on the plastic pipe combined with internal impingement on the end of the stiffener. This arrangement appears to have been the result of installation. The measured leak rate in the laboratory was 17.5 ml/min. This leak rate may be lower than the in-service rate as cutting the plastic pipe to remove the saddle would relax service stresses and could have closed up the breach a bit (MMR Project No. 92941, at 7).

Applying enough force on a plastic pipe to skew the transition fitting internals and then installing the pipe to leave that force intact places undue loading on plastic piping in general. When the resulting configuration causes that plastic pipe to press against the edge of a metal component, a crack like that present in the incident pipe is the logical outcome (MMR Project No. 92941, at 7) (Exhs. 8(g), 8(h), 8(i)).

Figure 24: Detail of saddle fitting service pipe after cleaning. Note scrubbed surface texture and dimpled region, arrow.

Figure 25: Facing view of saddle pipe dimple, arrow.

8(g) – Leak at transition fitting attached to the six inch cast iron main saddle

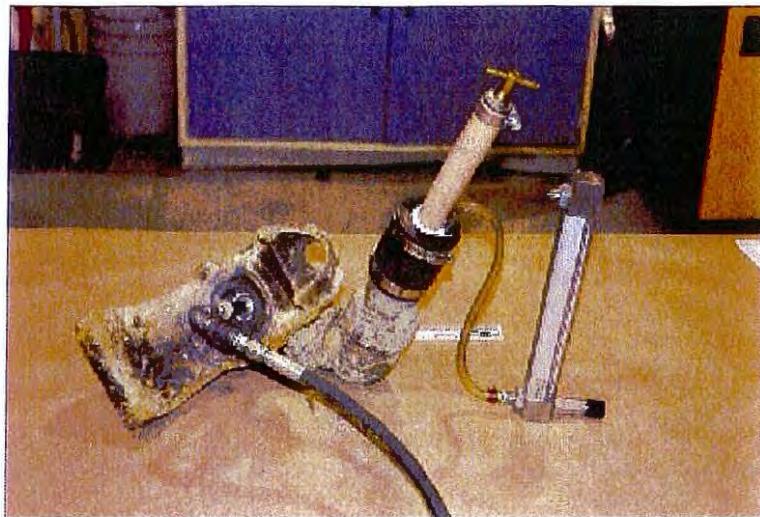
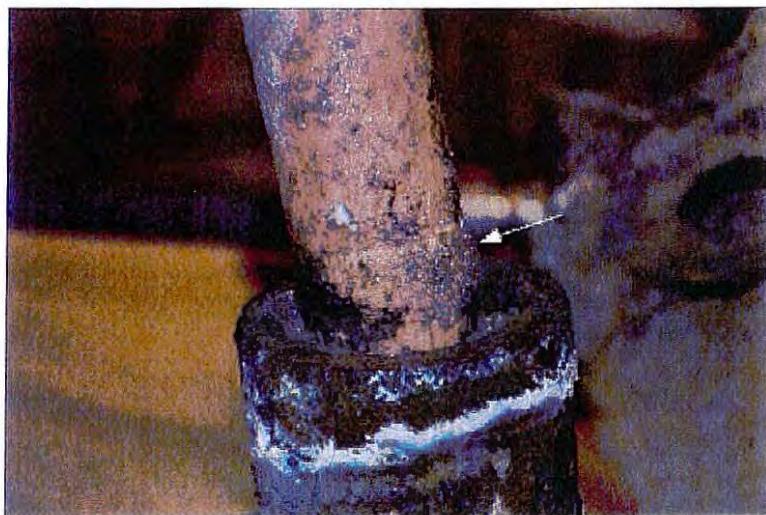
20. The MMR conclusion that, when the gas service line transition fitting assembly was leak tested and that "the leak rate may be lower than the in-service rate as cutting the plastic pipe to remove the saddle would relax service stresses and could have closed up the breach a bit," is reasonable and supported by substantial evidence.

Figure 16: The leak testing apparatus.

Figure 17: The dimpled region was the source of the leak, not the transition fitting, arrow.

8(h) – Leak at transition fitting attached to the six inch cast iron main saddle

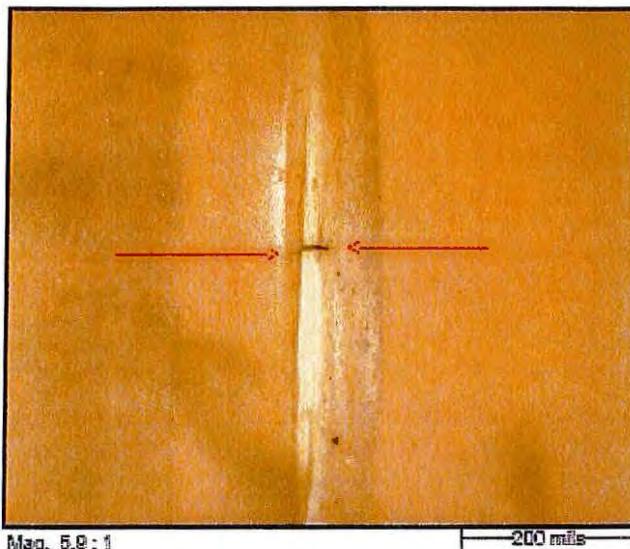
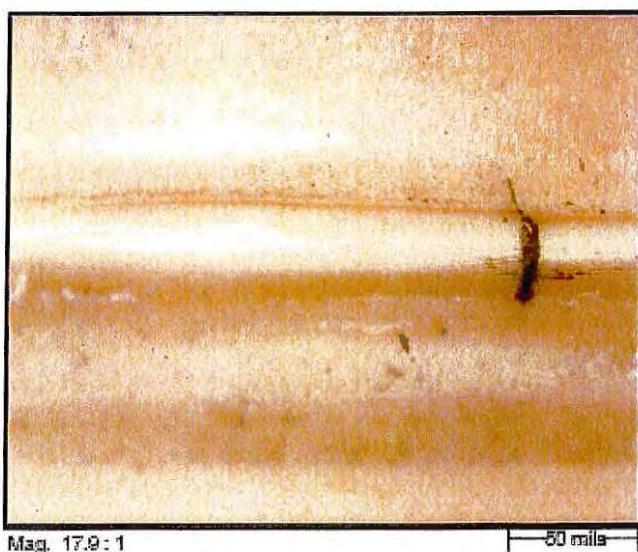
18. The MMR conclusion that, the plastic service pipe cracked at the edge of the saddle transition fitting attached to the main is reasonable, and supported by substantial evidence.

Figure 40: Saddle fitting ID with leak at arrows.

Figure 41: Detail of Figure 40 showing the crack and plastic stretching.

8(i) - Leak at transition fitting attached to the six inch cast iron main saddle
